HAZARDOUS MATERIALS ASSESSMENT REPORT

Job details: Owner/s: Mr. C. & Mrs. A. Grigg
Location: 3 Swales Place, Colyton NSW

Date of assessment: 13th November 2014

Our reference: HM03511114

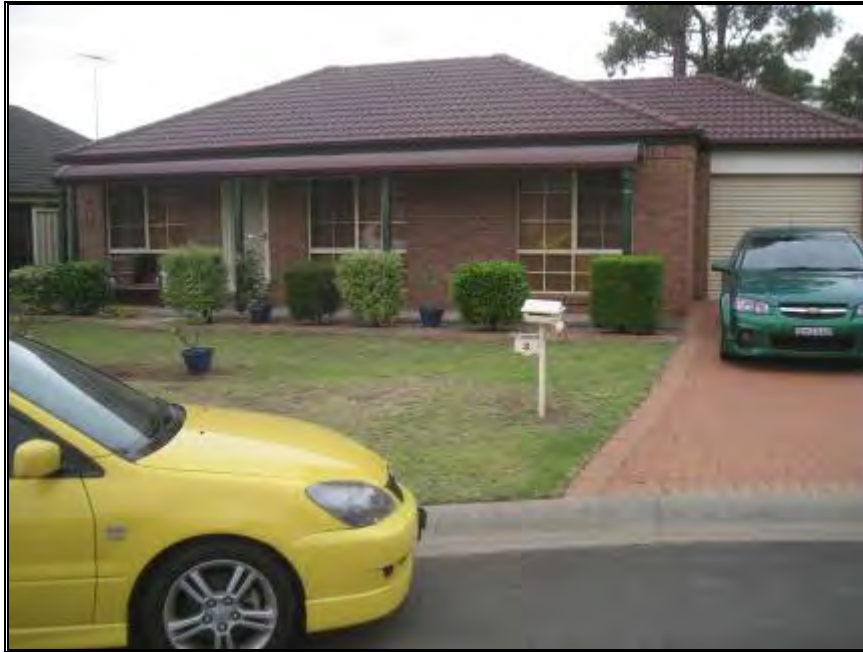
Front western elevation of the residence
