## Dilapidation Assessment Report

Prepared for: Cape Cod Australia Pty. Limited  
Job address: 72 Oberon Street, Randwick NSW 2031  
Property Owner/s: Mrs. Julian  
Report reference: **RANDWICK CITY COUNCIL**  
Development Application No: not available  
Date of assessment: 28<sup>th</sup> January 2016

**Re: Dilapidation Report - No. 72 Oberon Street, Randwick**

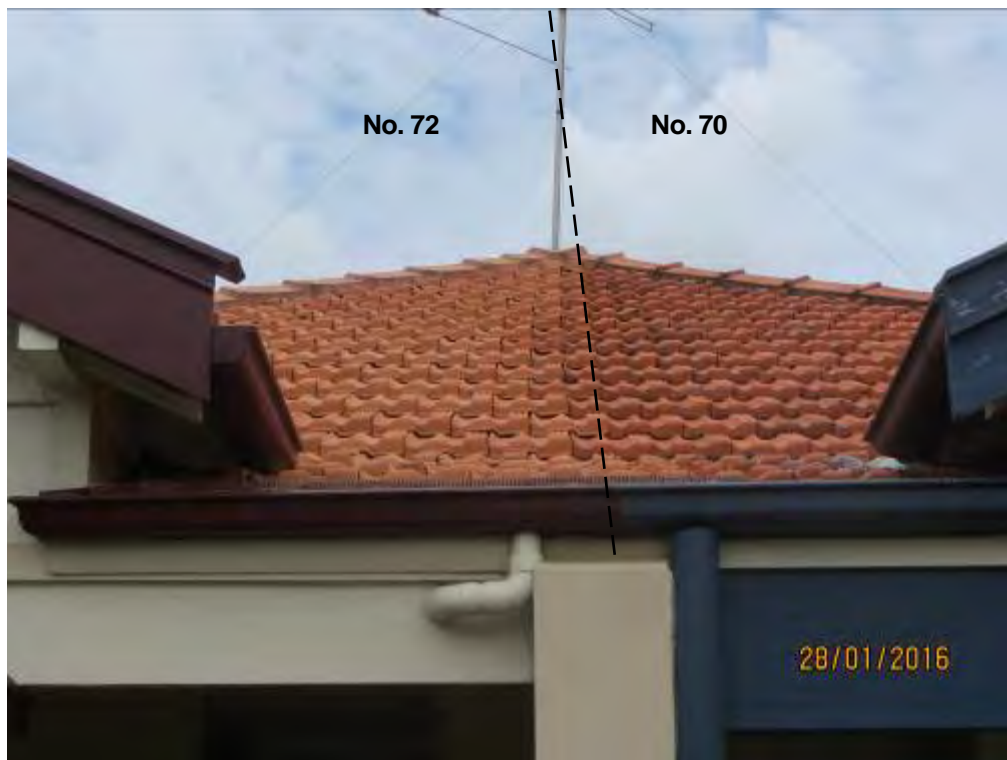
We noted that the terra cotta roofing tiles appear to be in good condition and appears to be securely fixed, in our opinion forming a weather resistant cover to the property. **[Photograph 1]**

**Photograph 1** shows the junction of the front elevation roof surfaces

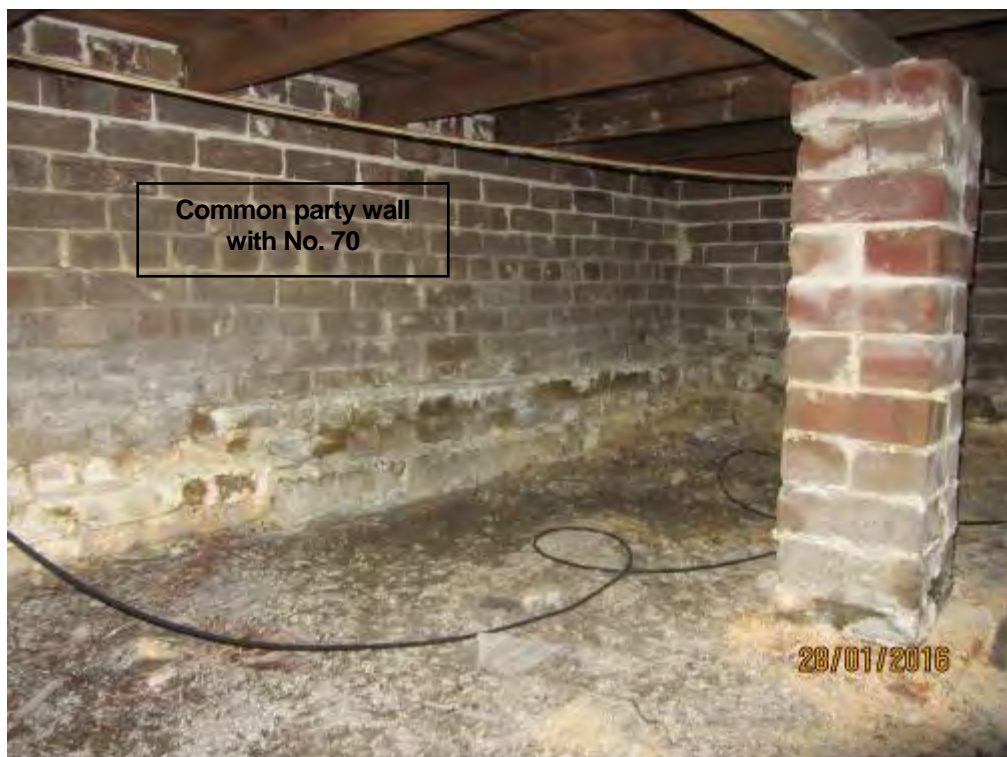
We also noted that there are areas of dampness [ground water seepage] in the under floor area including along the *common separating / party* wall with the adjoining property, No. 70 Oberon Street. **[Photographs 2, 3 and 4]**

We noted that the structural floor timbers are supported by clay brick piers. **[Photographs 2 and 3]**

**Photograph 2** shows rising dampness to the base of the common party / separation wall brickwork

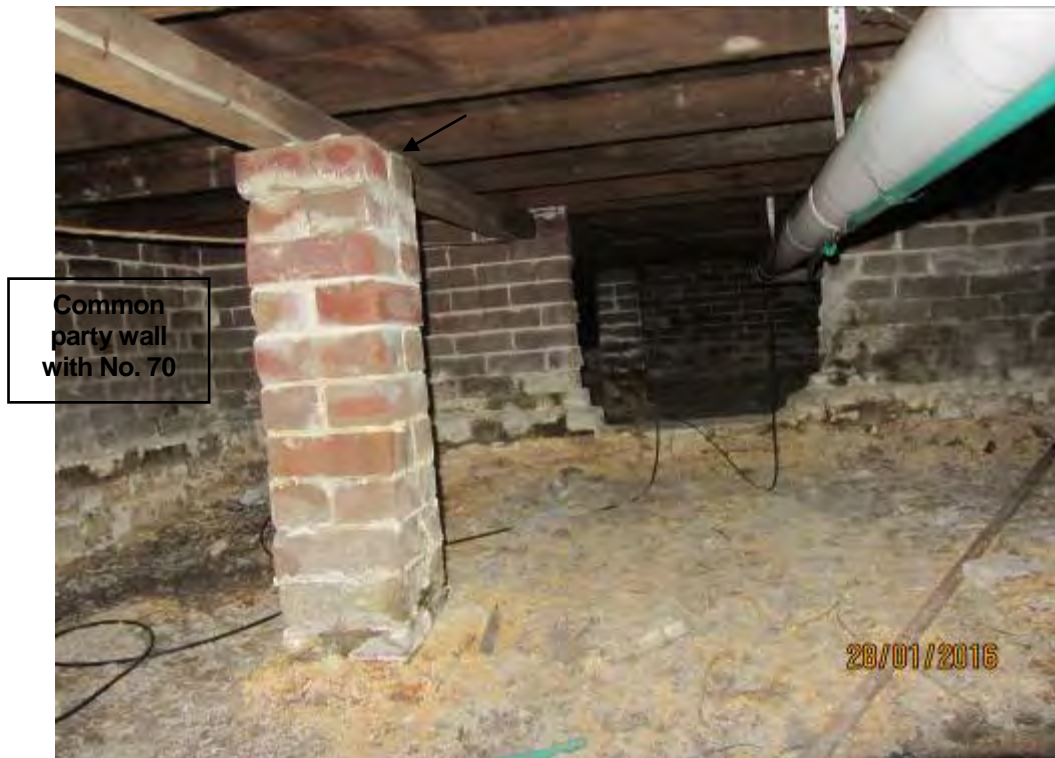
We noted that the floor system is hardwood timber bearers and joists and strip timber flooring and that there is a brick *common separating / party* wall with the adjoining property, No. 70 Oberon Street that extends to floor level. **[Photograph 3]**

We noted that there is no evidence of termite protection to the structural timbers built into or supported upon the base brickwork. **[Photograph 3]**

**Photograph 3** shows the underfloor area – Note: dampness to the soil and rising dampness to the base of the brickwork

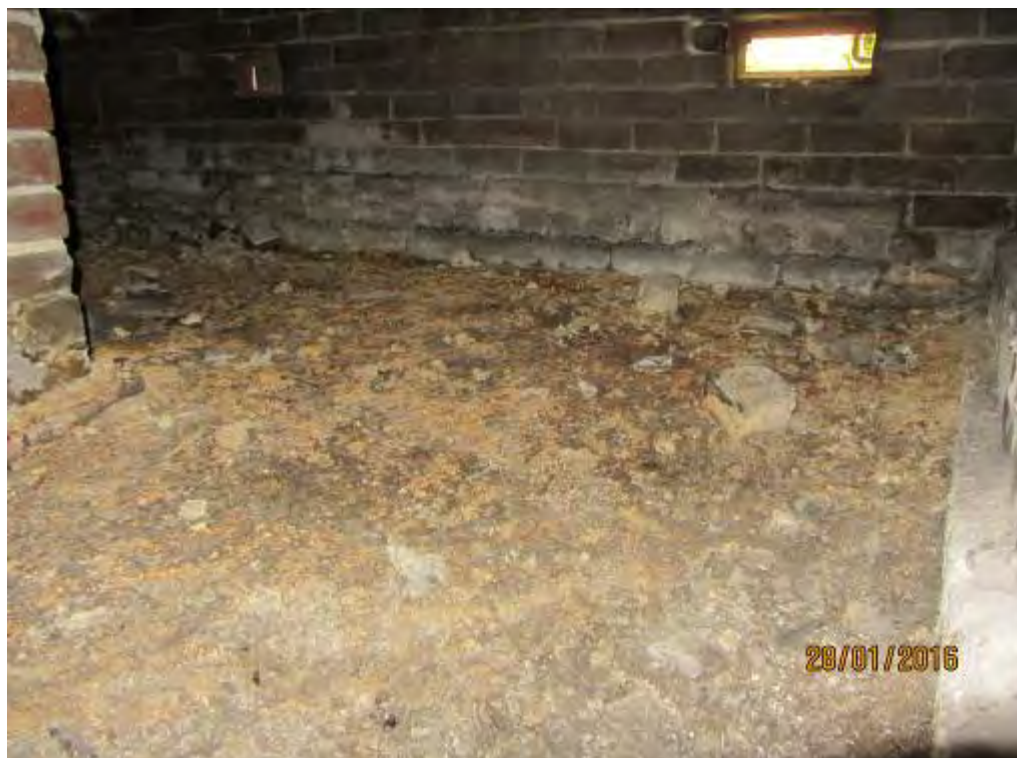
**Photograph 4** shows dampness to the underfloor area including the base brickwork

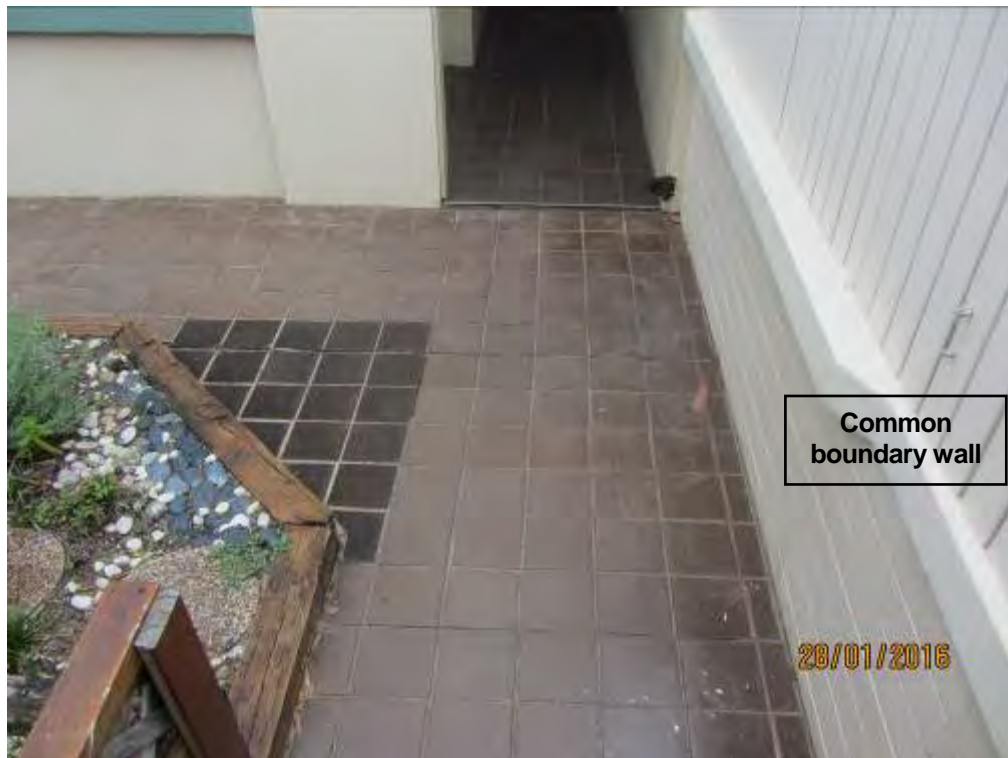
We noted that the grout to the tiles is complete and that the tiles when randomly "tap" tested were sound. Due to concealment we are unable to comment on the base strata to the tiles. **[Photograph 5]**

**Photograph 5** shows the condition of the quarry tile to the front garden / courtyard area

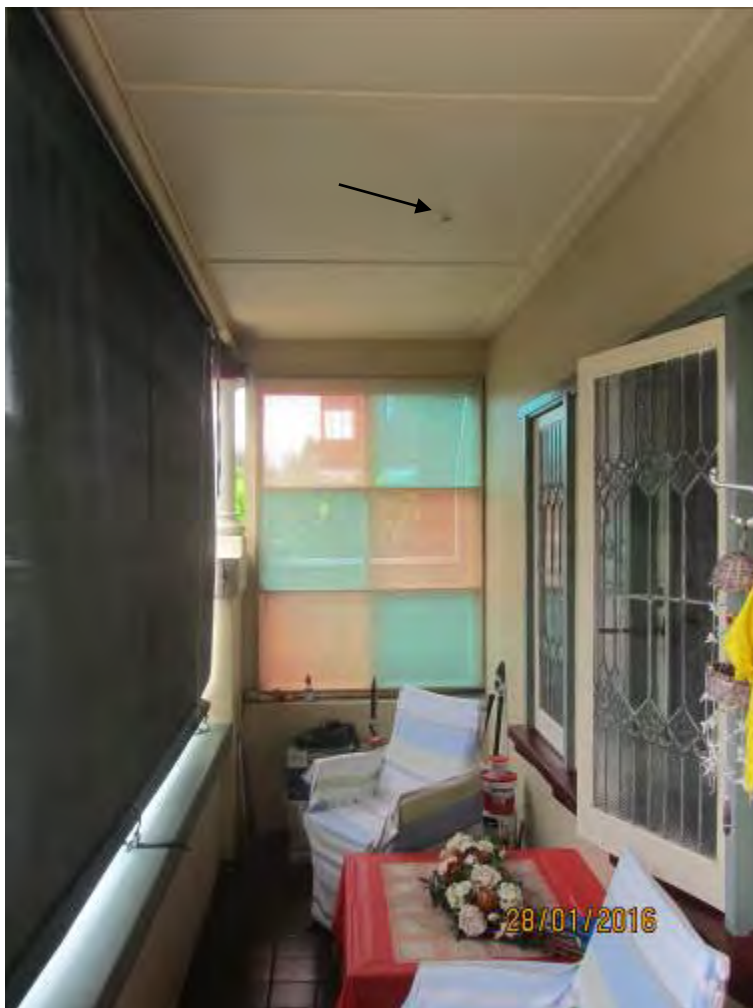
We noted that there is an area of peeling / lifting surface coating [paint] from the verandah soffit. **[Photograph 6]**

**Photograph 6** shows the front Verandah - Note: peeling / lifting of the surface coating from the soffit

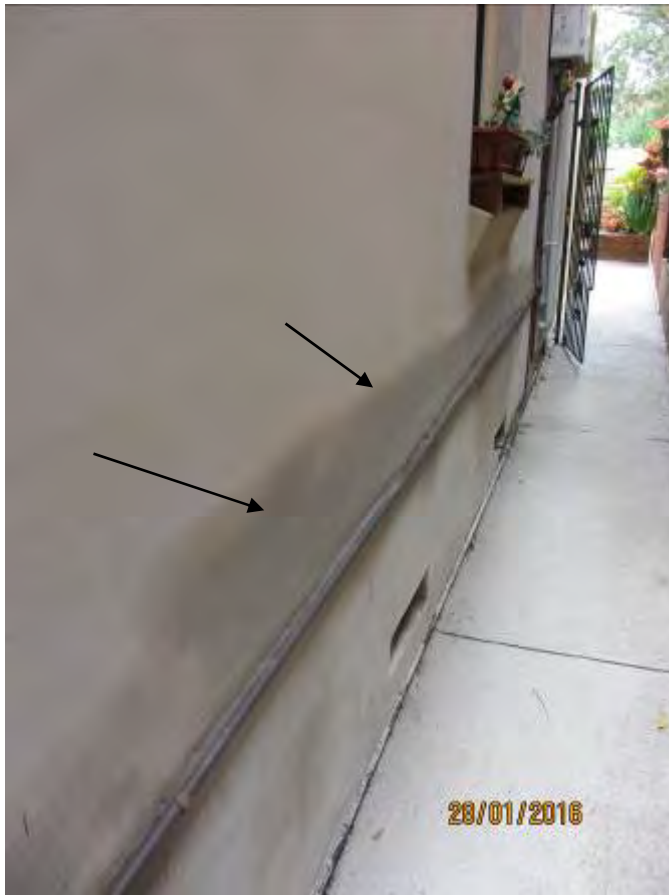
We previous repairs to the cement render finish abutting the exposed pipework. **[Photograph 7]**

**Photograph 7** shows previous repairs to the cement render to the eastern elevation

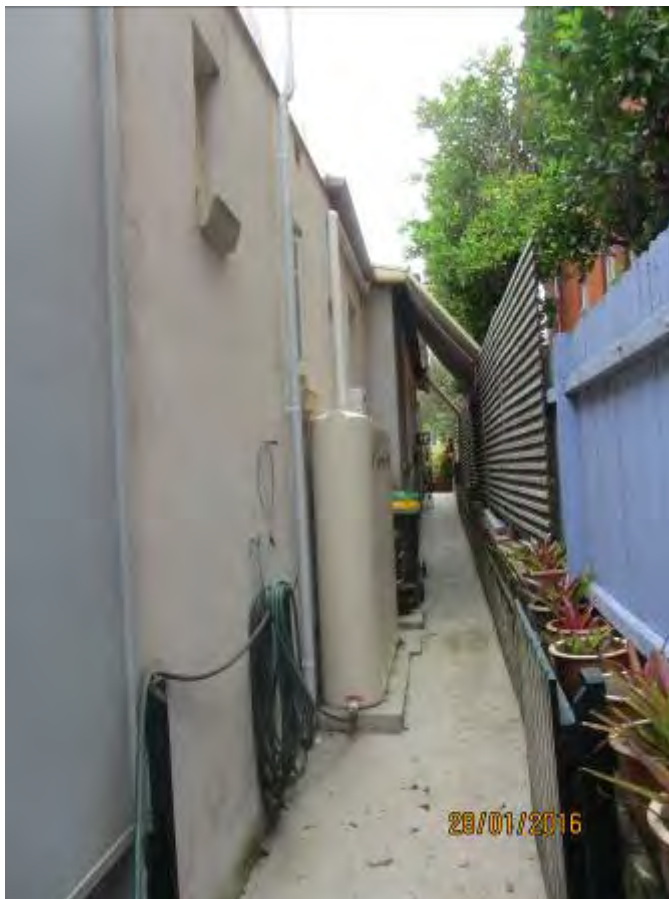
We noted dampness and lichen growth to the surface of the pavement between the residence and the western *common boundary* with the adjoining property, No. 74 Oberon Street. **[Photograph 8]**

**Photograph 8** shows the eastern elevation of the residence viewed from the rear [south] towards the front

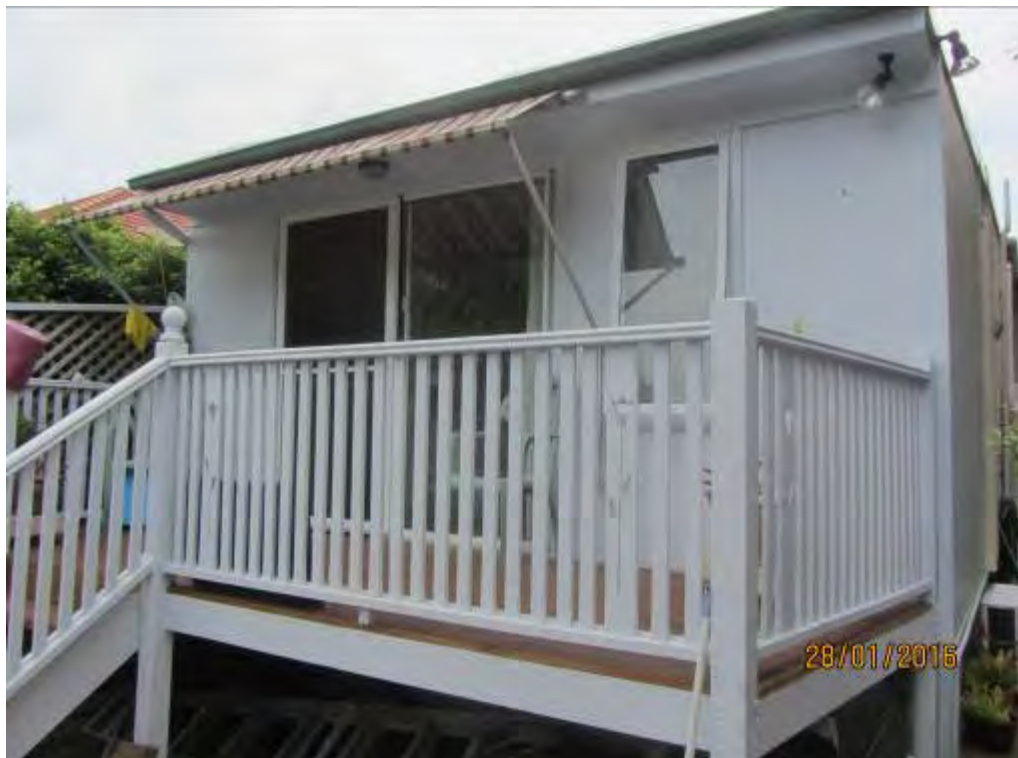
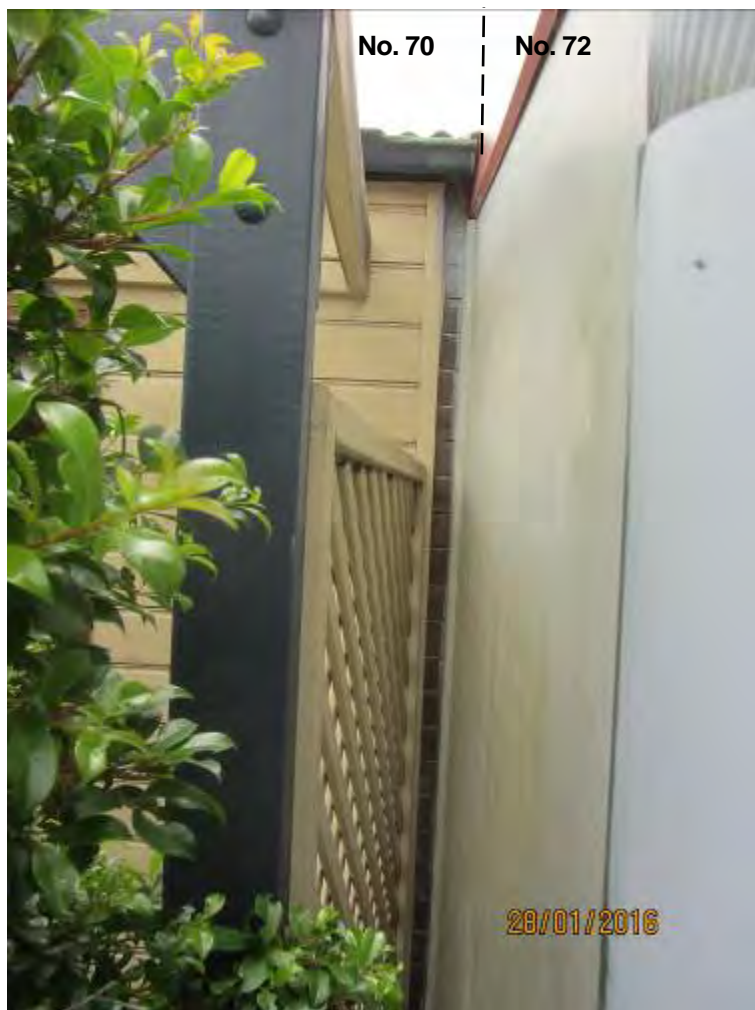
We noted that the timber decking structure and surface coating to the clad wall surfaces is generally in sound condition. **[Photographs 9 and 10]**

**Photograph 9** shows the rear elevation addition to the property

**Photograph 10** shows the rear elevation junction between the properties

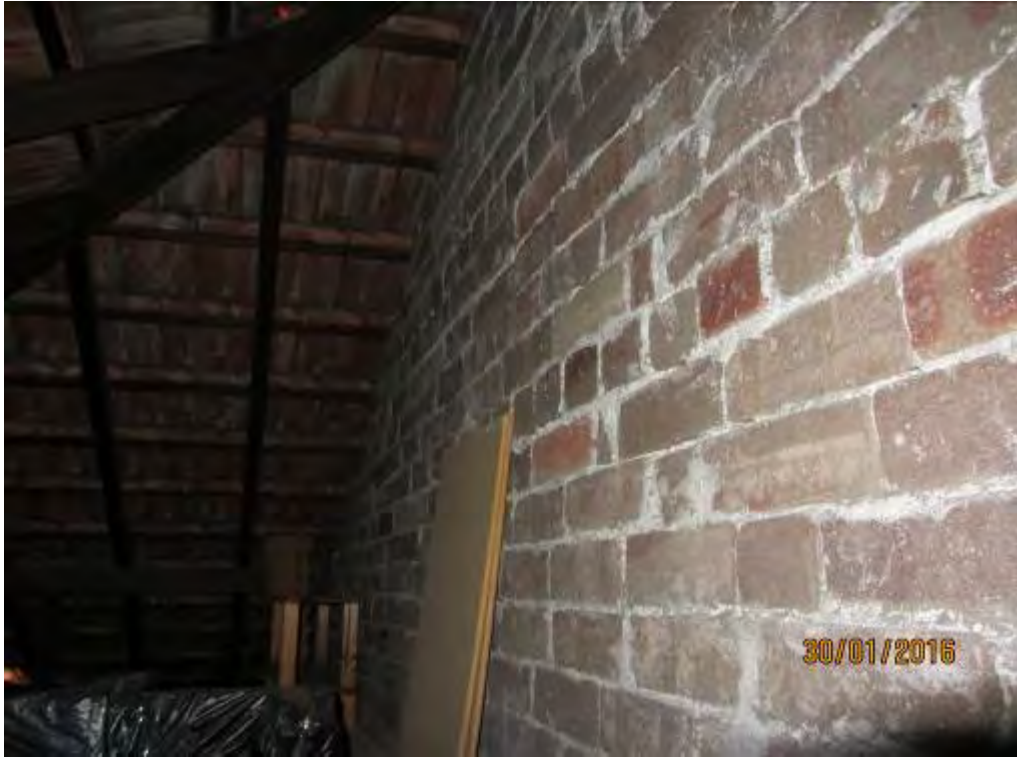
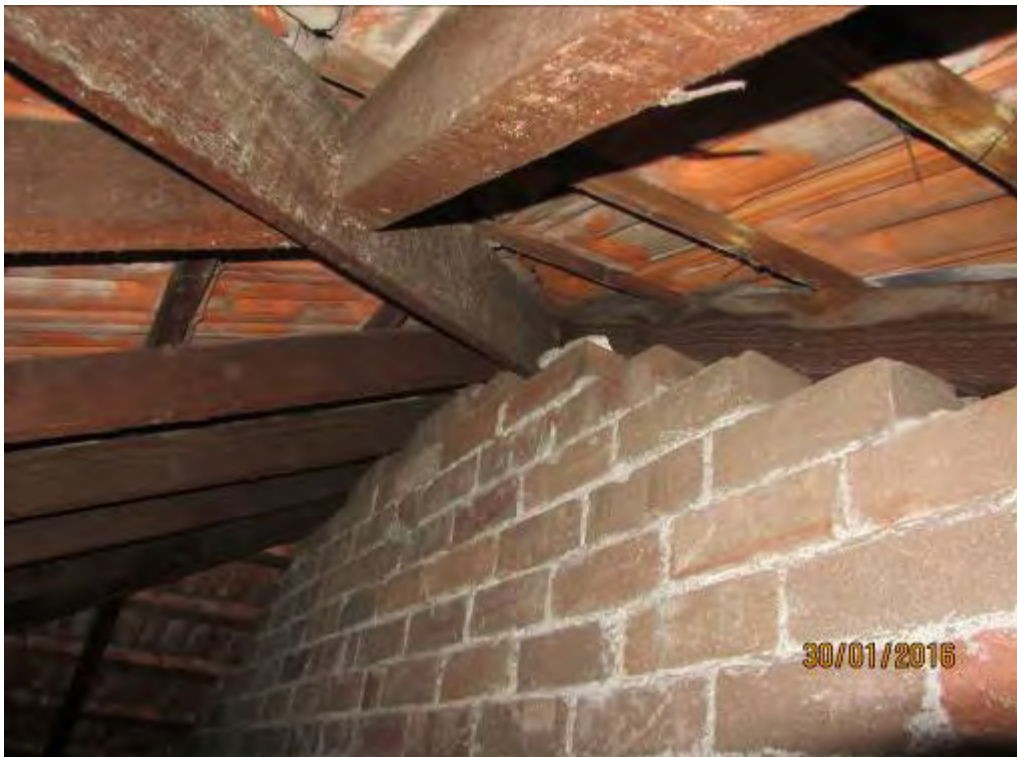
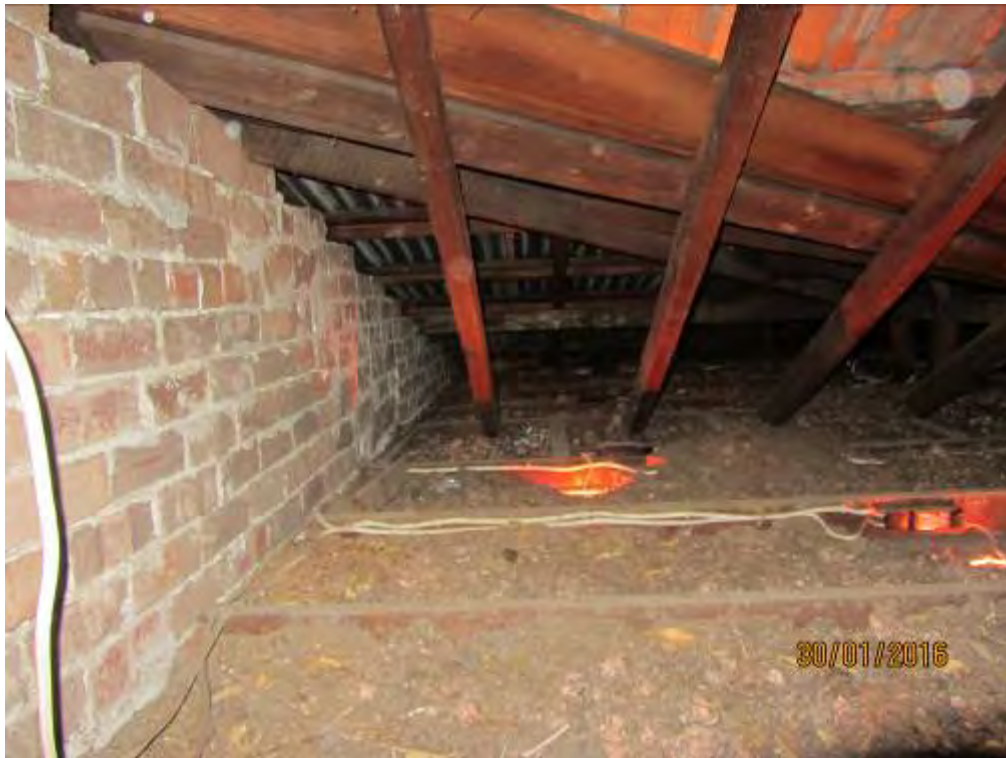
*“common roof to the properties is of traditional cut and pitched timber construction”.* **[Photographs 11, 12 and 13]**

*“timber ceiling joists are built into the common party/ separation wall. We further noted that the common ridge to the roof is located over the common party/ separation wall. [Photographs 11, 12 and 13]*

*“clay brick common separating / party wall and terminates just below the roof covering.”* **[Photographs 11, 12 and 13]**

**Photograph 11** shows the brick *common party / separation* wall within the roof space of the adjoining property; No. 70 Oberon Street

**Photograph 12** shows the roof timber joining over the brick *common party / separation* wall within the roof space of the adjoining property; No. 70 Oberon Street

**Photograph 13** shows the brick *common party /separation wall* and the corrugated sheet metal to the skillion roof surface within the roof space of the adjoining property; No. 70 Oberon Street

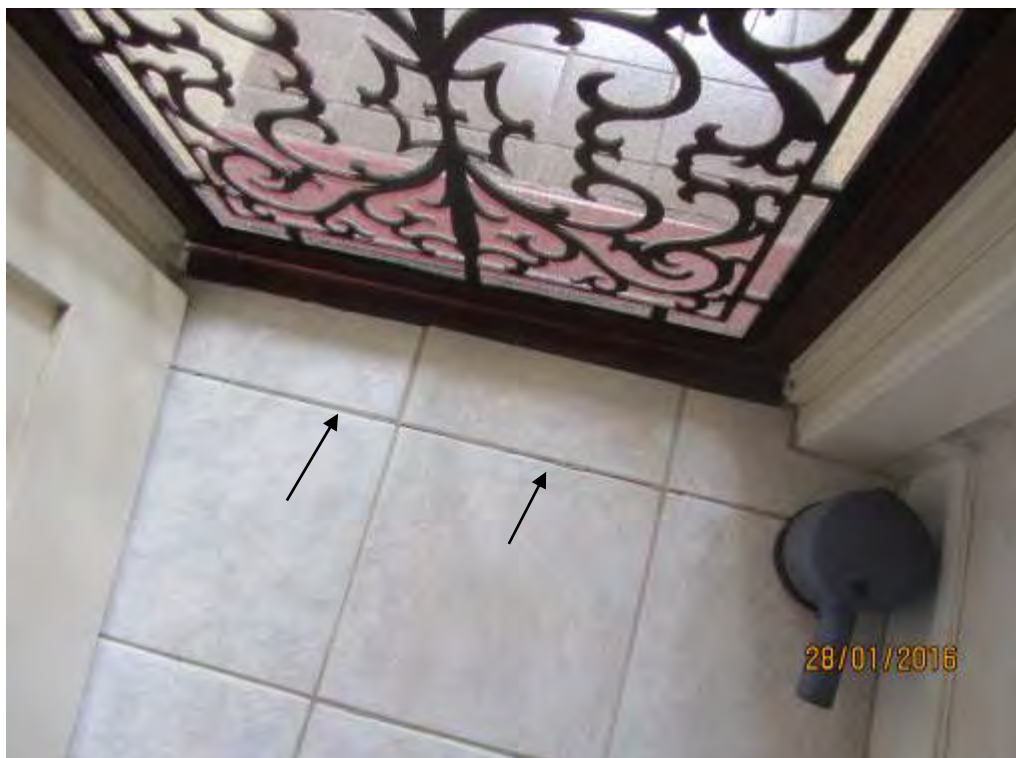
We noted that the floor is finished with ceramic tiles. We noted that the grout to the tiles is generally complete and that the tiles when randomly “tap” tested appeared to be sound. Notwithstanding this we noted a hairline crack and displaced grout the tiles at the front entry doorway. **[Photograph 14]**

**Photograph 14** shows cracking missing / displaced grout from the floor tiles at the front / entry

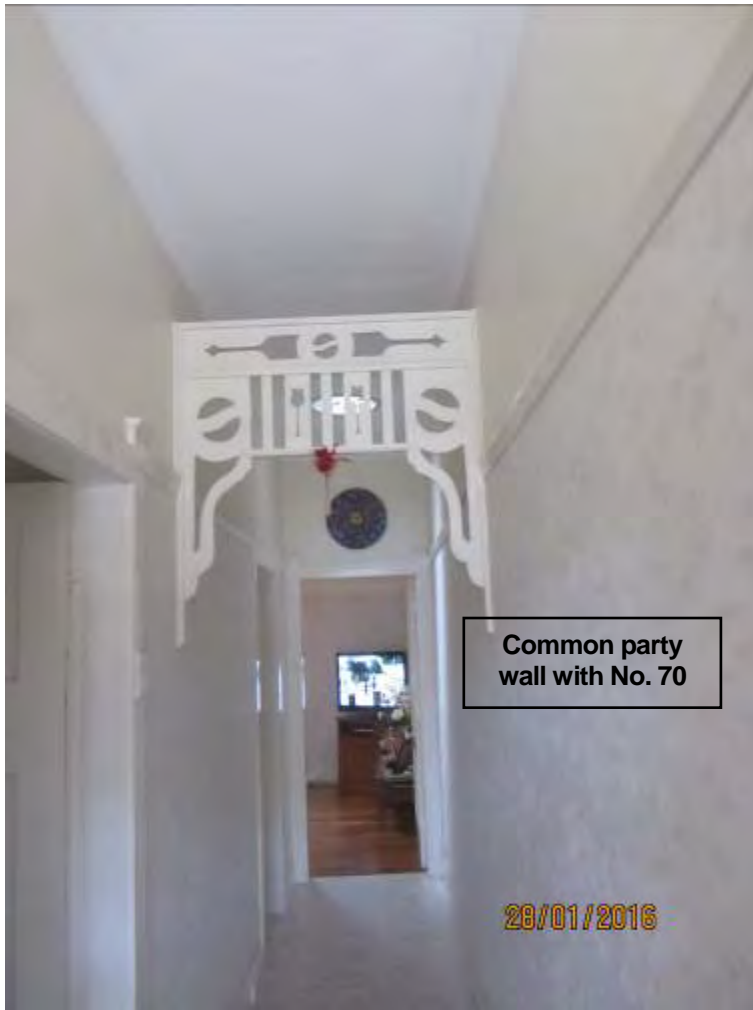
We noted that the wall surfaces below picture rail height and particularly the *common party / separation* wall are covered with wall paper. **[Photograph 15]**

**Photograph 15** shows the Entry / Hallway viewed towards the Lounge room – Note: wallpaper from the floor level to the picture rail height

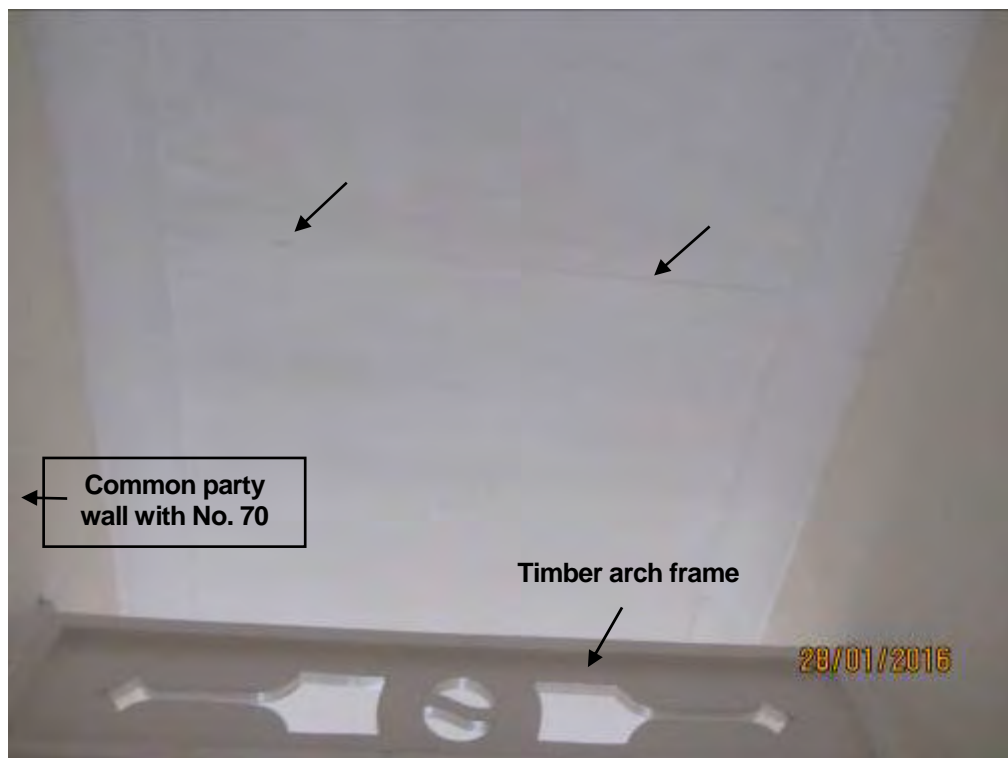
We noted a hairline crack [ $<1.0\text{mm}$ ] to the set joint in the ceiling in the immediate vicinity of the timber arch frieze. **[Photograph 16]**

**Photograph 16** shows a hairline crack to the set joint in the ceiling of the Hallway

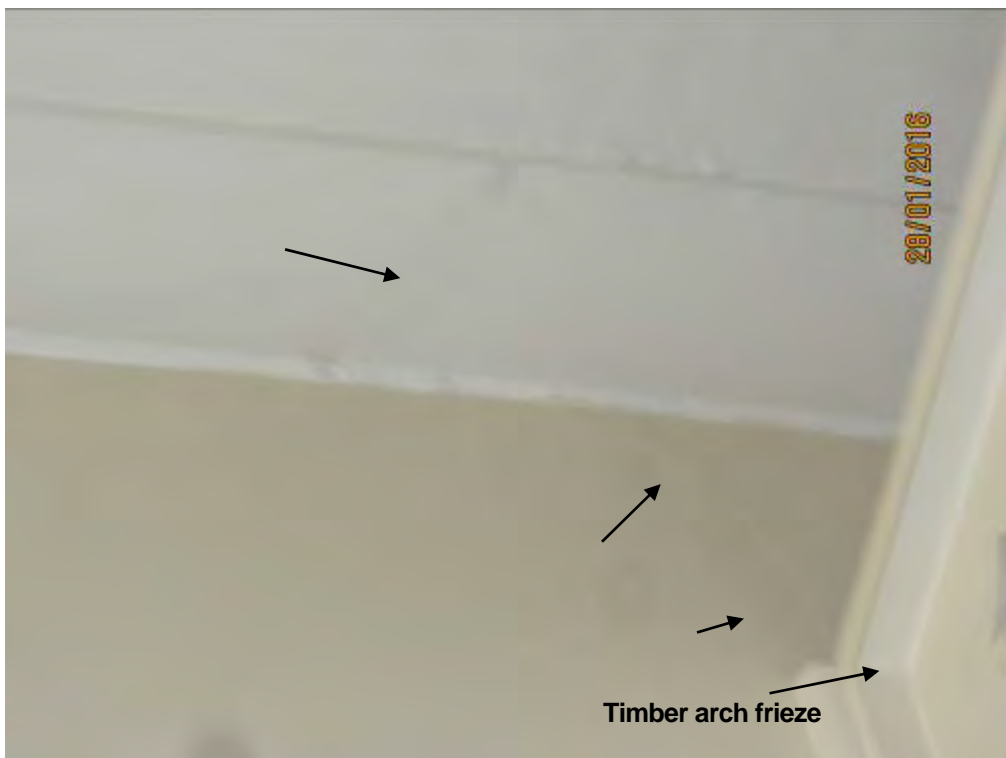
We also noted previous repairs to the mitre joints to the cove profile cornice in the immediate vicinity of the arch including abutting the *common party / separation* wall. **[Photographs 17 and 18]**

**Photograph 17** shows repairs to the ceiling in the immediate vicinity of the timber arch in the Hallway frieze

**Photograph 18** shows a previously repaired radial crack and repairs to the cornice in the Hallway in the immediate vicinity of the timber arch frieze

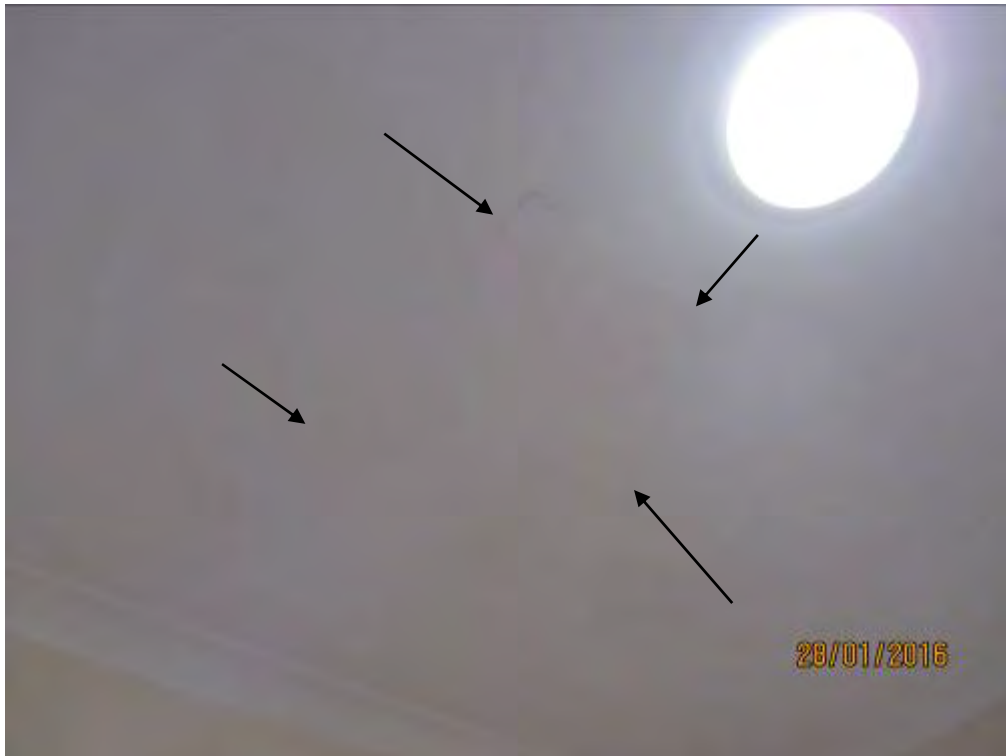
We a previously repaired section of ceiling [nominal 600mm x 600mm] abutting the *common party / separation* wall. **[Photograph 19]**

**Photograph 19** shows previously repaired and hairline crack to the ceiling of the Lounge room

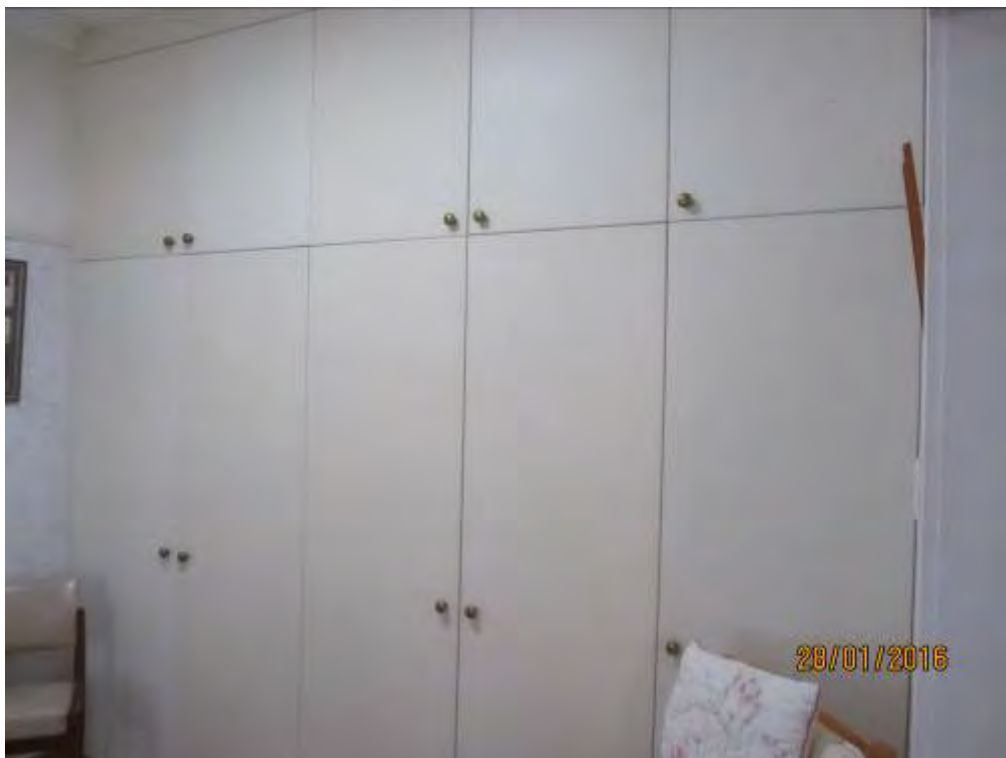
We noted that the *common party / separation* wall is fully concealed by a built cupboard. We also noted that the wall surfaces below picture rail height are covered with wall paper. **[Photograph 20]**

**Photograph 20** shows built in cupboard concealing the *common party / separation* wall in the Dining room

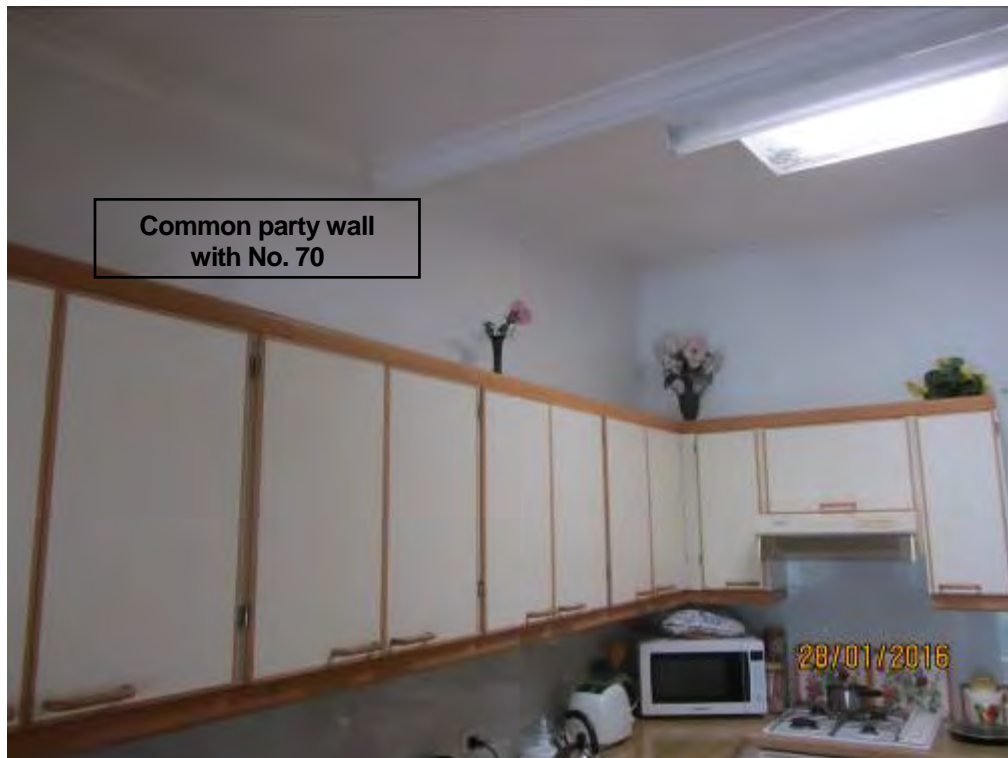
We noted that the *common party / separation* wall is partially concealed by wall mounted cupboards. **[Photograph 21]**

**Photograph 21** shows the *common party / separation* wall in the Kitchen

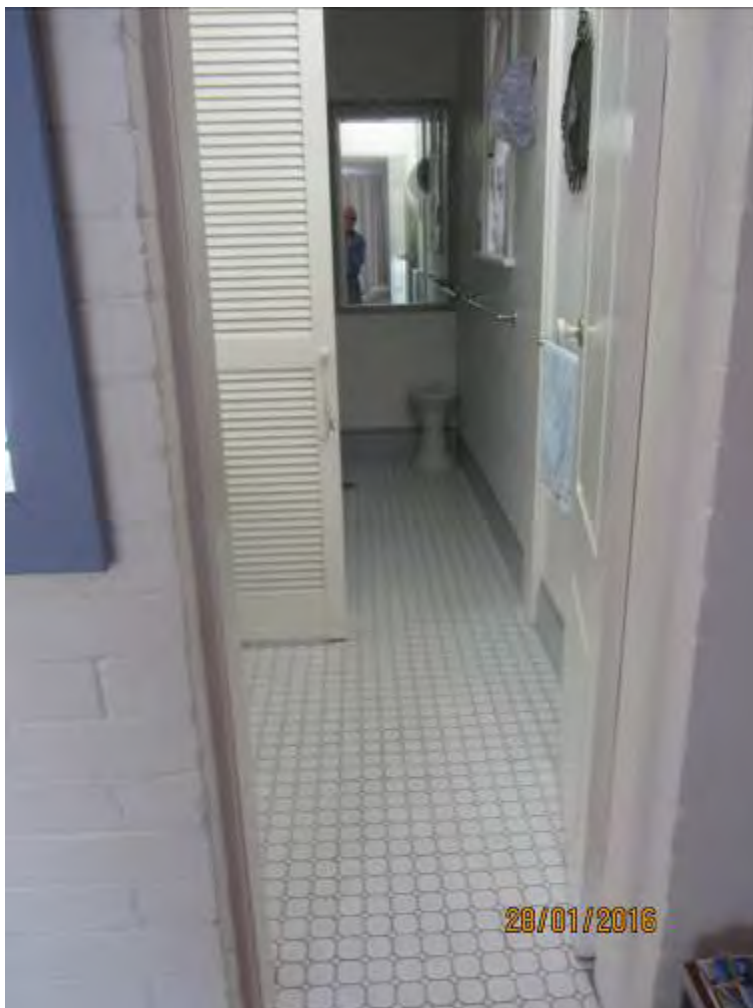
We noted that the grout to the wall and floor tiles is complete and that the wall and floor tiles when randomly "tap" tested appeared to be sound. We did not observe any recent cracking to the tile grout at the wall / wall, wall / floor junctions. **[Photograph 22]**

**Photograph 22** shows the layout of the Bathroom / WC
