## Dilapidation Assessment Report

Prepared for: Cape Cod Australia Pty. Limited  
Job address: 81 Formosa Avenue, Drummoyne.  
Property Owner/s: Mrs. Phyllis Blennerhassett.  
Report reference: **CITY OF CANADA BAY COUNCIL**  
Development Application No: not available  
Date of assessment: 15<sup>th</sup> August 2016

**Re: Dilapidation Report**

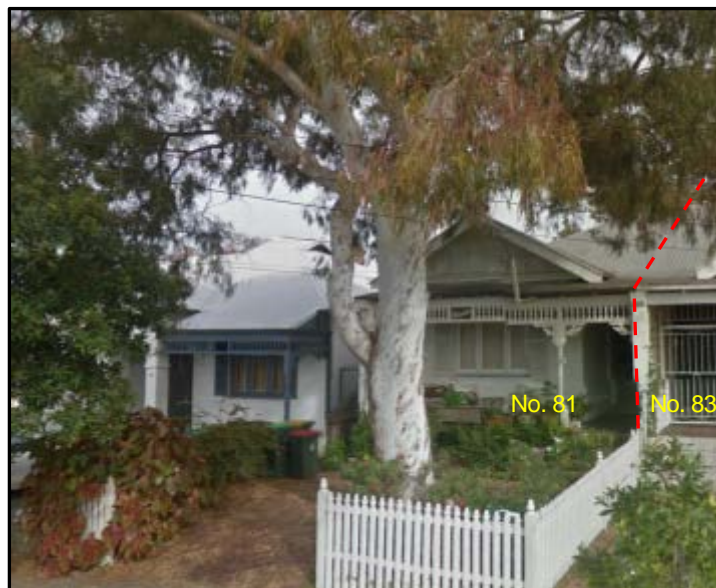
Shows the front north eastern elevation of the adjoining properties:  
No. 81 and No. 83 Formosa Street, Drummoyne.

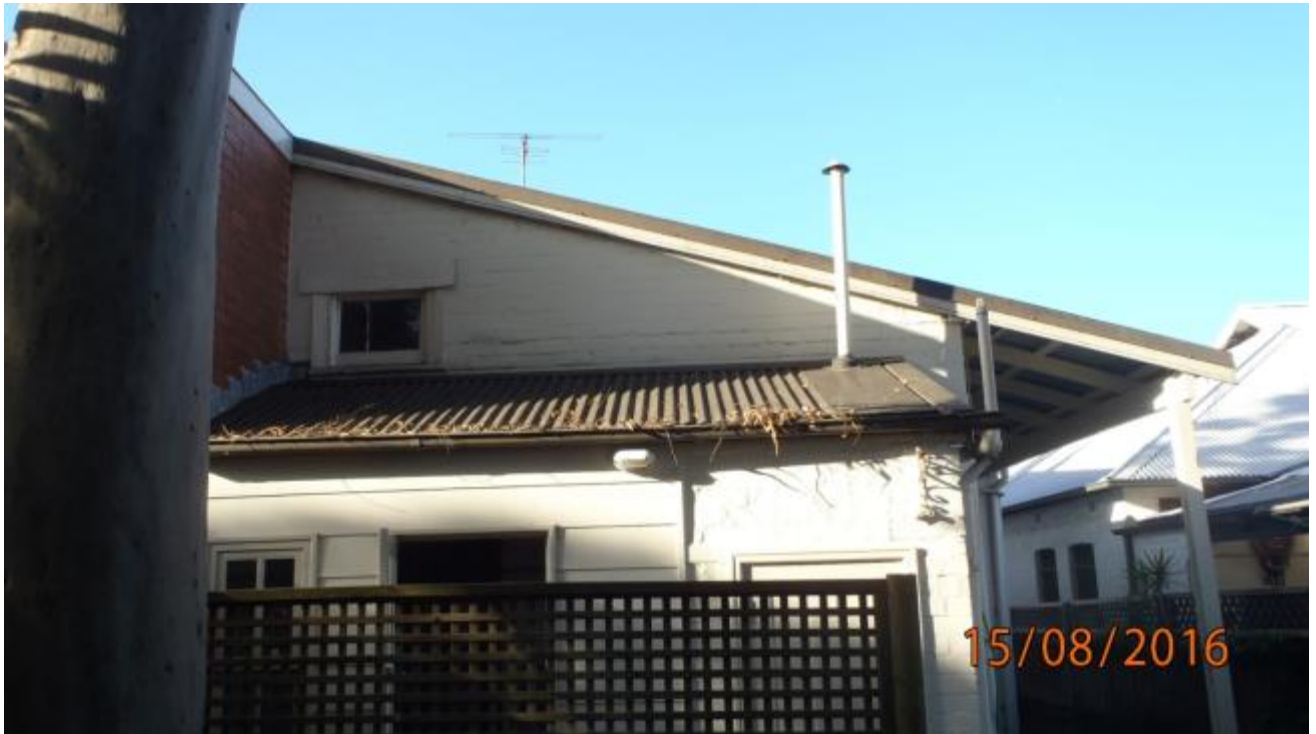
We observed that the corrugated profile sheet metal roof surface was securely fixed, in our opinion forming a weather resistant cover to the residence [**Photograph 1**]

**Photograph 1** shows the general condition of the sheet metal roofing.

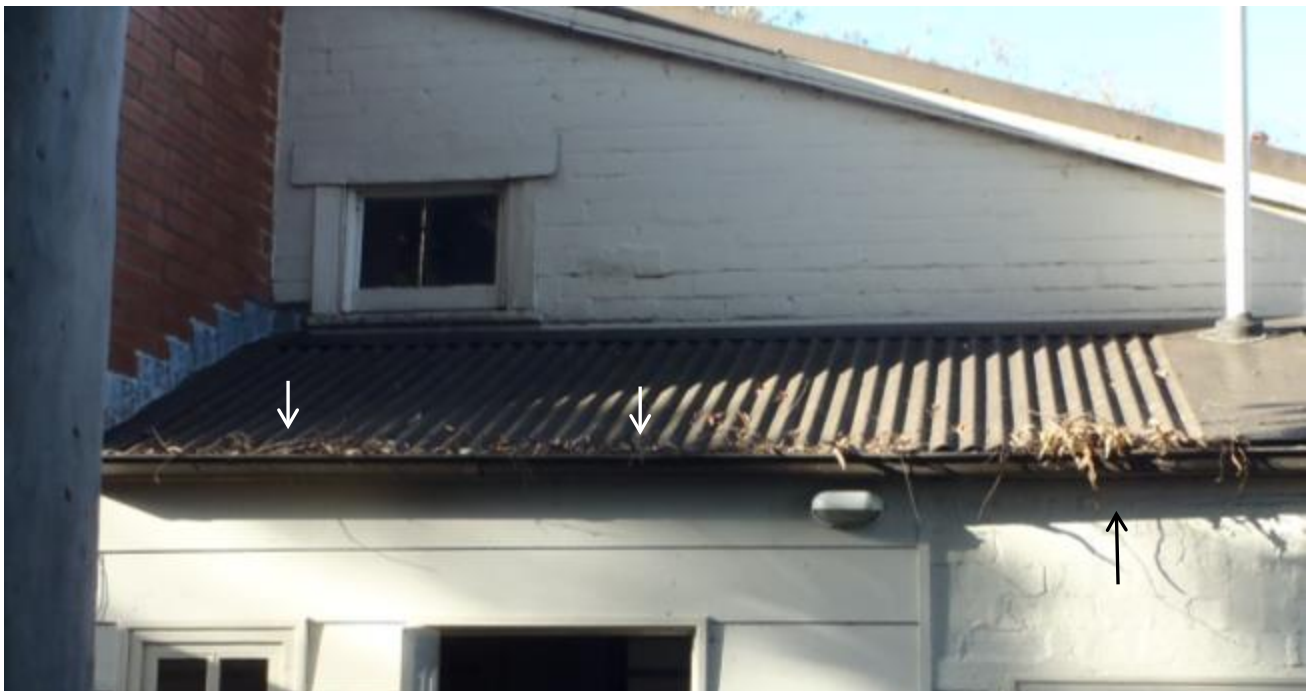
We noted that there was leaf litter build up to the rear and side section gutter [**Photograph 2**]

**Photograph 2** shows the leaf litter and debris build up on the rear elevation gutter and the condition of the flashing between the common party / separation wall and the sheet metal roofing surface.

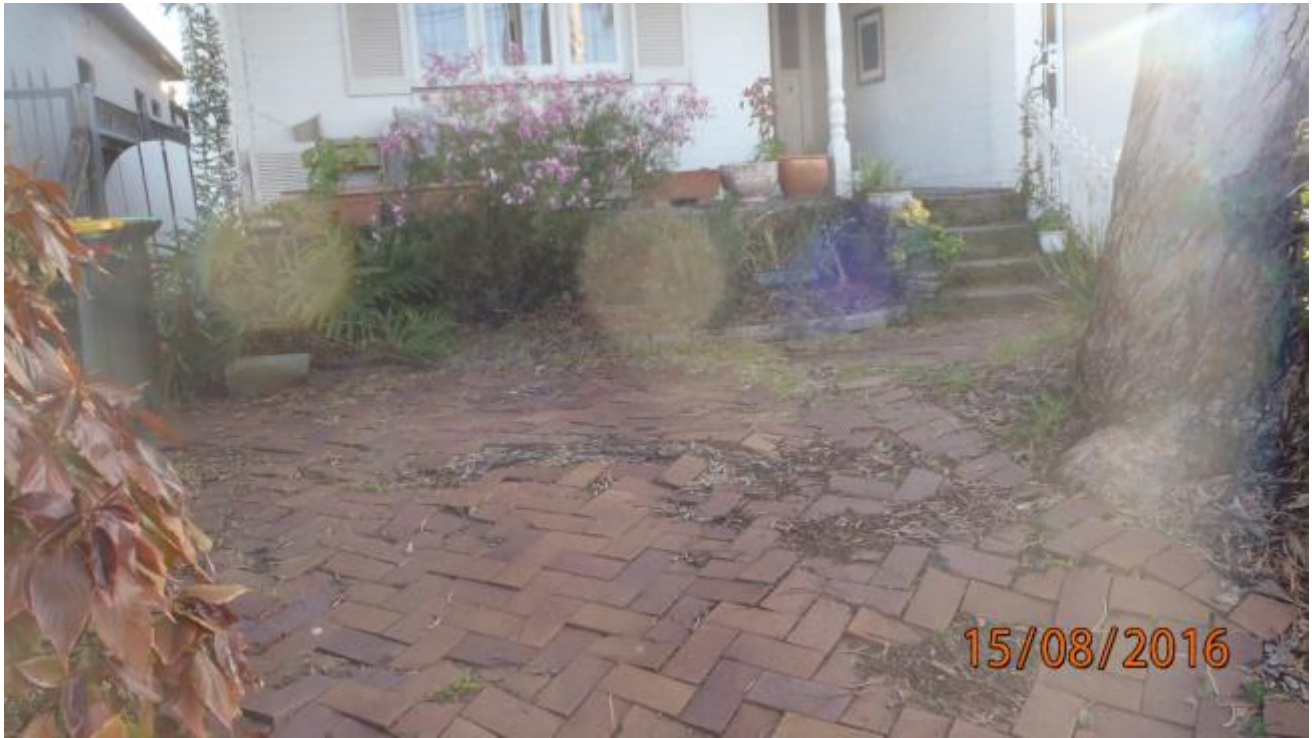
We noted that the front north eastern aspect has a paved driveway and path. We also noted lifting of the driveway and pathway adjacent to the large tree. [**Photograph 3**]

**Photograph 3** shows the frontal elevation of the residence and the displaced driveway pavers.

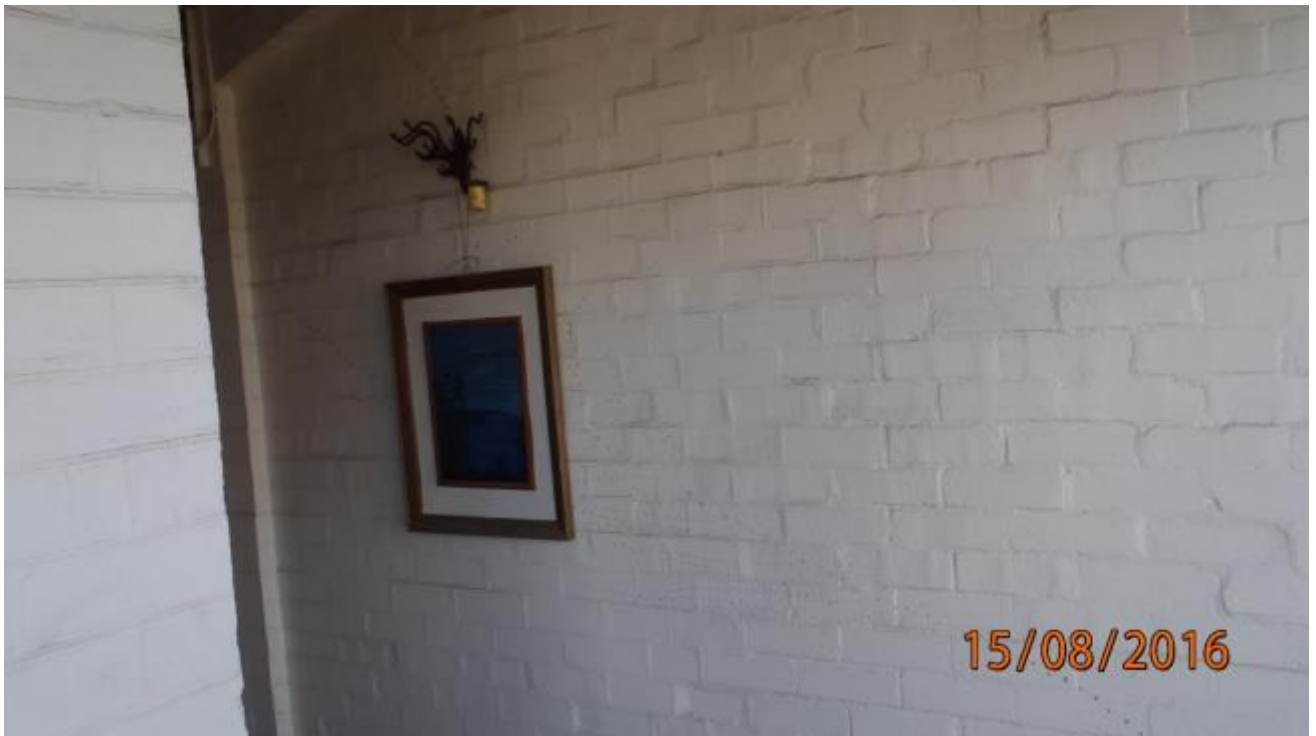
We did not observe any recent cracking to the surface coated clay masonry brickwork on the frontal aspect of the residence or to the *common privacy wall*. [**Photograph 4**]

**Photograph 4** shows the general condition of the common privacy wall.

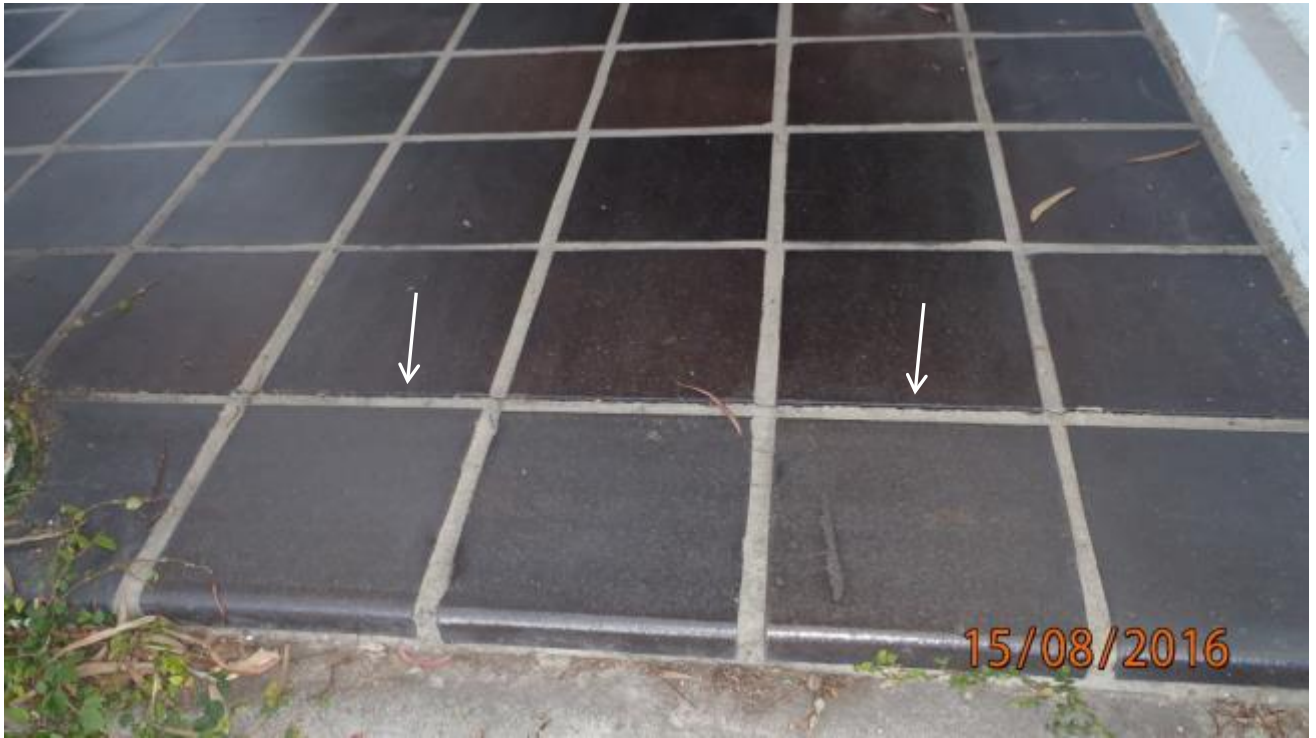
We observed that the front porch was a tiled suspended concrete slab construction. We noted separation cracking [ $<1.0\text{mm}$ ] along the grout joint along the first row of tiles. [**Photograph 5**]

**Photograph 5** shows cracking to the grout joint on the front porch.

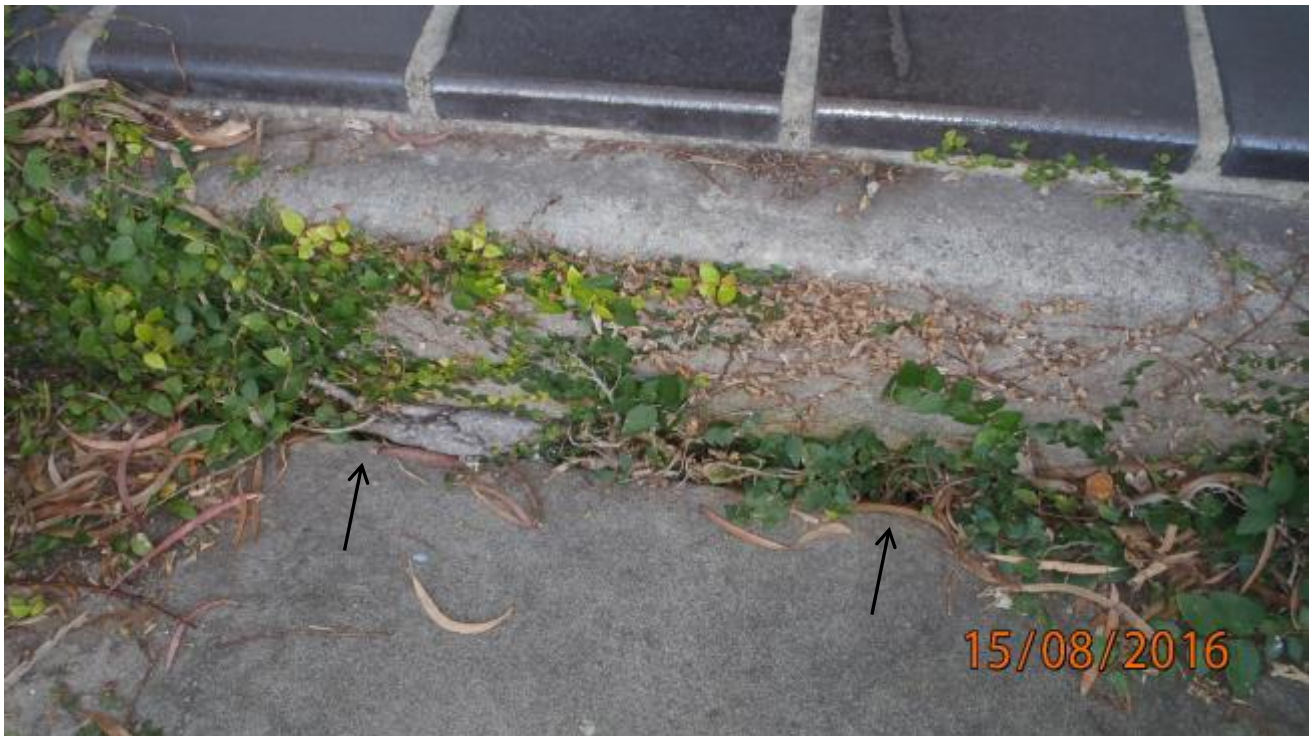
We noted settlement cracking between the 3<sup>rd</sup> step and the tiled porch landing and observed vegetation growth around the base of the front steps and porch. [**Photograph 6**]

**Photograph 6** shows settlement cracking between the 3<sup>rd</sup> step and the tiled porch landing and vegetation growth.

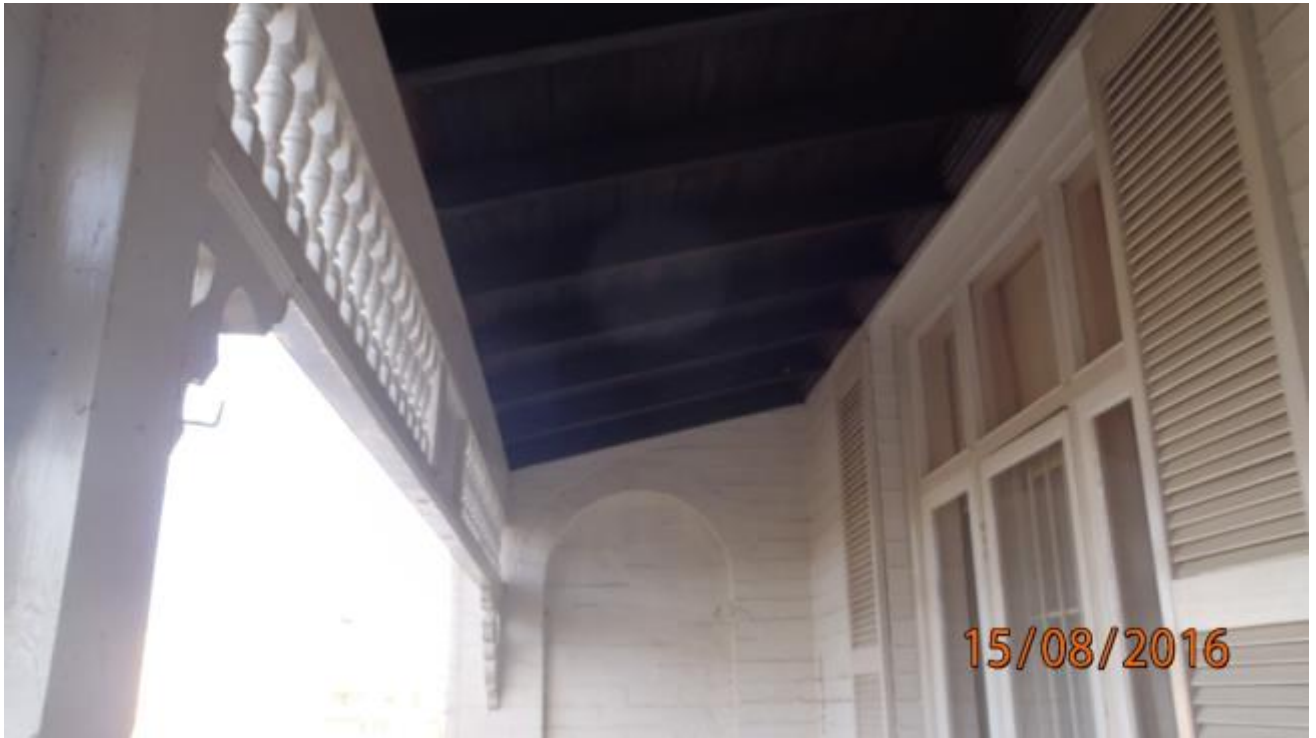
We noted that the front porch soffit was lined with timber boards to the top of the exposed rafters. [**Photograph 7**]

**Photograph 7** shows the general condition of the porch soffit lining and external wall.

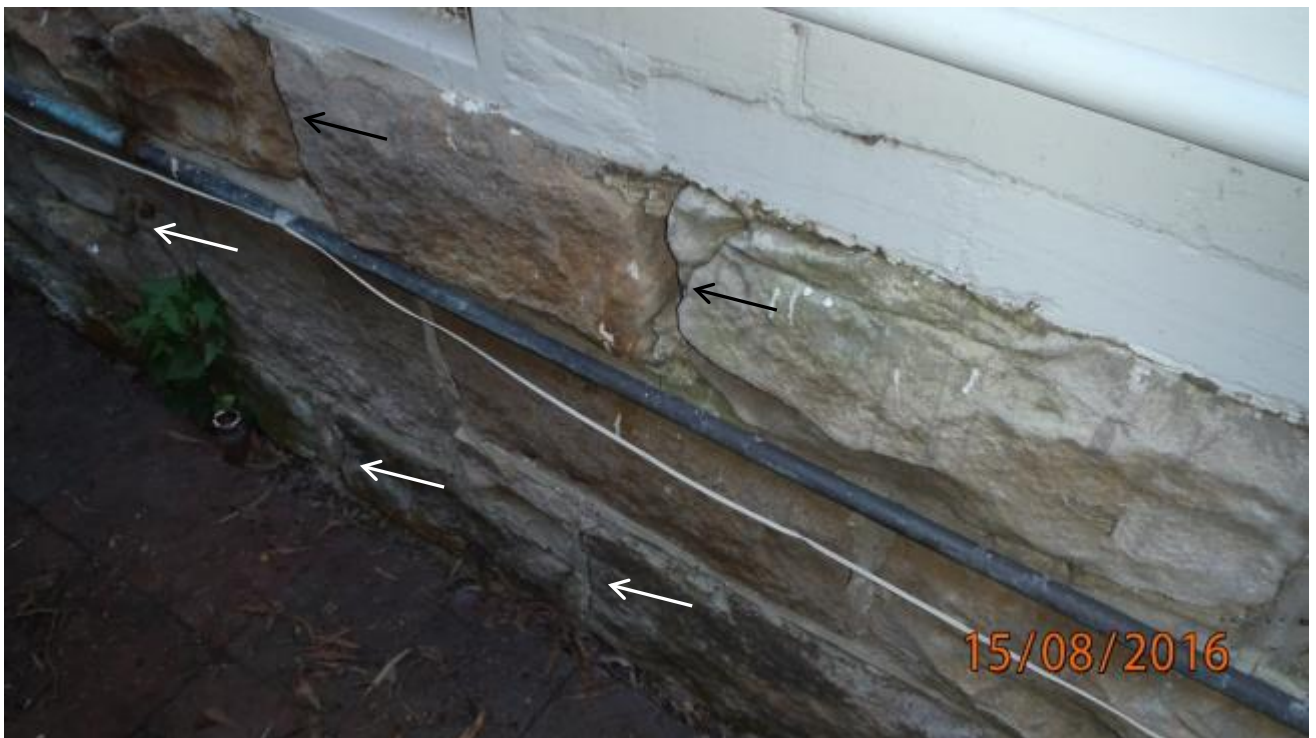
We observed general displacement and fretting of the mortar to the sandstone block footings to the side elevation. [**Photograph 8**]

**Photograph 8** shows displaced mortar to the sandstone block footings on the side south eastern elevation.

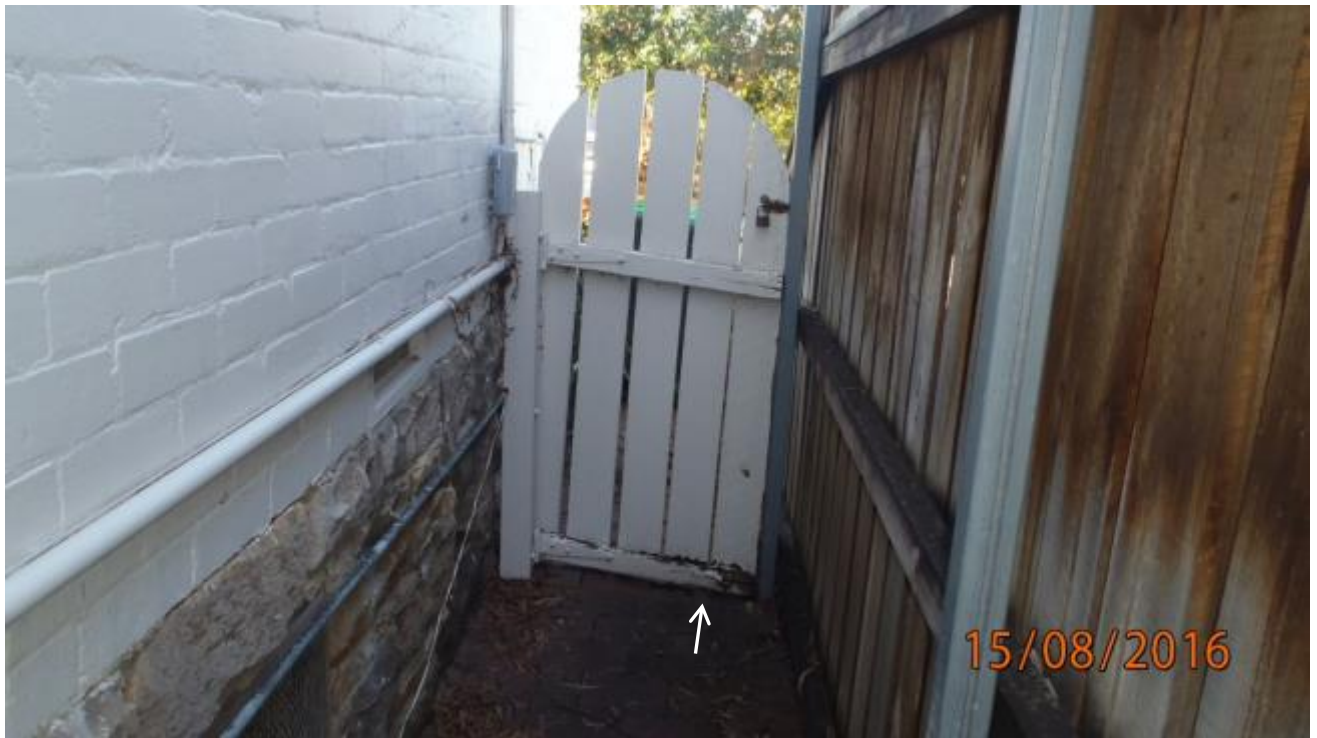
We noted some rotting of the timber bottom rail of the hinged side access gate. [**Photograph 9**]

**Photograph 9** shows rotting of the timber bottom rail of the hinged side access gate.

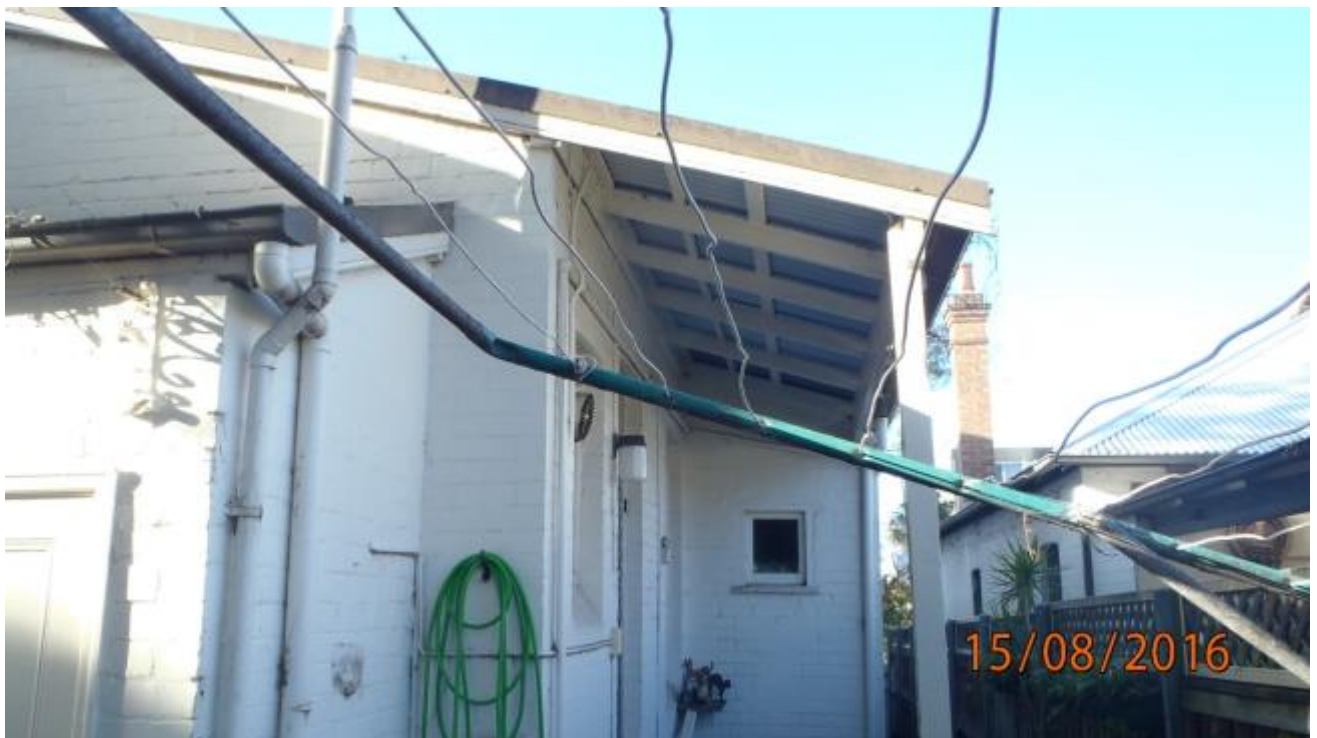
We observed that the attached timber framed verandah formed part of the main roof surface and was covered with corrugated profile sheet metal roofing. [**Photograph 10**]

**Photograph 10** shows the general condition of the rear elevation and the verandah.

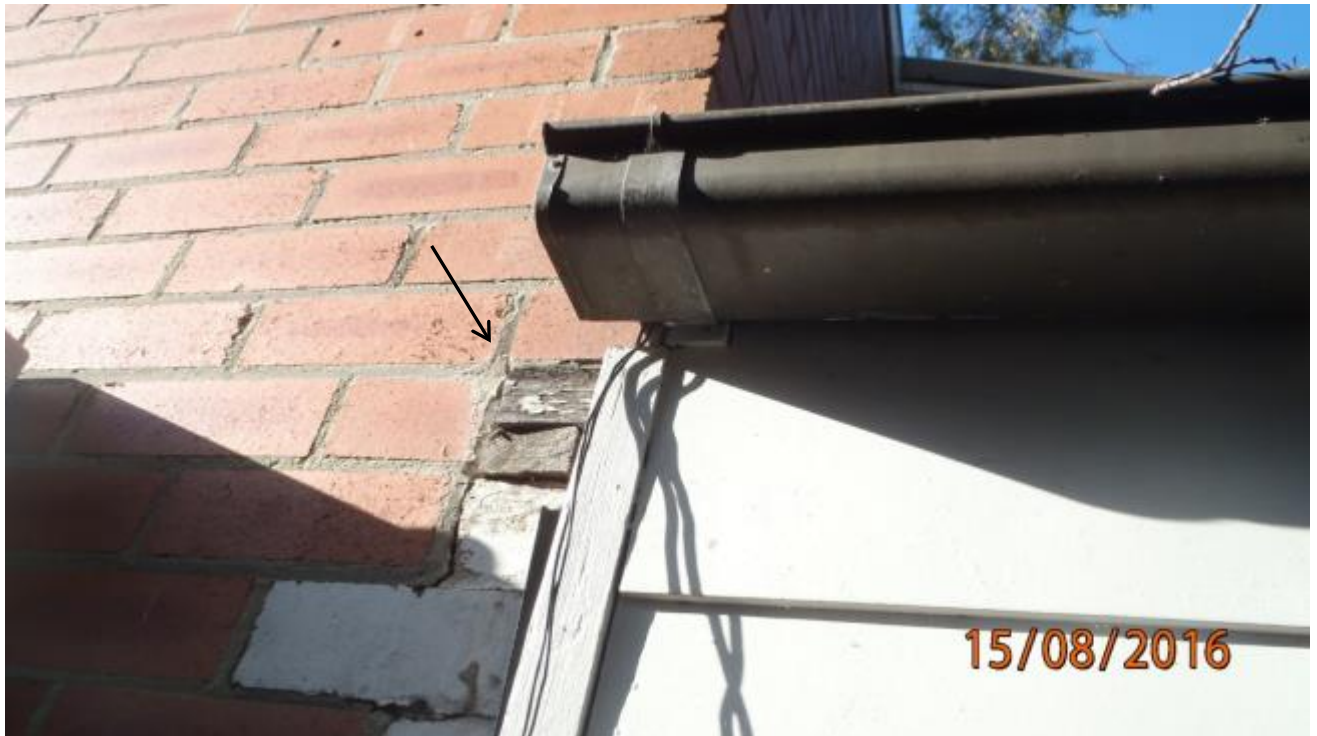
We noted that the timber roofing bearer was built into the brickwork of the common party wall for the adjoining property; No. 83 Formosa Street, Drummoyne. We also noted that the timber was exposed and not surface coated. **[Photograph 11]**

**Photograph 11** shows the junction of the timber roofing bearer with the *common* party wall.

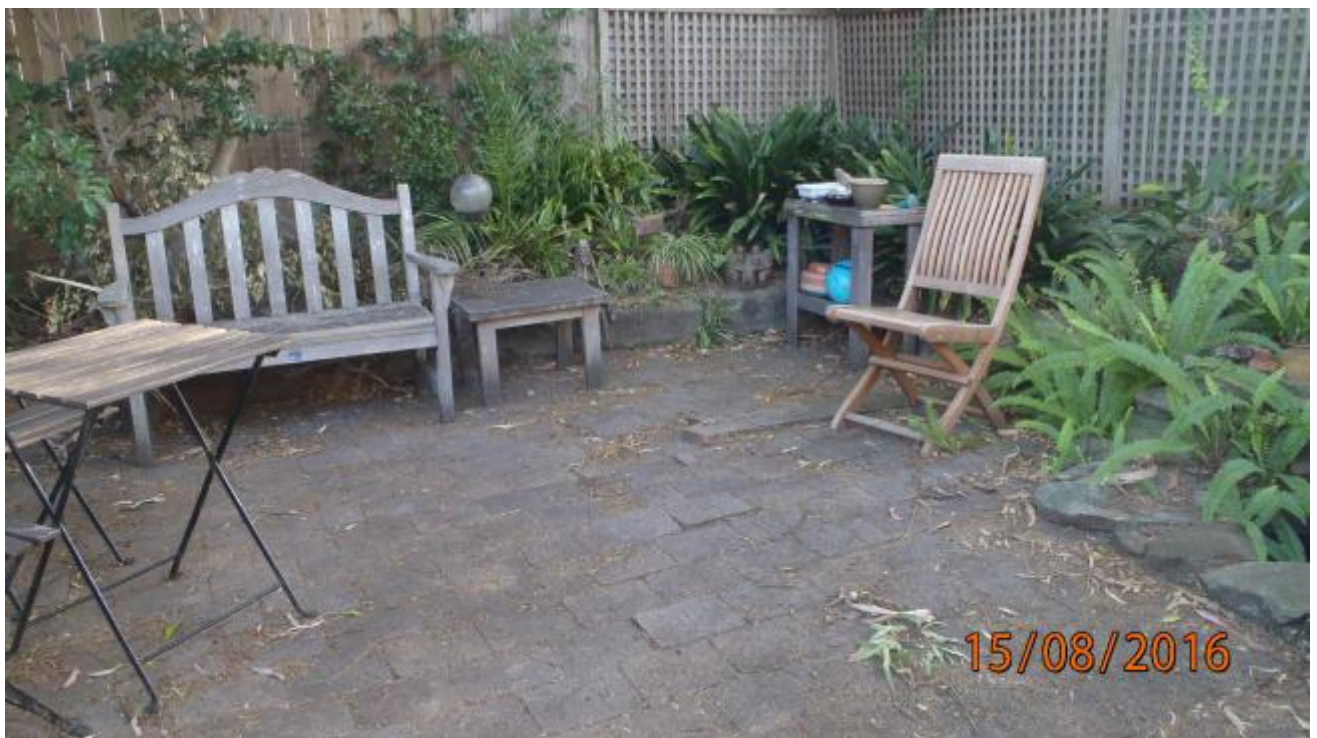
We observed a paved courtyard to the rear of the residence **[Photograph 12]**

**Photograph 12** shows the general condition of the paved courtyard to the rear.

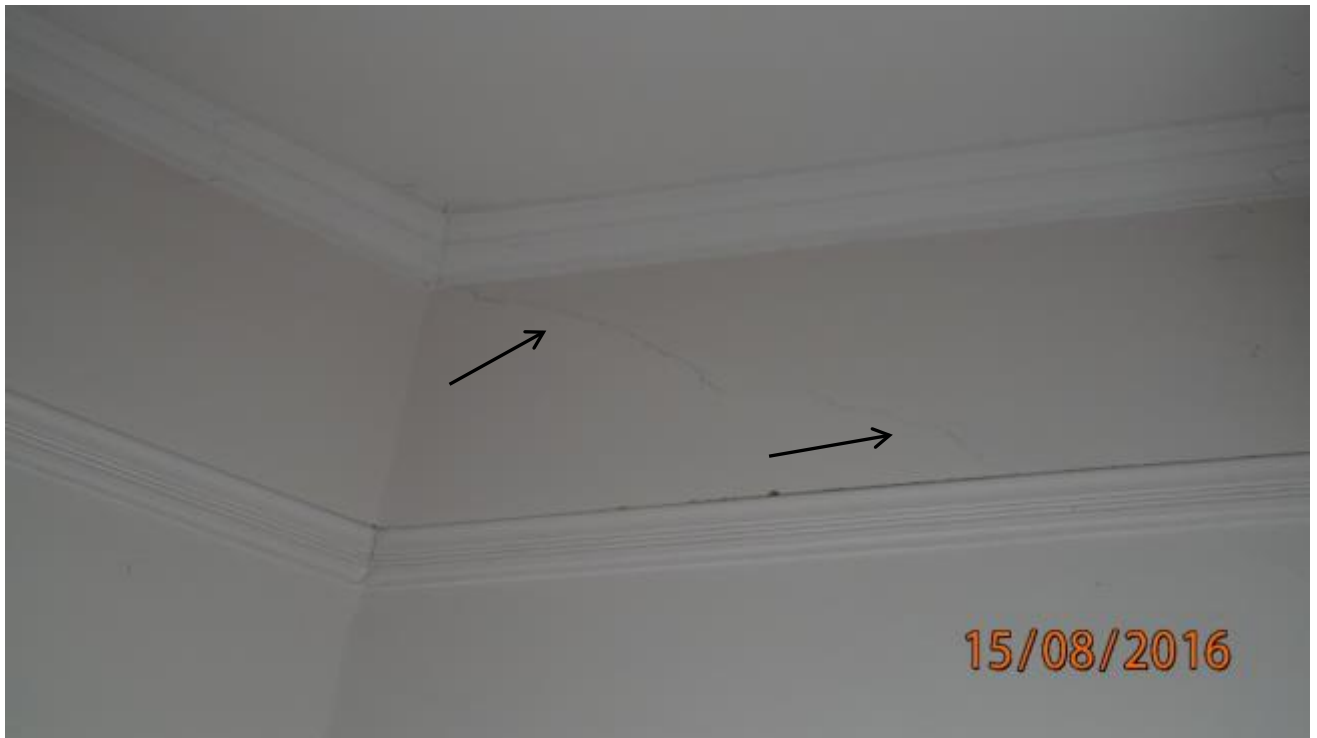
We noted hairline radial cracking [ $<1.0\text{mm}$ ] to the painted cement rendered wall above the fireplace. **[Photograph 13]**

**Photograph 13** shows hairline radial cracking to the painted cement rendered wall above the fireplace in Bedroom 1.

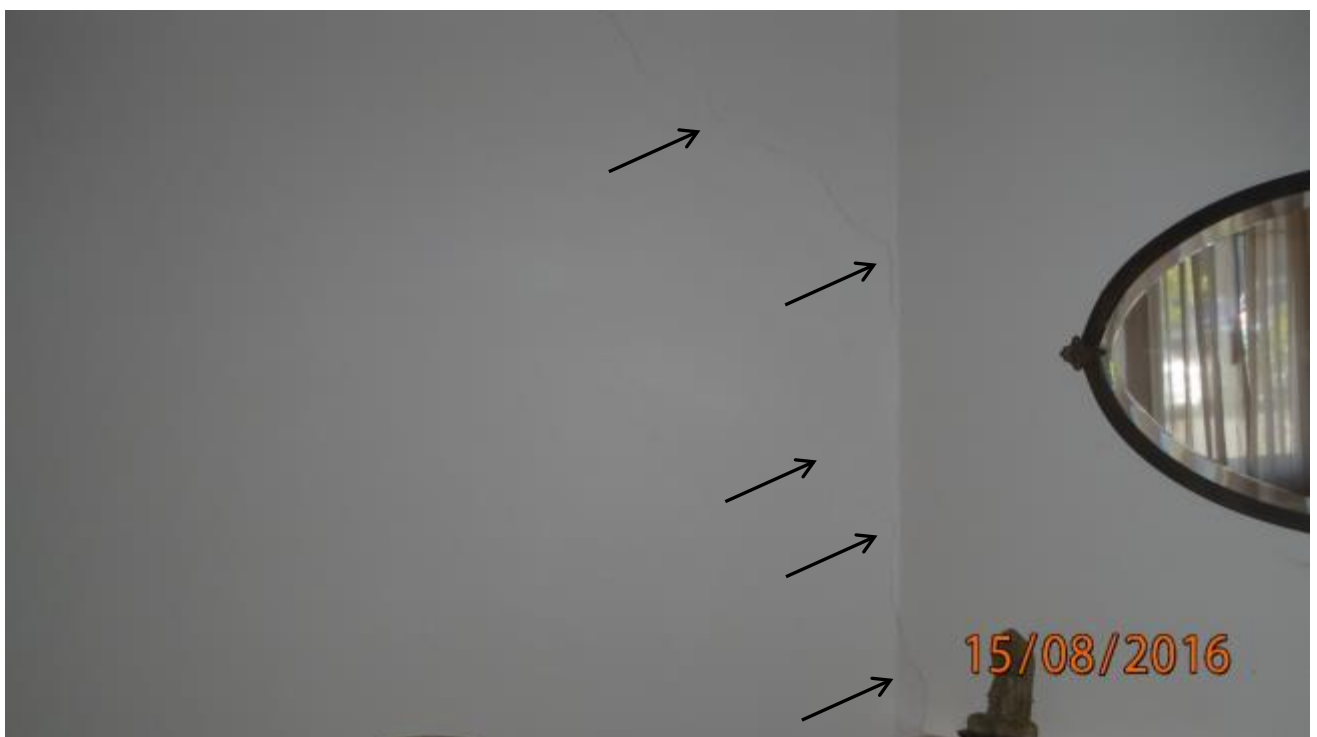
We noted hairline radial cracking [ $<1.0\text{mm}$ ] to the painted cement rendered wall adjacent to the mirror extending toward the ceiling on the south eastern external wall. **[Photograph 14]**

**Photograph 14** shows hairline radial cracking [ $<1.0\text{mm}$ ] to the painted cement rendered wall adjacent to the mirror extending toward the ceiling on the south eastern wall in Bedroom 1.

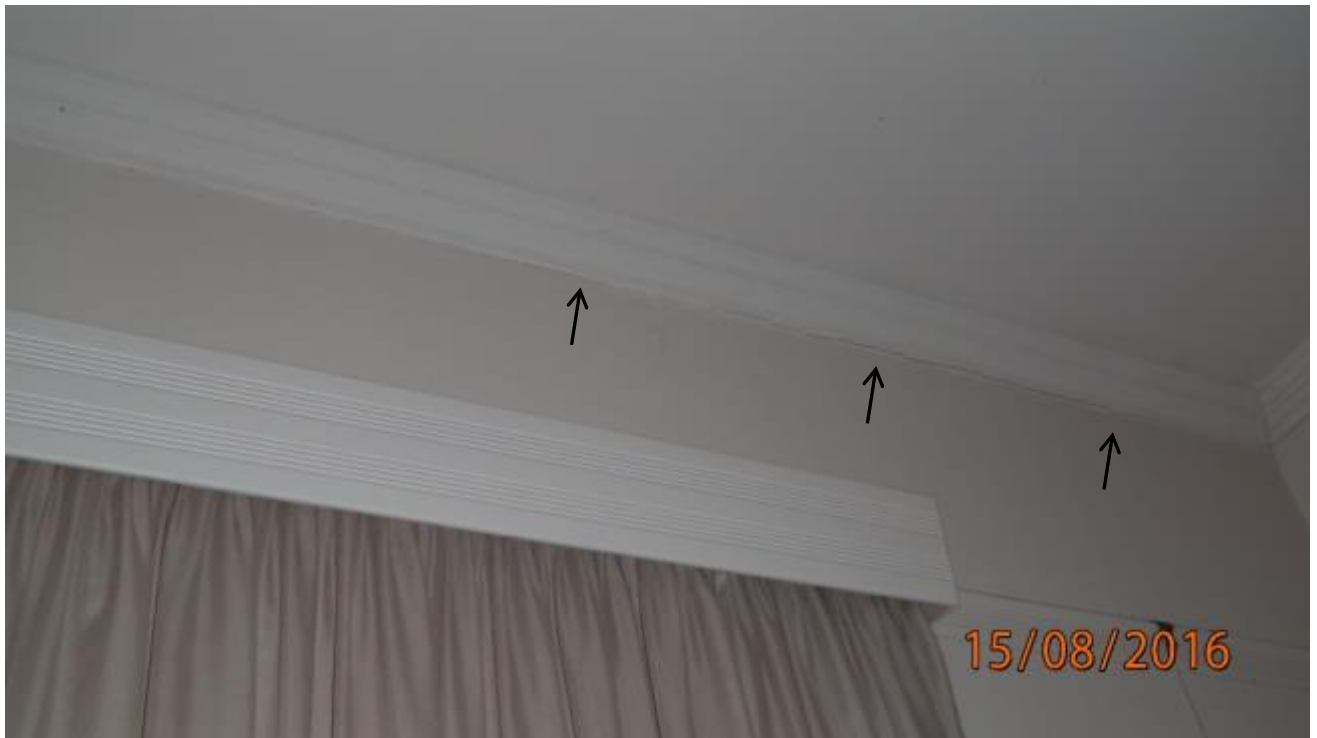
We noted separation cracking [ $<1.0\text{mm}$ ] to the wall / cornice junction on the front north eastern wall above the window. **[Photograph 15]**

**Photograph 15** shows separation cracking to the wall / cornice junction on the front north eastern wall above the window in Bedroom 1.

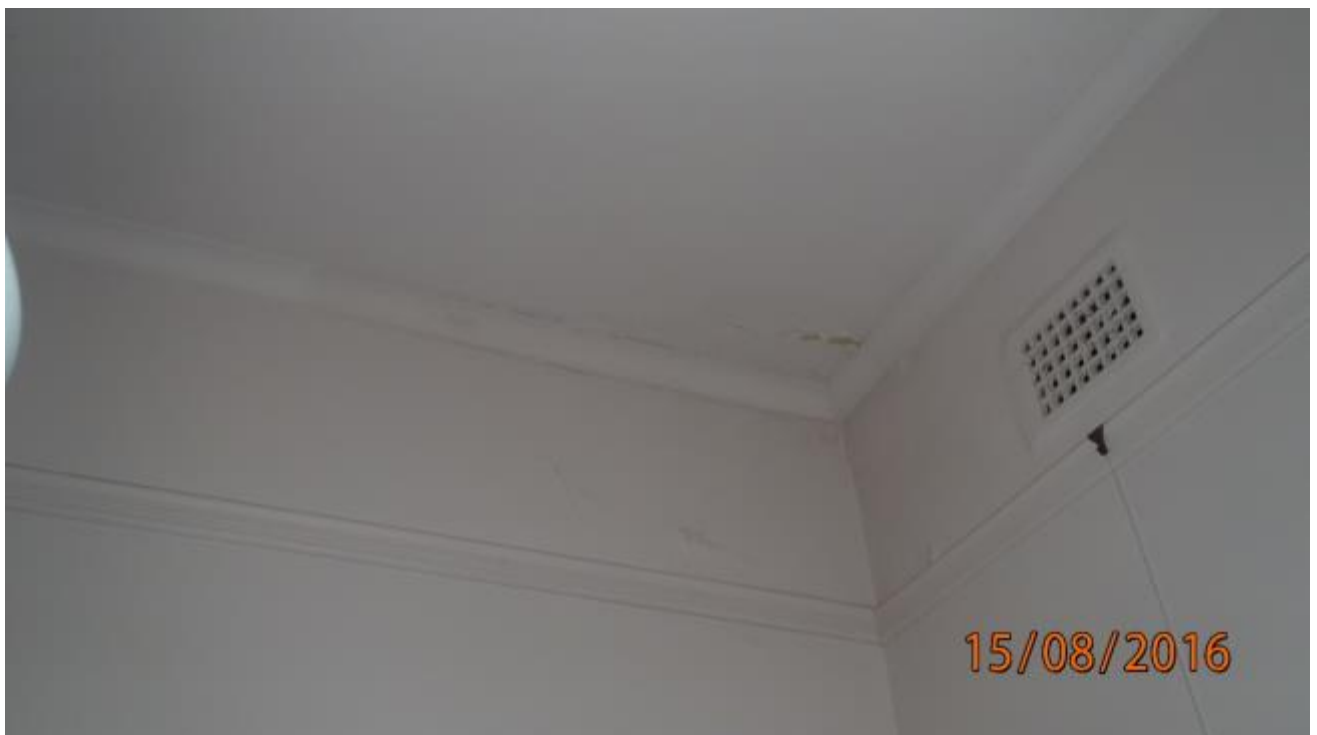
We noted flaking / peeling paint and stained surfaces to the cement rendered walls and the plaster ceiling lining in the eastern corner. **[Photograph 16]**

**Photograph 16** shows flaking / peeling paint and stained surfaces to the cement rendered walls and the plaster ceiling lining in the eastern corner in Bedroom 2.

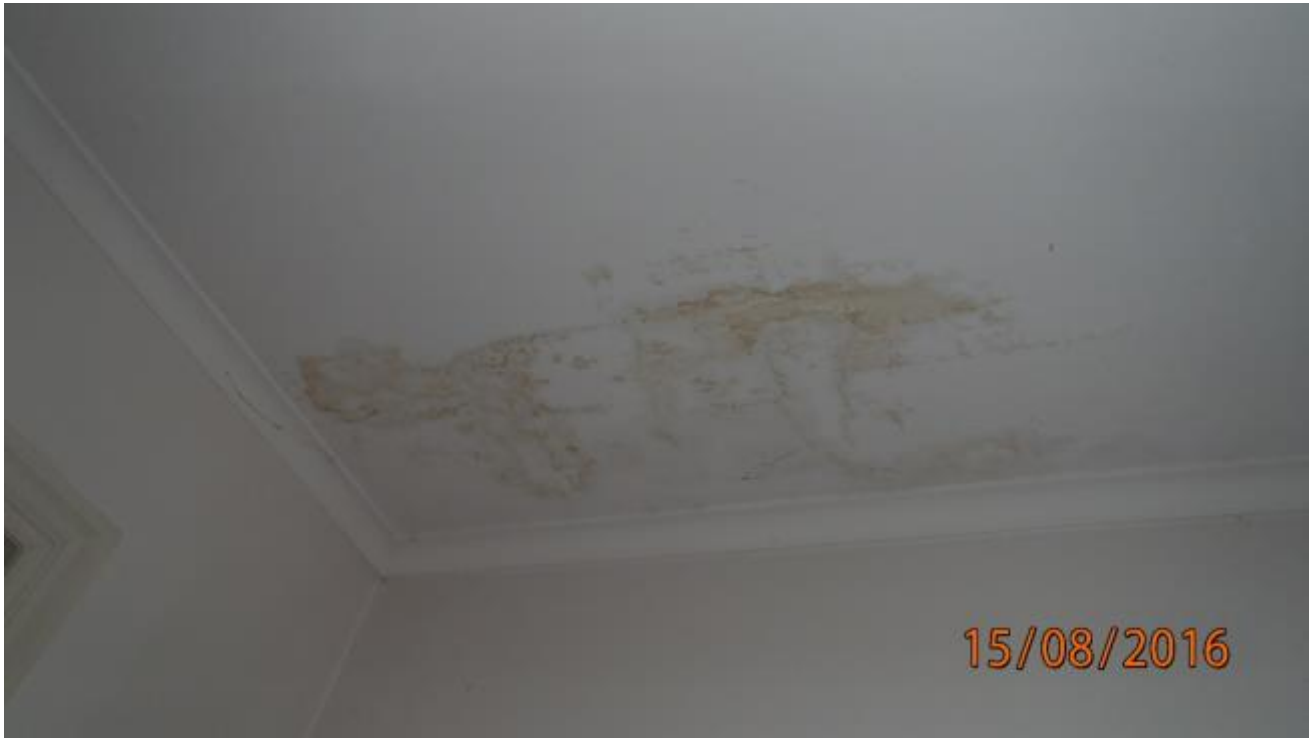
We noted flaking / peeling paint and stained surfaces to the plaster ceiling lining in the eastern corner. **[Photograph 17]**

**Photograph 17** shows flaking / peeling paint and stained surfaces to the plaster ceiling lining in the eastern corner of the Sewing Room.

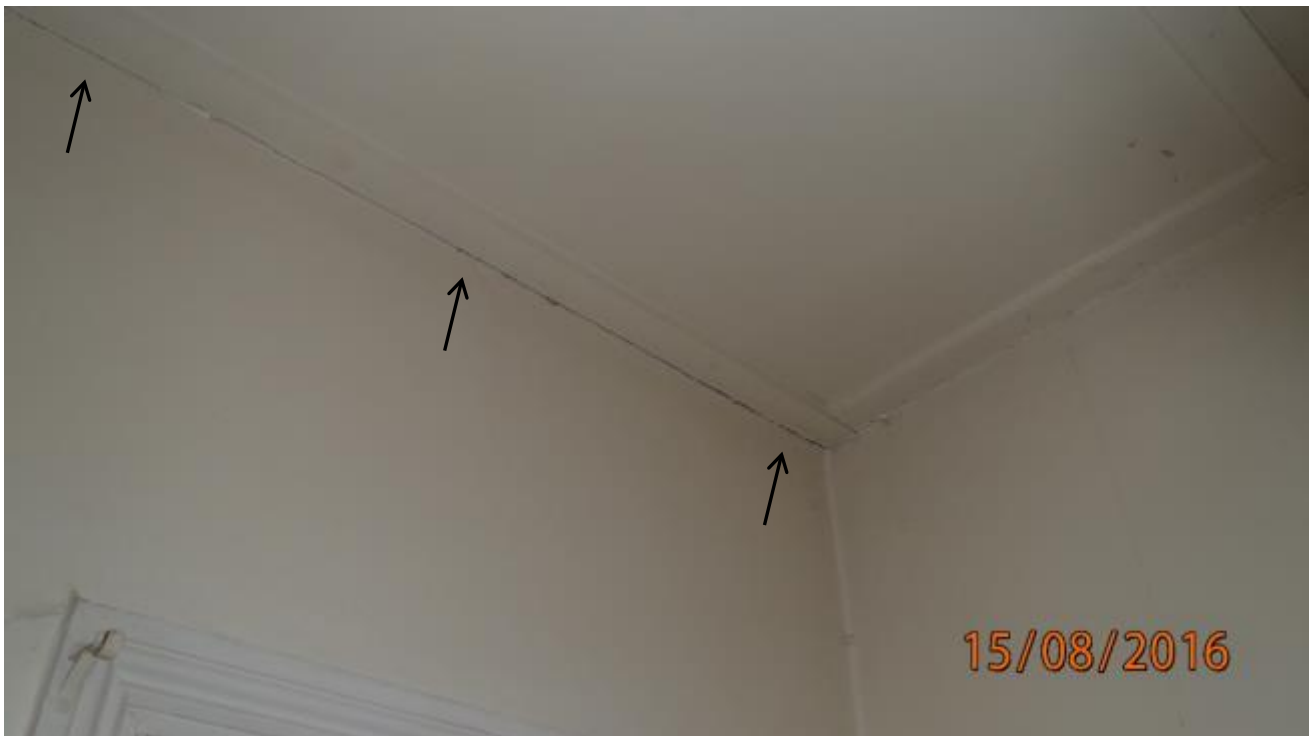
We noted separation cracking [ $<1.0\text{mm}$ ] to the wall / cornice moulding junction in the southern corner above the window. **[Photograph 18]**

**Photograph 18** shows separation cracking to the wall / cornice moulding junction in the southern corner above the window in the Kitchen.

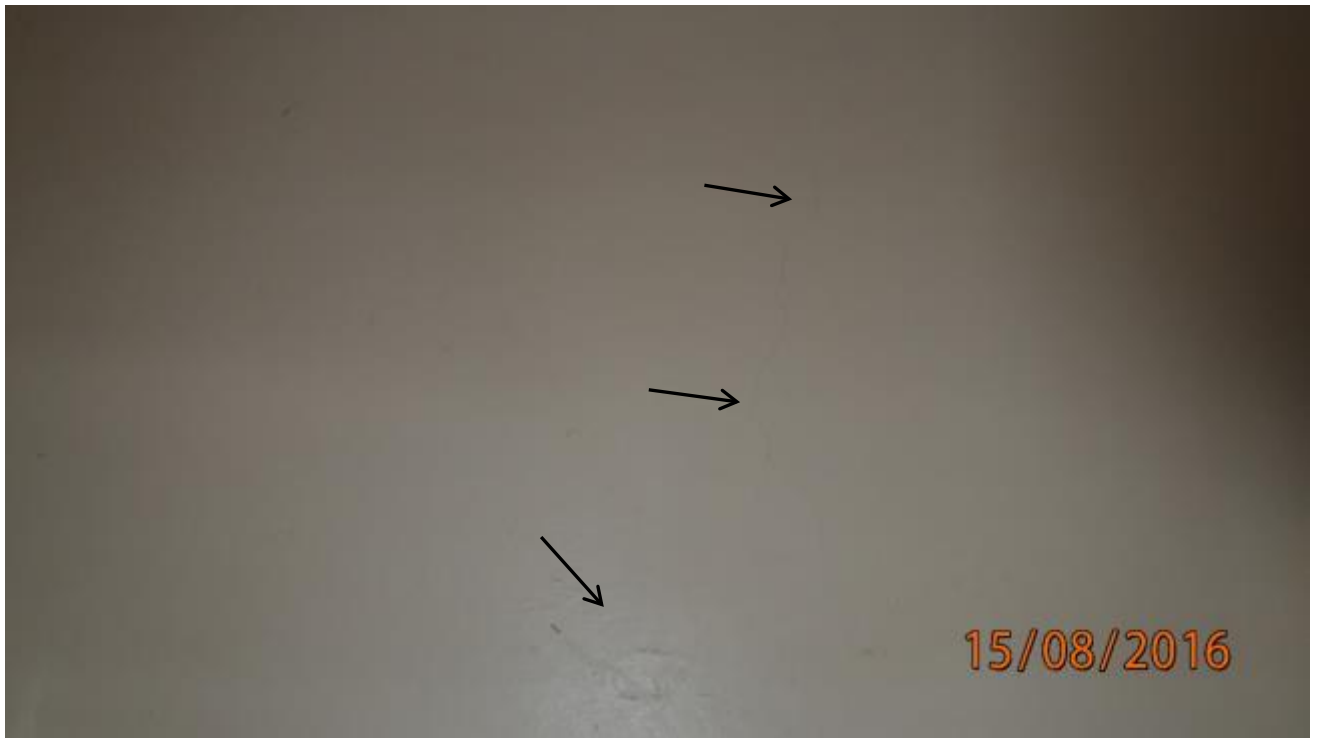
We noted hairline vertical cracking [ $<1.0\text{mm}$ ] to the painted cement rendered wall above the kitchen stove. **[Photograph 19]**

**Photograph 19** shows hairline vertical cracking to the painted cement rendered wall above the kitchen stove.

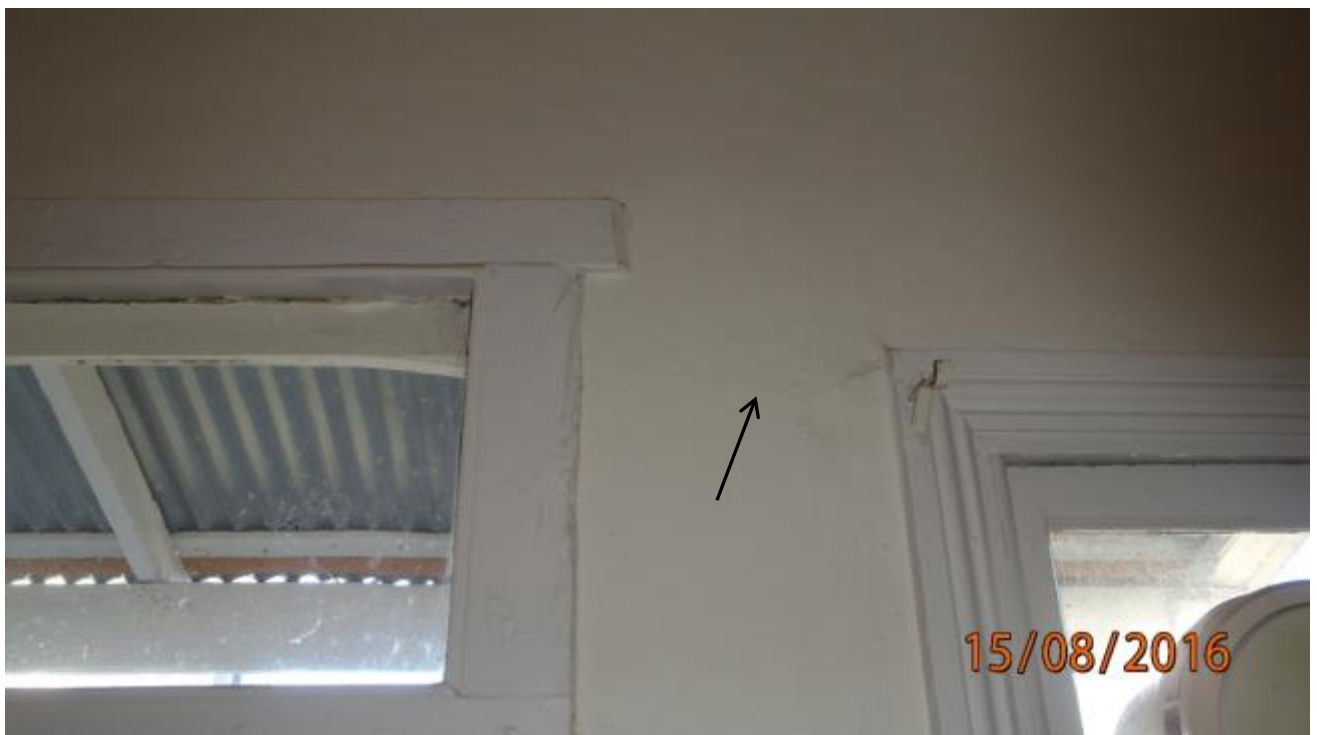
We noted hairline radial cracking [ $<1.0\text{mm}$ ] to the painted cement rendered wall extending from the left hand side of the window head. **[Photograph 20]**

**Photograph 20** shows hairline radial cracking to the painted cement rendered wall extending from the left hand side of the window head in the Kitchen.

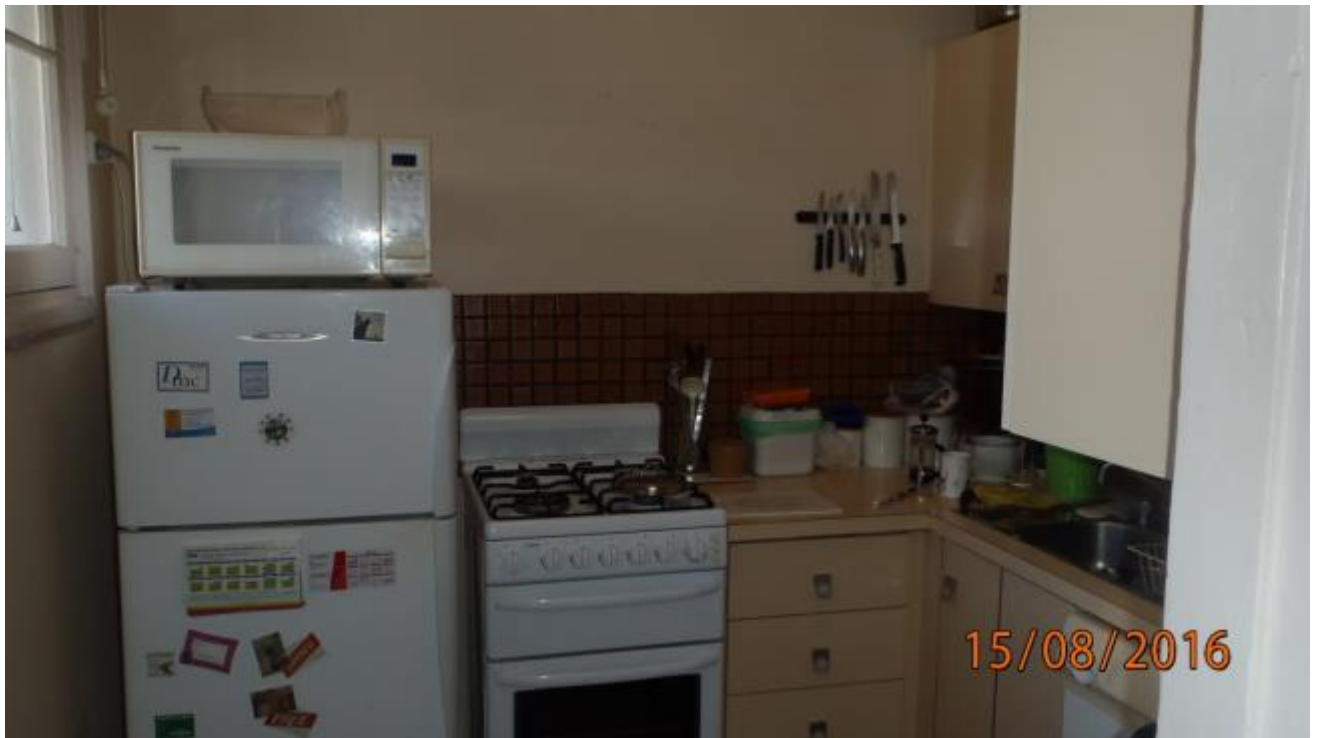
We noted that the grout to the wall tiles is complete and that the tiles when randomly “tap” tested appeared to be sound. We did not observe any recent cracking to the tile grout at the wall / wall junctions. **[Photograph 21]**

**Photograph 21** shows the general condition of the Kitchen.
