## Dilapidation Assessment Report

Prepared for: Cape Cod Australia Pty. Limited  
Job address: 81 Formosa Avenue, Drummoyne.  
Property Owner/s: Mrs. Phyllis Blennerhassett.  
Report reference: **CITY OF CANADA BAY COUNCIL**  
Development Application No: not available  
Date of assessment: 15<sup>th</sup> August 2016

**Re: Dilapidation Report**

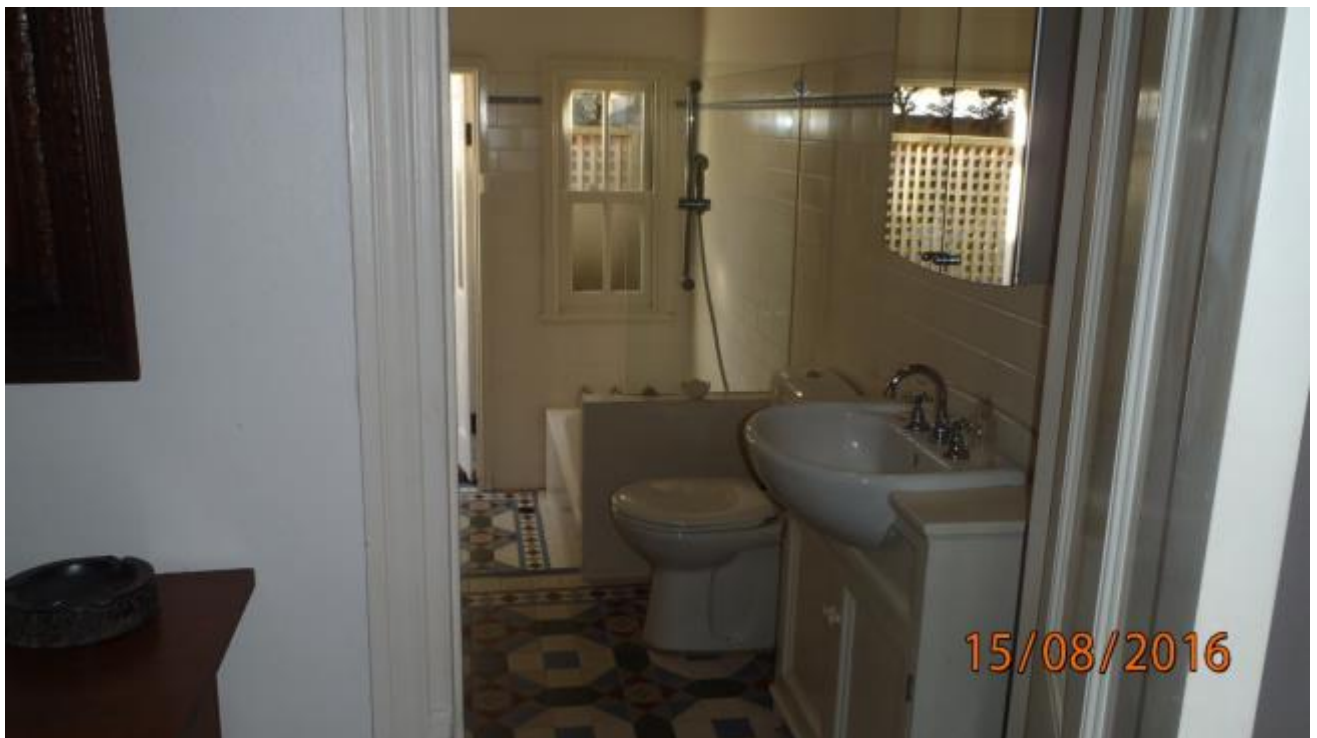
We noted that the grout to the tessellated tiles is complete and that the floor tiles when randomly “tap” tested appeared to be sound. [**Photograph 22**]

**Photograph 22** shows the general condition of the Bathroom.

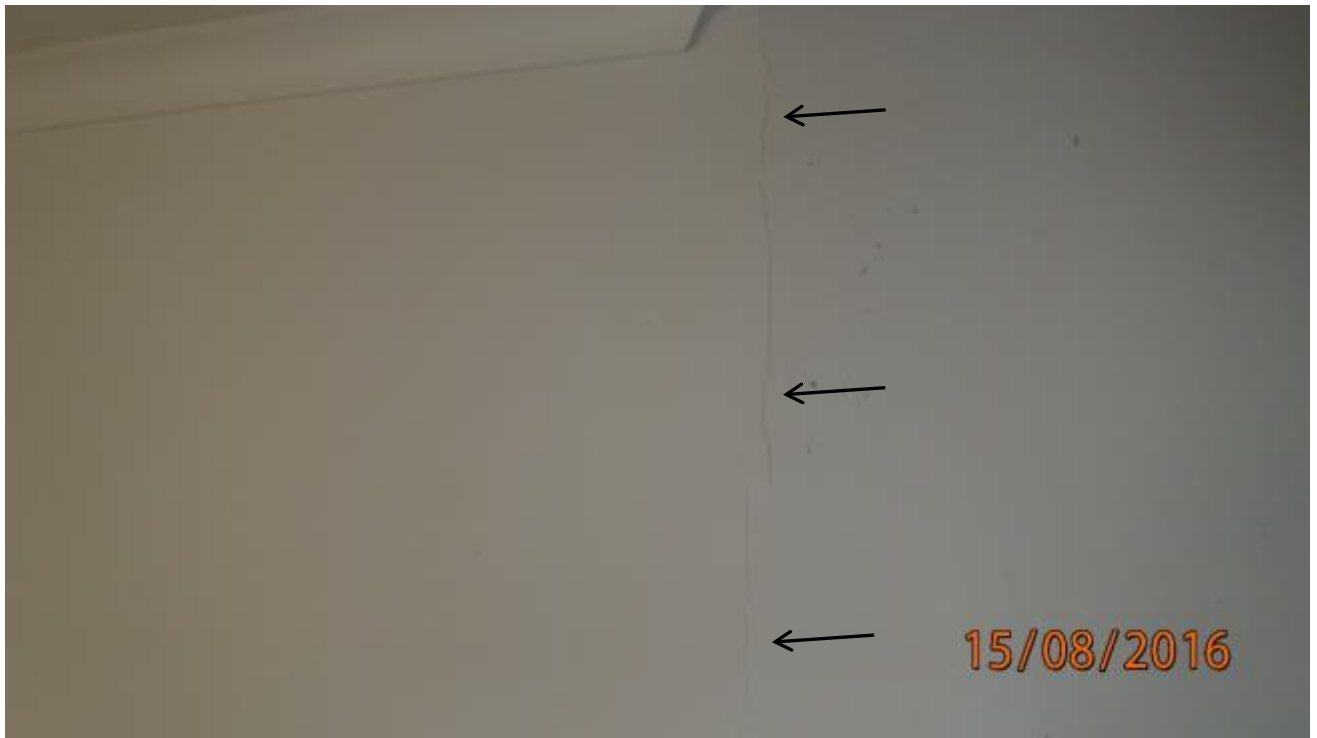
We noted hairline vertical cracking [ $<1.0\text{mm}$ ] to the painted cement rendered wall adjacent to the shower on the north western wall. **Note:** Common party separation wall with the adjoining property No. 83 Formosa Street, Drummoyne. [**Photograph 23**]

**Photograph 23** shows hairline vertical cracking to the painted cement rendered wall adjacent to the shower on the north western wall in the Bathroom.

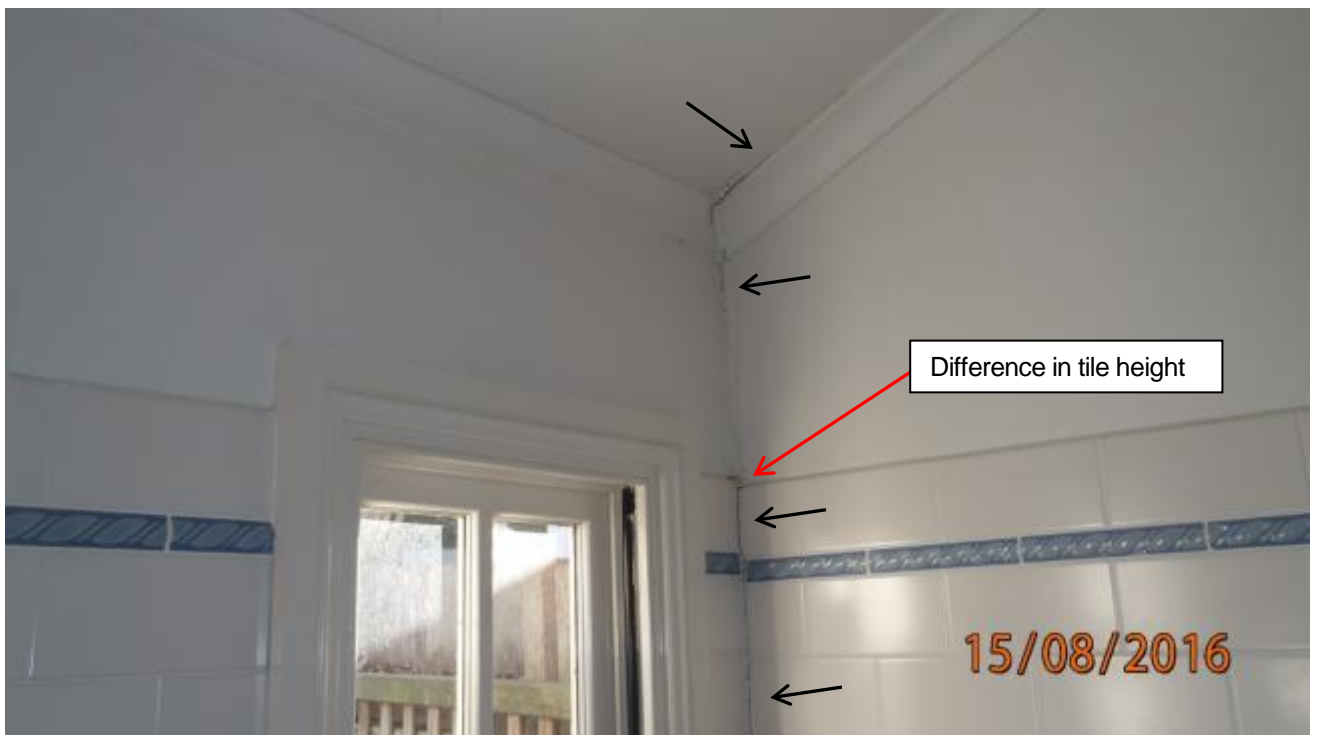
We noted vertical cracking [ $1.0\text{mm}$ - $3.0\text{mm}$ ] to the wall to wall junction in the western corner. We also noted separation cracking [ $1.0\text{mm}$ - $3.0\text{mm}$ ] to the ceiling / cornice junction [**Photograph 24**]

We noted a difference in tile and cornice height of approximately  $10.0\text{mm}$  to the south western external wall as compared to the north western (common party/separation) wall [**Photograph 24**]

**Photograph 24** shows vertical cracking to the wall to wall junction in the western corner. We also noted separation cracking to the ceiling / cornice junction of the Bathroom.

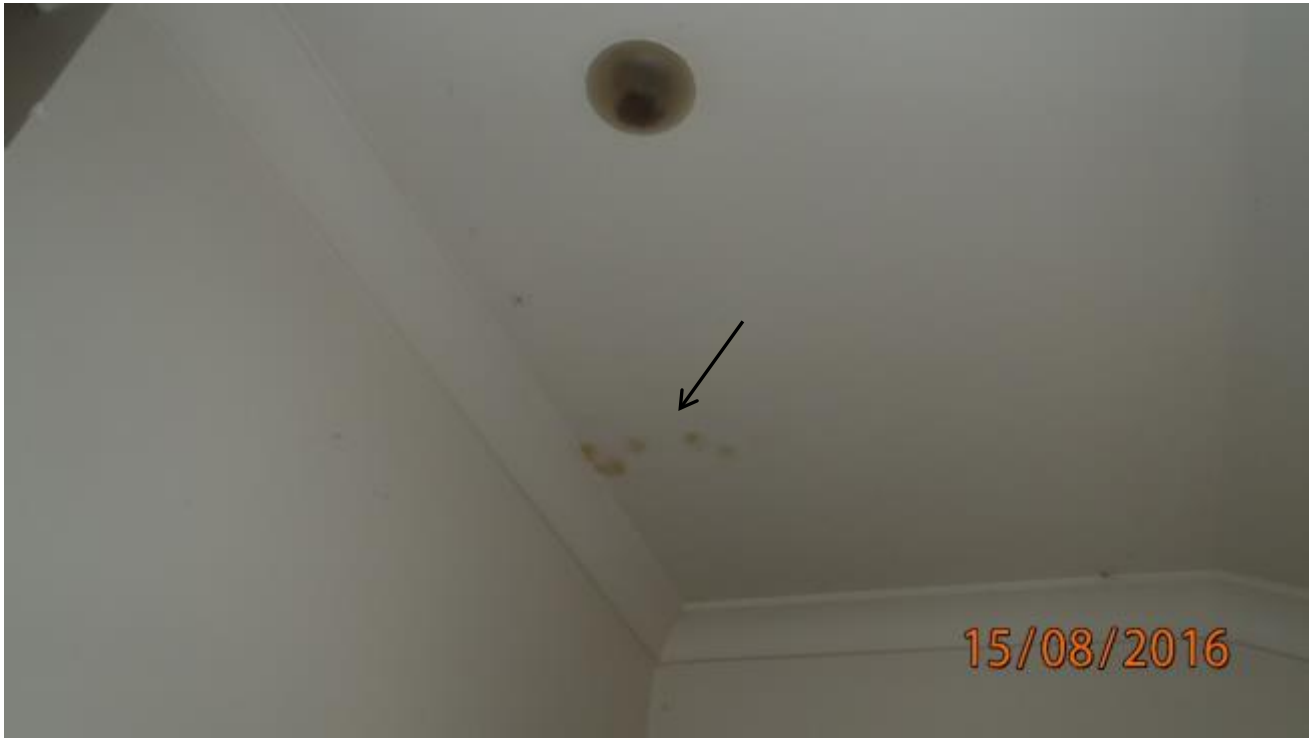
We noted staining to the ceiling lining in the eastern corner above the clothes dryer unit [**Photograph 25**]

**Photograph 25** shows staining to the ceiling lining in the eastern corner above the clothes dryer unit in the Laundry.

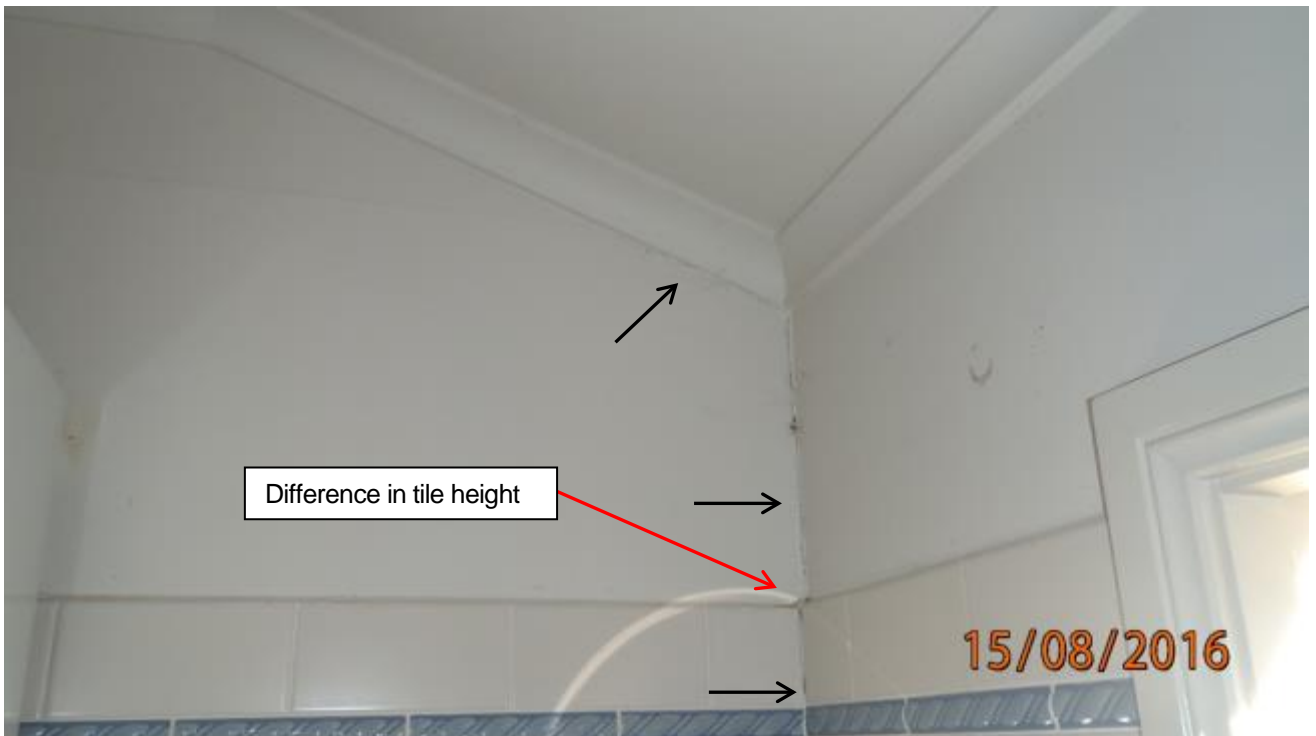
We noted vertical cracking [ $1.0\text{mm}$ - $3.0\text{mm}$ ] to the wall to wall junction in the southern corner. We also noted separation cracking [ $<1.0\text{mm}$ ] to the wall / cornice junction [**Photograph 26**]

We noted a difference in tile height of approximately  $5.0\text{mm}$  to the south western external wall as compared to the south eastern wall [**Photograph 26**]

**Photograph 26** shows vertical cracking to the wall to wall junction in the southern corner. We also noted separation cracking to the wall / cornice junction of the Bathroom.
