## Dilapidation Assessment Report

Prepared for: Cape Cod Australia Pty. Limited  
Job address: No. 60 Carrington Road, Randwick.  
Property Owner/s: Mr. Mark & Mrs. Ana McLeod.  
Report reference: **RANDWICK CITY COUNCIL**  
Development Application No: not available  
Date of assessment: 24<sup>th</sup> May 2017

**Re: Dilapidation Report – No. 60 Carrington Road, Randwick.**

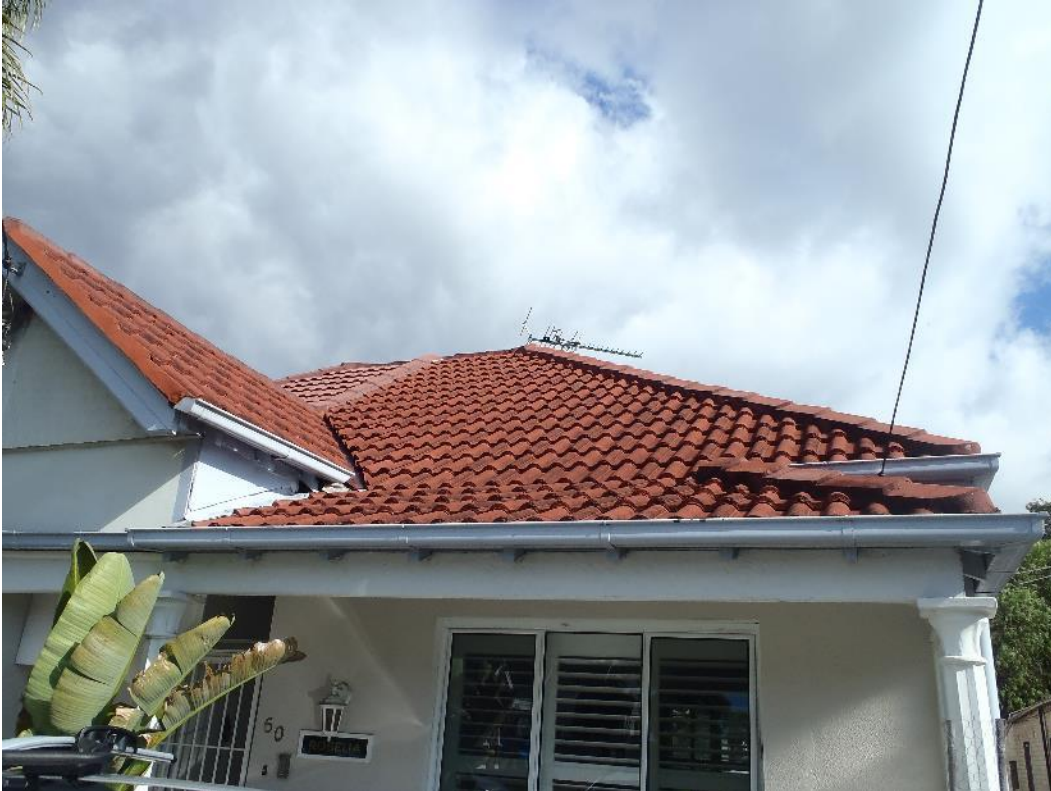
We observed that the concrete roof tiles to the original roof surfaces are generally interlinked and securely bedded, in our opinion forming a weather resistant cover to the residence. **[Photograph 1]**

**Photograph 1** shows the general condition of the front *common* tiled roof surface.

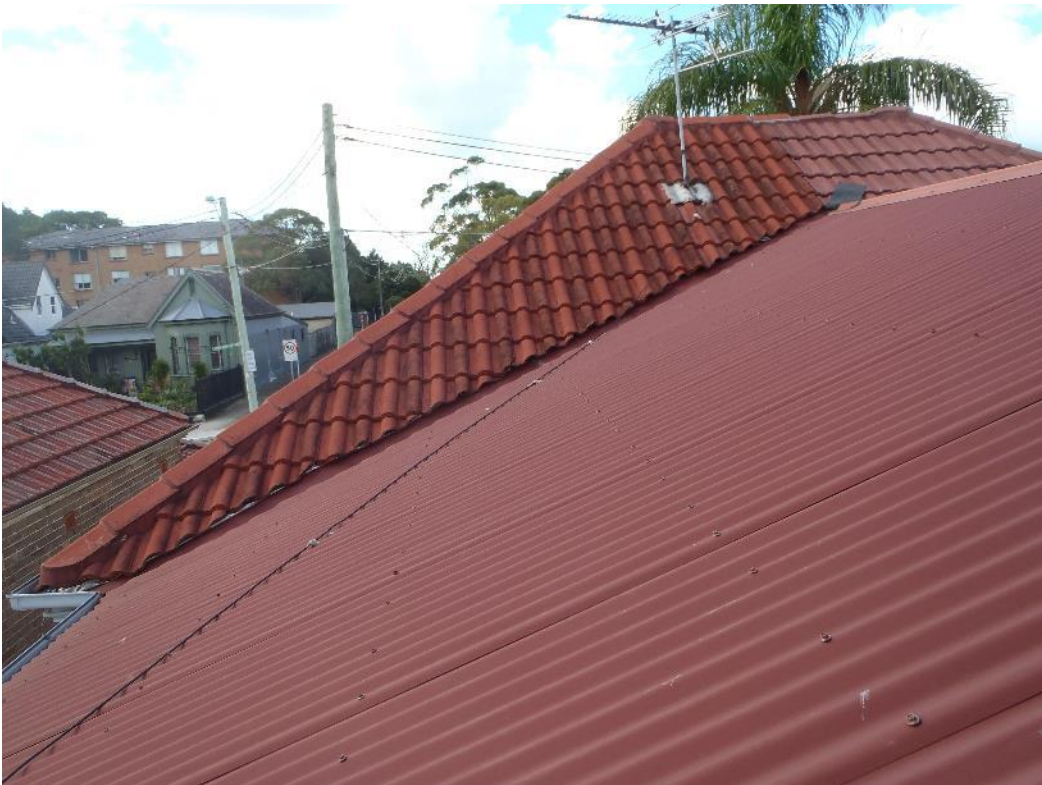
We noted that the corrugated profile sheet metal roofing to the rear addition roof surfaces is in good condition and is securely fixed, in our opinion forming a weather resistant cover to the rear section *common* roof and first-floor addition. **[Photograph 2]**

**Photograph 2** shows the general condition of the front *common* sheet metal roof surface.

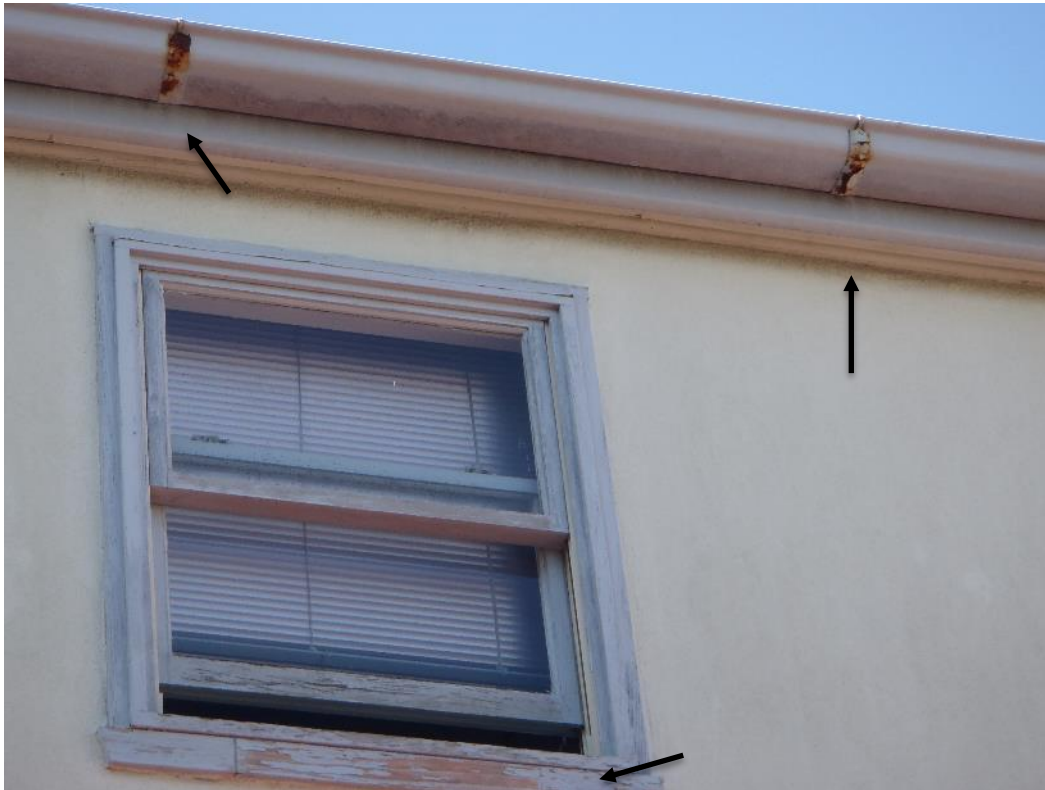
We noted rusting and flaking paint to the gutter system and clips to the rear western and side northern elevations **[Photographs 3 & 4]**

**Photograph 3** shows rusting and flaking paint to the gutter system and clips to the rear western elevation and deterioration to the window sill coating.

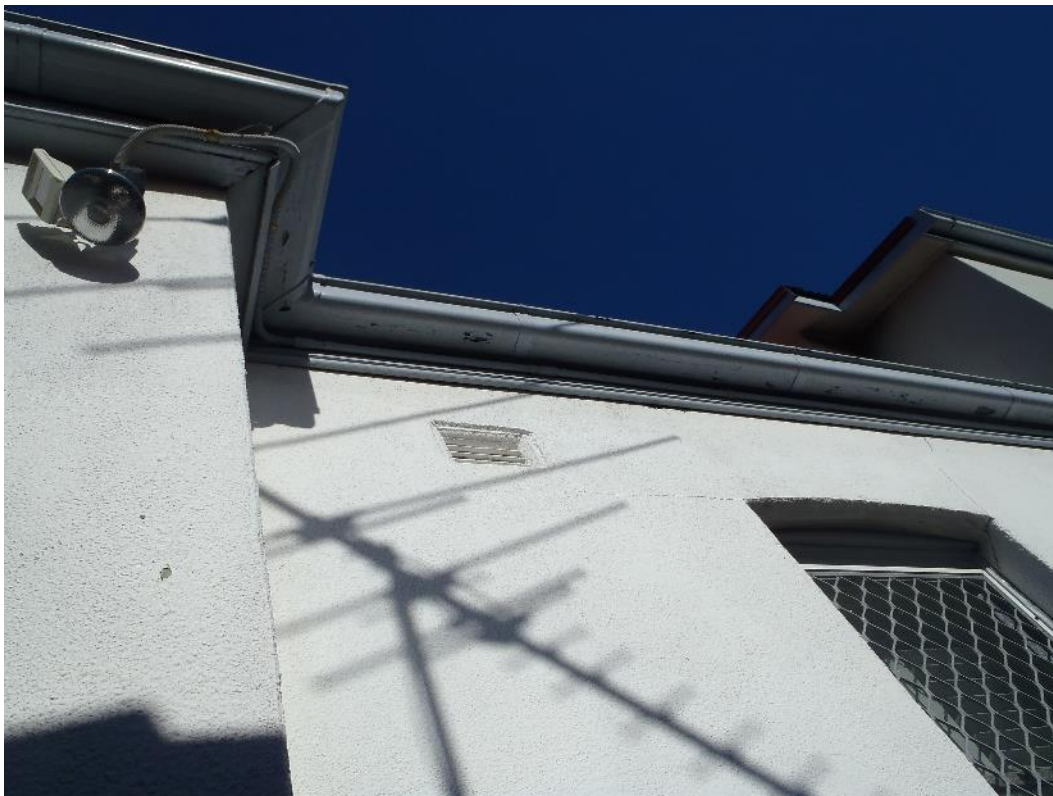
**Photograph 4** shows rusting and flaking paint to the gutter system and clips to the side northern elevation.

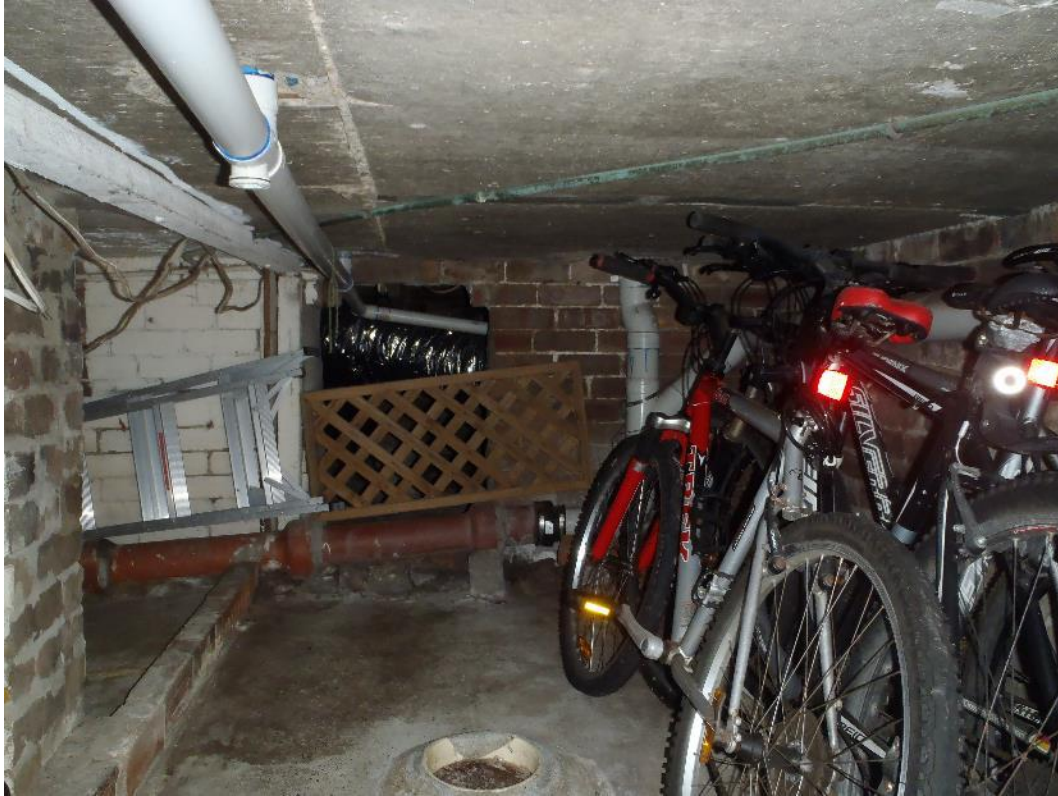
We noted that there are areas of dampness [ground water seepage] in the under-floor area including along the common party wall with the adjoining property, No. 62 Carrington Road, Randwick. **[Photograph 5]**

We further noted that there is a suspended concrete floor slab floor to the Laundry and Bathroom area of the residence. **[Photograph 5]**

**Photograph 5** shows the general condition of the under-floor space.

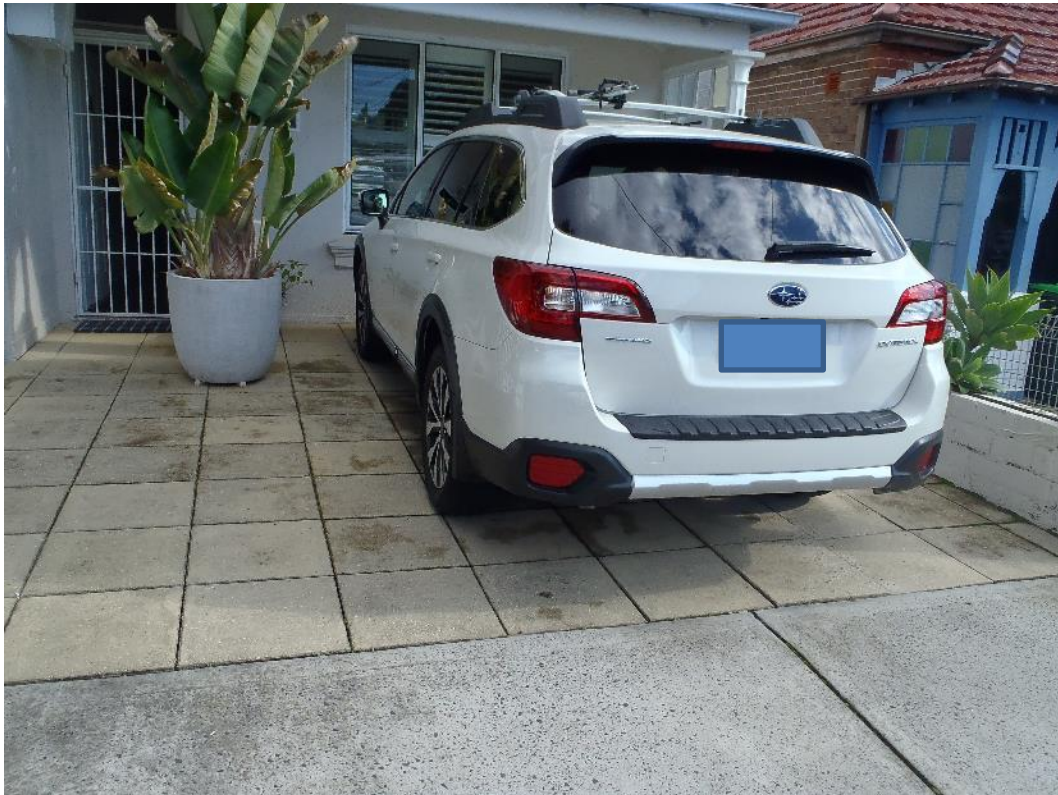
We noted that the front car space was paved. **[Photograph 6]**

**Photograph 6** shows the general condition of the paved car space area.

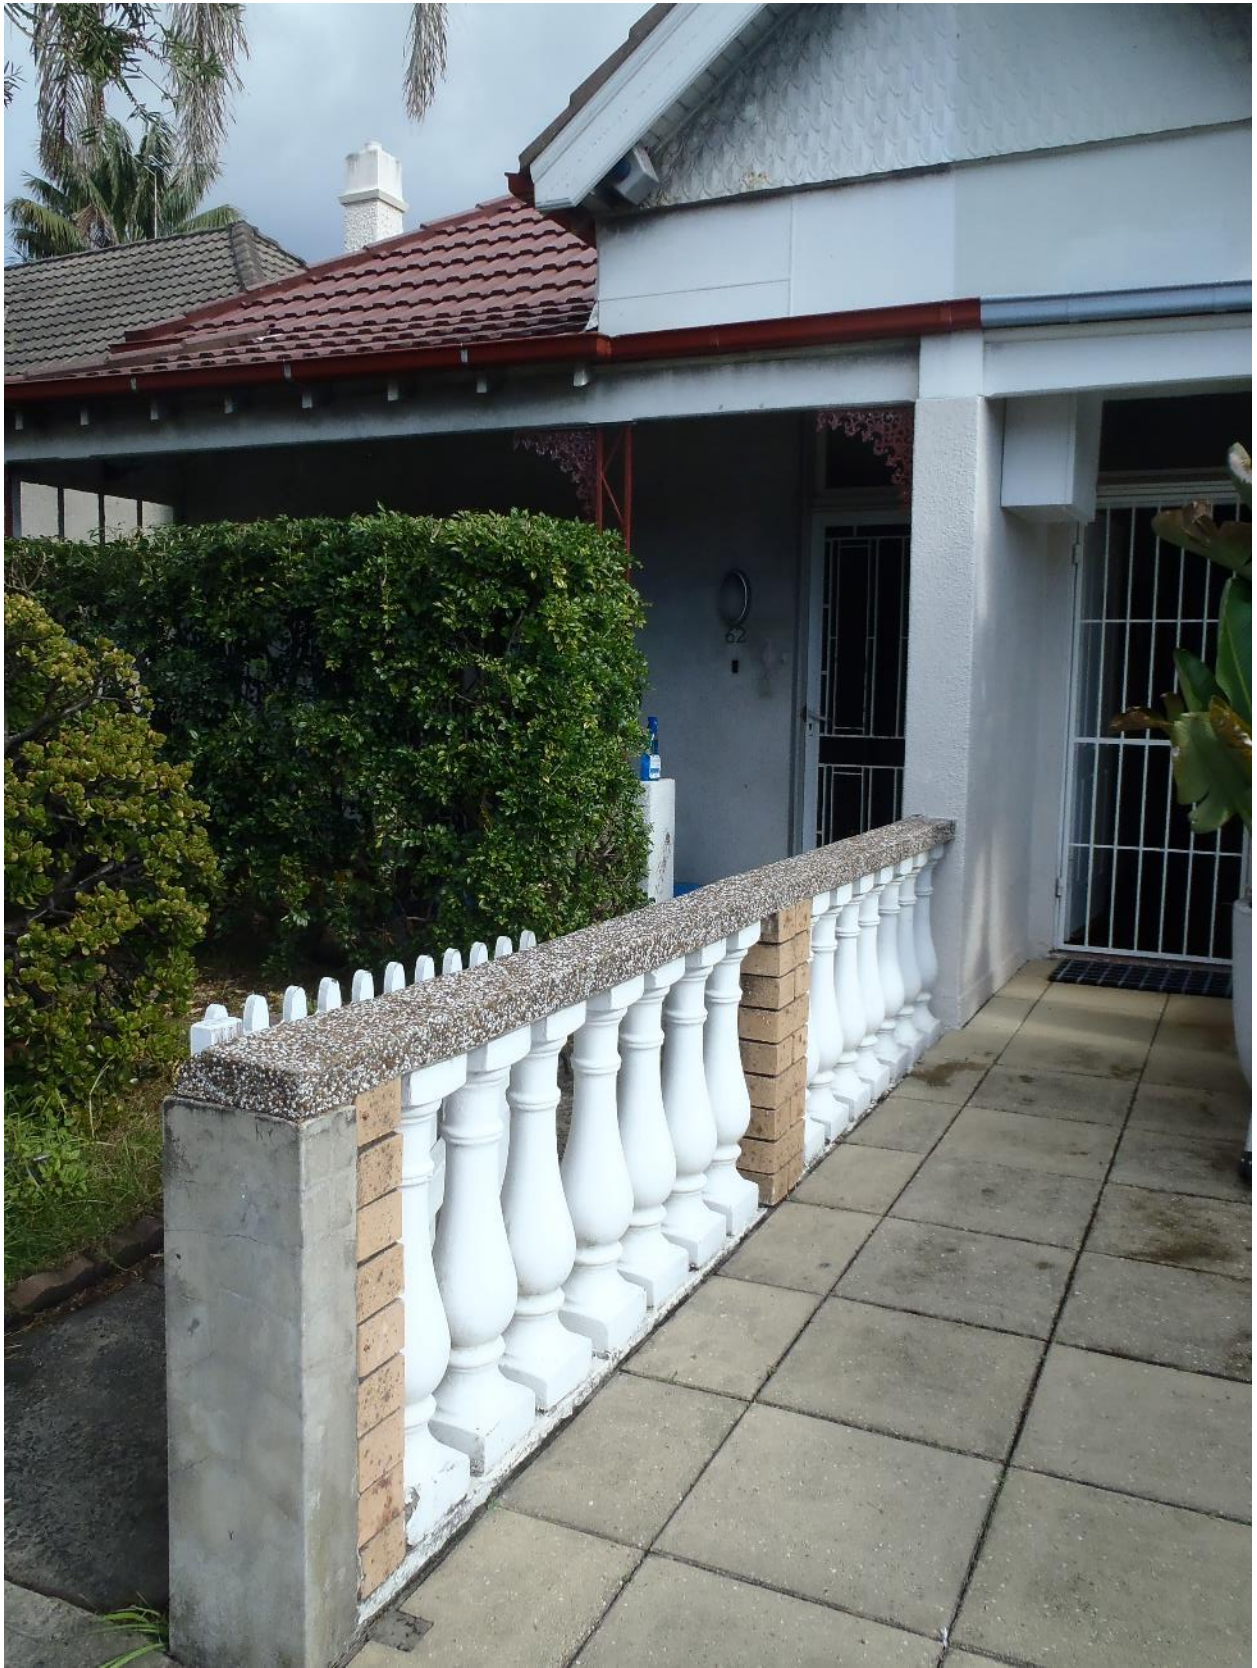
We noted that the *common* boundary fence between the adjoining property No. 62 Carrington Road, Randwick was a combination of clay brick and concrete bollard construction. **[Photograph 7]**

**Photograph 7** shows the general condition of the *common* boundary fence between the adjoining property No. 62 Carrington Road, Randwick

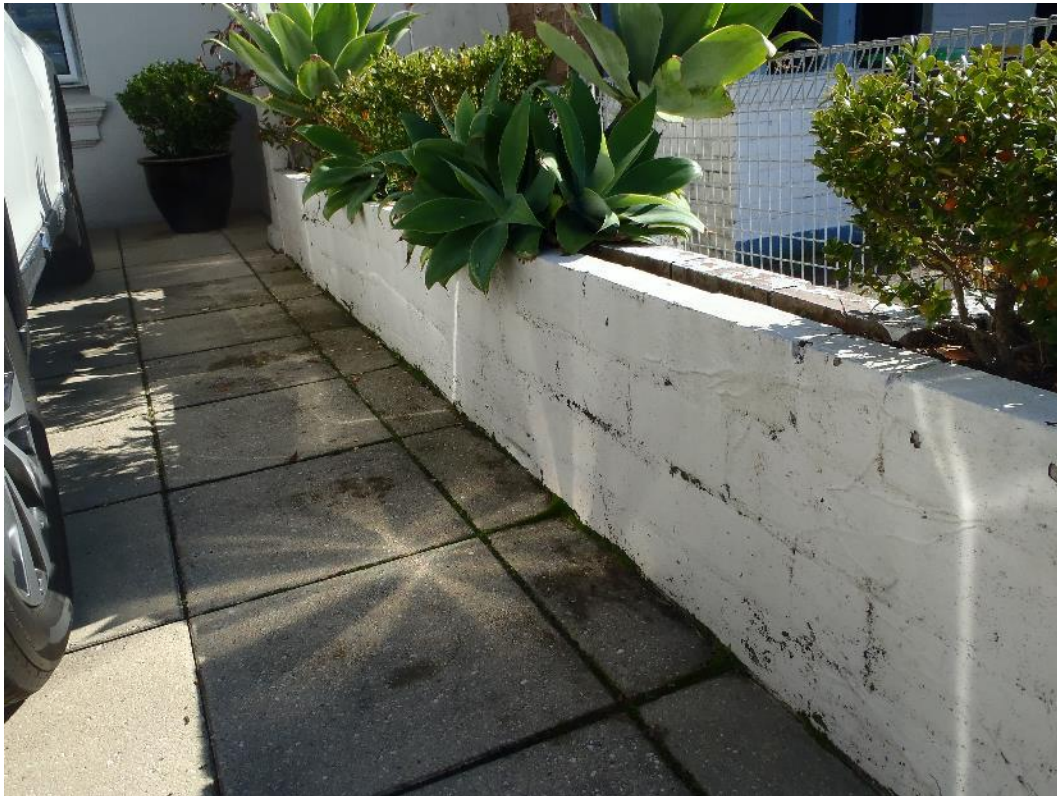
We noted that the northern boundary fence with the adjacent property was of surface coated brick construction. We further noted areas of dampness, lichen growth and flaking paint. **[Photograph 8]**

**Photograph 8** shows the northern boundary fence with the adjacent property.  
Note: Dampness and flaking paint.

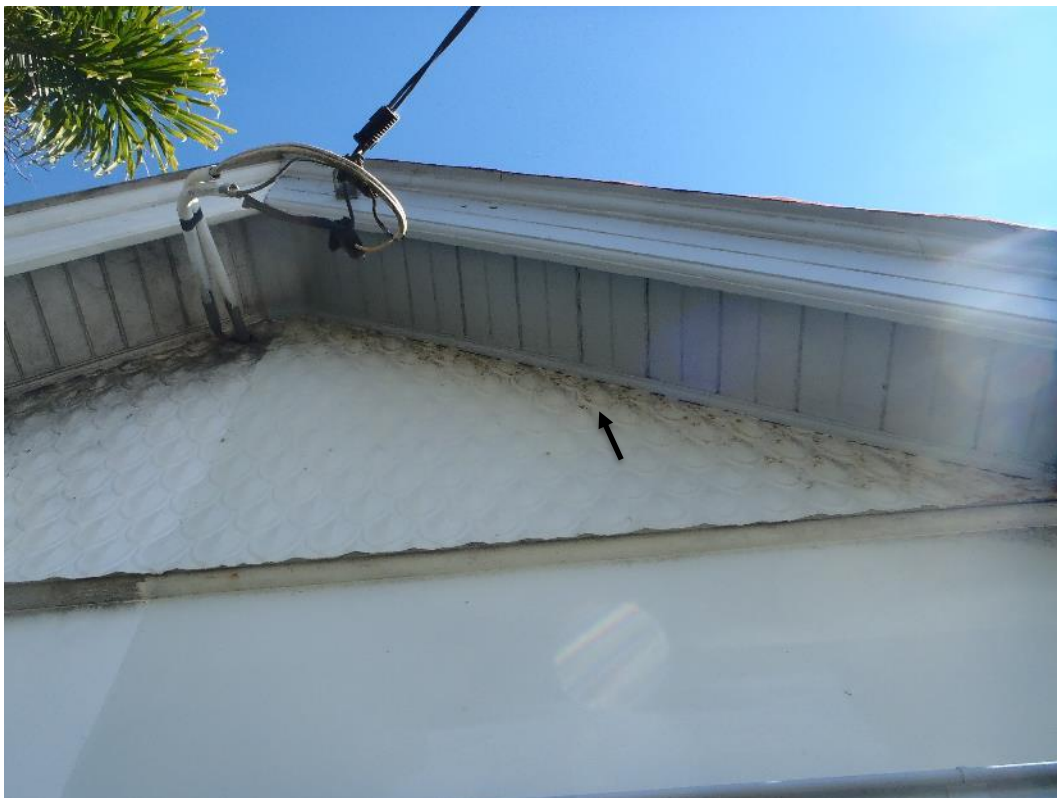
We noted rusting to the patterned pressed metal gable end lining. **[Photograph 9]**

**Photograph 9** shows rusting to the patterned pressed metal front gable end lining.

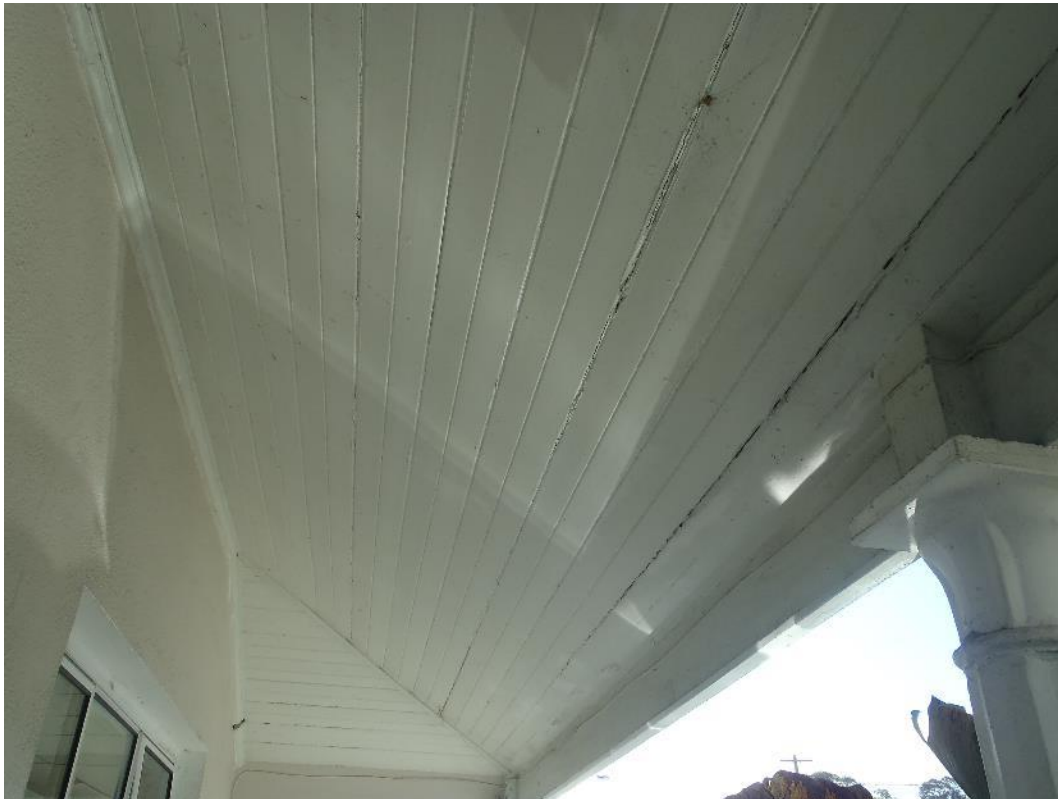
We noted that the verandah ceiling was finished with timber lining boards to the underside of the ceiling rafters. We further noted some gaps and cracking between the lining boards.

**Photograph 10** shows the general condition of the verandah soffit lining.

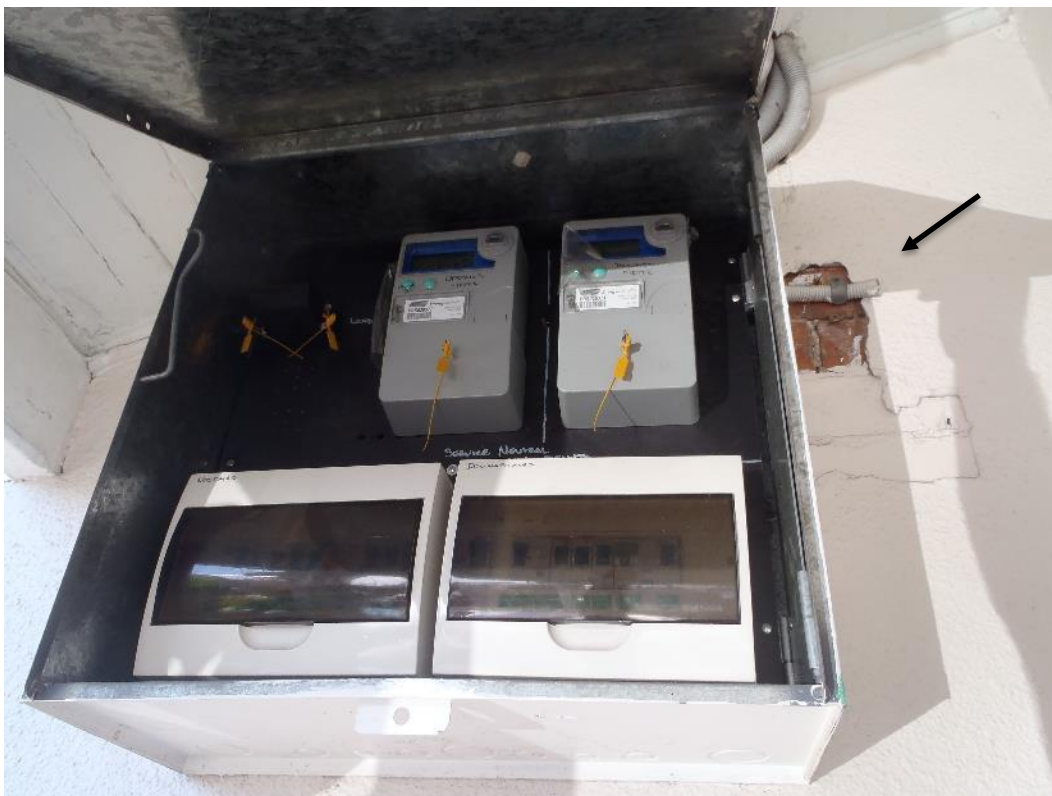
We noted damage to the cement rendered finish of the *common privacy* wall between the adjoining property No. 62 Carrington Road, Randwick adjacent to the electrical meter board **[Photograph 11]**

**Photograph 11** shows damage to the cement rendered finish of the *common privacy* wall between the adjoining property No. 62 Carrington Road, Randwick.

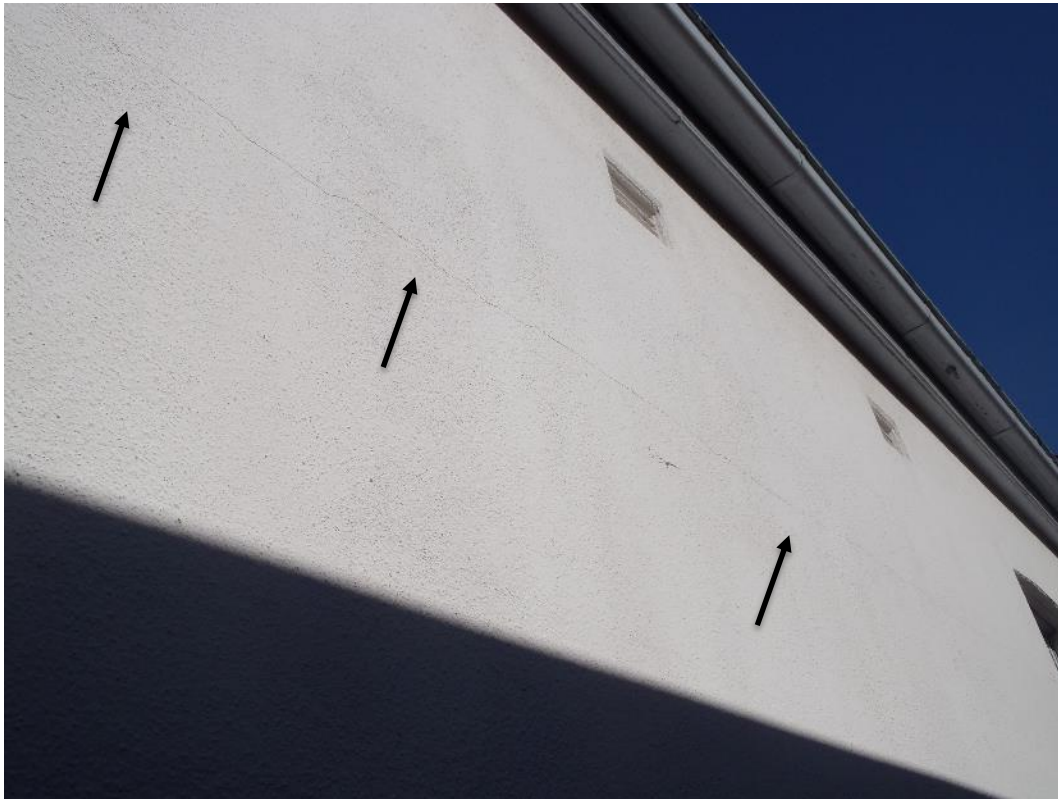
We noted horizontal cracking [1mm – 3mm] to the surface coated clay masonry brickwork extending from the Bedroom 2 window towards the front of the residence. **[Photograph 12]**

**Photograph 12** shows horizontal cracking to the surface coated clay masonry brickwork extending from the Bedroom 2 window.

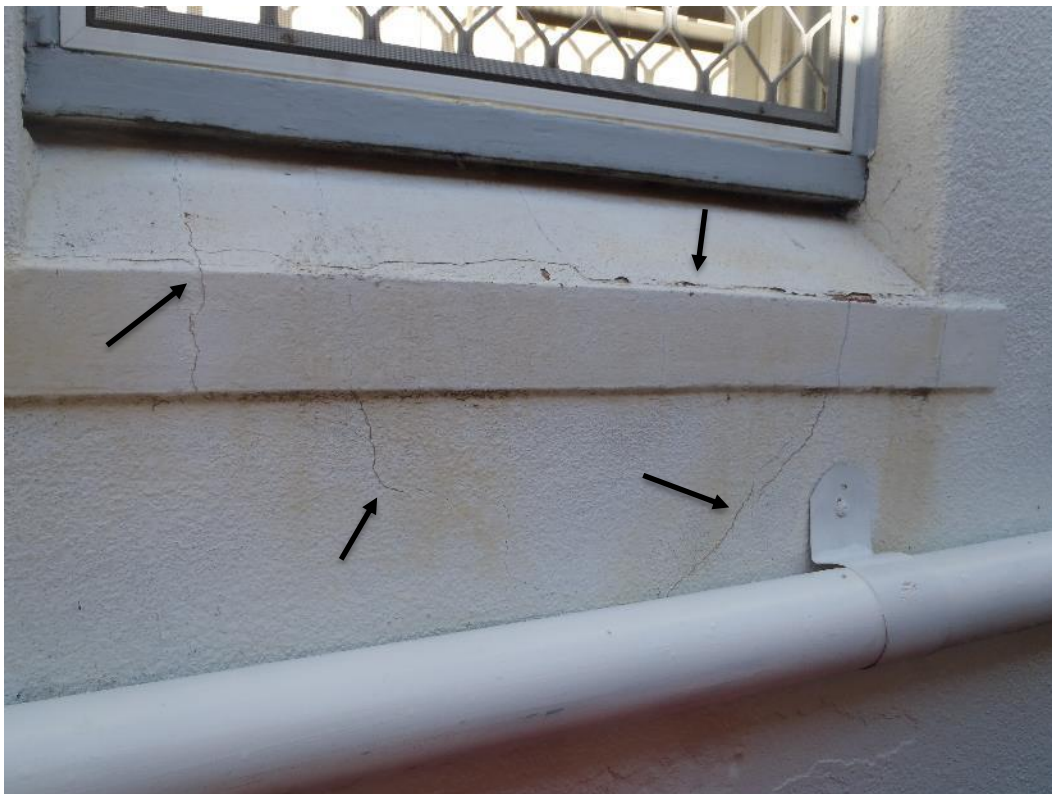
We noted horizontal and radial cracking [1mm – 3mm] to the surface coated clay masonry brickwork around the Bedroom 3 window sill. **[Photograph 13]**

**Photograph 13** shows horizontal and radial cracking to the surface coated clay masonry brickwork around the Bedroom 3 window sill.

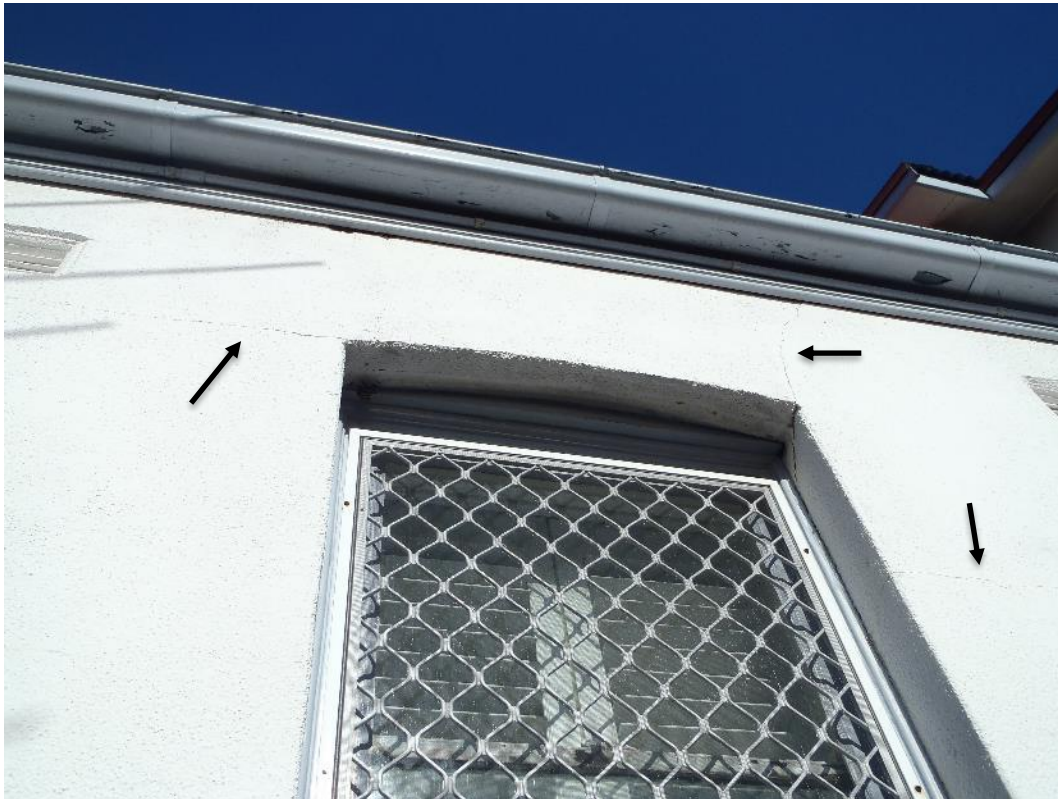
We noted horizontal and vertical cracking [1mm – 3mm] to the surface coated clay masonry brickwork around the Bedroom 3 window head. **[Photograph 14]**

**Photograph 14** shows horizontal and vertical cracking to the surface coated clay masonry brickwork around the Bedroom 3 window head.

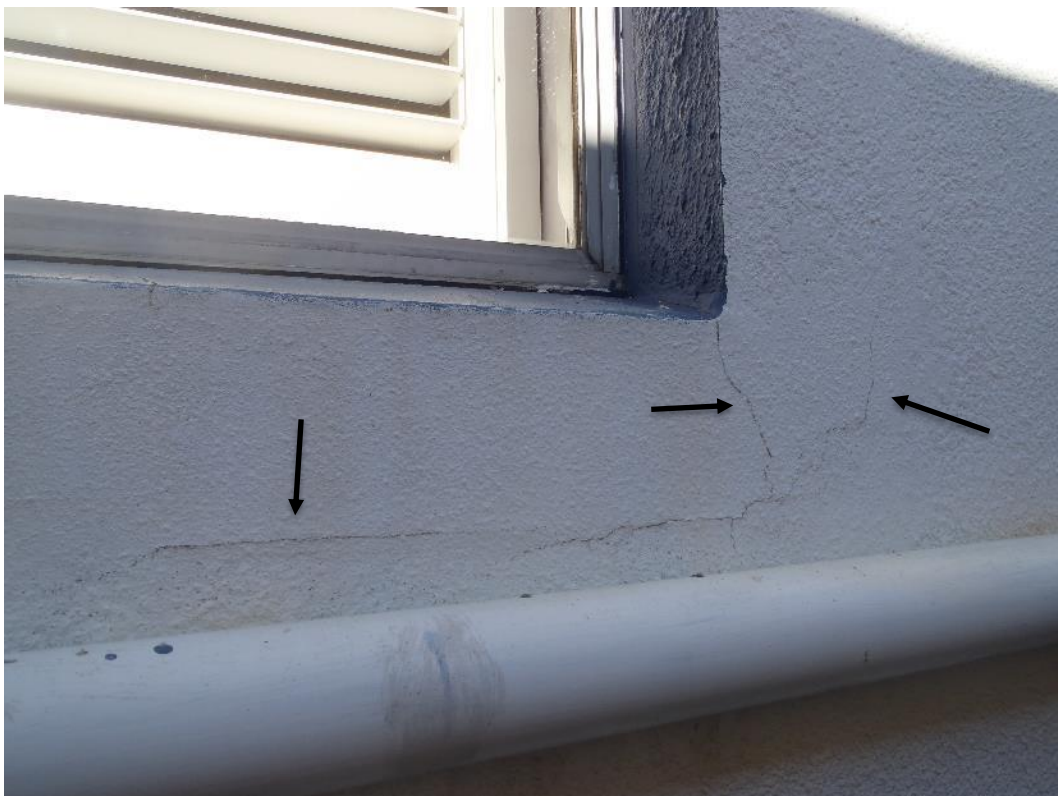
We noted horizontal and radial cracking [1mm – 3mm] to the surface coated clay masonry brickwork around the Lounge Room window sill. **[Photograph 15]**

**Photograph 15** shows horizontal and radial cracking to the surface coated clay masonry brickwork around the Lounge Room window sill.

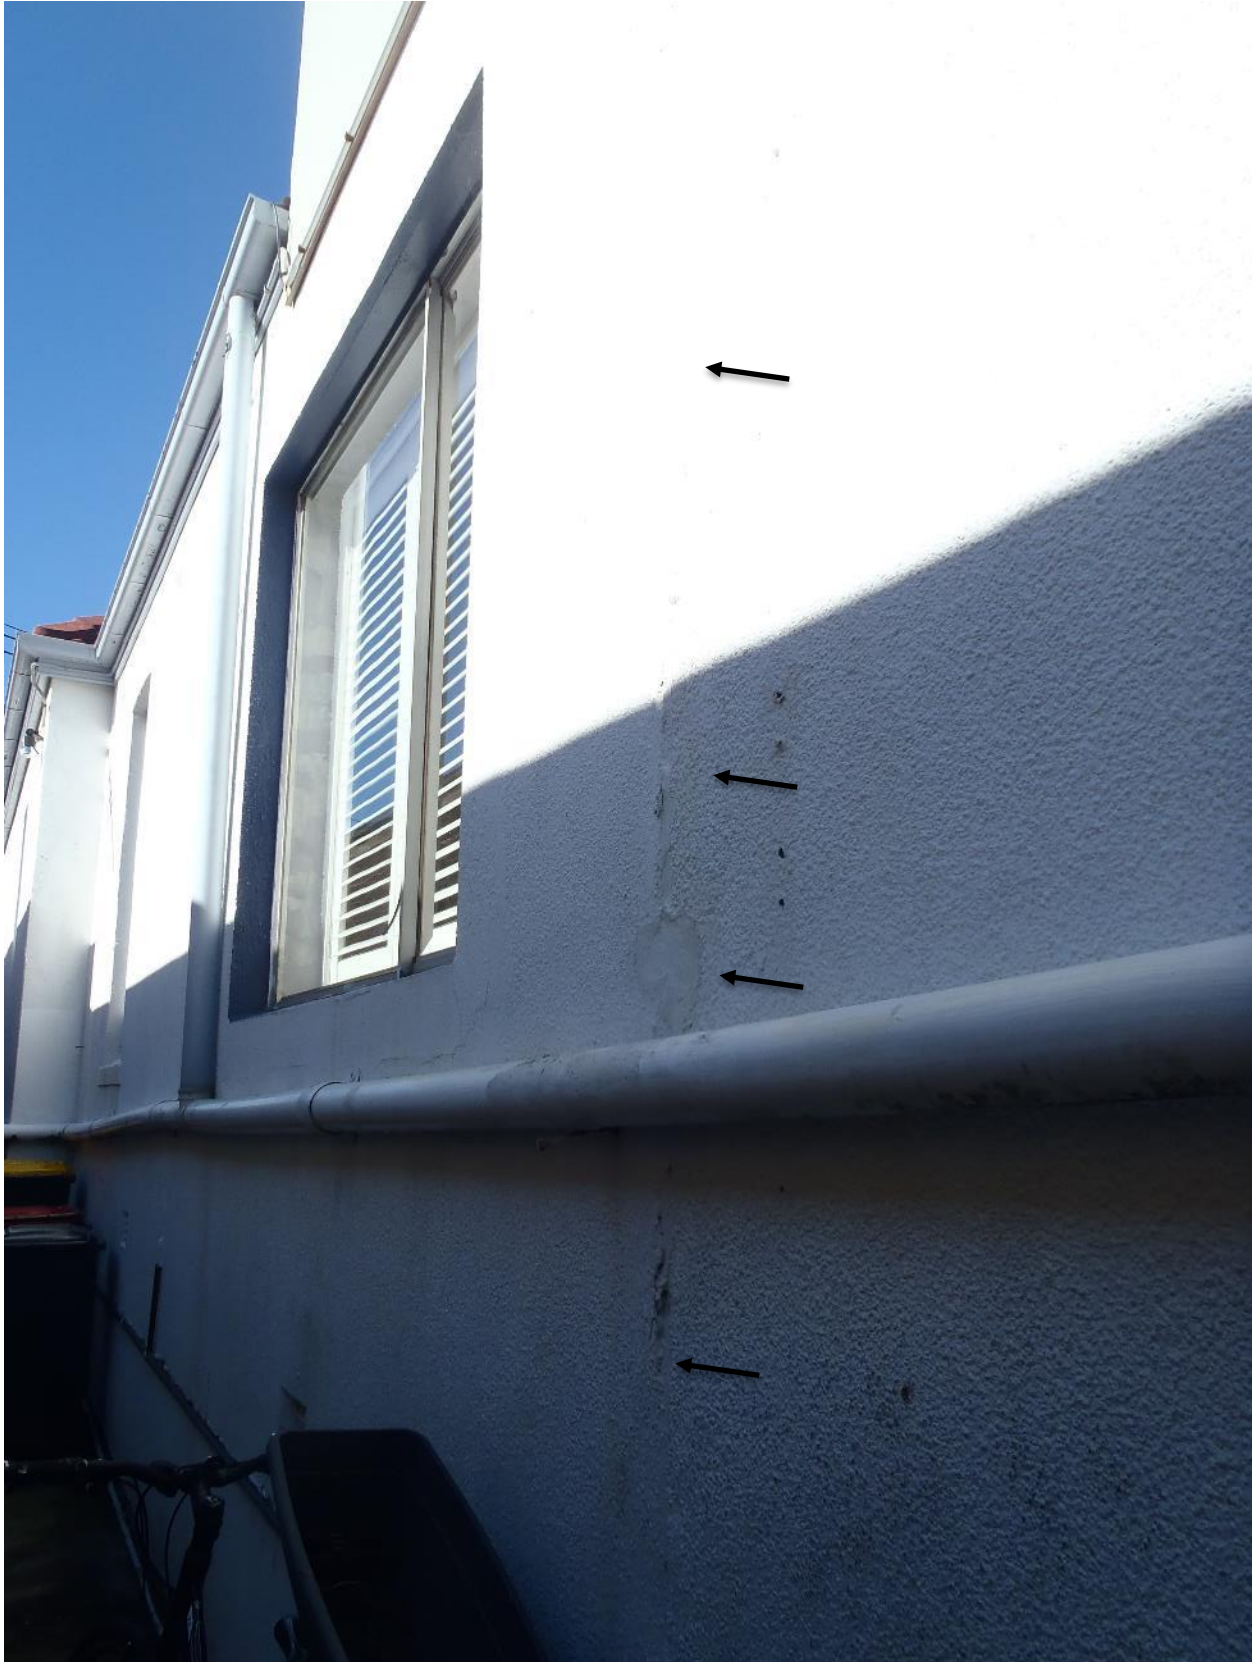
We noted vertical cracking [1mm – 3mm] and evidence of previous repairs to the surface coated clay masonry brickwork adjacent to the Kitchen window. **[Photograph 16]**

**Photograph 16** shows vertical cracking and evidence of previous repairs to the surface coated clay masonry brickwork adjacent to the Kitchen window.

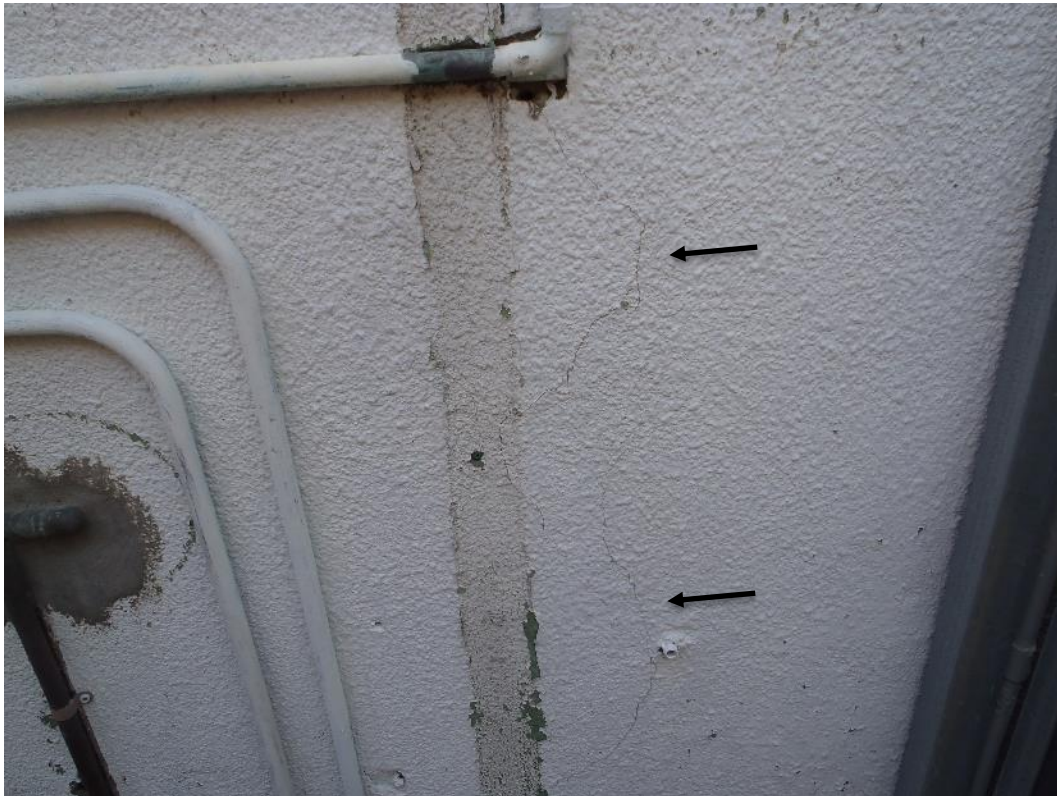
We noted radial cracking [ $<1$ mm] to the surface coated clay masonry brickwork toward the ground between the Kitchen and Laundry. **[Photograph 17]**

**Photograph 17** shows radial cracking to the surface coated clay masonry brickwork toward the ground between the Kitchen and Laundry.

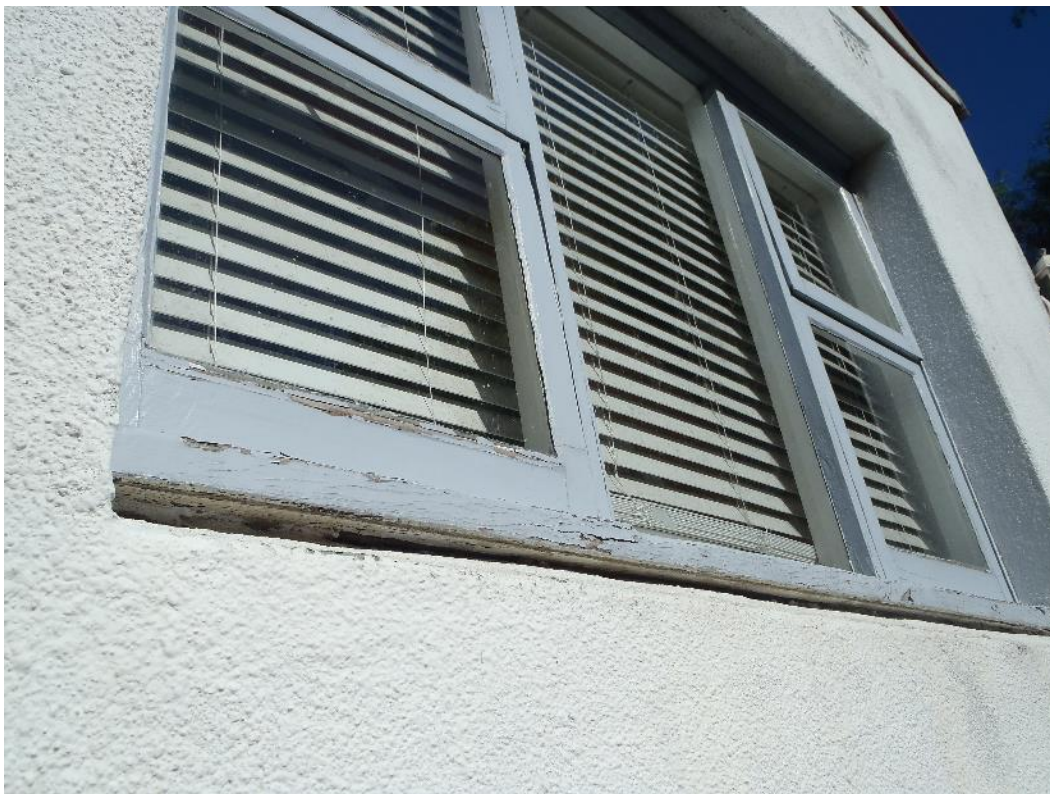
We noted general deterioration to the painted surface of the Laundry window. **[Photograph 18]**

**Photograph 18** shows general deterioration to the painted surface of the Laundry window.

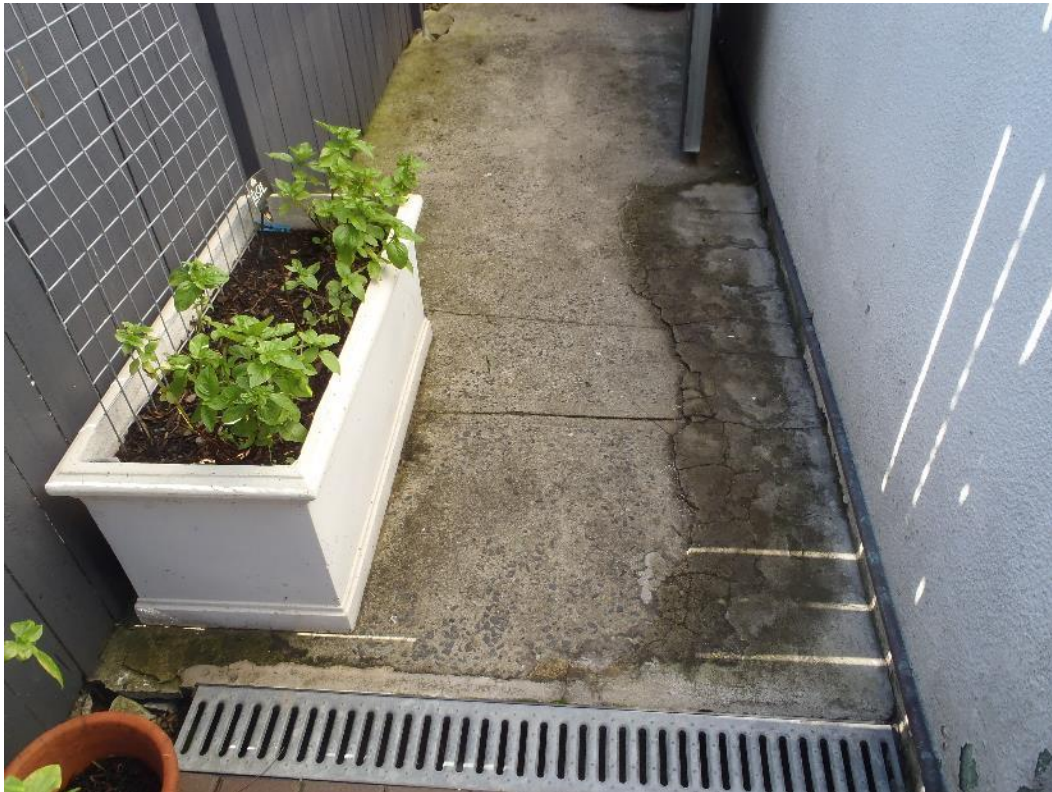
We noted dampness and cracking to the concrete pathway outside the Laundry. **[Photograph 19]**

**Photograph 19** shows dampness and cracking to the concrete pathway outside the Laundry.

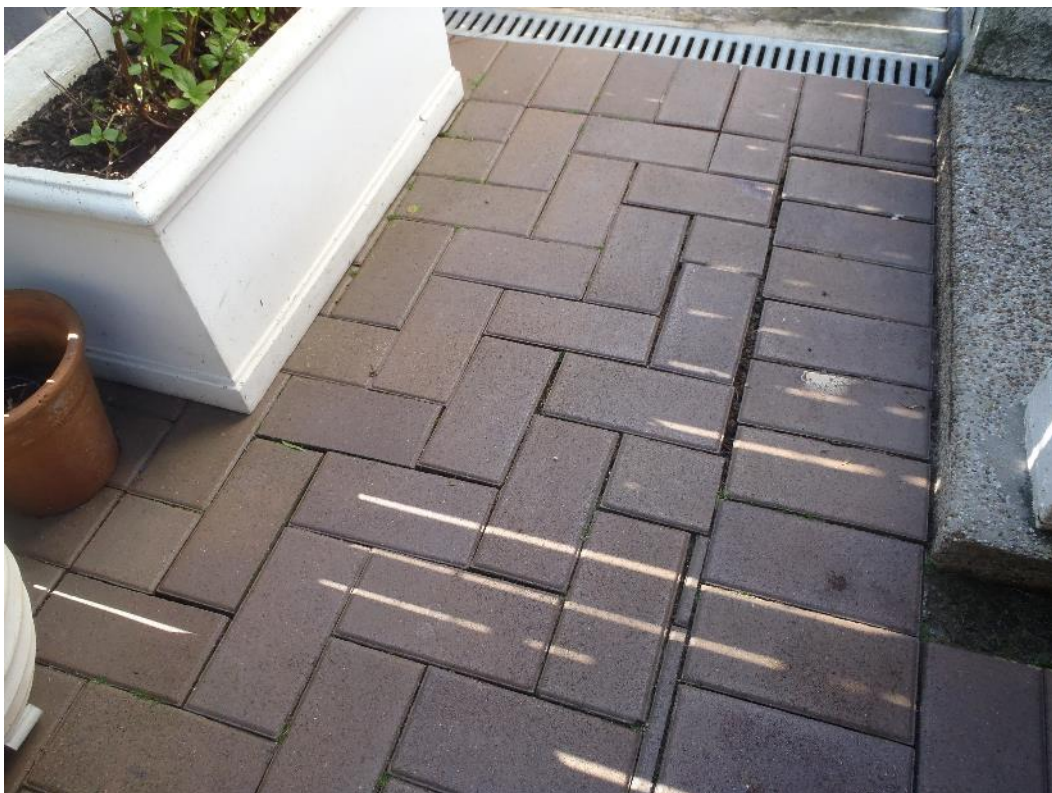
We noted displacement to the paved surface outside the Laundry steps. **[Photograph 20]**

**Photograph 20** shows displacement to the paved surface outside the Laundry steps.

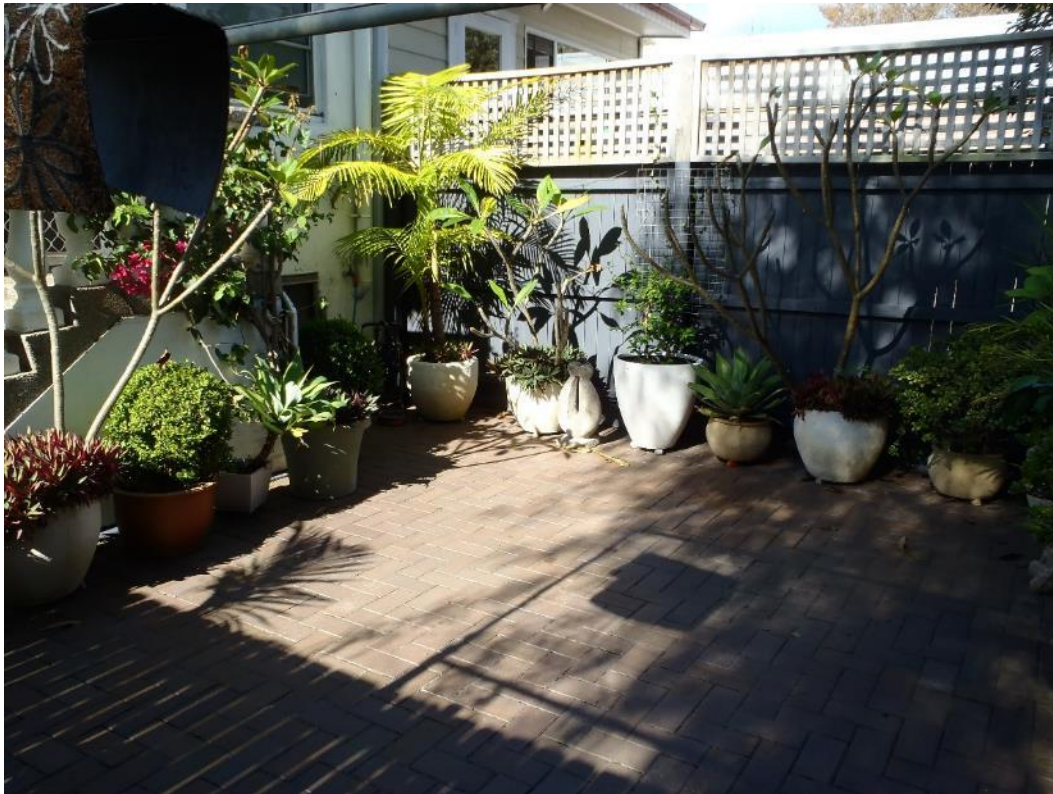
We noted that the common rear boundary fence was of timber post and rail construction with lattice above. We further noted that the rear courtyard was paved. **[Photograph 21]**

**Photograph 21** shows the general condition of the *common* rear boundary fence and the rear courtyard area.

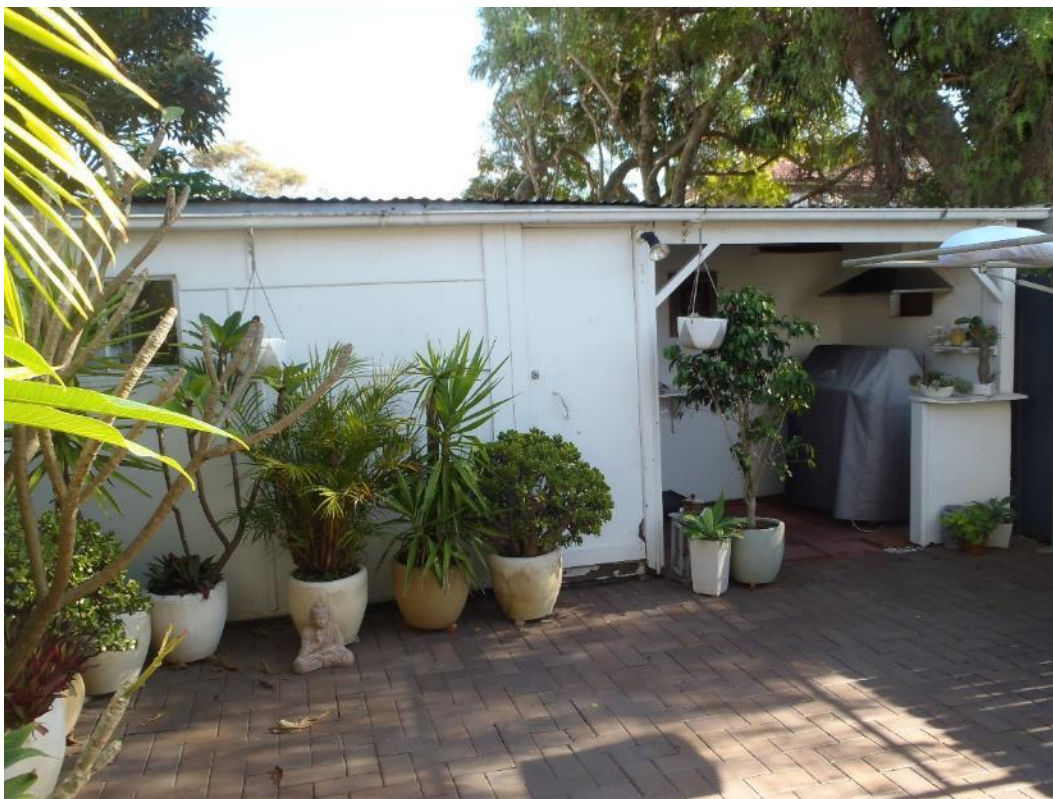
We noted a timber framed fibro shed at the rear with corrugated profile sheet metal roofing. **[Photograph 22]**

**Photograph 22** shows the general condition of the timber framed fibro shed.
