## Dilapidation Assessment Report

Prepared for: Cape Cod Australia Pty. Limited  
Job address: No. 60 Carrington Road, Randwick.  
Property Owner/s: Mr. Mark & Mrs. Ana McLeod.  
Report reference: **RANDWICK CITY COUNCIL**  
Development Application No: not available  
Date of assessment: 24<sup>th</sup> May 2017

**Re: Dilapidation Report – No. 60 Carrington Road, Randwick.**

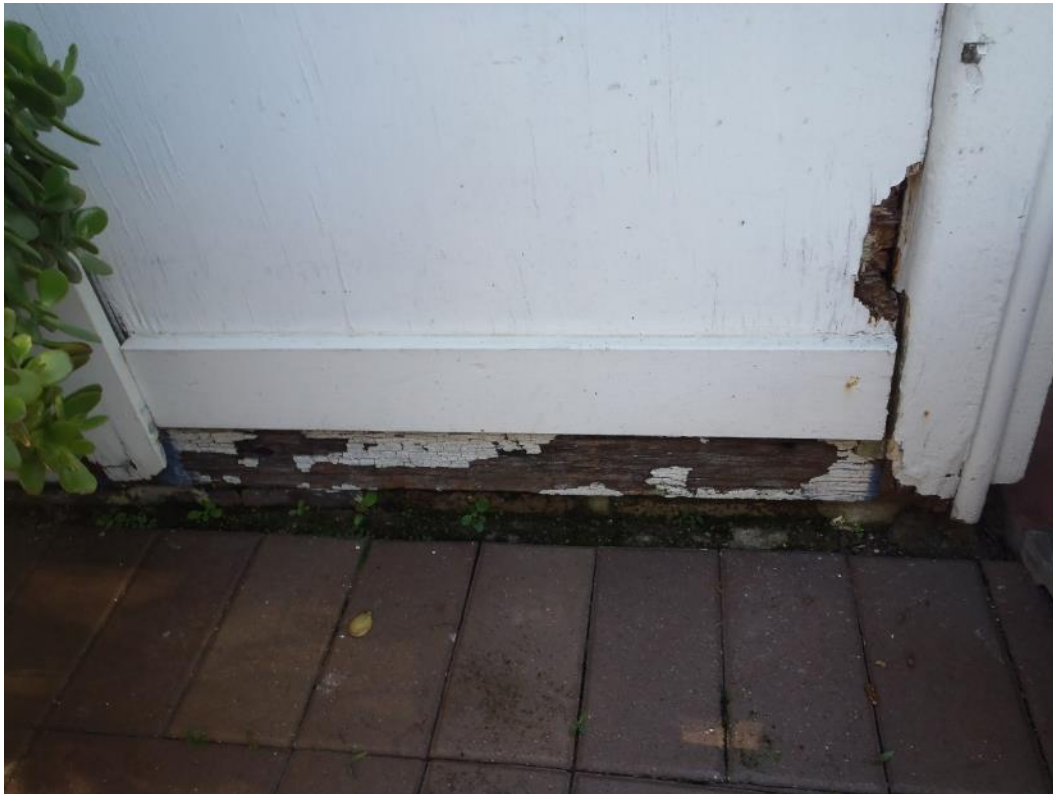
We noted deterioration, dampness and rotting to the door and threshold of the shed.

**Photograph 23** shows deterioration, dampness and rotting to the door and threshold of the rear shed.

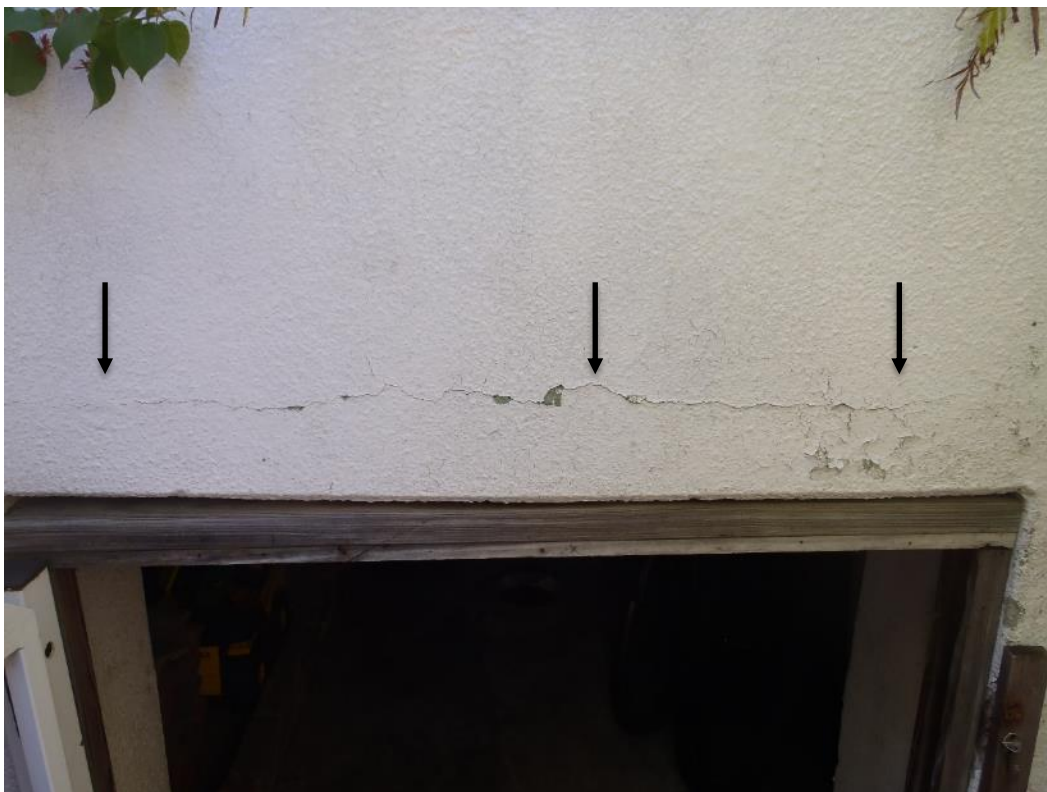
We noted horizontal cracking [1mm – 3mm] to the surface coated clay masonry brickwork above the under-floor access door. **[Photograph 24]**

**Photograph 24** shows horizontal cracking to the surface coated clay masonry brickwork above the under-floor access door.

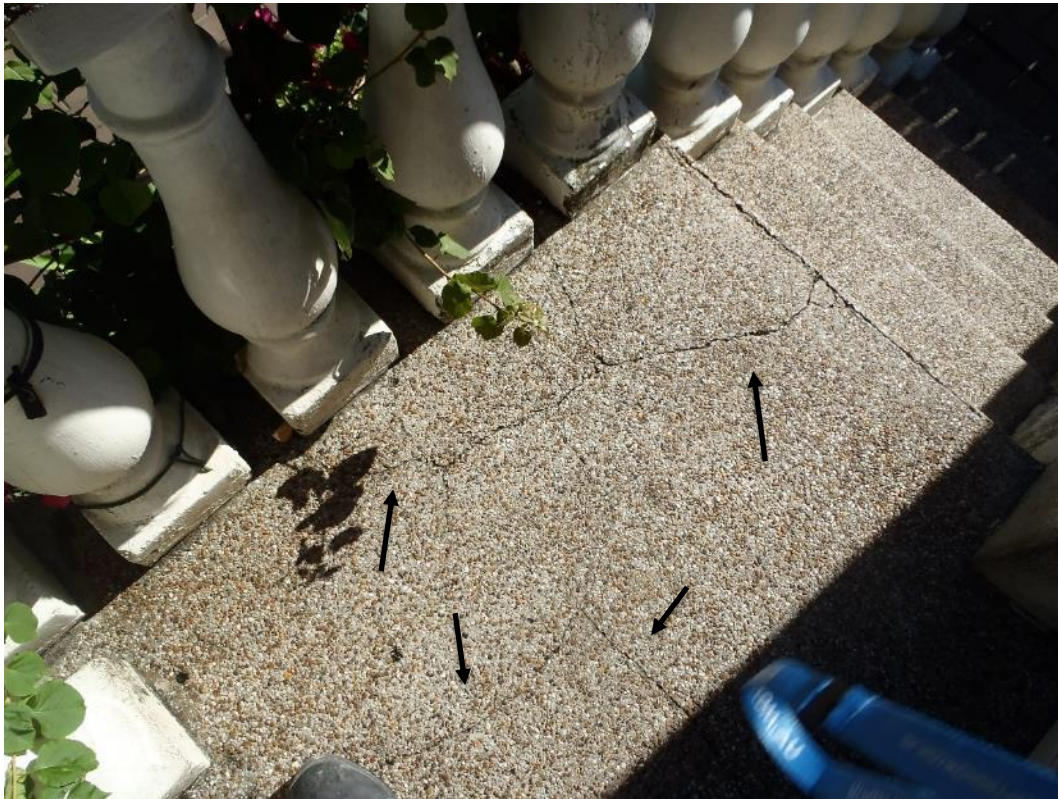
We noted radial cracking [1mm - 3mm] to the suspended concrete slab rear step landing.

**Photograph 25** shows radial cracking to the suspended concrete slab rear step landing.

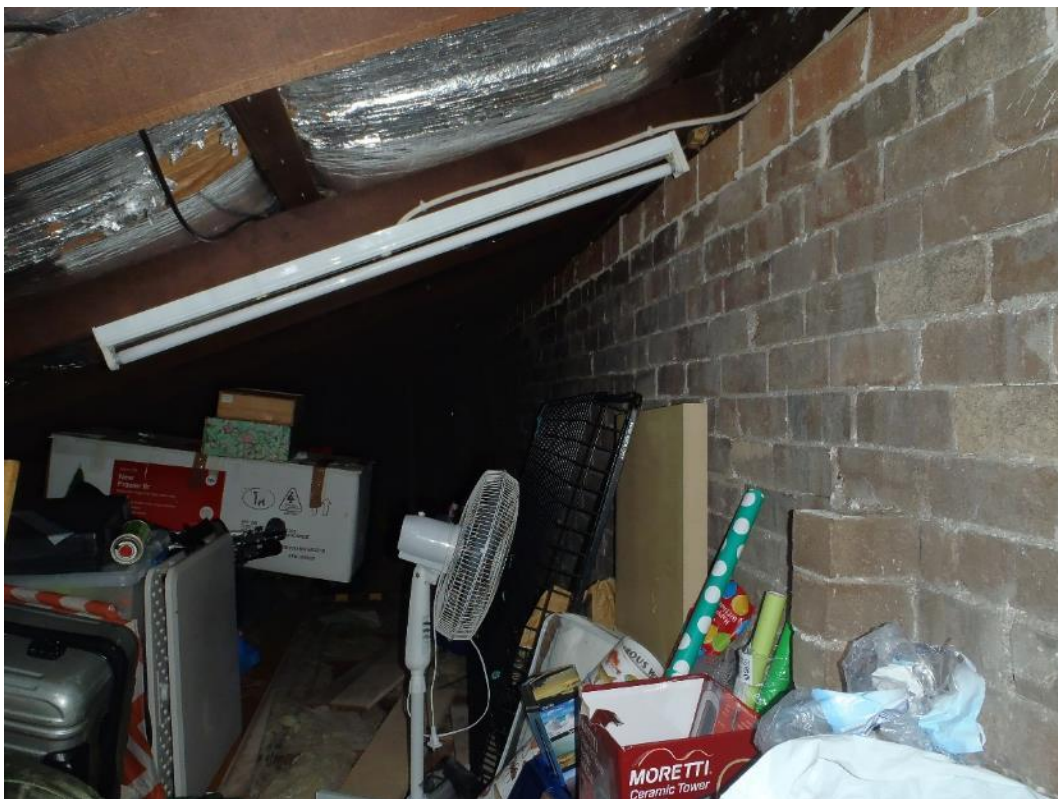
We noted that the *common* ridge to the roof is located over the common party wall. We also noted that the clay brick common party wall extends to the underside of the rafters. **[Photograph 26]**

**Photograph 26** shows the general condition of the roof space.

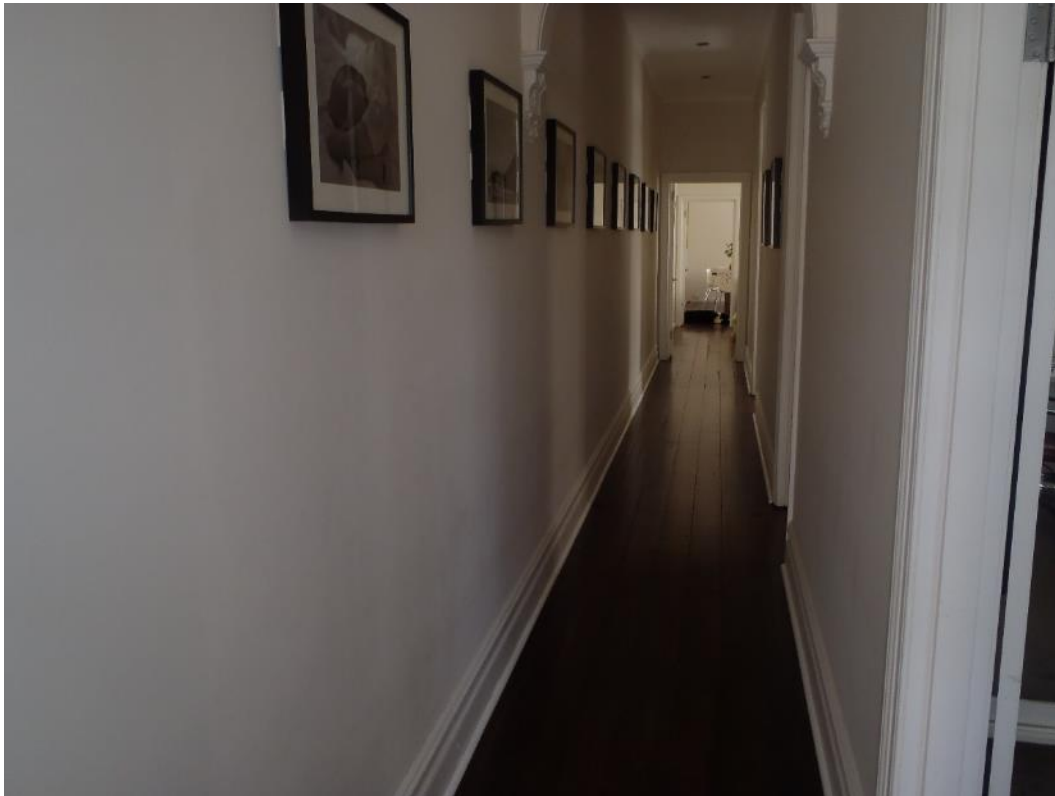
**Photograph 27** shows the general condition of the hallway.

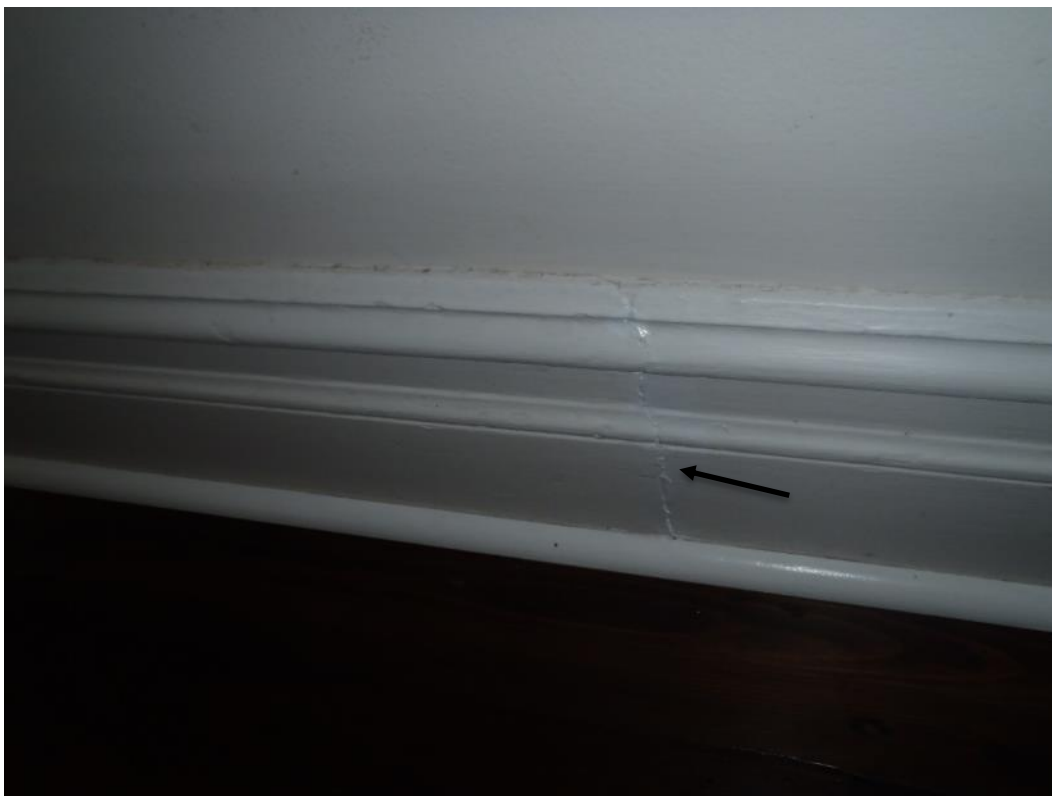
We noted cracking to the mitre joint in the skirting along the *common party / separation* wall opposite the doorway to Bedroom 1. **[Photograph 28]**

**Photograph 28** shows cracking to the mitre joint in the skirting along the *common party / separation* wall opposite the doorway to Bedroom 1 in the hallway.

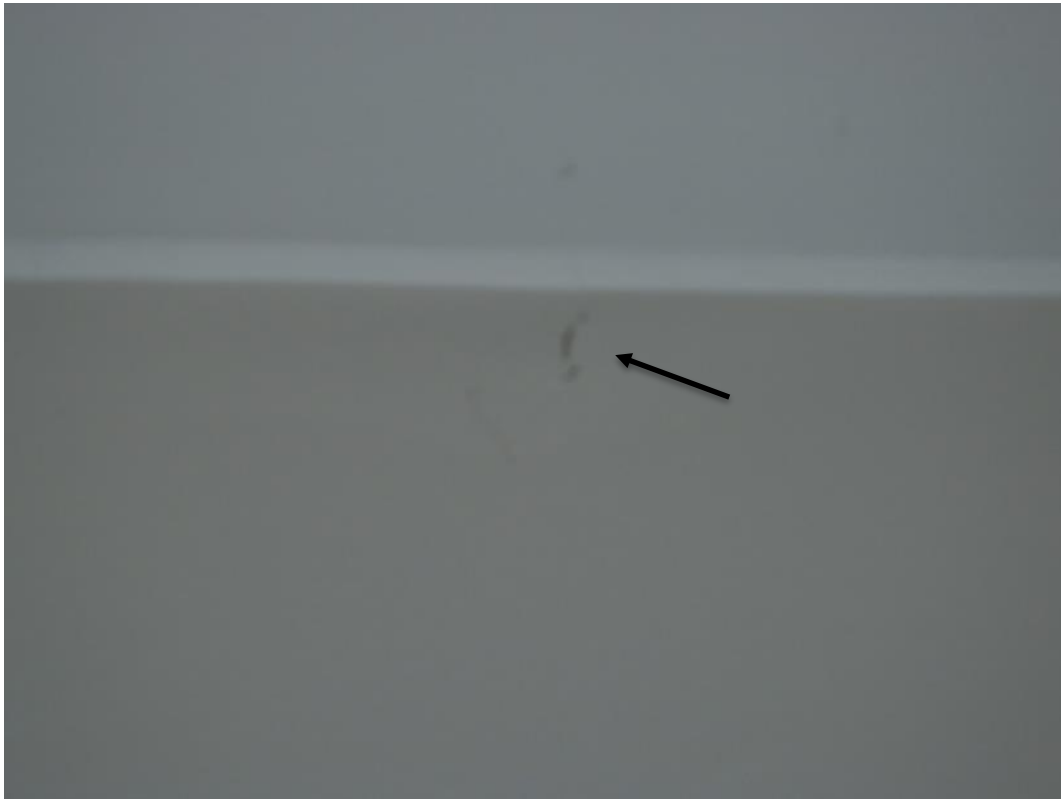
We noted a radial hairline crack [<1mm] outside Bedroom 3. **[Photograph 29]**

**Photograph 29** shows a radial hairline crack outside Bedroom 3 near the plaster cornice in the hallway.

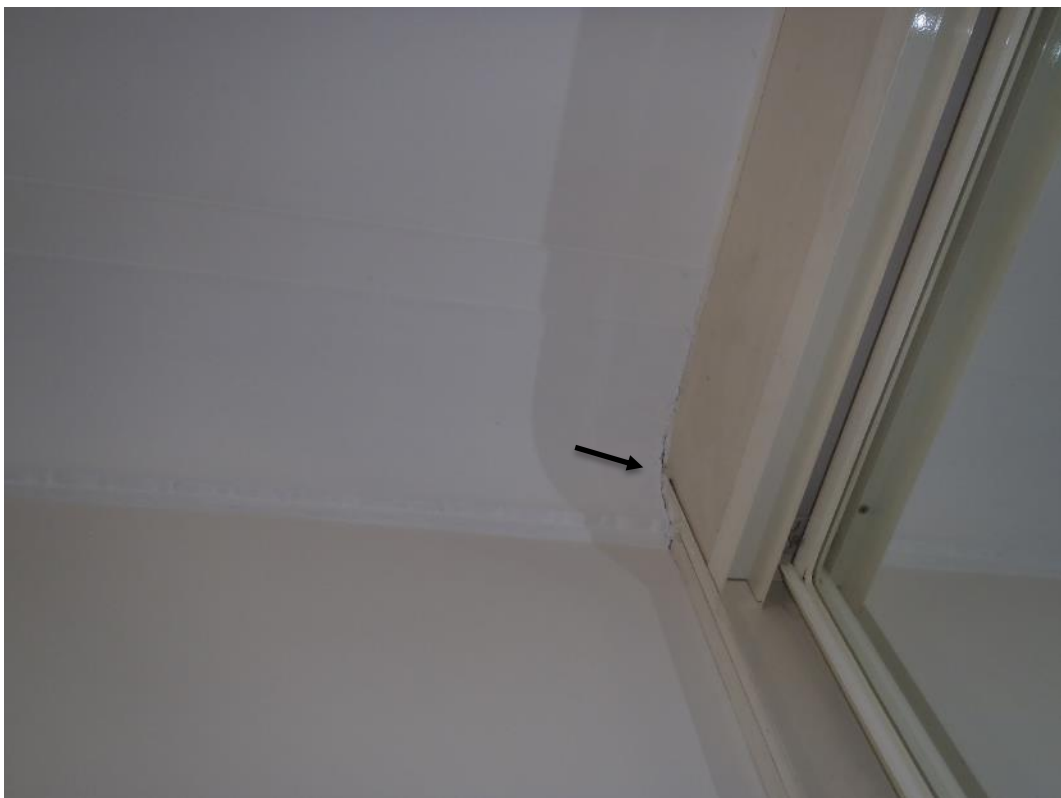
We noted separation cracking [ $<1\text{mm}$ ] to the cornice / cupboard junction in the south-west corner.

**Photograph 30** shows separation cracking to the cornice / cupboard junction in the south-west corner in Bedroom 1.

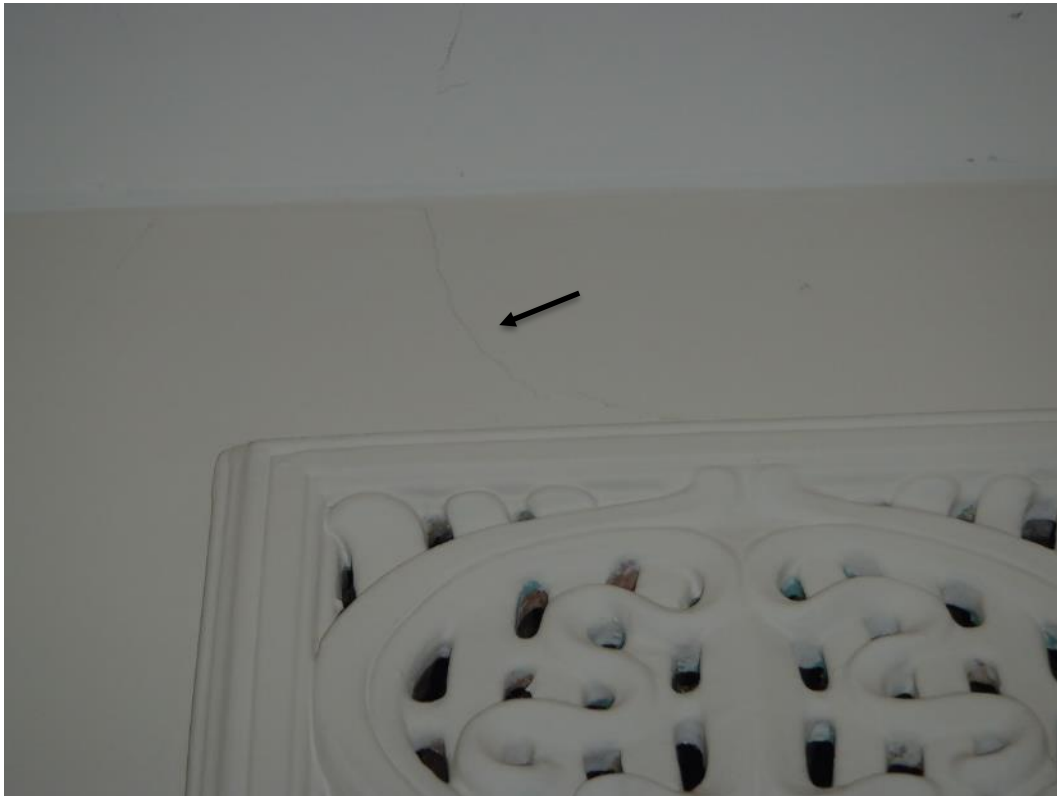
We noted radial hairline cracking [ $<1\text{mm}$ ] above the wall vent on the northern external wall.

**Photograph 31** shows radial hairline cracking above the wall vent on the northern external wall in Bedroom 2.

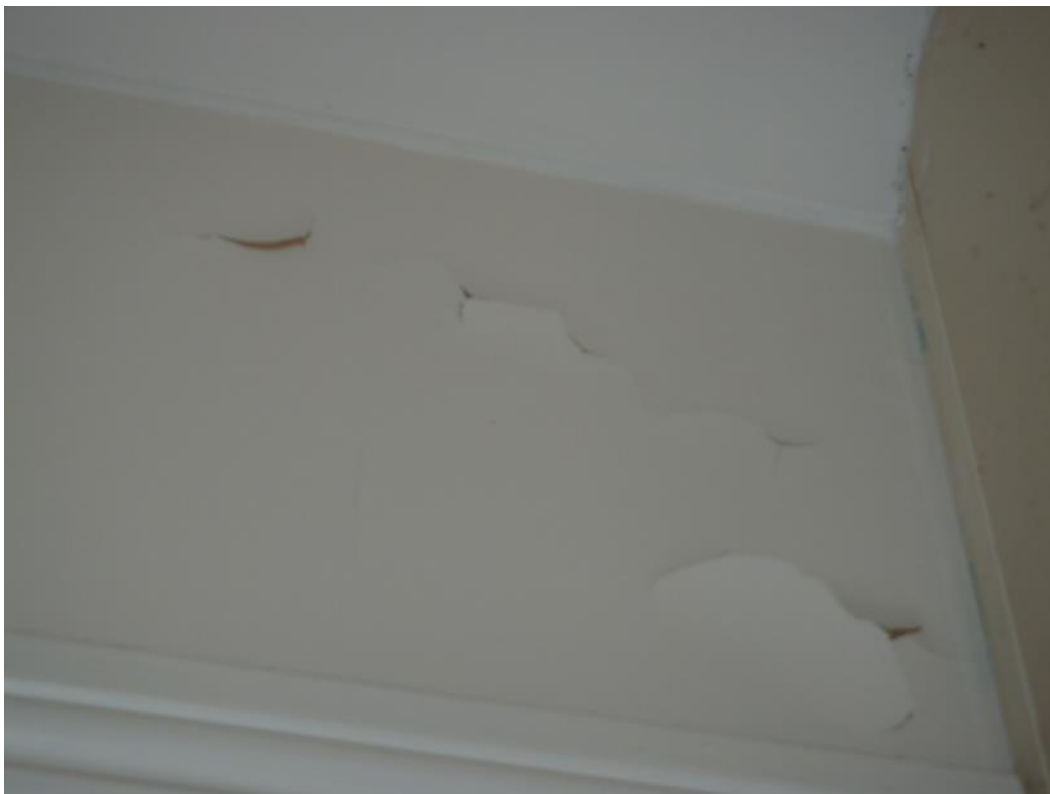
We noted flaking paint to the surface coated cement rendered wall surface in the south-western corner. **[Photograph 32]**

**Photograph 32** shows flaking paint to the surface coated cement rendered wall surface in the south-western corner of Bedroom 2.

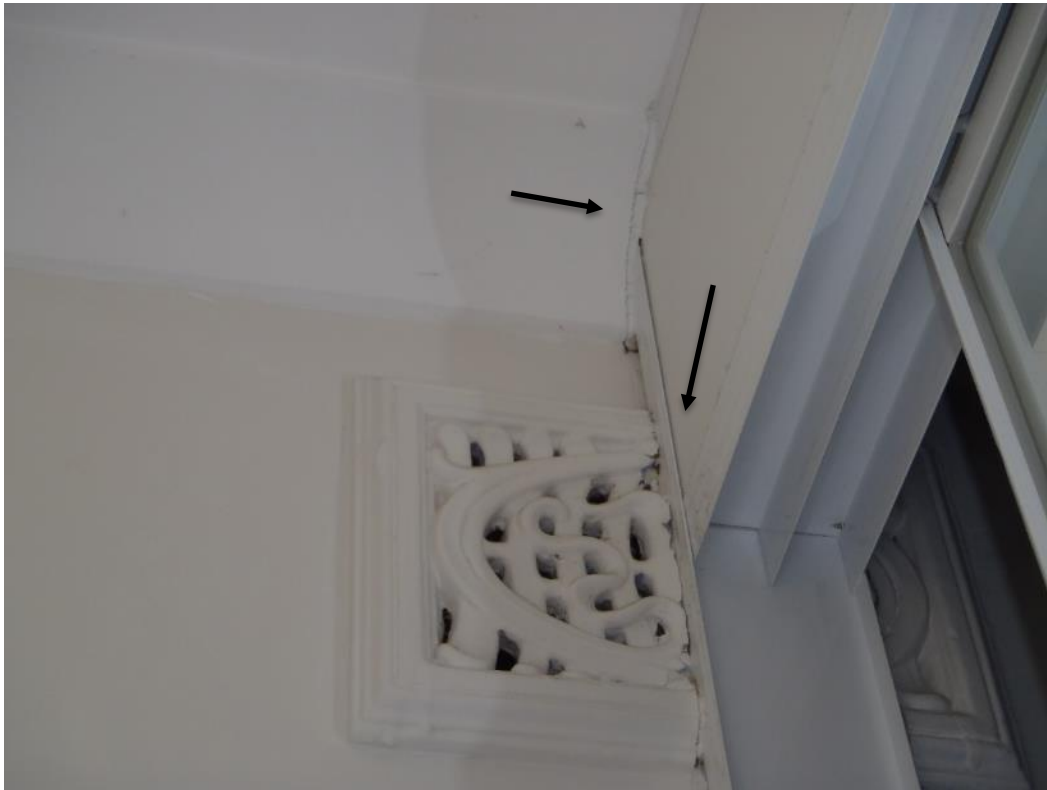
We noted separation cracking [ $<1\text{mm}$ ] to the cornice / cupboard junction in the north-eastern corner.

**Photograph 33** shows separation cracking to the cornice / cupboard junction in the north-eastern corner of Bedroom 3.

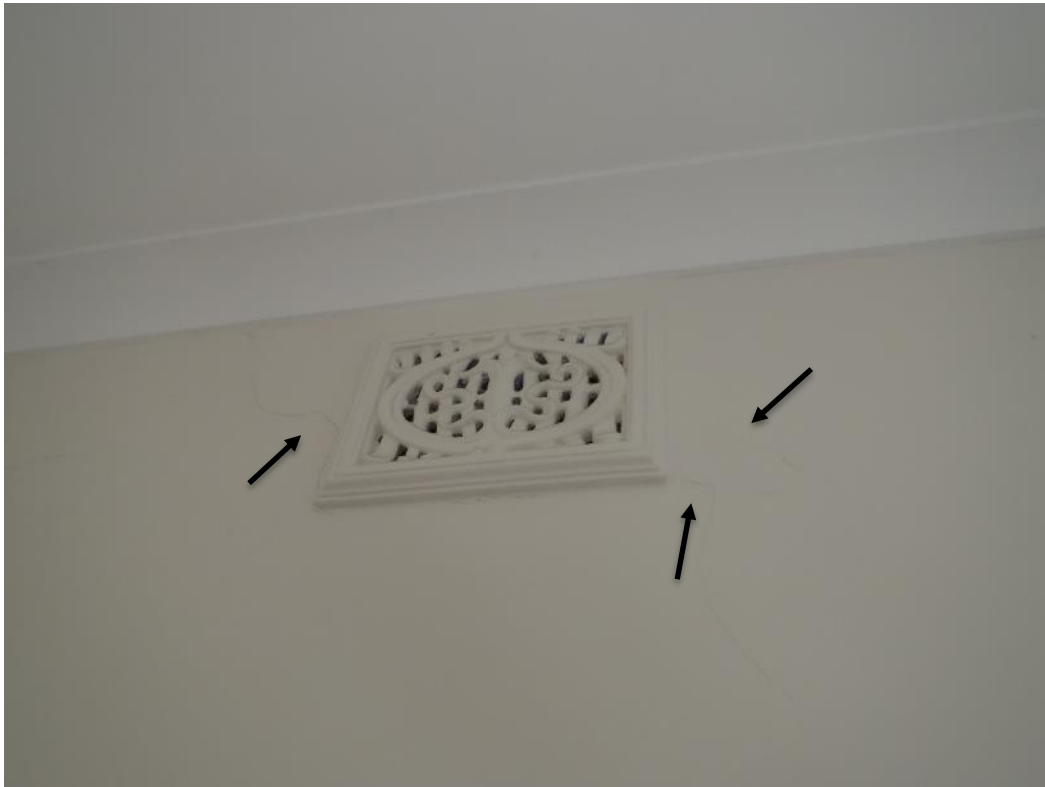
We noted radial cracking [ $<1\text{mm}$ ] around the wall vent on the northern external wall.

**Photograph 35** shows radial cracking around the wall vent on the northern external wall in Bedroom 3.

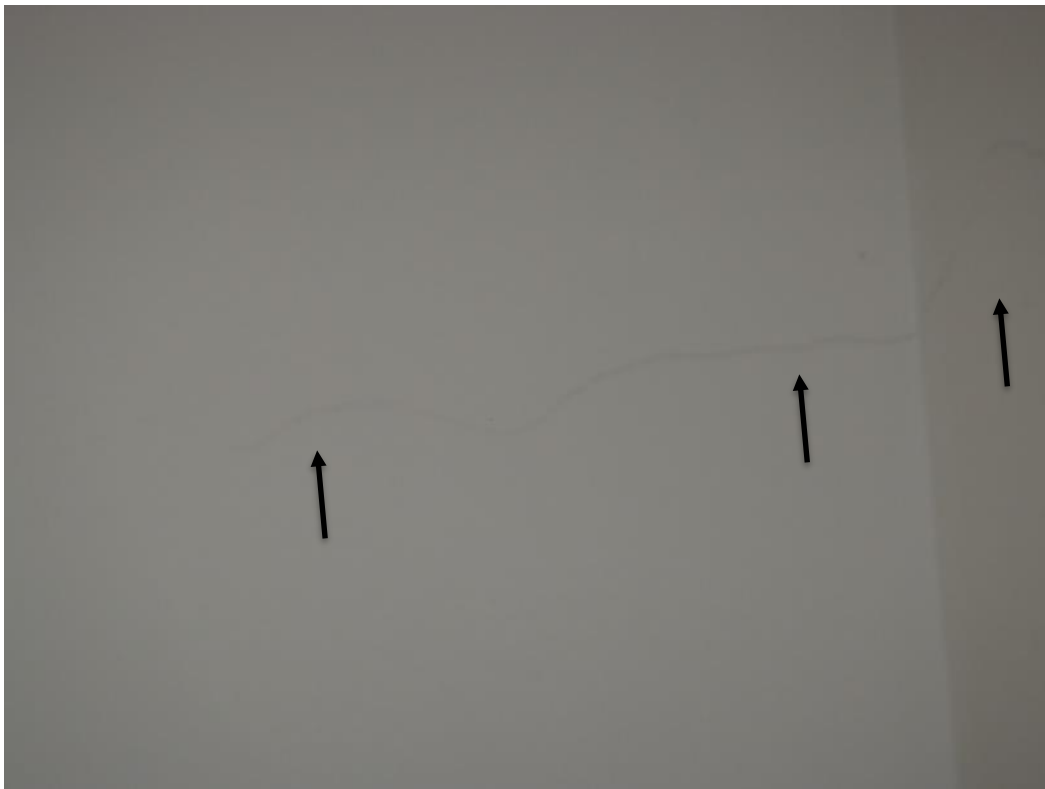
We noted horizontal hairline cracking [ $<1\text{mm}$ ] in the north-western corner. **[Photograph 36]**

**Photograph 36** shows horizontal hairline cracking in the north-western corner of Bedroom 3.

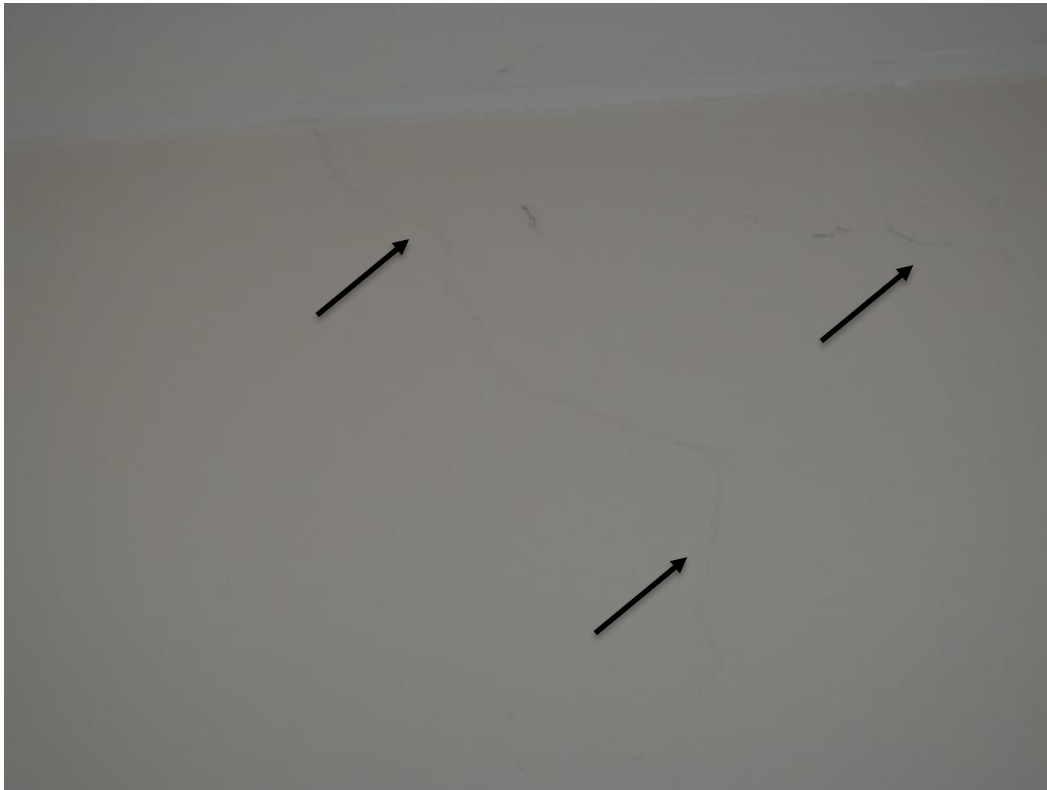
We noted vertical and radial hairline cracking [ $<1\text{mm}$ ] on the eastern wall adjacent to the Hallway.

**Photograph 37** shows vertical and radial hairline cracking [ $<1\text{mm}$ ] on the eastern wall adjacent to the Hallway in the Lounge room

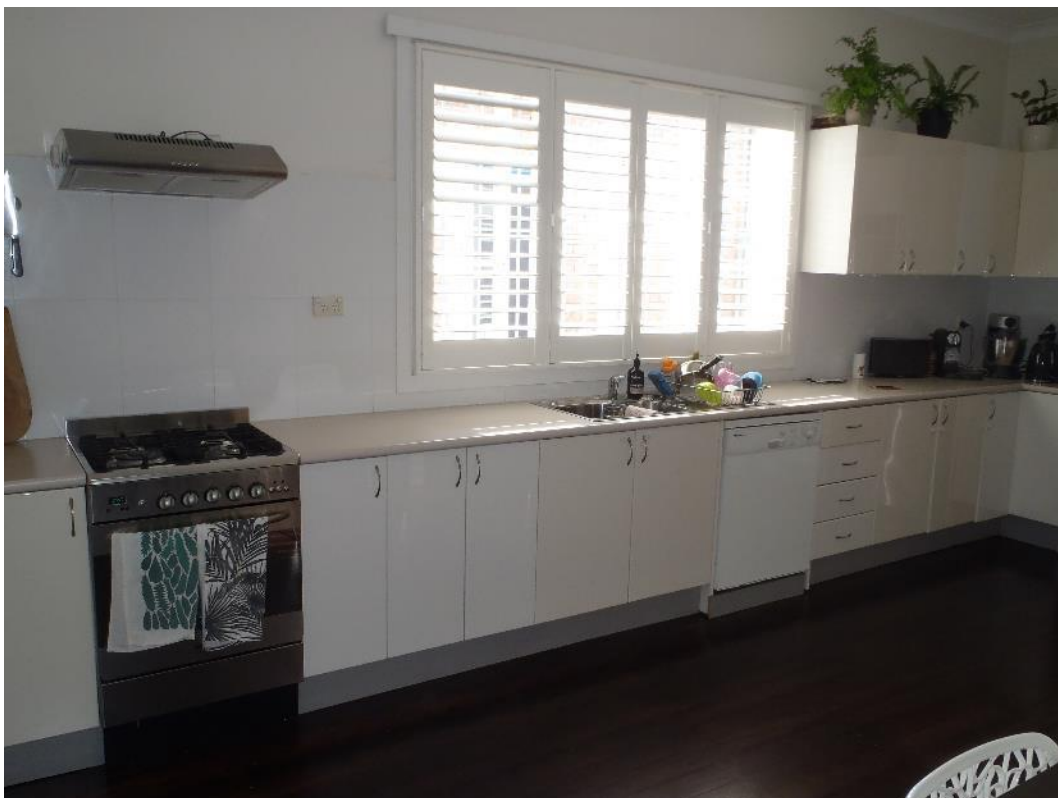
We noted that the kitchen was of open plan design. **[Photograph 38]**

**Photograph 38** shows the general layout of the Kitchen.

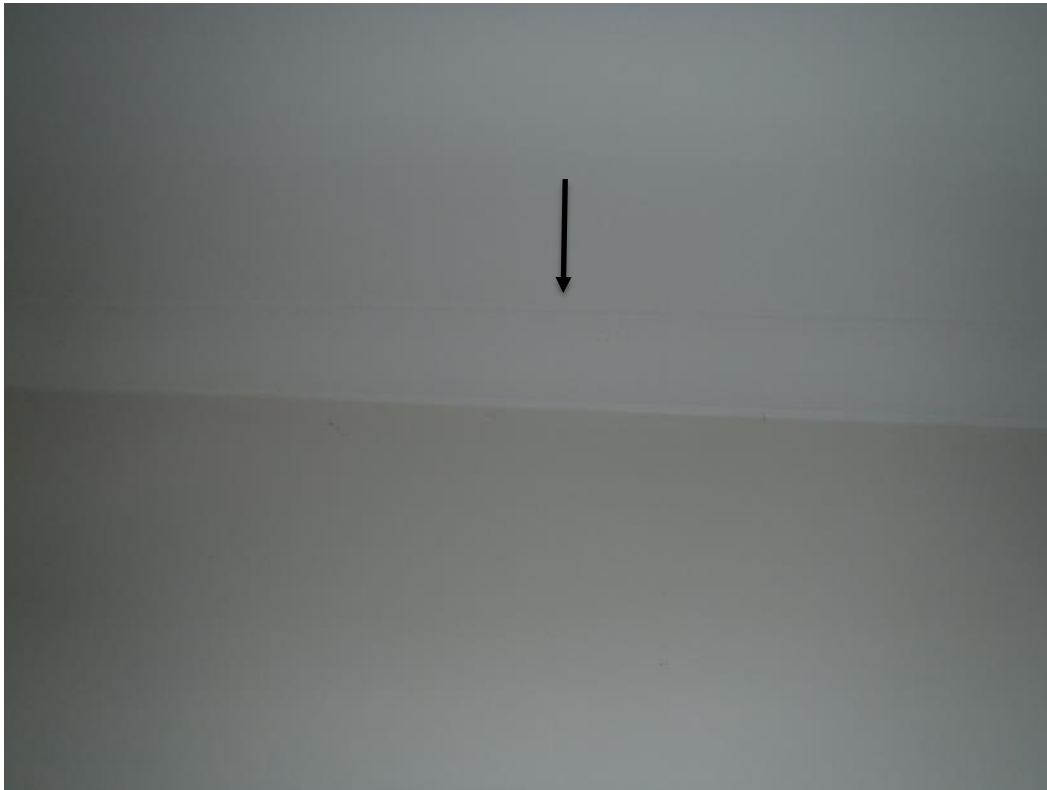
We noted evidence of a previous repair to the cove profiled plaster cornice above the eastern wall.

**Photograph 39** shows evidence of a previous repair to the cove profiled plaster cornice above the eastern wall in the Kitchen.

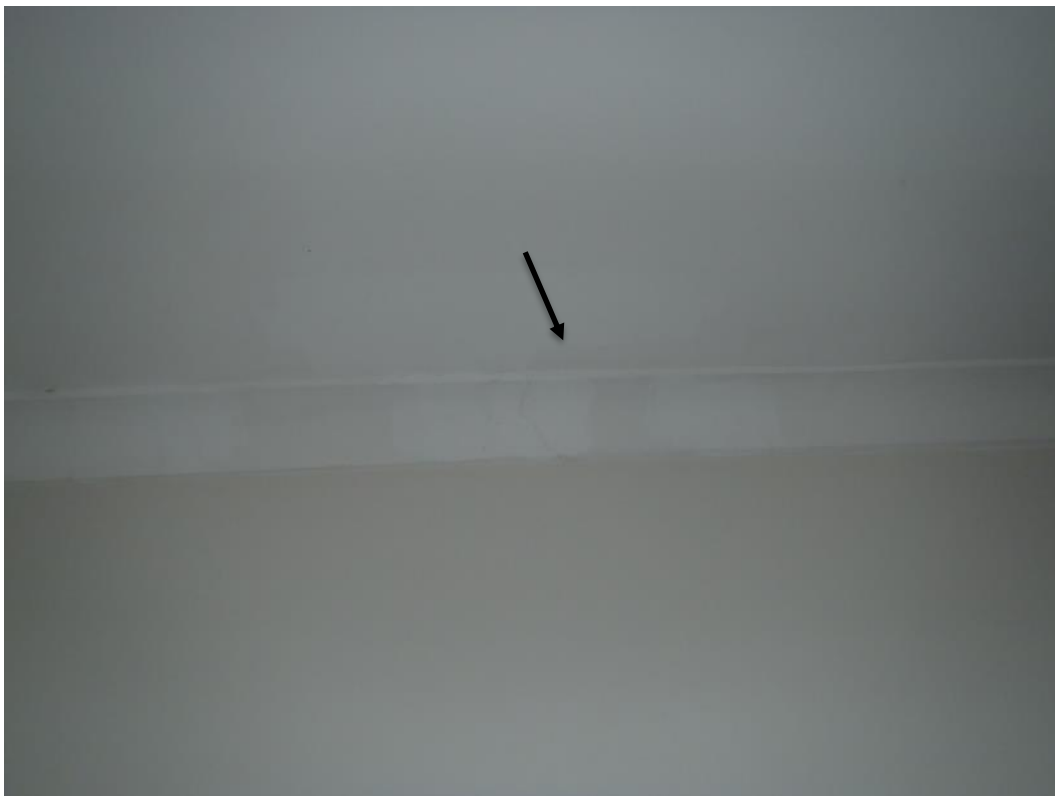
We noted evidence of a previous repair to the cove profiled plaster cornice above the *common party / separation* wall with the adjoining property No. 62 Carrington Road, Randwick. **[Photograph 40]**

**Photograph 40** shows evidence of a previous repair to the cove profiled plaster cornice above the *common party / separation* wall with the adjoining property No. 62 Carrington Road, Randwick in the Kitchen.

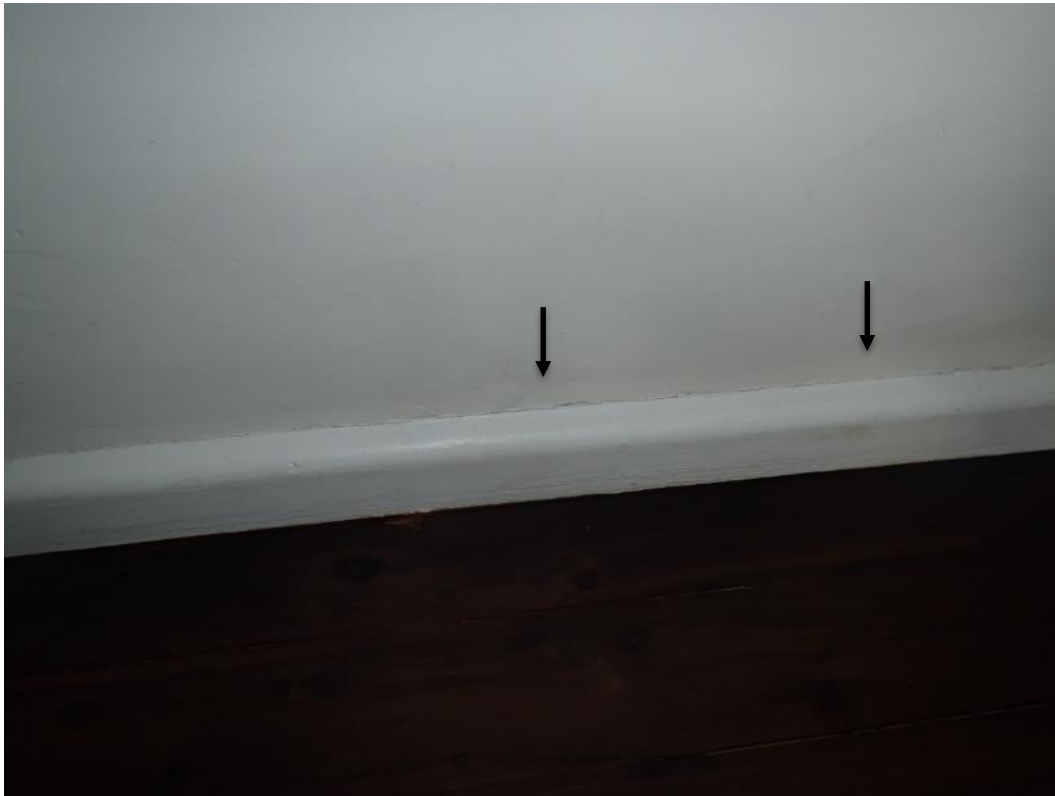
We noted separation cracking [ $<1\text{mm}$ ] between the timber skirting and the *common party / separation* wall with the adjoining property No. 62 Carrington Road, Randwick. **[Photograph 41]**

**Photograph 41** shows separation cracking between the timber skirting and the *common party / separation* wall with the adjoining property No. 62 Carrington Road, Randwick in the Kitchen.

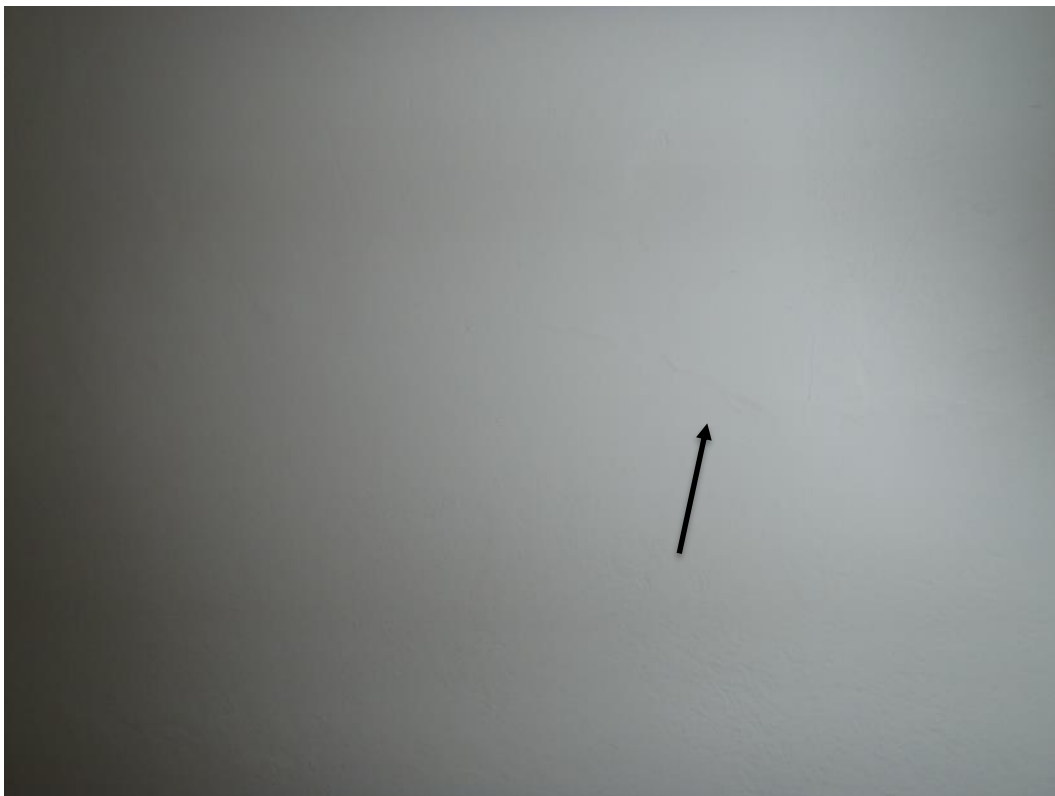
We noted evidence of a previous repair to the painted cement rendered surface on the western wall. **[Photograph 42]**

**Photograph 42** shows evidence of a previous repair to the painted cement rendered surface on the western wall in the Kitchen.

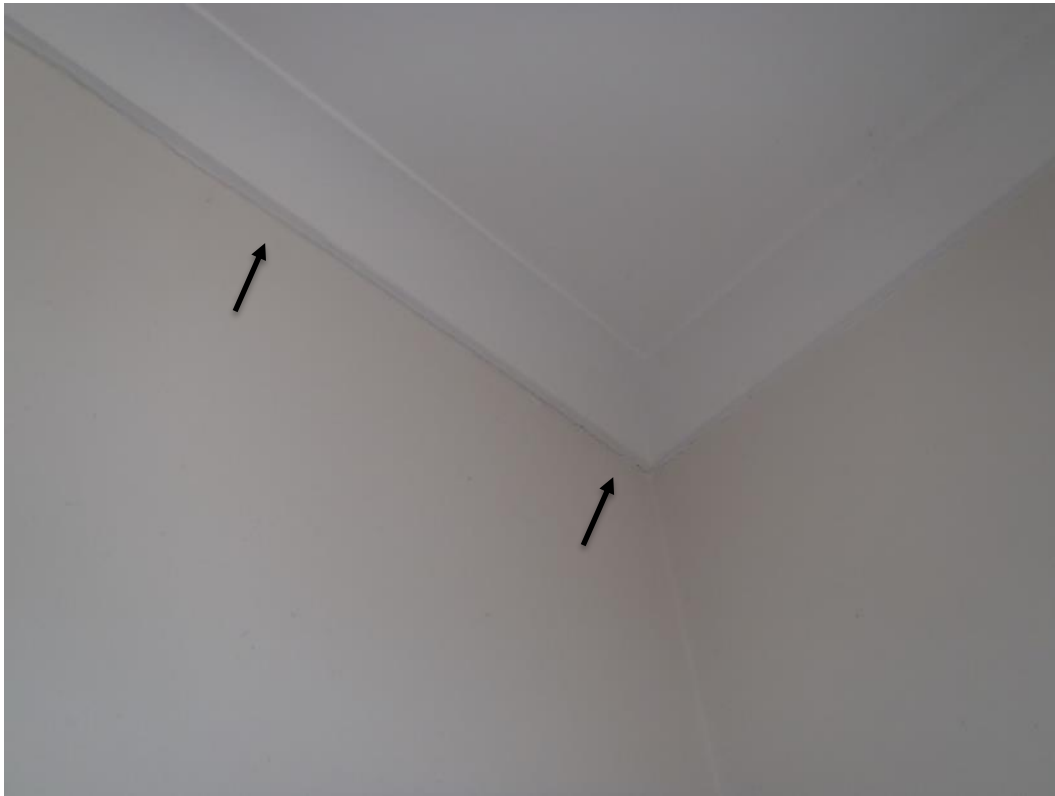
We noted separation cracking [ $<1\text{mm}$ ] between the cove profiled plaster cornice and the wall surface in the north-western corner. **[Photograph 43]**

**Photograph 43** shows separation cracking between the cove profiled plaster cornice and the wall surface in the north-western corner in the Kitchen.

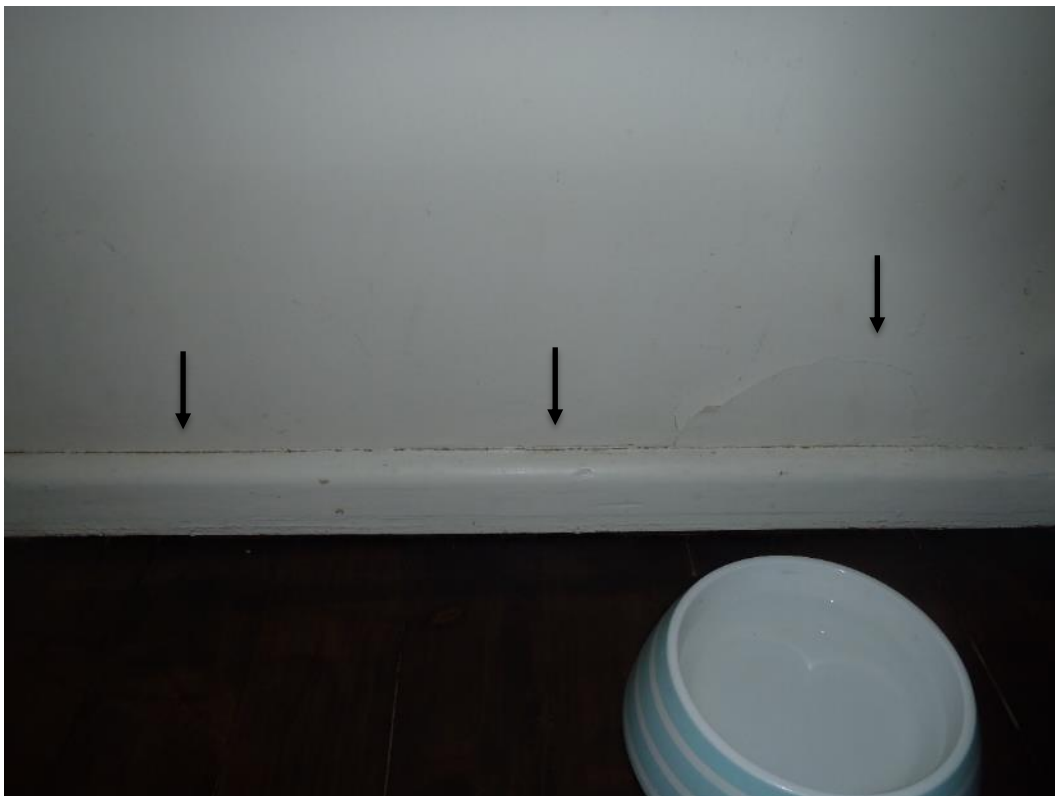
We noted separation cracking [ $<1\text{mm}$ ] between the timber skirting and the wall surface in the north-western corner. **[Photograph 44]**

**Photograph 44** shows separation cracking [ $<1\text{mm}$ ] between the timber skirting and the wall surface in the north-western corner in the Kitchen.

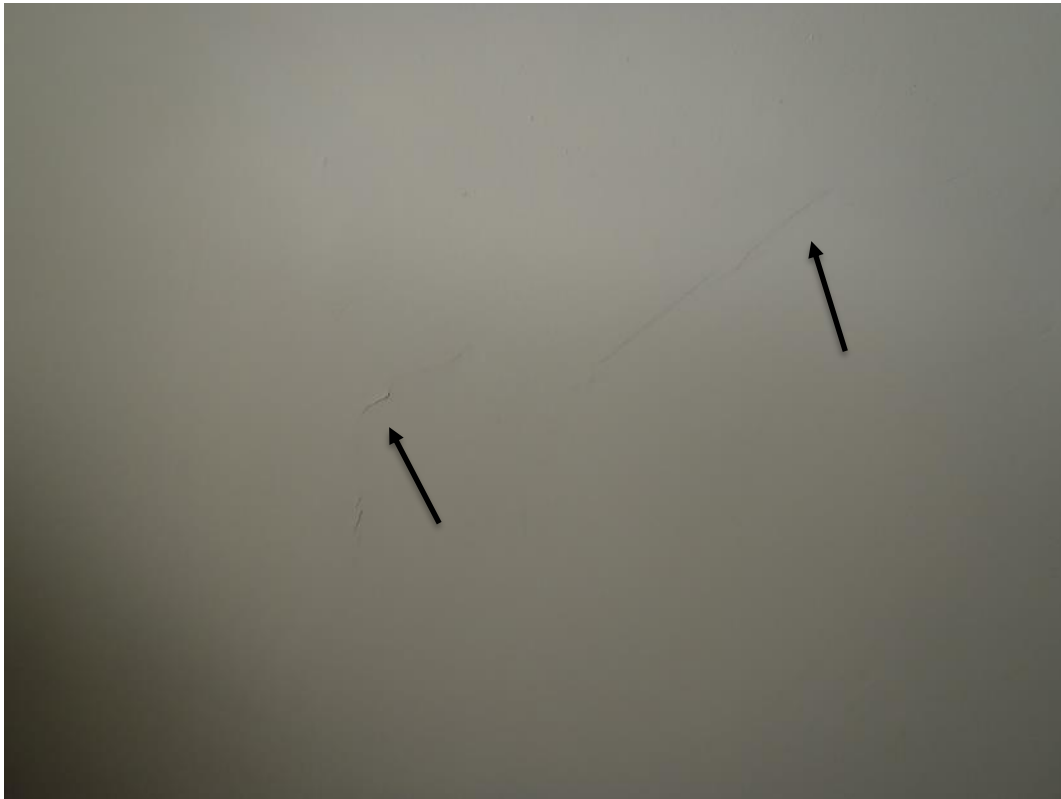
We noted evidence of a previous repair and flaking paint to the plaster ceiling lining. **[Photograph 45]**

**Photograph 45** shows evidence of a previous repair and flaking paint to the plaster ceiling lining in the Kitchen.

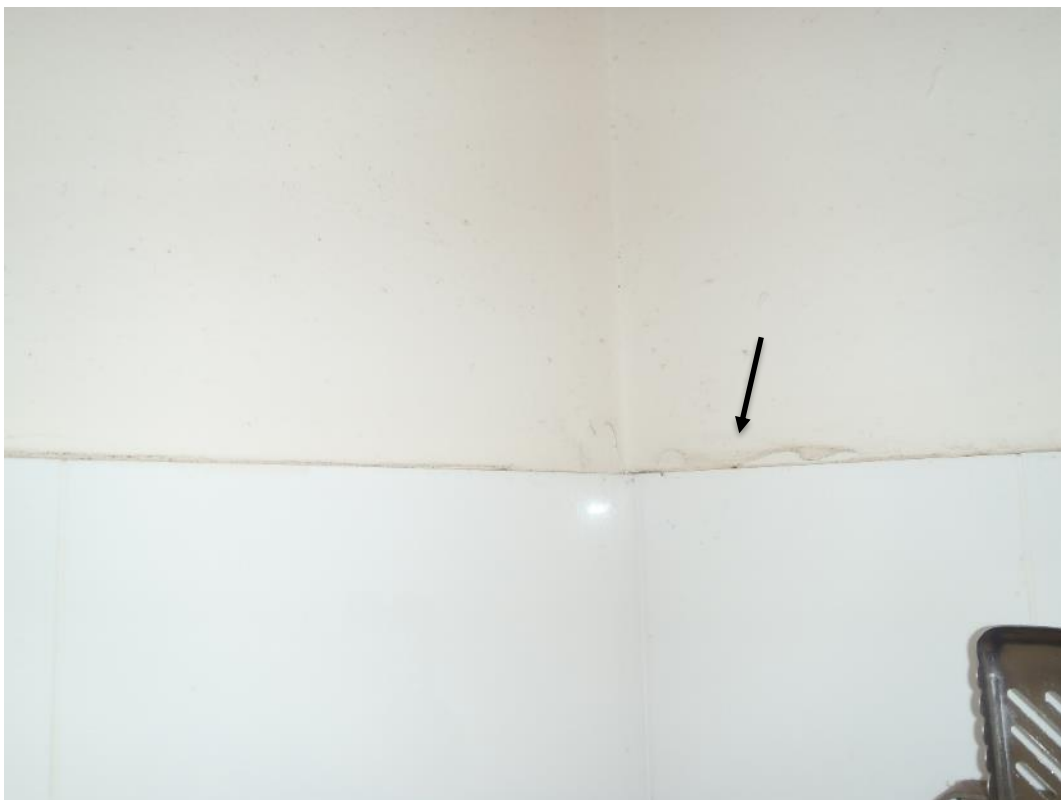
We noted flaking paint in the north-western corner above the tiled splashback. **[Photograph 46]**

**Photograph 46** shows flaking paint in the north-western corner above the tiled splashback in the Kitchen.

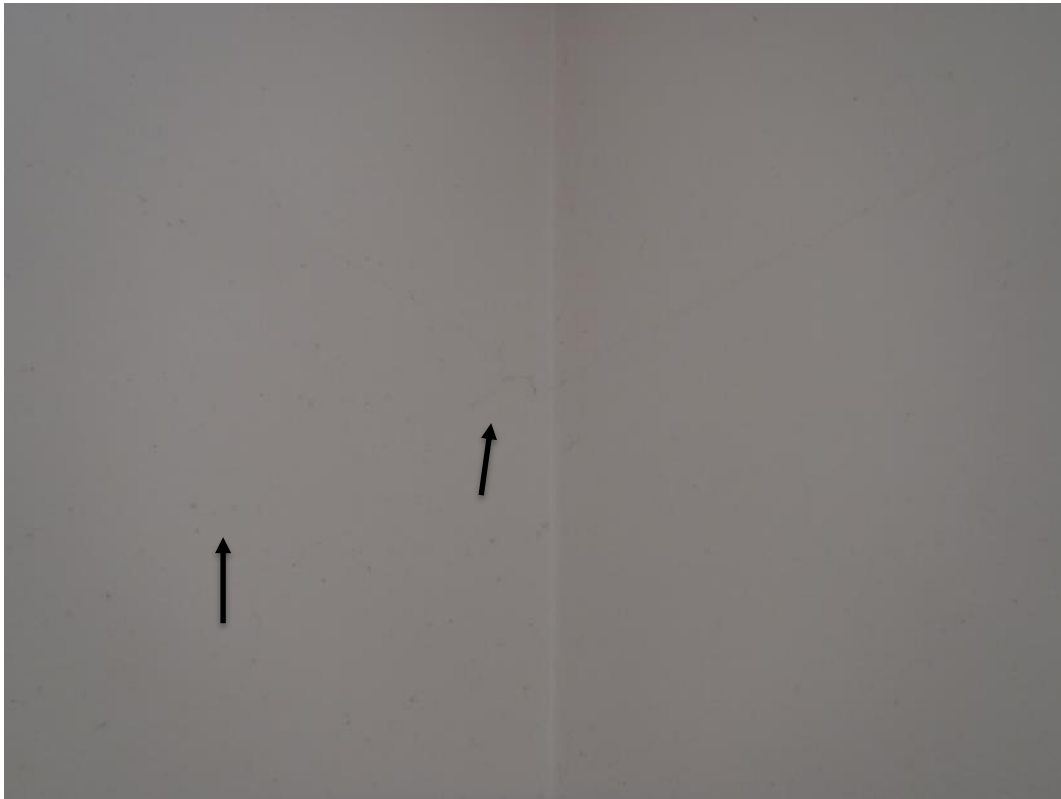
We noted horizontal hairline cracking [ $<1\text{mm}$ ] in the north-western corner. **[Photograph 47]**

**Photograph 47** shows horizontal hairline cracking in the north-western corner of the Kitchen.

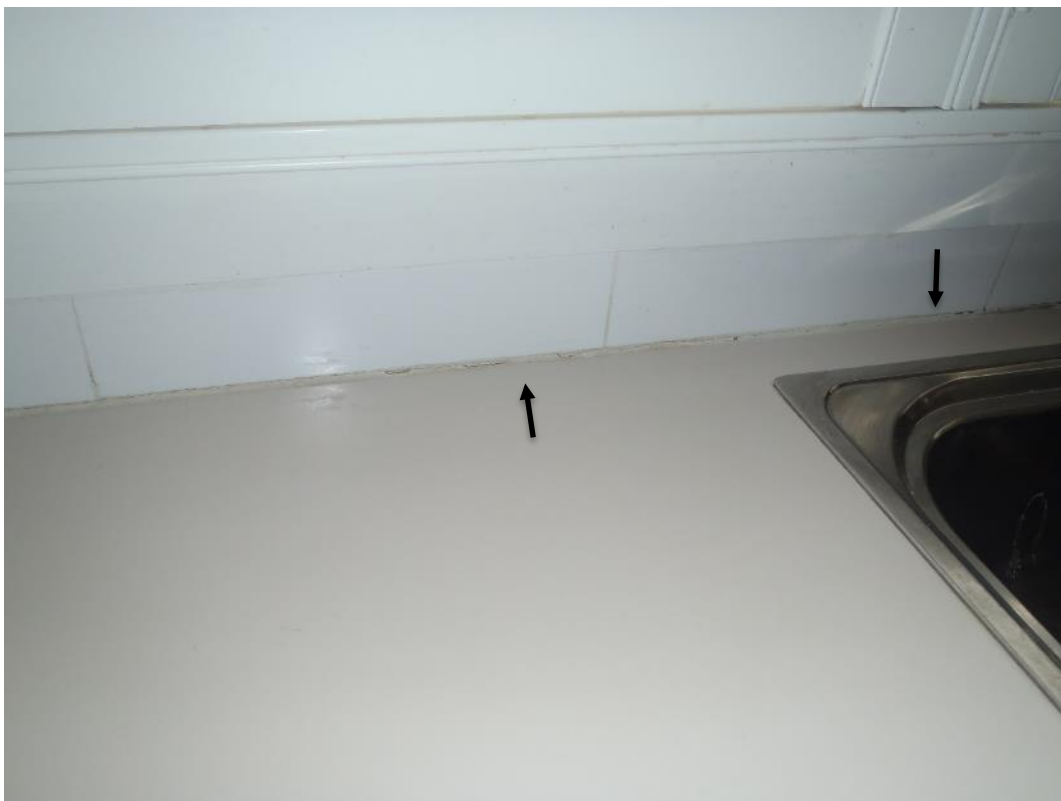
We noted separation cracking between the kitchen benchtop and the tiled splashback. **[Photograph 48]**

**Photograph 48** shows separation cracking between the kitchen benchtop and the tiled splashback.
