## Dilapidation Assessment Report

Prepared for: Cape Cod Australia Pty. Limited  
Job address: No. 60 Carrington Road, Randwick.  
Property Owner/s: Mr. Mark & Mrs. Ana McLeod.  
Report reference: **RANDWICK CITY COUNCIL**  
Development Application No: not available  
Date of assessment: 24<sup>th</sup> May 2017

**Re: Dilapidation Report – No. 60 Carrington Road, Randwick.**

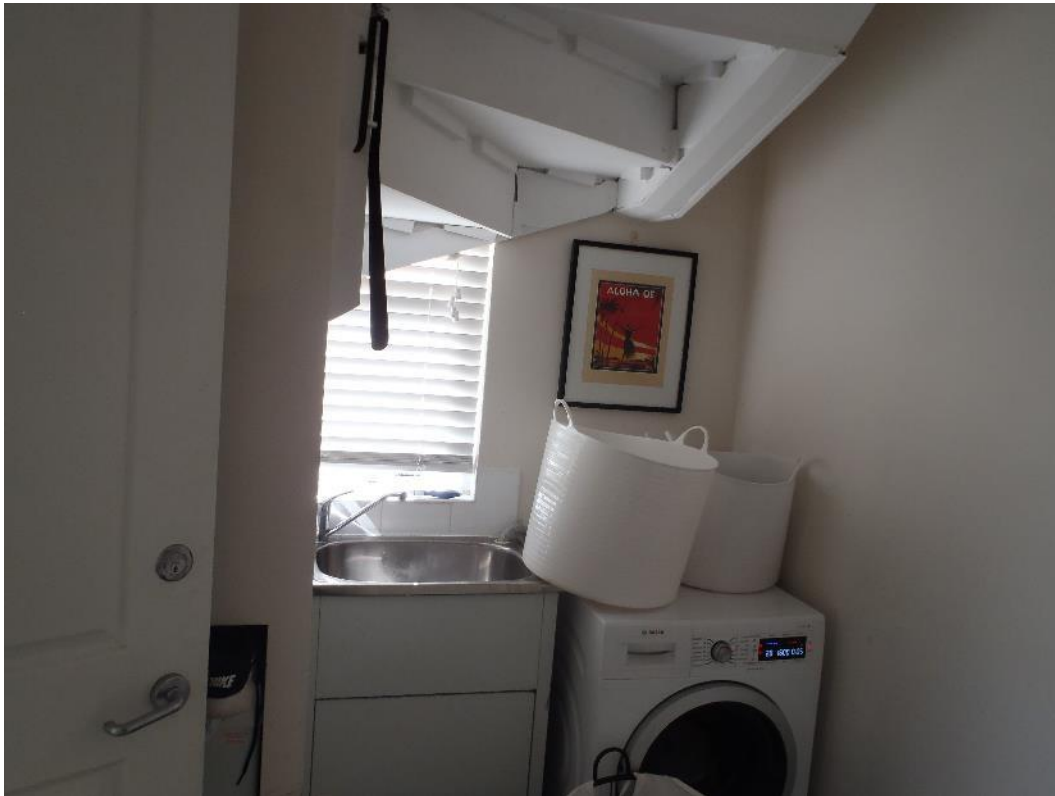
We observed that the Laundry was situated under the first-floor addition stairs. **[Photograph 49]**

**Photograph 49** shows the general layout of the Laundry.

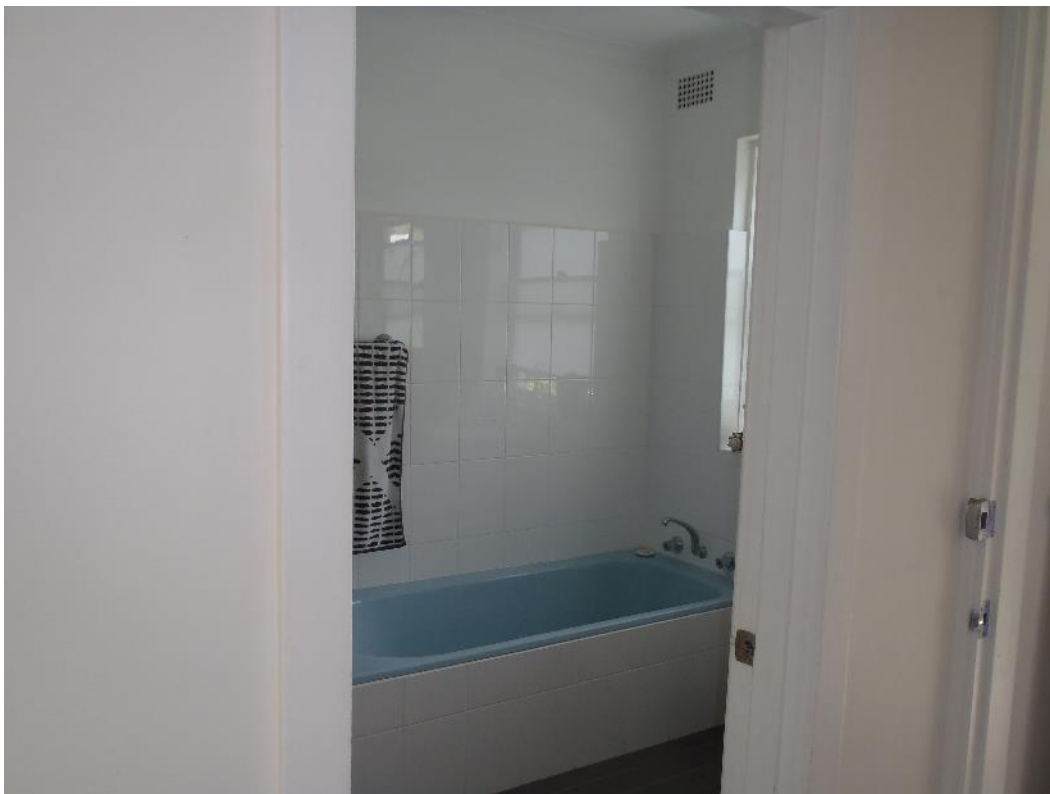
We noted that the southern wall is the *common party / separation* wall with the adjoining property No. 62 Carrington Road, Randwick. **[Photograph 50]**

**Photograph 50** shows the general layout of the Bathroom.

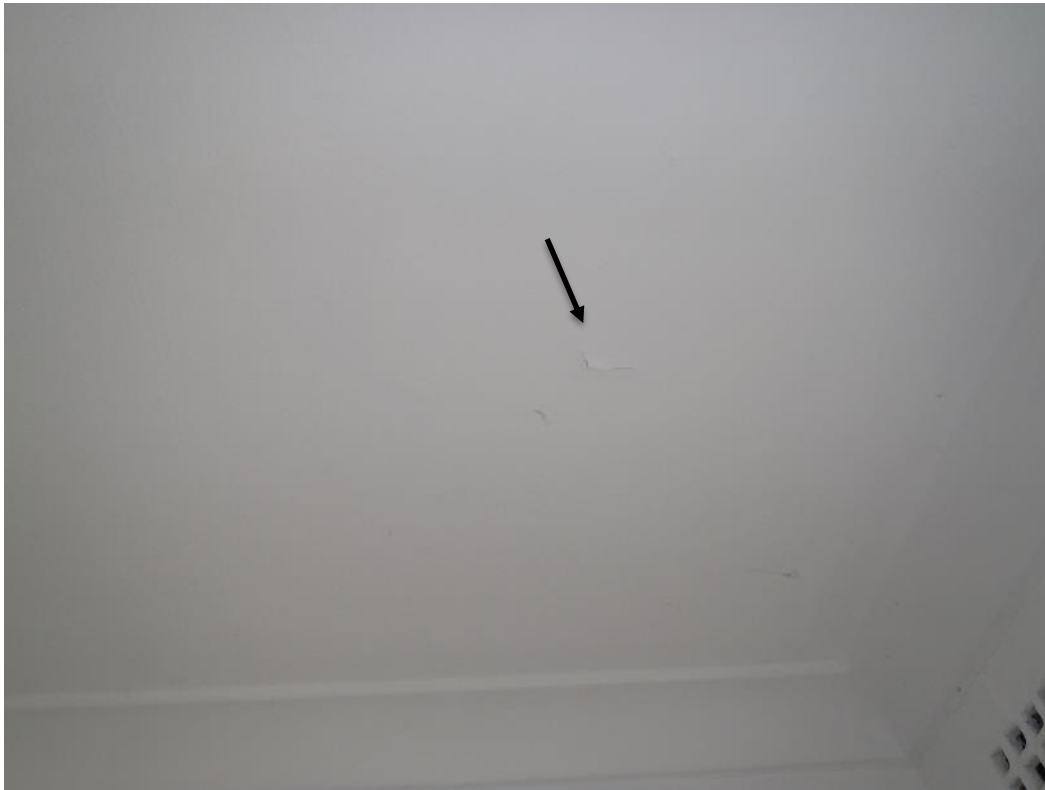
We noted flaking paint to the plaster ceiling lining above the bath. **[Photograph 51]**

**Photograph 51** shows flaking paint to the plaster ceiling lining above the bath.

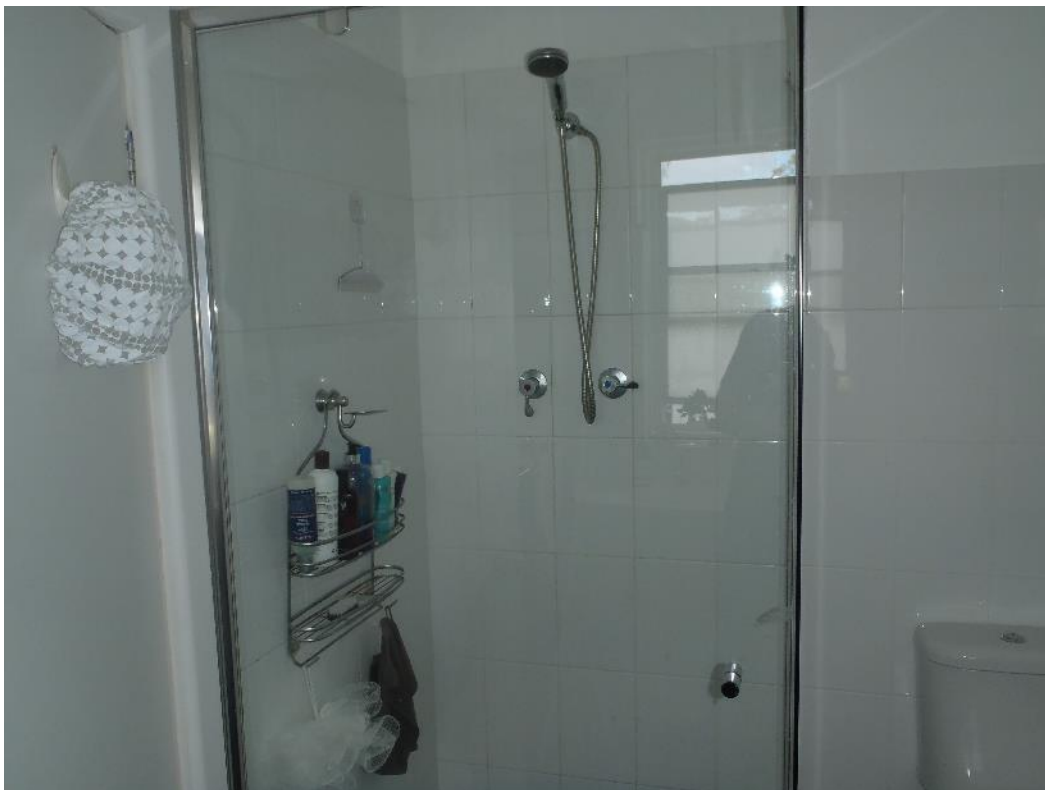
We did not observe any recent cracking to the ceramic wall tiles or to the painted cement rendered walls above the wall tiles. **[Photograph 52]**

**Photograph 52** shows the general condition of the Bathroom.

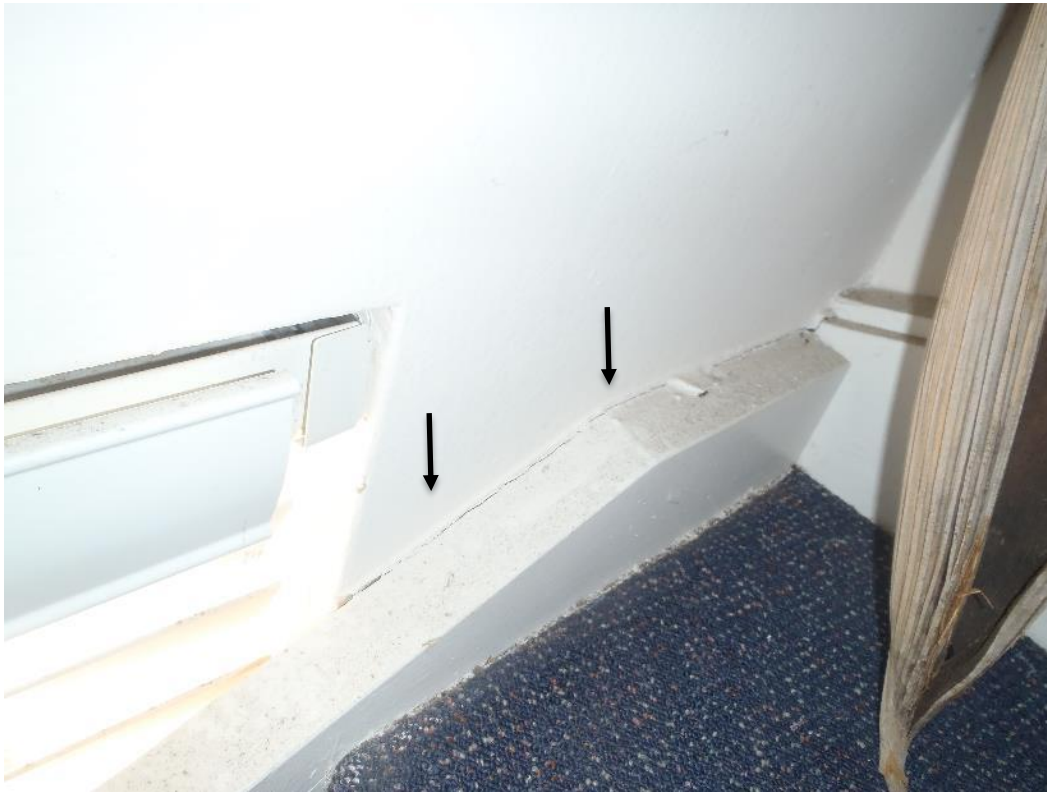
We noted separation cracking between the cement rendered wall surface and the stair stringer. **[Photograph 53]**

**Photograph 53** shows separation cracking between the cement rendered wall surface and the stair stringer in the stairwell.

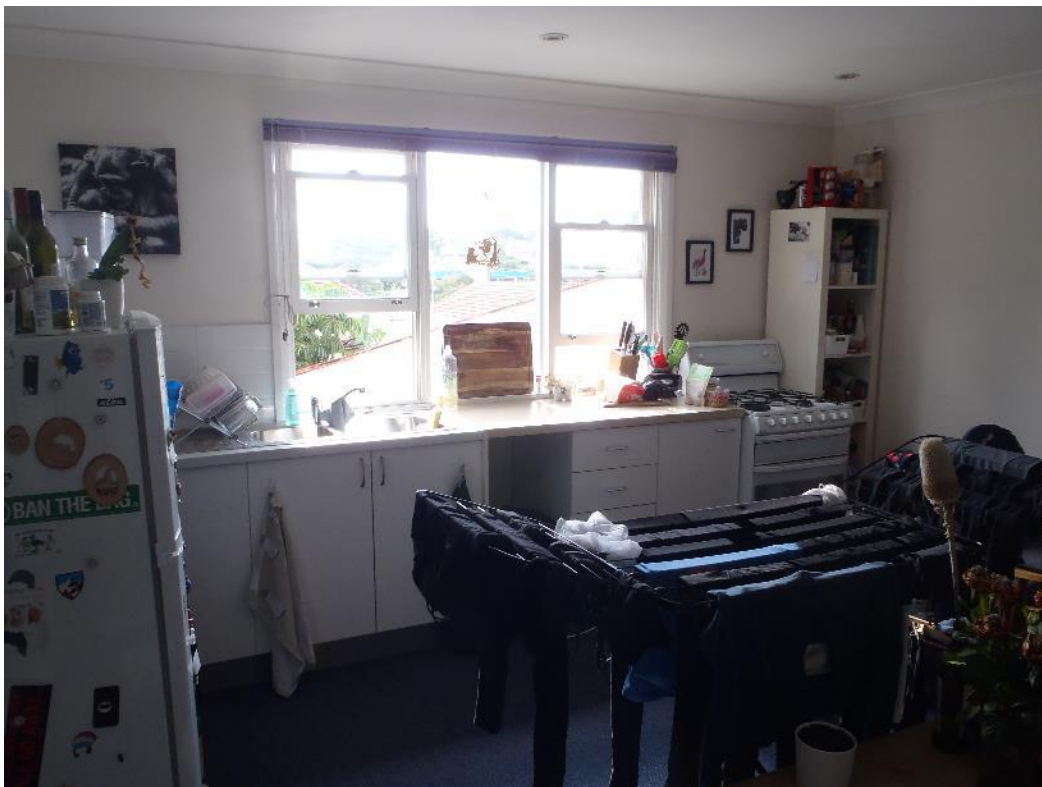
We noted that the grout to the splashback tiles is complete and that the tiles when randomly “tap” tested appeared to be sound. **[Photograph 54]**

**Photograph 54** shows the general layout of the Kitchenette.

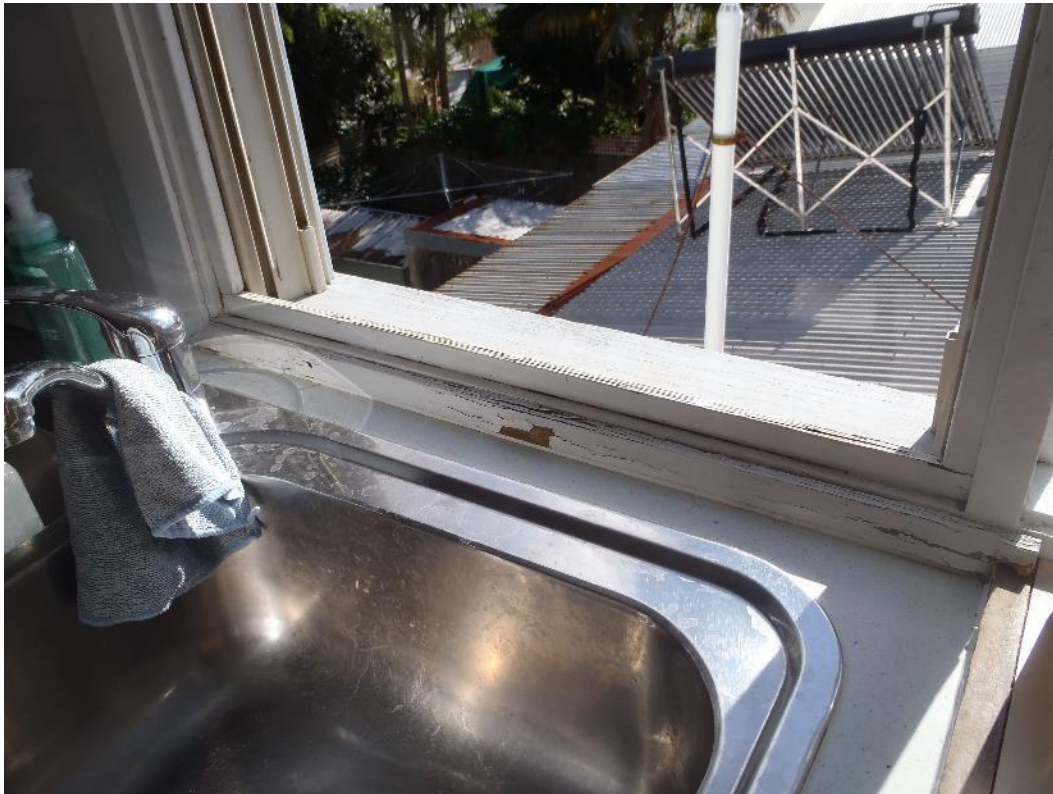
We noted flaking paint to the window sill and timber trim. **[Photograph 55]**

**Photograph 55** shows flaking paint to the window sill and timber trim in the Kitchenette.

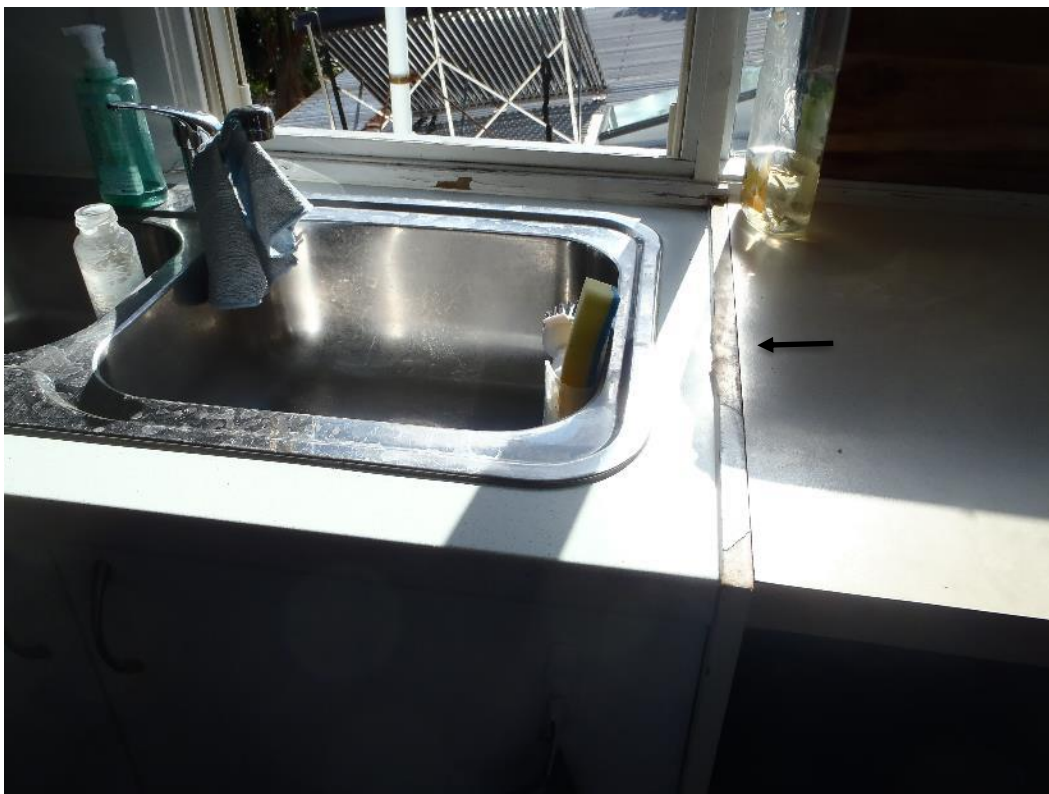
We noted water damaged and swollen Medium Density Fibre (MDF) board to the kitchenette bench top. **[Photograph 56]**

**Photograph 56** shows water damaged and swollen Medium Density Fibre (MDF) board to the kitchenette bench top.

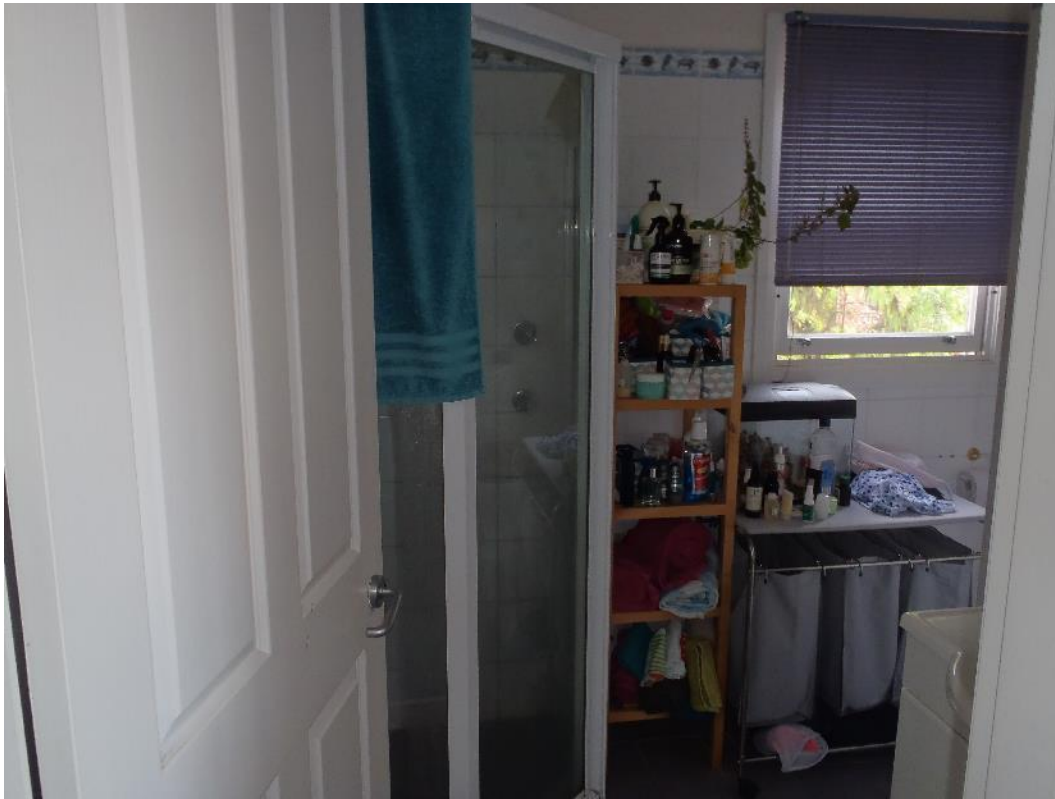
We observed that the floor is finished with ceramic tiles. We noted that the grout to the tiles is complete and that the tiles when randomly “tap” tested appeared to be sound. **[Photograph 57]**

**Photograph 57** shows the general layout of the upstairs Bathroom.

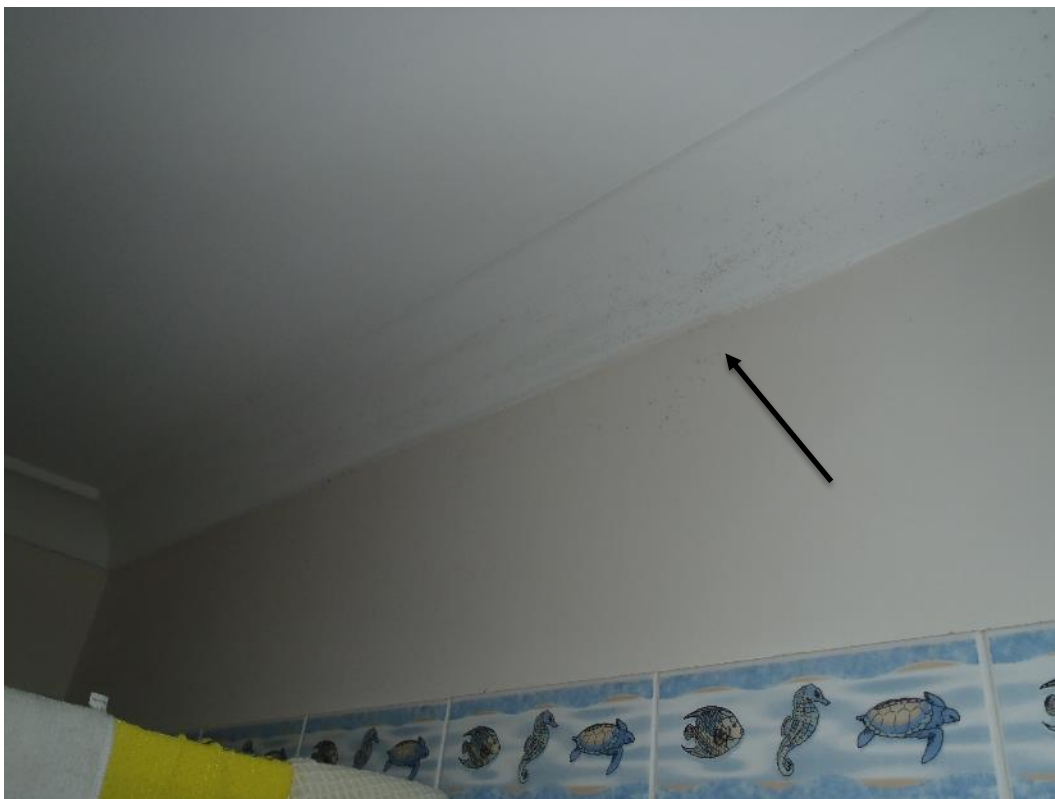
We noted mould growth to the rendered wall surface, cove profile plaster cornice and the plaster ceiling in the south-western corner above the shower. **[Photograph 58]**

**Photograph 58** shows mould growth to the wall surface, cornice and the plaster ceiling in the south-western corner above the shower in the upstairs Bathroom.

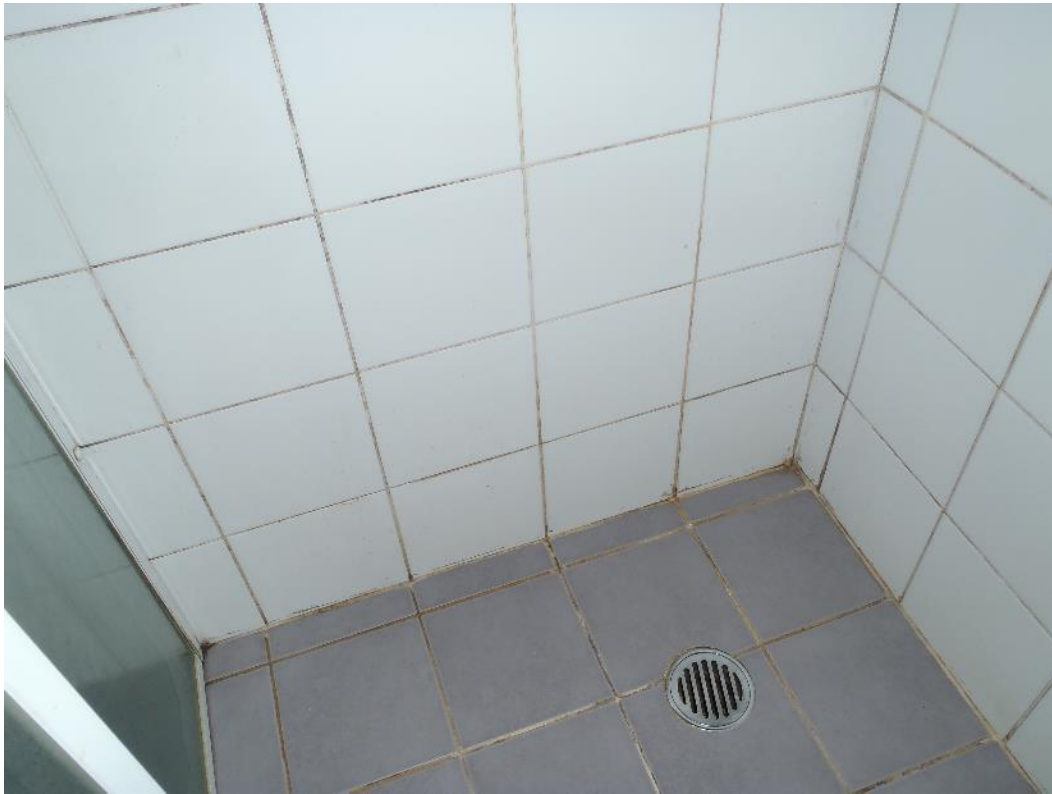
We noted mould growth to the grout of the floor and wall tiles of the in the shower. **[Photographs 59 & 60]**

**Photograph 59** shows mould growth to the grout of the floor and wall tiles of the in the upstairs shower.

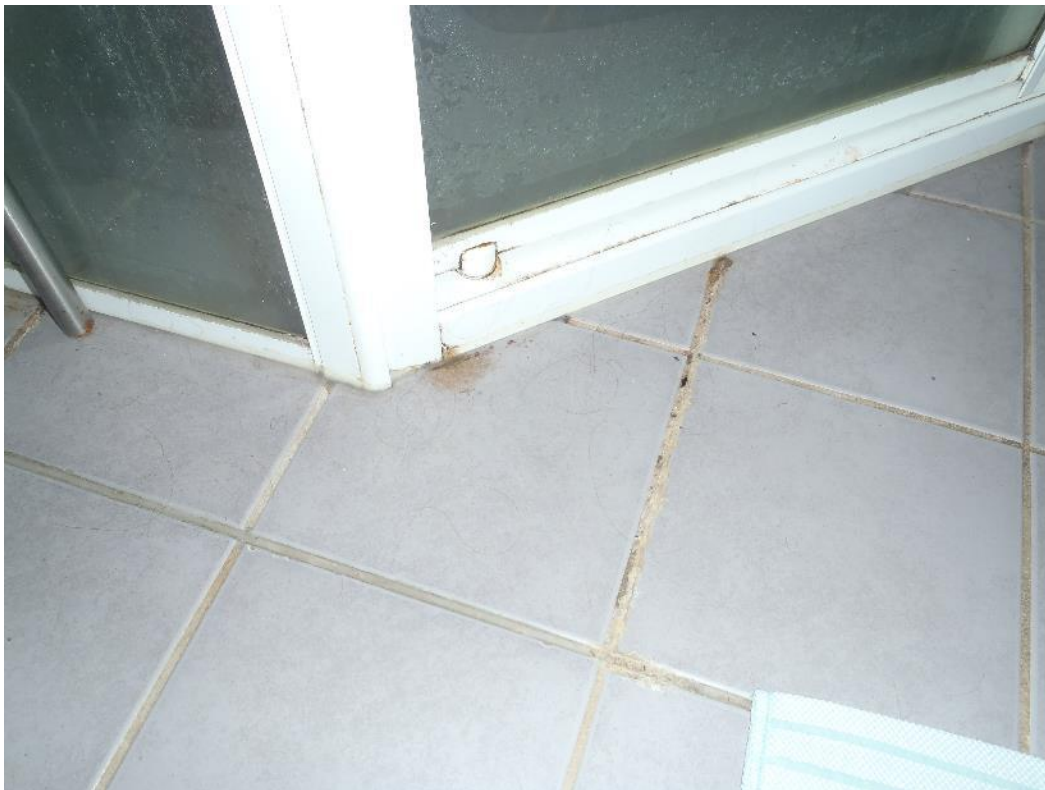
**Photograph 60** shows mould growth to the grout of the floor tiles upstairs Bathroom

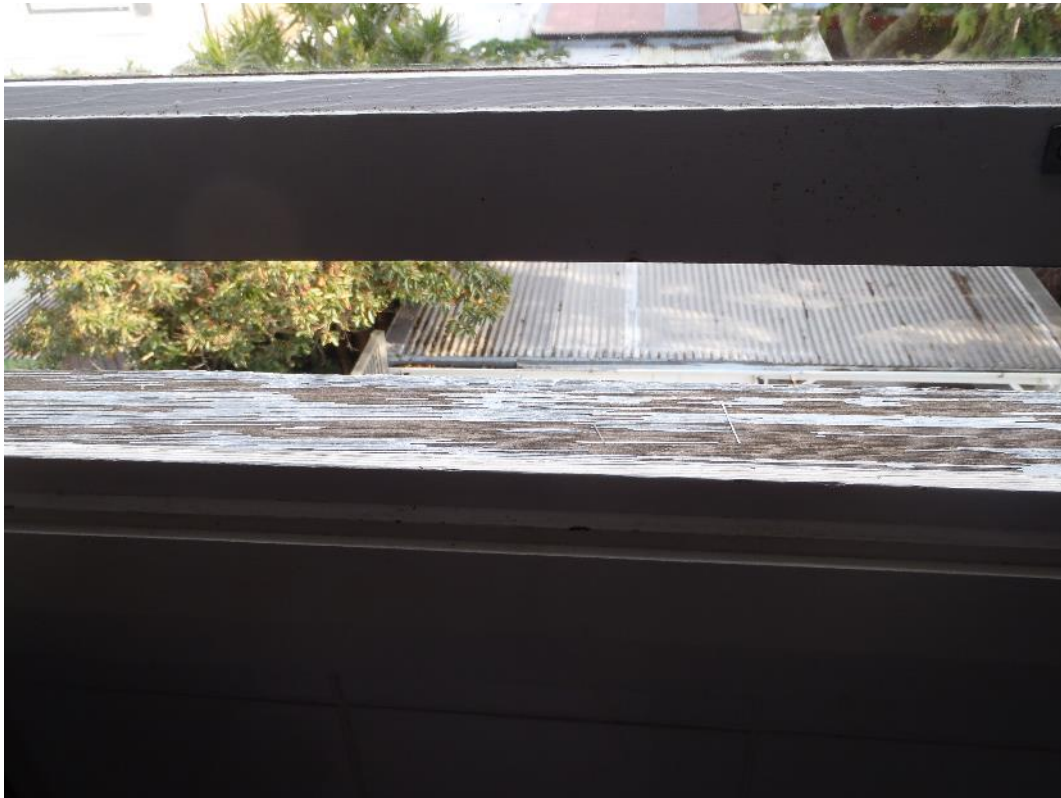
We noted deterioration and flaking paint to the window sill. **[Photograph 61]**

**Photograph 61** shows deterioration and flaking paint to the window sill in the upstairs Bathroom.

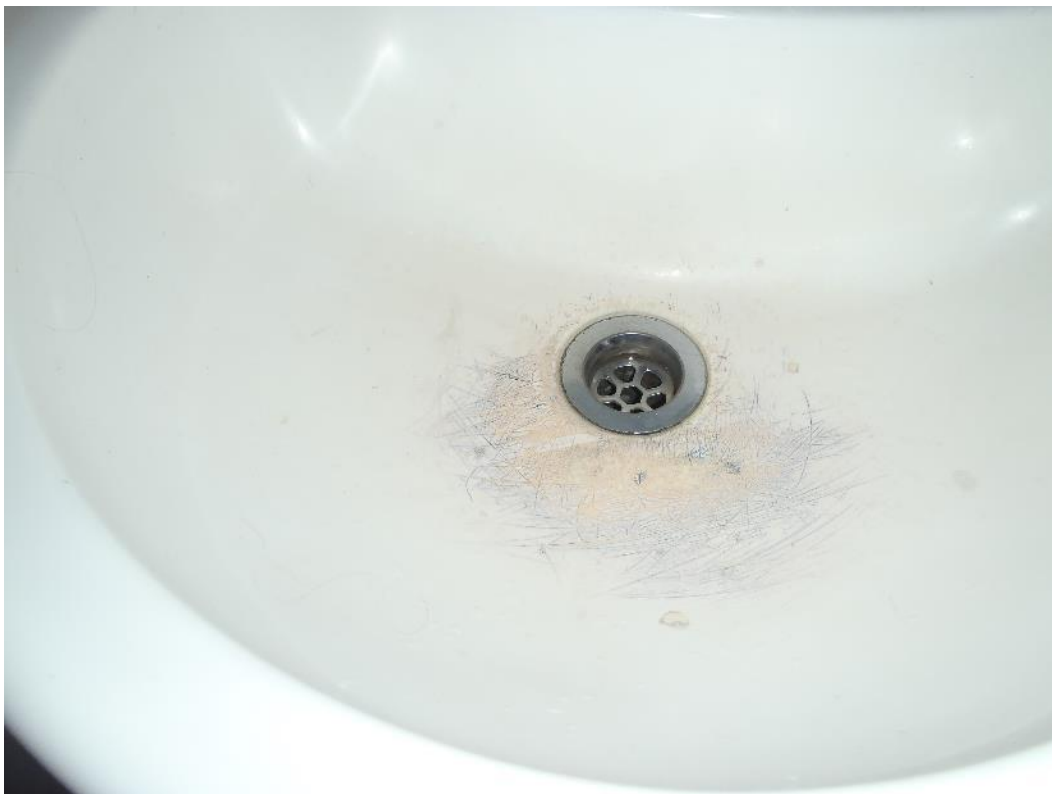
We noted scratching to the surface of the sink bowl. **[Photograph 62]**

**Photograph 62** shows scratching to the surface of the sink bowl in the upstairs Bathroom.

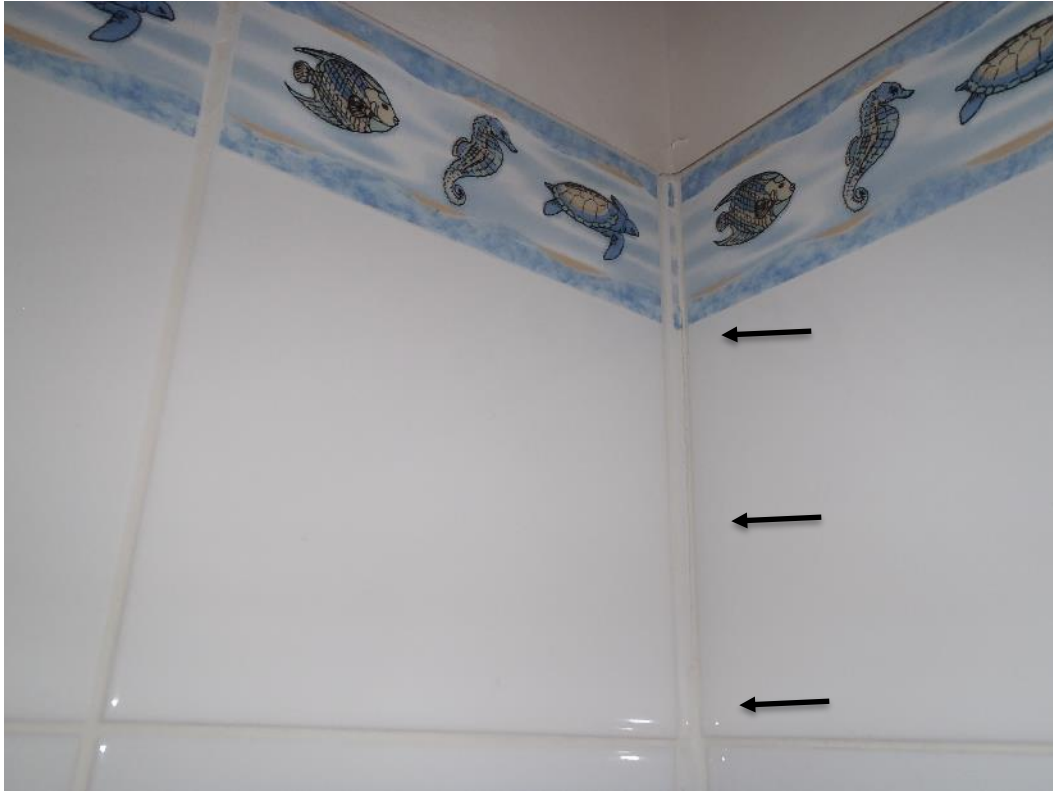
We noted hairline cracking to the grout in the wall to wall joint of the tiles. **[Photograph 63]**

**Photograph 63** shows hairline cracking to the grout in the wall to wall joint of the tiles in the upstairs Bathroom.
