## **HAZARDOUS MATERIALS ASSESSMENT REPORT**

**Job details:** Owner/s: Mr. R. & Mrs. S. Stephens  
Location: 33 Wangara Street, Doonside NSW

**Plans for Job No:** 7737/16      **Revision No:** D      **Dated:** 13-04-16

**Date of assessment:** 29<sup>th</sup> April 2016

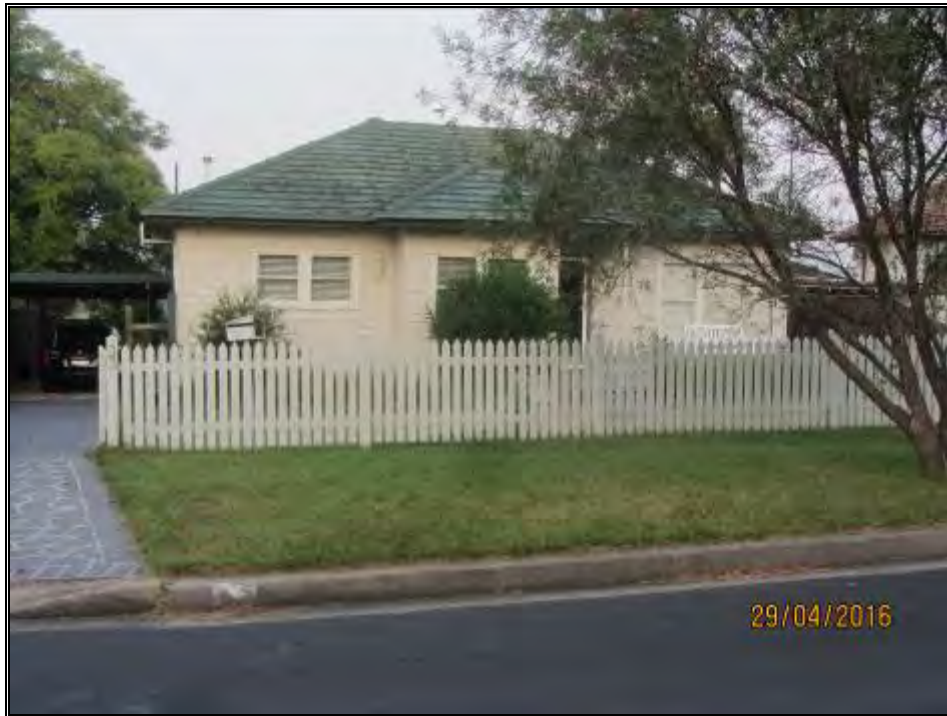
Front north eastern elevation of the residence
