HAZARDOUS MATERIALS ASSESSMENT REPORT

Job details: Owner: Mr. B. & Mrs. M. Pacque.
Location: 30 Highfield Road, Lindfield.

Our reference: HM05780617

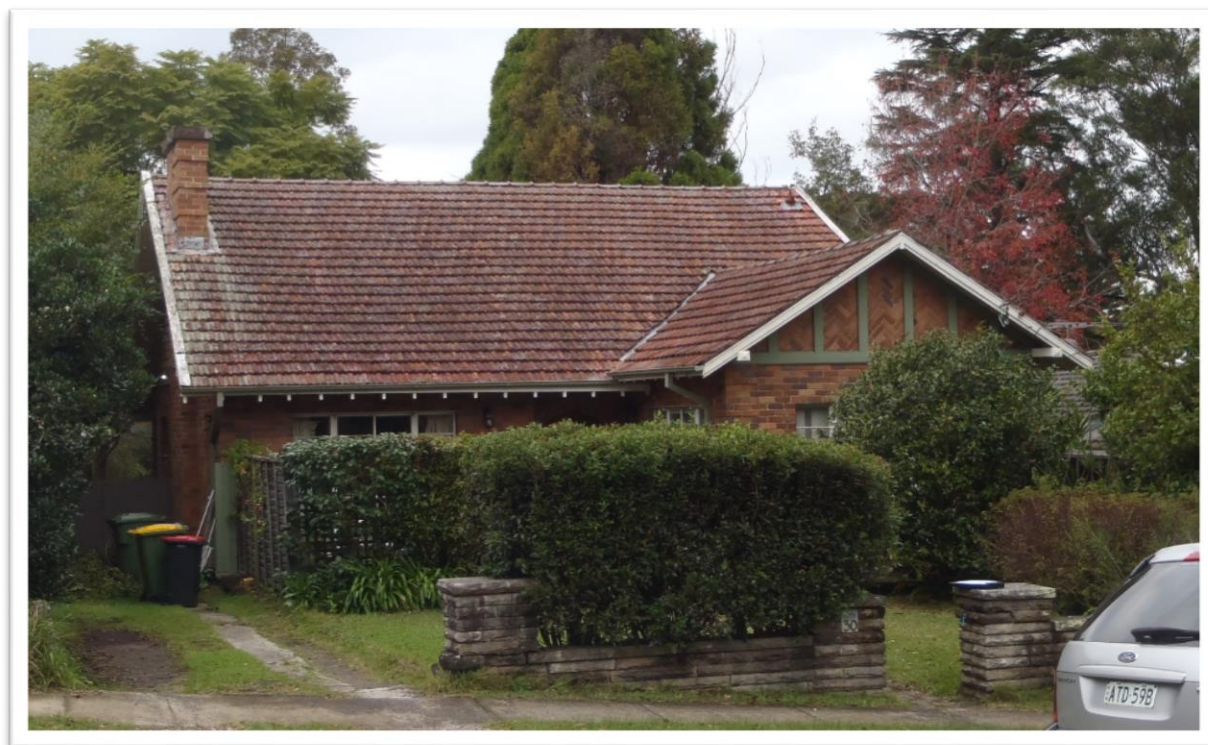
Front north-western elevation of the residence
