HAZARDOUS MATERIALS ASSESSMENT REPORT

Job details: Owner/s: Mr. S. & Mrs. F. Congdon
Location: 8 Burton Street, Randwick

Date of assessment: 28th October 2014

Our reference: HM03411014

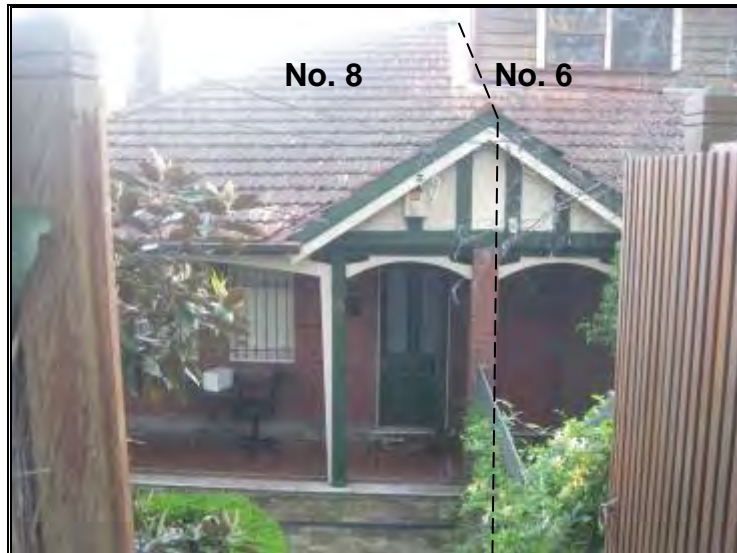
Front southern elevation of this residence; No. 8 Burton Street, Randwick
