HAZARDOUS MATERIALS ASSESSMENT REPORT

Job details: Owner/s: Mr. J. & Ms. M. Carruthers
Location: 122 Old Berowra Road, Hornsby

Plans for Job No: 7569/14

Our reference: HM03350914

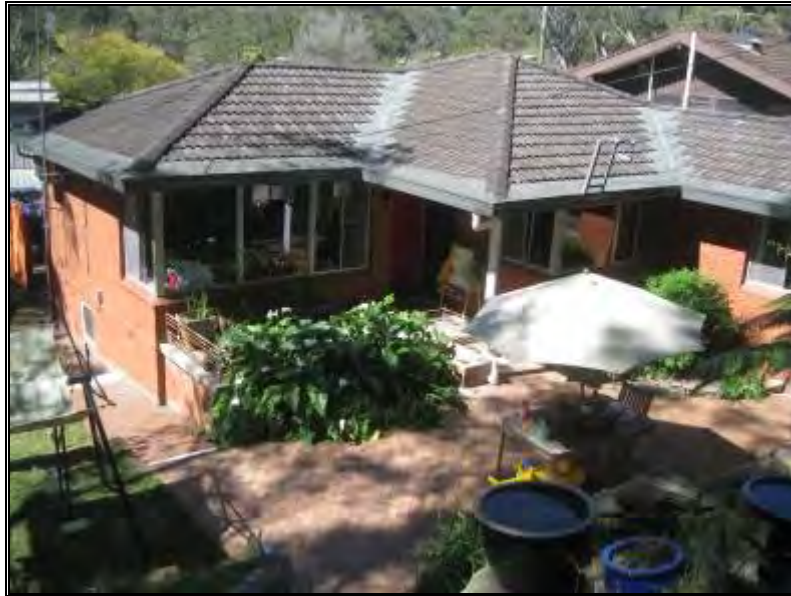
Front western elevation of the residence
