HAZARDOUS MATERIALS ASSESSMENT REPORT

Job details: Owner: Mrs. N. Gamerov.
Location: 9 Kobada Rd, Dover Heights.

Date of assessment: 5th May 2017

Our reference: HM05610517

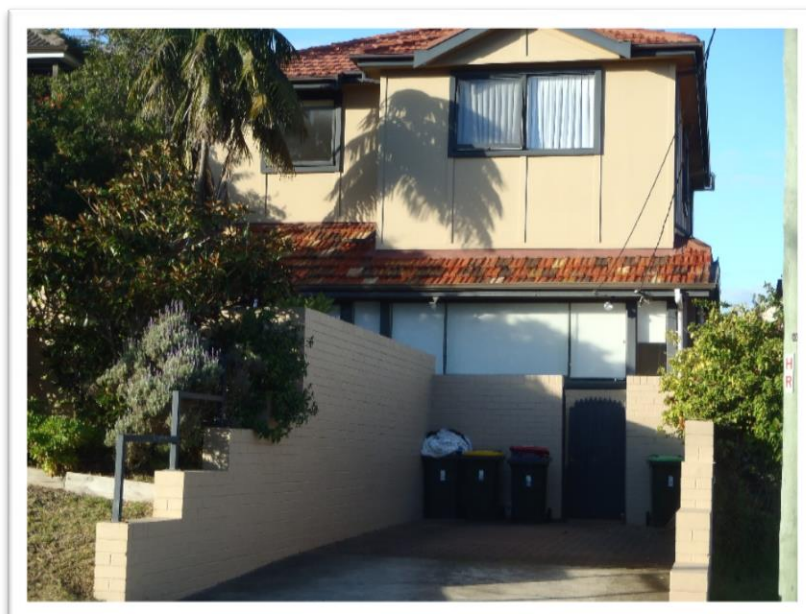
Front northern elevation of the residence
