Dilapidation Assessment Report

Prepared for: Cape Cod Australia Pty. Limited
Job address: 52 Varna Street, Waverley NSW 2024
Property Owner: Not known
C/o PRD Nationwide Real Estate
59 Macpherson Street, Waverley NSW 2024
Report reference: **RANDWICK CITY COUNCIL**
Development Application No: DA/649/2015
Date of assessment: 5th May 2016

Re: Dilapidation Report - No. 52 Varna Street, Waverley

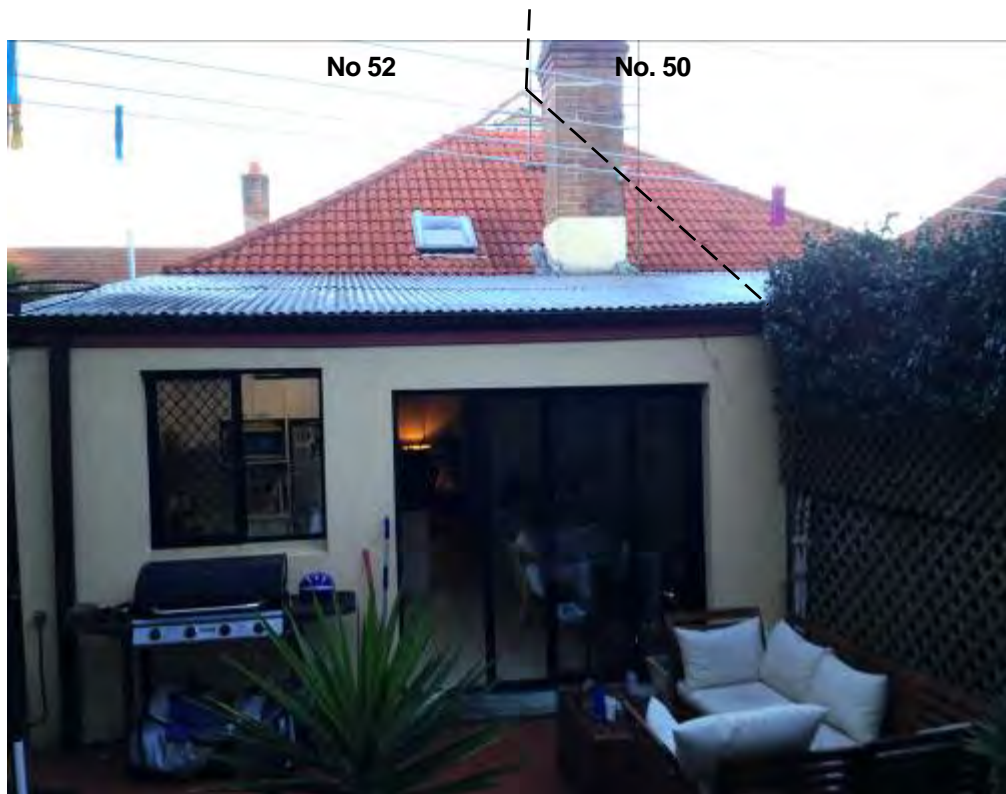
We noted that the corrugated profile sheet metal roofing to the rear *common* pitched hipped roof and skillion roof surfaces in good condition and appears to be securely fixed, in our opinion forming a weather resistant cover to the property. **[Photograph 1]**

We did not observe any other noticeable cracking to the wall including to the junction between the properties. **[Photograph 1]**

Photograph 1 shows the rear northern elevation of this property

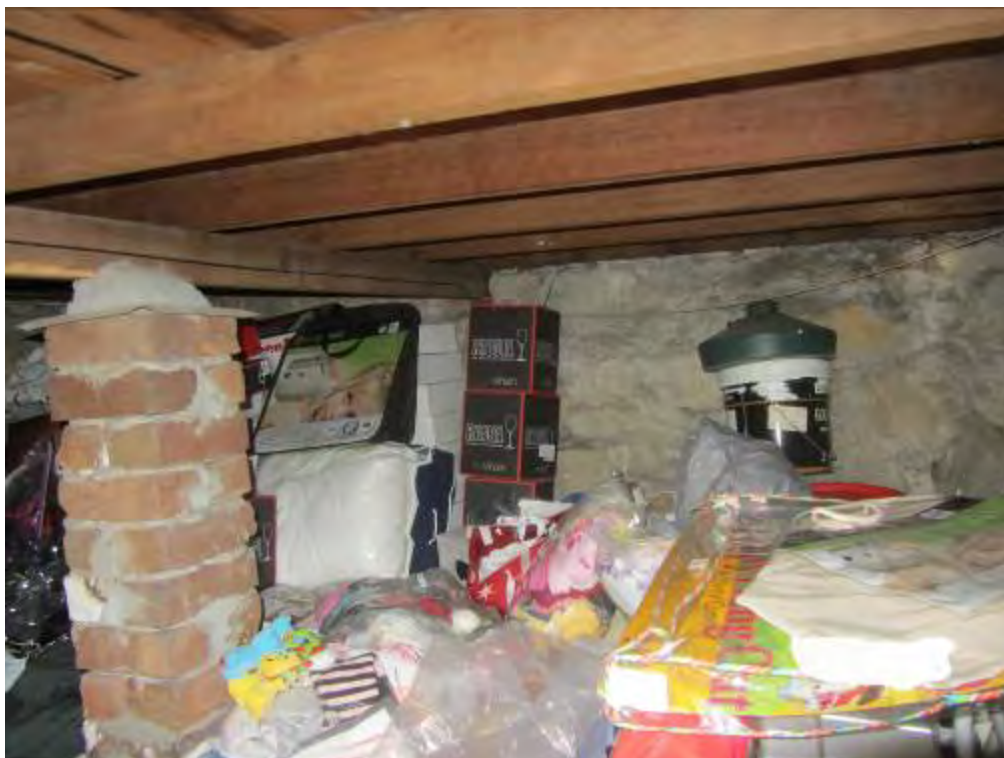
We are unable to comment on the structural adequacy of the random sandstone rock *common party / separation* wall. **[Photograph 2]**

Photograph 2 shows the random sandstone rock *common party / separation* wall within the underfloor space of the adjoining property No. 50

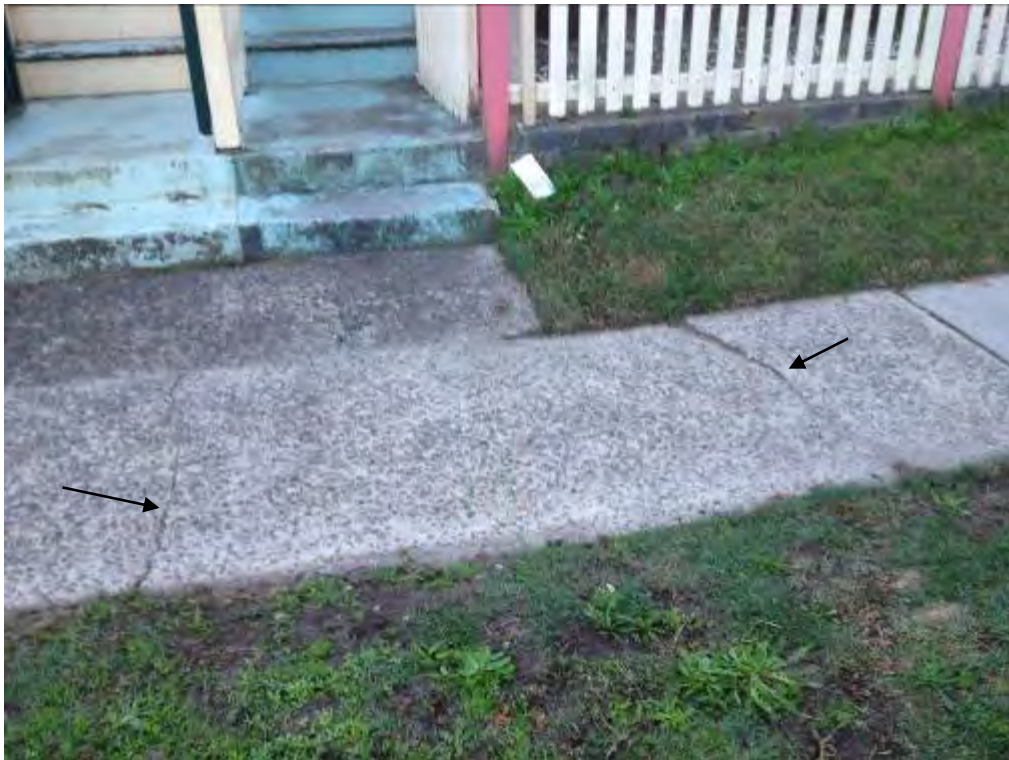
We noted that there is cracking and settlement to the concrete public footpath at the front entry to the property. **[Photograph 3]**

Photograph 3 shows the cracking to the concrete footpath

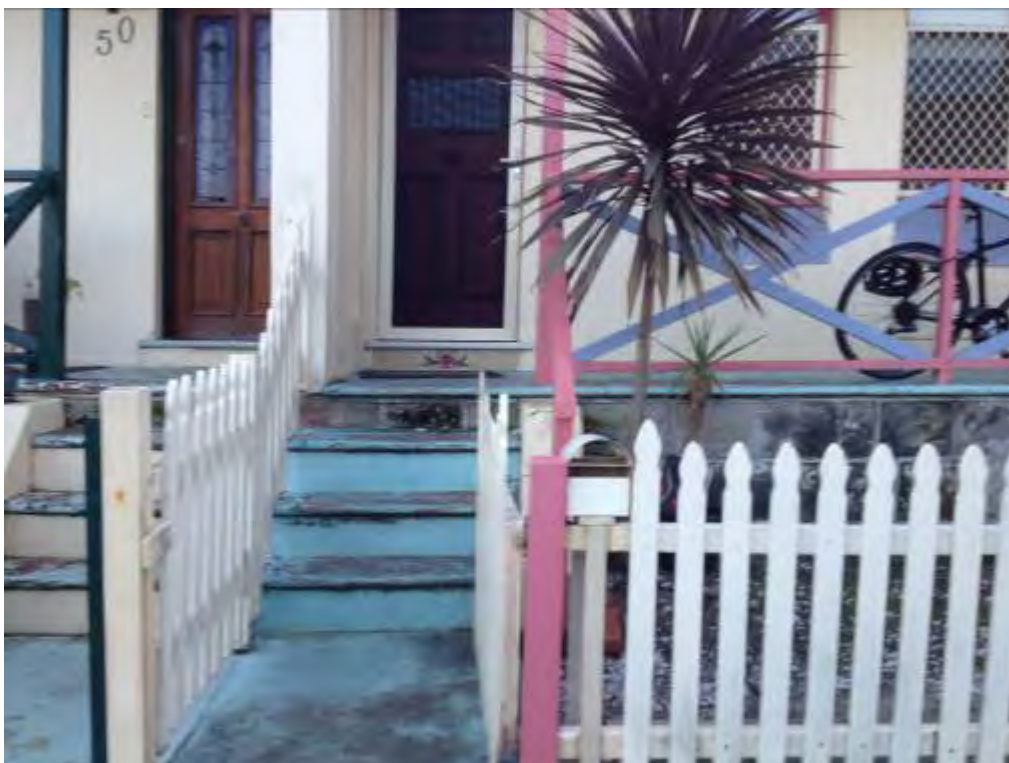
We noted that there is ageing and general deterioration of the surface coating to the *common* concrete entry steps to the verandah. **[Photograph 4]**

Photograph 4 shows the condition of the front entry pathway and steps

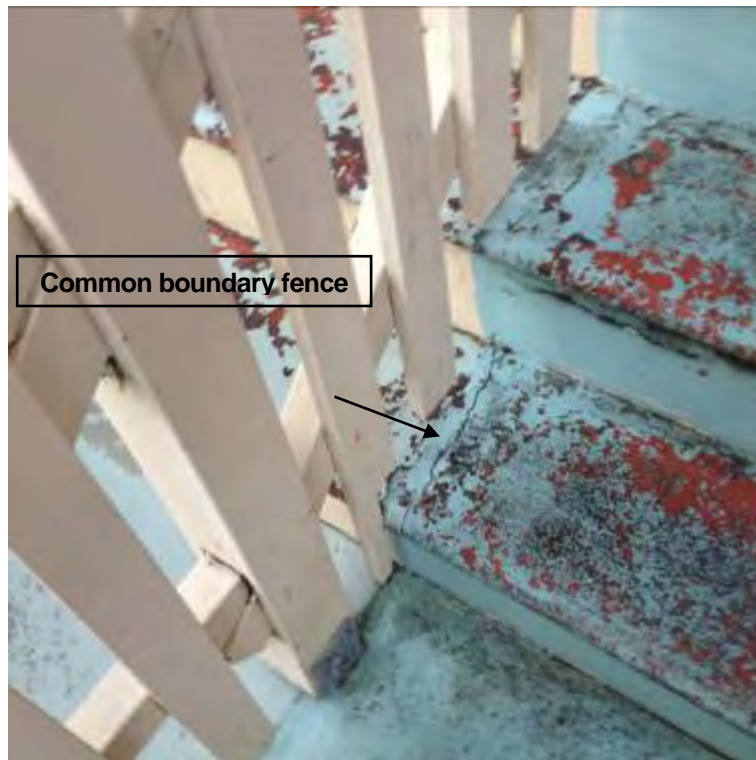
We noted that there is cracking [1.0mm - <3.0mm] to the step treads abutting the *common boundary*. **[Photographs 5 and 6]**

Photograph 5 shows cracking to the front entry steps – Note: ageing and general deterioration of the surface coating

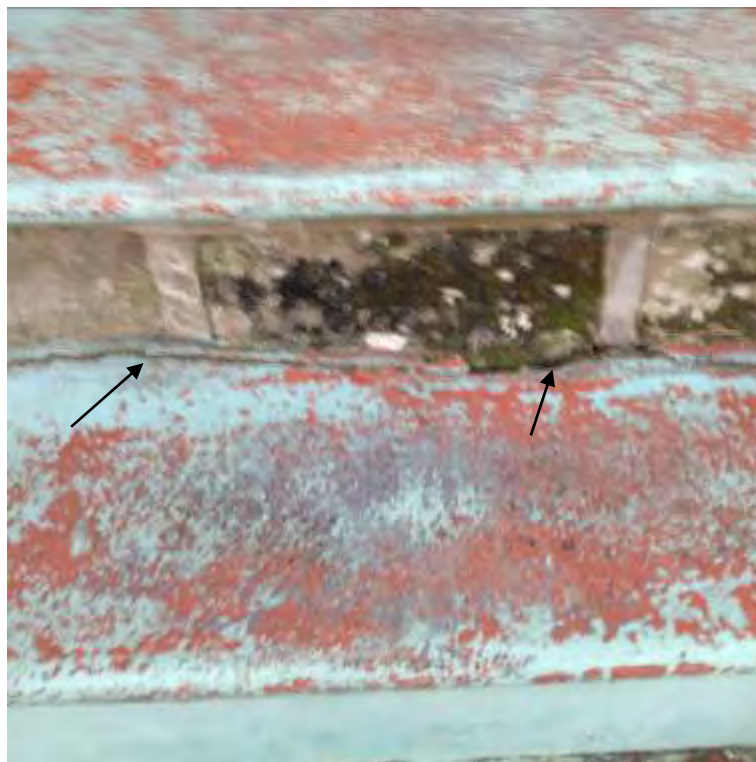
Photograph 6 shows cracking between the top tread and the verandah to the front entry steps

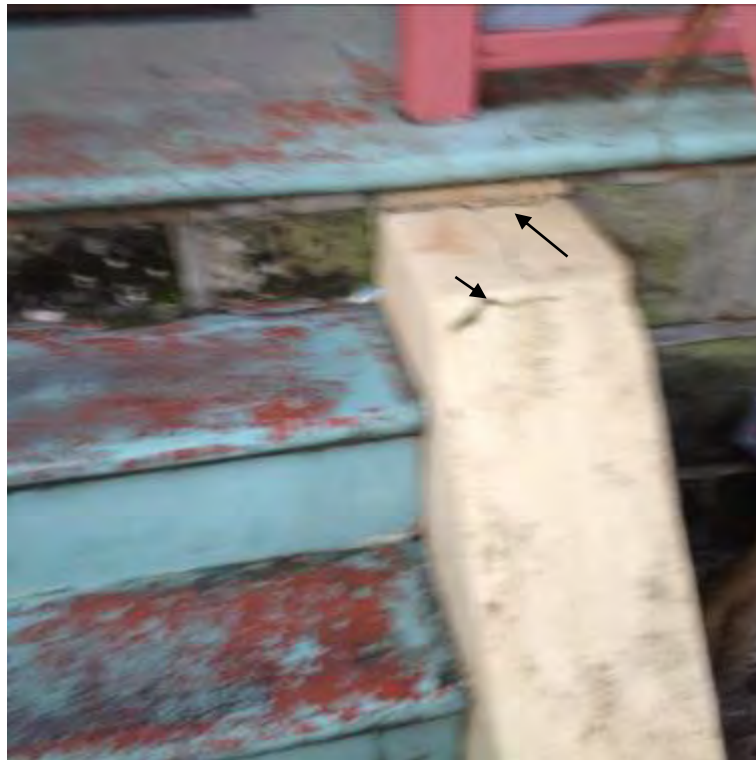
We noted that there is cracking [1.0mm - <3.0mm] to the rendered coping to steps. **[Photograph 7]**

Photograph 7 shows cracks to the right hand side of the front entry step coping

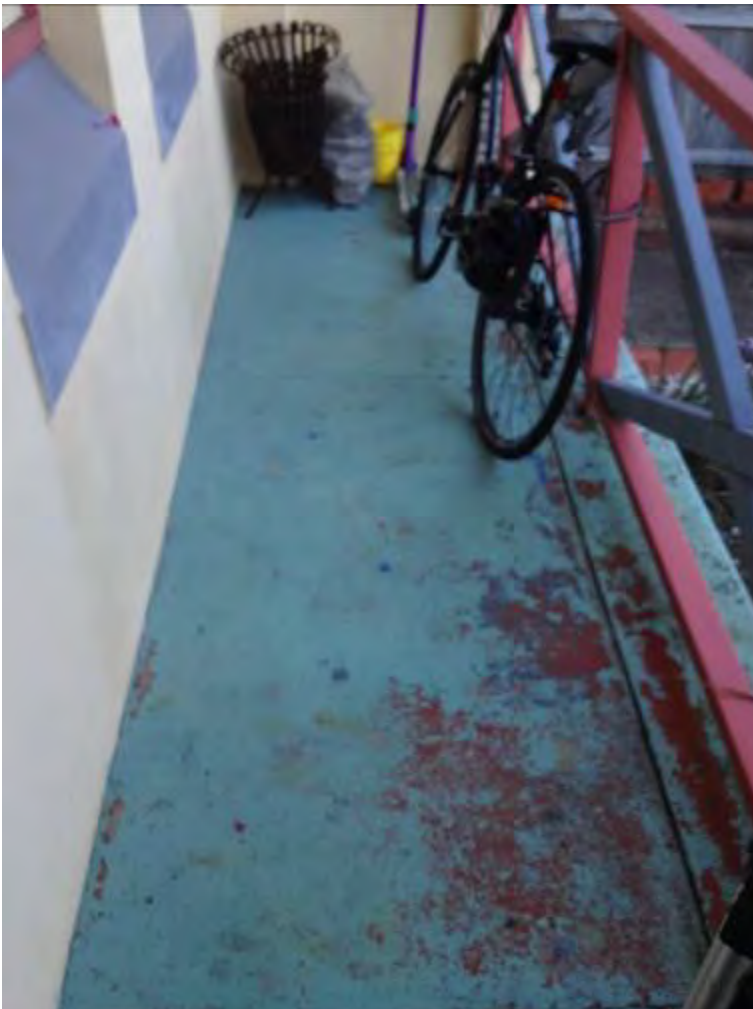
We noted that there is ageing and general deterioration of the surface coating to the Verandah deck. **[Photograph 8]**

Photograph 8 shows the condition of the surface coating to the front verandah

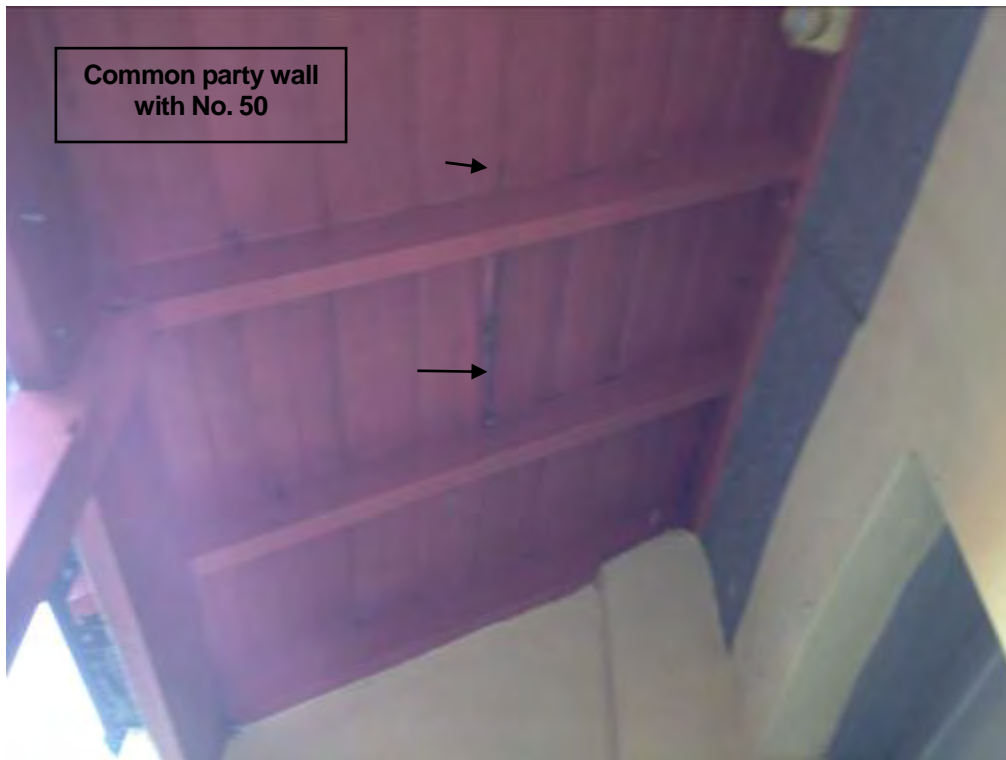
We noted ageing and general deterioration [rotting and decay] to the timber lining boards to the verandah soffit. **[Photograph 9]**

Photograph 9 shows rotting and decay to the timber lining board soffit to the front verandah

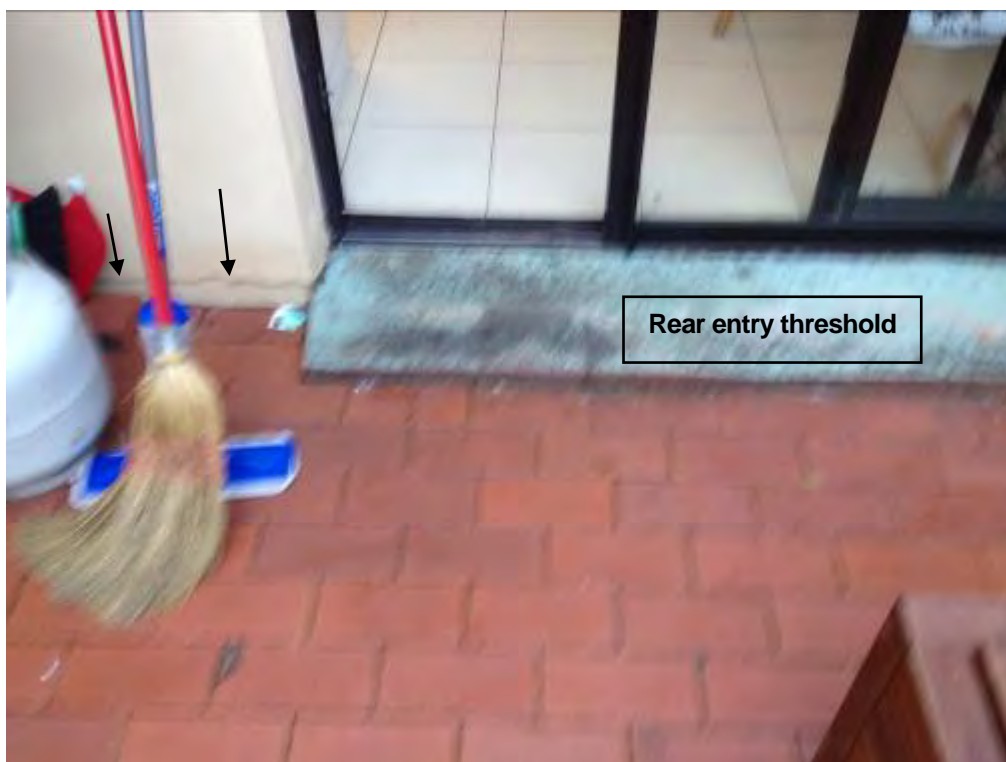
We noted a horizontal crack to the surface coated cement render masonry brickwork extending from the rear entry door threshold towards the east. **[Photograph 10]**

Photograph 10 shows horizontal cracking to the base of the Kitchen wall and adjacent to the rear entry threshold

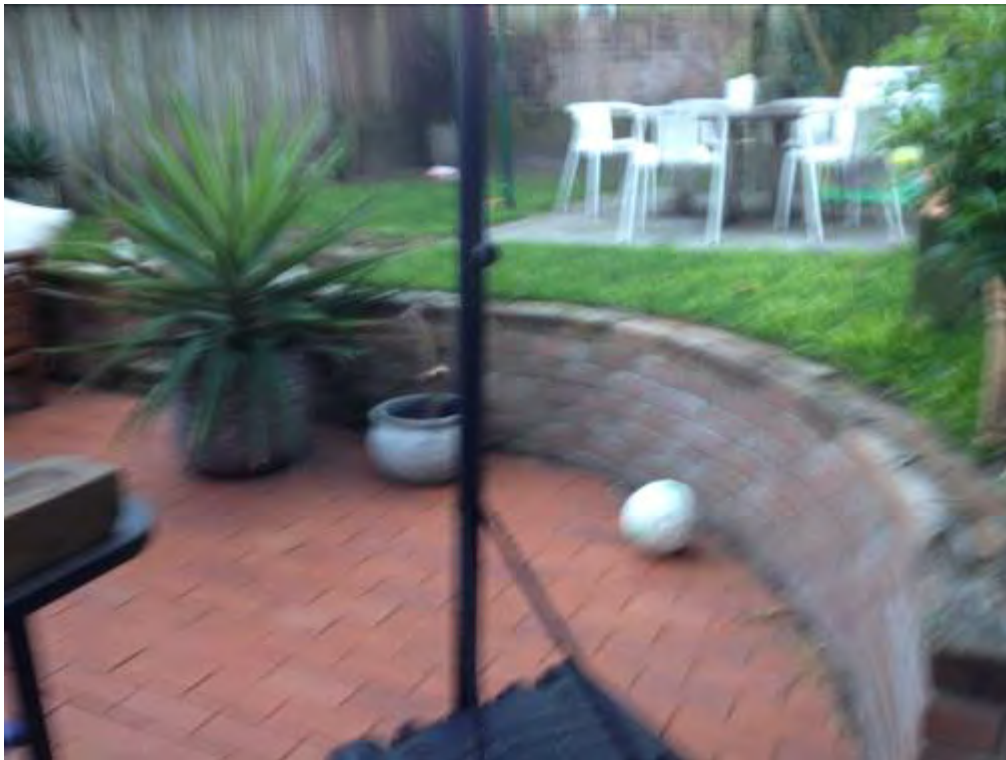
We noted that there is a brick retaining wall forming the courtyard area and that the area is finished with clay pavers. We noted that the pavers are generally uniform in plane and that the pavers when randomly "tap" tested appeared to be sound. **[Photograph 11]**

Photograph 11 shows the condition of the clay pavers and retaining wall to the rear courtyard area

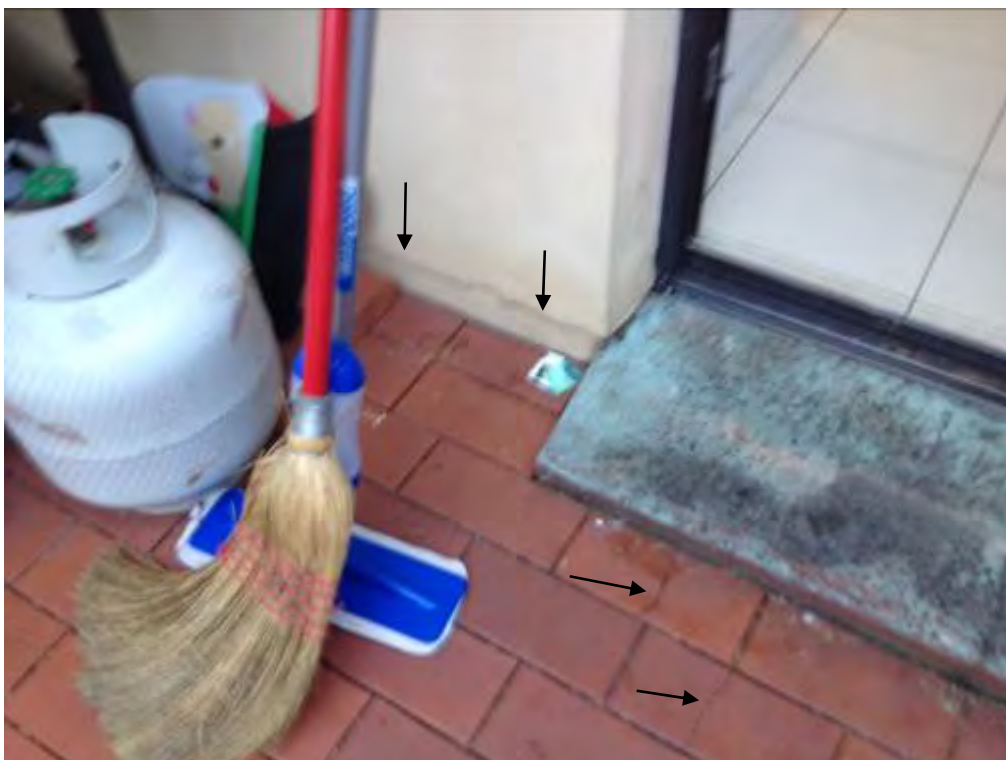
We noted that there a number of cracked pavers in the immediate vicinity of the rear entry door. **[Photograph 12]**

Photograph 12 shows horizontal cracking to the base of the Kitchen wall and adjacent to the rear entry threshold – Note: the cracks to the clay pavers

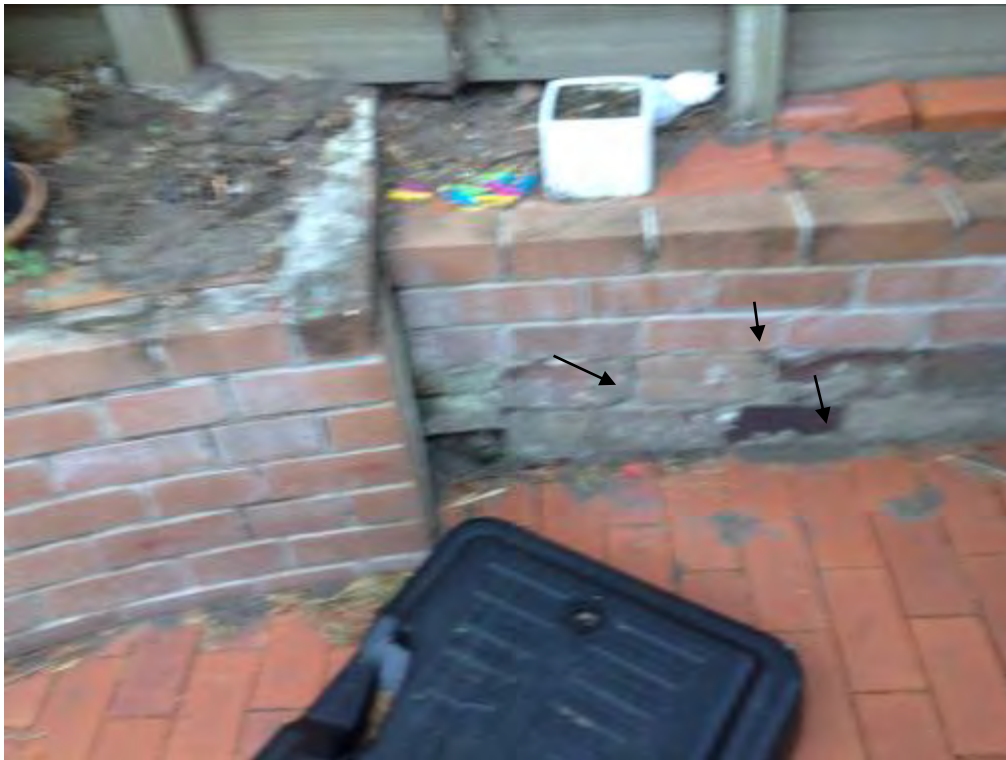
We noted that there is stepped cracking [1.0mm] to the brick garden bed retaining walls. **[Photograph 13]**

Photograph 13 shows previous repairs and a stepped crack to the brick retaining wall to the rear courtyard

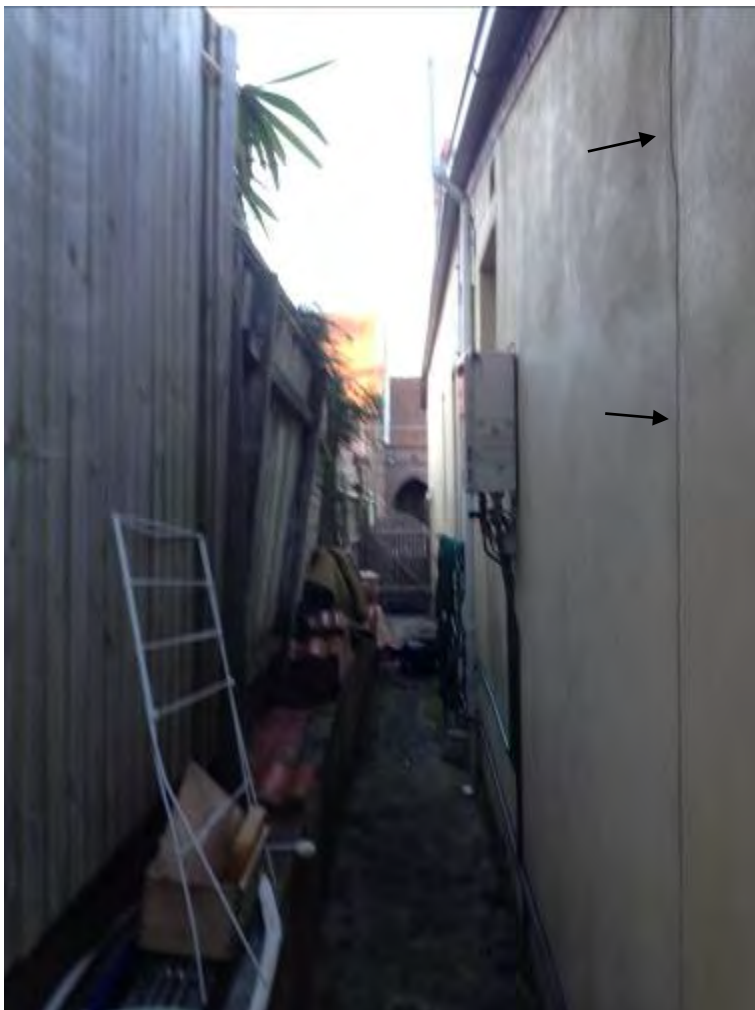
We noted a vertical crack [1.0mm- 3.0mm] extending the full height of the to the Kitchen wall. **[Photographs 14 and 15]**

Photograph 14 shows the eastern elevation boundary – Note: the vertical crack to the Kitchen wall

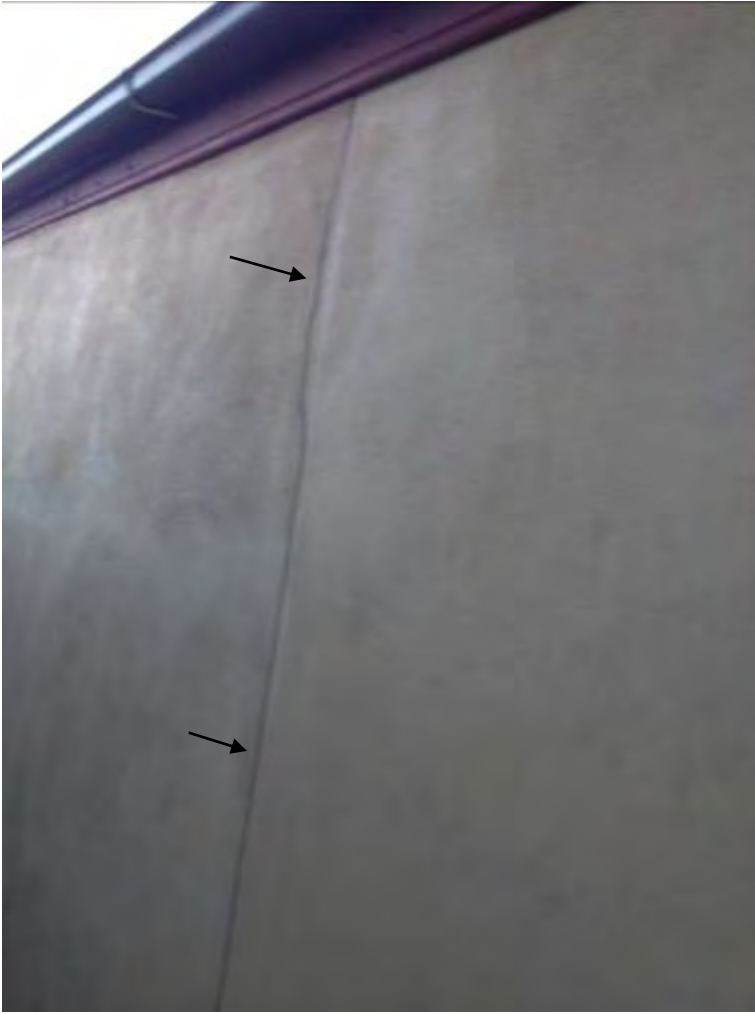
Photograph 15 shows the vertical crack to the cement rendered finish to the Kitchen wall

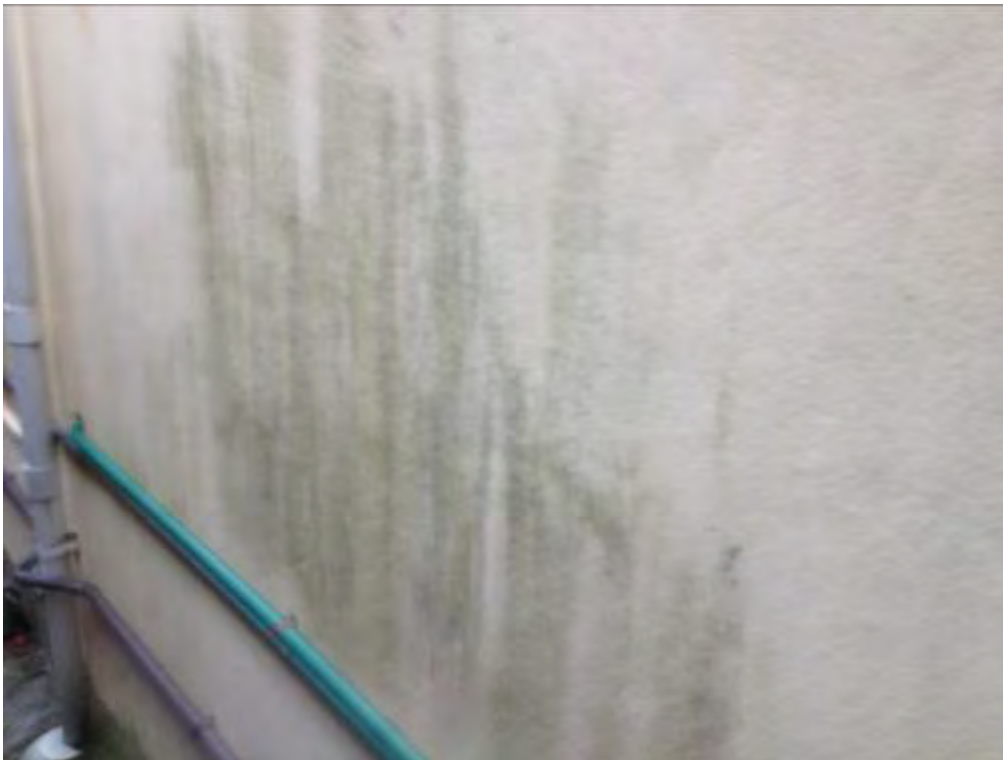
We noted green staining [dampness] to the wall surface below the Bathroom window. **[Photograph 16]**

Photograph 16 shows green staining to the Bathroom wall below the windows

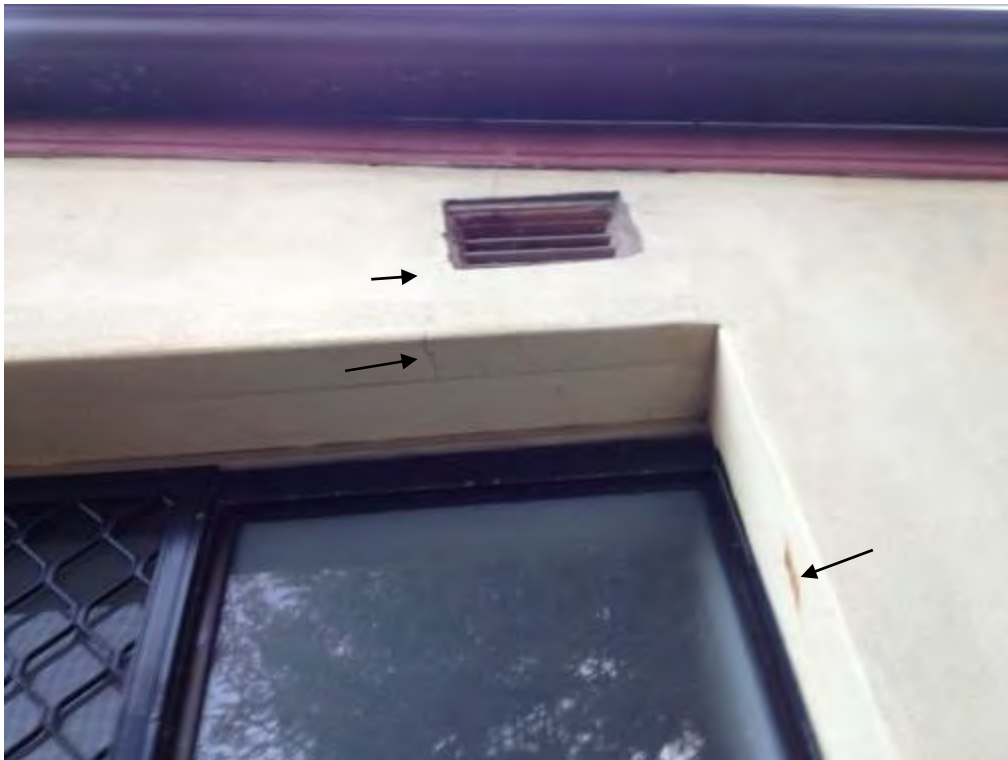
We noted a hairline crack [<1.0mm] extending from the right hand side of the Bathroom window head towards the wall vent. We also noted that there is a brown stain to the window reveal **[Photograph 17]**

Photograph 17 shows hairline cracking above the right hand side of the Bathroom window extending from the window reveal towards the wall vent – Note: brown stain to the reveal

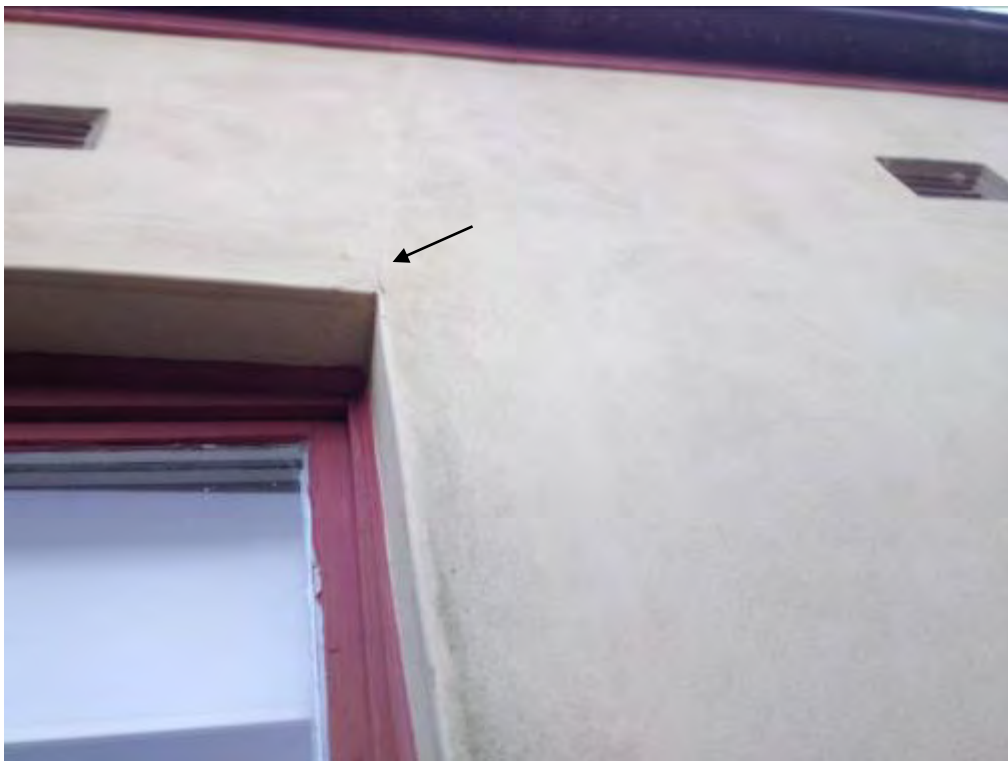
We noted a vertical hairline crack [<1.0mm] extending from the right hand side of the Lounge room window head. **[Photograph 18]**

Photograph 18 shows a vertical crack above the right hand side of the Lounge room window head

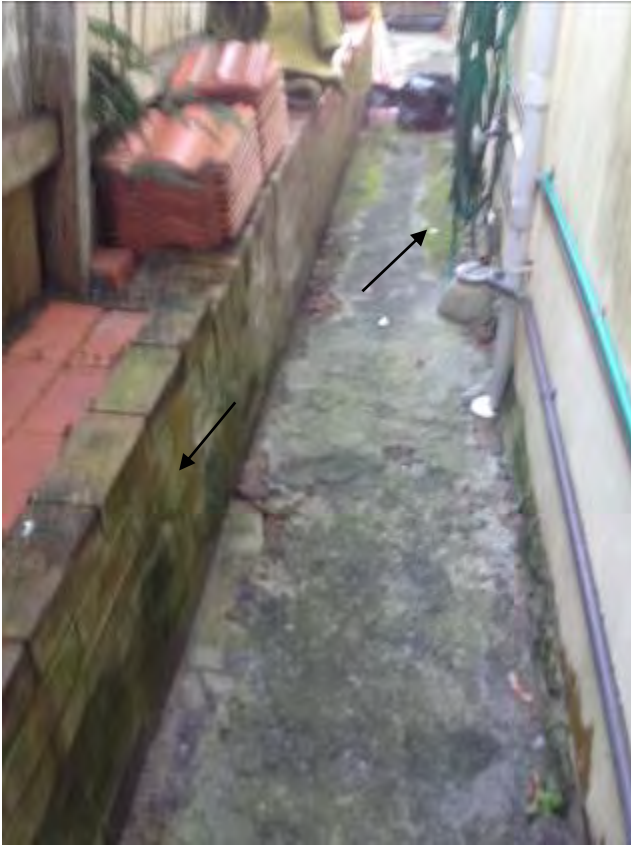
We noted differing uneven paving between the base of the eastern wall and the eastern boundary. We also noted green staining and dampness to the brick retaining wall and to the pavement **[Photographs 19 and 20]**

Photograph 19 shows the condition of the pavement to the eastern boundary - Note: green staining [dampness] to the retaining wall and the pavement

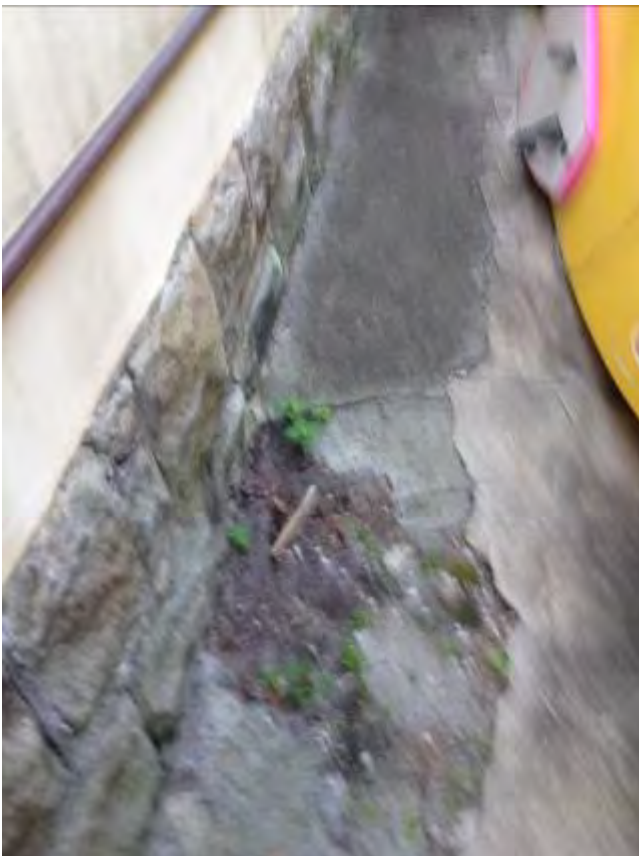
Photograph 20 shows the condition of the pavement to the eastern boundary

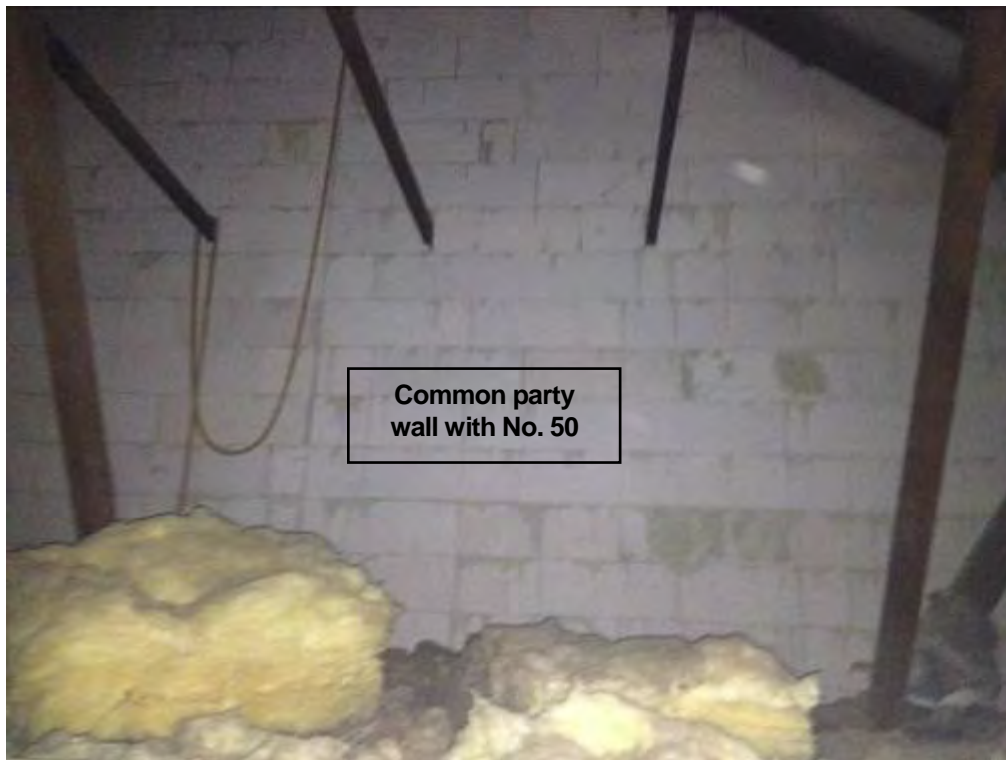
We noted that there is concrete block *common separating / party* wall within the roof space and that the wall terminates just below the roof covering. **[Photograph 21]**

We noted that the timber ceiling joists and *common* ridge to the roof structure are built into the *common party / separation wall*.

Photograph 21 shows the *common party / separation* wall within the roof space – Note: timbers build into the wall

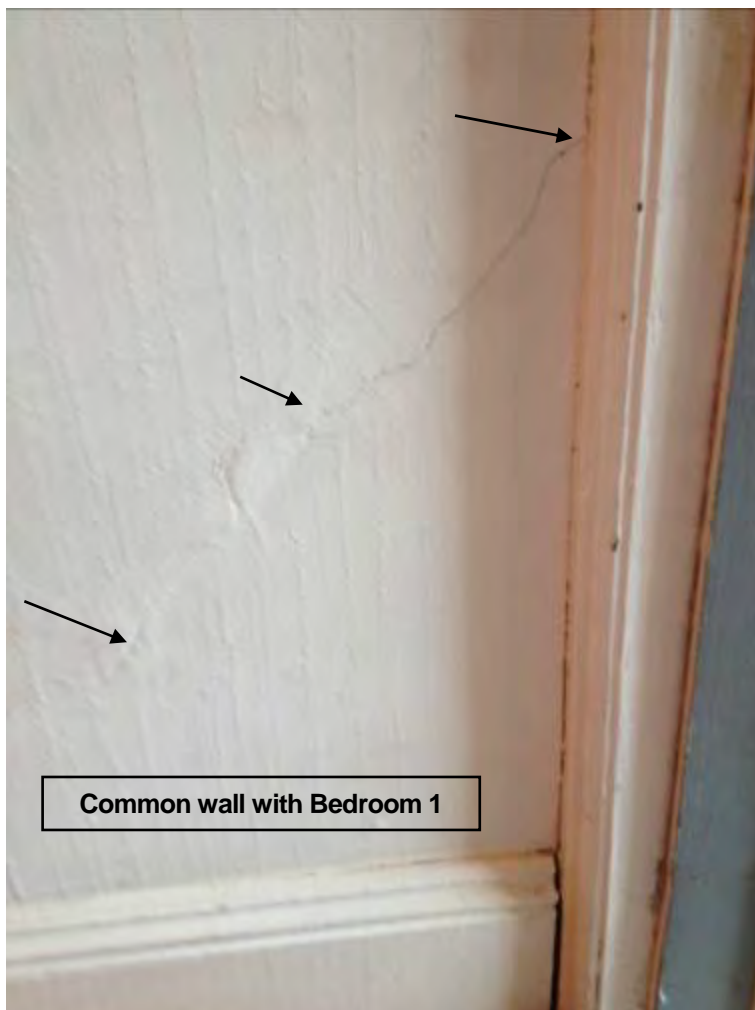
We noted a radial crack [1.0mm] to the base of the *common internal* wall with Bedroom 1 and abutting the front entry door. We further noted that there is a gap [5.0mm] between the skirting and the architrave to the front entry door. **[Photograph 22]**

Photograph 22 shows radial cracking to the wall adjacent to the front entry door

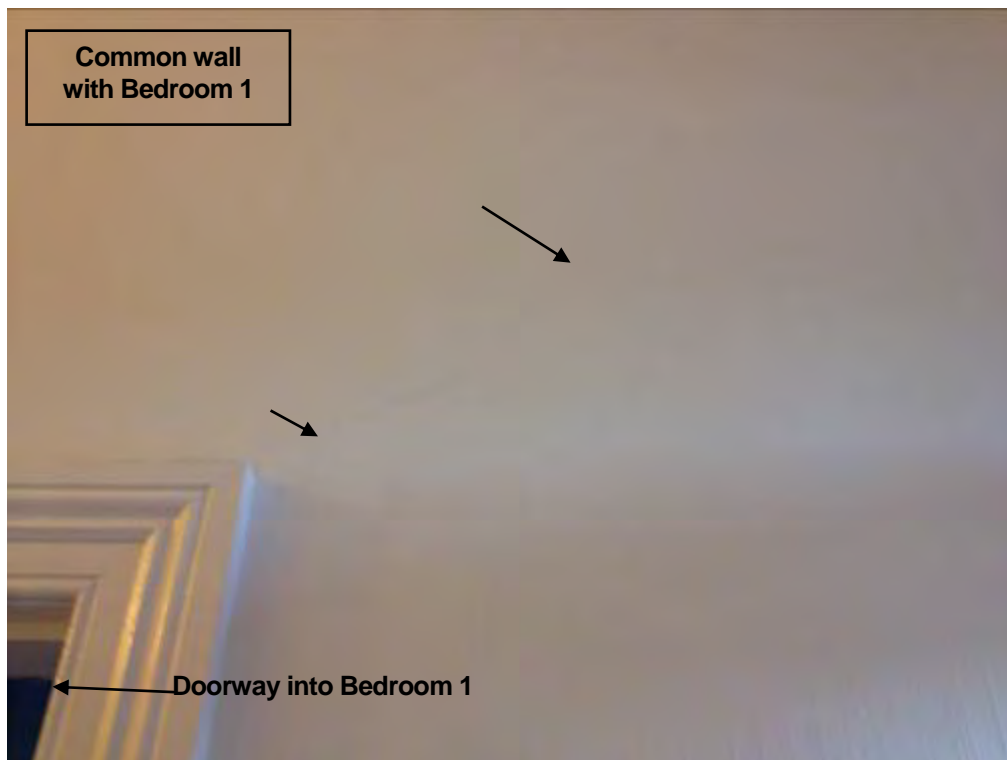
We also noted a hairline radial crack [<1.0mm] extending from the right hand side of the door head to Bedroom 1 towards the cornice line. **[Photograph 23]**

Photograph 23 shows a hairline radial crack extending from the right hand side of Bedroom 1 door head towards the cornice

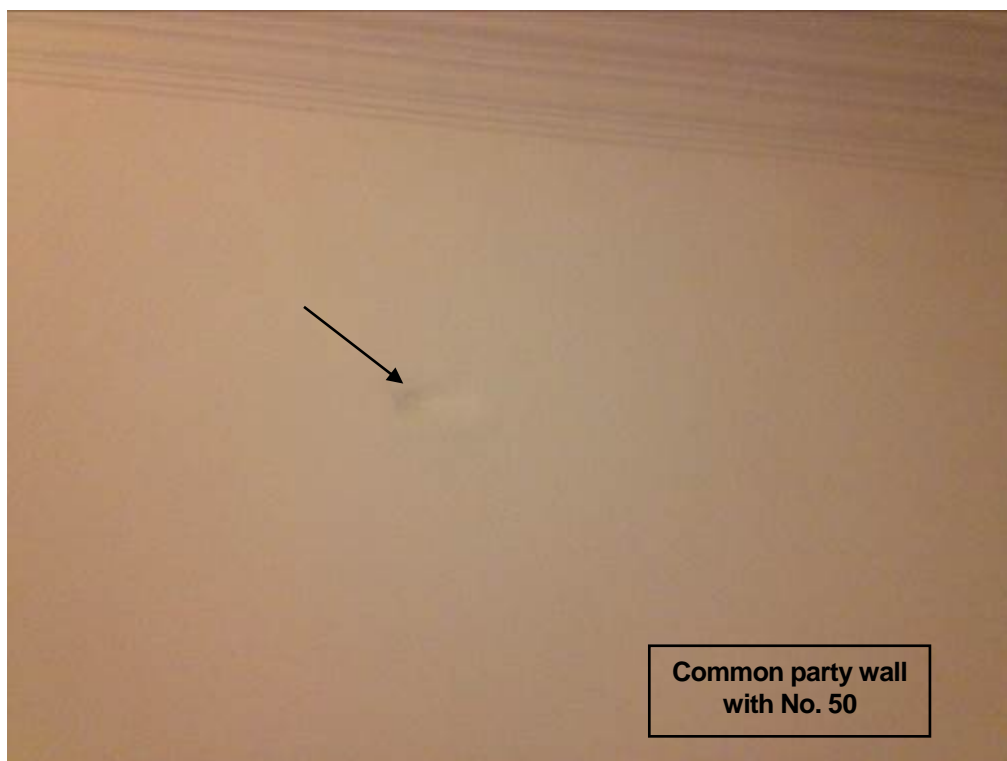
We further noted that there are previously repaired patches to the *common party / separation* wall. **[Photograph 24 - typical]**

Photograph 24 shows typical indent repairs to the Hallway *common party / separation* wall

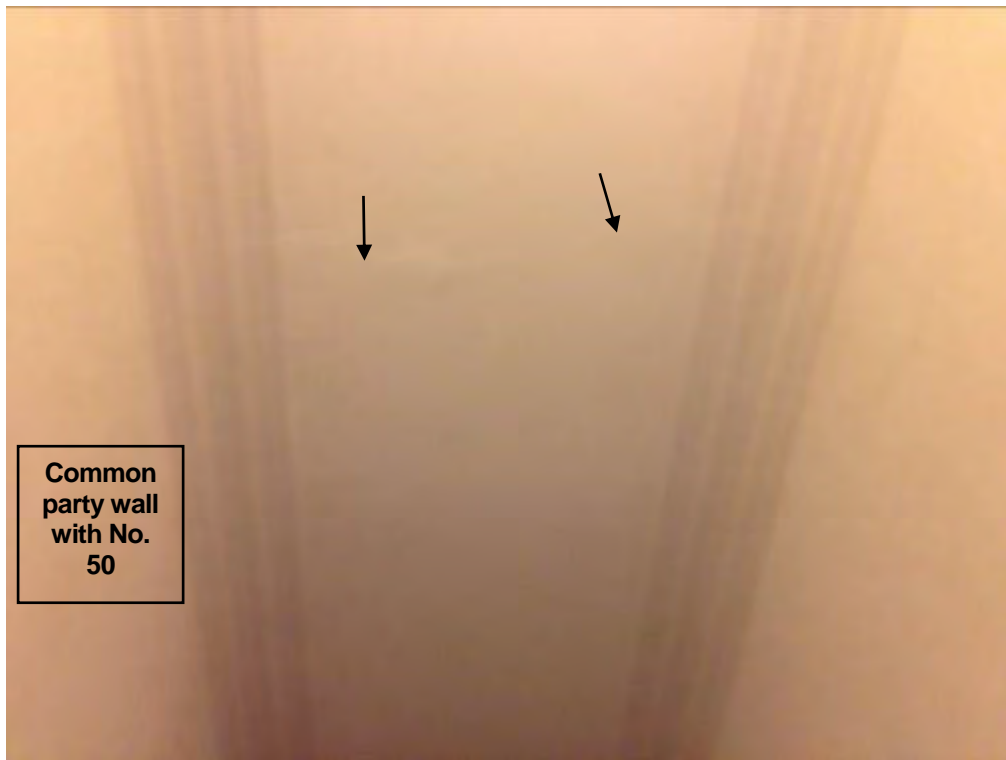
We noted that there is a hairline crack [<1.0mm] to the set joint in the fibrous plaster ceiling and to the decorative profiled plaster cornice above the door way into Bedroom 2 and abutting the *common party / separation* wall. **[Photograph 25]**

Photograph 25 shows hairline cracking to the set joint in the Hallway ceiling above the doorway into Bedroom 2

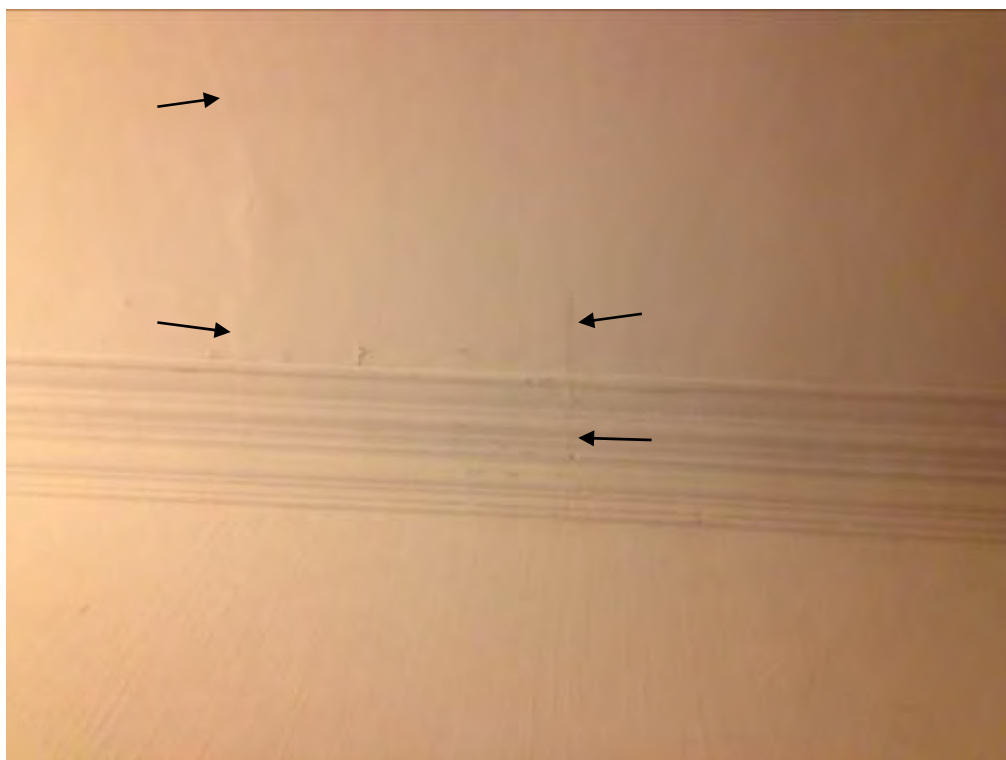
We noted that there is a hairline crack [<1.0mm] to the set joint in the fibrous plaster ceiling and to the decorative profiled plaster cornice northern end of the Hallway and abutting the *common party / separation* wall. **[Photograph 26]**

Photograph 26 shows hairline cracking to the set joint in the Hallway ceiling and cornice towards the north end of the Hallway ceiling

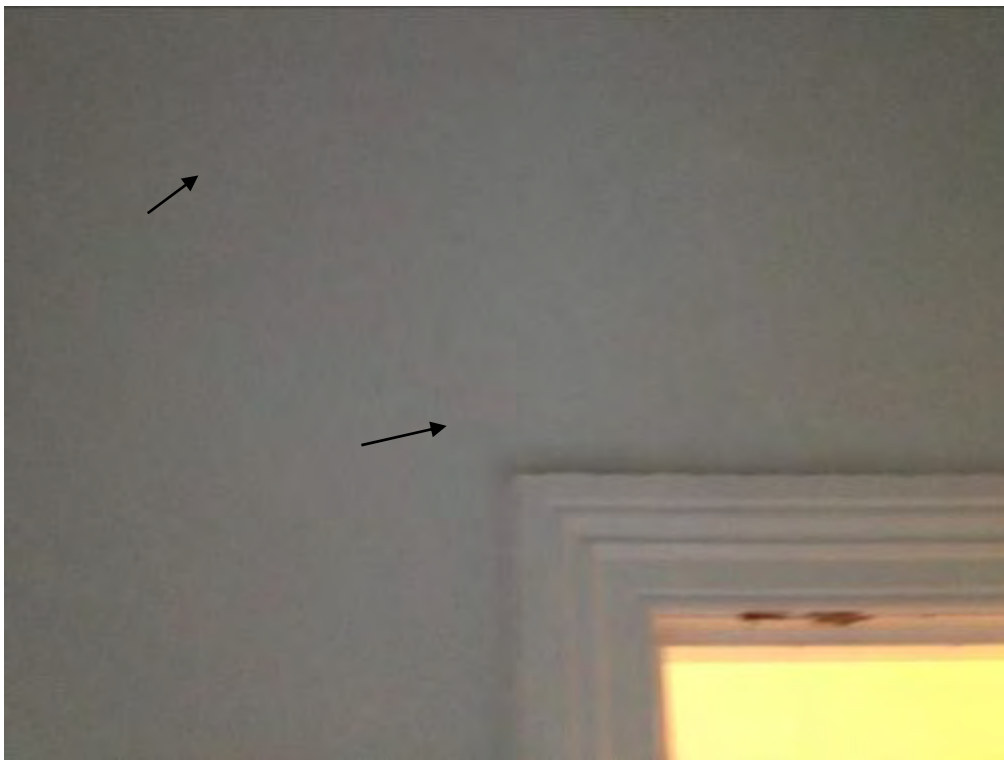
We noted a hairline radial crack [$<1.0\text{mm}$] extending from the left hand side of the door opening towards the ceiling and southwest corner of the room. **[Photograph 27]**

Photograph 27 shows a hairline radial crack extending from the left hand side of Bedroom 1 door head towards the cornice

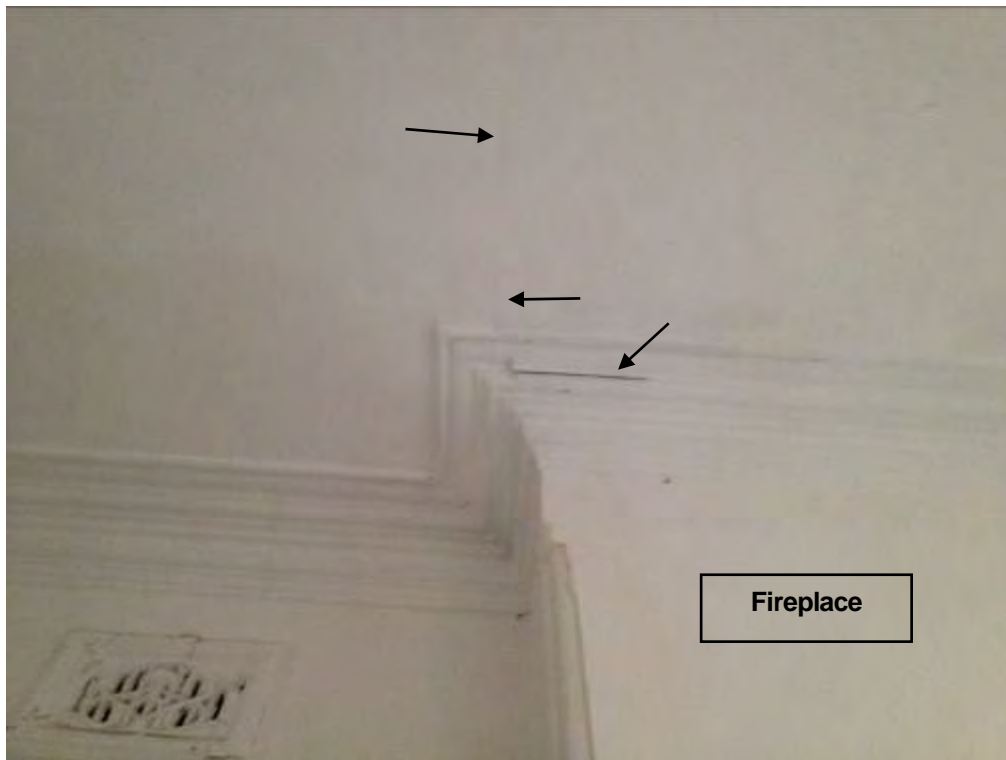
We noted that there is damage to the decorative profile plaster cornice and a hairline crack [$<1.0\text{mm}$] to the ceiling extending from the external left hand side of the fireplace. **[Photograph 29]**

Photograph 29 shows a hairline crack to the ceiling and damage to the cornice abutting the fireplace in Bedroom 1
