Dilapidation Assessment Report

Prepared for: Cape Cod Australia Pty. Limited
Job address: 52 Varna Street, Waverley NSW 2024
Property Owner: Not known
C/o PRD Nationwide Real Estate
59 Macpherson Street, Waverley NSW 2024
Report reference: **RANDWICK CITY COUNCIL**
Development Application No: DA/649/2015
Date of assessment: 5th May 2016

Re: Dilapidation Report - No. 52 Varna Street, Waverley

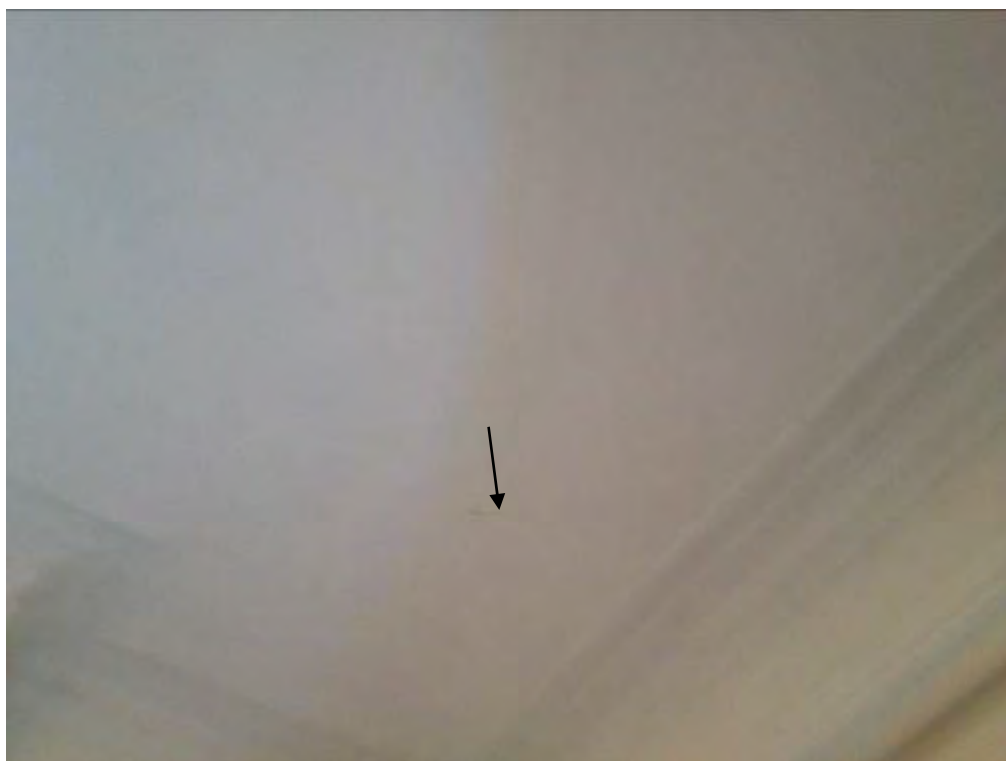
We also noted areas of flaking [lifting] paint from the fibrous plaster ceiling. **[Photograph 30]**

Photograph 30 shows flaking paint from the southeast corner of Bedroom 1 ceiling

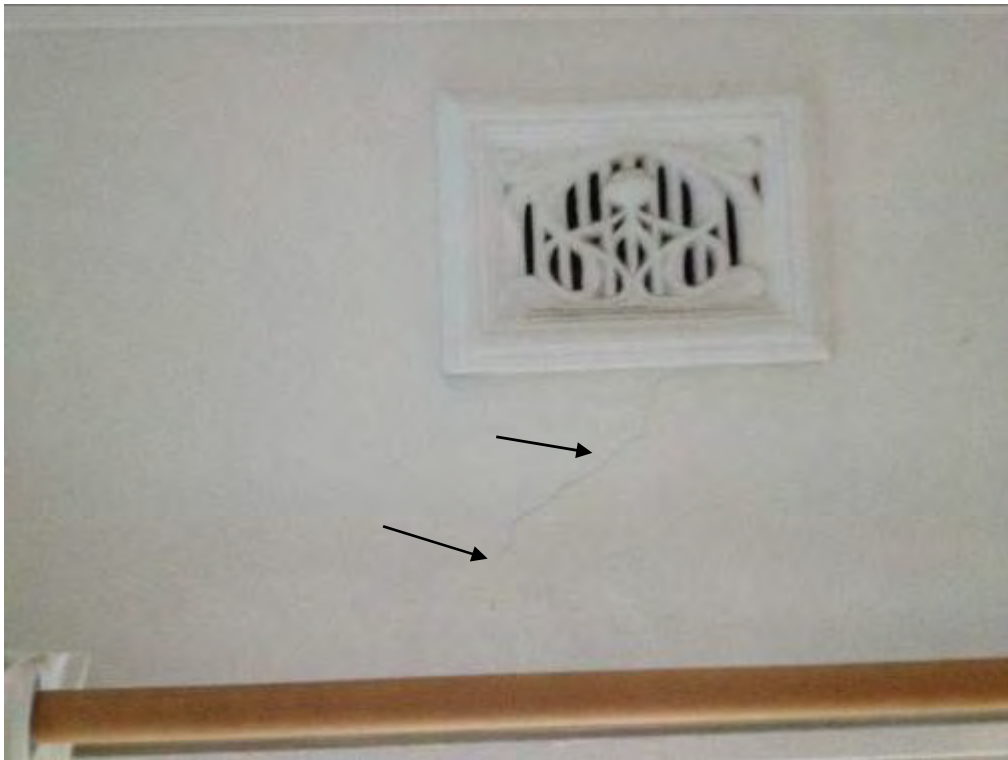
We did not observe any cracking to the surface coated cement rendered wall surfaces. Notwithstanding this we noted a hairline radial crack [$<1.0\text{mm}$] extending from the left hand side of the window head towards the wall vent. **[Photograph 31]**

Photograph 31 shows a radial crack from the left hand side of the Bedroom 2 window head towards the wall vent

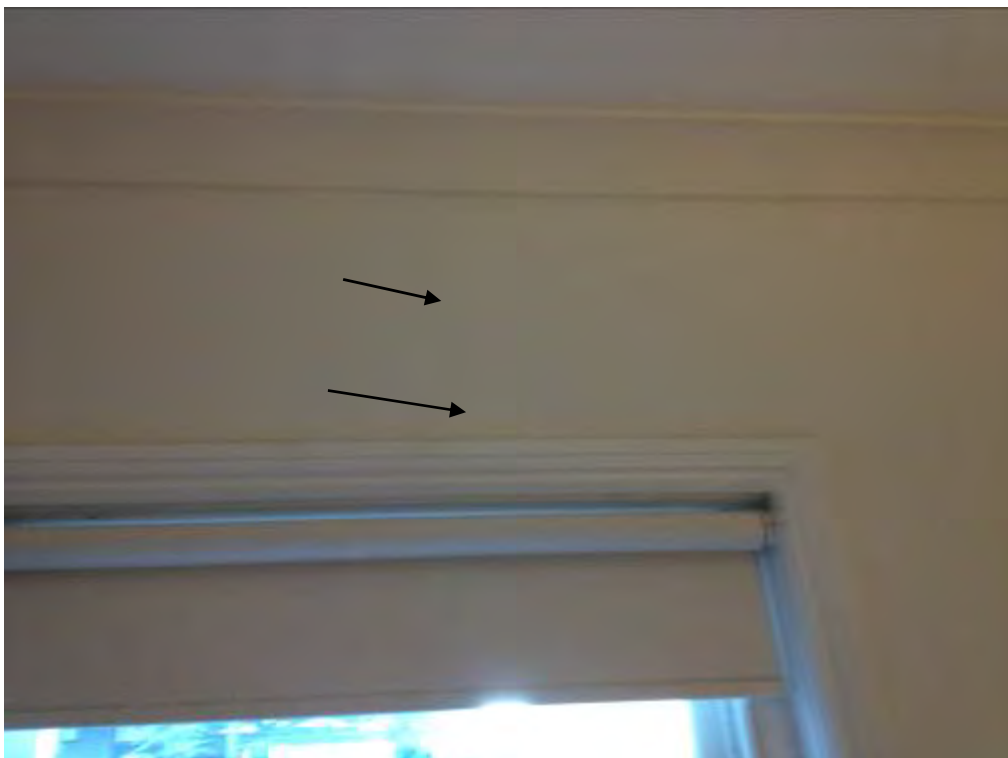
We did not observe any recent noticeable cracking to the surface coated cement rendered wall surfaces particularly along the *common party / separation* wall. Notwithstanding this, we noted a hairline vertical crack [$<1.0\text{mm}$] above the window head towards the cornice. **[Photograph 32]**

Photograph 32 shows the location of the hairline vertical crack above the Lounge room window head

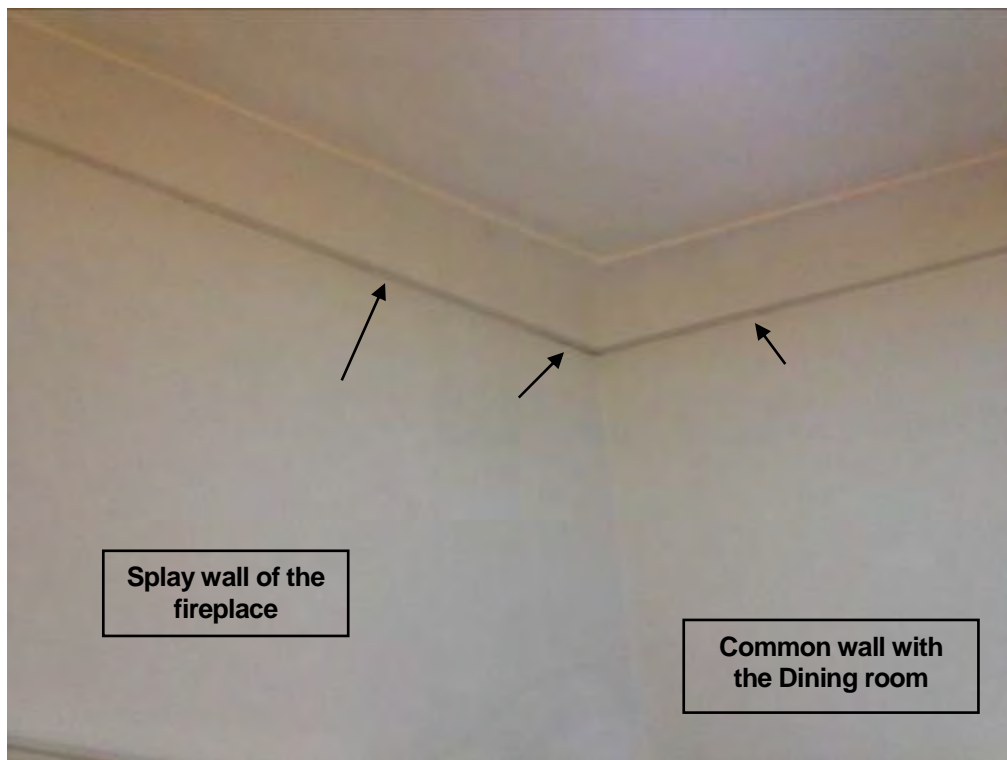
We did not observe any cracking to the plasterboard ceiling or to the mitred joints in the cove profile plaster cornice. Notwithstanding this, we noted separation cracking between the cornice and the wall surface over the fireplace. **[Photograph 33]**

Photograph 33 shows separation cracking between the cornice and the wall surface above the fireplace in the Lounge room

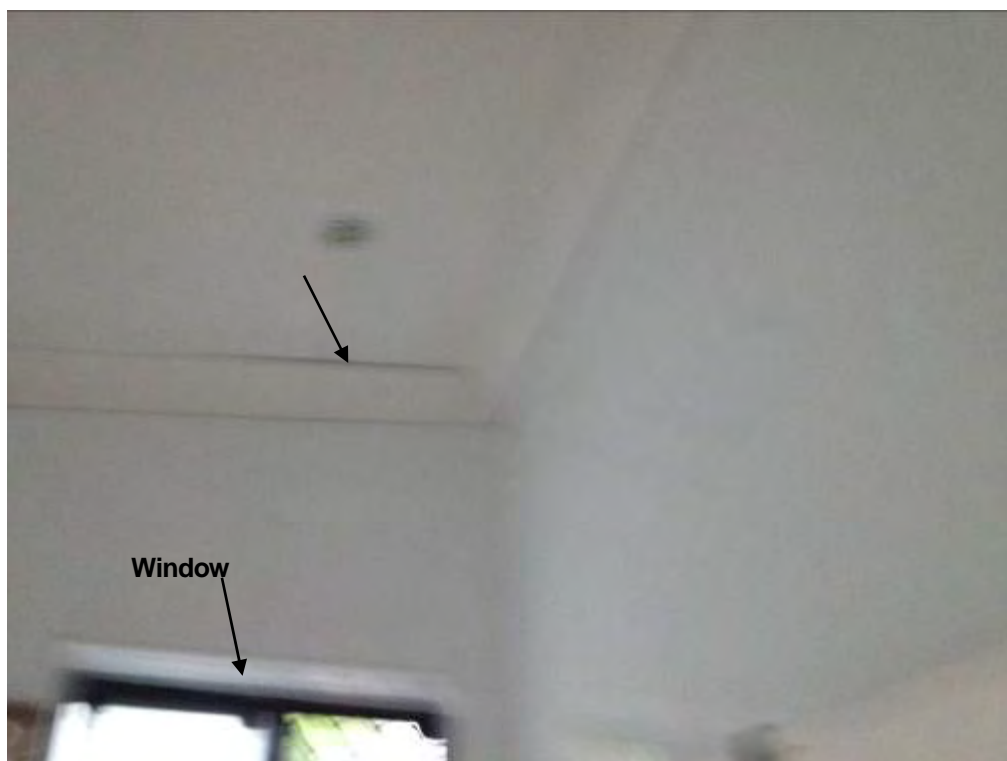
We did not observe any cracking to the plasterboard ceiling or to the cove profiled plaster cornices. Notwithstanding this, we noted separation cracking between the cornice and the ceiling lining to the south eastern and north western corner of the Bathroom. **[Photographs 34, 35 and 36]**

Photograph 34 shows a separation crack between the cornice and the ceiling to the south east corner of the Bathroom

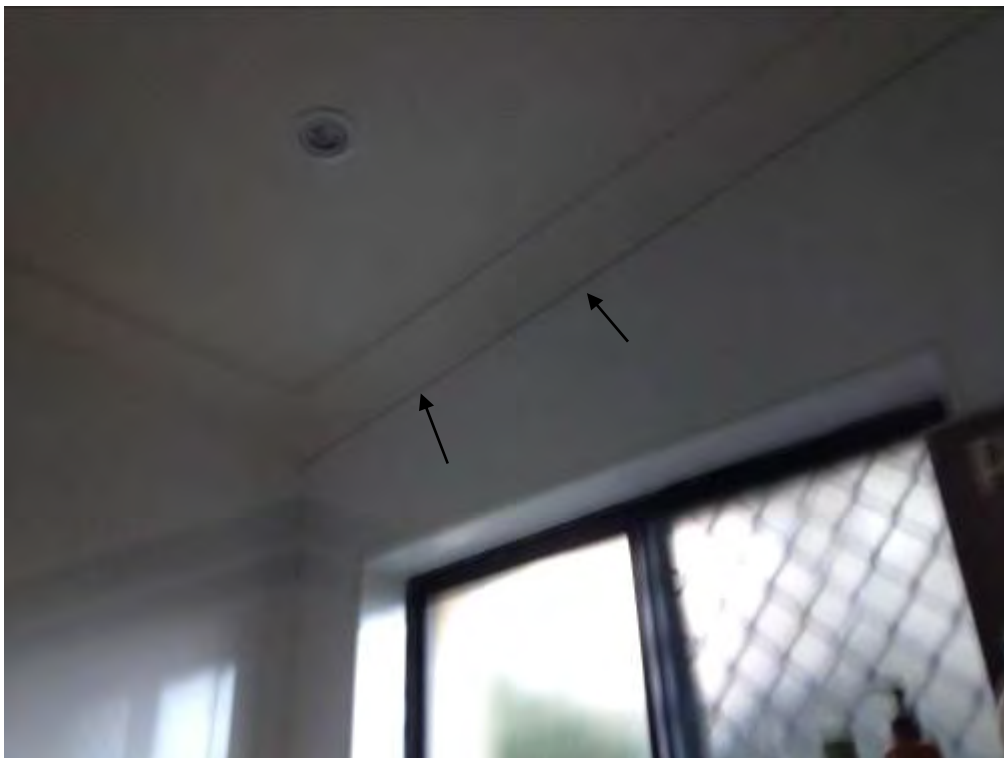
Photograph 35 shows separation cracking between the cornice and the wall tiles above the Bathroom window

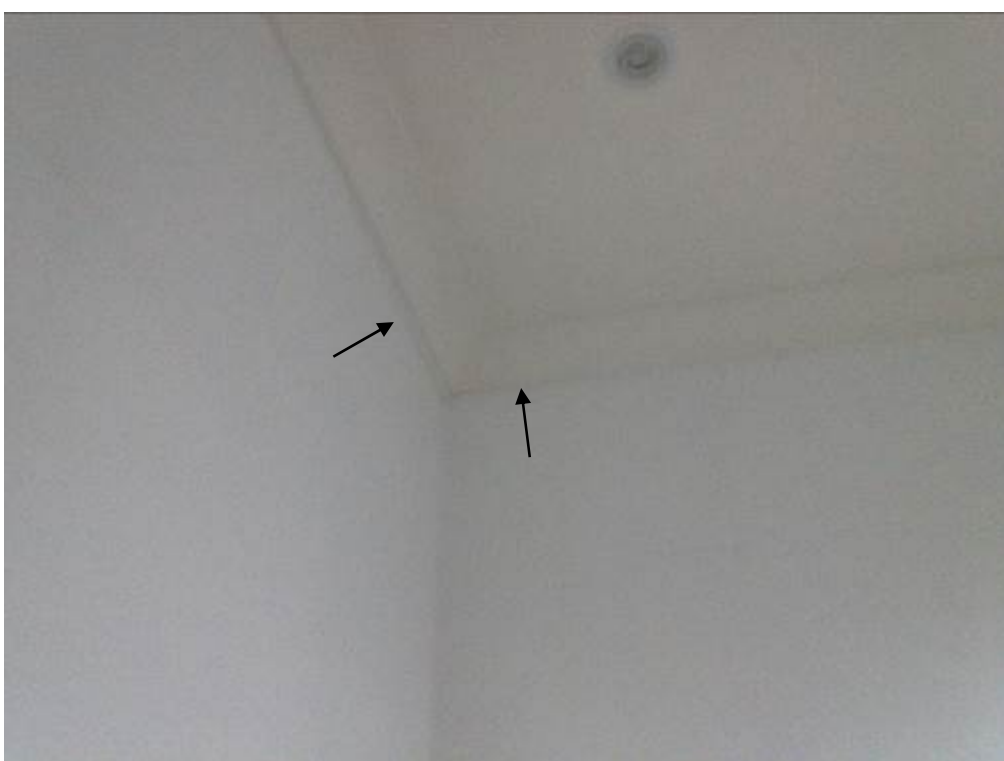
Photograph 36 shows separation cracking between the cornice and the wall tiles to the northeast corner of the Bathroom

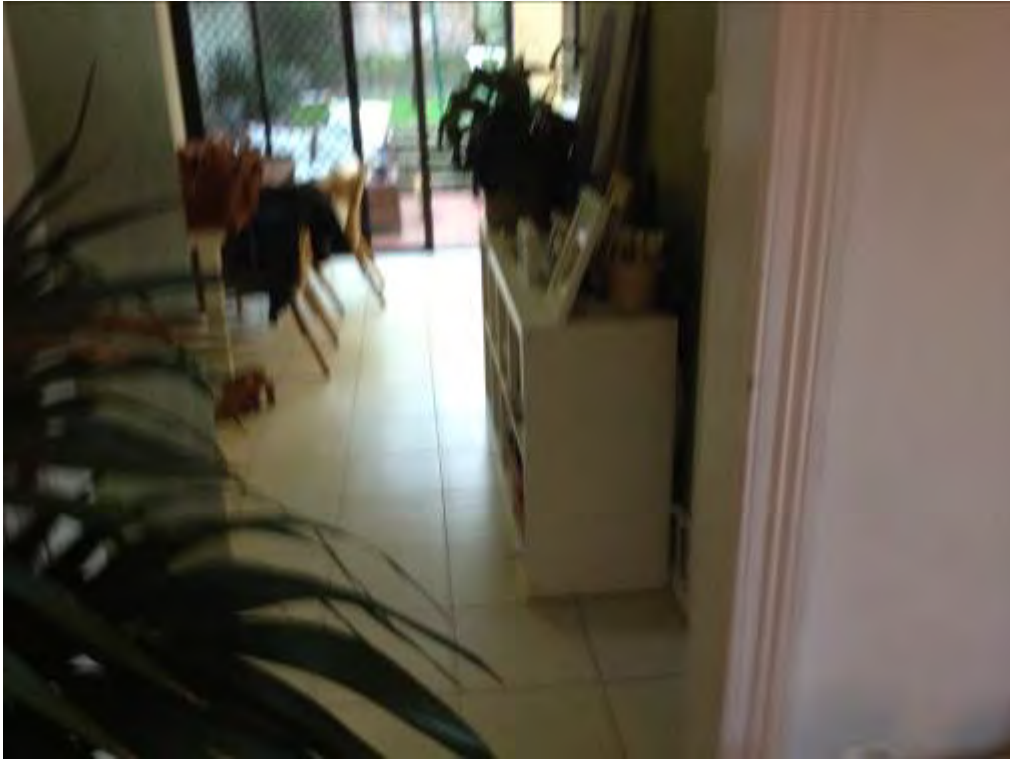
We noted that the floor is finished with ceramic tiles. We noted that the grout to the tiles is complete and that the tiles when randomly "tap" tested appeared to be sound. **[Photograph 37]**

Photograph 37 shows the condition of the floor tiles in the Dining room
