HAZARDOUS MATERIALS ASSESSMENT REPORT

Job details: Owner/s: Mr. L. & Mrs. G. Bilfolco
Location: 12 Moonbi Close, Greenfield Park

Plans for Job No: 7585/14 Revision No: C Dated: 31-10-14

Our reference: HM03471114

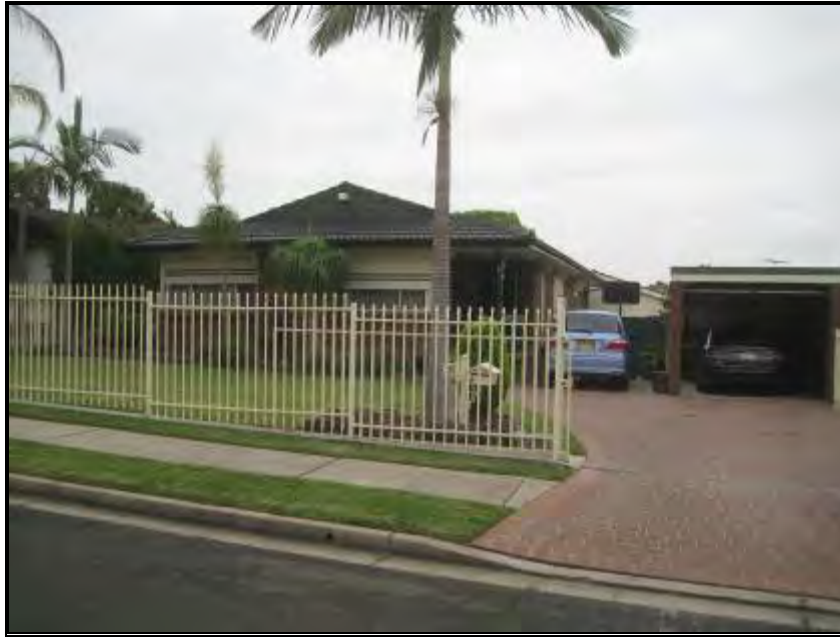
Front southwest elevation of the residence
