HAZARDOUS MATERIALS ASSESSMENT REPORT

Job details: Owner: Mr. J. & Mrs. A Hill
Location: 75 Renwick Street, Drummoyne.

Our reference: HM05321116

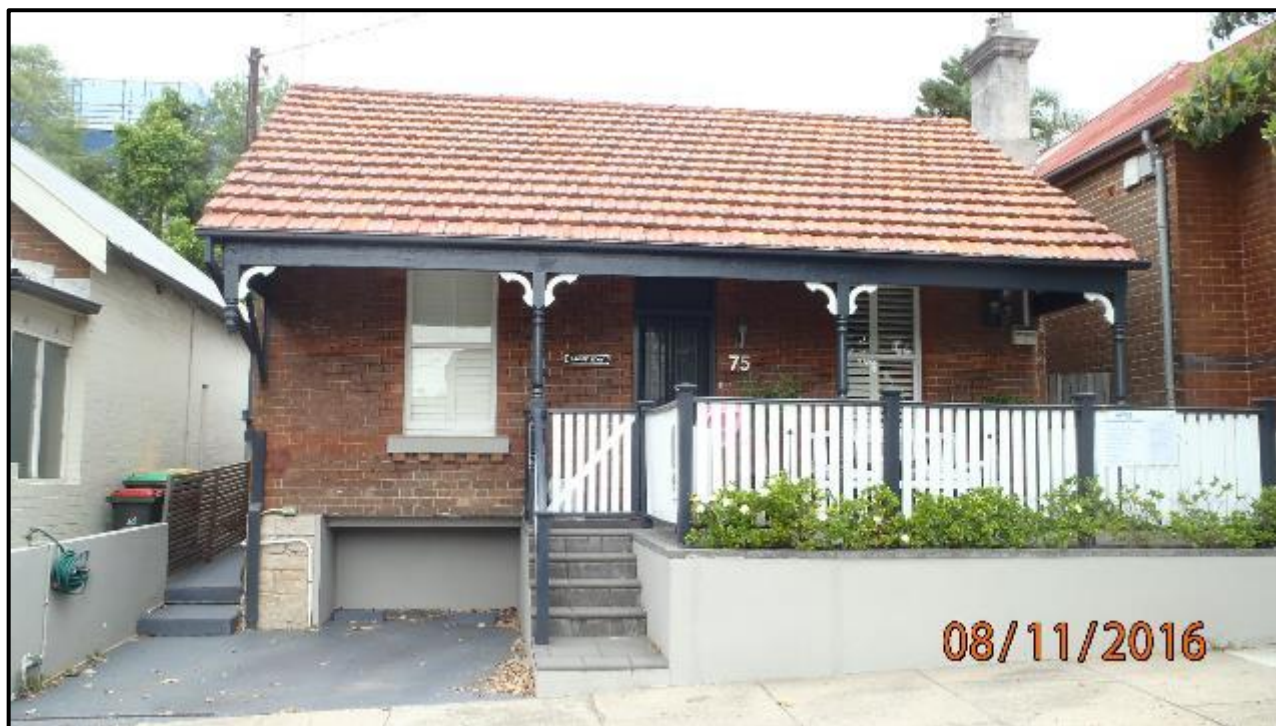
Front north east elevation of the residence
