HAZARDOUS MATERIALS ASSESSMENT REPORT

Client: Cape Cod Australia Pty. Limited

Job details: Owner: Mr. D. & Mrs. R. De Beer.
Location: 147 Galston Road, Hornsby Heights.

Our reference: HM06101017

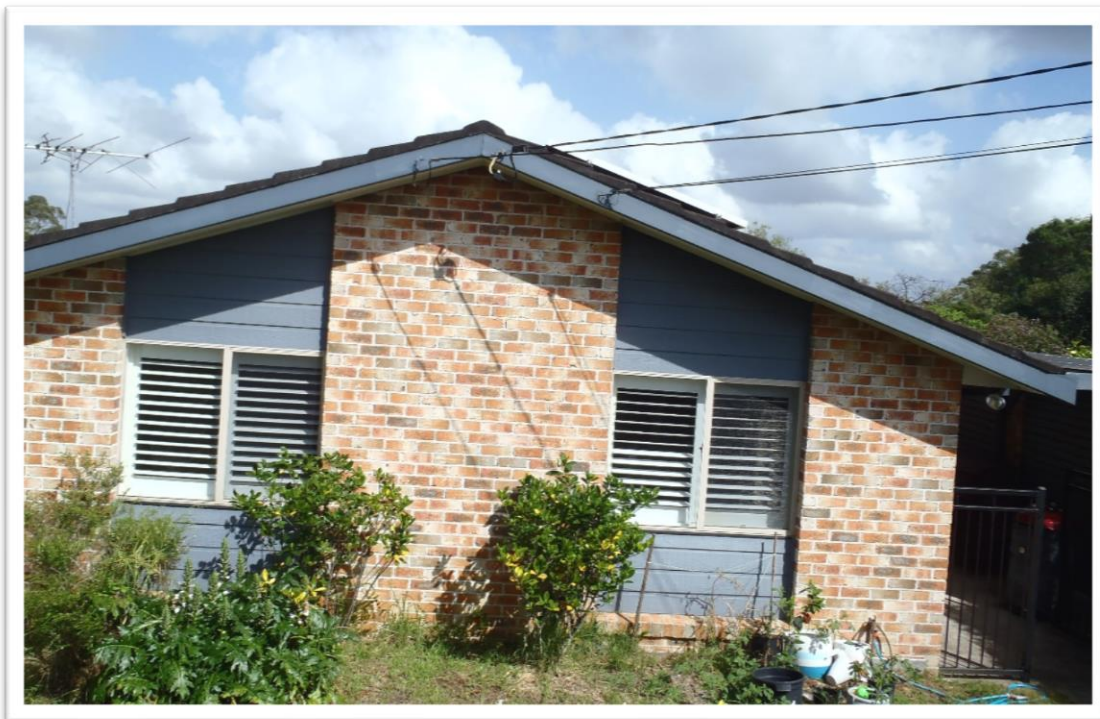
Front eastern elevation of the residence
