HAZARDOUS MATERIALS ASSESSMENT REPORT

Job details: Owner: Mr. R. Clarke & Ms. A. Ho
Location: 9 Morrice Street, Lane Cove. NSW.

Our reference: HM05251116

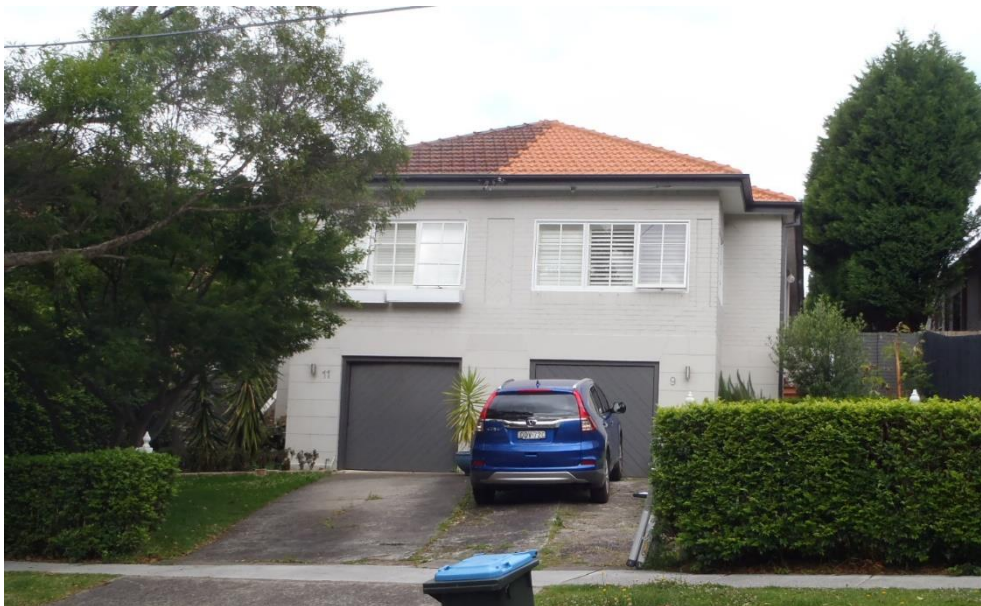
Front eastern elevation of the residence
