Dilapidation Assessment Report

Prepared for: Cape Cod Australia Pty. Limited
Job address: No. 31 Clyde Street, Croydon Park.
Property Owner/s: Mrs. Monique Apostle.
Report reference: CANTERBURY COUNCIL
Development Application No: not available
Date of assessment: 18th November 2016

Re: Dilapidation Report – No. 31 Clyde Street, Croydon Park.

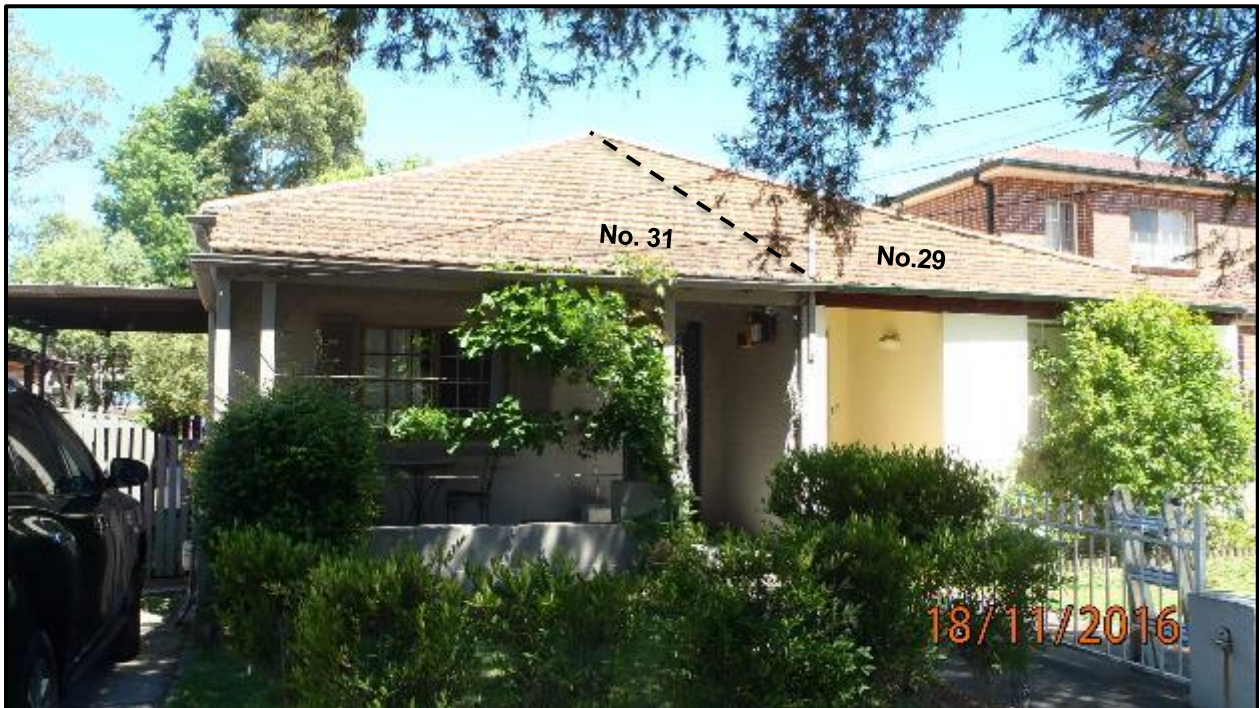
Shows the front eastern elevation of the adjoining properties:
No.31 and No.29 Clyde Street, Croydon Park.

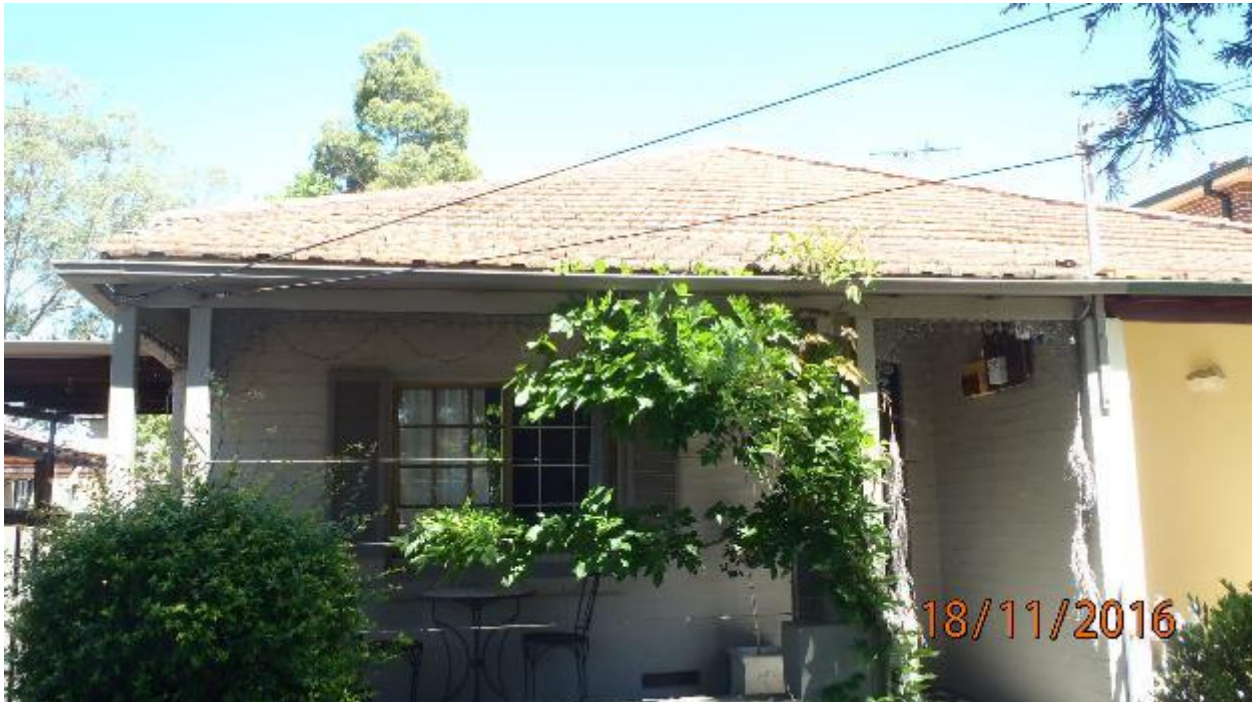
We observed that the terracotta roof tiles to the original roof surfaces are generally interlinked and securely bedded, in our opinion forming a weather resistant cover to the residence. **[Photograph 1]**

We also noted vegetation growth to the timber support posts of the front verandah and guttering system. **[Photograph 1]**

Photograph 1 shows the general condition of the front roof surface and the vegetation growth.

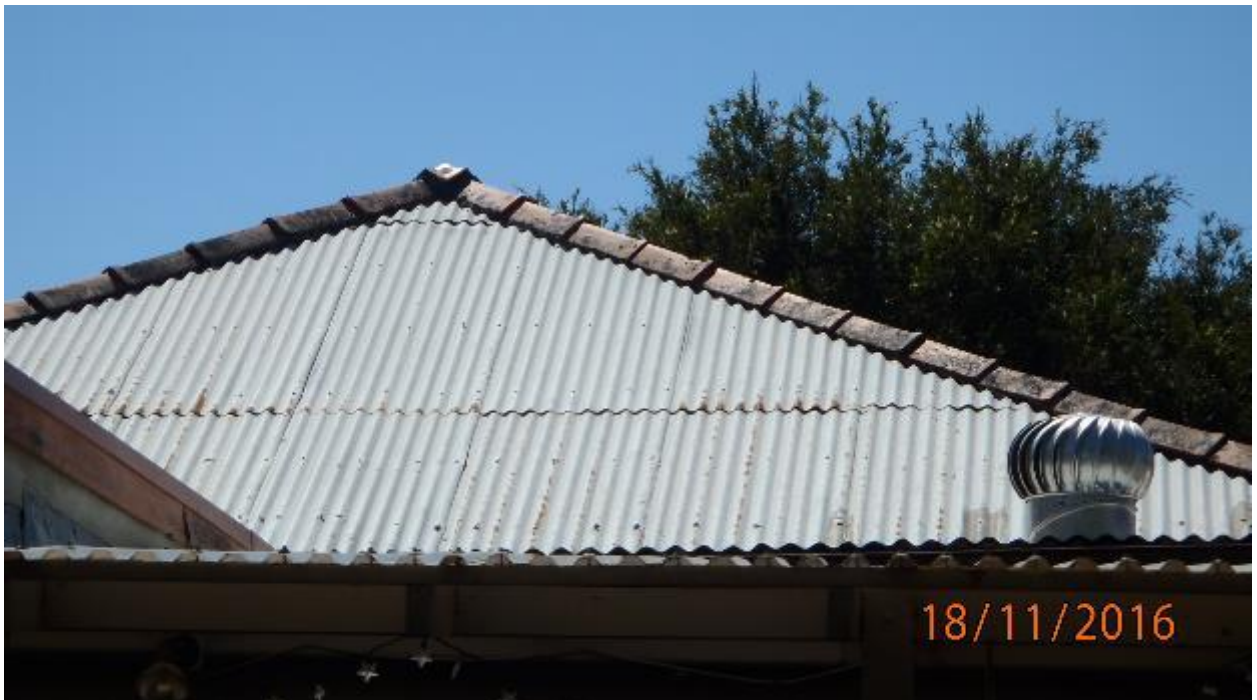
We noted that the corrugated profile sheet metal roofing to the rear addition roof surfaces is showing signs of deterioration and rust. **[Photograph 2]**

We noted that the surface water from the pitched section of the roof discharges directly onto the skillion roof section over the Dining room. **[Photograph 2]**

Photograph 2 shows the general condition of the rear sheet metal roof section.

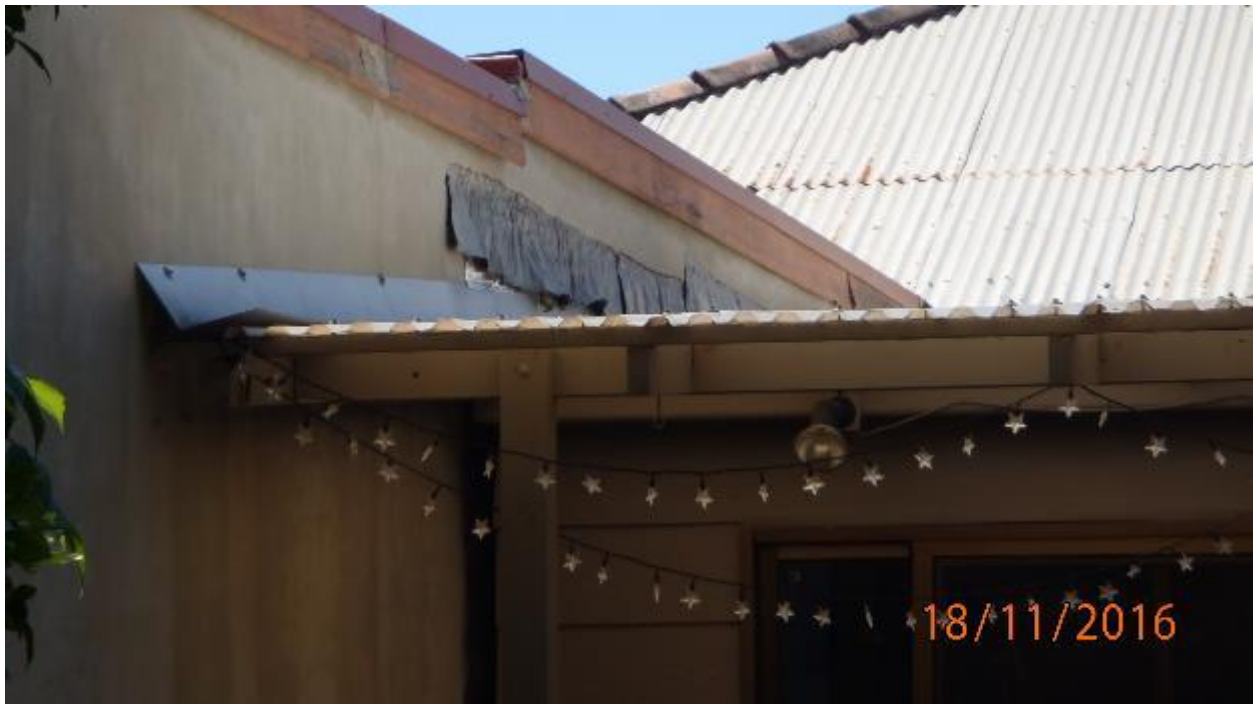
We also noted that the side flashing between the brick wall of rear addition of the adjoining property, No. 29 Clyde Street, Croydon Park and the metal skillion roof is generally intact and forming a weather resistant seal between the wall and the roof surface. **[Photograph 3]**

We further noted that the timber barge boards of rear addition of the adjoining property, No. 29 Clyde Street, Croydon Park were not surface coated. **[Photograph 3]**

Photograph 3 shows the side flashing between No.29 Clyde Street and the rear section of roof. Note: Timber barge boards not painted.

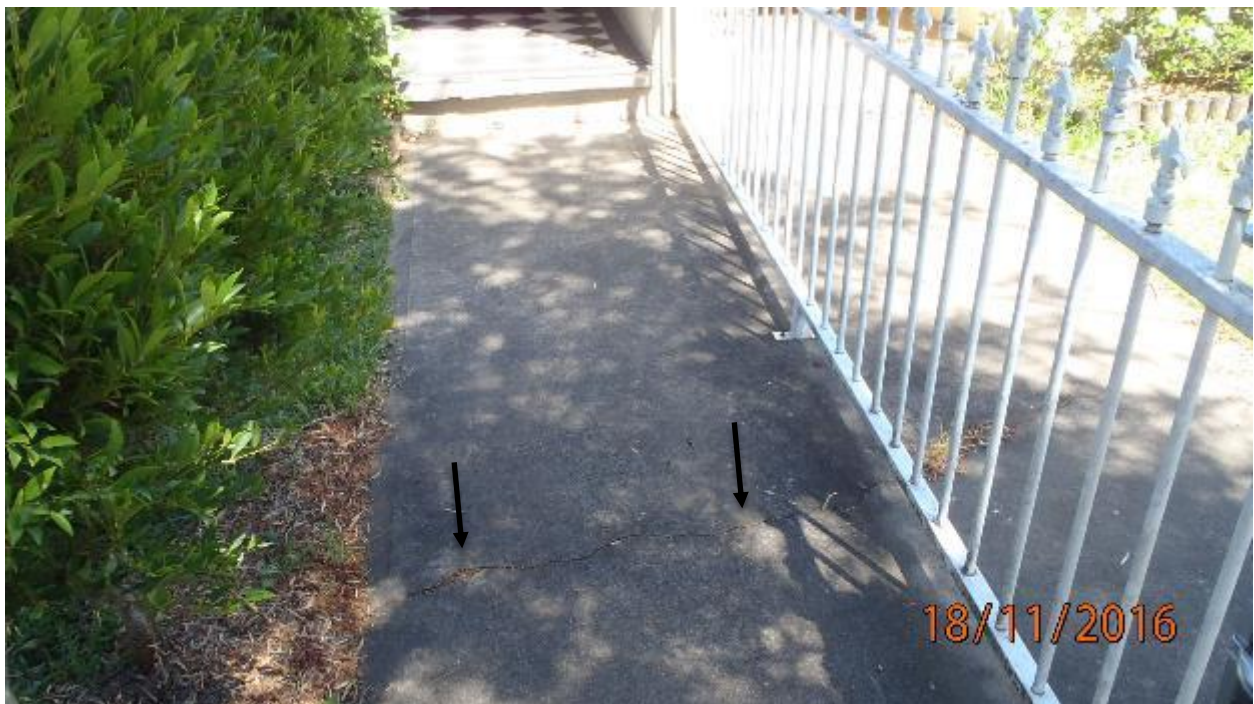
We noted shrinkage cracking to concrete slab front pathway. **[Photograph 4]**

We noted that the front *common* boundary fence is of metal pool style construction. **[Photograph 4]**

Photograph 4 shows cracking to the front pathway and the common boundary fence with the adjoining property, No.29 Clyde Street, Croydon Park.

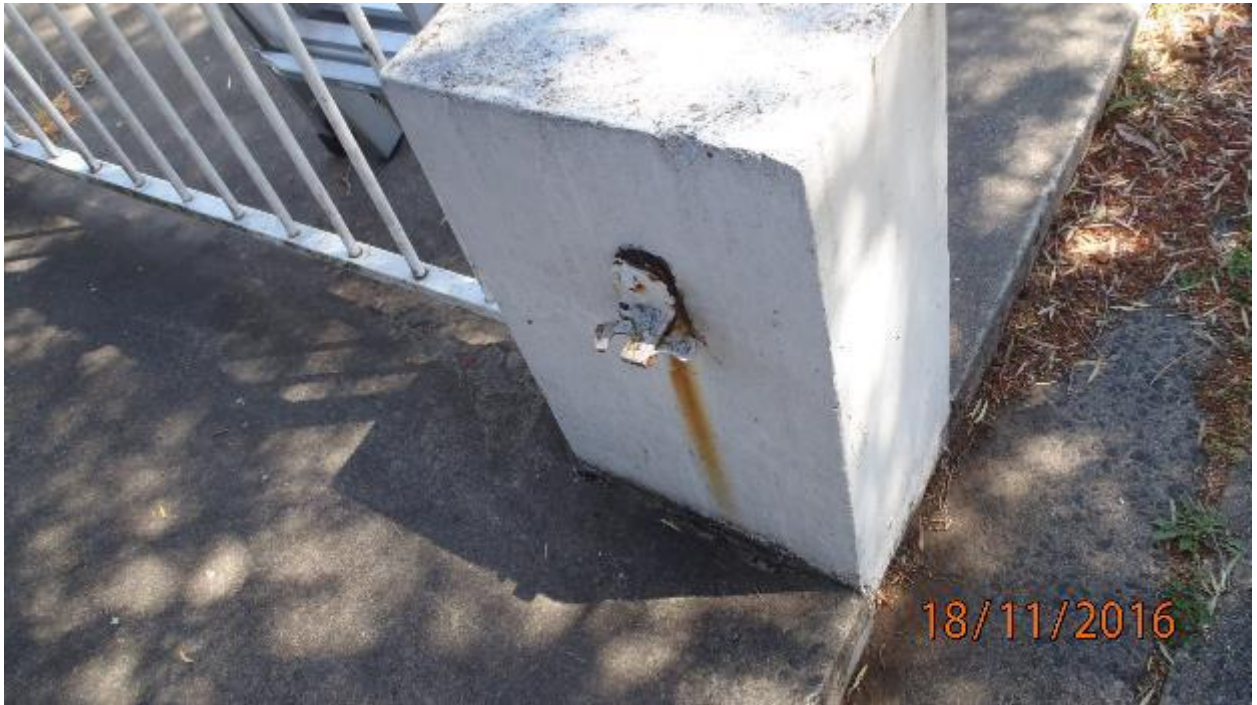
We noted that the front gate latch was rusted and loose **[Photograph 5]**

Photograph 5 shows the rusted gate latch at the front boundary wall.

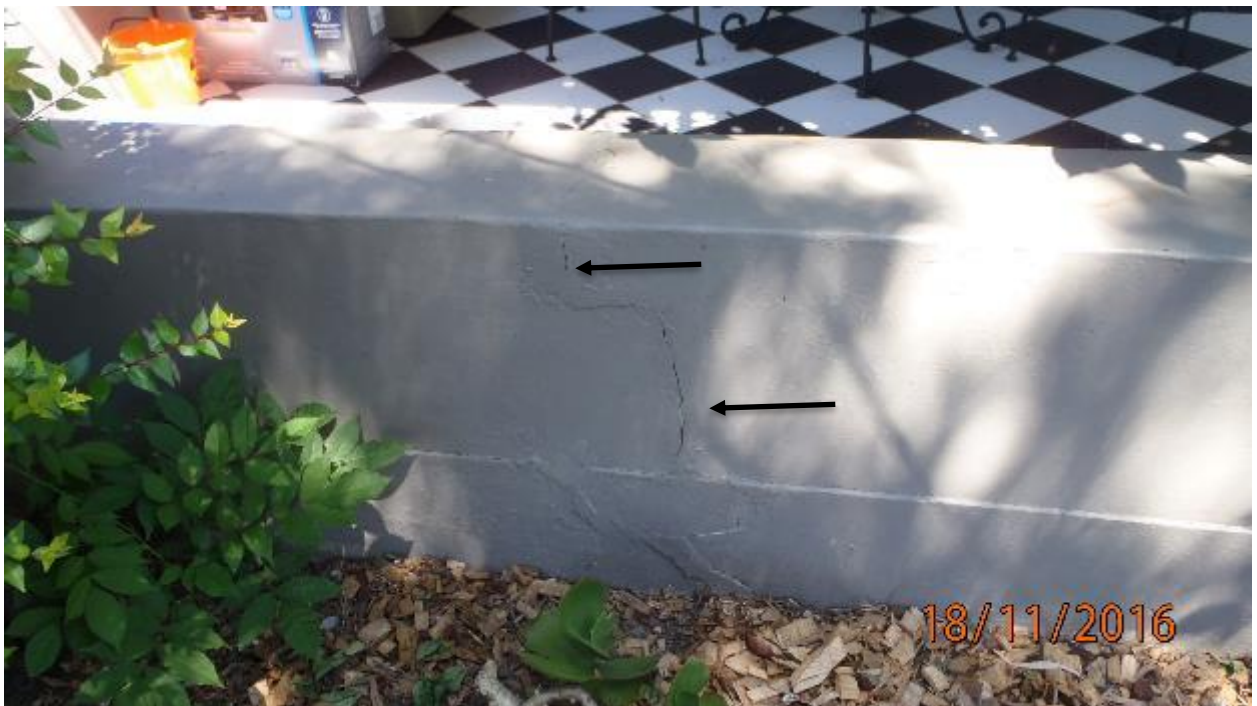
We noted step cracking in the surface coated verandah wall **[Photograph 6]**

Photograph 6 shows step cracking to the verandah wall.

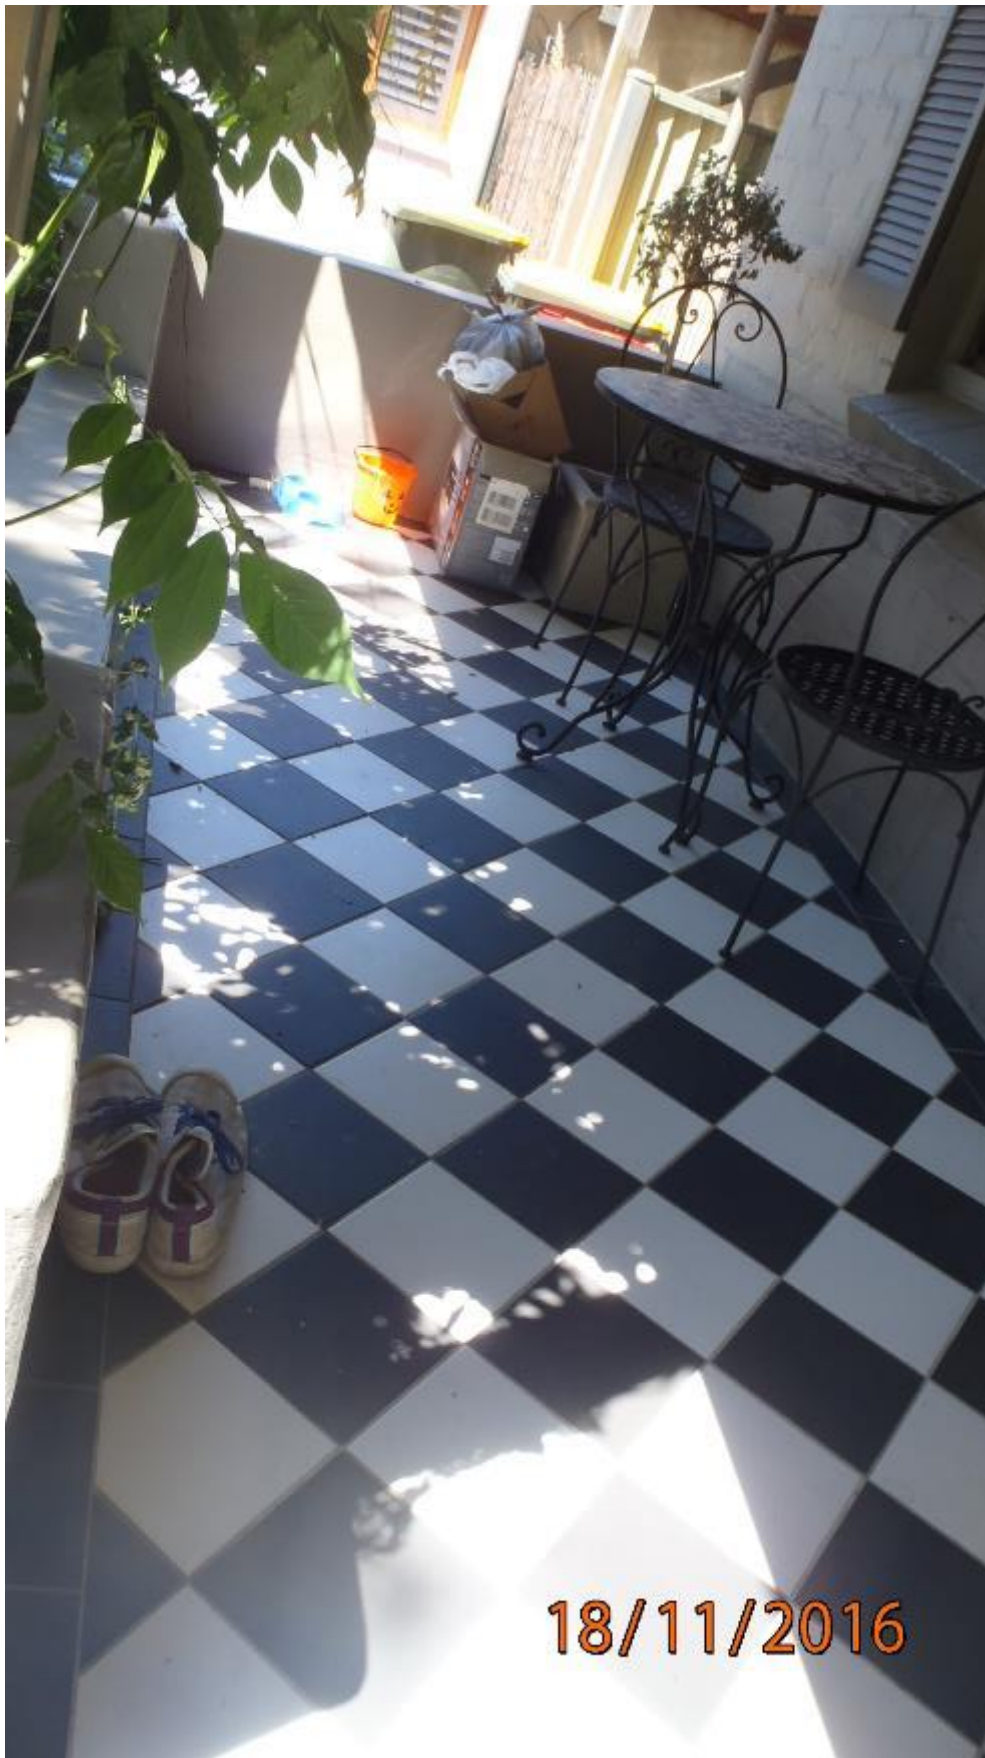
We noted that the checker board patterned tiles to the front verandah were generally sound with the grout complete. **[Photograph 7]**

Photograph 7 shows the general condition of the front verandah tiled surface.

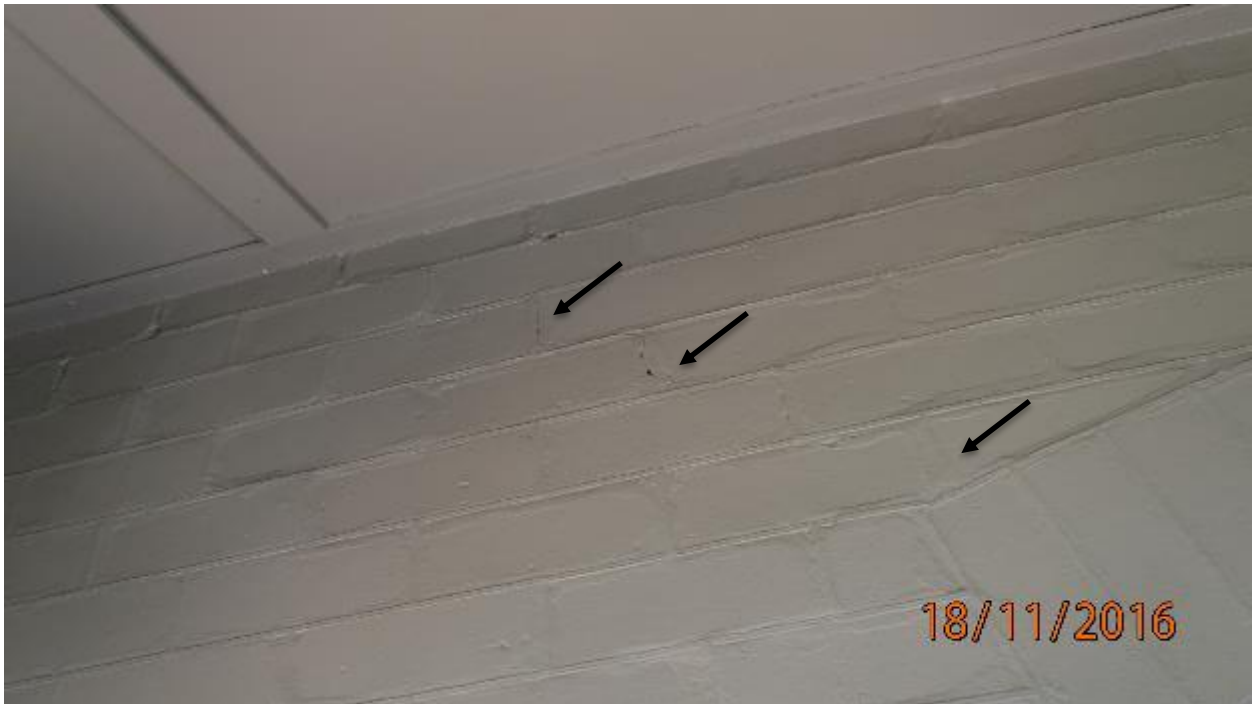
We observed evidence of previous repairs and step cracking to the surface coated brickwork above the Bedroom 1 window. **[Photographs 8 & 9]**

Photograph 8 shows step cracking and evidence of previous repairs to the front verandah wall above the Bedroom 1 window.

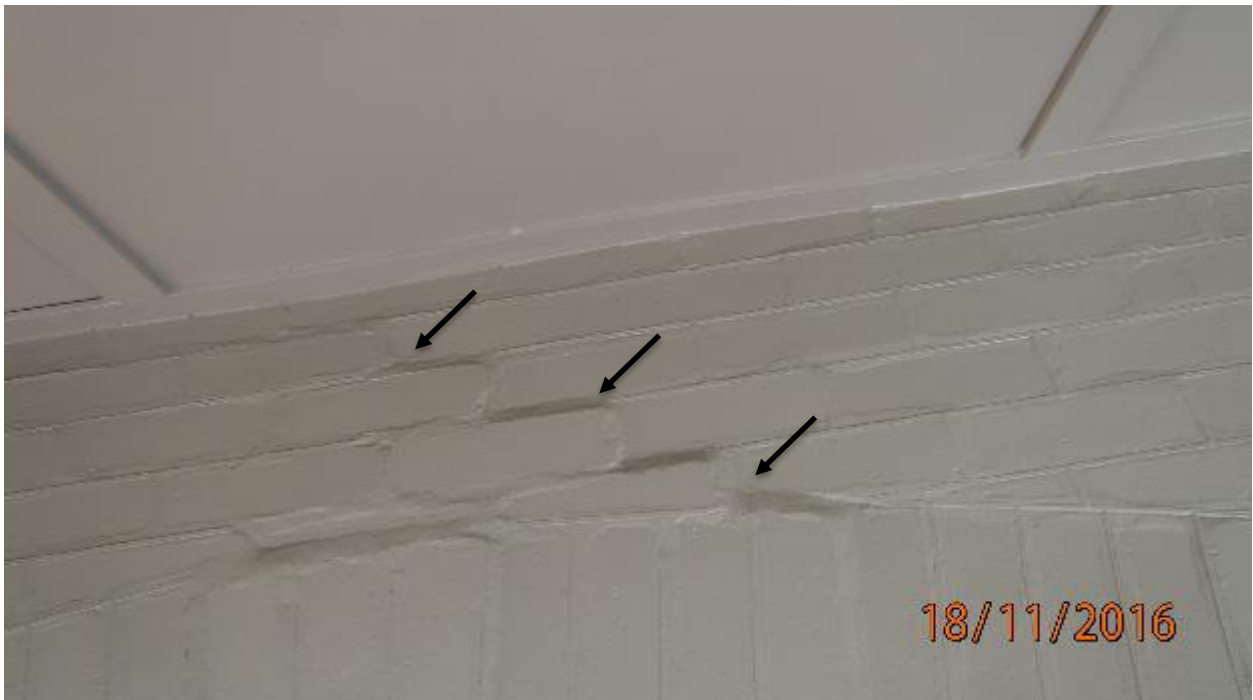
Photograph 9 shows step cracking to the front verandah wall above the Bedroom 1 window.

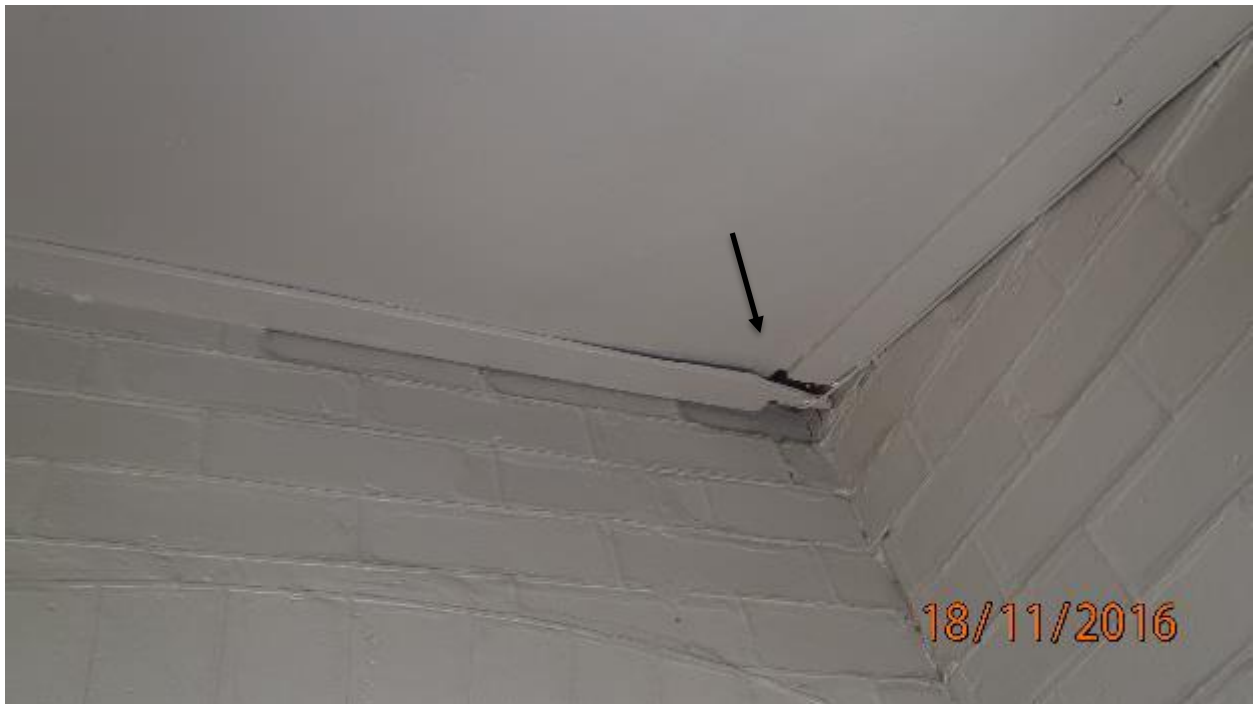
We noted damage to the cover batten and gaps between the brick wall and ceiling lining in the north-western corner of the verandah. **[Photograph 10]**

Photograph 10 shows damage to the cover batten and gaps between the brick wall and ceiling lining in the north-western corner of the verandah.

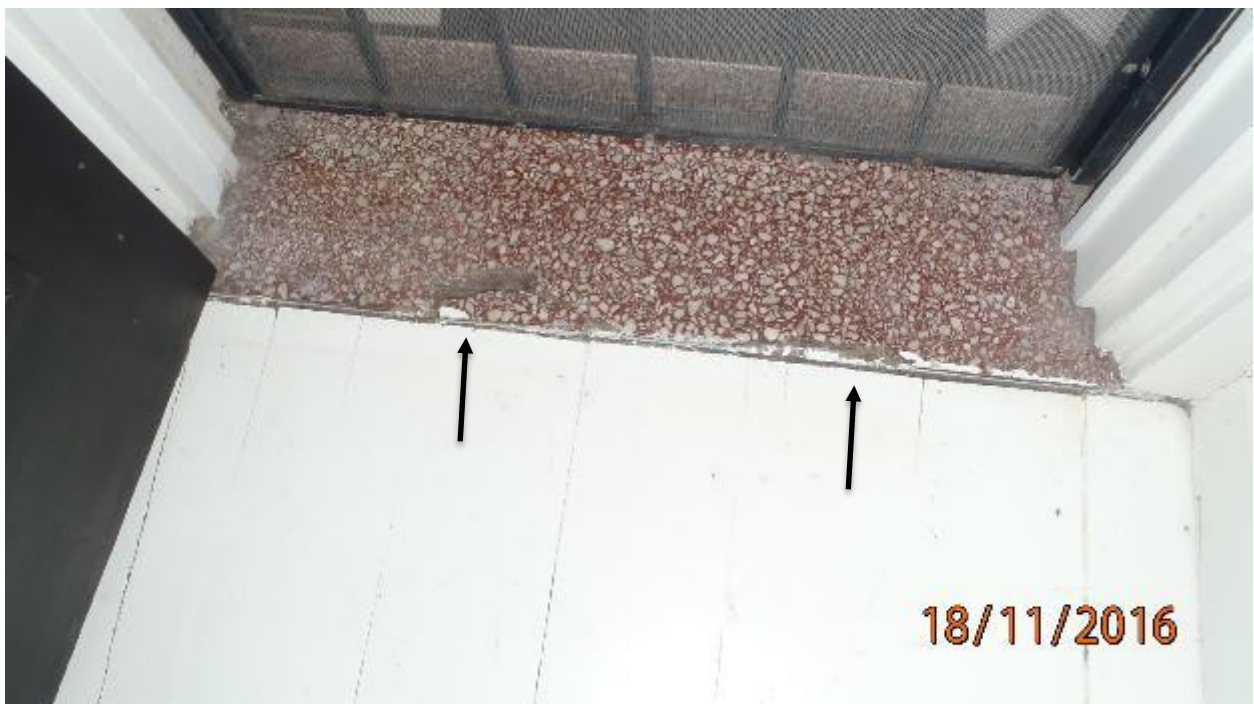
We noted cracking and damage to the front door threshold step. **[Photograph 11]**

Photograph 11 shows damage to the front threshold step.

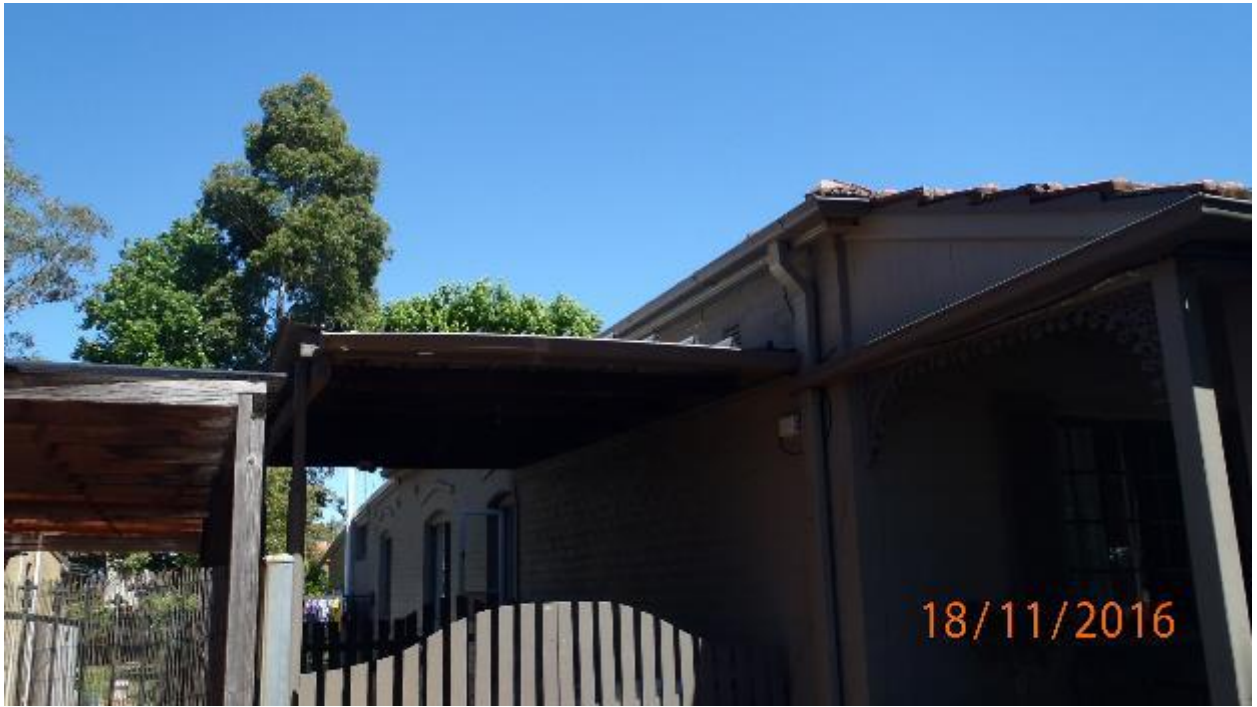
We noted there is an attached timber framed carport with pan profiled sheet metal roofing to the front south eastern elevation. **[Photograph 12]**

Photograph 12 shows the general condition of the carport structure.

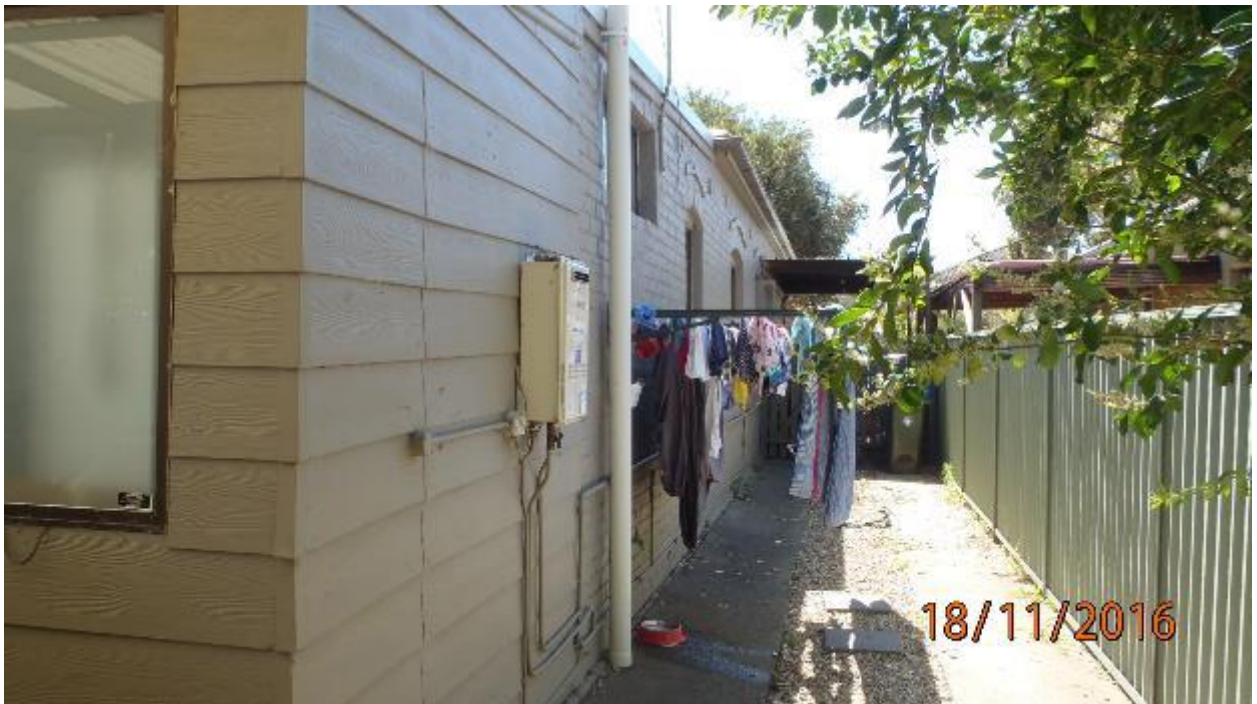
We noted that the front eastern section is surface coated brickwork and the rear extension section is clad with weatherboards. **[Photograph 13]**

Photograph 13 shows the general condition of the side southern elevation.

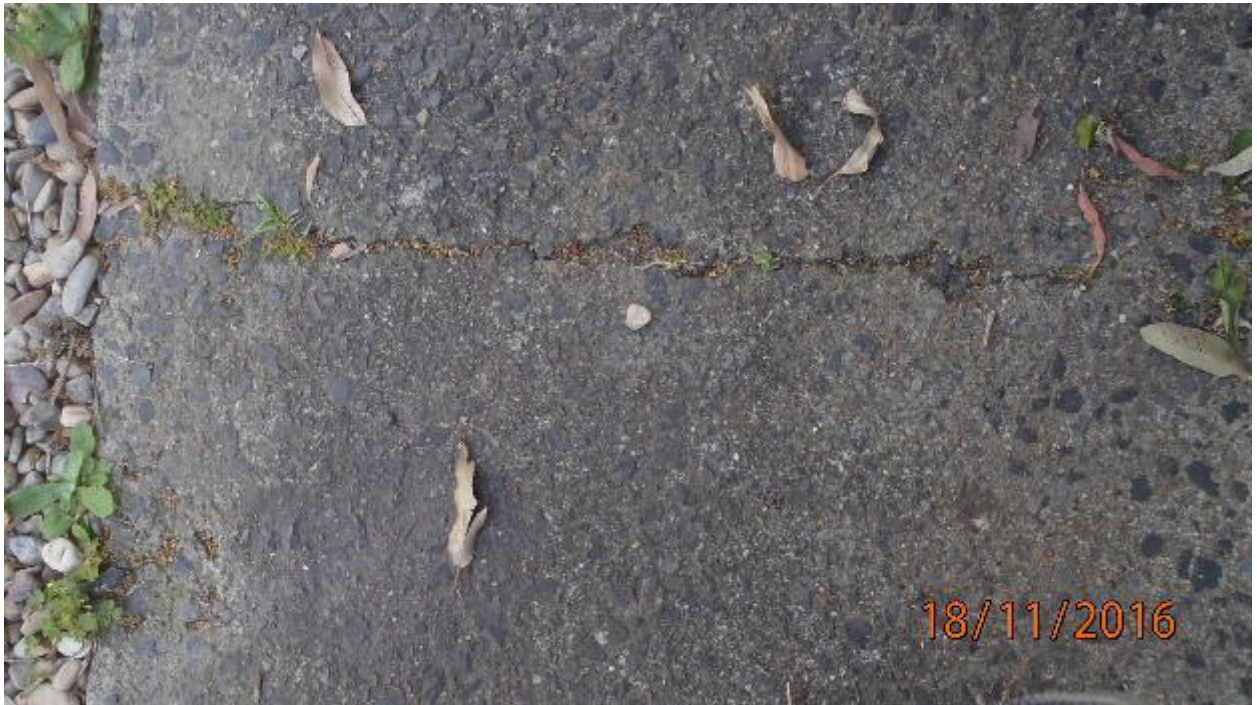
We noted cracking to the strip concrete driveway and vegetation growth through the cracks. **[Photographs 14 and 15]**

Photograph 14 shows cracking to the side concrete driveway and vegetation growth.

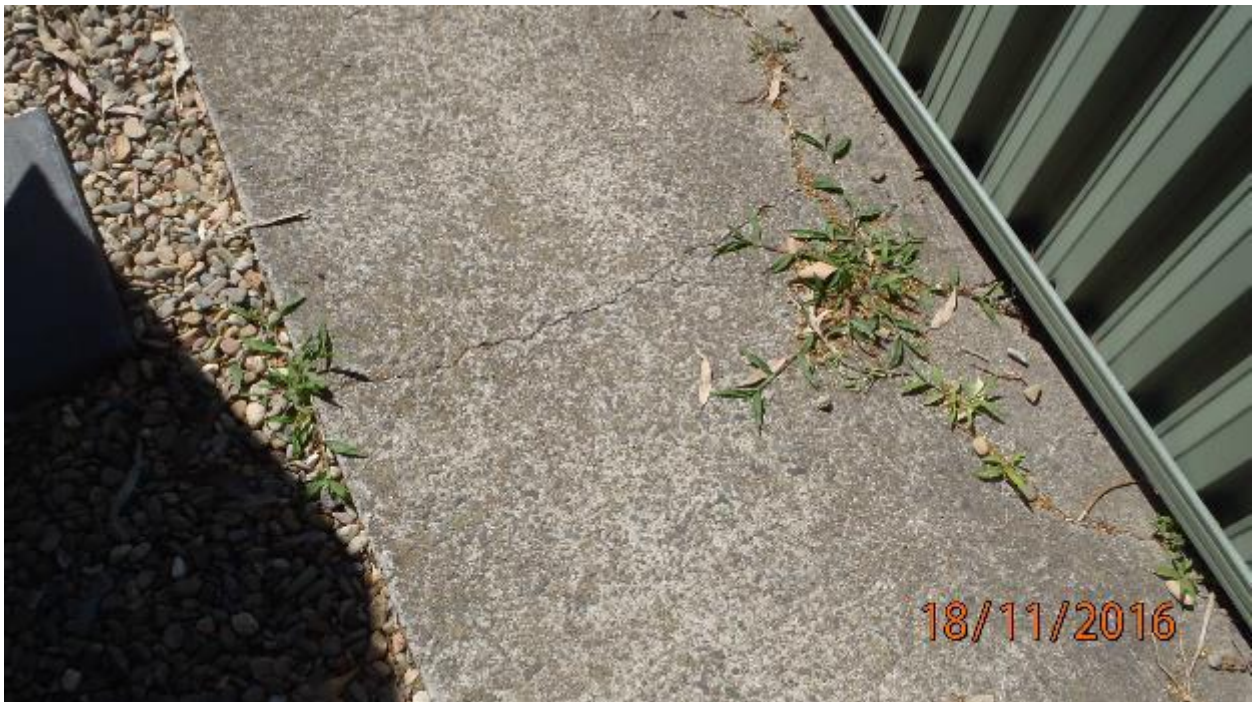
Photograph 15 shows cracking to the side concrete driveway and vegetation growth.

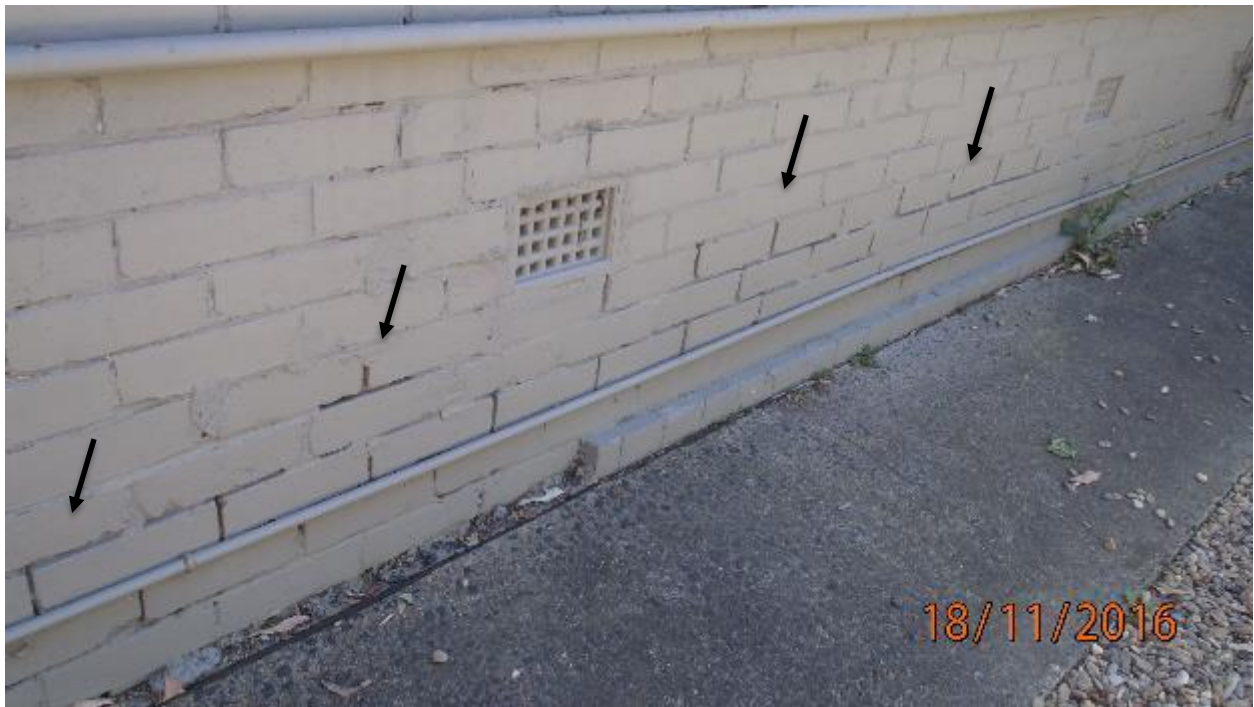
We noted displaced and fretting mortar along the brick footings. **[Photographs 16 and 17]**

Photograph 16 shows displaced and fretting mortar along the brick footings along the side southern elevation.

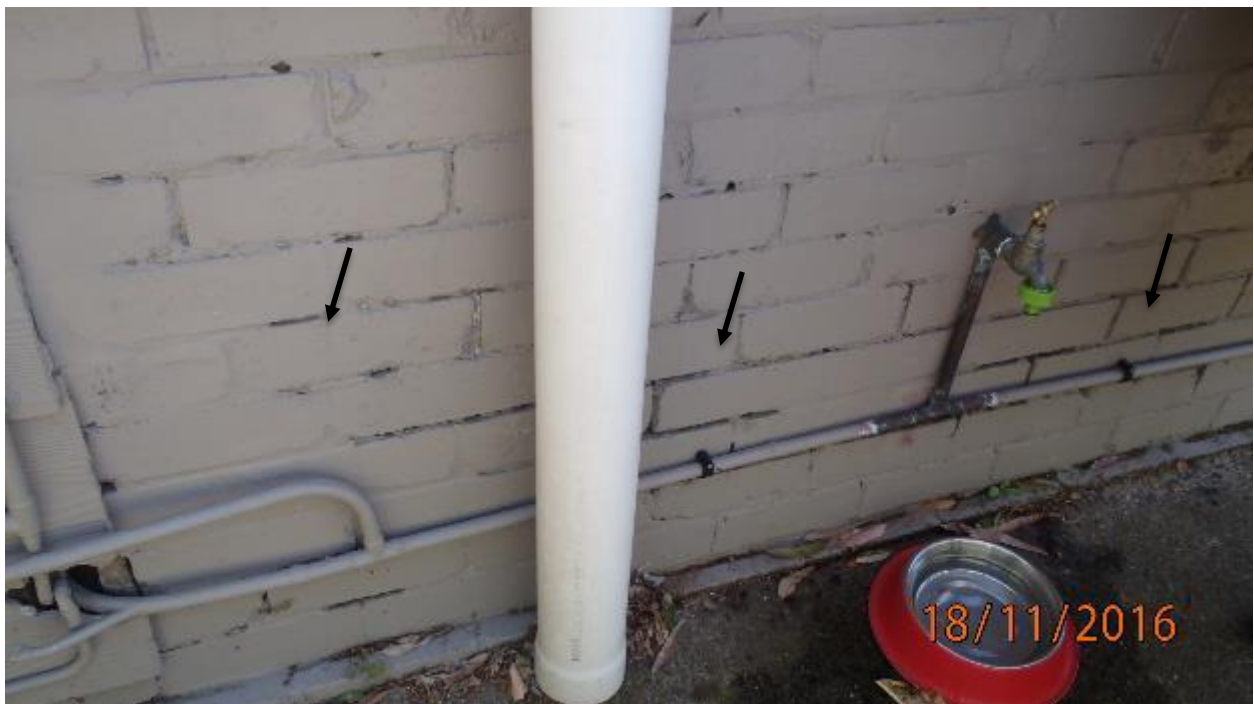
Photograph 17 shows displaced and fretting mortar along the brick footings along the side southern elevation.

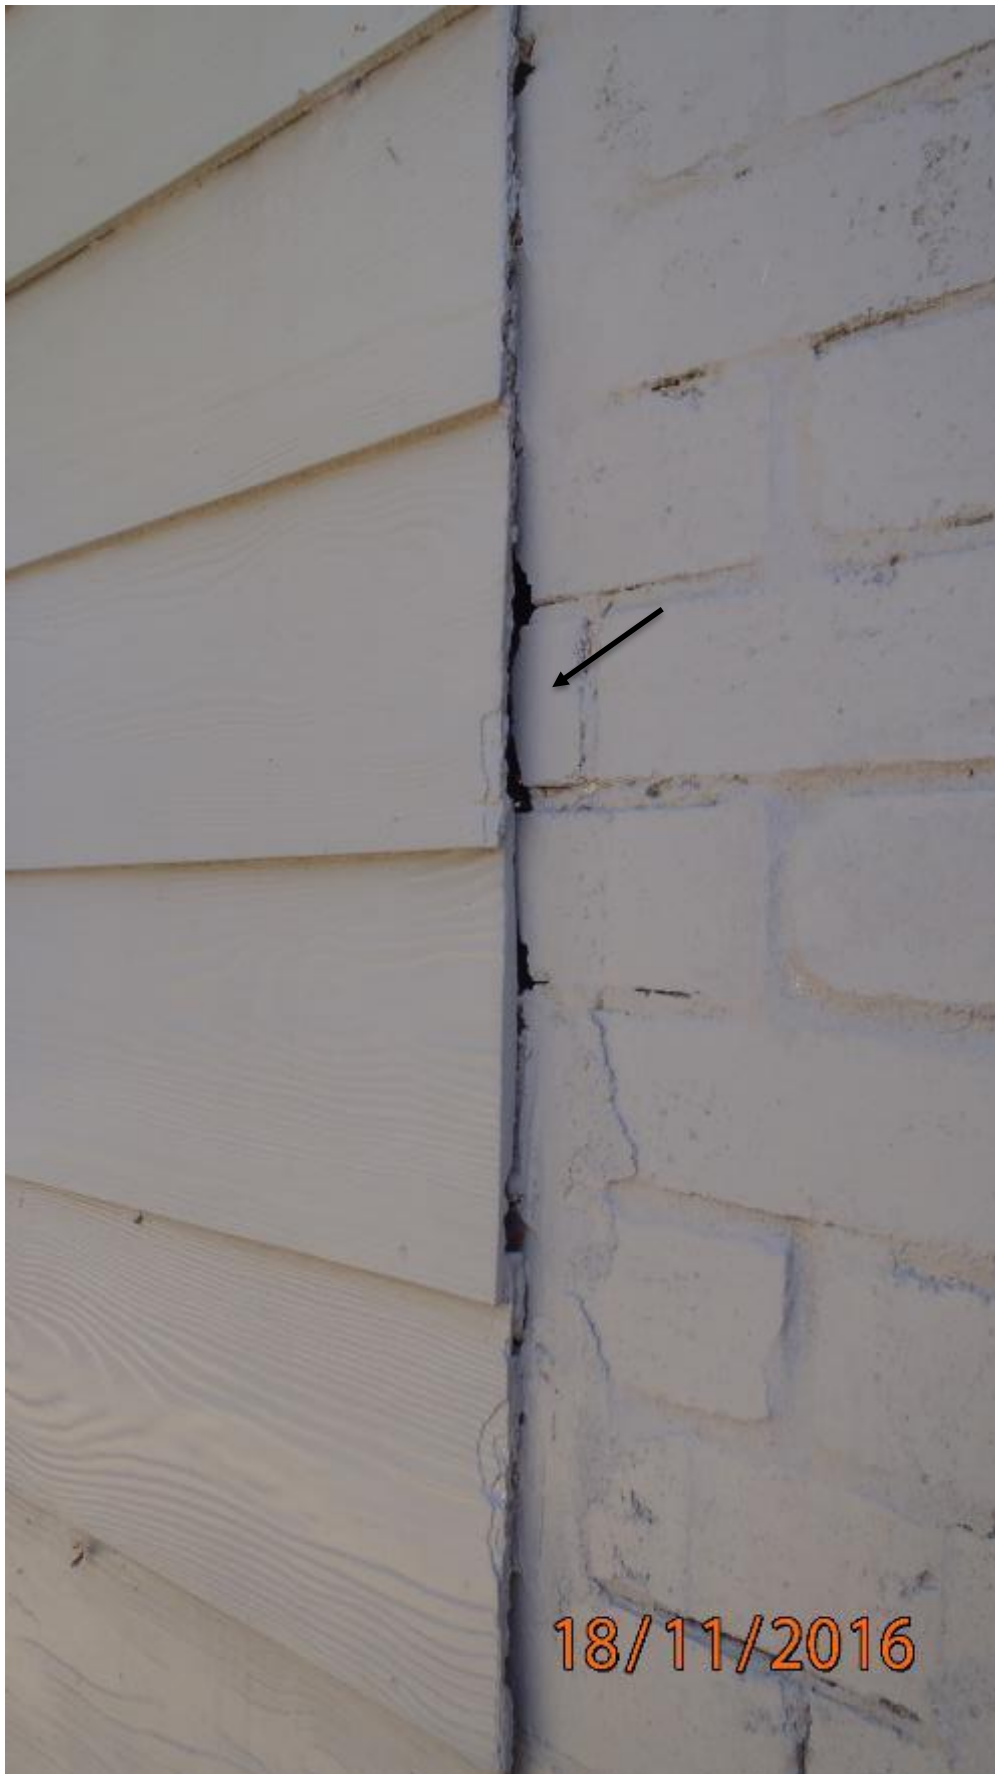
We noted gaps between the surface coated brickwork and the weatherboard cladding. **[Photograph 18]**

Photograph 18 shows gaps between the surface coated brickwork and the weatherboard cladding to the side southern elevation.

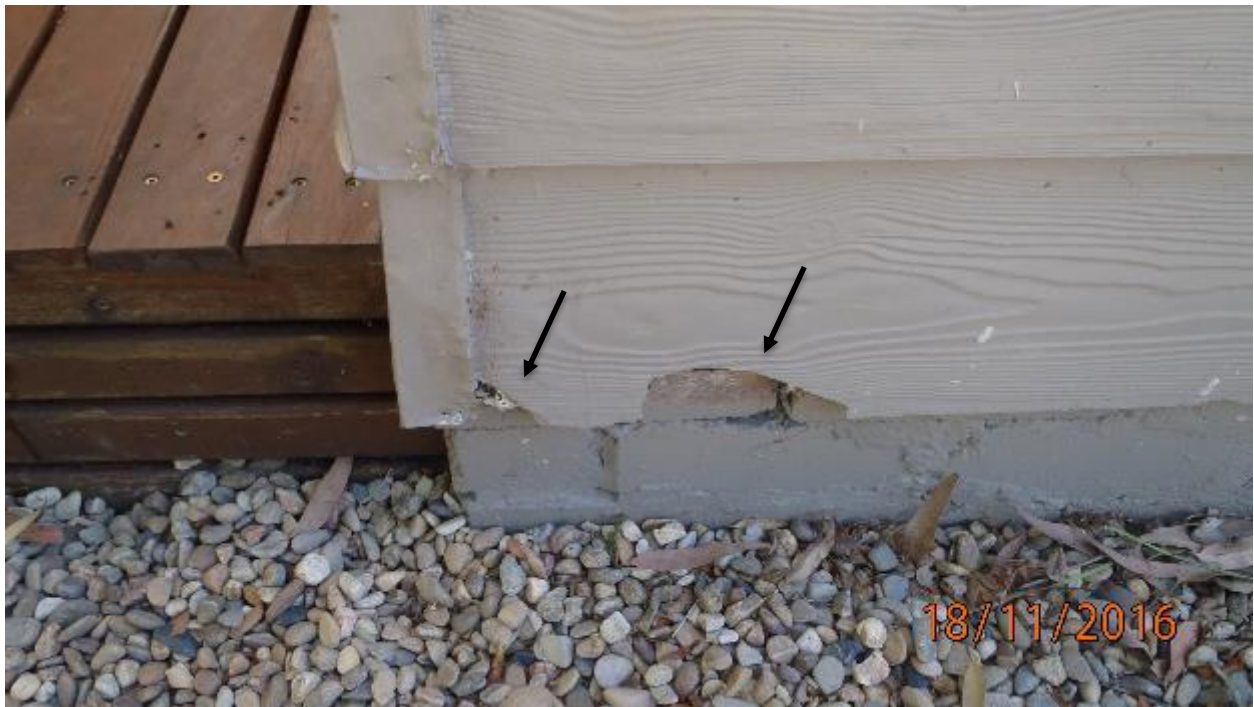
We noted damage to the base of the surface coated weatherboards adjacent to the rear deck. **[Photograph 19]**

Photograph 19 shows damaged weatherboards to the rear south-western corner.

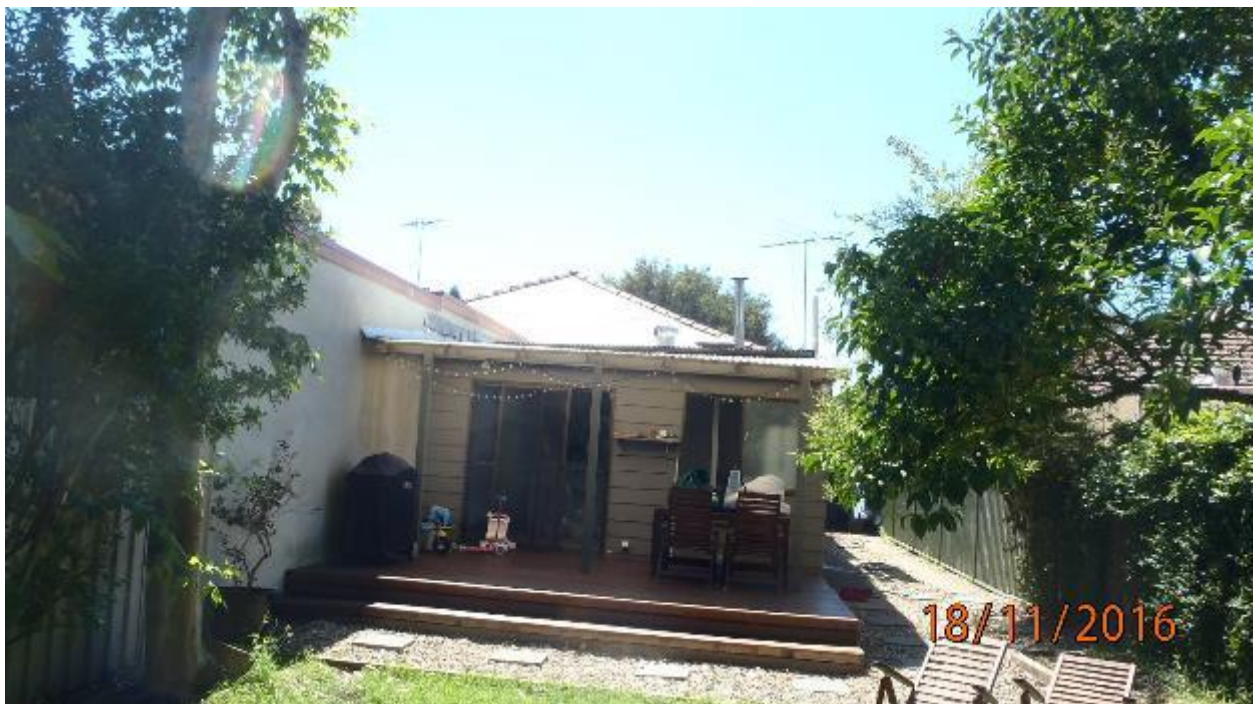
We noted that the rear of the residence has a timber framed deck structure with corrugated profile acrylic sheet roofing. **[Photograph 20]**

We noted that the rear western elevation is clad with weatherboards. **[Photograph 20]**

Photograph 20 shows the general condition of the rear western elevation of the residence.

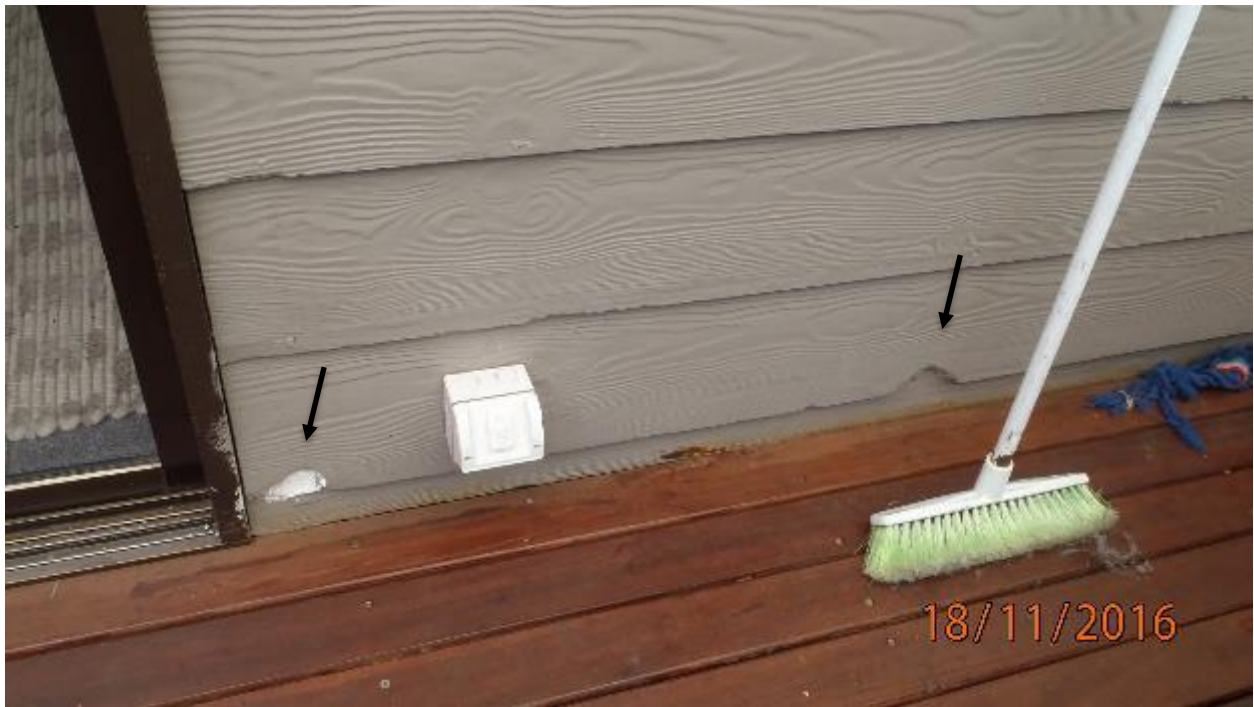
We noted damage to the bottom of the weatherboards adjacent to the rear door. **[Photograph 21]**

Photograph 21 shows damage to the bottom of the weatherboards adjacent to the rear door.
