Dilapidation Assessment Report

Prepared for: Cape Cod Australia Pty. Limited
Job address: No. 31 Clyde Street, Croydon Park.
Property Owner/s: Mrs. Monique Apostle.
Report reference: CANTERBURY COUNCIL
Development Application No: not available
Date of assessment: 18th November 2016

Re: Dilapidation Report – No. 31 Clyde Street, Croydon Park.

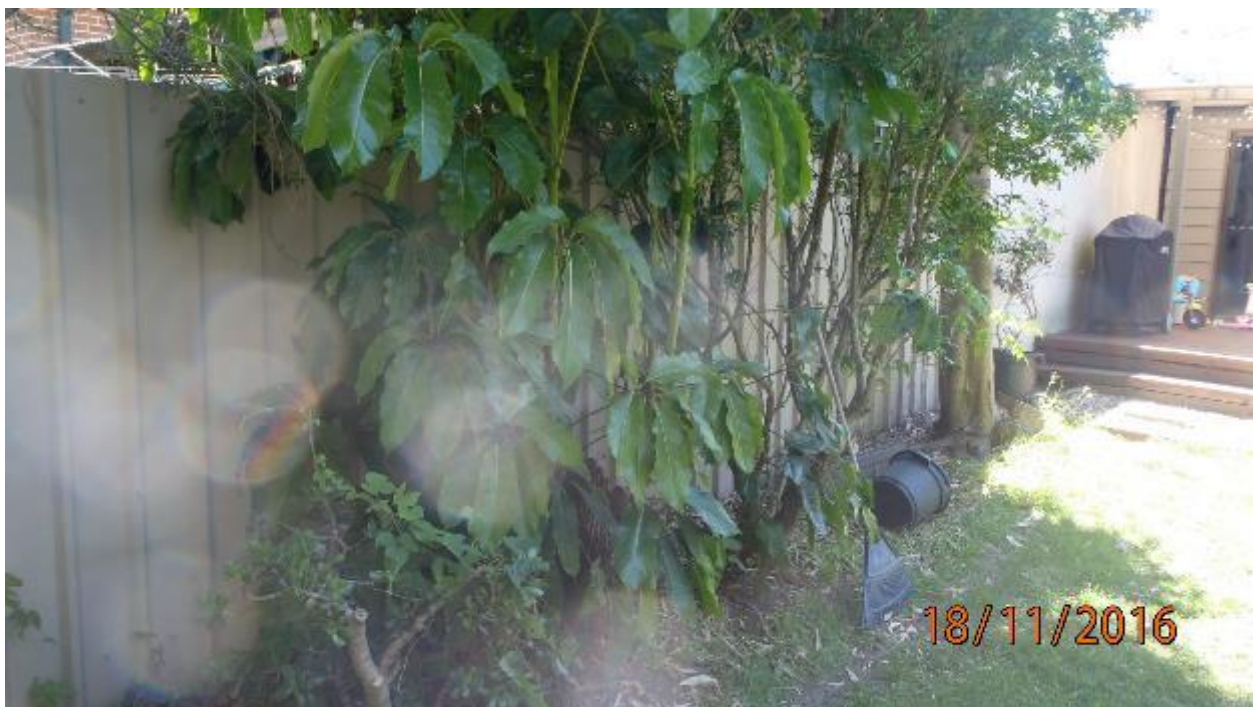
We noted that the rear common boundary fence is constructed of pan profile sheet metal. **[Photograph 22]**

Photograph 22 shows the general condition of the rear common boundary fence with the adjoining property, No.29 Clyde Street, Croydon Park.

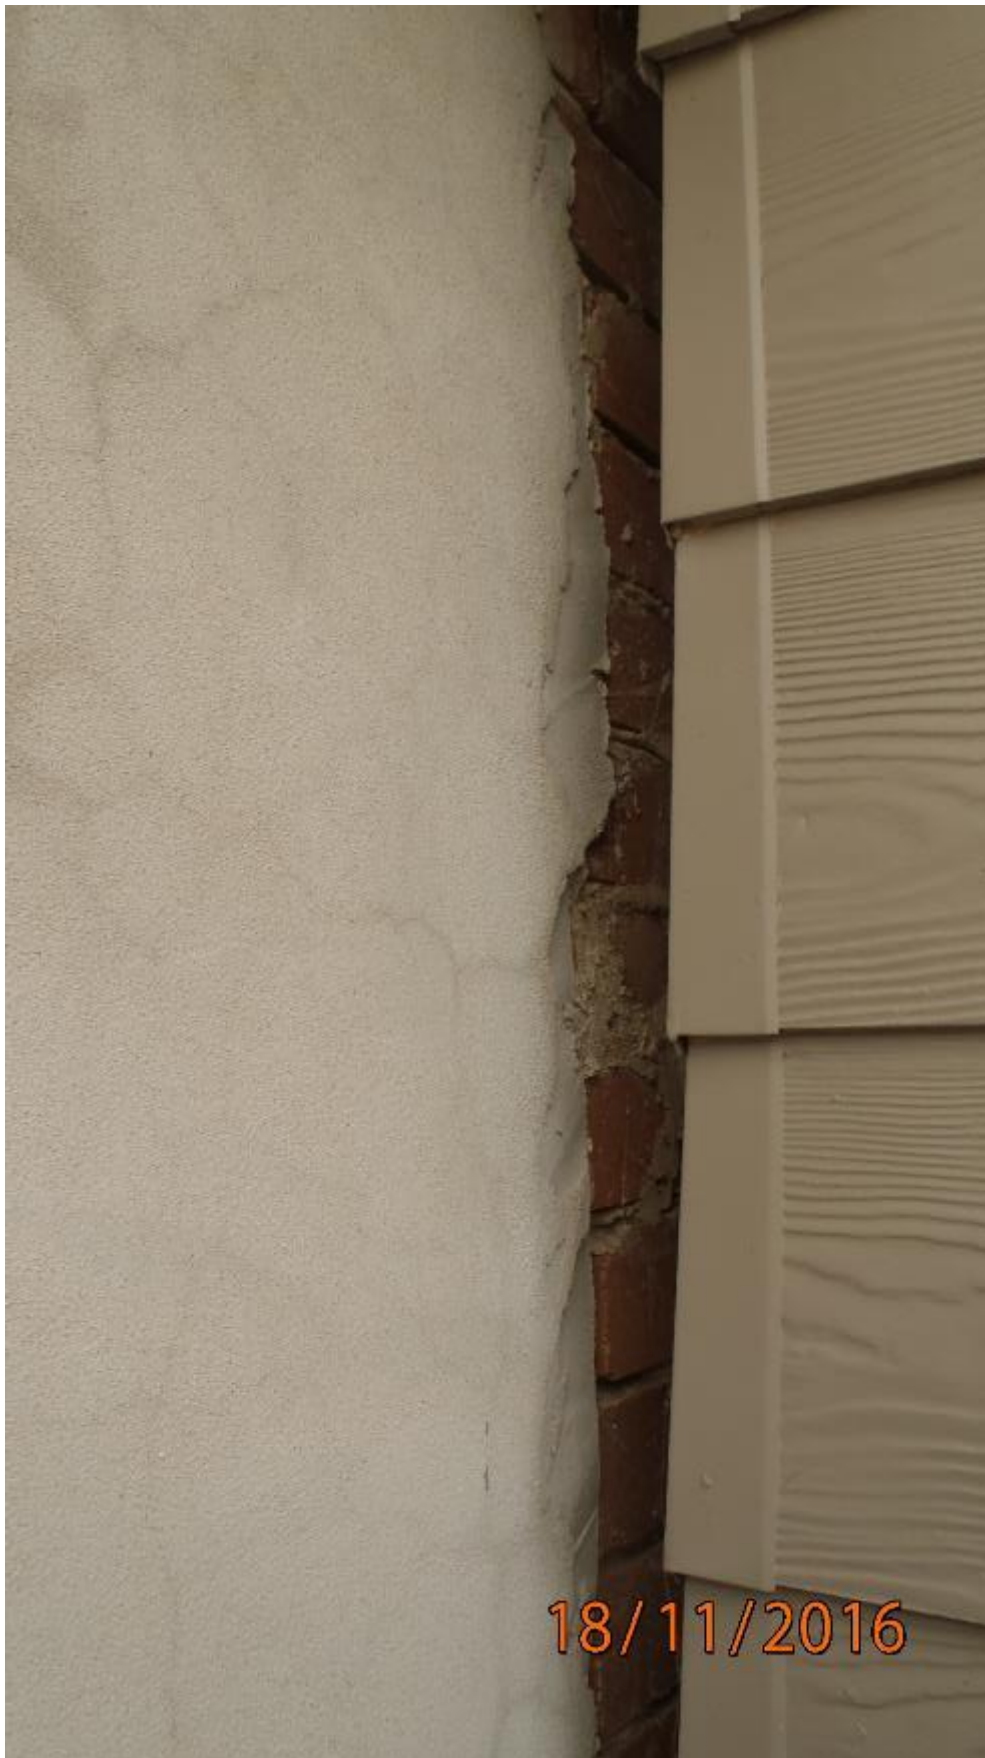
We noted that there is a built-in void between the wall of the rear addition and the *common* boundary wall with the adjoining property, No. 29 Clyde Street, Croydon Park. **[Photograph 23]**

Photograph 23 shows the void between the wall of the rear addition and the *common* boundary wall with the adjoining property, No. 29 Clyde Street, Croydon Park and the condition of the finish.

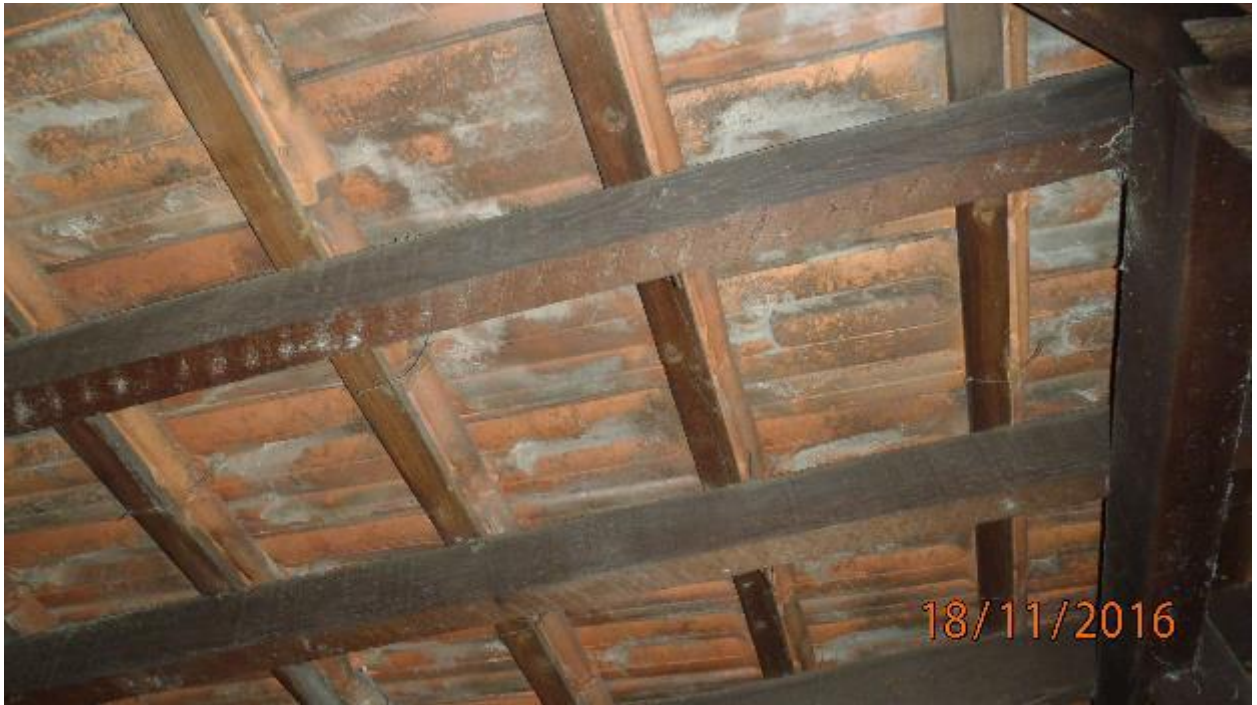
We noted that there is no sarking provided to the underside of the roofing tiles. We further noted signs of general deterioration and efflorescence of the terracotta tiles **[Photograph 24]**

We observed that the roof and ceiling timbers that are accessible are generally in good condition. **[Photograph 24]**

Photograph 24 shows the general condition of the roofing structure and underside of the roof tiles.

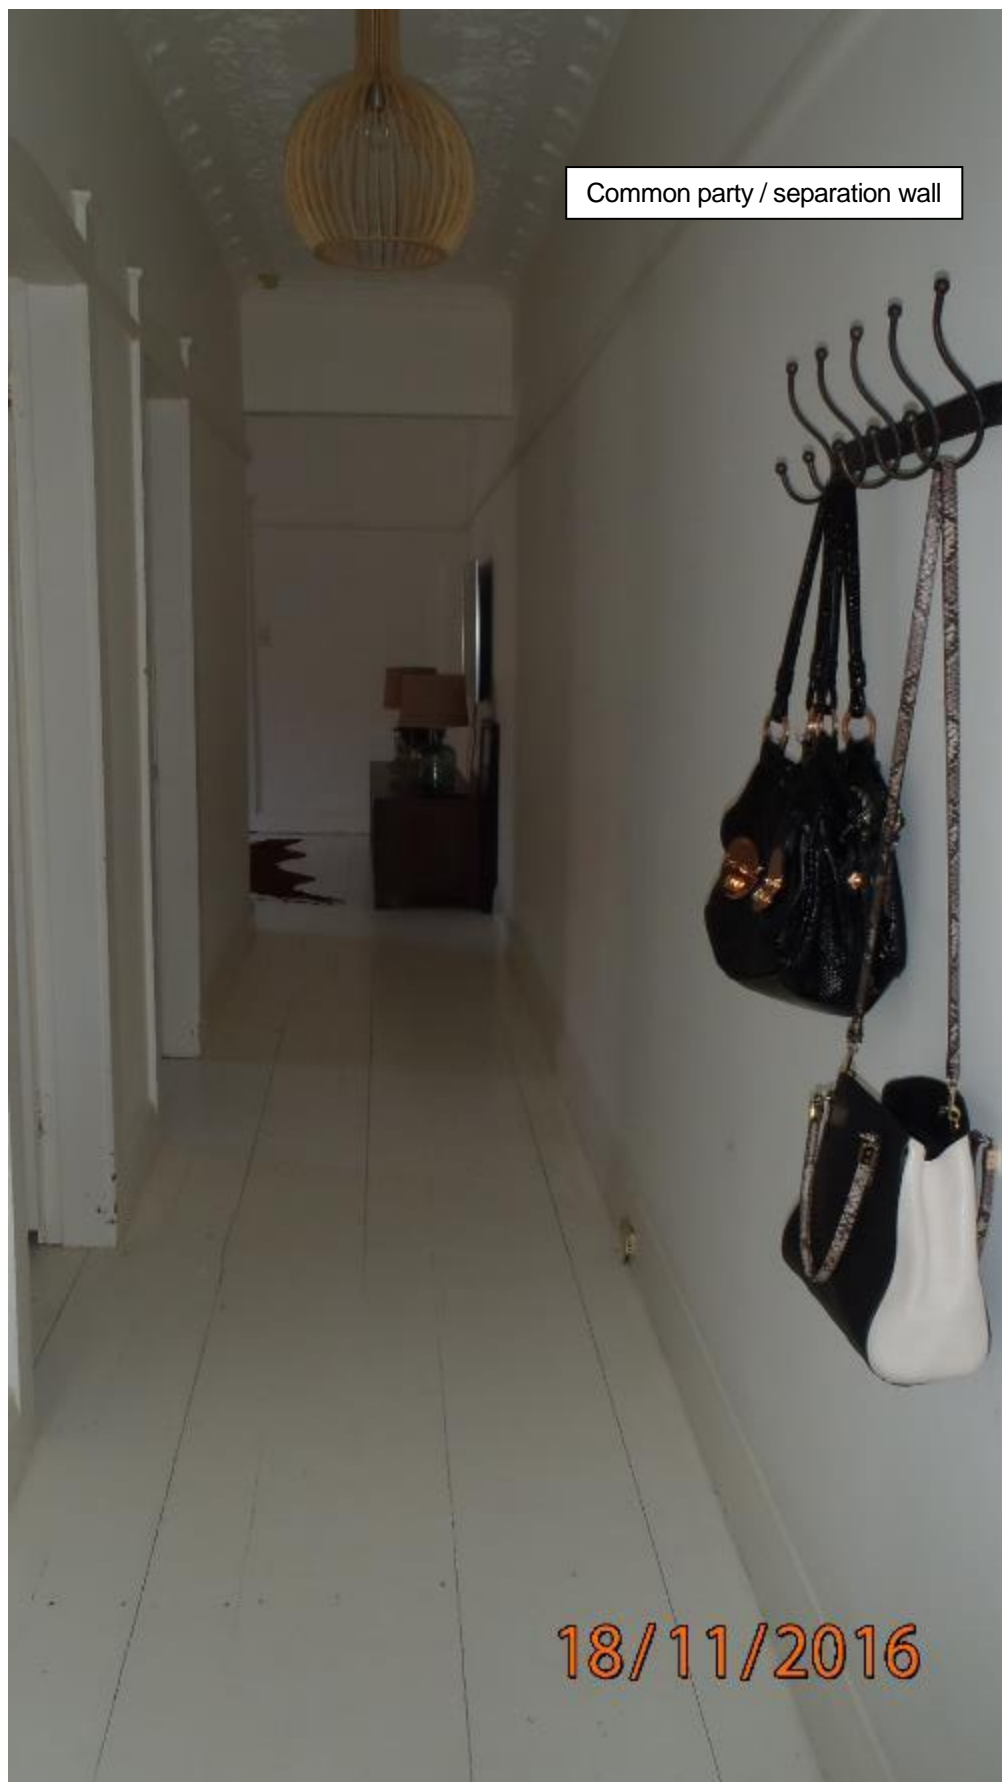
We noted that the floor throughout was painted strip timber flooring and that the *common party / separation* wall with the adjoining property, No. 29 Clyde Street, Croydon Park was painted cement rendered brickwork. **[Photograph 25]**

We noted that a strip of hat / coat hooks was fixed to the *common party / separation* wall with the adjoining property, No. 29 Clyde Street, Croydon Park. **[Photograph 25]**

Photograph 25 shows the general condition of the painted strip timber flooring and the coat hooks installed on the *common party / separation* wall with the adjoining property, No. 29 Clyde Street, Croydon Park.

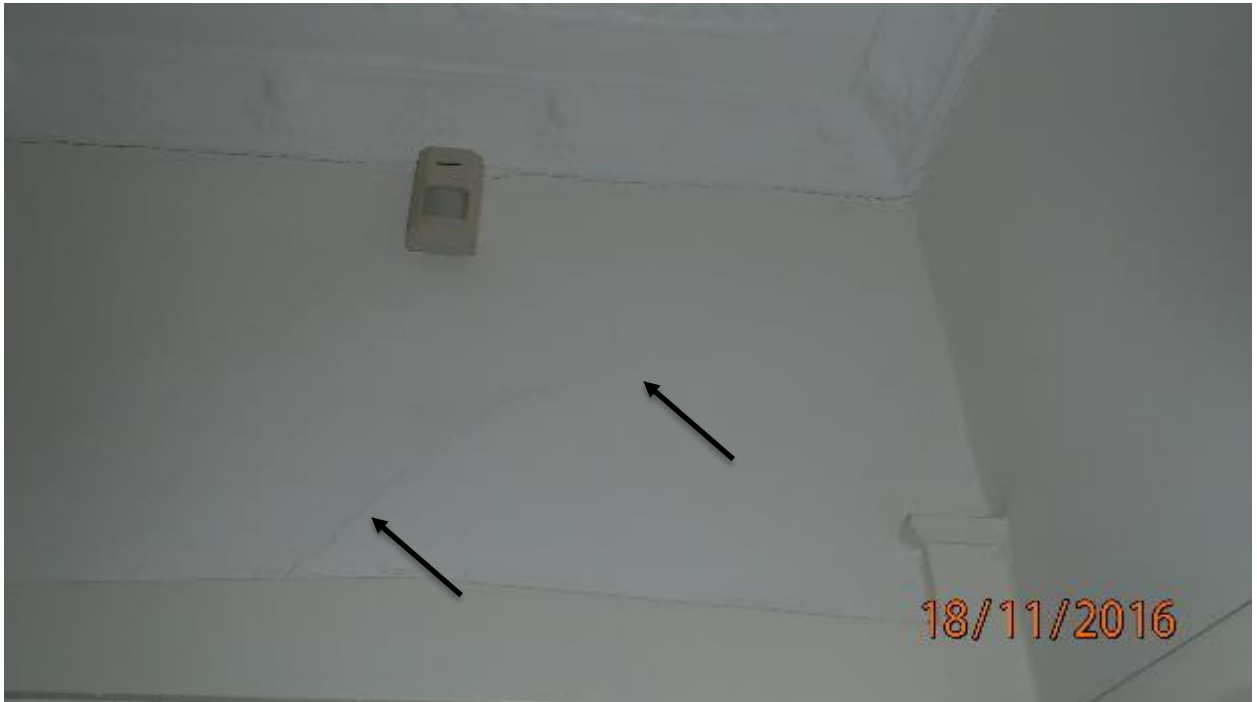
We noted radial cracking [$<1.0\text{mm}$] to the wall above the entry door head. **[Photograph 26]**

Photograph 26 shows radial cracking to the wall above the entry door head.

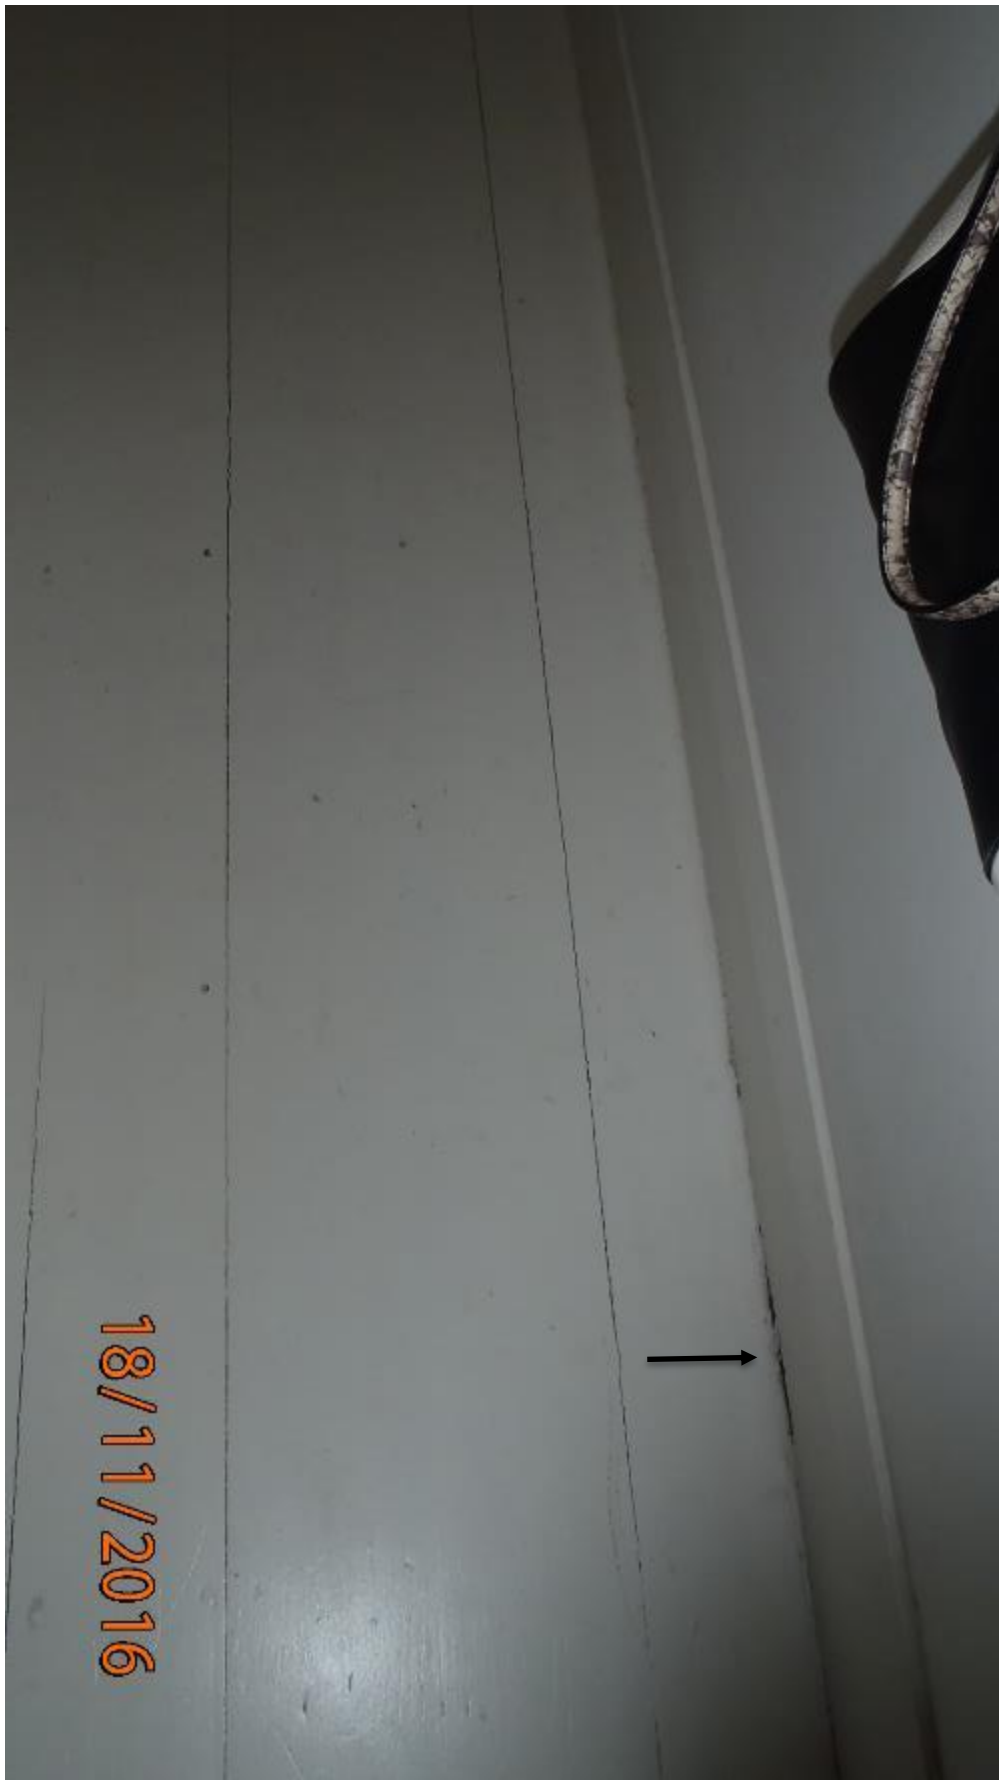
We noted gaps to the floor boards and between the skirting and the floor boards. **[Photograph 27]**

Photograph 27 shows gaps to the floor boards and between the skirting and the floor boards in the Hallway.

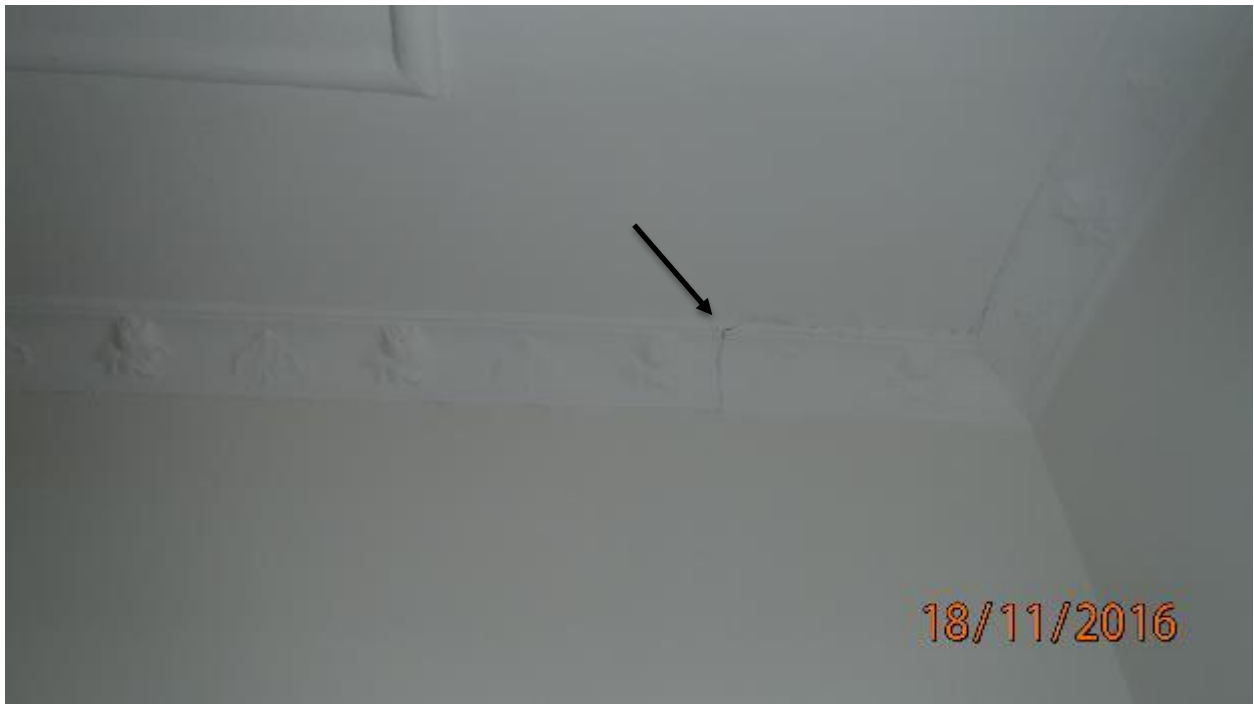
We noted cracking to the decorative cornice joint in the north-eastern corner. **[Photograph 28]**

Photograph 28 shows cracking to the decorative cornice joint in the north-eastern corner of Bedroom 1.

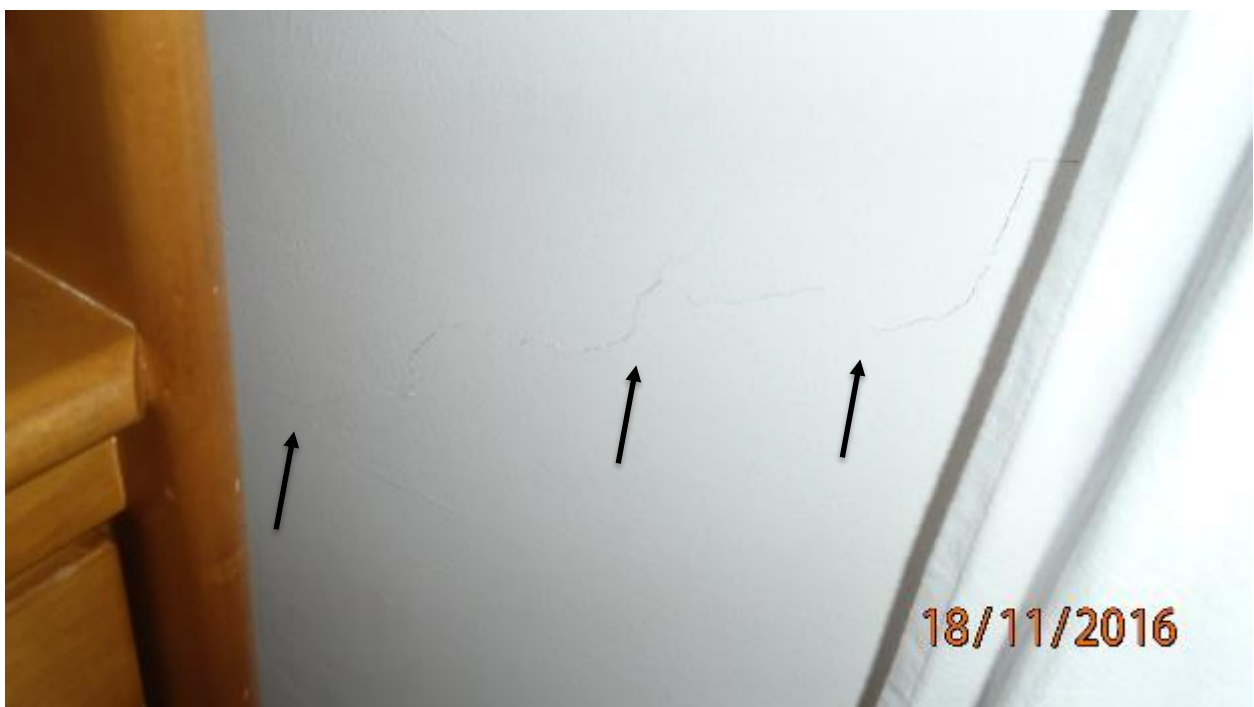
We noted radial cracking [$<1.0\text{mm}$] adjacent to the front verandah window. **[Photograph 29]**

Photograph 29 shows radial cracking adjacent to the front verandah window in Bedroom 1.

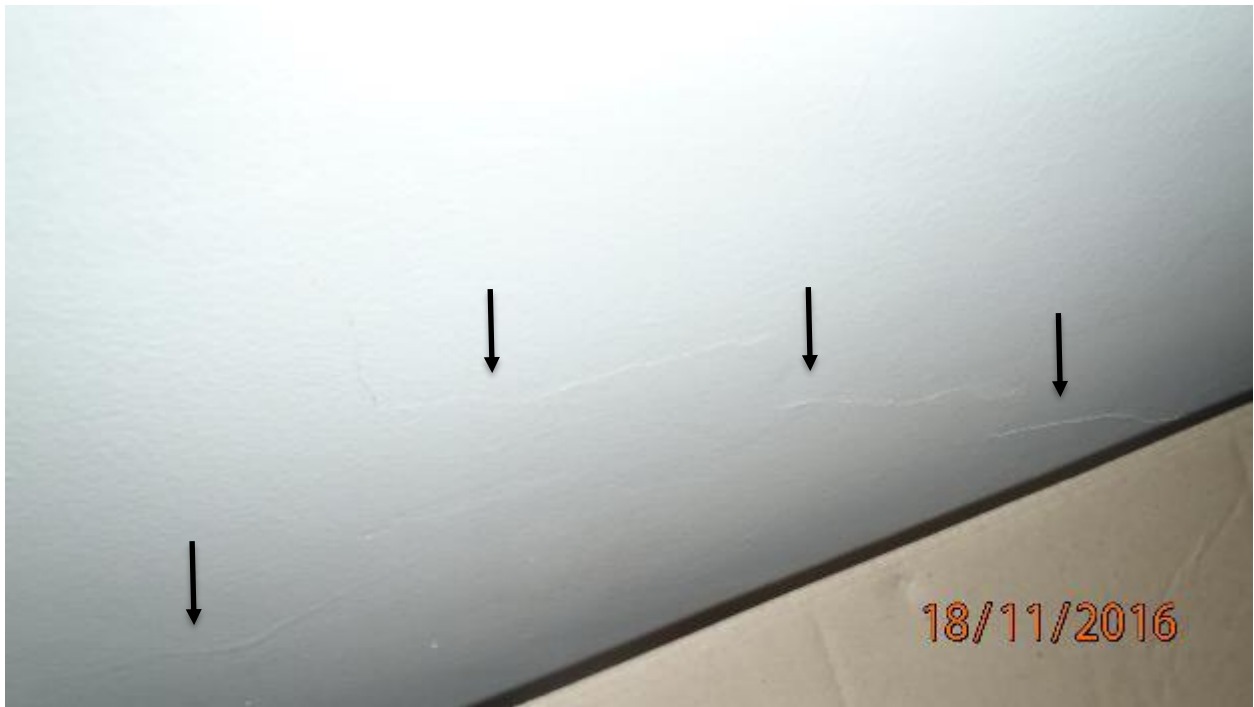
We noted step cracking [$<1.0\text{mm}$] adjacent to the front verandah window. **[Photograph 30]**

Photograph 30 shows step cracking adjacent to the front verandah window in Bedroom 1.

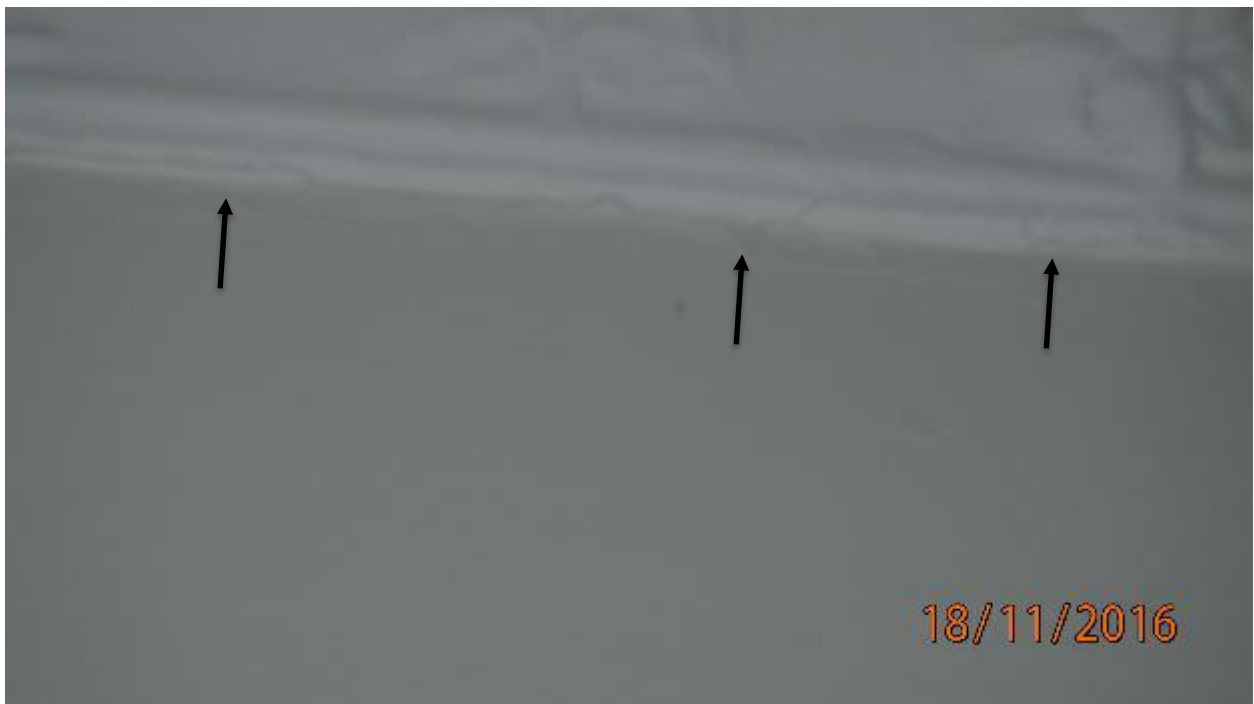
We noted general separation cracking [$<1.0\text{mm}$] to the wall / cornice junction. **[Photograph 31]**

Photograph 31 shows general separation cracking to the wall / cornice junction in Bedroom 1.

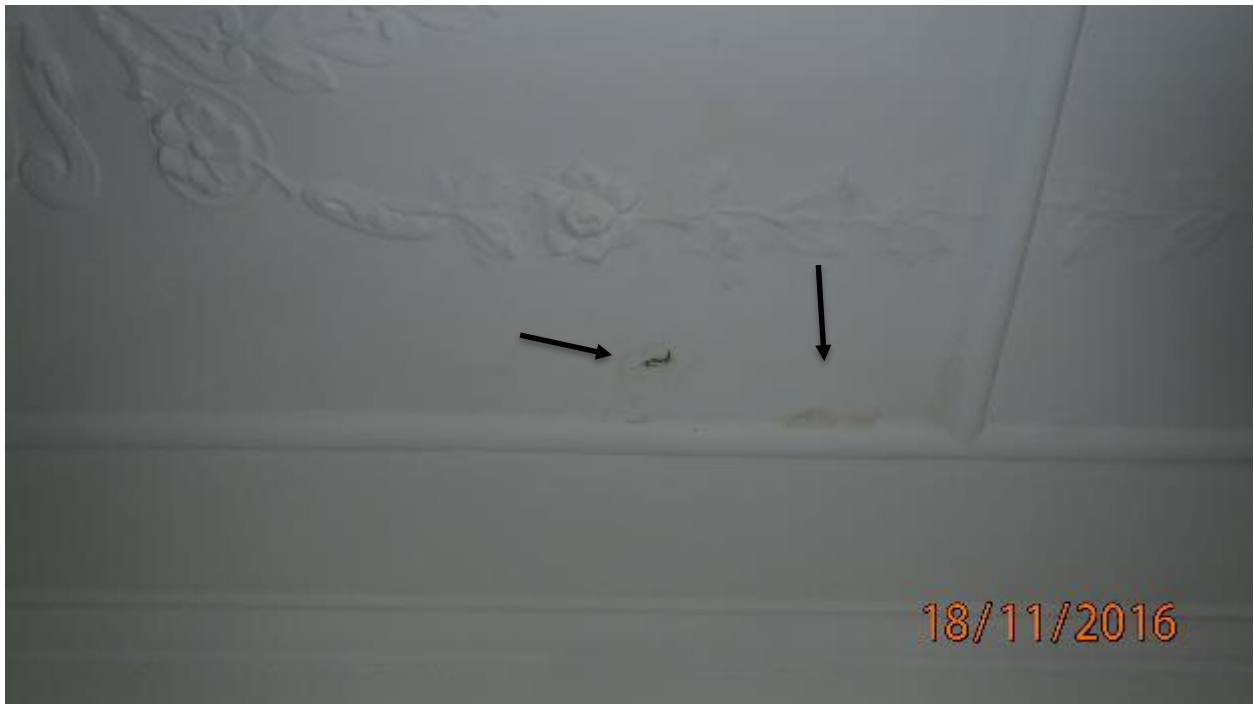
We noted staining to the decorative plaster ceiling lining adjacent to the southern wall. **[Photograph 32]**

Photograph 32 shows staining to the decorative plaster ceiling lining adjacent to the southern wall in Bedroom 2.

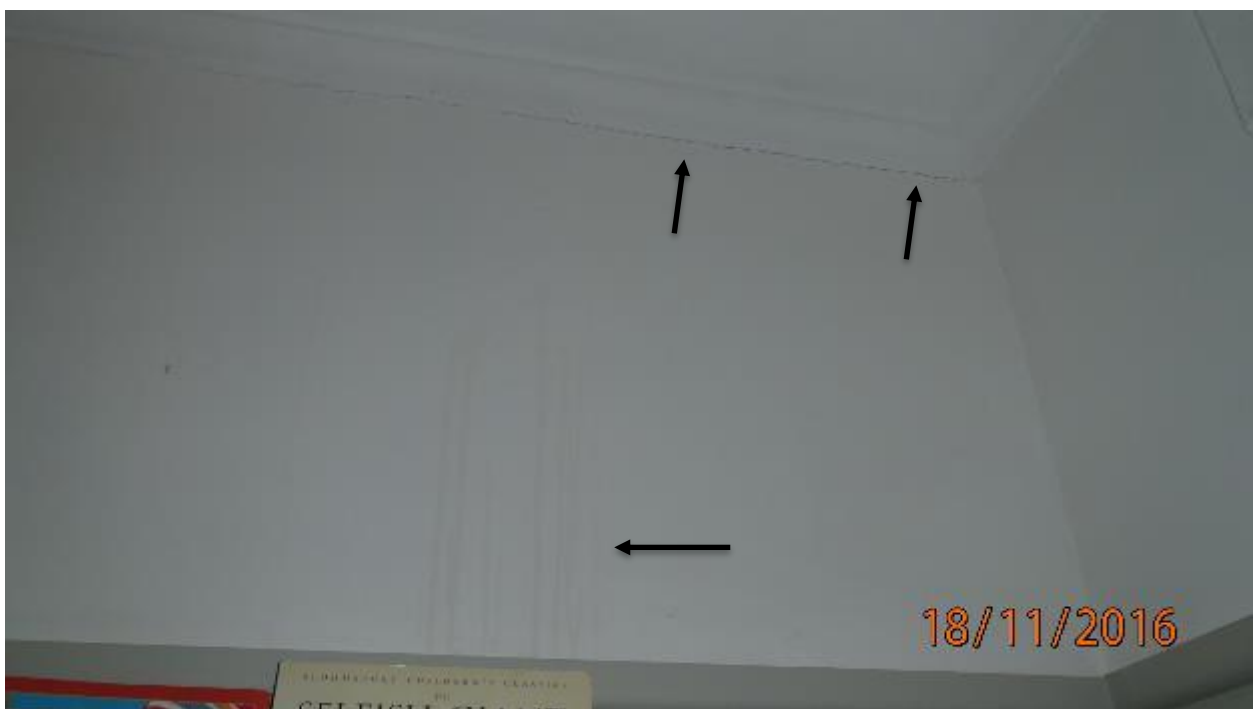
We noted staining (water marks) to the southern wall and separation cracking [$<1.0\text{mm}$] to the wall / cornice junction. **[Photograph 33]**

Photograph 33 shows staining (water marks) to the southern wall and separation cracking to the wall / cornice junction in Bedroom 2.

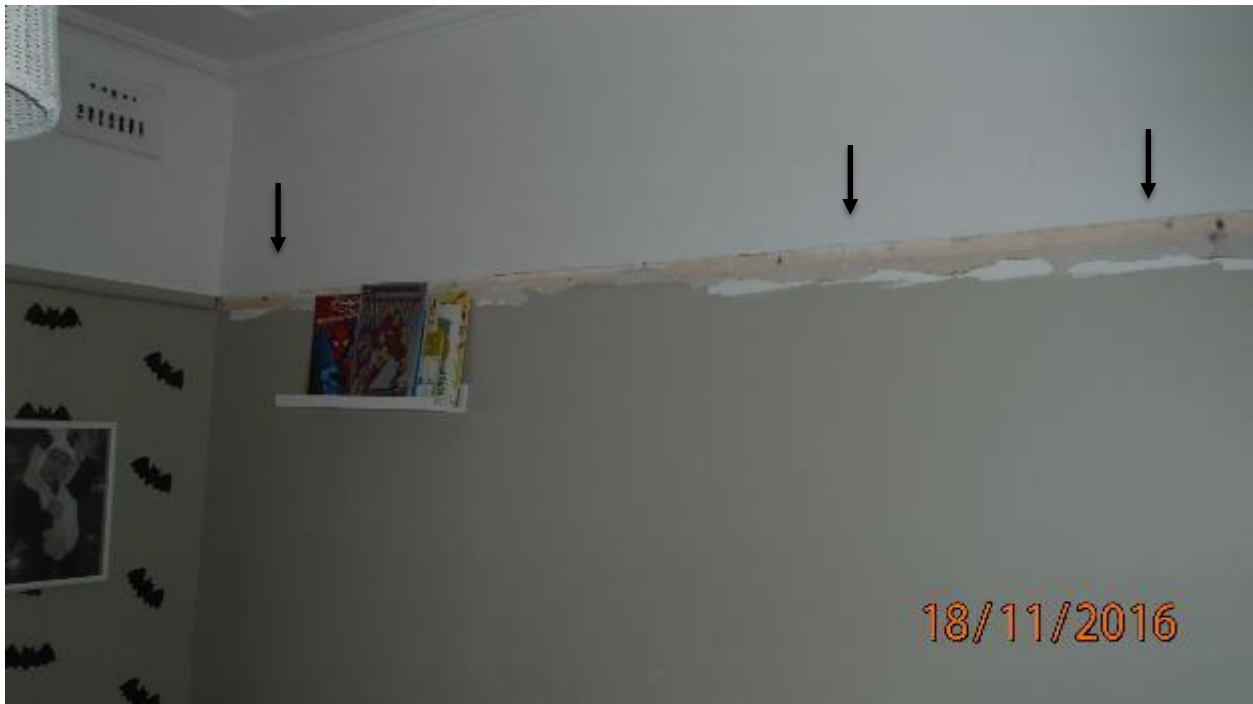
We noted that the picture rail had been removed from the western wall and not repaired. **[Photograph 34]**

Photograph 34 shows that the picture rail had been removed from the western wall and not repaired in Bedroom 2.

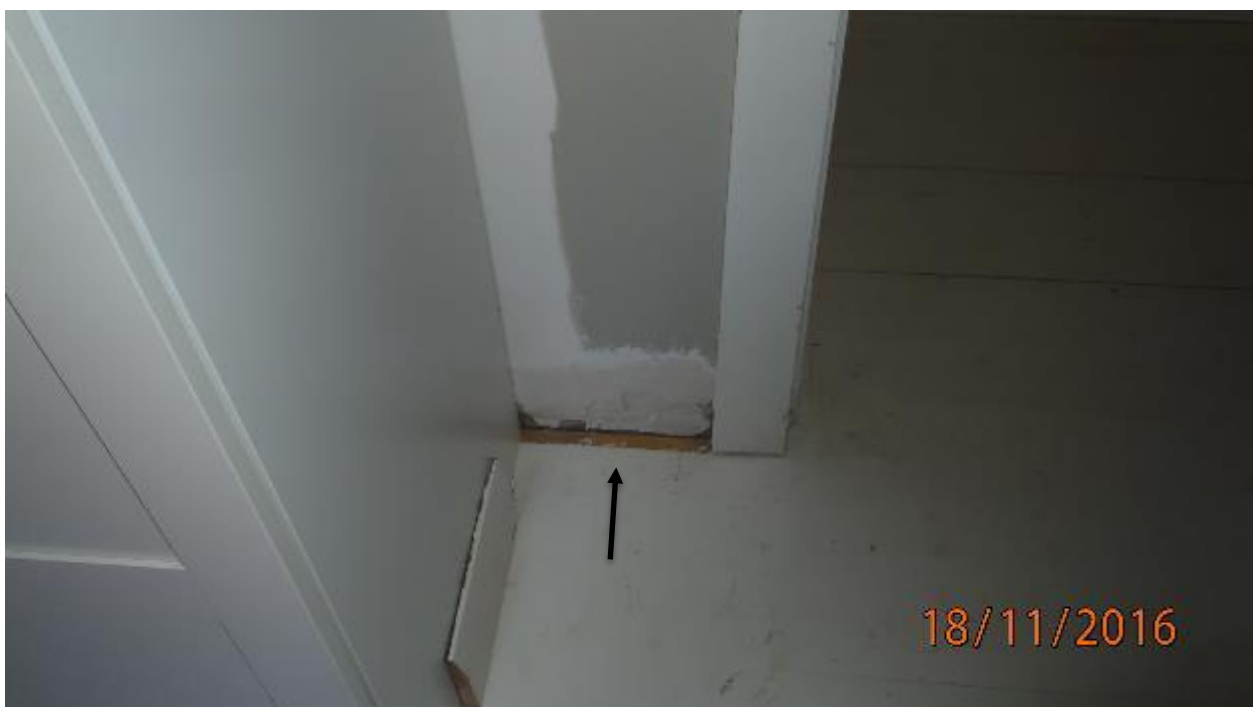
We noted that the picture rail and skirting board had been removed from the northern wall adjacent to the door and not repaired. **[Photographs 35 and 36]**

Photograph 35 shows the skirting board had been removed from the northern wall adjacent to the door and not repaired in Bedroom 2.

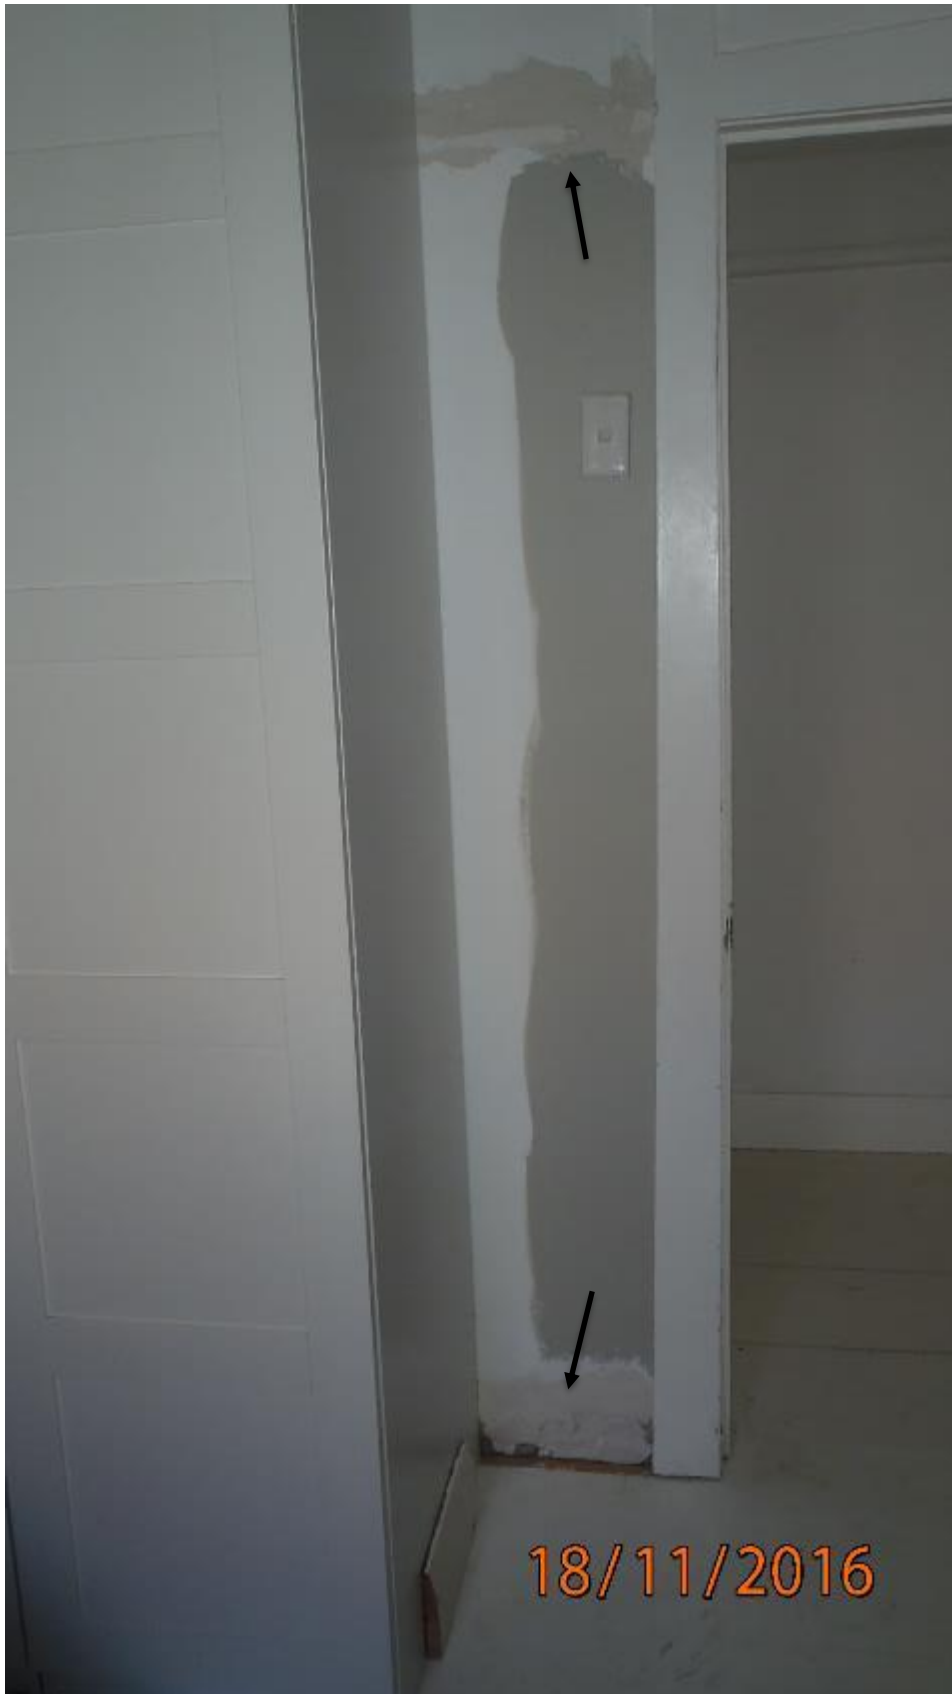
Photograph 36 shows the picture rail and skirting board had been removed from the northern wall adjacent to the door and not repaired in Bedroom 2.

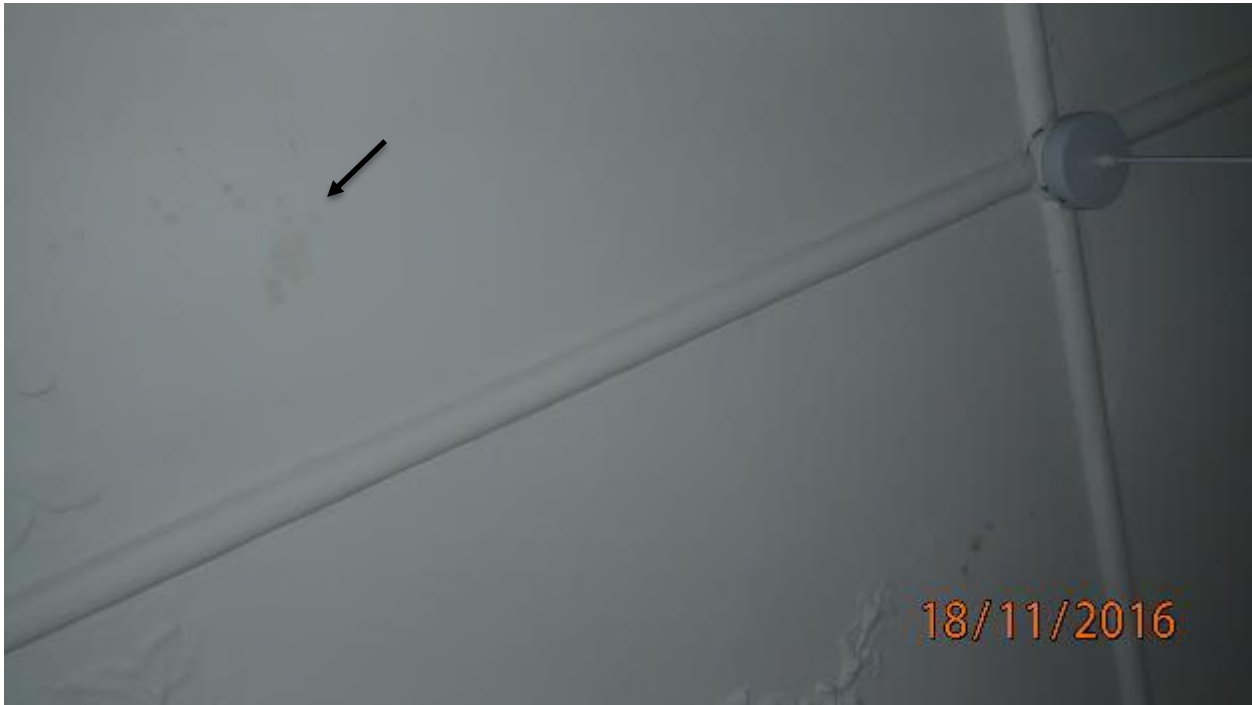
We noted staining to the decorative plaster ceiling lining in the centre of the room. **[Photograph 37]**

Photograph 37 shows staining to the decorative plaster ceiling lining in the centre of the room in Bedroom 2.

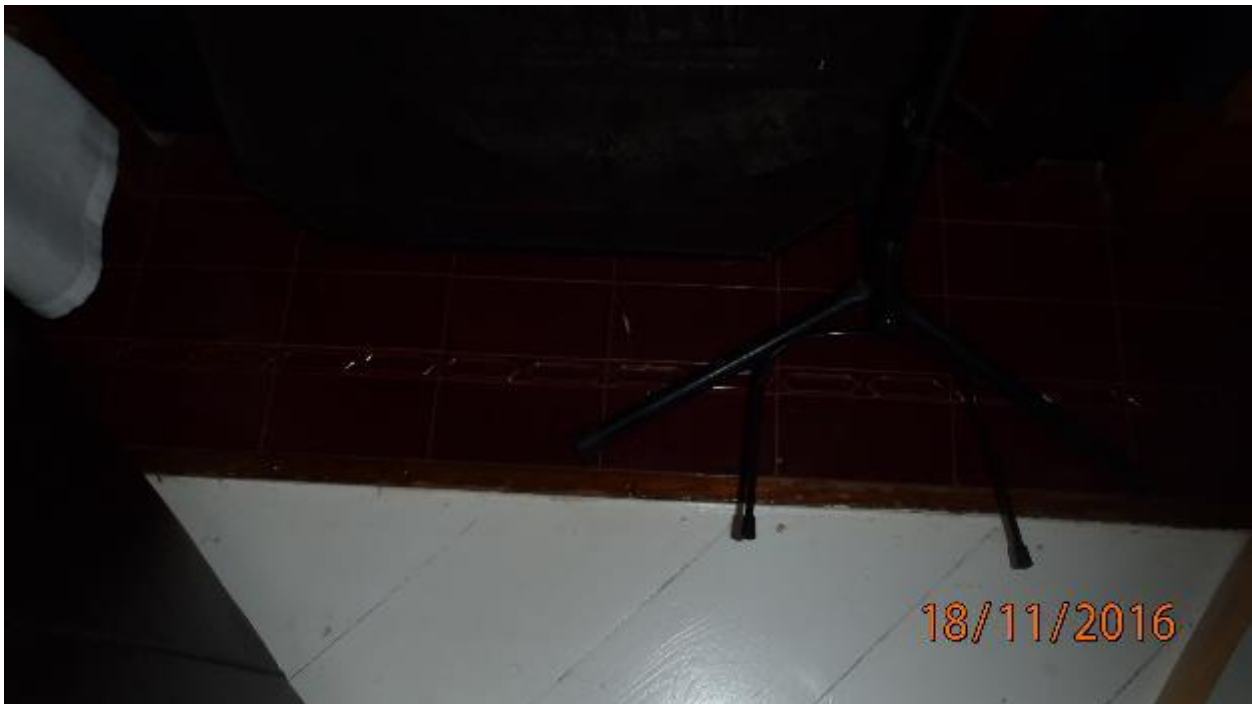
We noted general cracking to the hearth tiles to the fireplace. **[Photograph 38]**

Photograph 38 shows the condition of the Lounge Room fireplace heart tiles.

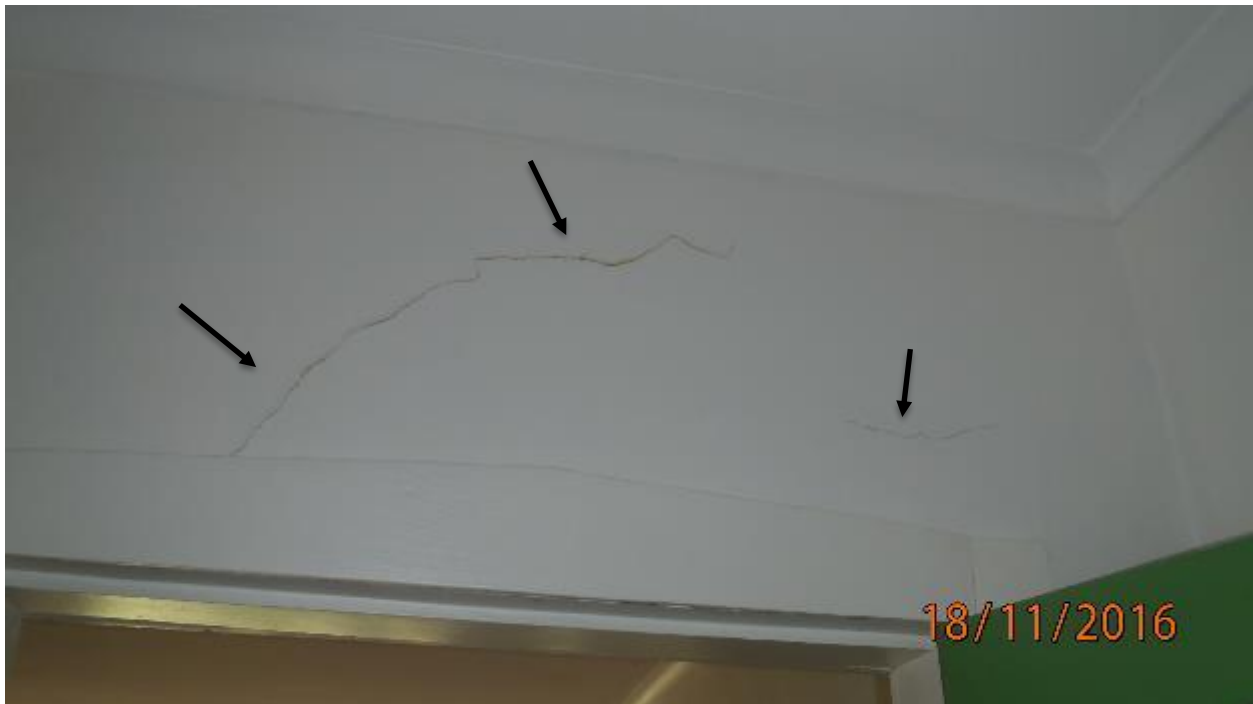
We noted radial cracking [$<1.0\text{mm}$] above the Kitchen doorway extending toward the *common party / separation* wall with the adjoining property, No. 29 Clyde Street, Croydon Park. **[Photograph 39]**

Photograph 39 shows radial cracking above the Kitchen doorway extending toward the common party / separation wall with the adjoining property, No. 29 Clyde Street, Croydon Park.

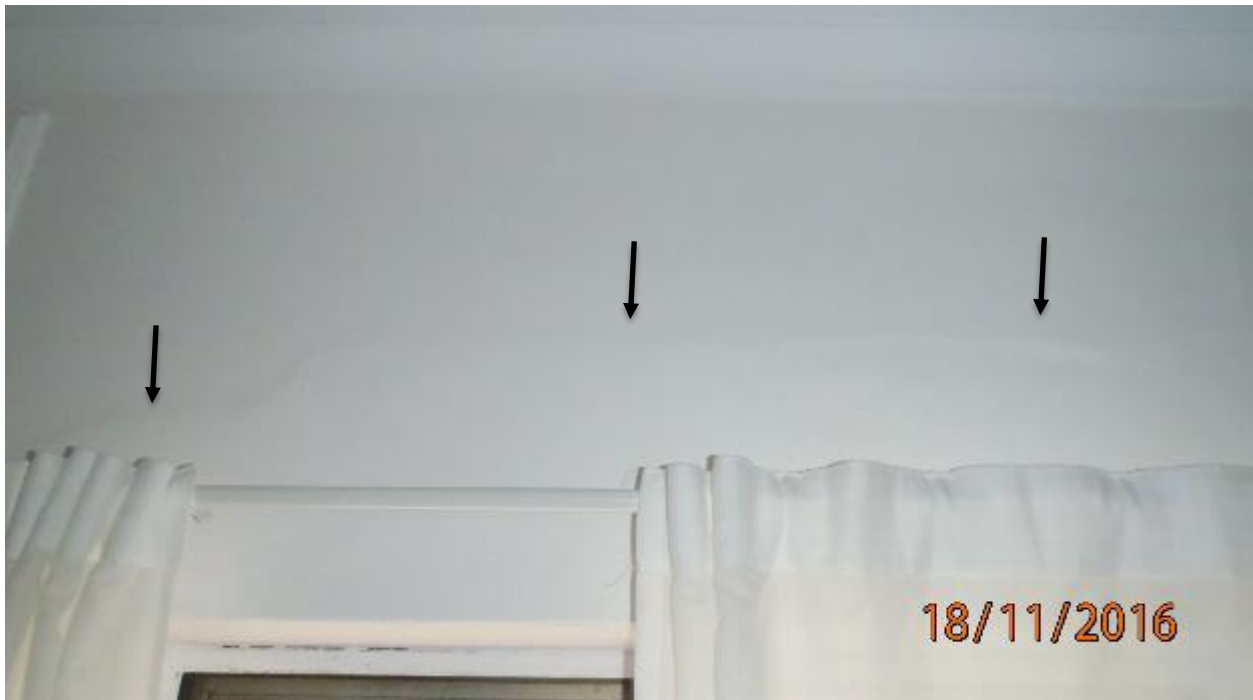
We noted evidence of a previous repair above the window head. **[Photograph 40]**

Photograph 40 shows evidence of a previous repair above the window head in the Dining Room.

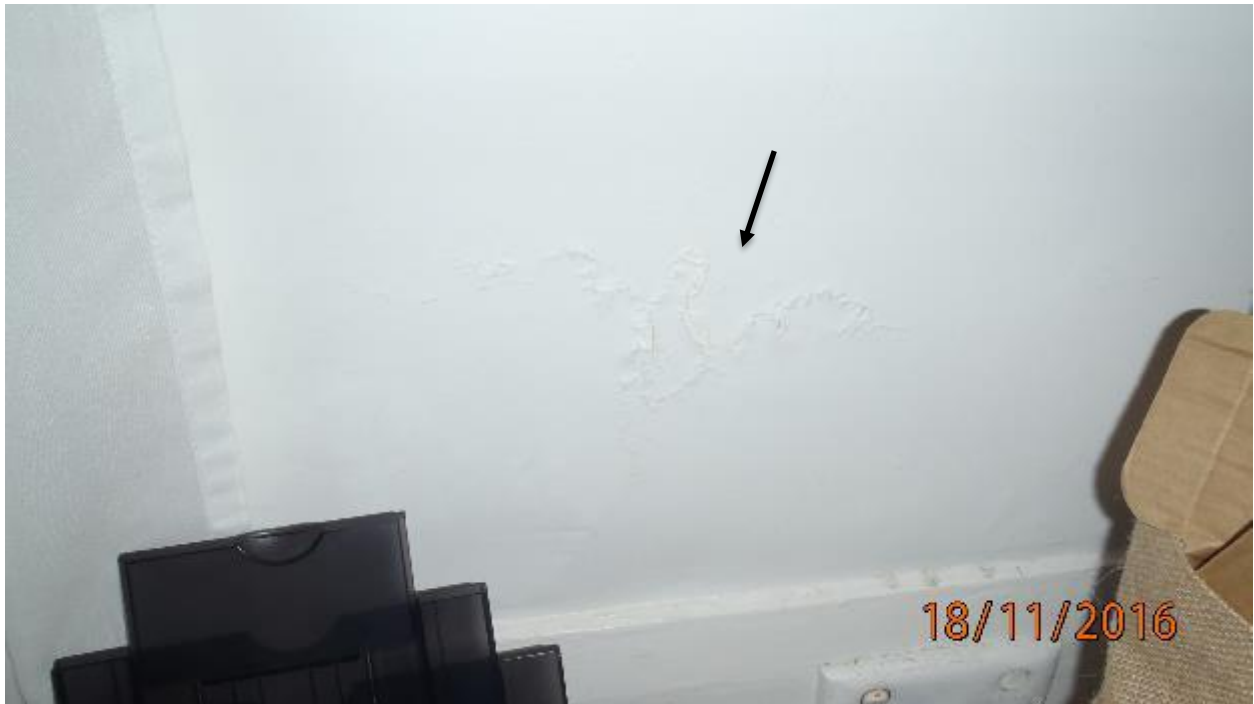
We noted areas of flaking / lifting paint to the south-western wall. This in our experience, is consistent with rising damp. **[Photographs 41, 42 & 43]**

Photograph 41 shows flaking / lifting paint to the south-western wall in the Dining Room.
