Dilapidation Assessment Report

Prepared for: Cape Cod Australia Pty. Limited
Job address: No. 31 Clyde Street, Croydon Park.
Property Owner/s: Mrs. Monique Apostle.
Report reference: CANTERBURY COUNCIL
Development Application No: not available
Date of assessment: 18th November 2016

Re: Dilapidation Report – No. 31 Clyde Street, Croydon Park.

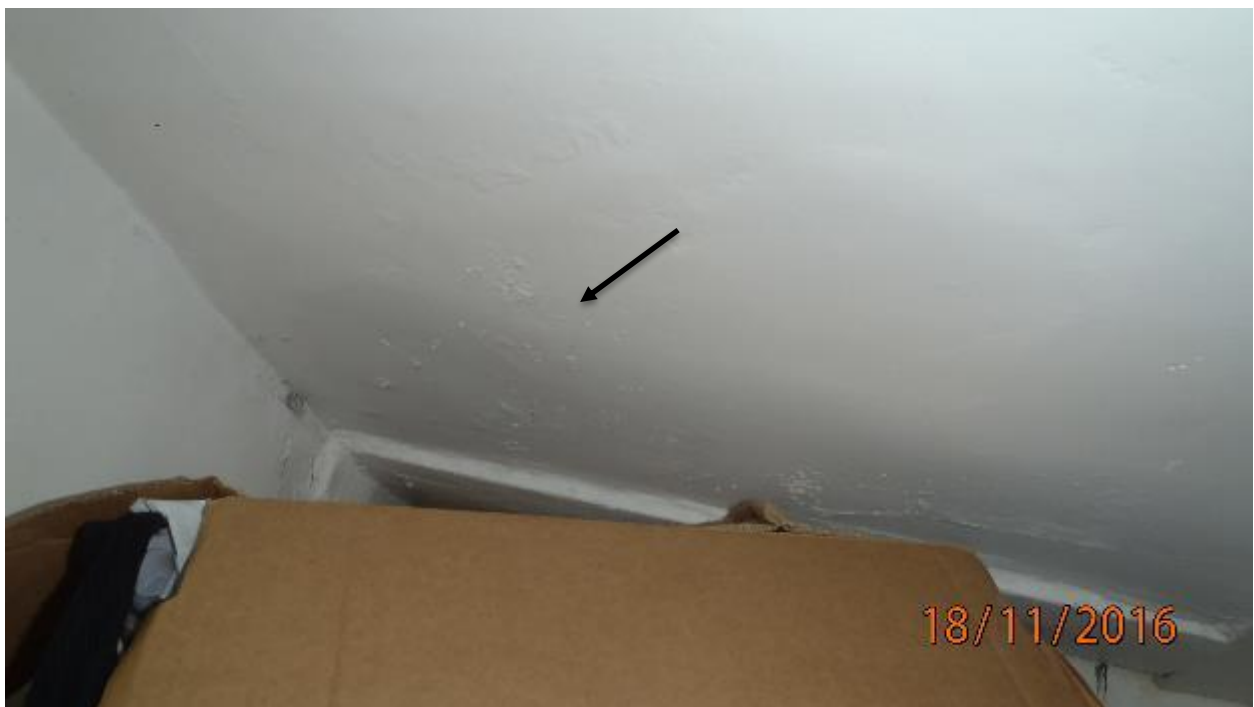
We noted areas of flaking / lifting paint to the south-western wall. This in our experience, is consistent with rising damp. **[Photographs 41, 42 & 43]**

Photograph 42 shows flaking / lifting paint to the south-western wall in the Dining Room

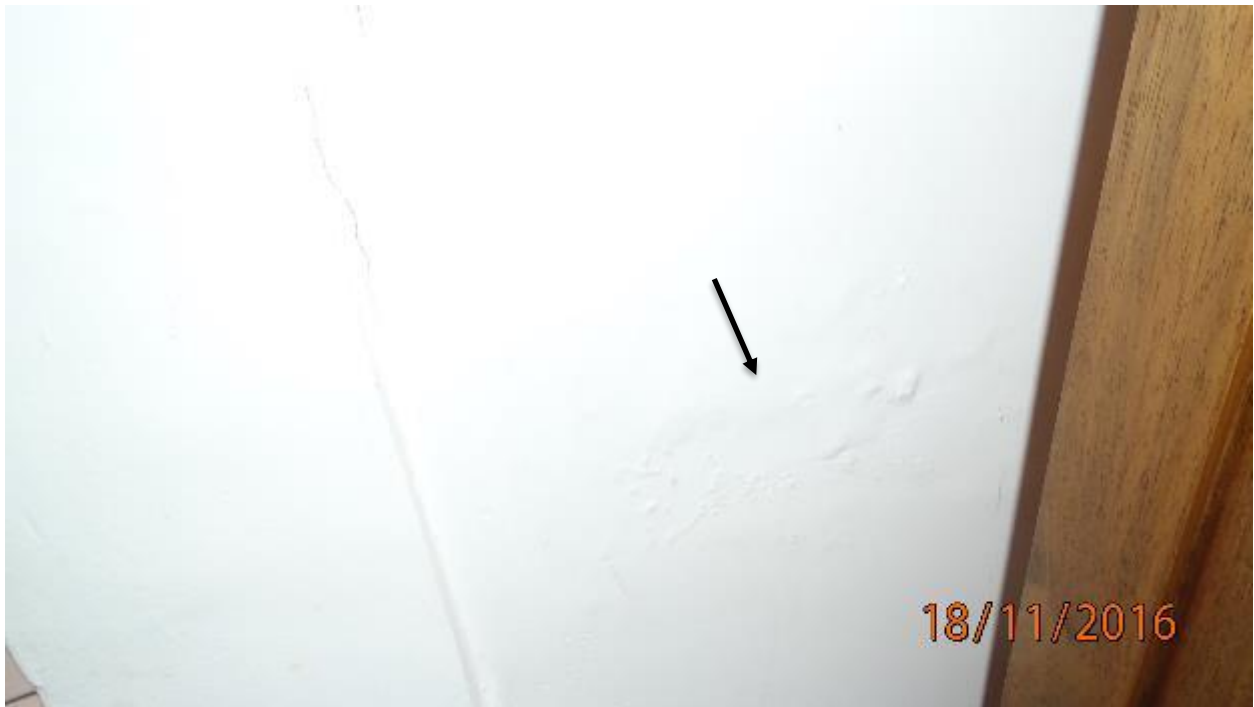
Photograph 43 shows flaking / lifting paint to the south-western wall in the Dining Room

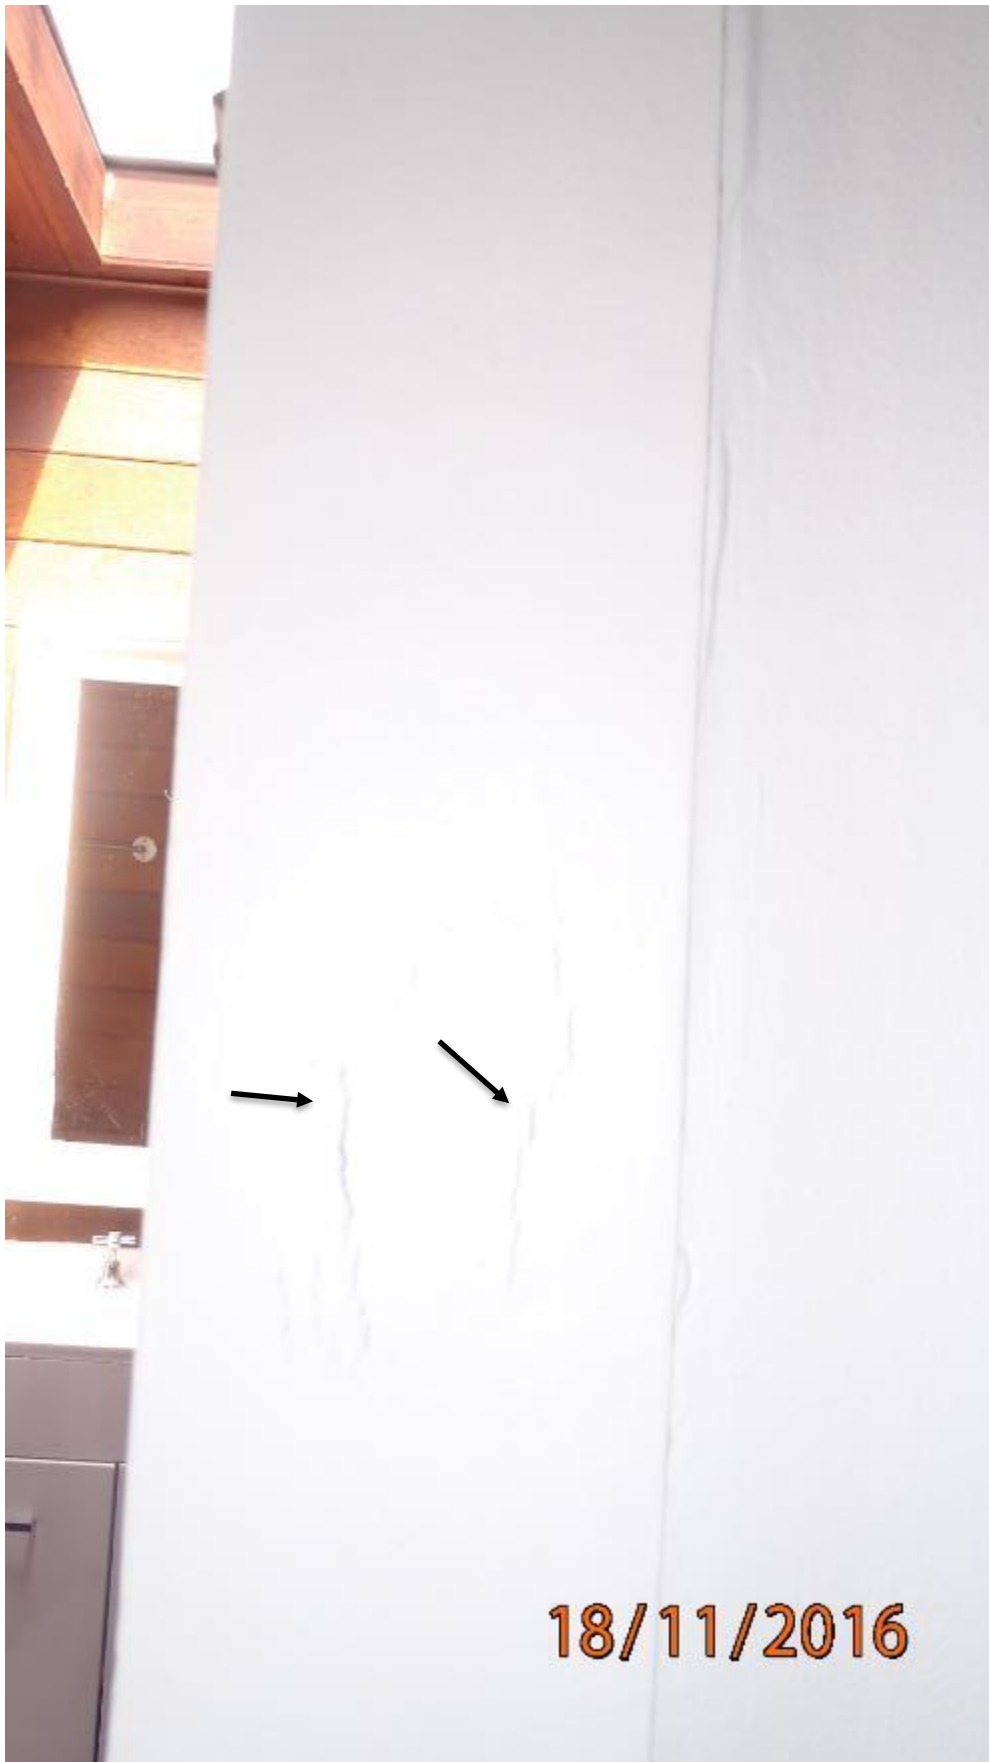
We noted flaking paint to the door jamb on the right-hand side. **[Photograph 44]**

Photograph 44 shows flaking paint to the right-hand side door jamb in the Bathroom.

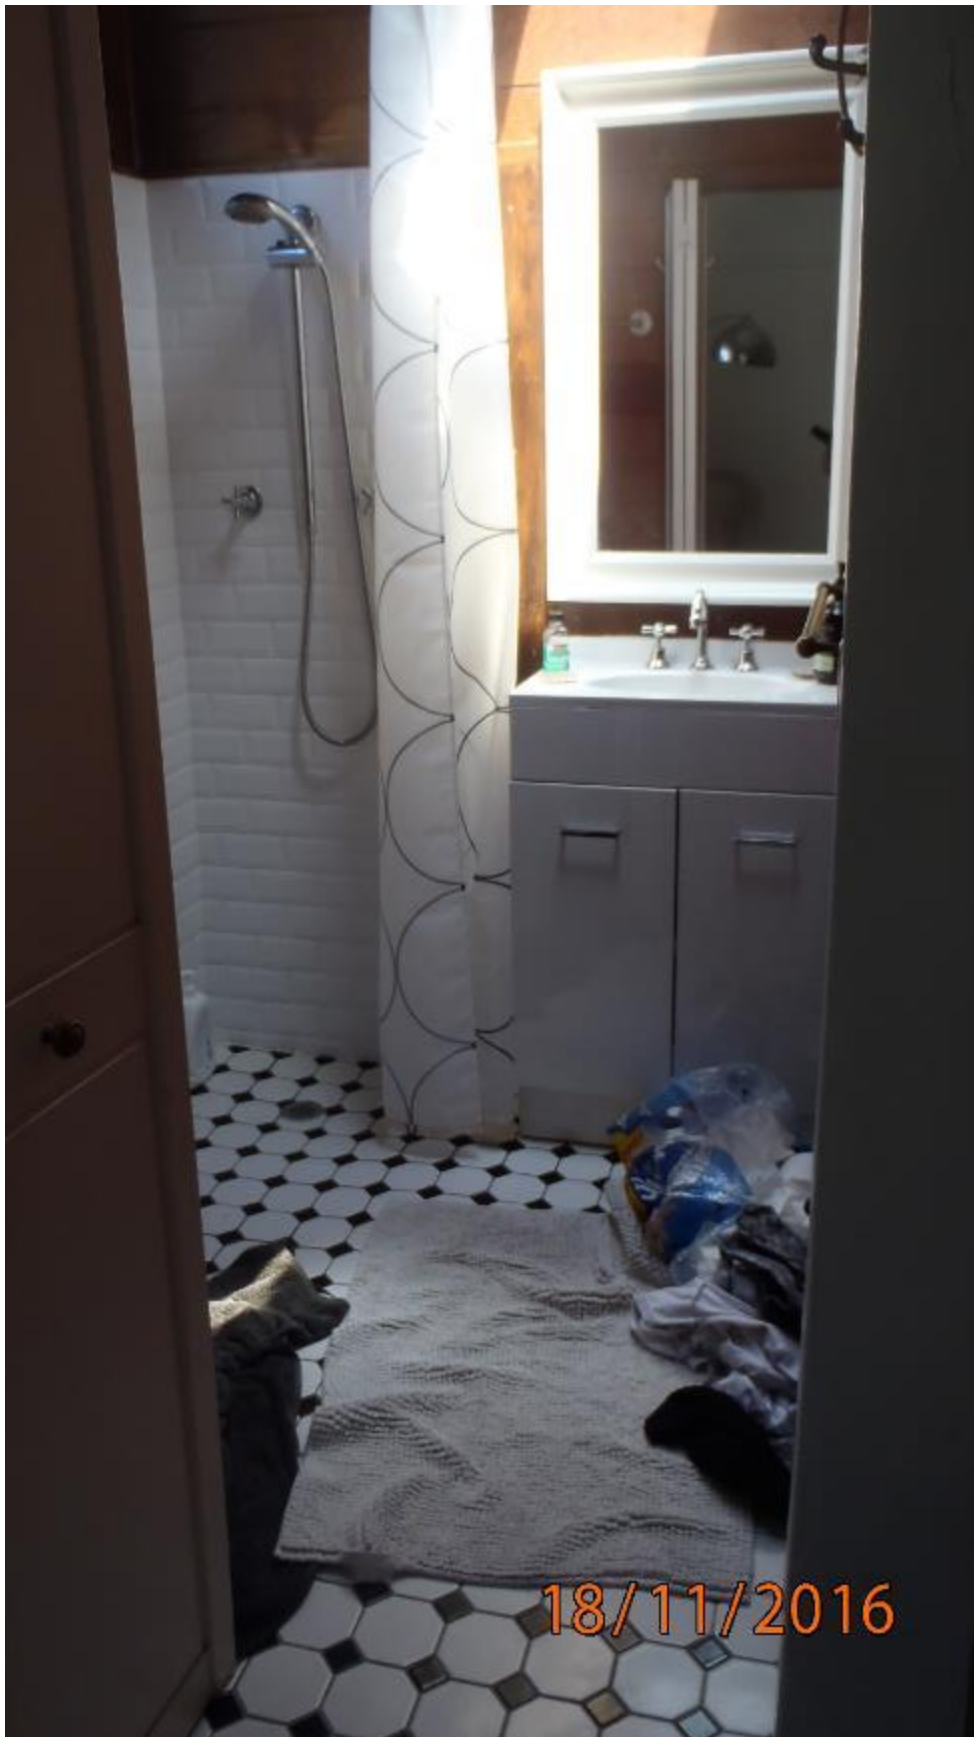
We noted that the grout to the wall and floor tiles is complete and that the wall and floor tiles when randomly “tap” tested appeared to be sound. We did not observe any recent cracking to the tile grout at the wall / wall, wall / floor junctions. **[Photograph 45]**

Photograph 45 shows the general layout of the bathroom.

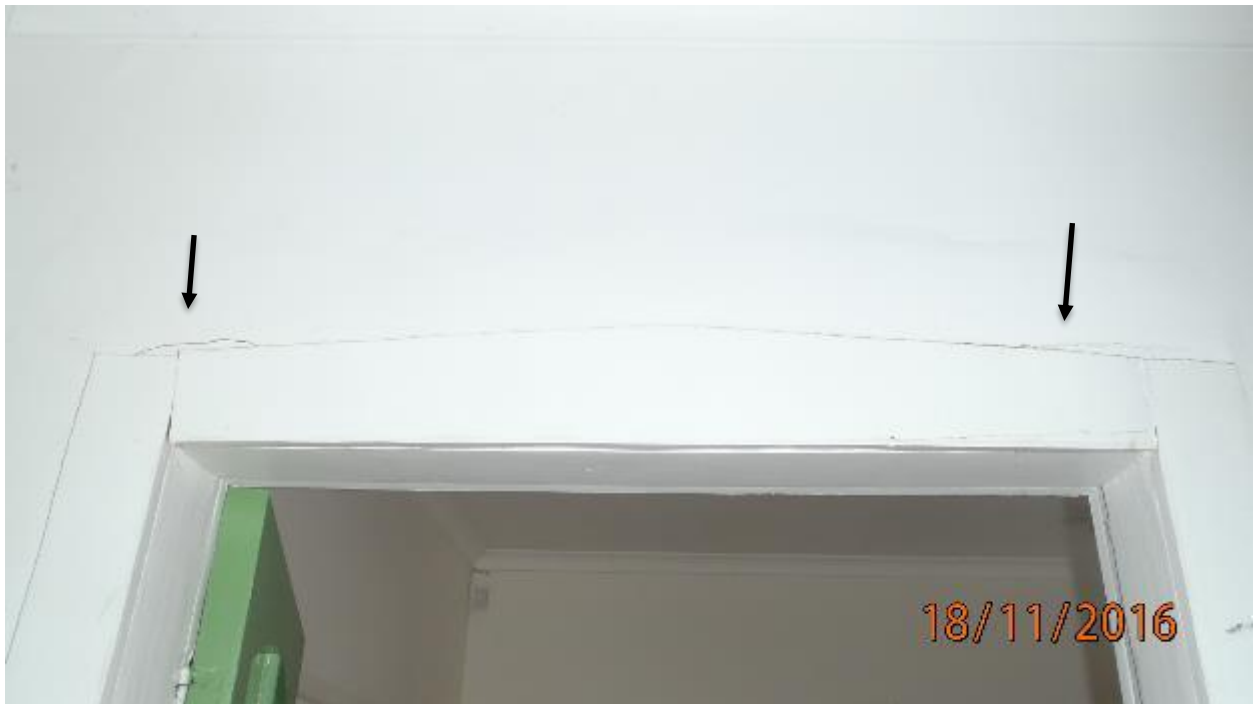
We noted horizontal cracking [$<1.0\text{mm}$] above the door head (opposite side to Photograph 38). **[Photograph 46]**

Photograph 46 shows horizontal cracking above the door head (opposite side to Photograph 39).

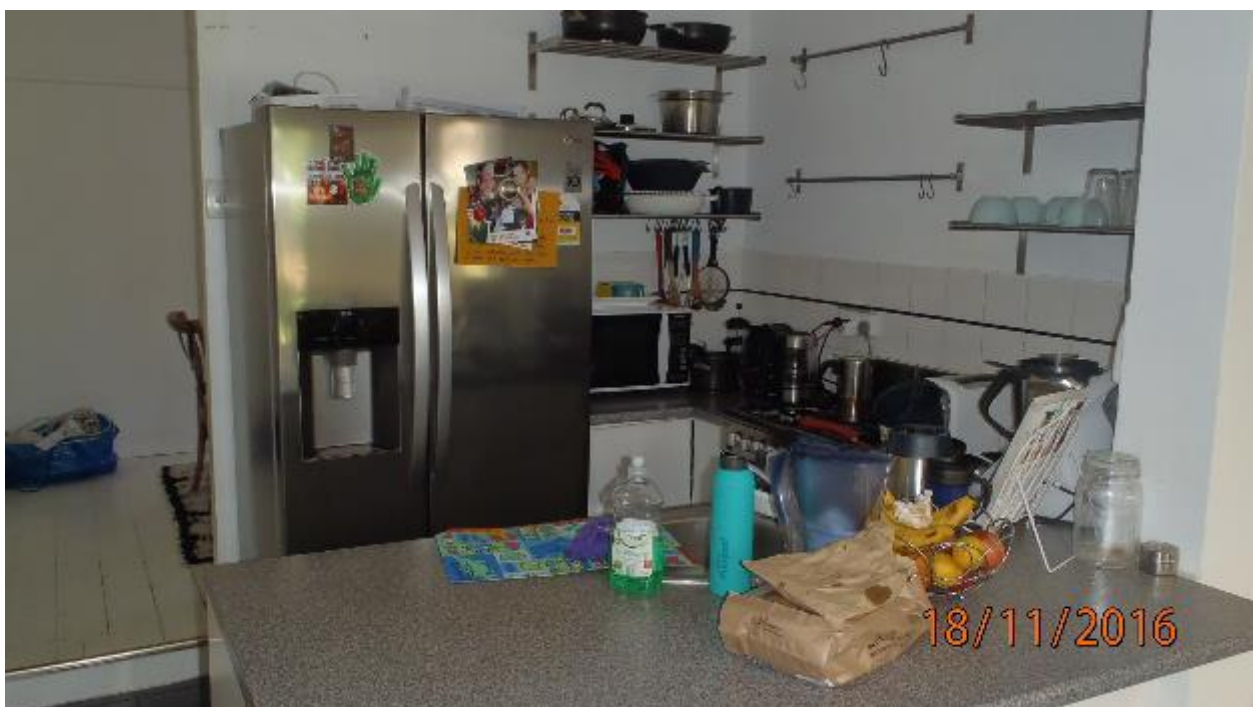
We observed that the painted cement rendered walls are tiled to splashback level. We noted that the grout to the tiles is complete and that the tiles when randomly “tap” tested appeared to be sound. **[Photograph 47]**

Photograph 47 shows the general layout of the Kitchen.

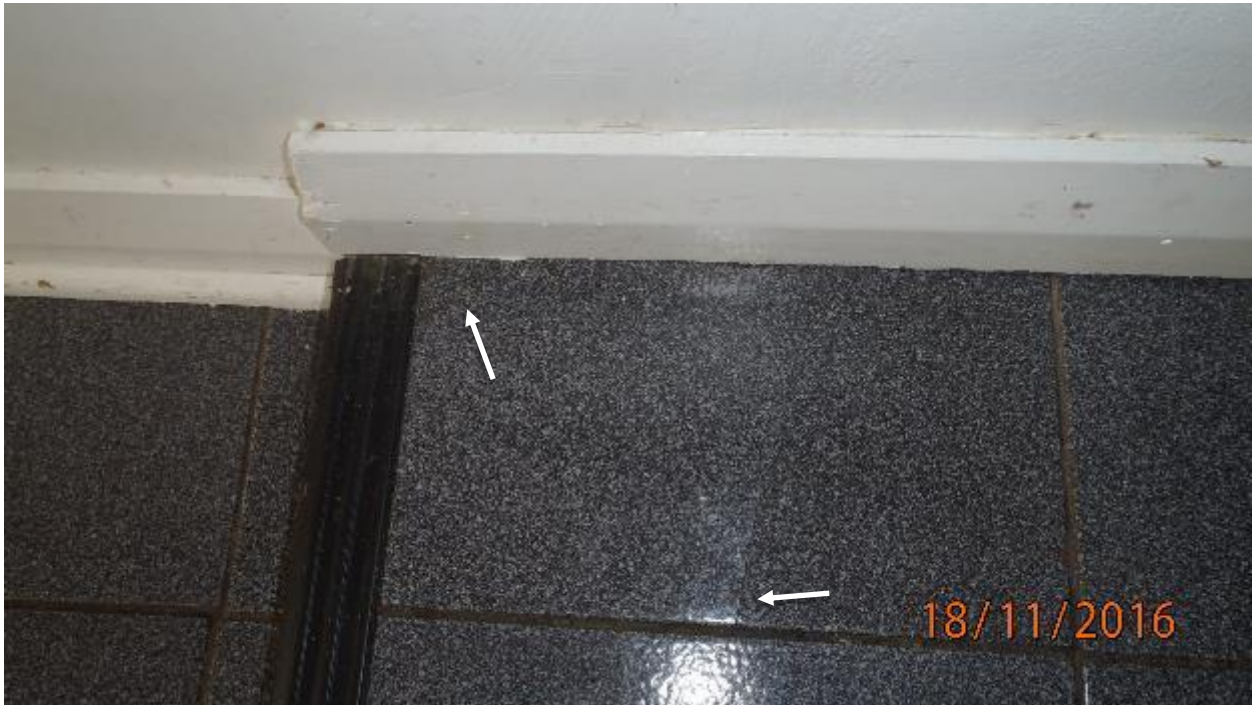
We noted cracking to the floor tiles adjacent to the step. **[Photograph 48]**

Photograph 48 shows cracking to the floor tiles adjacent to the step in the Kitchen.

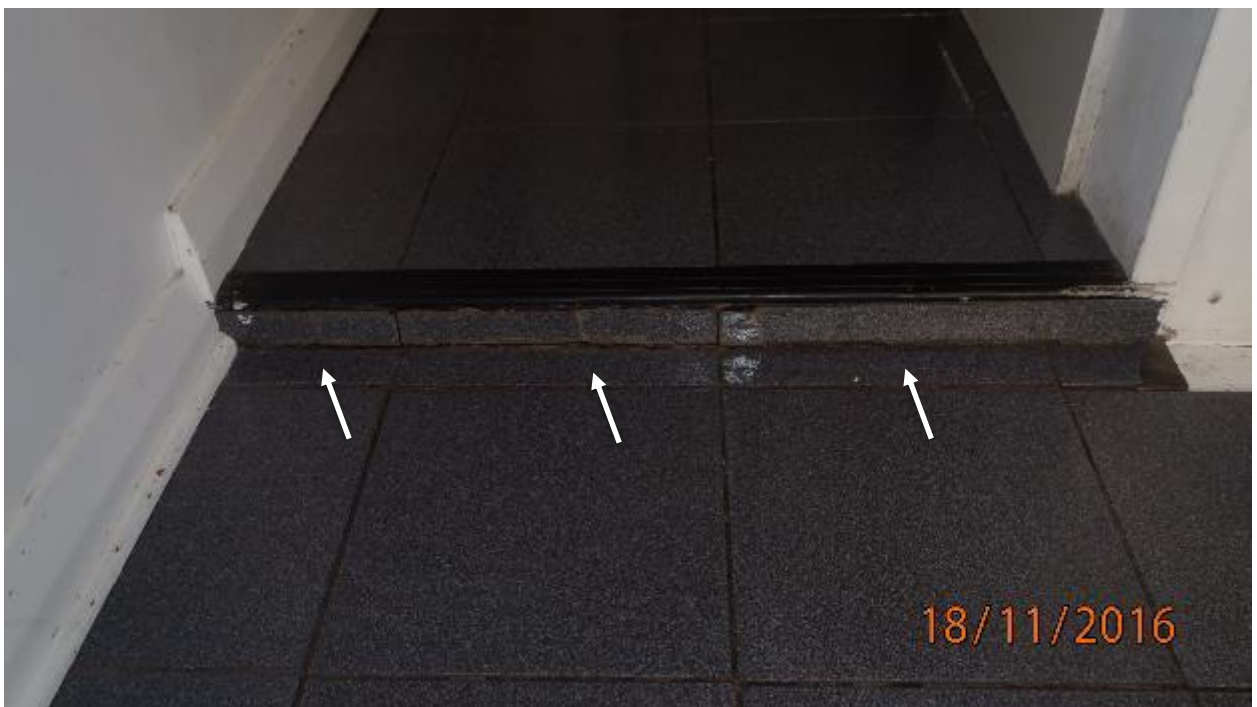
We observed that the floor is finished with ceramic tiles. We noted cracking and displaced grout to the Kitchen step. **[Photograph 49]**

Photograph 49 shows cracking and displaced grout to the Kitchen step.

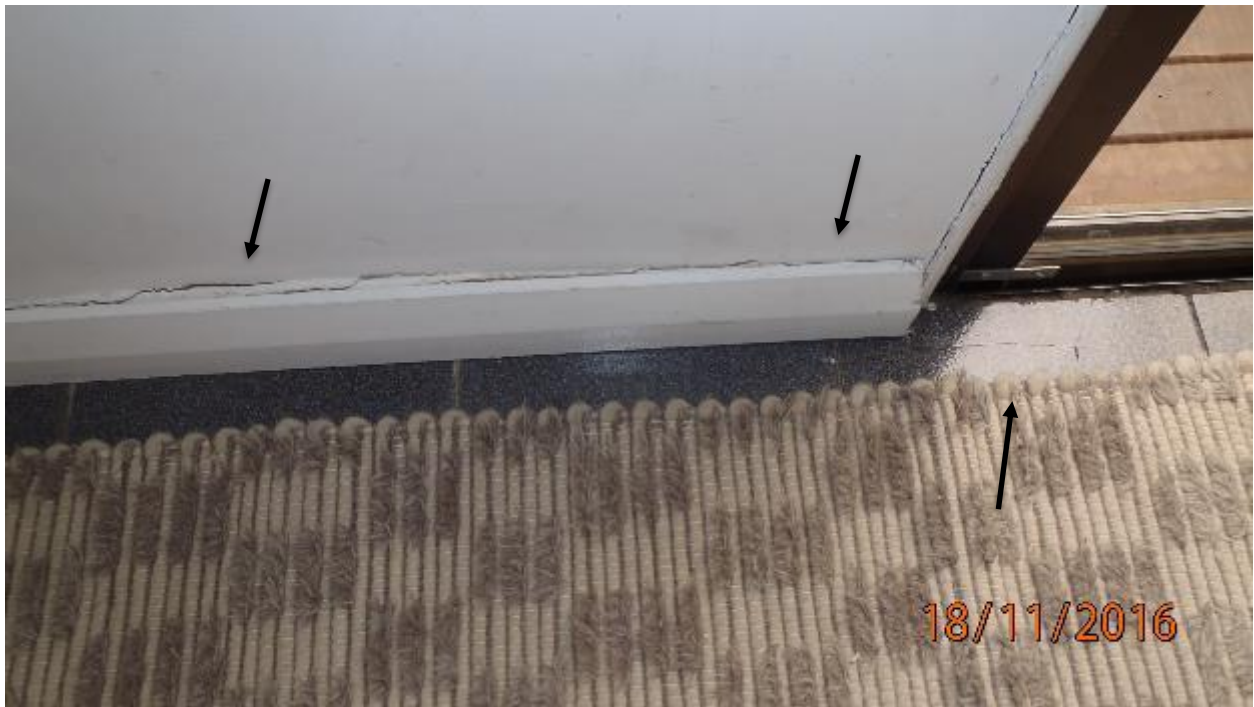
We noted cracked floor tiles and separation cracking [1.0mm - 3.0mm] to the wall / skirting junction adjacent to the external door. **[Photograph 50]**

Photograph 50 shows cracked floor tiles and separation cracking to the wall / skirting junction adjacent to the rear external door in the Kitchen.

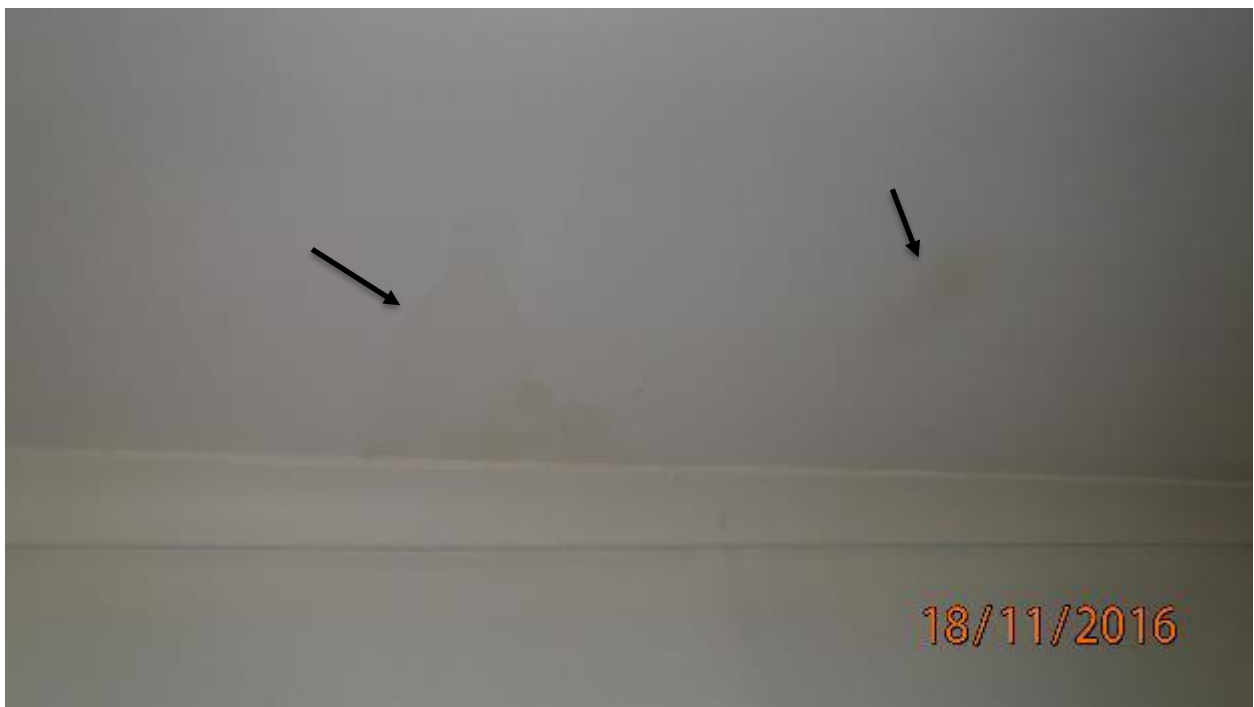
We noted staining to the plaster ceiling lining above the *common party / separation* wall with the adjoining property, No. 29 Clyde Street, Croydon Park. **[Photograph 51]**

Photograph 51 shows staining to the plaster ceiling lining above the common party / separation wall with the adjoining property, No. 29 Clyde Street, Croydon Park in the Kitchen.

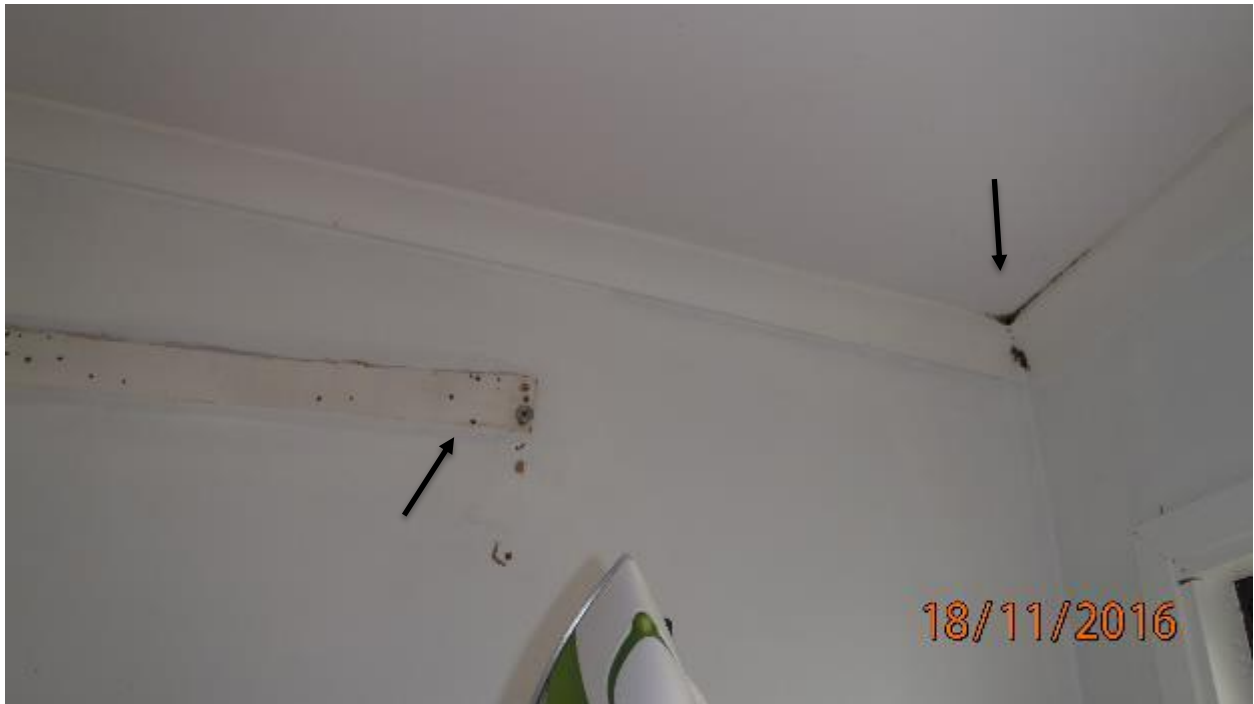
We noted unrepaired holes in the wall lining from a removed bracket. **[Photograph 52]**

We noted mildew / mould growth to the cornice junction in the external south-western corner. **[Photograph 52]**

Photograph 52 shows unrepaired holes in the wall lining from a removed bracket and mildew / mould growth to the cornice junction in the external south-western corner.
