HAZARDOUS MATERIALS ASSESSMENT REPORT

Job details: Owner: Mr. D. Miller & Ms. L. Windeyer.
Location: 20 Tantallon Road, Lane Cove West.

Date of assessment: 2nd February 2017

Our reference: HM05570217

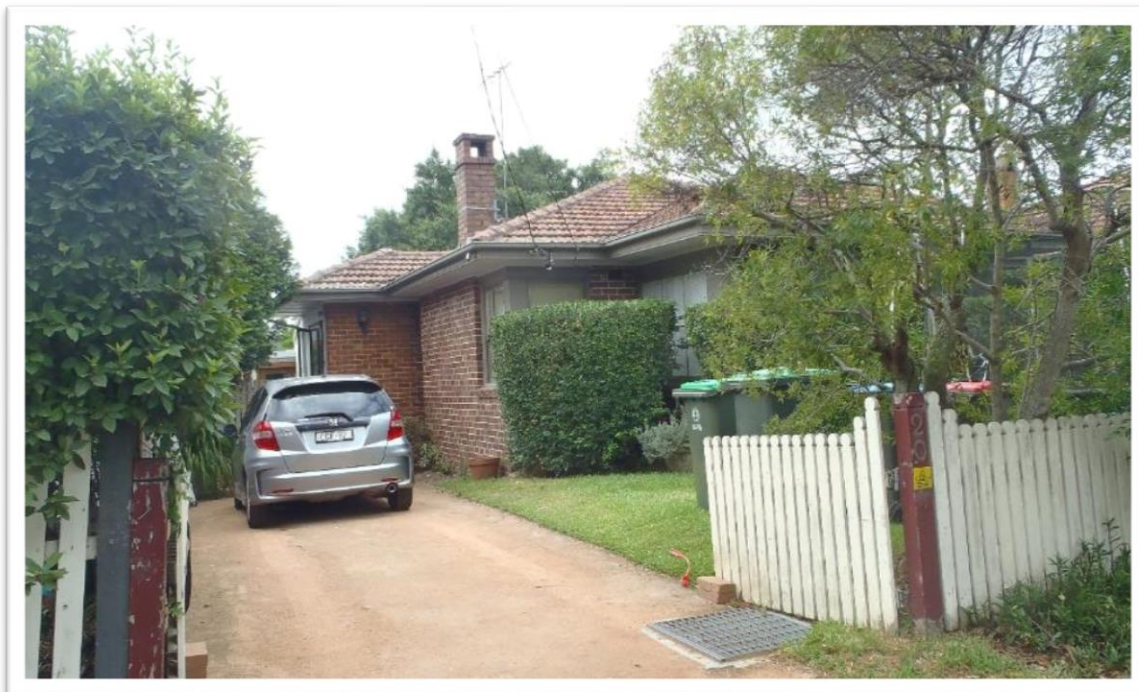
Front western elevation of the residence
