## **HAZARDOUS MATERIALS ASSESSMENT REPORT**

**Job details:** Owner/s: Mr. T. Gorey & Ms. N. Meekan  
Location: 62 Hallam Avenue, Lane Cove West

**Plans for Job No:** 7707/15      **Revision No:** D      **Dated:** 12-02-16

**Date of assessment:** 22<sup>nd</sup> February 2016

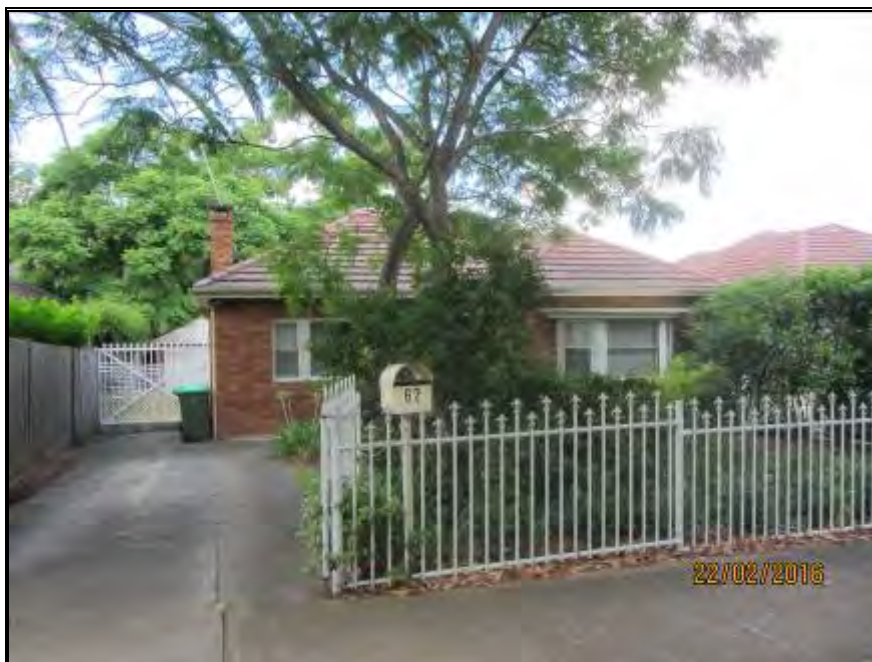
Front northern elevation of the residence
