HAZARDOUS MATERIALS ASSESSMENT REPORT

Job details: Owner/s: Mr. A. & Mrs. P. Butler
Location: 76 Hopetoun Avenue, Vaucluse

Date of assessment: 21st May 2015

Our reference: HM03940515

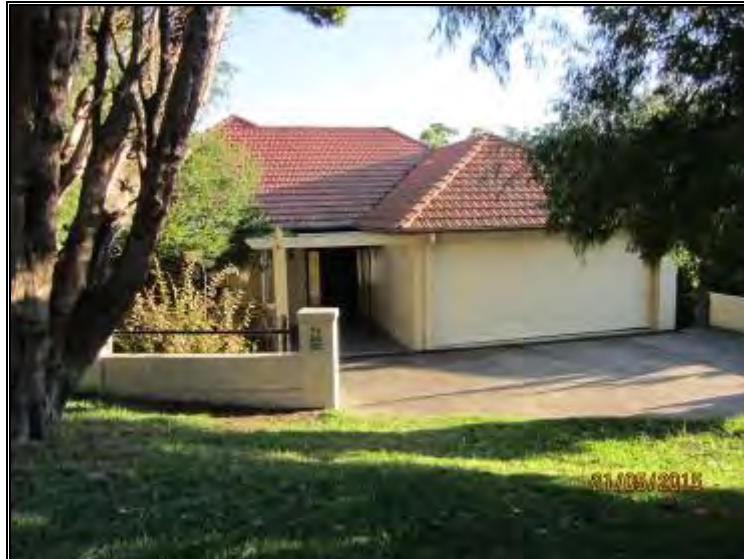
Front south eastern elevation of the residence
