Dilapidation Assessment Report

Prepared for: Cape Cod Australia Pty. Limited
Job address: 10 Banks Street, Ashfield NSW 2131
Property Owner: Ms. T. Adam
Report reference: **ASHFIELD COUNCIL**
Development Application No: not available
Date of assessment: 5th May 2016

Re: Dilapidation Report - No. 10 Bank Street, Ashfield

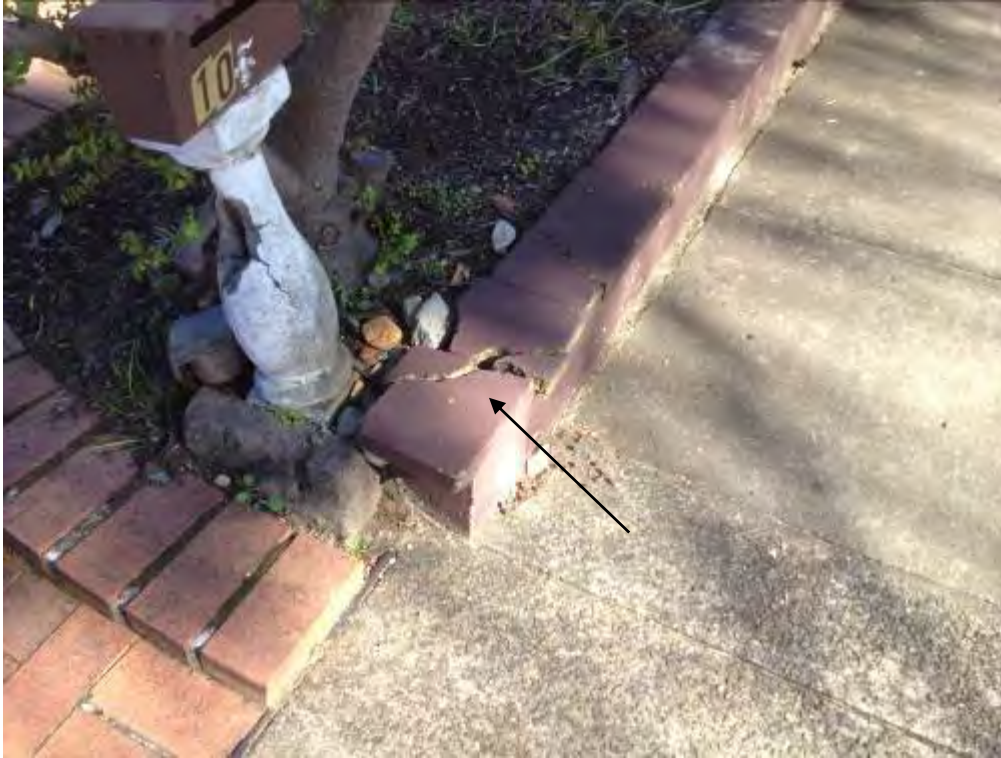
We noted that there is cracking and displacement of capping to the front boundary fence. **[Photograph 1]**

Photograph 1 shows cracking and displacement of the front boundary wall capping

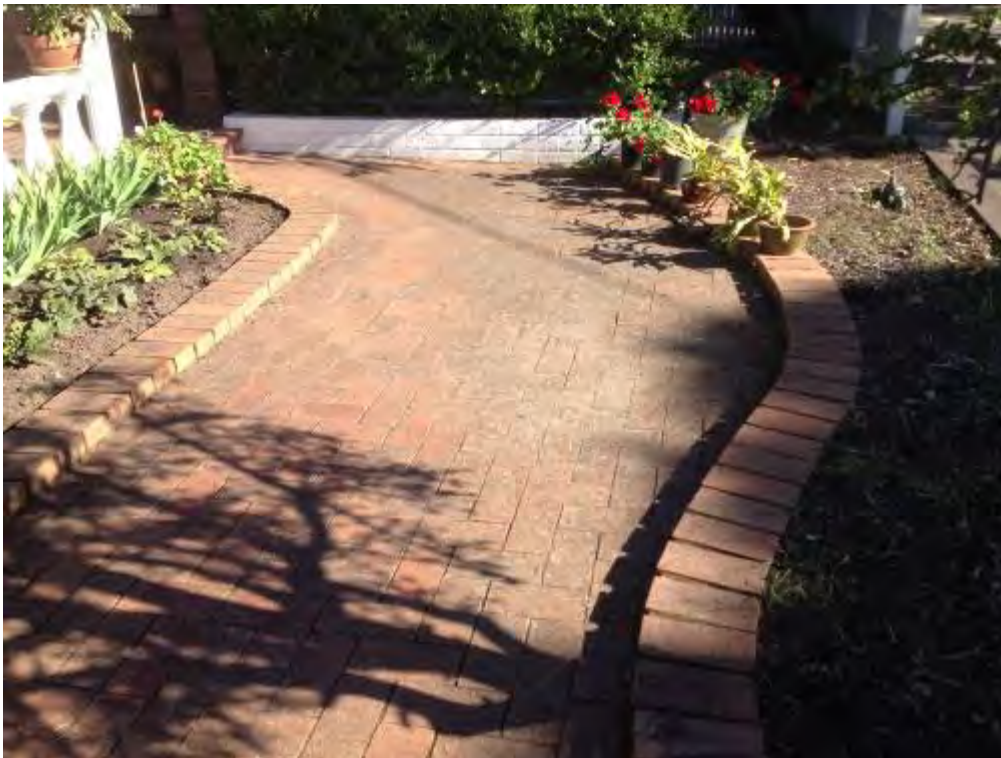
We noted that clay brick pavers forming the entry pathway are generally level in plane and were generally sound. Due to concealment we are unable to comment on the base strata to the pavers. **[Photograph 2]**

Photograph 2 shows the condition of the clay pavers to the front entry pathway

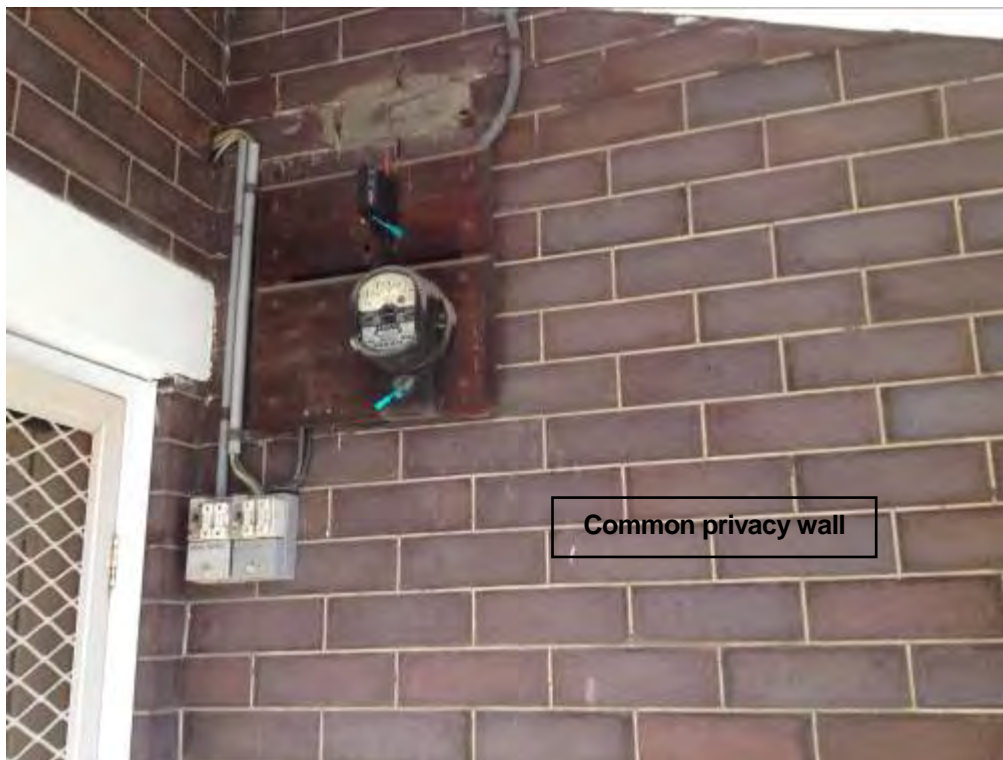
We did not note any recent cracking to the clay masonry brickwork particularly at the junction between the properties and to the *common boundary privacy* wall. **[Photographs 3 and 4]**

Photograph 3 shows the condition of the brickwork to the front *common boundary privacy* wall

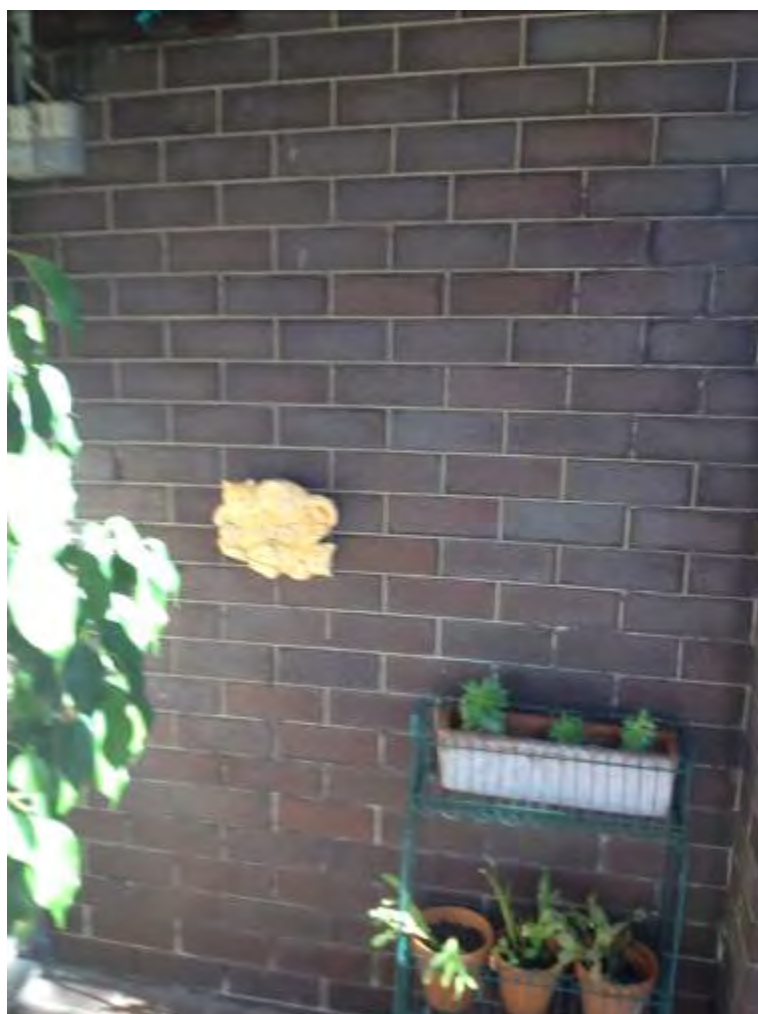
Photograph 4 shows the condition of the brickwork to the front north eastern elevation wall [Bedroom 1]

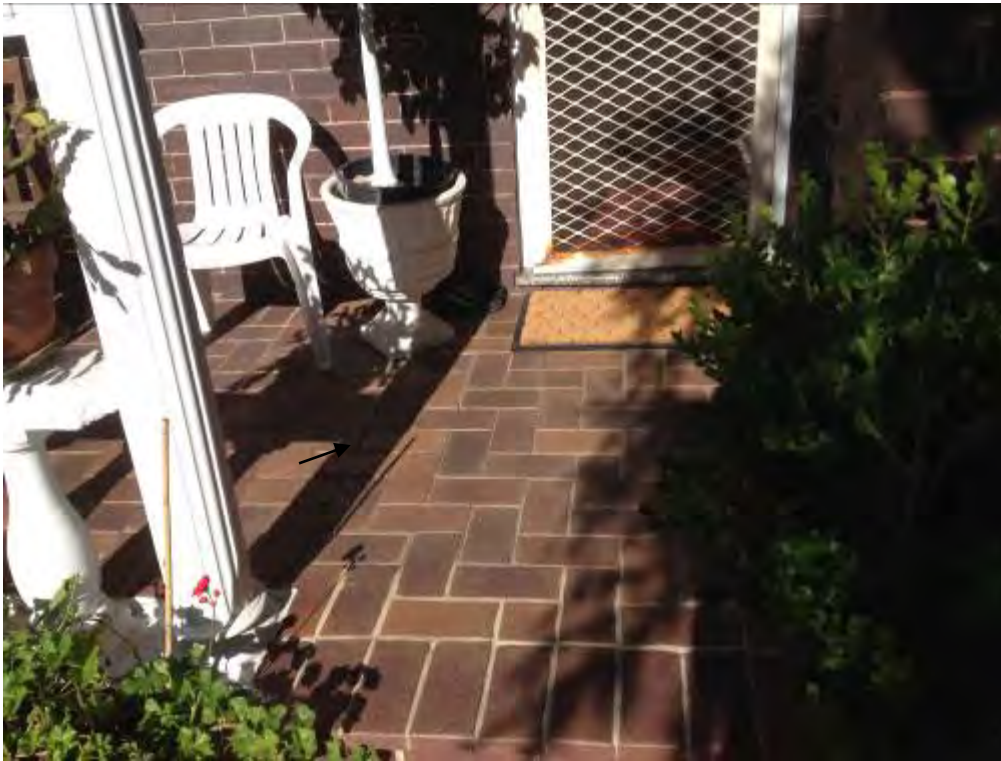
We noted that the front verandah is finished with clay pavers. We noted that the grout to the pavers is generally complete and that the pavers when randomly “tap” tested were sound. **[Photograph 5]**

Photograph 5 shows the condition of the clay pavers to the front verandah

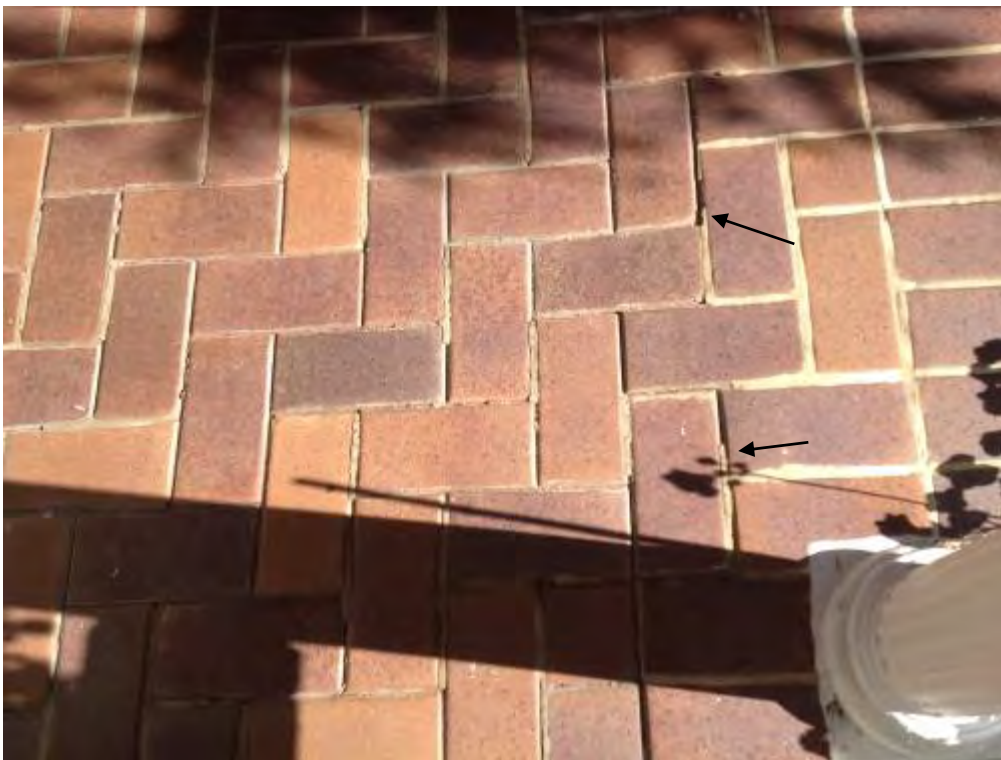
Notwithstanding this, we did note a small area of pavers located between the front entry step and the front entry door where there are hairline cracks [$<1.0\text{mm}$] between the pavers and displacement of the grout. **[Photograph 6]**

Photograph 6 shows displaced grout and hairline cracking to the grout to the front verandah between the front step and the front door entry

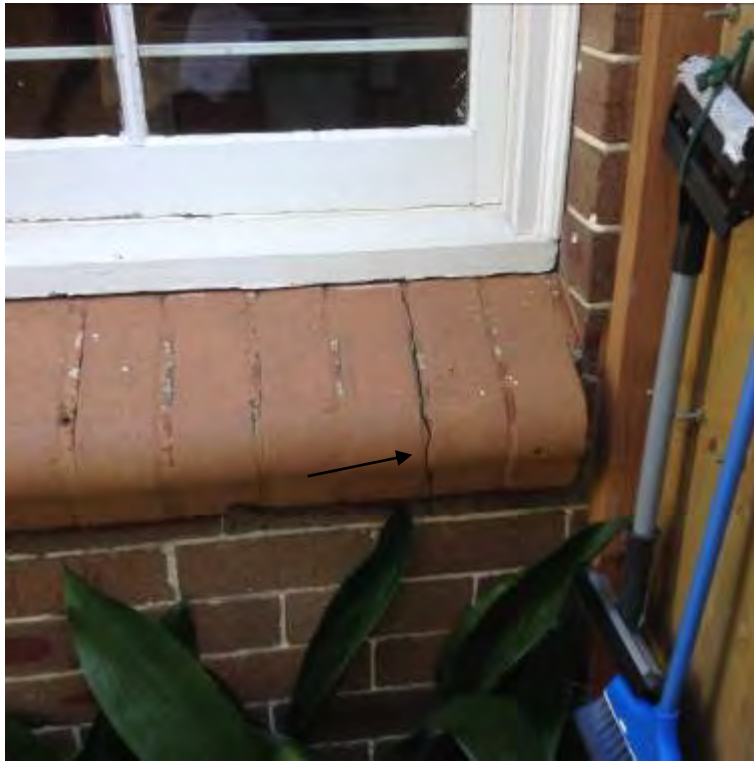
We noted a hairline crack [$<1.0\text{mm}$] and brick window sill to Bedroom 2. **[Photograph 7]**

Photograph 7 shows a crack to the brick sill to the right hand side of the Bedroom 2 window

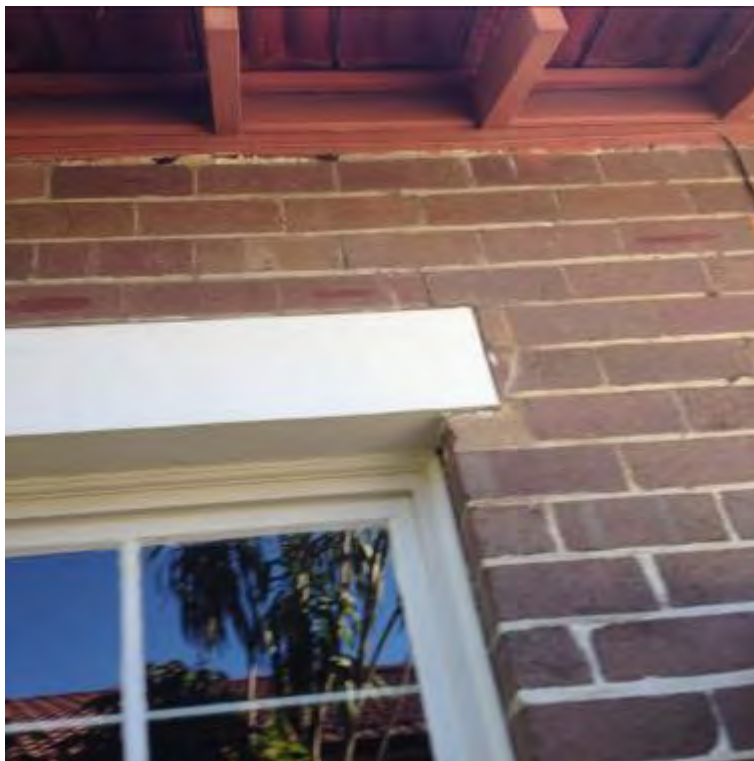
We noted hairline stepped cracks [$<1.0\text{mm}$] extending from both the right and left hand side of Bedroom 2 window head [rendered lintel] extending towards the wall vents. **[Photographs 8 and 9]**

Photograph 8 shows a hairline stepped crack extending from the right hand side of the rendered lintel to Bedroom 2 window towards the wall vent

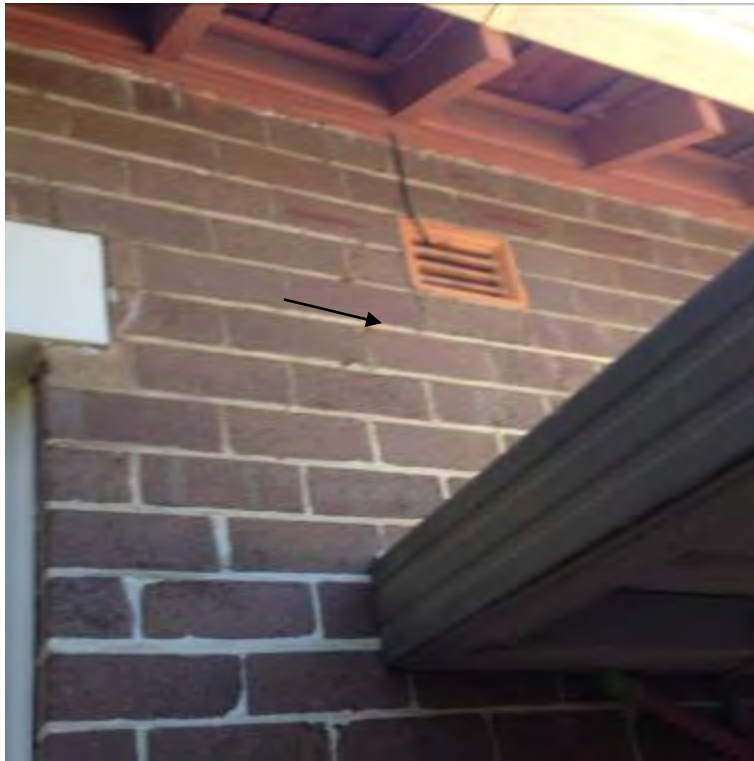
Photograph 9 shows a hairline stepped crack extending from the right hand side of the rendered lintel to Bedroom 2 window towards the wall vent

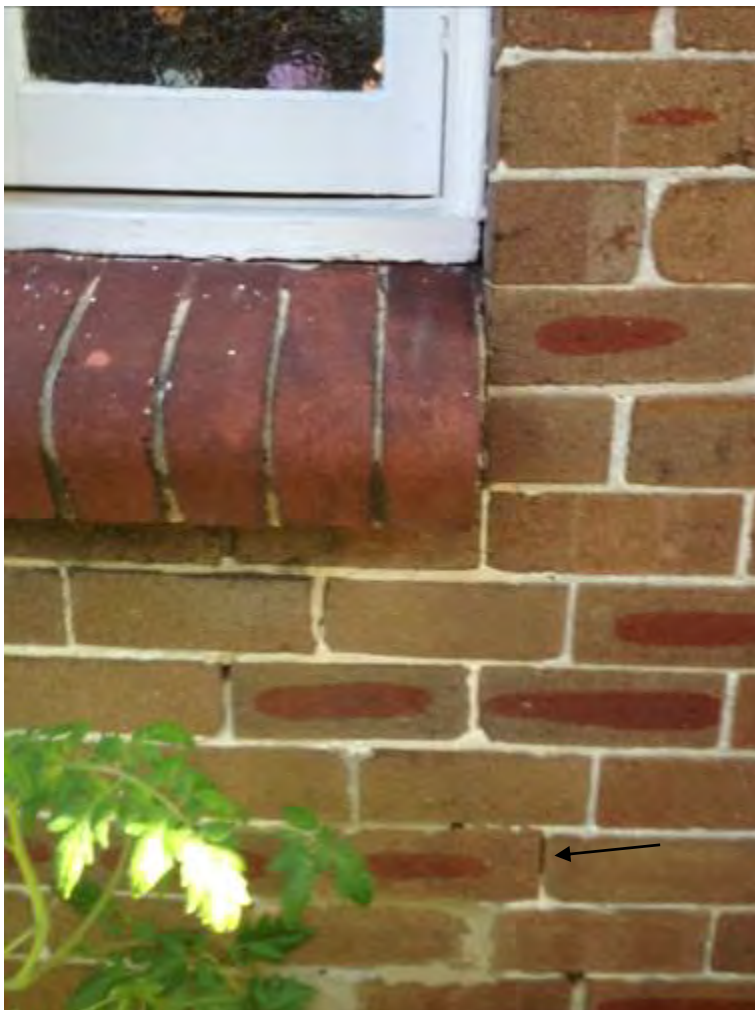
We noted a hairline stepped crack [$<1.0\text{mm}$] extending from the right hand window sill to the Bathroom towards the base of the wall. **[Photograph 10]**

Photograph 10 shows the hairline stepped crack below the right hand side of the Bathroom window sill

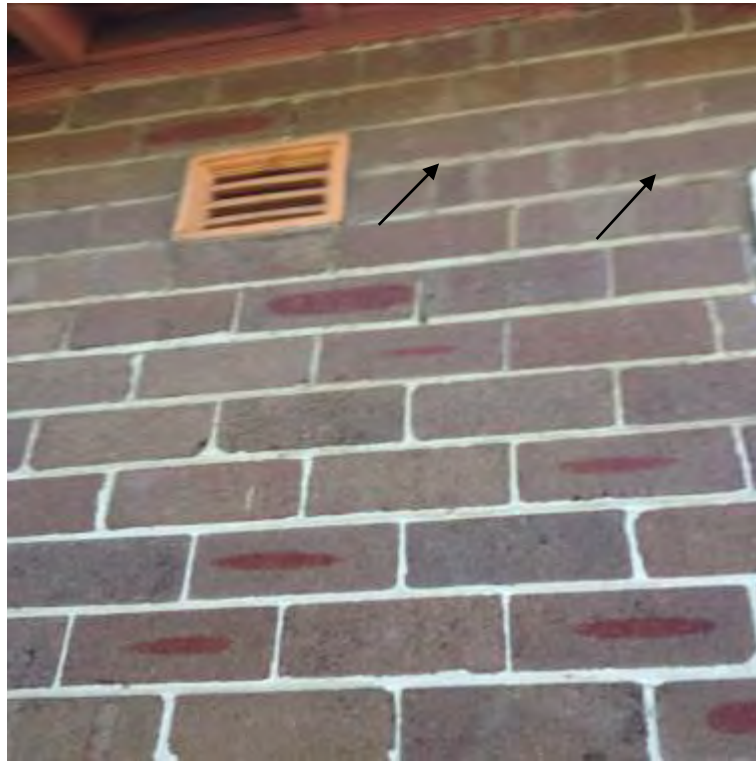
We noted hairline stepped cracks [$<1.0\text{mm}$] extending from the right hand side of Bathroom window head [rendered lintel] extending towards the wall vent. **[Photographs 11 and 12]**

Photograph 11 shows the hairline stepped crack extending from the left hand side of the rendered lintel to Bedroom 2 window towards the wall vent

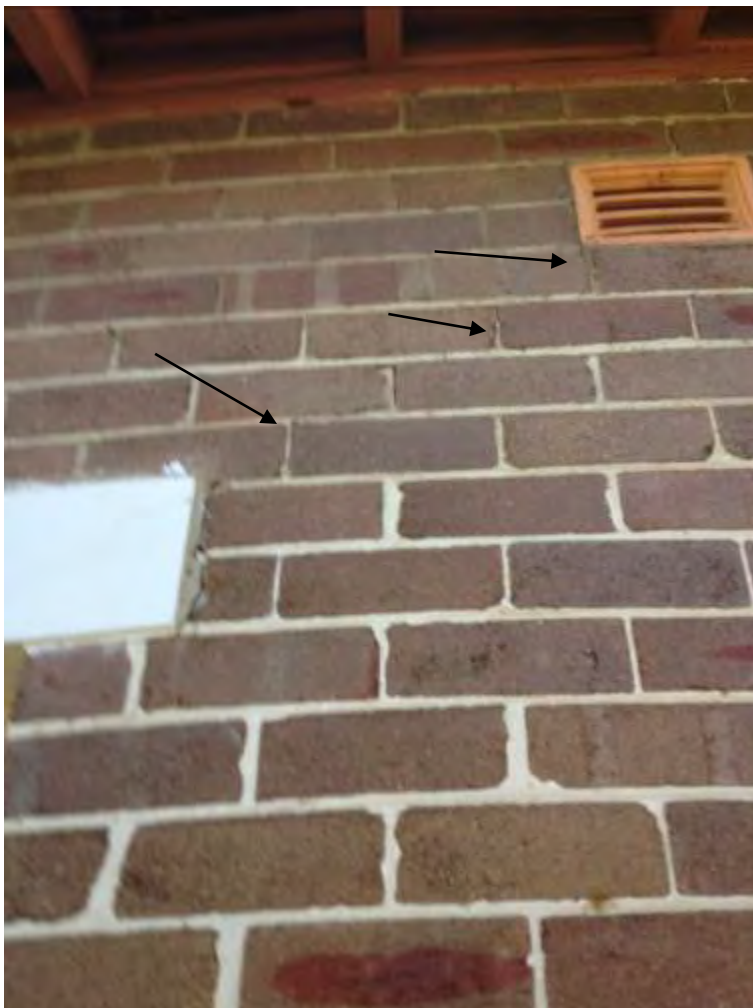
Photograph 12 shows the hairline stepped crack extending from the right hand side of the rendered lintel to the Bathroom window towards the wall vent

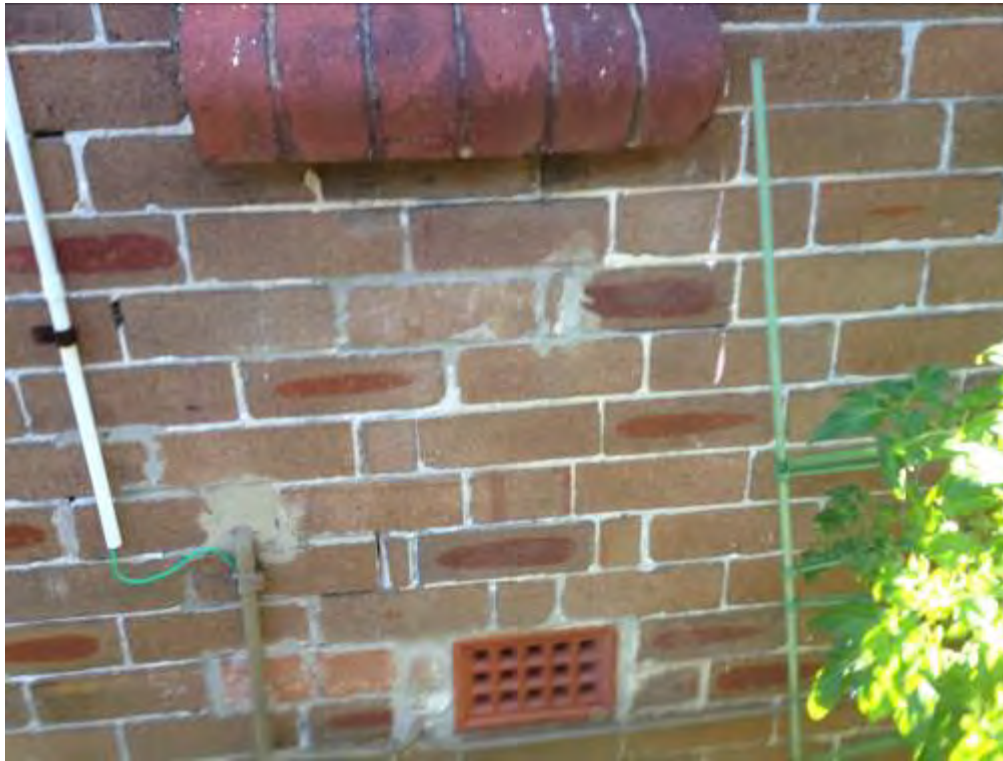
We noted a previous repairs to the mortar joints and a hairline stepped crack [$<1.0\text{mm}$] extending from the left hand window sill to the Bathroom towards the base of the wall. **[Photograph 13]**

Photograph 13 shows previous repairs to the stepped crack and to the brickwork below the left hand window to the Bathroom

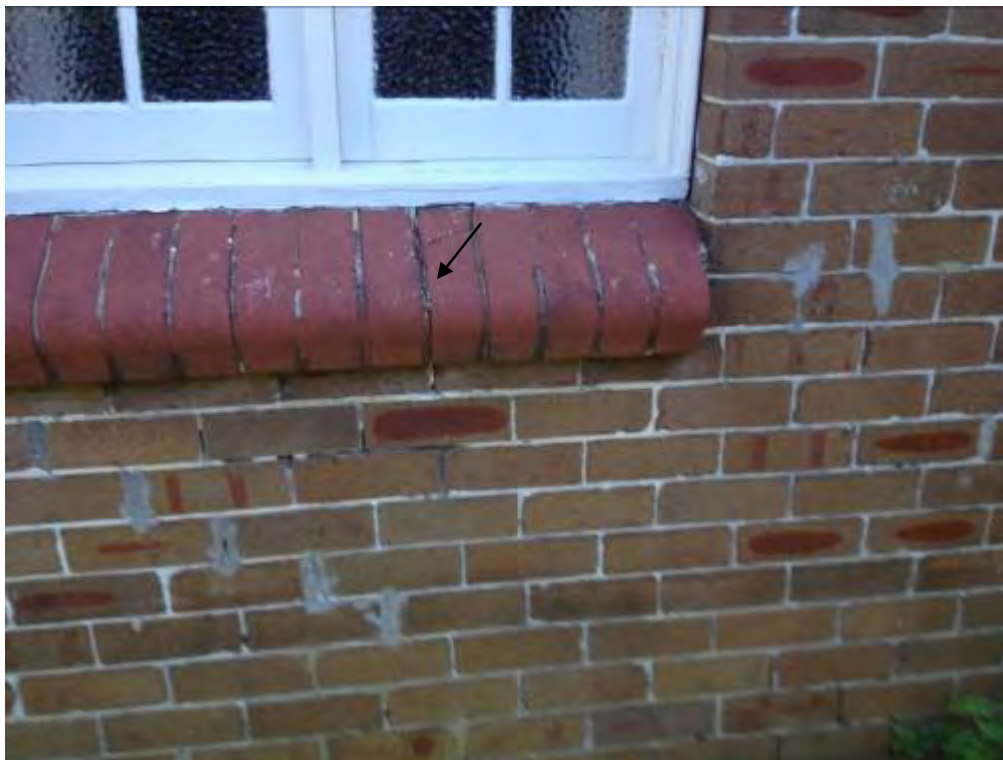
We noted a hairline crack to the brick sill and hairline stepped crack [$<1.0\text{mm}$] extending from the window sill to the Lounge room towards the base of the wall. **[Photograph 14]**

Photograph 14 shows a hairline crack to the brick sill to the Lounge room – Note: previous repairs to the brickwork

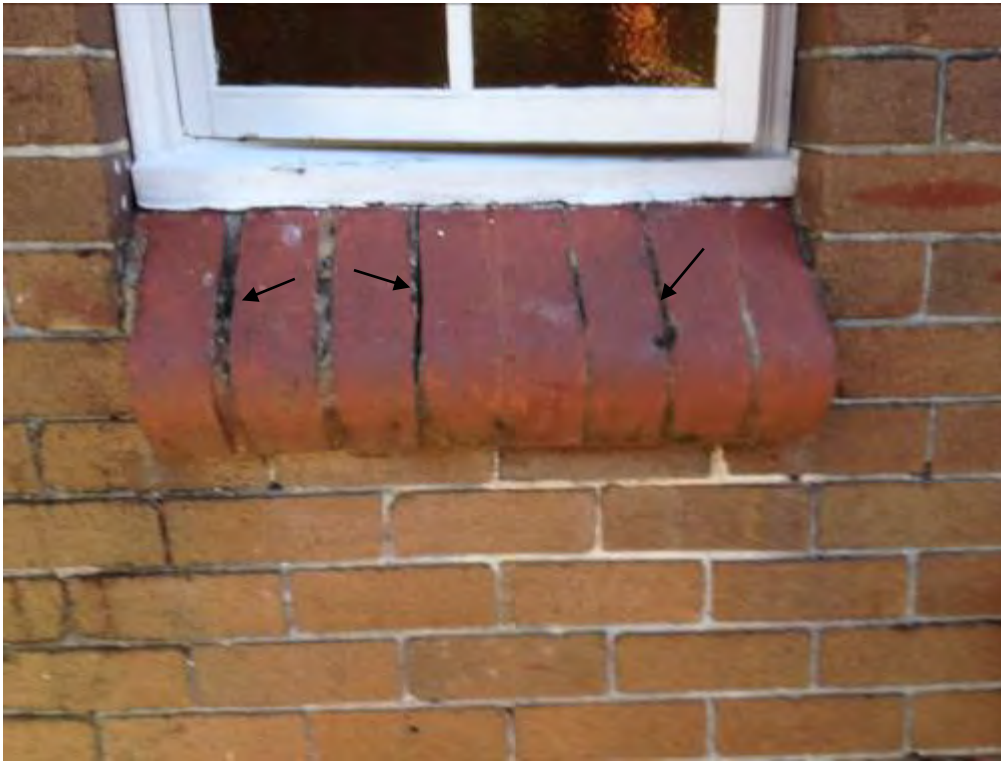
We noted a hairline crack [$<1.0\text{mm}$] and brick sill to Kitchen window. **[Photograph 15]**

Photograph 15 shows displaced mortar from the brick sill to the Kitchen window

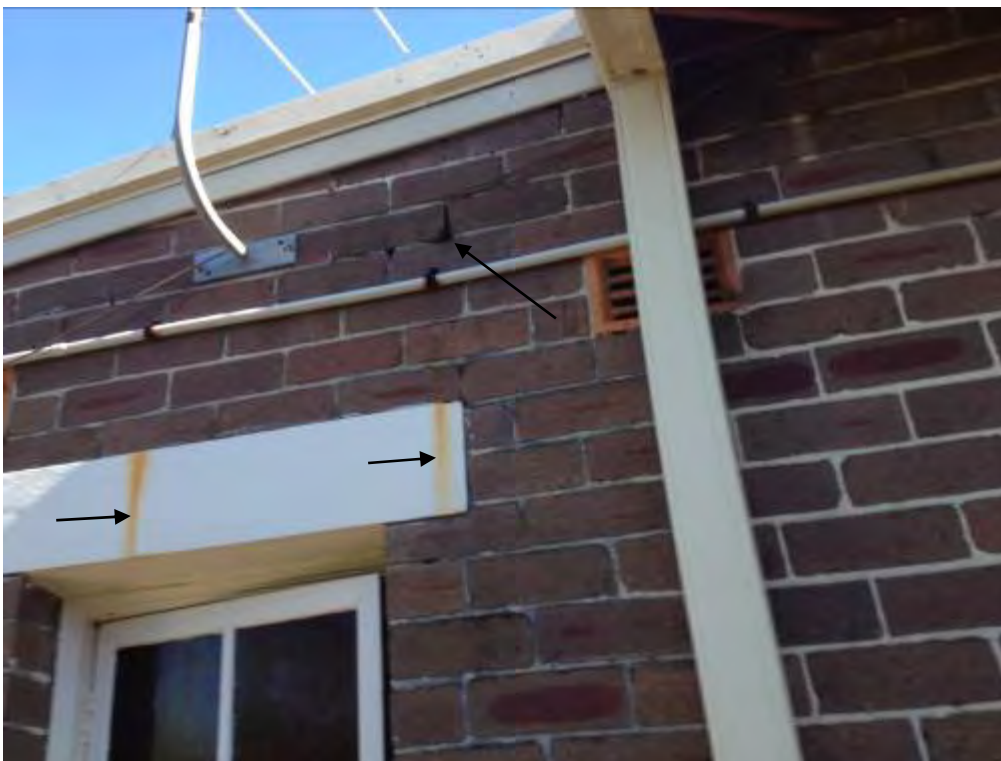
We noted displaced mortar from the brickwork above the Kitchen window and brown staining to the rendered lintel over the window. **[Photograph 16]**

Photograph 16 shows displaced mortar from the brickwork above the Kitchen window – Note: brown stains to the rendered lintel from the corrugated pipe clips above

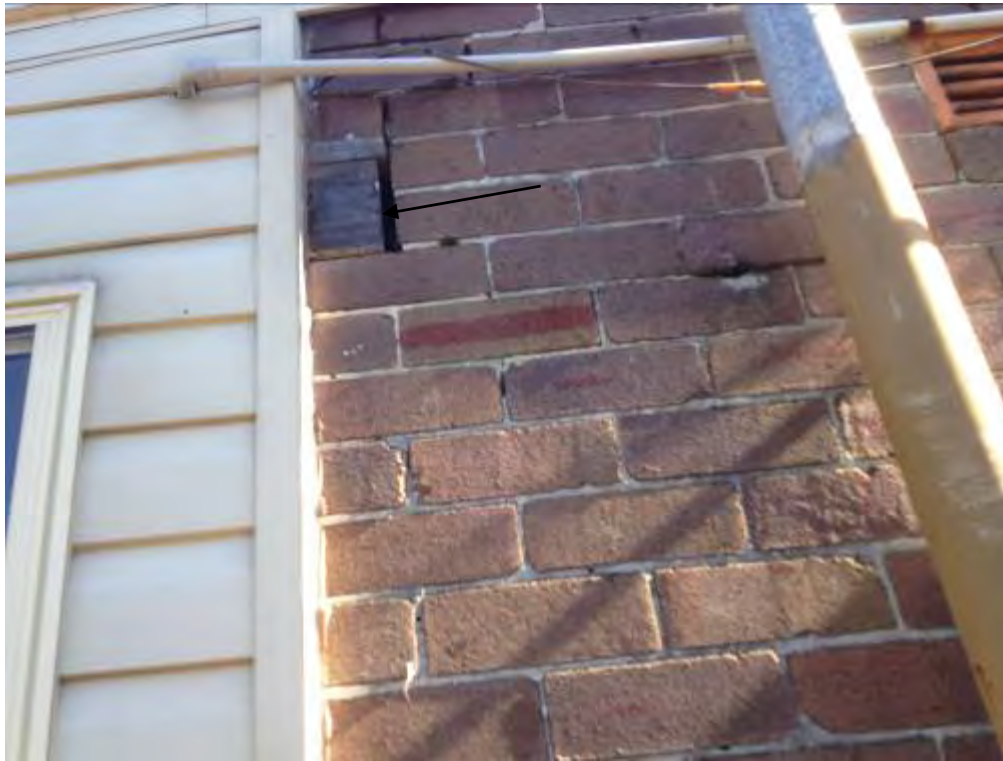
We noted the exposed end of a timber beam and displaced mortar to the brickwork at the junction between the framed wall of the Sunroom addition and the original brickwork. **[Photograph 17]**

Photograph 17 shows exposed timber beam and displaced mortar at the junction between the framed addition and the brickwork

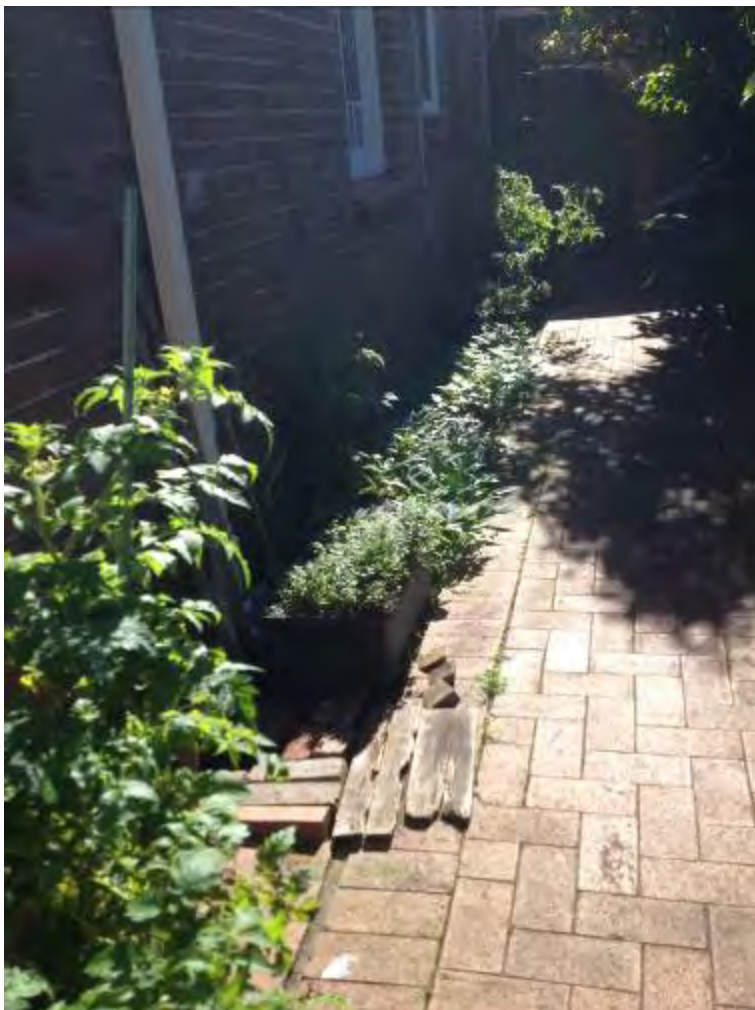
We noted that clay brick pavers between the base of the wall and the south eastern boundary are generally level in plane and were generally sound. We noted that there is moss growth between the pavers. Due to concealment we are unable to comment on the base strata to the clay brick pavers. **[Photographs 18 and 19]**

Photograph 18 shows the condition of the clay pavers to the south eastern boundary pathway

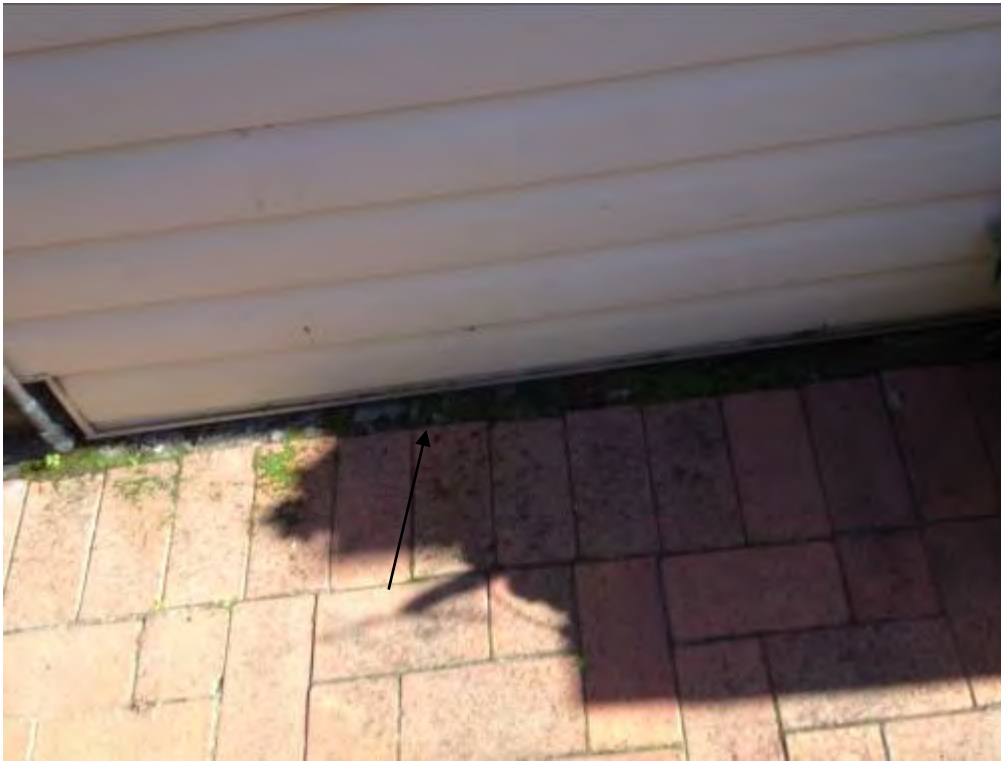
Photograph 19 shows moss growth to the pavers abutting the framed wall of the addition

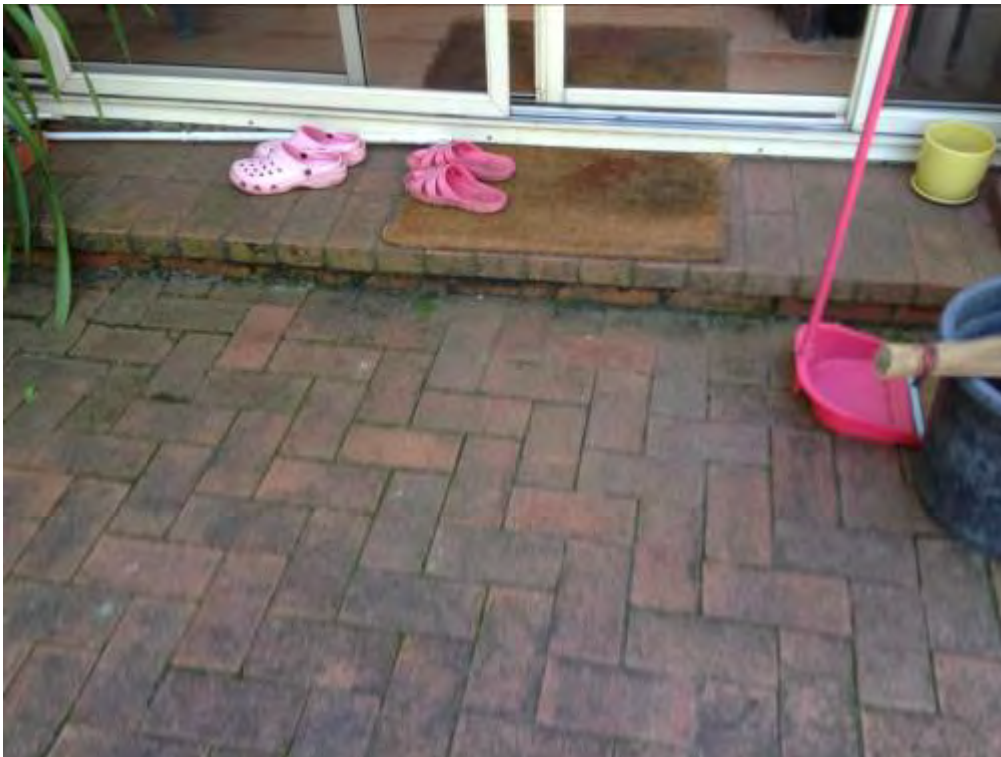
We noted that clay brick pavers to the rear paved area are generally level in plane and were generally sound. We noted that there is moss growth between the pavers. Due to concealment we are unable to comment on the base strata to the clay brick pavers. **[Photograph 20]**

Photograph 20 shows the condition of the clay pavers and the rear entry step – Note: green staining and moss growth between the pavers

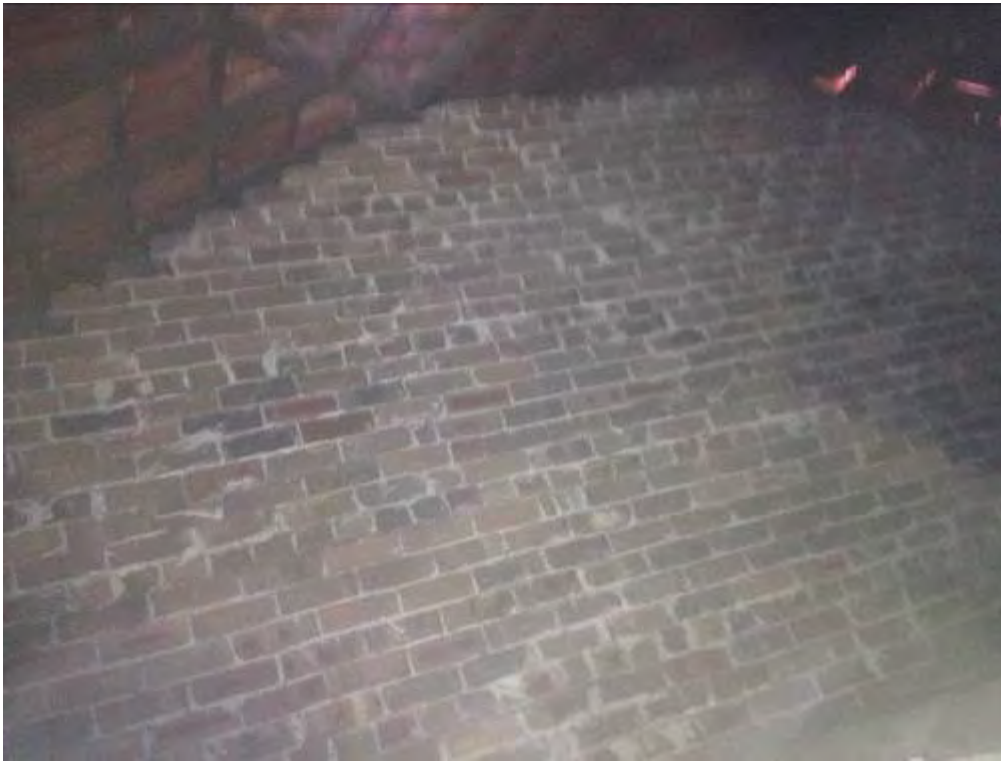
We observed that the *common* roof structure to the properties is of traditional cut and pitched timber construction. We noted that the clay brick *common party* / *separation* wall extends to the underside of the rafters and that the *common* ridge to the roof surfaces is located over the *common party* / *separation* wall. **[Photograph 21]**

Photograph 21 shows the condition of the brick *common party / separation* wall within the roof space

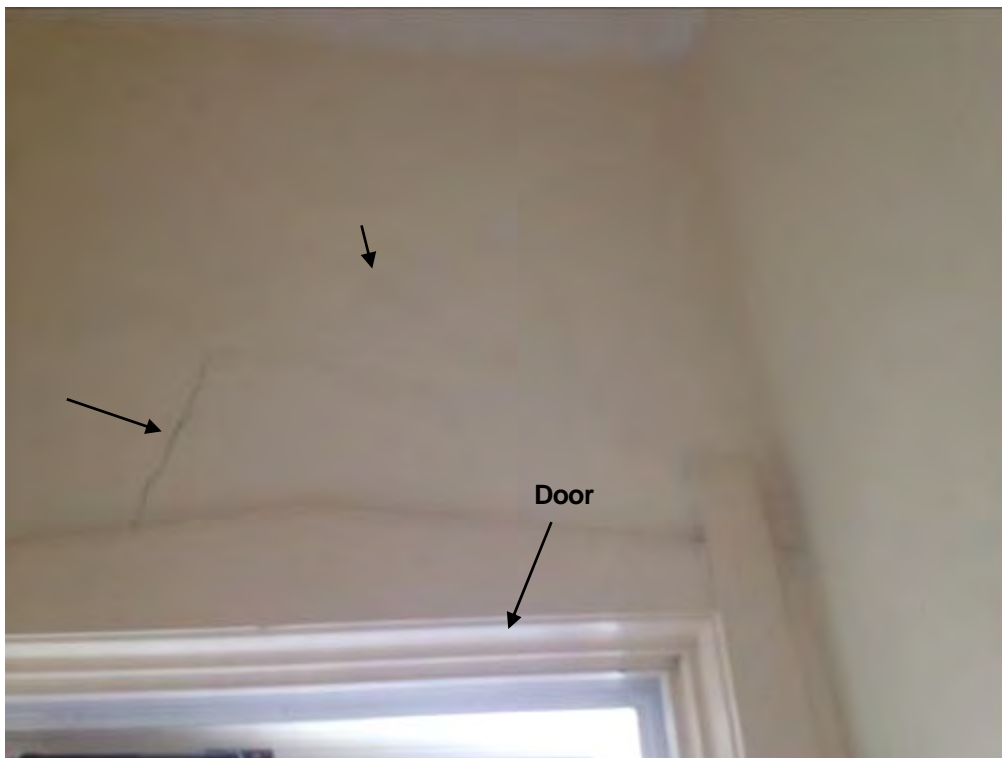
We noted a radial crack [$<1.0\text{mm}$] above the front entry doorway. **[Photograph 22]**

Photograph 22 shows a radial crack above the front entry door

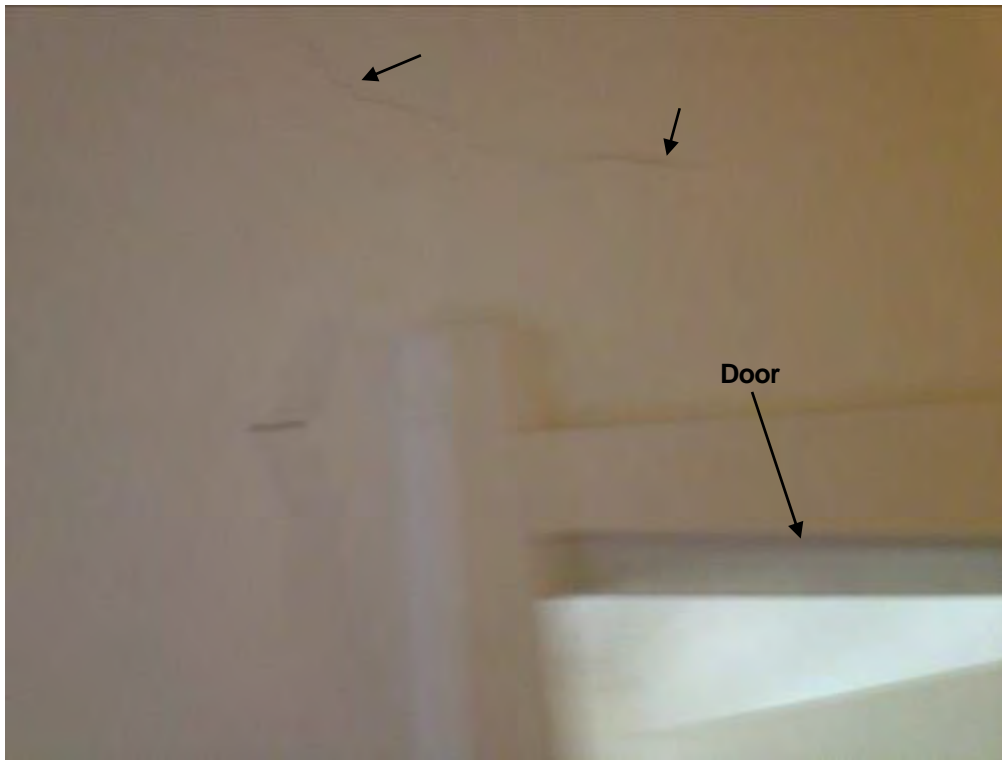
We noted a hairline radial crack [$<1.0\text{mm}$] extending from the left hand side of the doorway head into Bedroom 1. **[Photograph 23]**

Photograph 23 shows hairline radial cracks extending from the left hand side of the door head from the Hallway into Bedroom 1

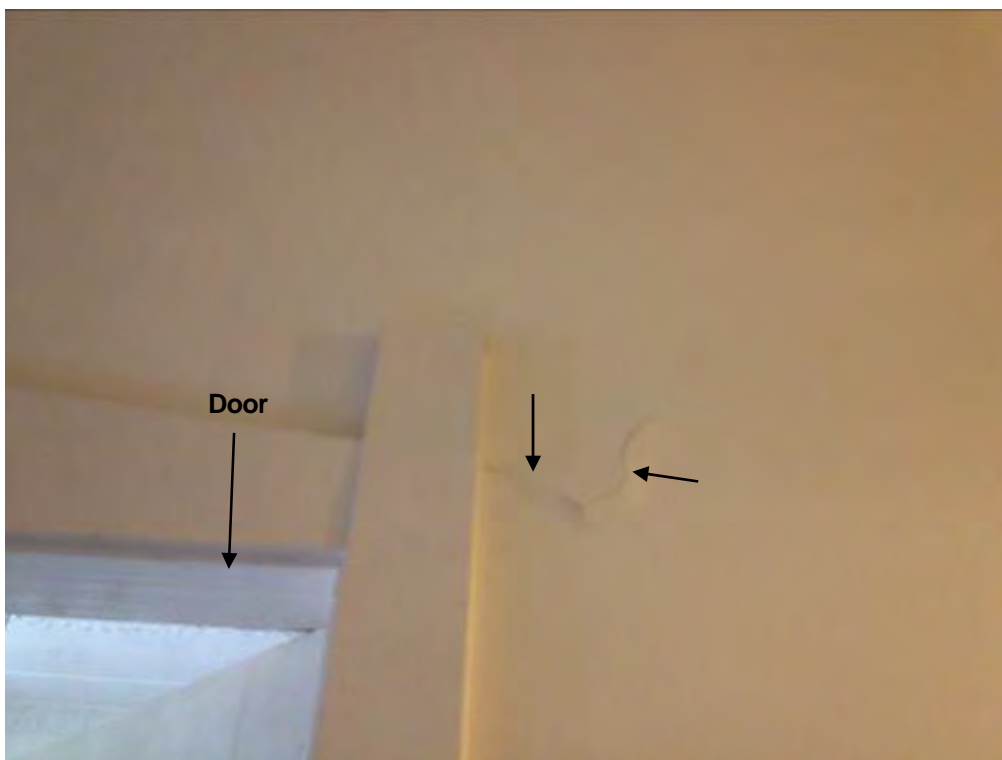
We noted a hairline radial crack [$<1.0\text{mm}$] extending from the right hand side of the doorway head into Bedroom 1. **[Photograph 24]**

Photograph 24 shows a hairline radial crack extending from the right hand side of the door head from the Hallway into Bedroom 1

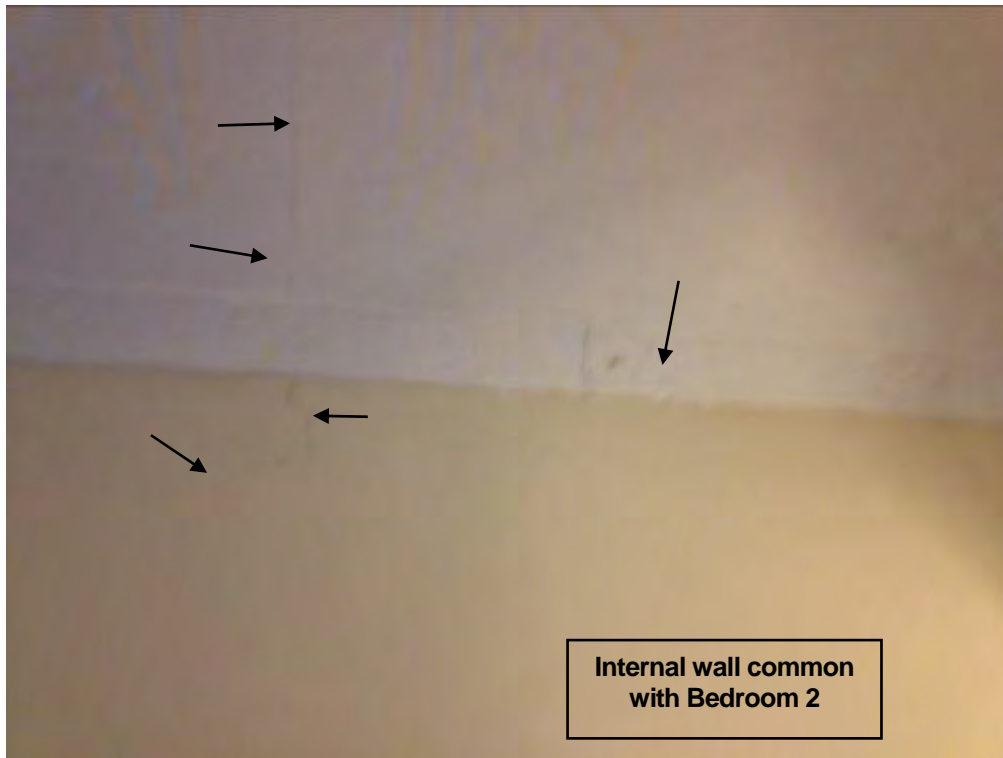
We noted a hairline cracks [$<1.0\text{mm}$] to the set joint in the decorative panelled fibrous plaster ceiling and to the butt joint in the decorative profile cornice and extending to the wall surface the *common* with Bedroom 2. **[Photograph 25]**

Photograph 25 shows a hairline crack to the set joint in the Hallway ceiling and hairline crack to the cornice and wall

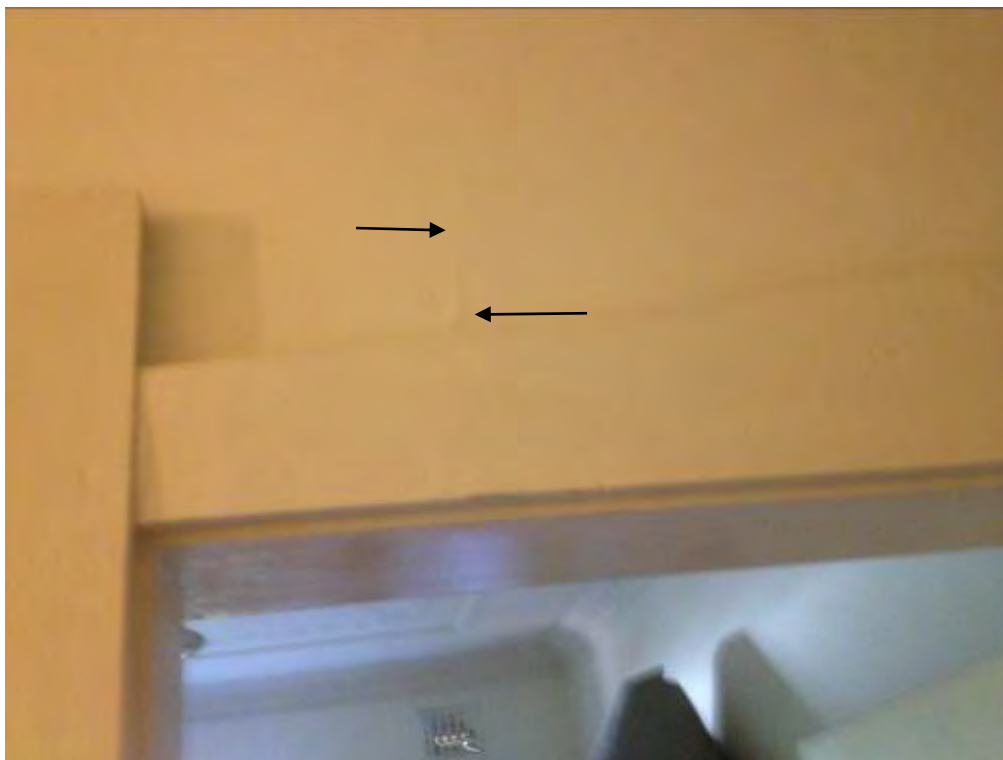
We noted a vertical crack [$<1.0\text{mm}$] extending from the left hand side of the doorway head into Bedroom 2. [**Photograph 26**]

Photograph 26 shows the vertical hairline crack extending from the left hand side of the door head into Bedroom 2

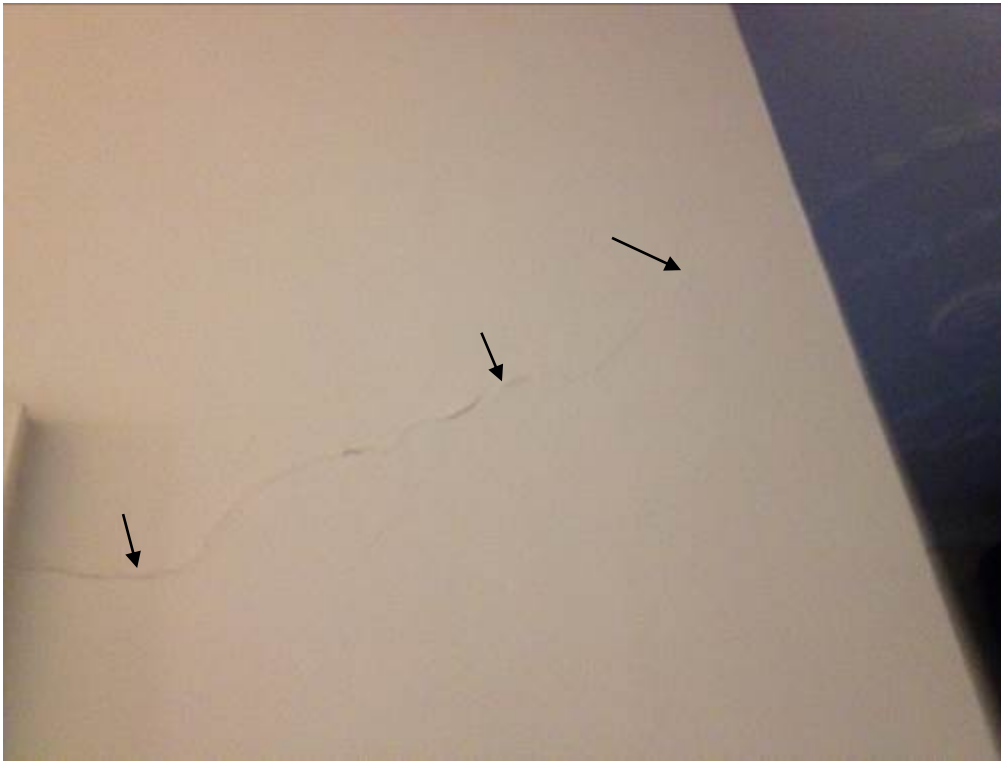
We noted a hairline radial crack [$<1.0\text{mm}$] extending from the right hand side of the doorway head into Bedroom 2. [**Photograph 27**]

Photograph 27 shows a radial hairline crack extending from the right hand side of the doorway head to Bedroom 2

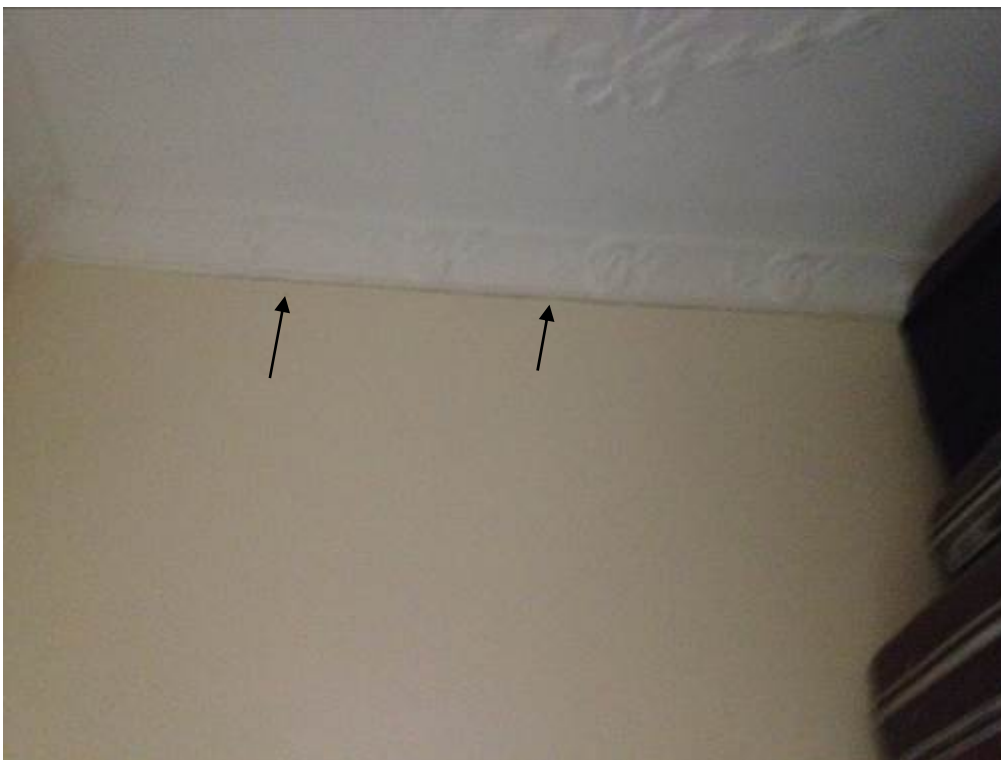
We noted separation cracking between the cornice and the wall surface above the Bathroom doorway. [**Photograph 28**]

Photograph 28 shows the separation crack between the cornice and the wall surface above the Bathroom door
