Dilapidation Assessment Report

Prepared for: Cape Cod Australia Pty. Limited
Job address: 10 Banks Street, Ashfield NSW 2131
Property Owner: Ms. T. Adam
Report reference: **ASHFIELD COUNCIL**
Development Application No: not available
Date of assessment: 5th May 2016

Re: Dilapidation Report - No. 10 Bank Street, Ashfield

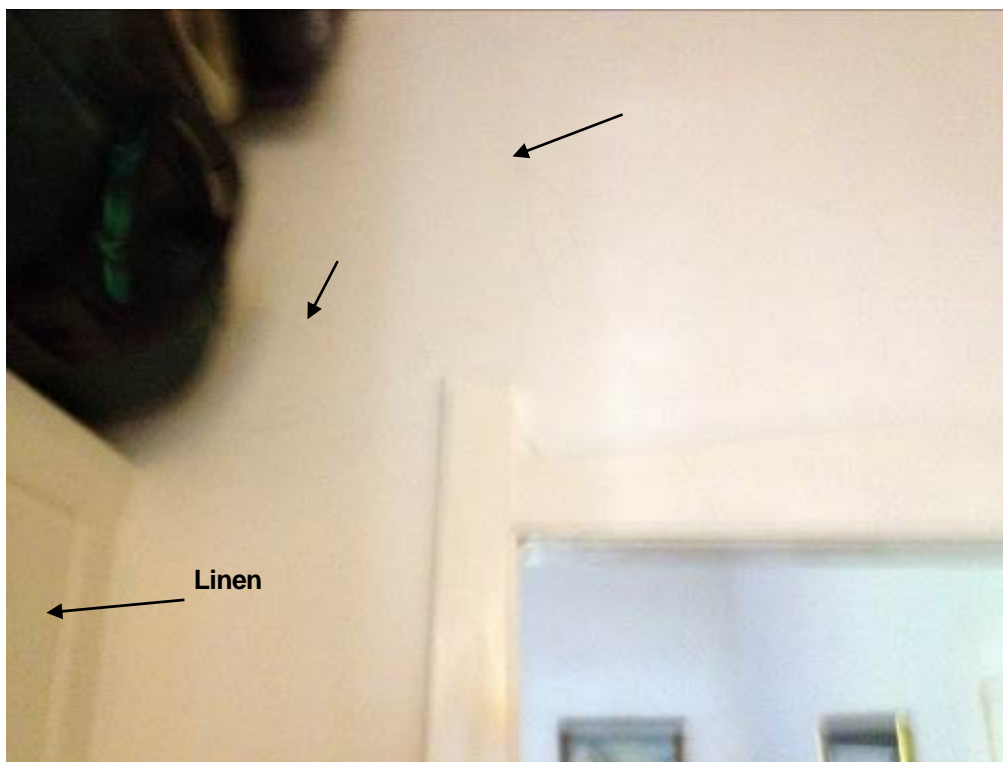
We noted interlinked hairline radial and horizontal crack [$<1.0\text{mm}$] between the end of the linen cupboard and the door from the Hallway into the Lounge room. [**Photograph 29**]

Photograph 29 shows vertical and horizontal hairline cracks extending from the left hand side of the door head to the Lounge room from the hallway

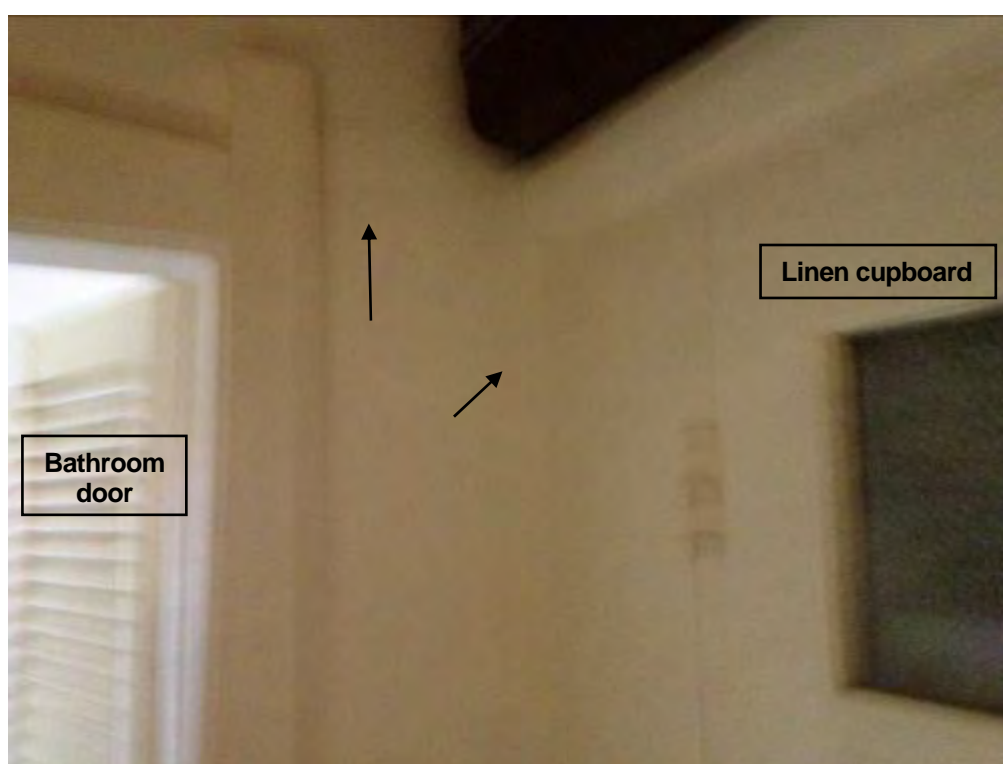
We noted a hairline radial crack [$<1.0\text{mm}$] extending from the right hand side of the Bathroom door heads towards the linen cupboard. [**Photograph 30**]

Photograph 30 shows the location of the radial crack extending from the right hand side of the Bathroom door head towards the linen cupboard

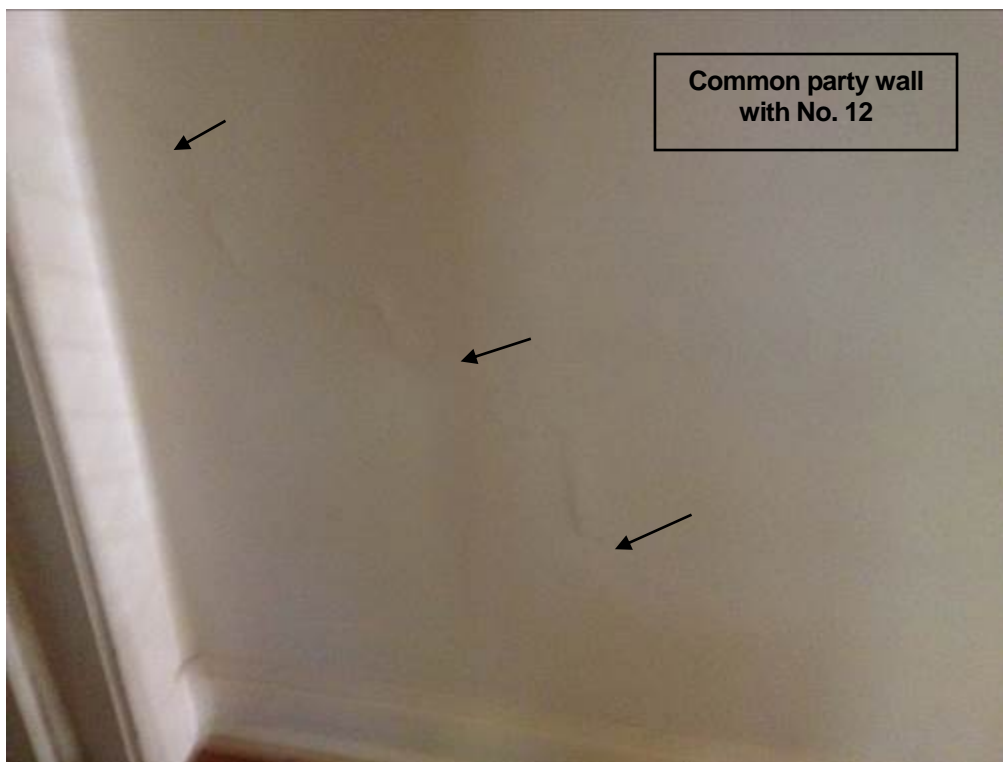
We noted a radial crack [$<2.0\text{mm}$] to the base of the *common party / separation* wall adjacent to the door into the Lounge room. [**Photograph 31**]

Photograph 31 shows the radial crack to the base of the *common party / separation* wall adjacent to the doorway from the Hallway into the Lounge room

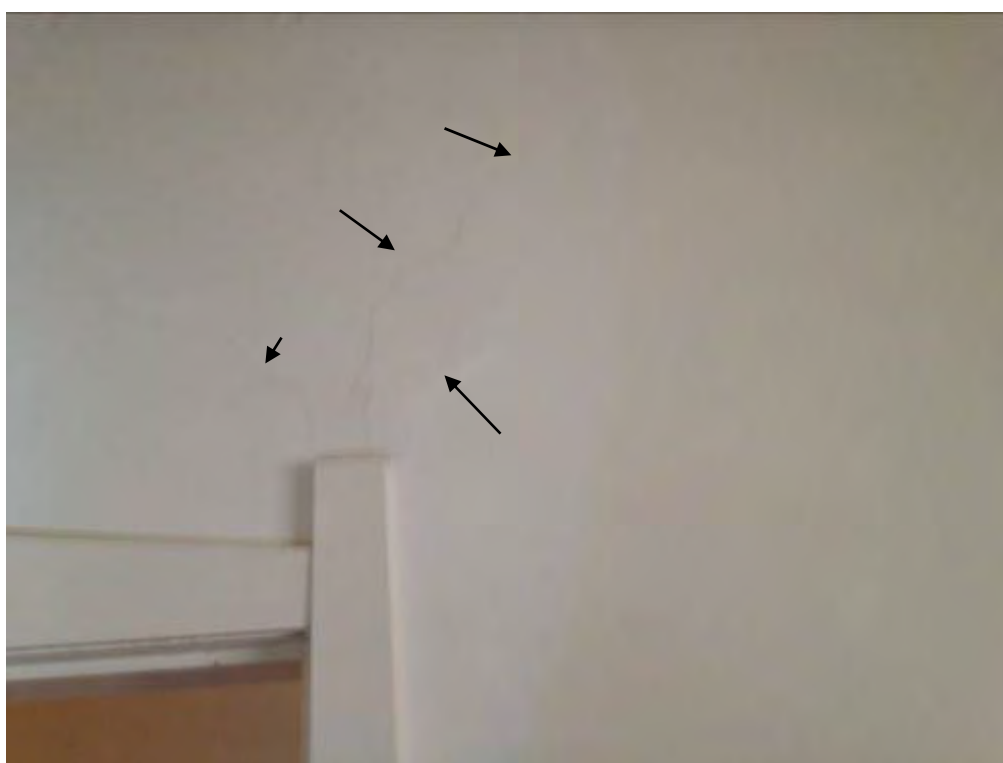
We noted hairline radial cracks [$<1.0\text{mm}$] extending from the right hand side of the door head towards the ceiling. [**Photograph 32**]

Photograph 32 shows hairline cracks extending from the right hand side of the door head in Bedroom 1

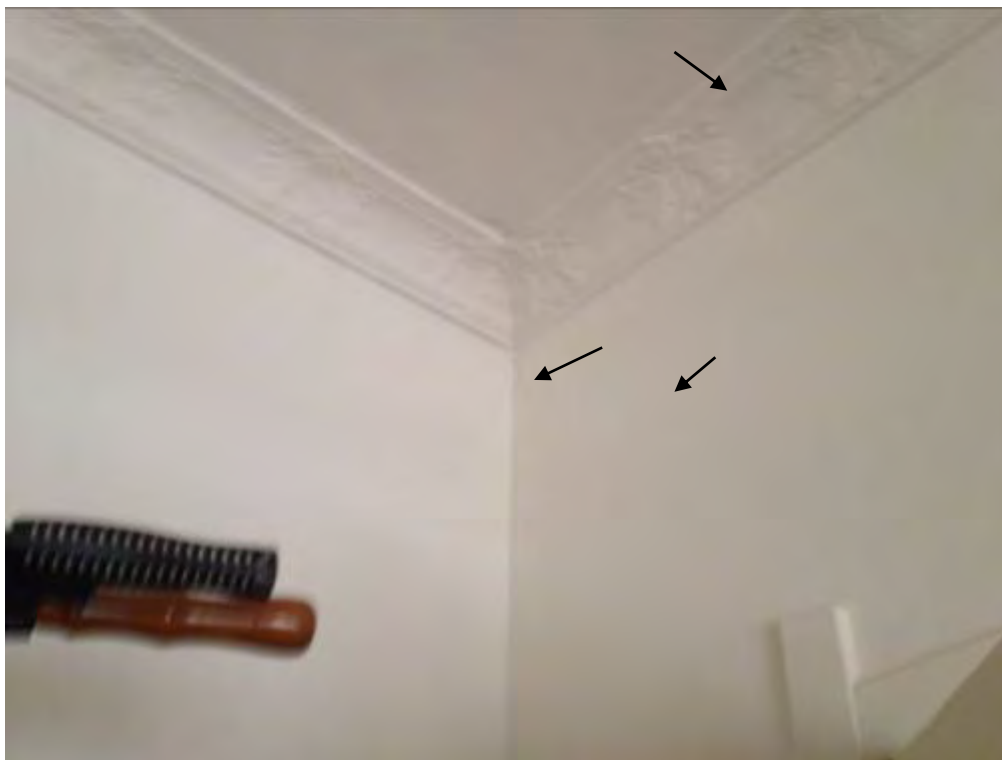
We noted a previously repaired radial crack extending from the left hand side of the window head towards the northern corner of the room. We also noted a hairline crack [$<1.0\text{mm}$] the butt joint to the decorative cornice at the northern corner of the room. [**Photograph 33**]

Photograph 33 shows previous repairs to a radial crack extending from the left hand side of the window head towards the northern corner of Bedroom 1 – Note: the hairline crack to the cornice

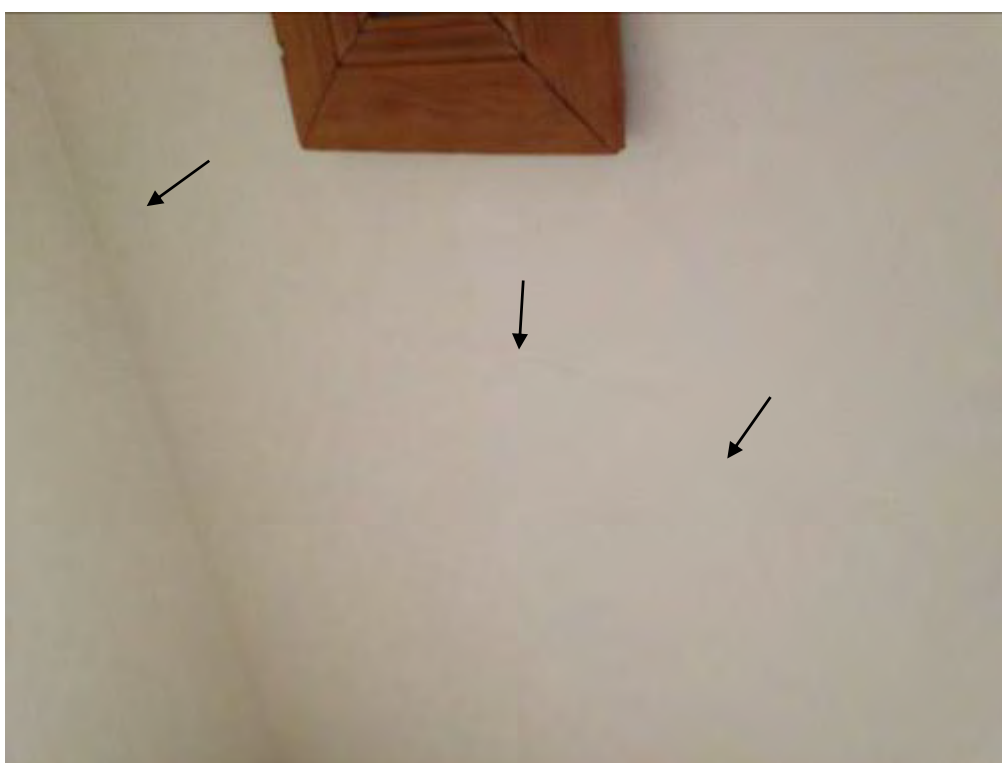
We noted a hairline radial crack [$<1.0\text{mm}$] extending from the eastern corner of the room along the south eastern wall. [**Photograph 34**]

Photograph 34 shows a hairline radial crack extending from the eastern corner to the cornice in Bedroom 1

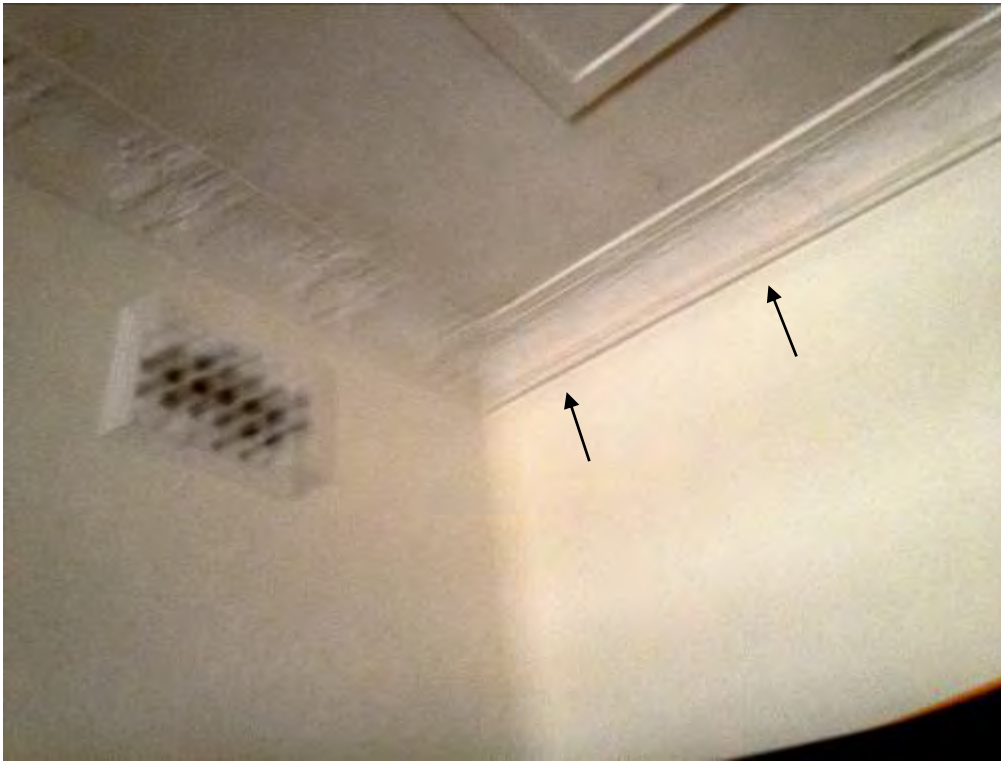
We noted separation of the decorative profiled cornice from the ceiling lining to the south western wall and at the southern corner of the room. [**Photograph 35**]

Photograph 35 shows a separation crack between the cornice and the wall to the southern corner of Bedroom 1

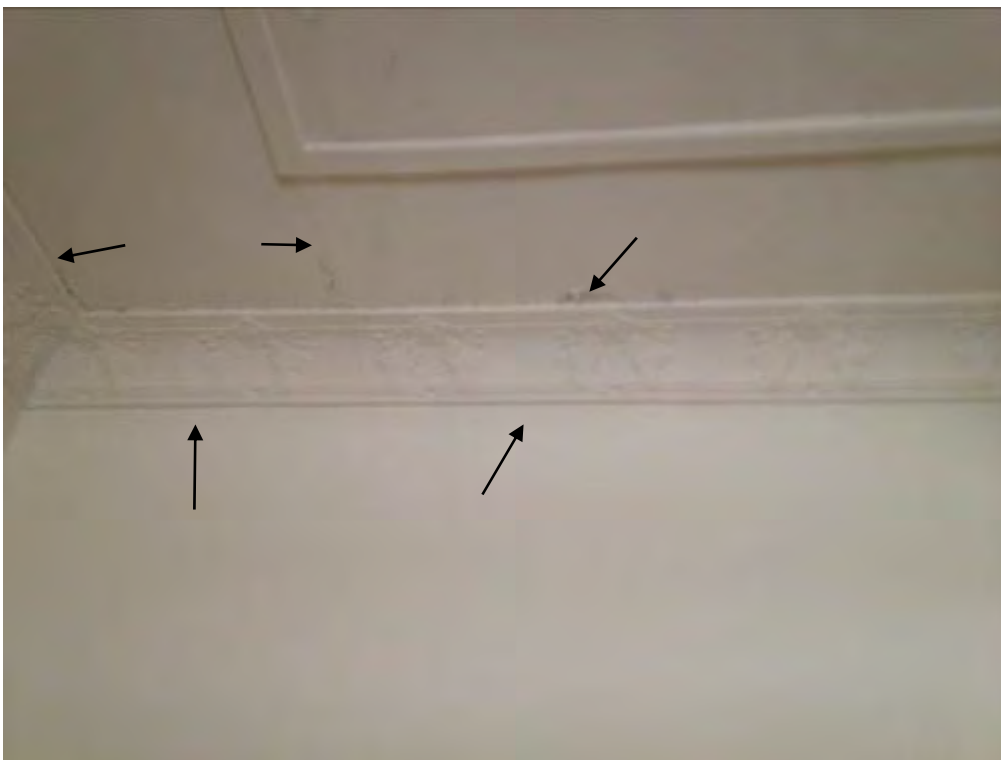
We also noted flaking [lifting] paint from the decorative fibrous plaster ceiling along the south western wall of the room. [**Photograph 36**]

Photograph 36 shows flaking paint and a separation crack between the cornice and the ceiling to the southern corner of Bedroom 1

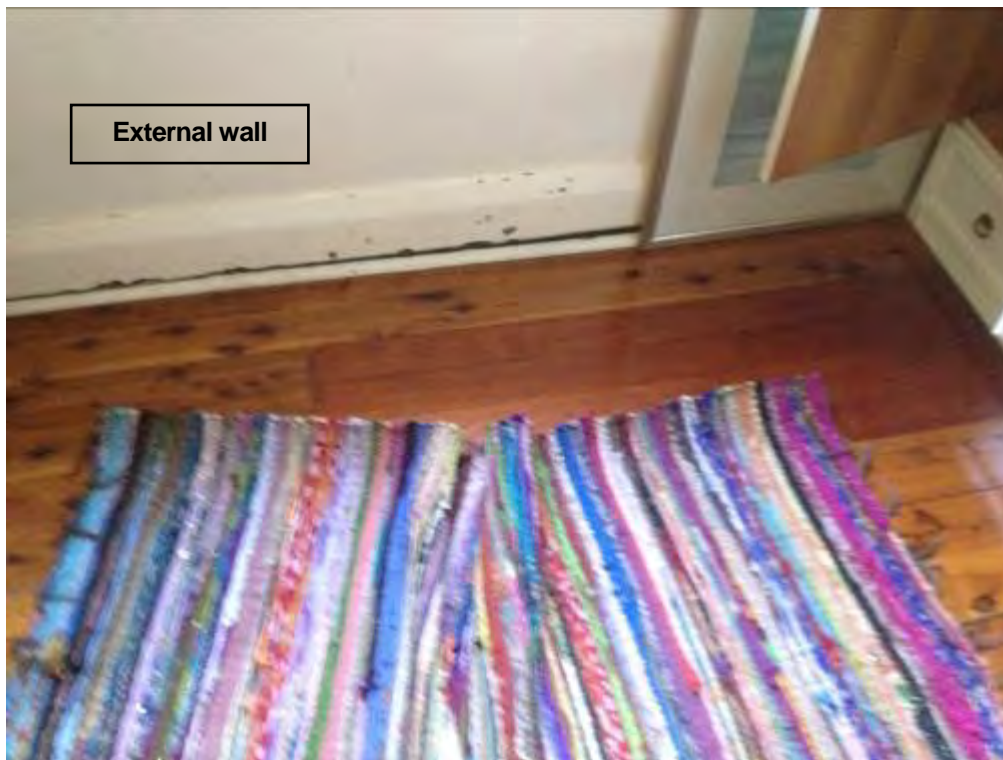
We noted settlement in the strip timber floor abutting the external south eastern wall of the room. We noted that the settlement in the level is a nominal 30mm. [**Photograph 37**]

Photograph 37 shows the settlement within the floor adjacent to the external wall in Bedroom 2

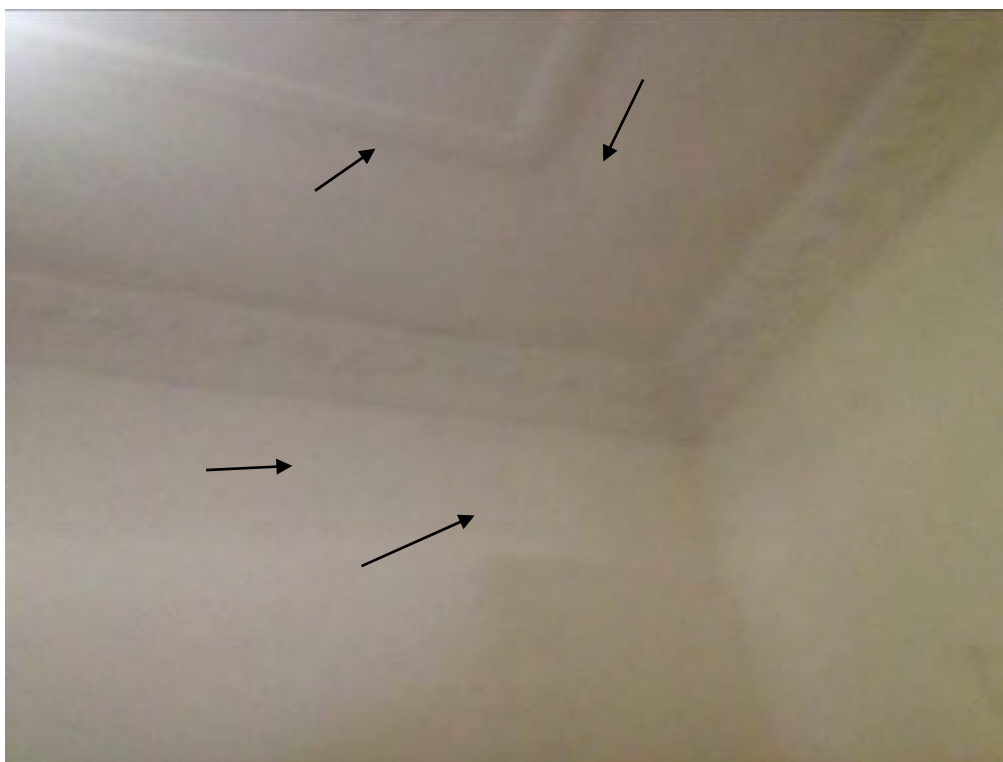
We noted a previously repaired radial crack and separation cracking between the cornice and wall surface to the western corner of the room. [**Photograph 38**]

We noted separation cracking between the decorative profile plaster cornice and the wall surface to the perimeter of the room. [**Photographs 38 and 39 - typical**]

Photograph 38 shows the location of previously repaired radial crack and separation between the cornice and the ceiling to the western corner of Bedroom 2

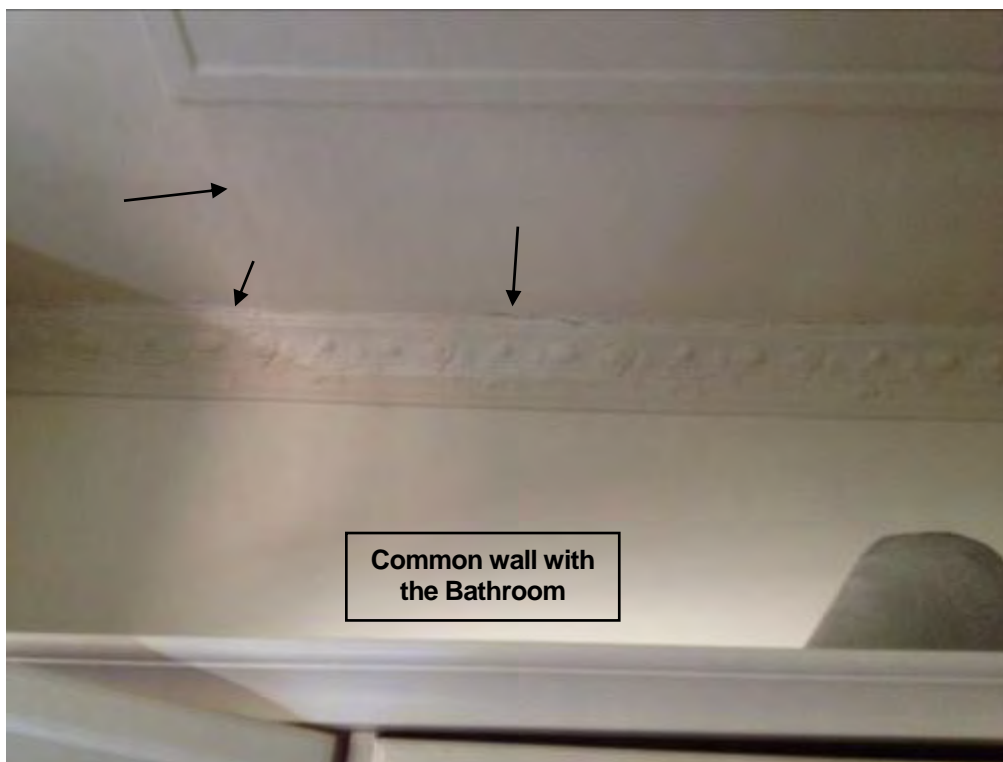
Photograph 39 shows typical separation cracking between the cornice and the ceiling in bedroom 2 –
Note: probable repaired crack to the set joint in the ceiling

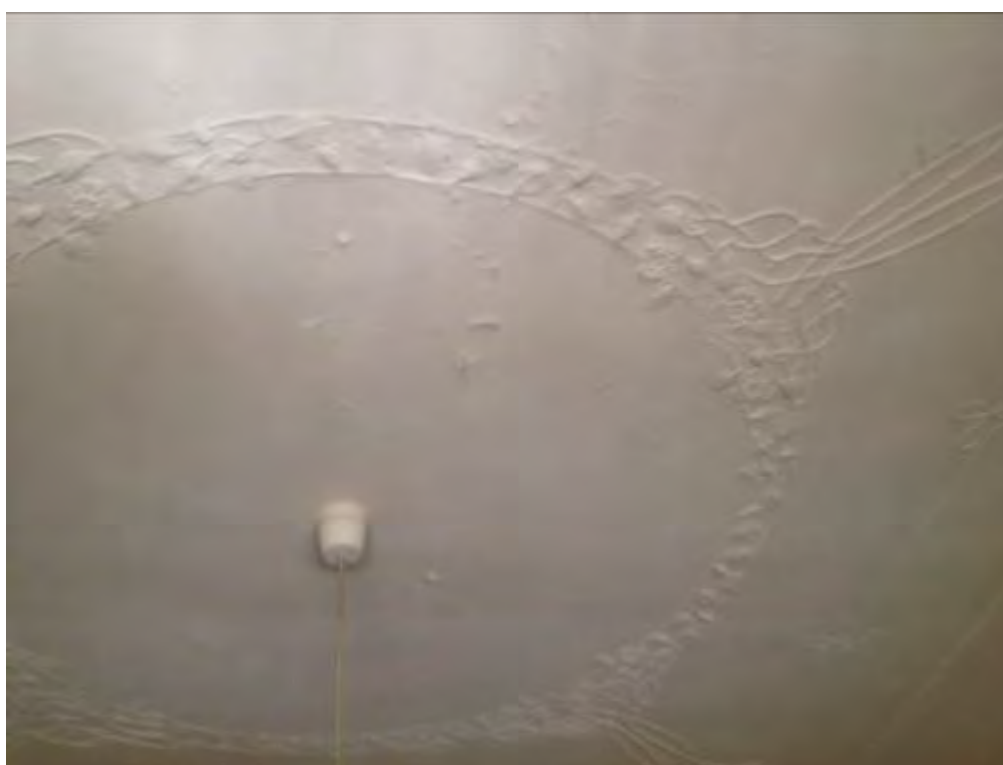
We noted flaking [lifting] paint from the decorative fibrous plaster ceiling. [**Photograph 40**]

Photograph 40 shows typical flaking paint from the ceiling of Bedroom 2

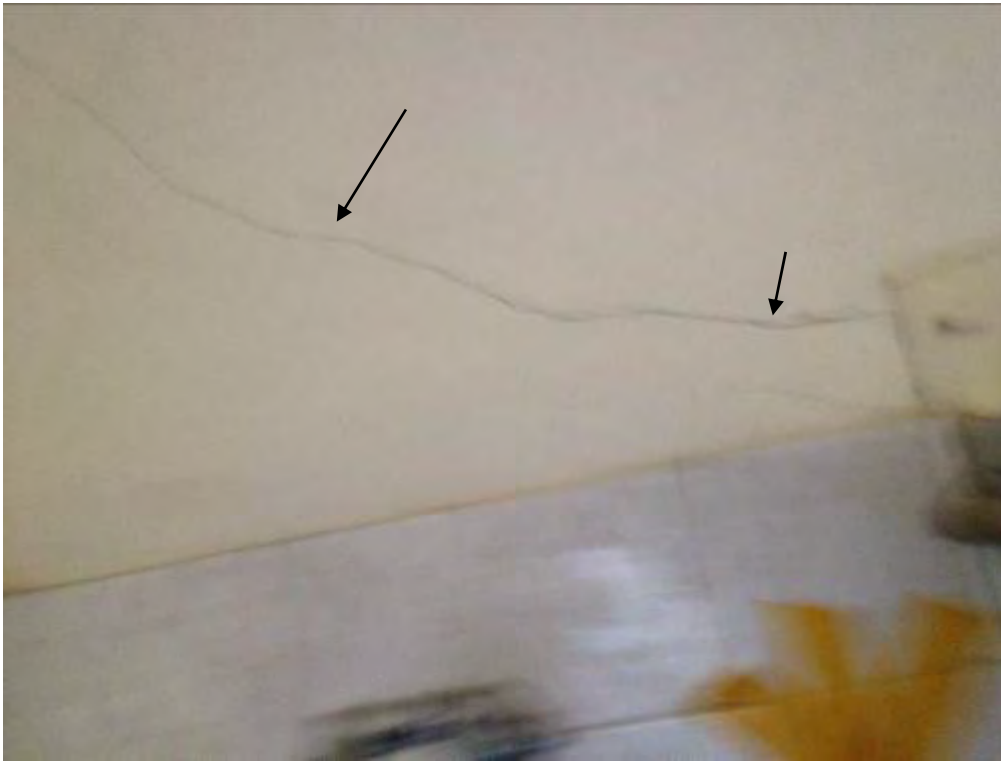
We noted a radial crack [1.0mm] to the wall above the shower recess. **[Photograph 41]**

Photograph 41 shows a radial crack to the Bathroom wall over the shower recess

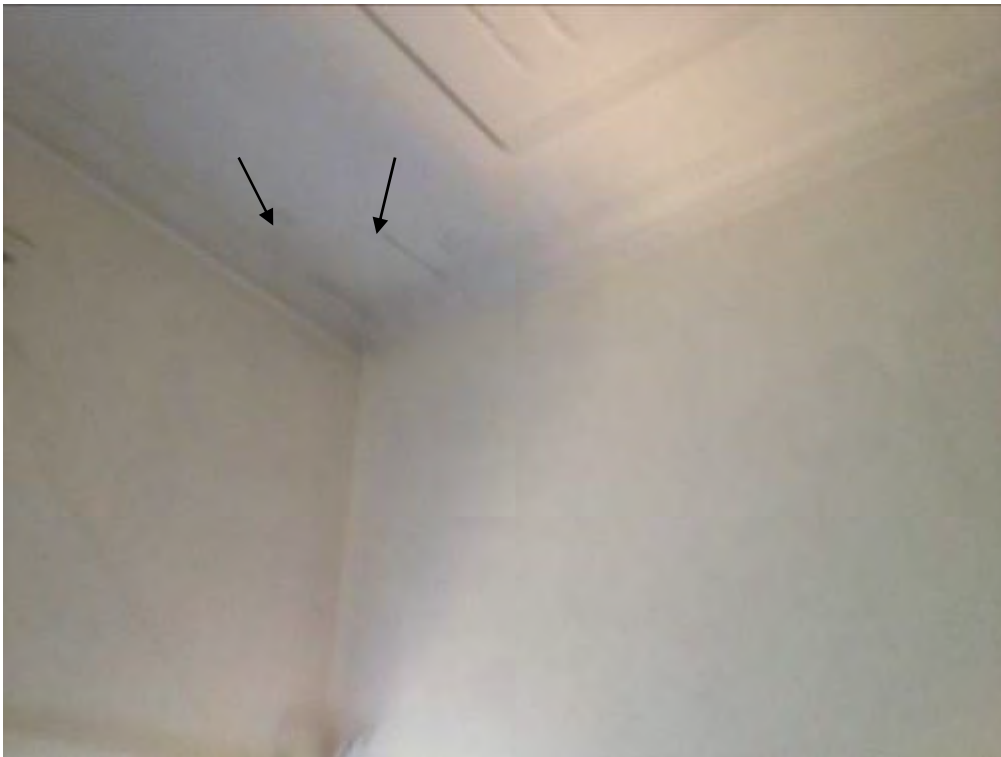
We did not observe any cracking to the decorative fibrous plaster ceiling or to the mitred joints in the decorative profile plaster cornice. Notwithstanding this we did note a previous patch repair to the ceiling to the southern corner of the room and staining [mould growth] to the ceiling. **[Photographs 42 and 43]**

Photograph 42 shows previous patch repairs and mould growth to the southern corner of the Bathroom ceiling

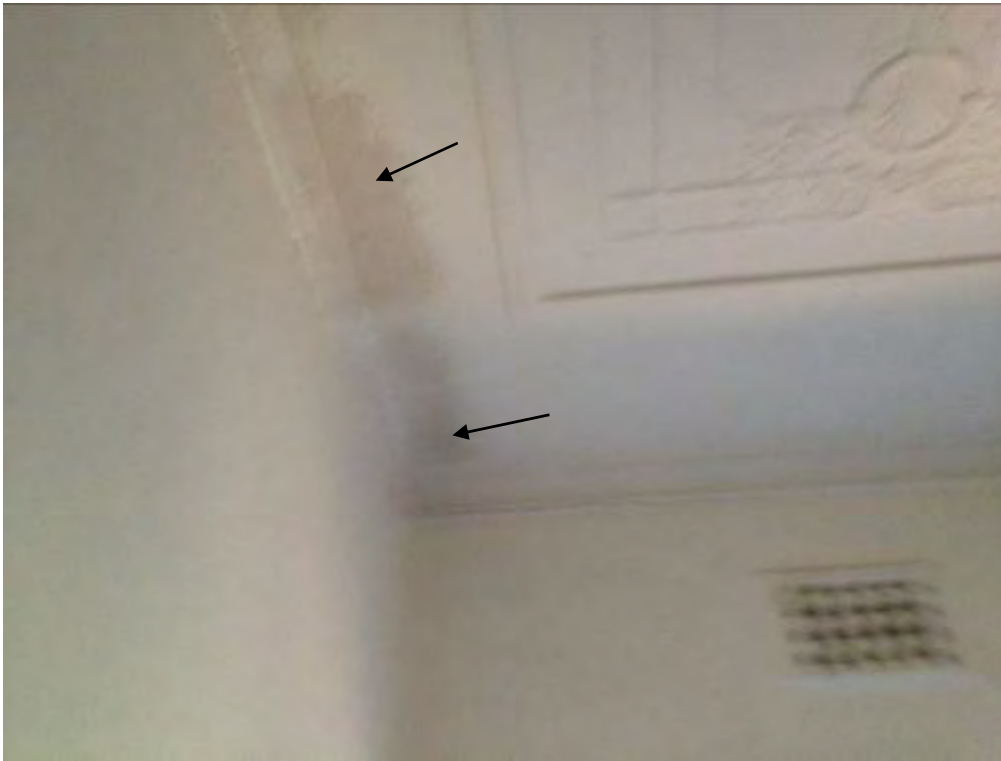
Photograph 43 shows mould growth to the northern corner of the Bathroom ceiling

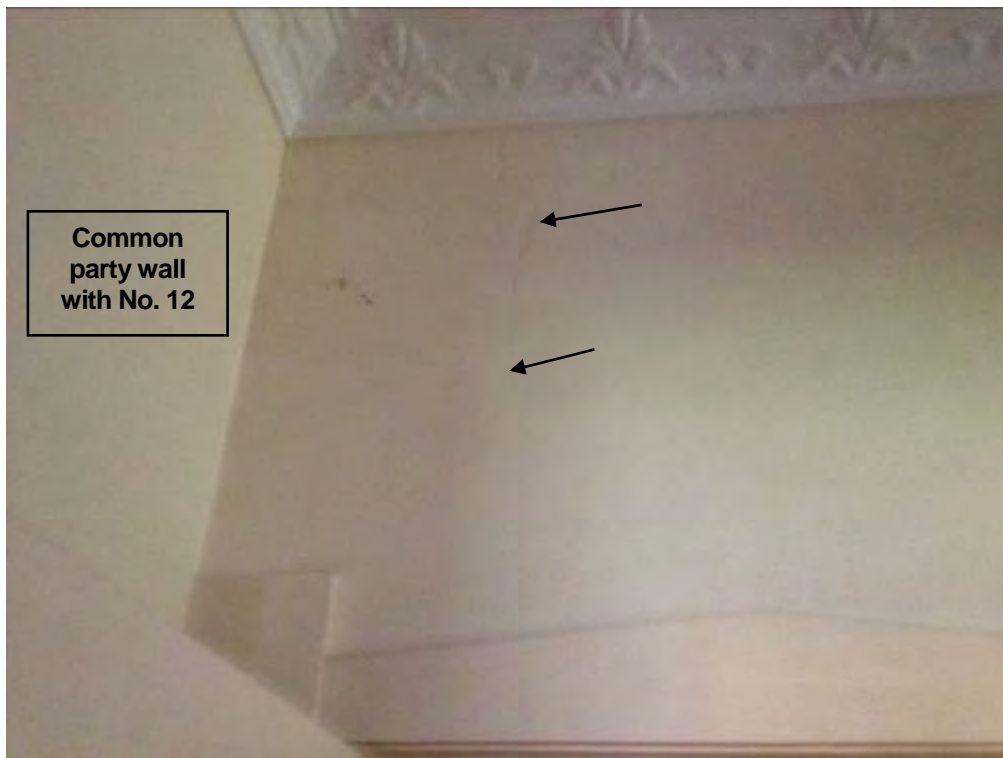
We note a hairline vertical crack [$<1.0\text{mm}$] extending from the left hand side of the door head into the Hallway towards the cornice and the northern corner of the room. **[Photograph 44]**

Photograph 44 shows the vertical hairline crack extending from the left hand side of the door head from the Lounge room to the Hallway

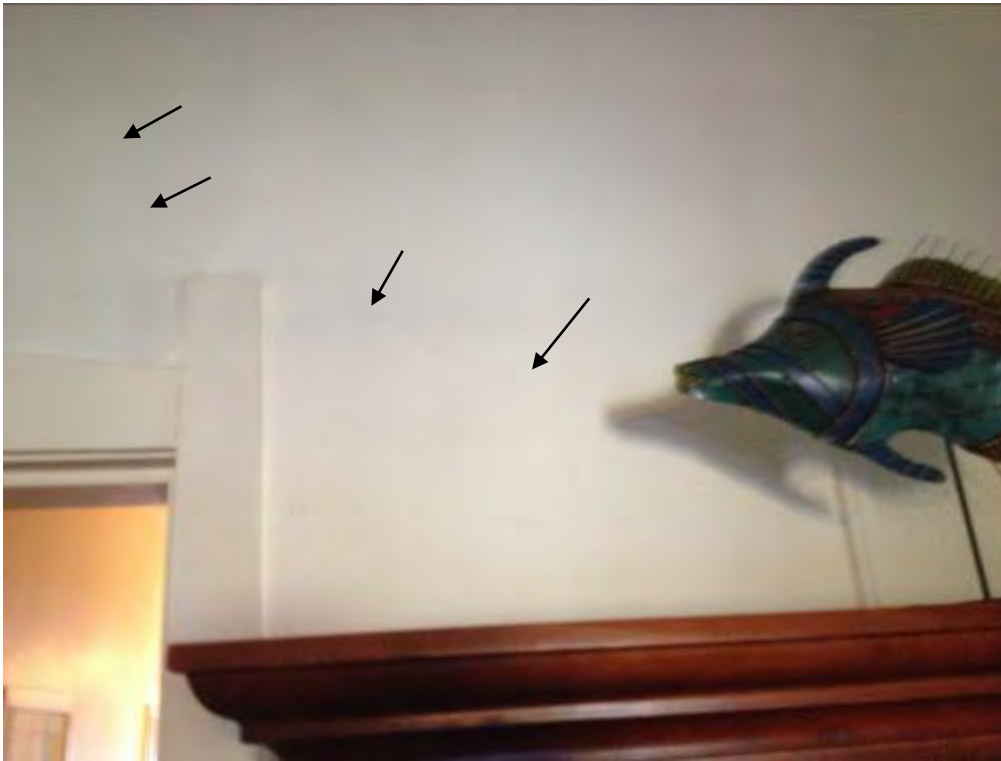
We also hairline vertical and interlinked horizontal crack [$<1.0\text{mm}$] extending from the right hand side of the door head into the Hallway towards the cornice. **[Photograph 45]**

Photograph 45 shows hairline and vertical cracks extending from the right hand side of the door head from the Lounge room to the Hallway

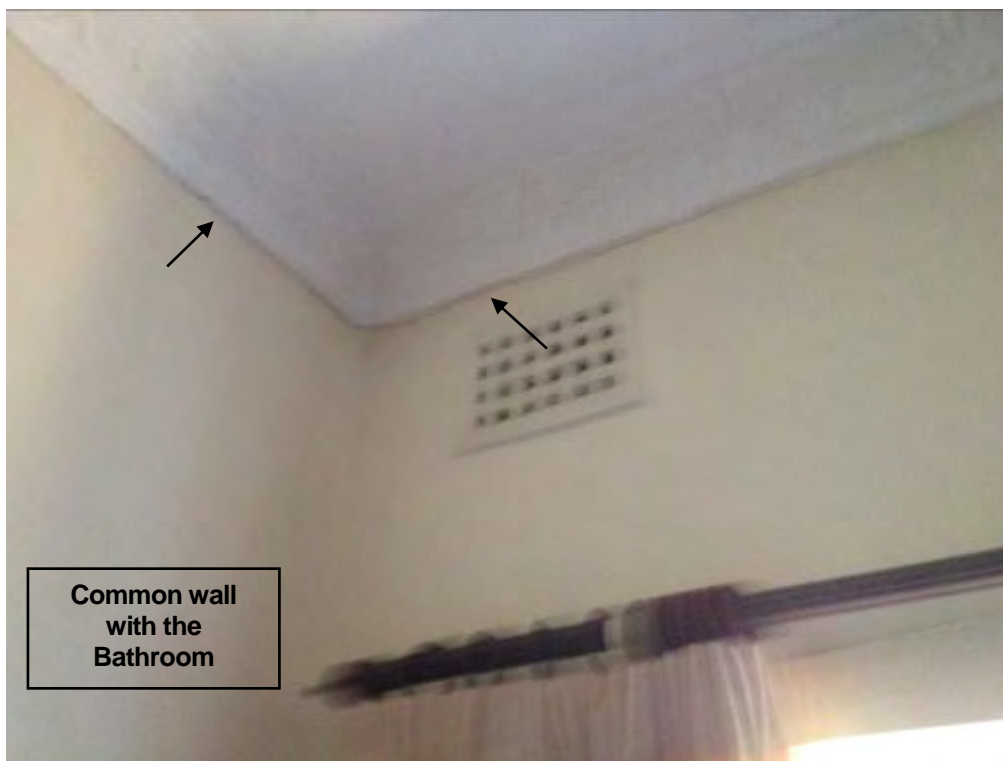
We did not observe any cracking to the decorative fibrous plaster ceiling or to the mitred joints in the wide decorative profile plaster cornice. Notwithstanding this we did note separation cracking between the cornice and the wall surface to the eastern corner of the room. **[Photograph 46]**

Photograph 46 shows a separation crack between the cornice and the wall to the eastern corner of the Lounge room

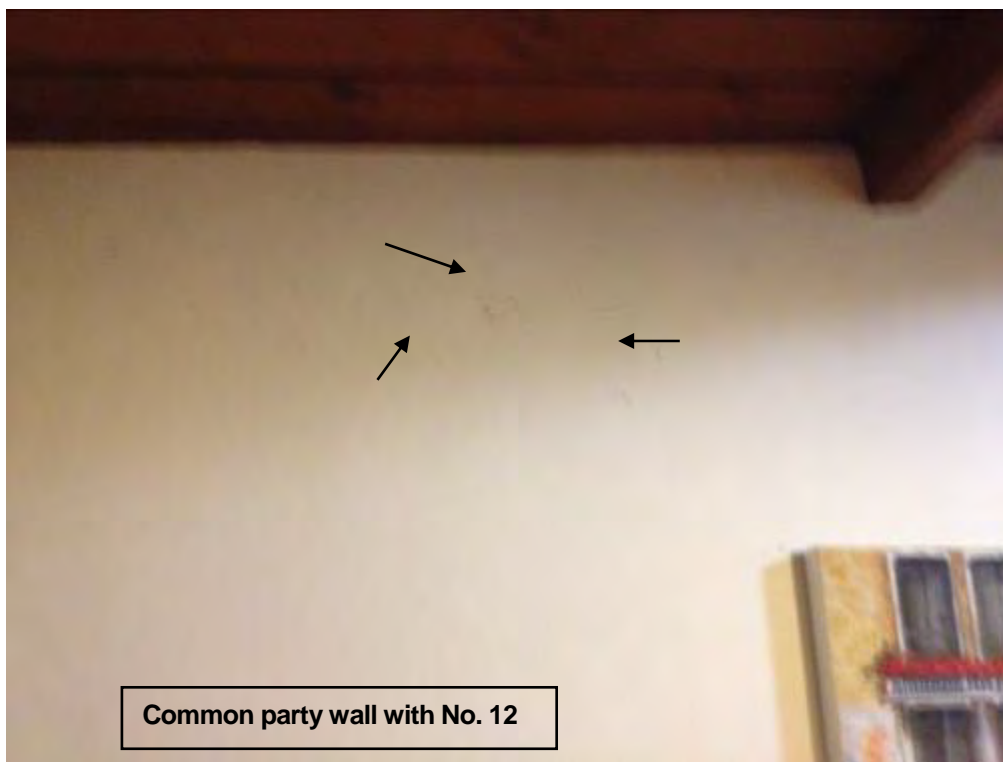
Photograph 47 shows flaking paint and interlinked spider cracking to the *common party / separation* wall to the dining room

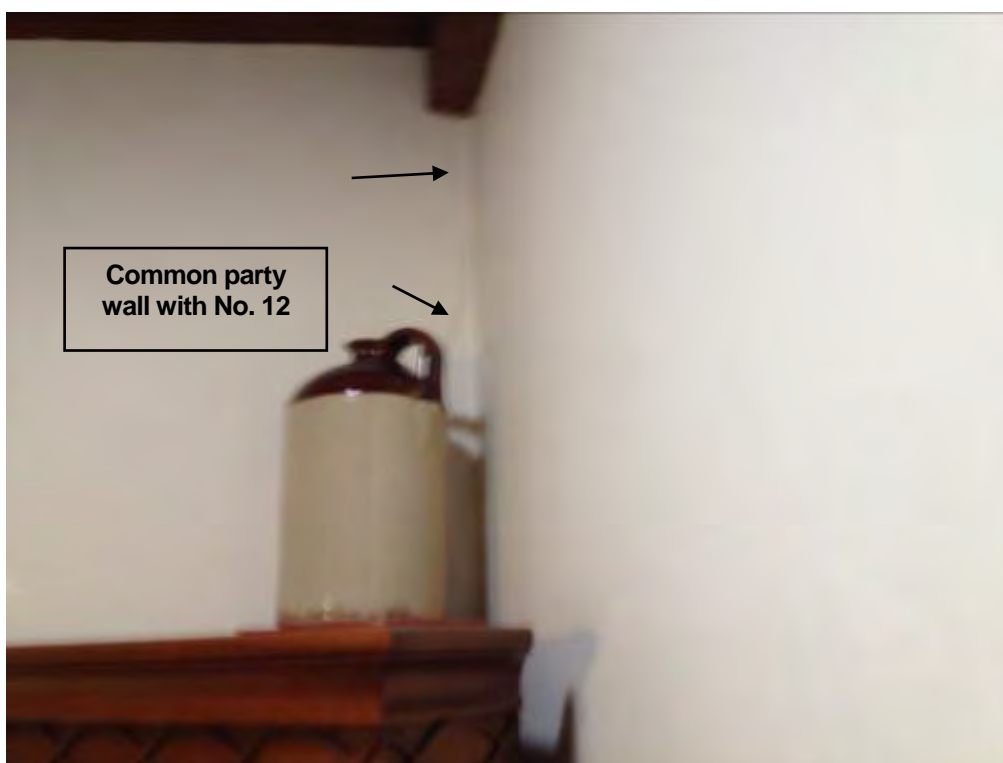
Photograph 48 shows the vertical crack to the wall at the northern corner of the Dining room

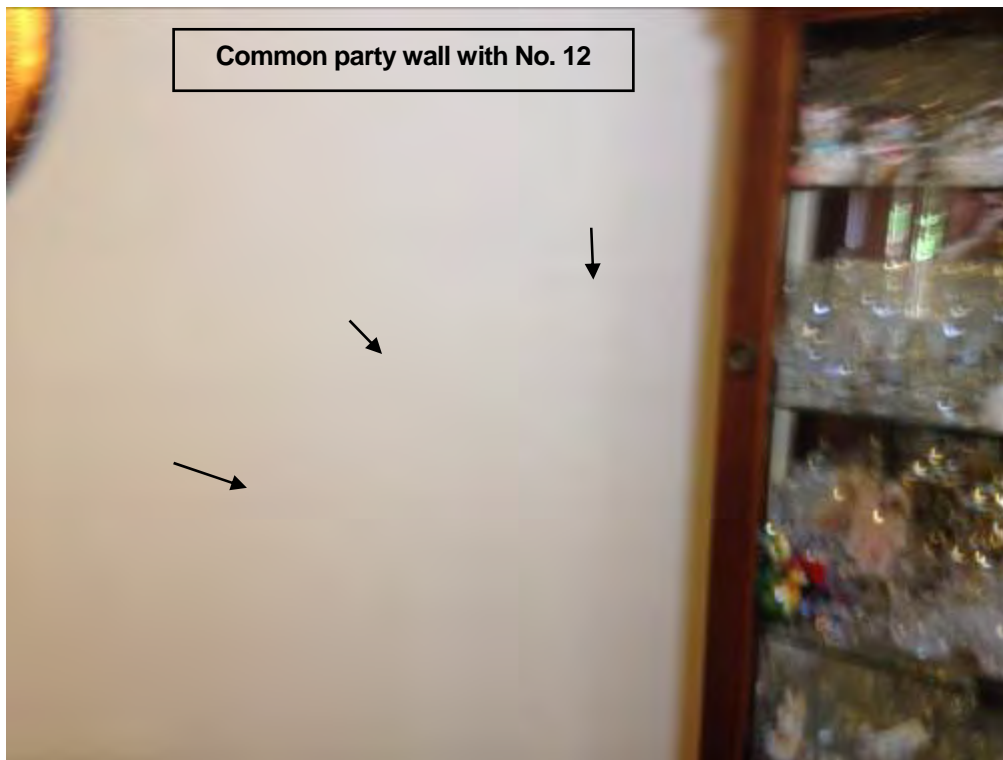
Photograph 49 shows the radial crack to the *common party / separation* wall to the northern corner of the Dining room

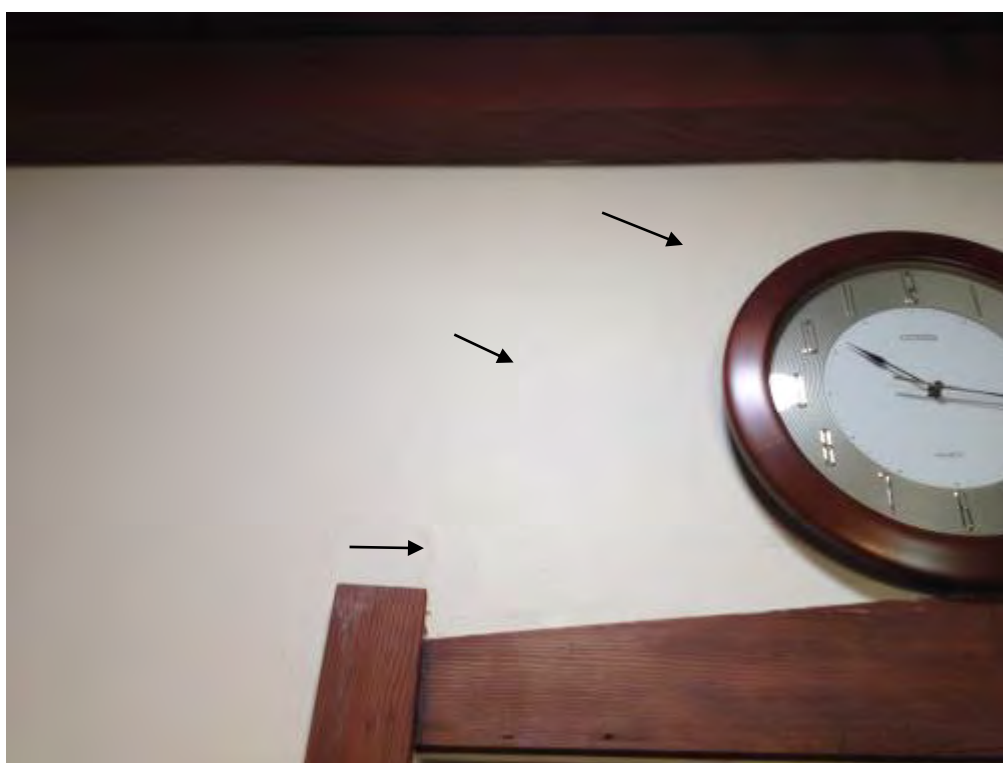
Photograph 50 shows a radial crack extending from the left hand side of the door to the Lounge room towards the ceiling

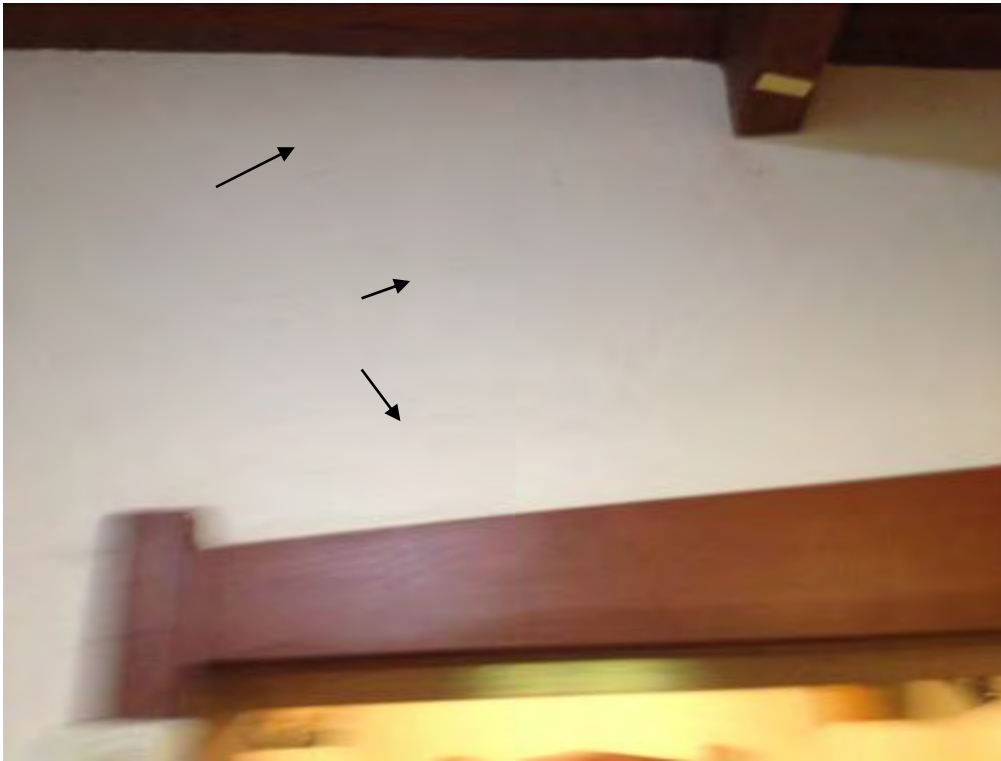
Photograph 51 shows a previously repaired radial crack extending from the left hand side of the door head from the Dining room into the Kitchen towards the ceiling

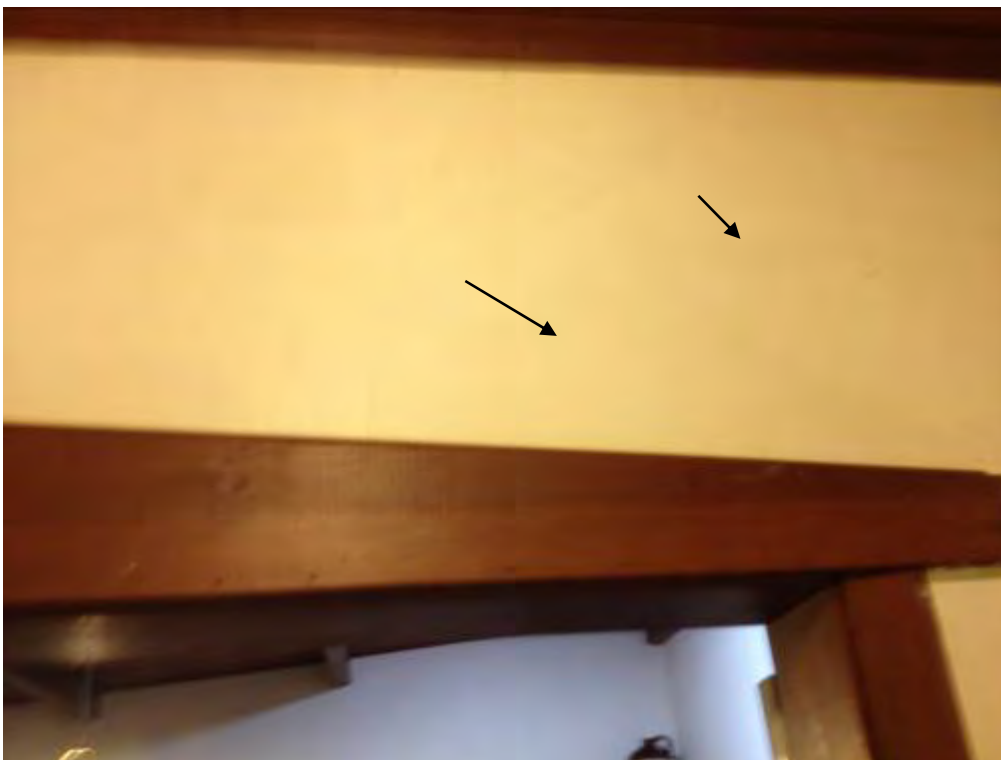
Photograph 52 shows previously repaired radial crack to the right hand side of the door head from the Kitchen to the Dining room

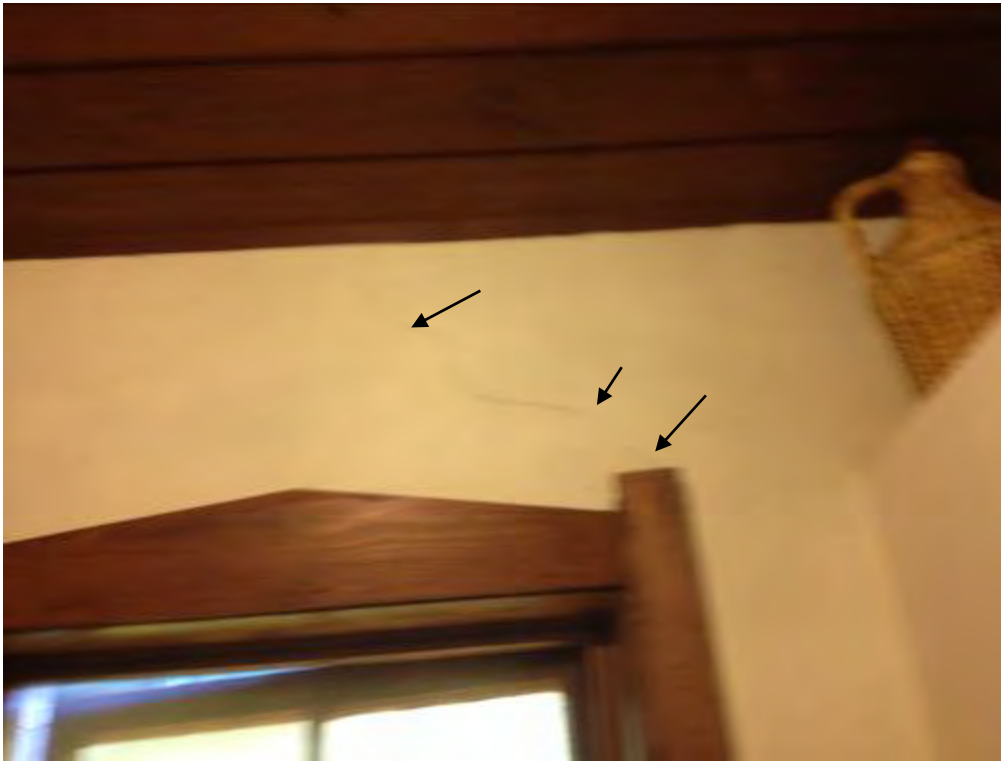
Photograph 53 shows a radial crack extending from the right hand side of the Kitchen window head towards the ceiling

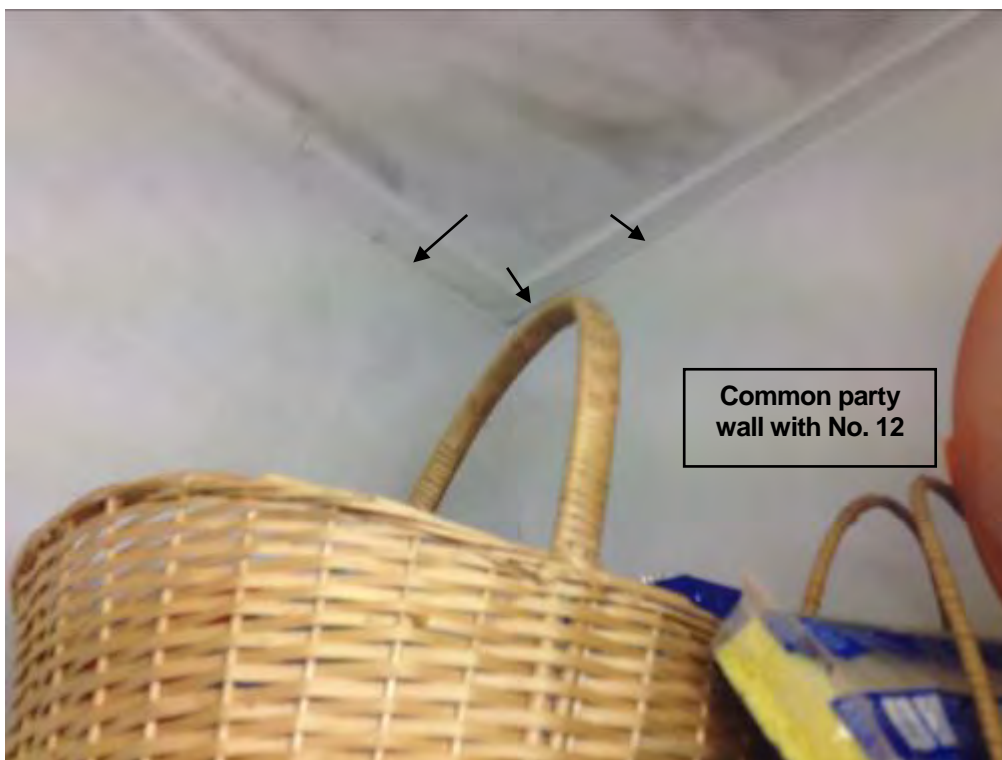
Photograph 54 shows a separation crack between the timber mould cornice and the *common party / separation* wall in the pantry

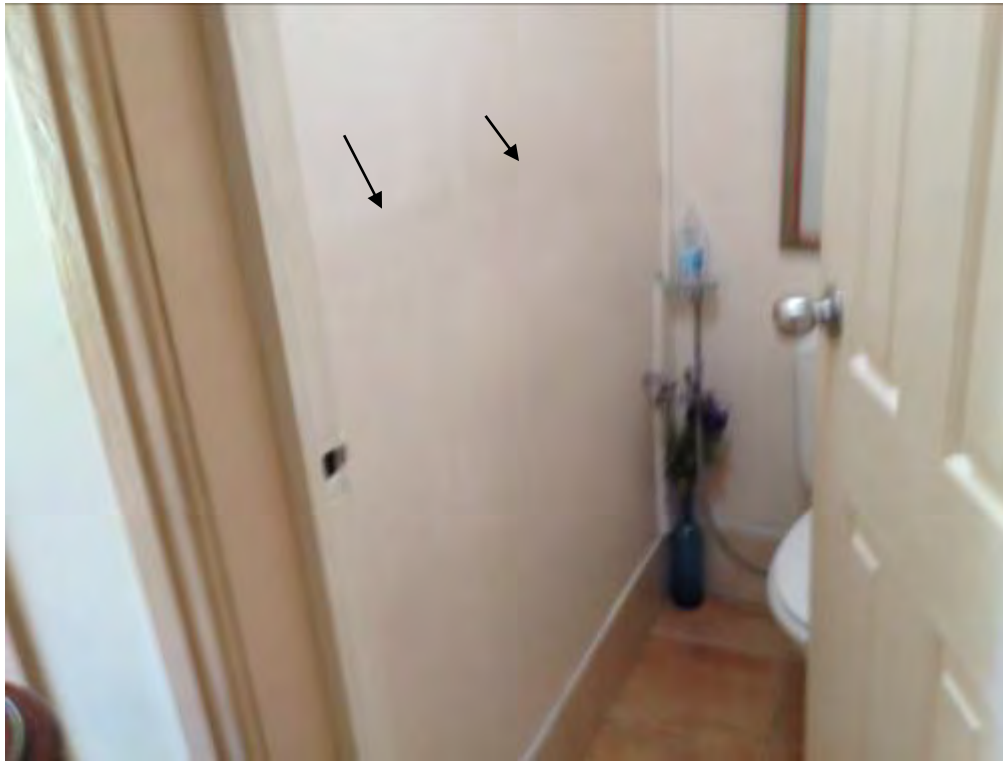
Photograph 55 shows the hairline crack to the set joint in the wall lining to the WC.

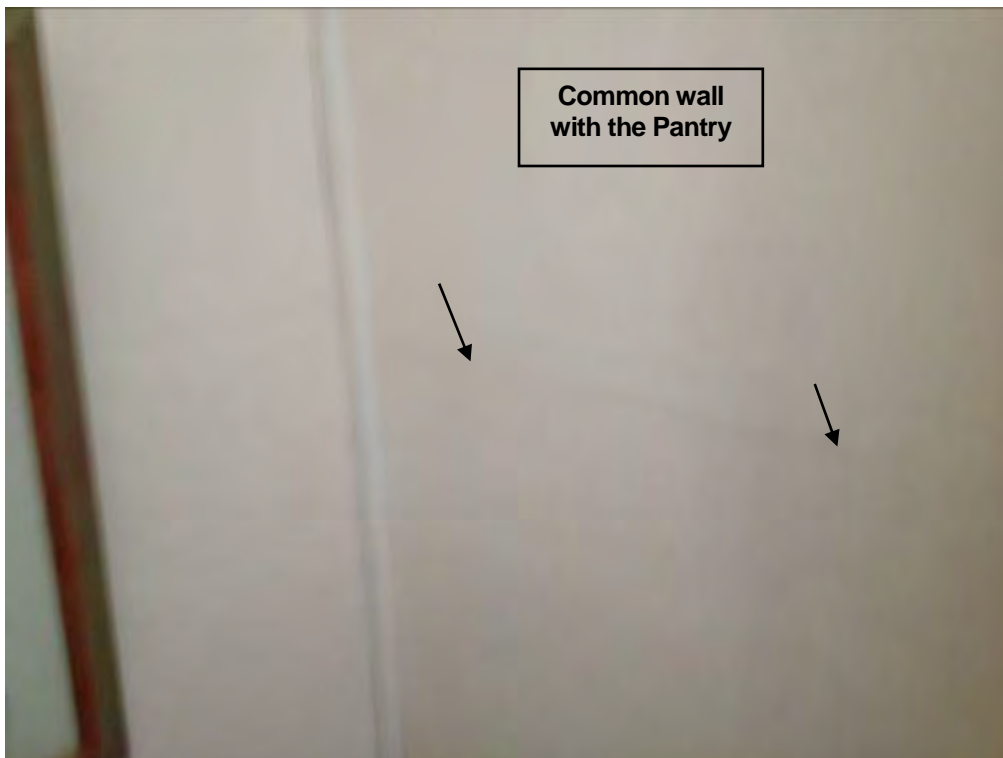
Photograph 56 shows the hairline crack to the set joint in the wall lining to the WC
