Dilapidation Assessment Report

Prepared for: Cape Cod Australia Pty. Limited
Job address: 10 Banks Street, Ashfield NSW 2131
Property Owner: Ms. T. Adam
Report reference: **ASHFIELD COUNCIL**
Development Application No: not available
Date of assessment: 5th May 2016

Re: Dilapidation Report - No. 10 Bank Street, Ashfield

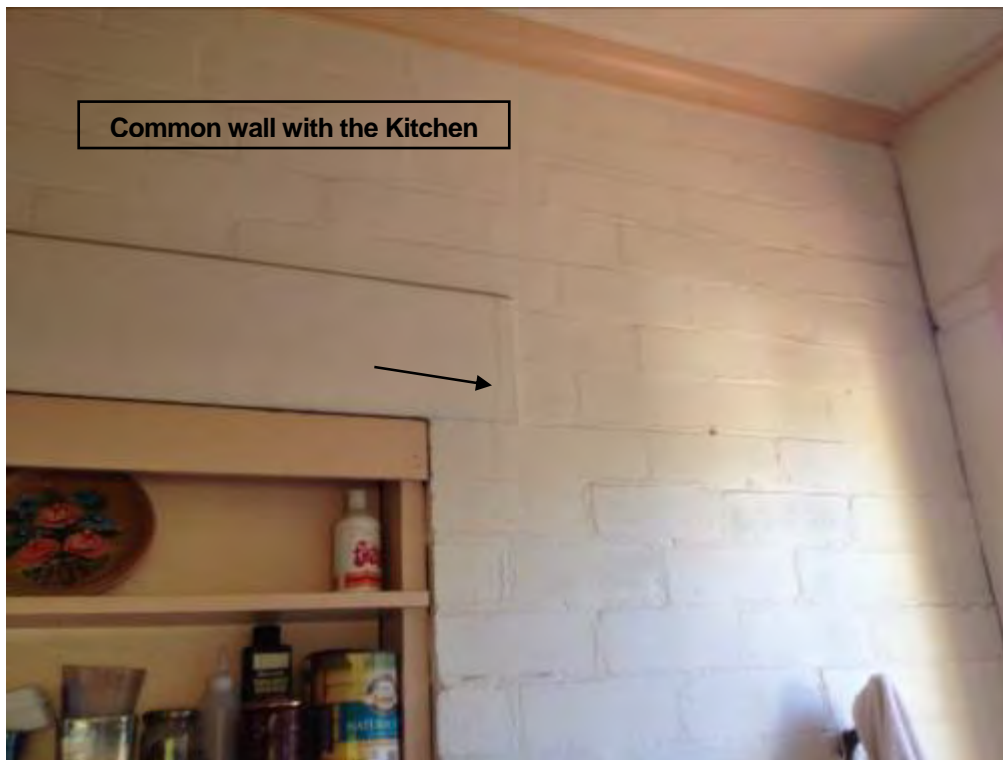
Photograph 57 shows the vertical crack to the right hand side of the lintel in the *common* wall with the Kitchen

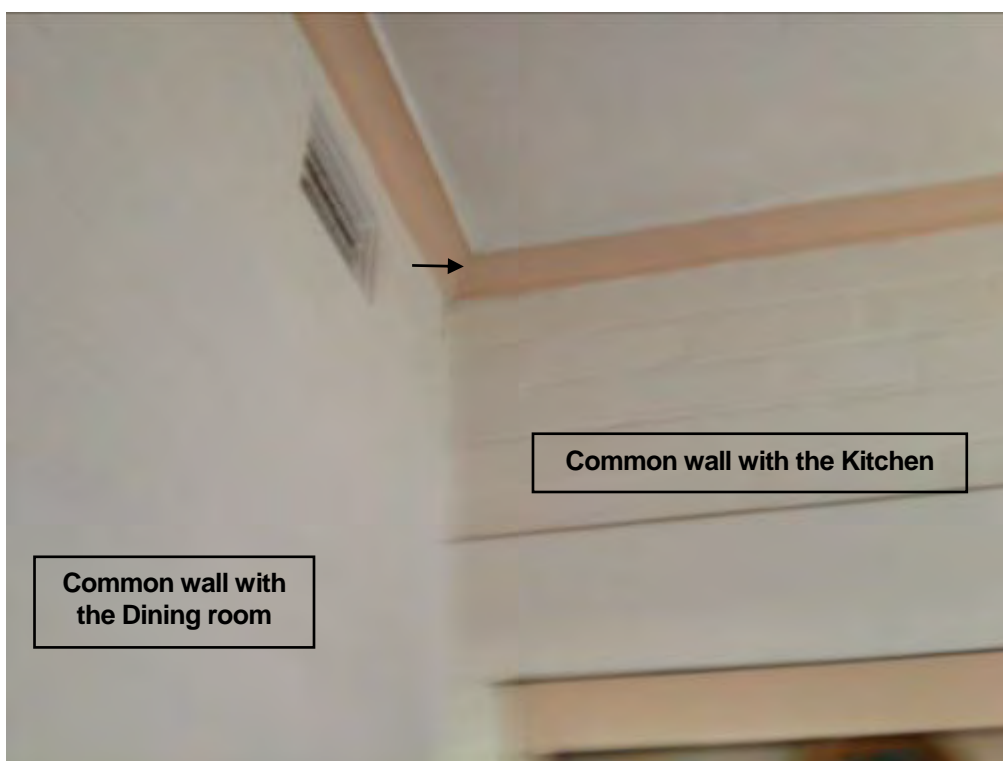
Photograph 58 shows a hairline crack to the mitre joint in the cornice to the northern corner of the Laundry

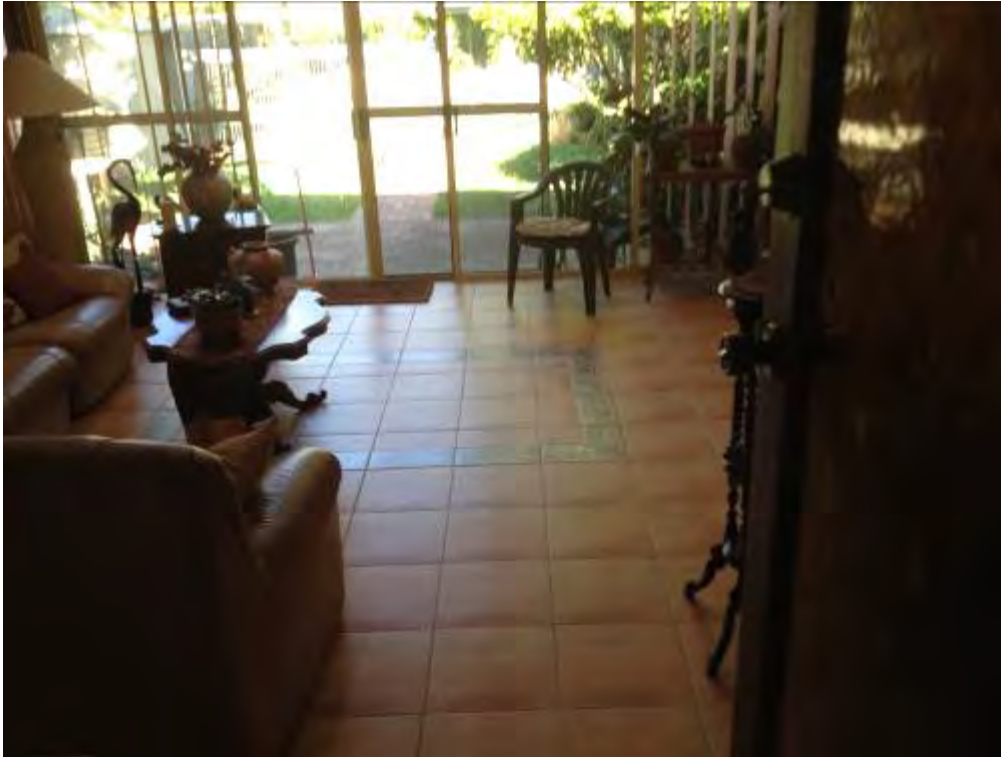
Photograph 59 shows the condition of the floor tiles to the rear Sunroom addition

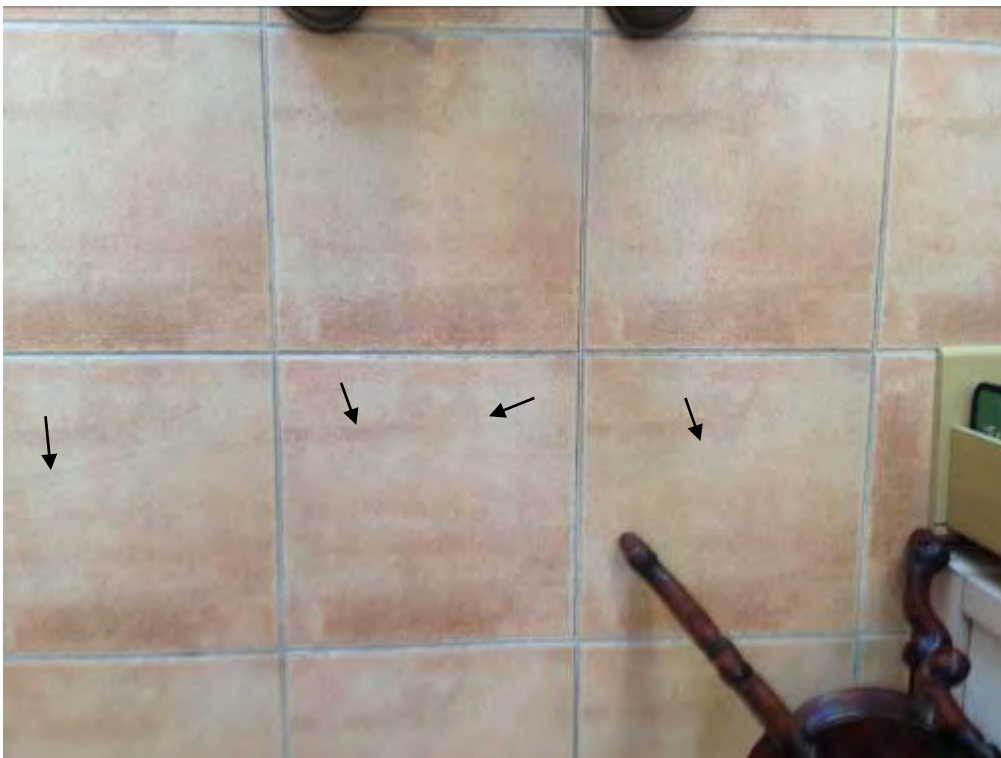
Photograph 60 shows a hairline crack to the Sunroom floor tiles extending from the corner of the WC towards the southeast external wall

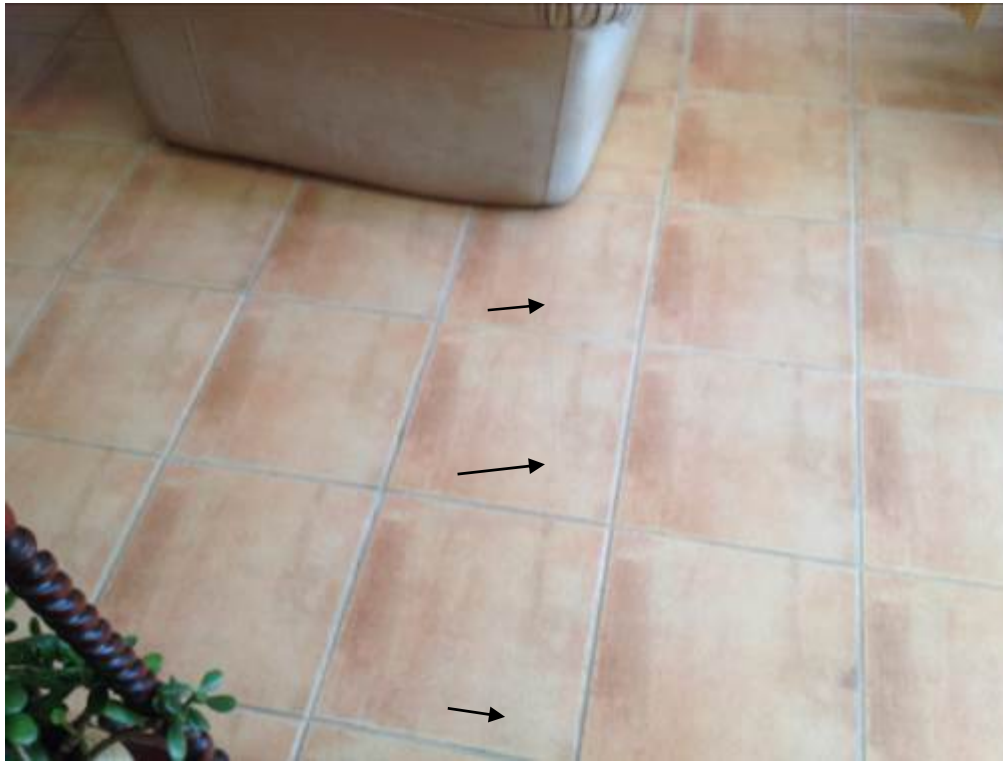
Photograph 61 shows the hairline cracking to the Sunroom floor tiles extending from the external corner of the WC

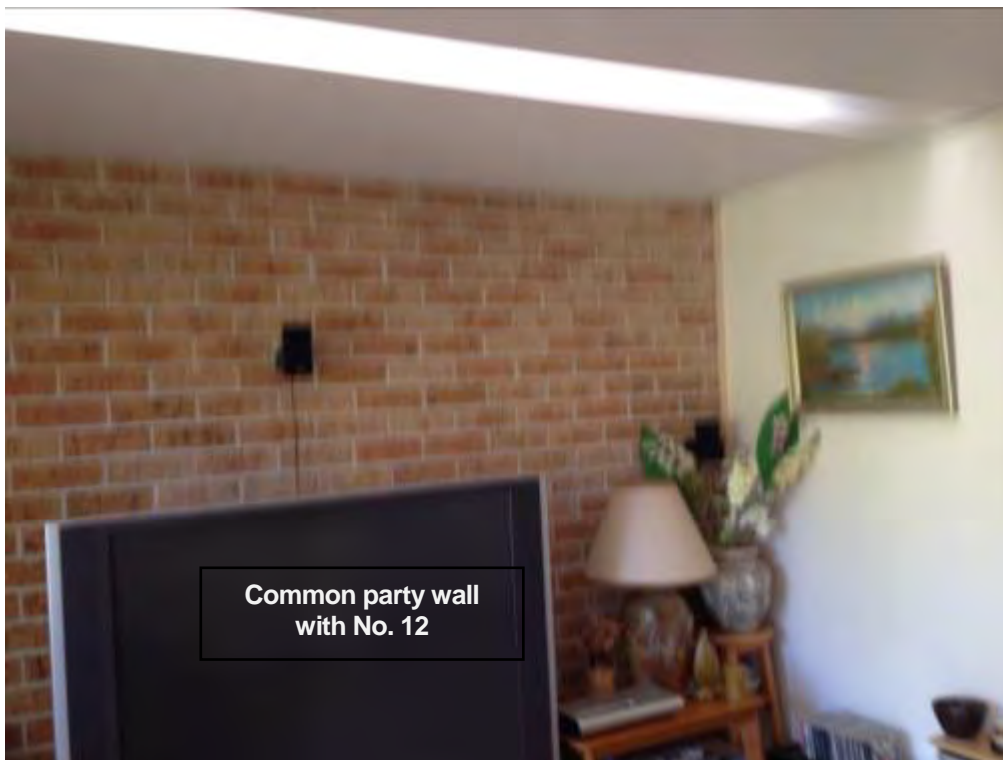
Photograph 62 shows the condition of the face brickwork to the *common party* / *separation* wall in the Sunroom addition

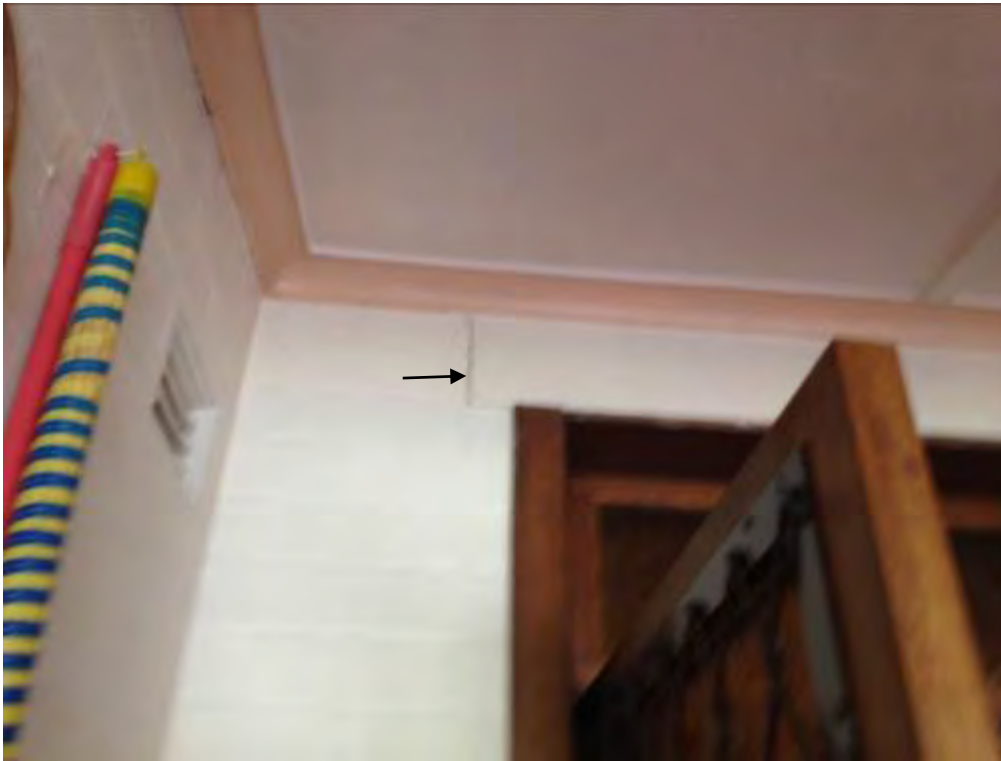
Photograph 63 shows the vertical crack extending from the left hand side of the lintel over the door head from the Sunroom to the Dining room

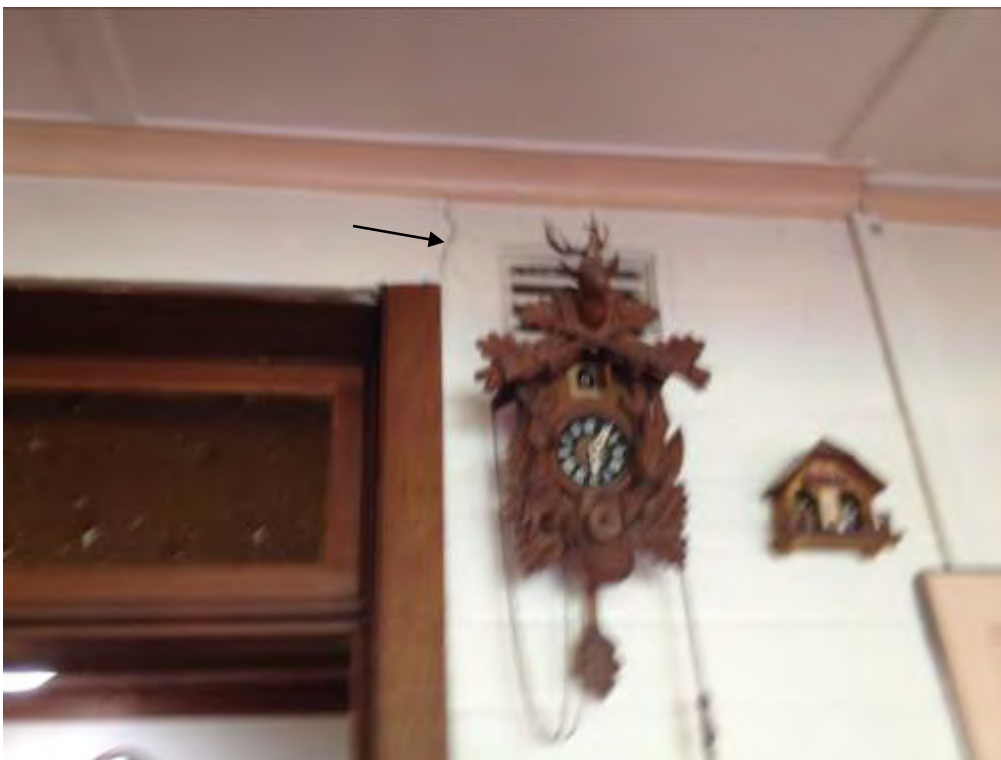
Photograph 64 shows the vertical crack extending from the right hand side of the lintel over the door head from the Sunroom to the Dining room
