## **HAZARDOUS MATERIALS ASSESSMENT REPORT**

**Client:** Cape Cod Australia Pty. Limited

**Job details:** Owner: Mr. Tim & Mrs. Amy Smith  
Location: 66 Oberon Street

**Our reference:** HM04960716

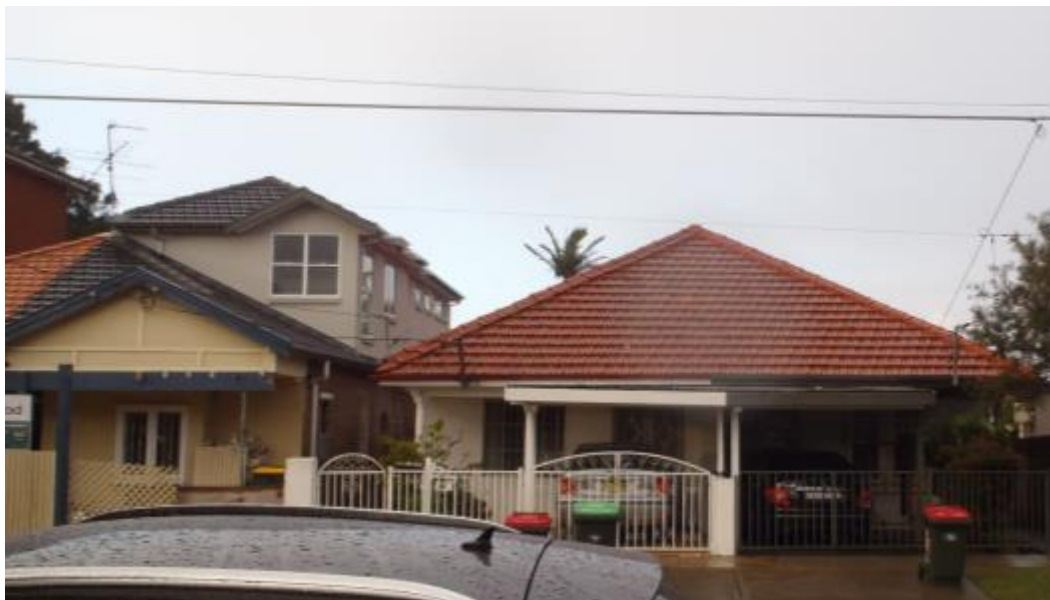
Front northern elevation of the residence

Note: Current Cape Cod construction on the left 70 Oberon Street, Randwick.
