HAZARDOUS MATERIALS ASSESSMENT REPORT

Client: Cape Cod Australia Pty. Limited

Job details: Owner/s: Mr. G. & Mrs. L. Andrews
Location: 18 Ellerstone Court, Kellyville

Our reference: HM04840416

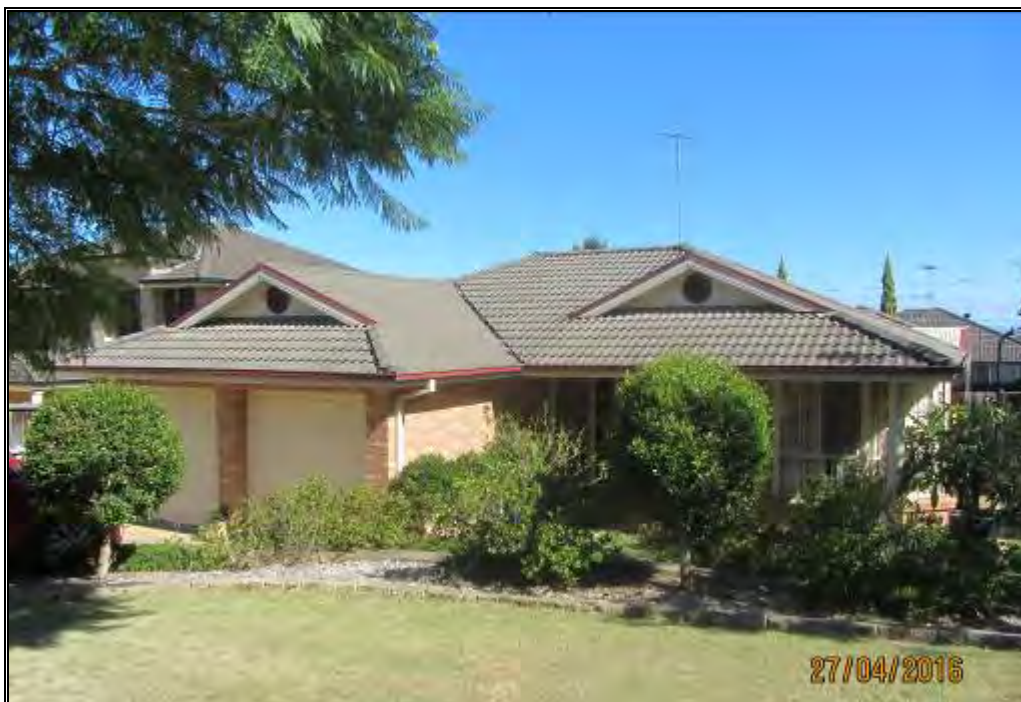
Front eastern elevation of the residence
