HAZARDOUS MATERIALS ASSESSMENT REPORT

Job details: Owner: Mr. D. Perera
Location: 18 Highland Avenue, Toongabbie

Our reference: HM03481114

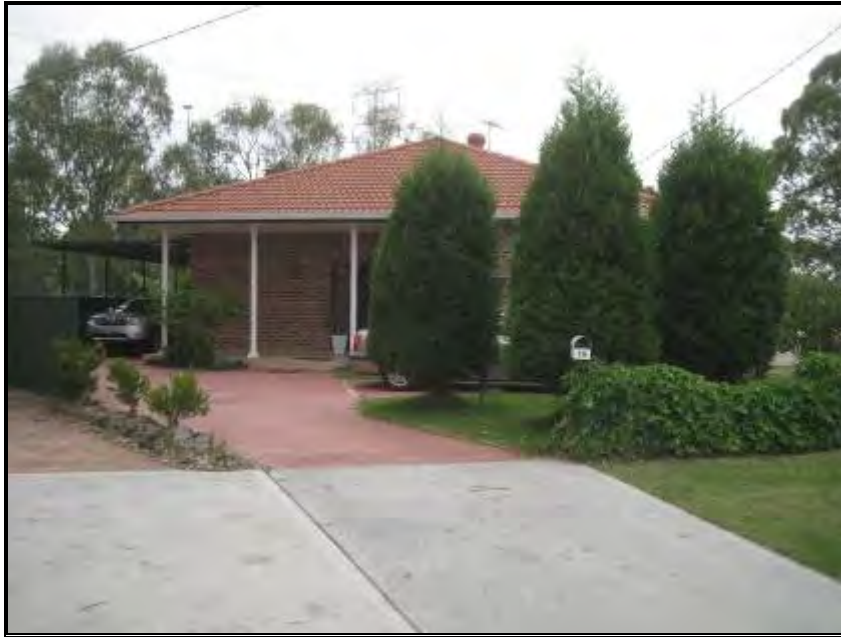
Front western elevation of the residence
