HAZARDOUS MATERIALS ASSESSMENT REPORT

Job details: Owner/s: Mr. T. & Mrs. L. Reid
Location: 3 Marguerite Crescent, West Pennant Hills

Date of assessment: 9th January 2015

Our reference: HM03601214

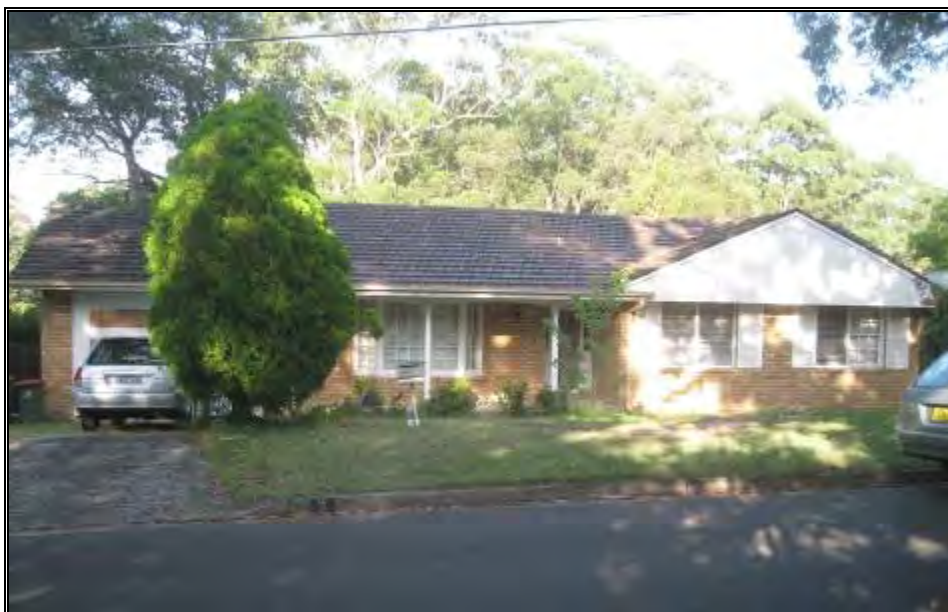
Front eastern elevation of the residence
