## Dilapidation Assessment Report

Prepared for: **Cape Cod Australia Pty. Limited**  
Job address: **67 Glenayr Avenue, North Bondi NSW**  
Property Owner/s: **Mr. P. Bize**  
Report reference: **WAVERLEY COUNCIL**  
Development Application No: not available  
Date of assessment: **4<sup>th</sup> April 2016**

**Re: Dilapidation Report: No. 67 Glenayr Avenue, North Bondi**

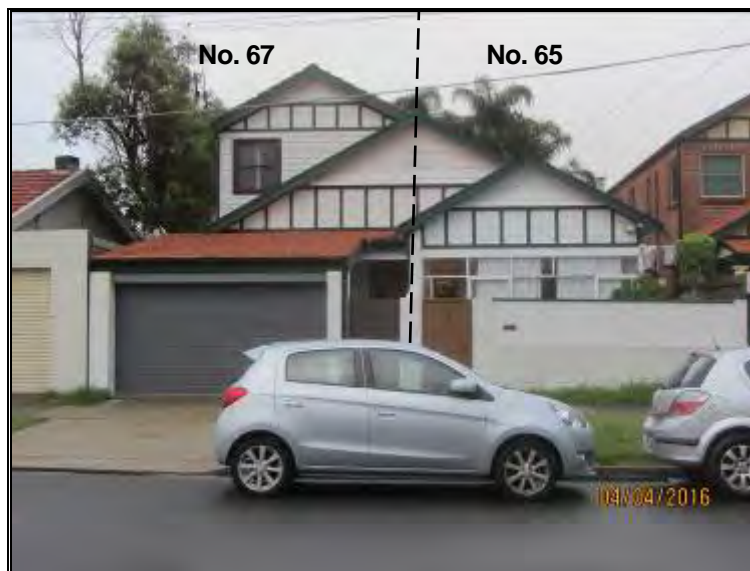
Shows the front eastern elevation of the adjoining properties:  
No. 65 & No. 67 Glenayr Avenue, North Bondi

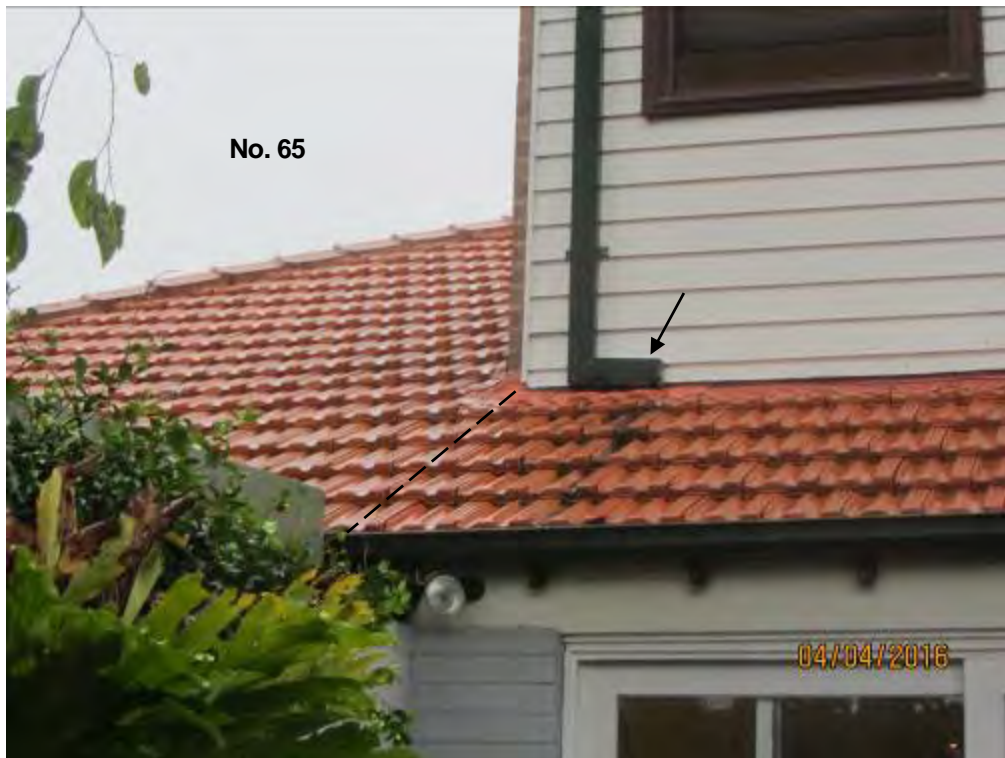
We noted that the northern surface water from the upper floor addition roof discharges into an eave gutter located over the *common party / separation* wall with the adjoining property, No. 65 Glenayr Avenue. We noted that the gutter discharges via a spreader onto the tiled western roof surface. **[Photograph 1]**

**Photograph 1** shows the downpipe spreader servicing the northern roof gutter of the upper floor addition discharging onto the roof tiles

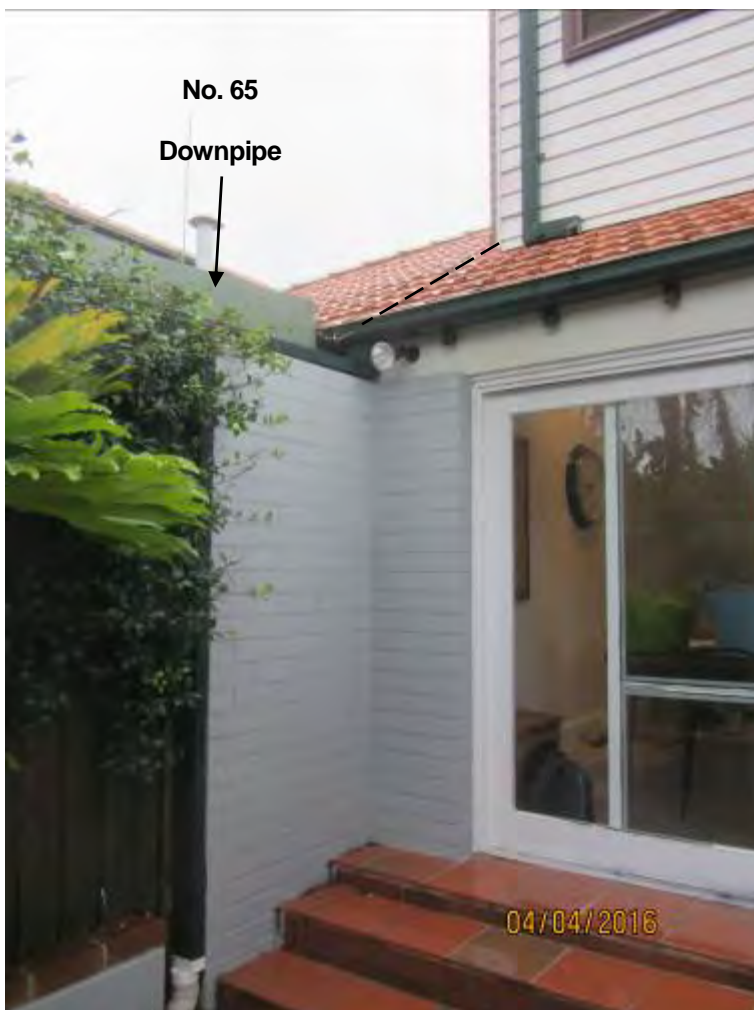
We further noted that the downpipe servicing the lower roof is located over the *common boundary privacy* wall with the adjoining property. **[Photograph 2]**

We did not observe any recent cracking to the surface coated wall surfaces including the *common boundary privacy* wall with the adjoining property, No. 65 Glenayr Avenue. **[Photograph 2]**

**Photograph 2** shows the *common privacy wall* – Note: the downpipe servicing the eave gutter is located on the top of the wall

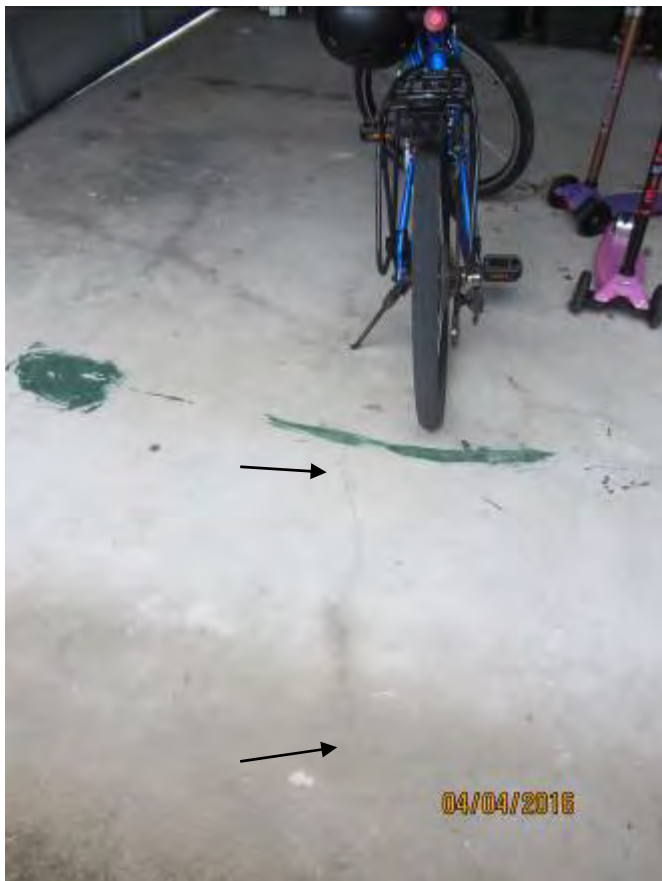
We noted that the hardstand off-street parking / courtyard area has a concrete floor and a skillion roof structure with terra cotta roofing tiles. We noted that there is shrinkage cracking [1.0mm] within the concrete slab. **[Photographs 3 and 4]**

**Photograph 3** shows typical hairline cracking to the Garage / Courtyard slab

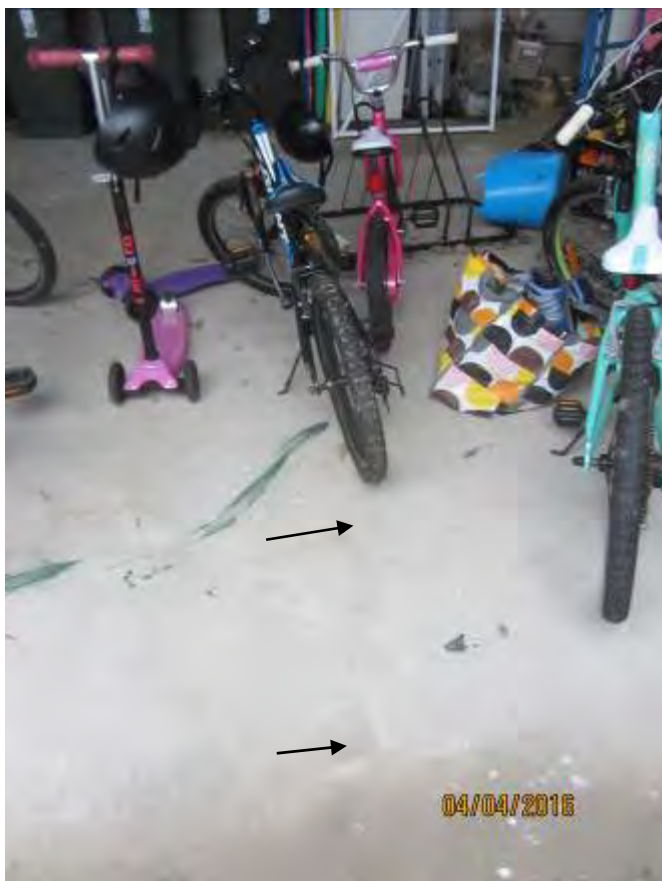
**Photograph 4** shows typical hairline cracking to the Garage / Courtyard slab

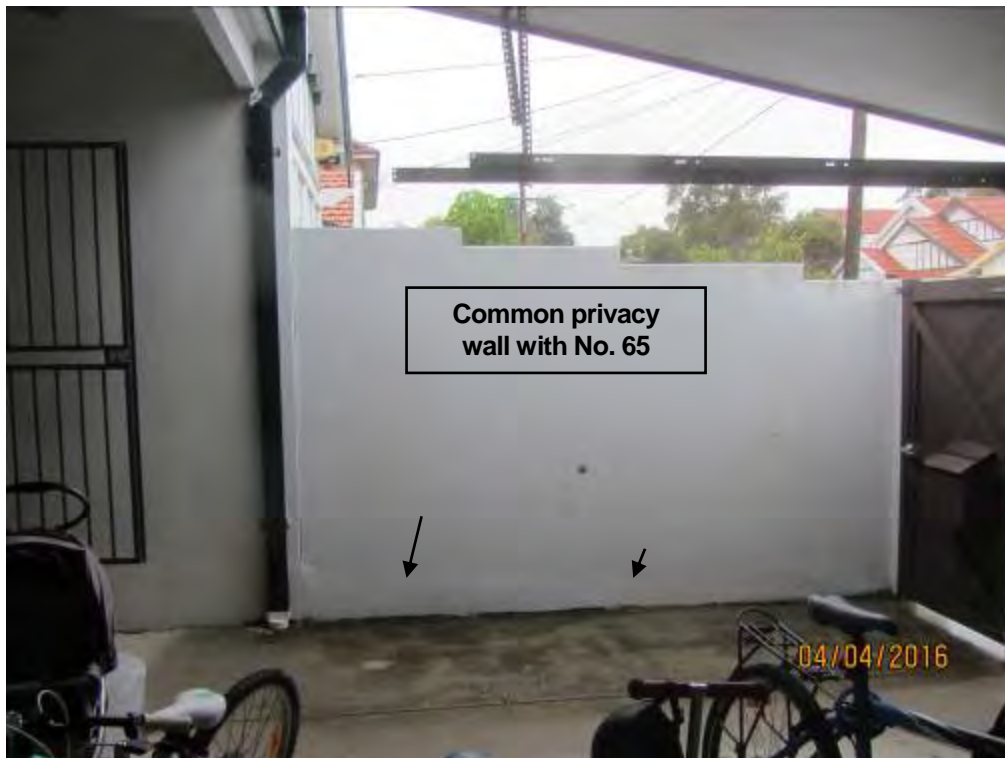
We noted that the Garage / Courtyard has a *common privacy* wall with the adjoining property, No. 65 Glenayr Avenue. We noted that the wall is surface coated cement rendered brickwork and that there is a different texture to the cement render to the base of the wall. We further noted efflorescence to the base of the wall on the adjoining property side of the wall. **[Photographs 5 and 6]**

**Photograph 5** shows different surface texture to the render to the base of the *common privacy* wall in the Garage / Courtyard area

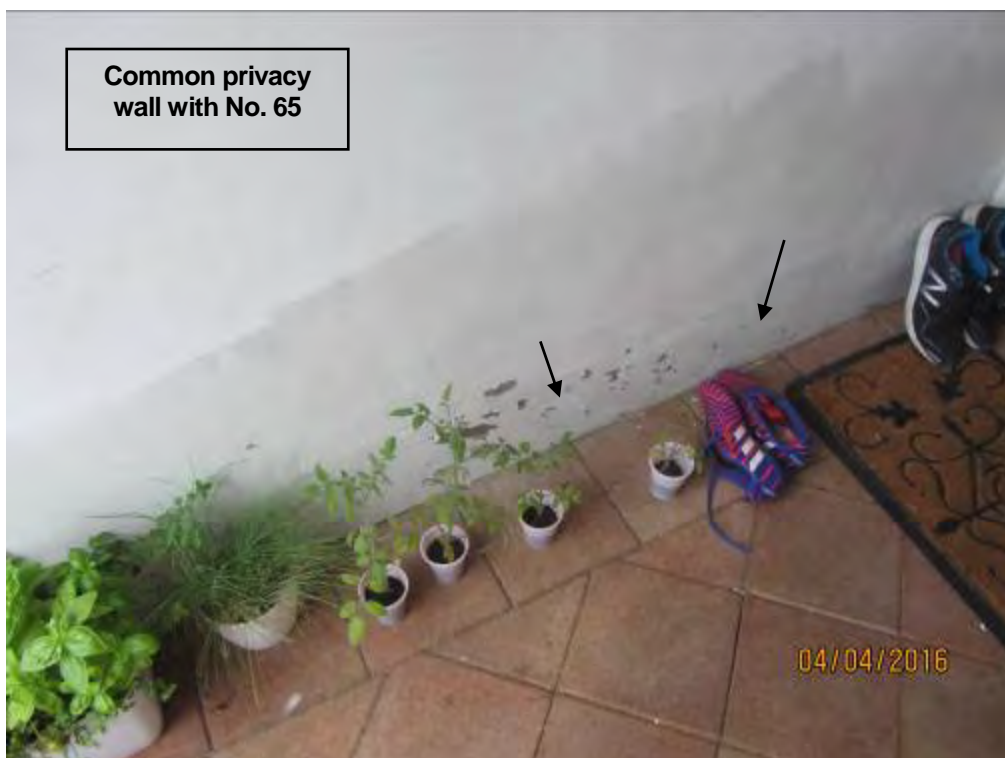
**Photograph 6** shows efflorescence and different surface texture to the base of the front *common privacy* wall viewed from No. 65

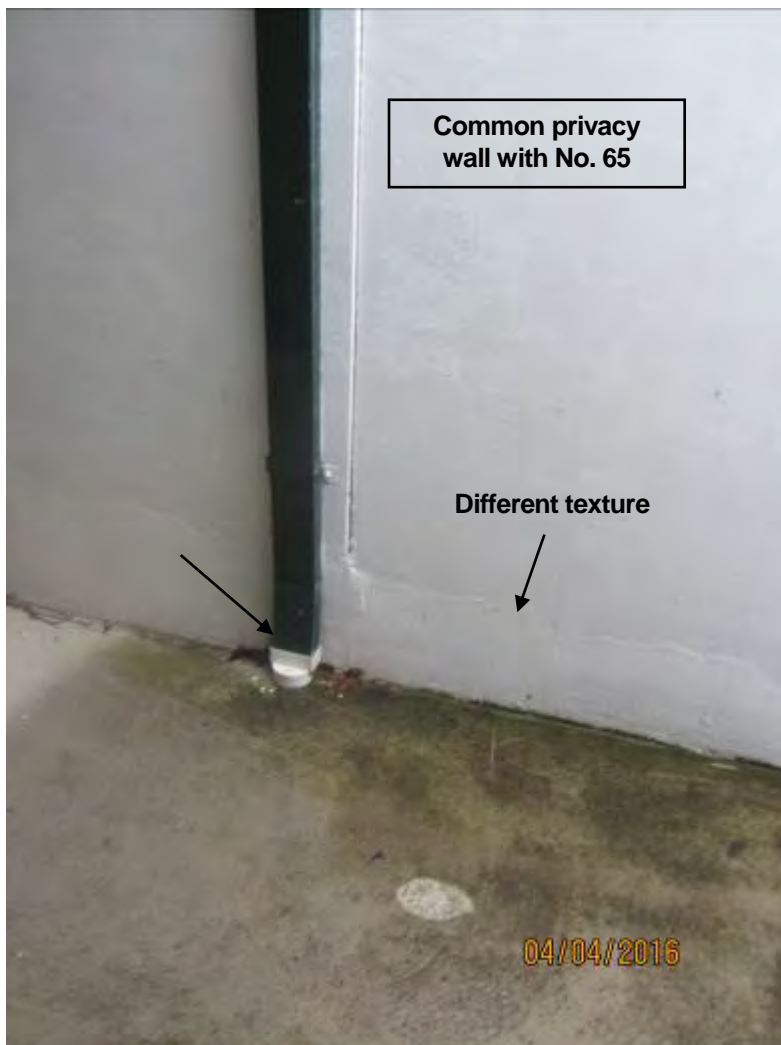
We noted that there is staining and dampness to the concrete in the immediate vicinity of the downpipe servicing the front roof and abutting the *common privacy* wall. **[Photograph 7]**

**Photograph 7** shows staining to the concrete extending from the downpipe servicing the front tiled roof surface

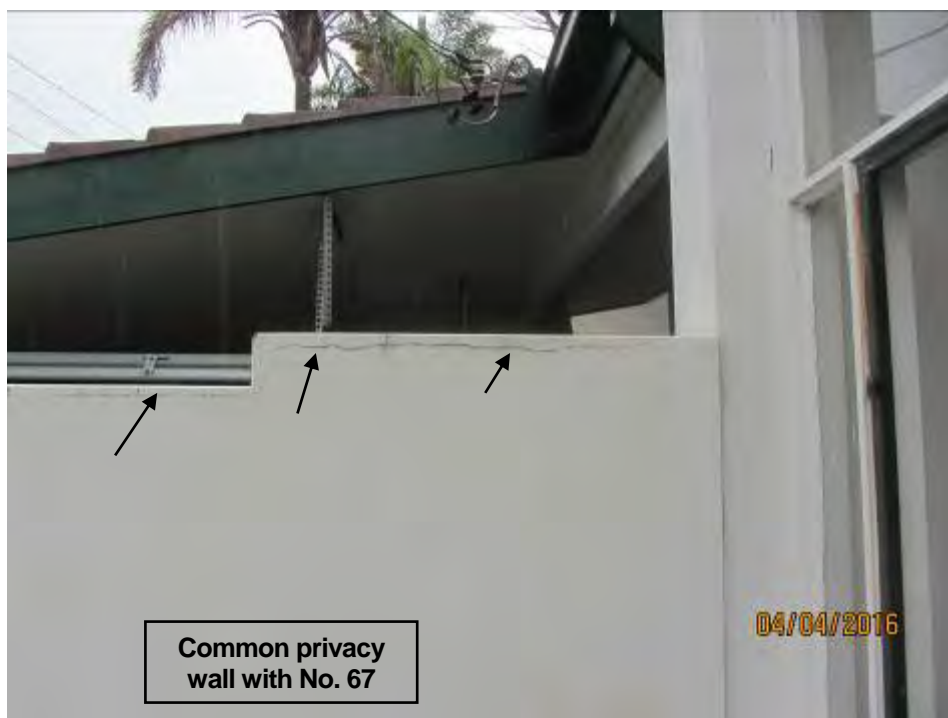
We also noted horizontal cracking of the cement render to the top of the common privacy wall on the adjoining property side. **[Photograph 8]**

**Photograph 8** shows a hairline cracking to the top of the *common privacy* wall viewed from No 65

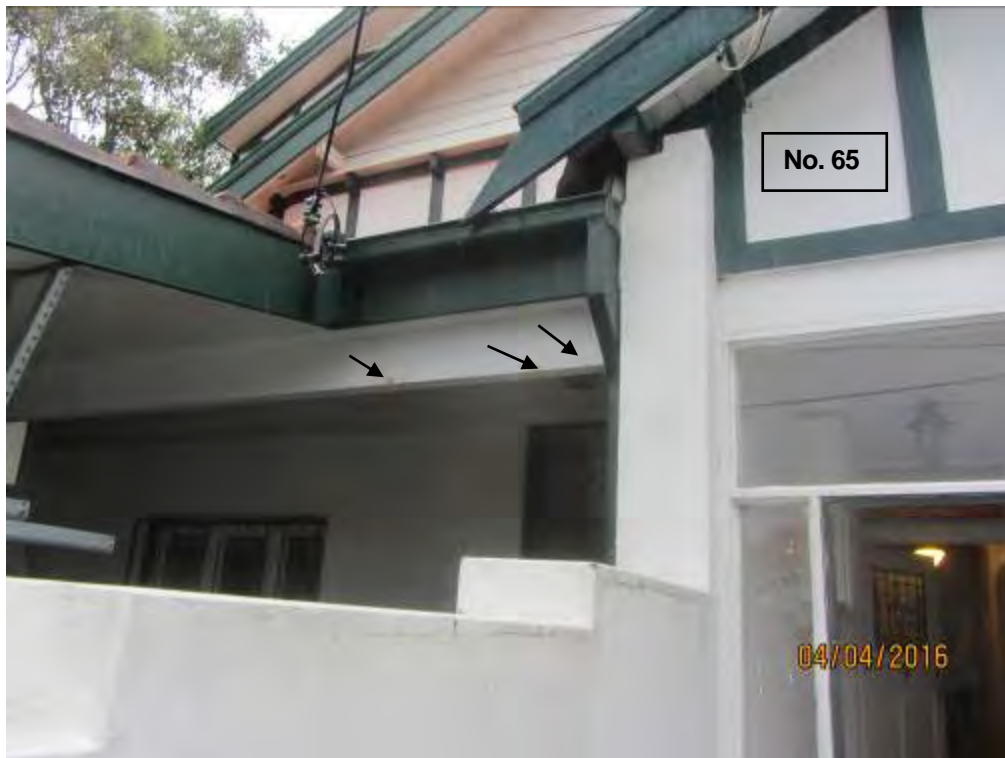
We noted that there is surface corrosion [rust] to the structural steel beam supporting the roof structure. **[Photograph 9]**

**Photograph 9** shows corrosion [rust] to the structural steel beam supporting the Garage skillion roof

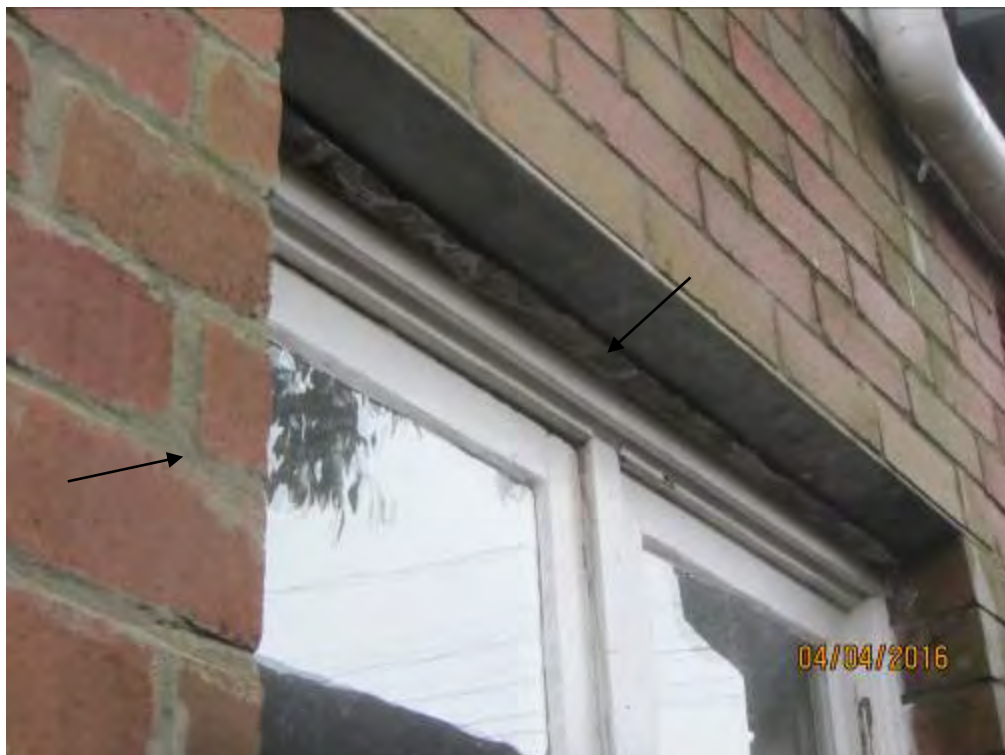
We noted different brickwork around the window opening to Bedroom 1 and that the original lintel has been replaced with a steel lintel. **[Photograph 10]**

**Photograph 10** shows different brickwork and replaced lintel to Bedroom 1 window in the southern wall

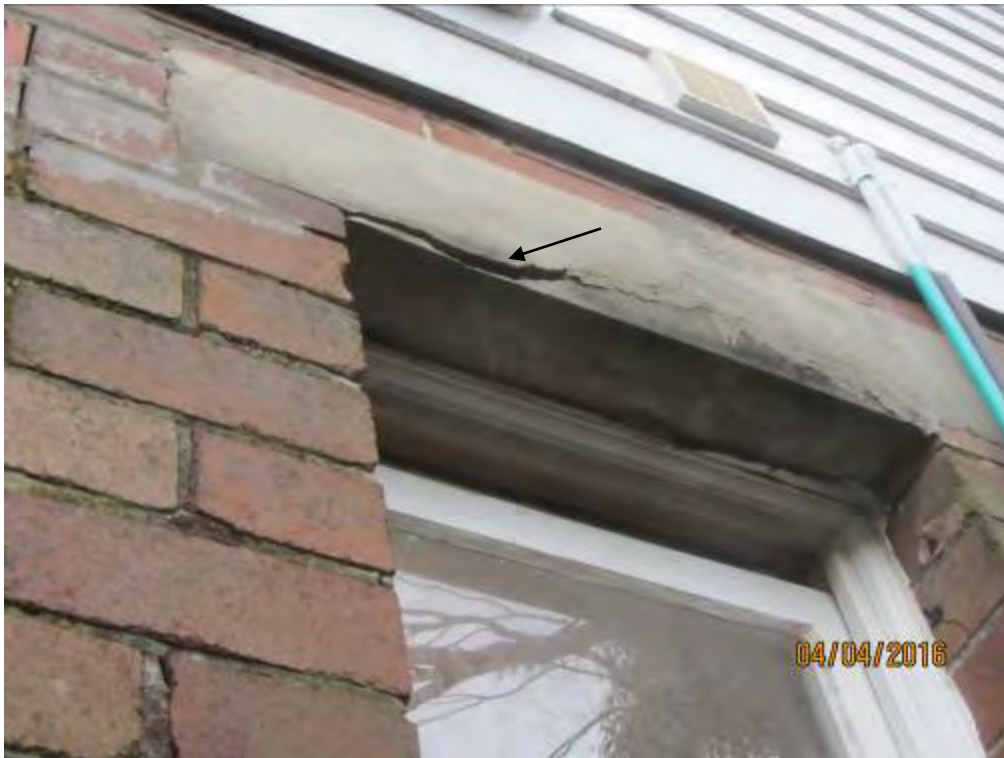
We noted cracking of the concrete lintel to the Bathroom window. **[Photograph 11]**

**Photograph 11** shows cracking to the concrete lintel over the ground floor Bathroom window

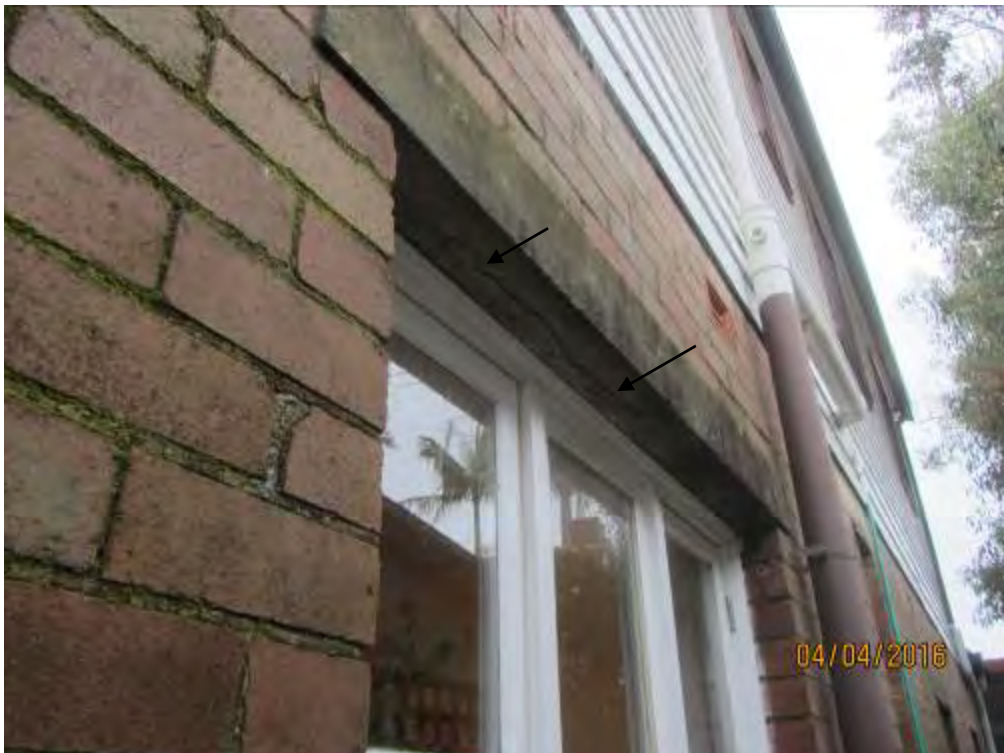
We noted cracking of the concrete lintel to the Living room window. **[Photographs 12 and 13]**

**Photograph 12** shows cracking to the concrete lintel over the Living room window

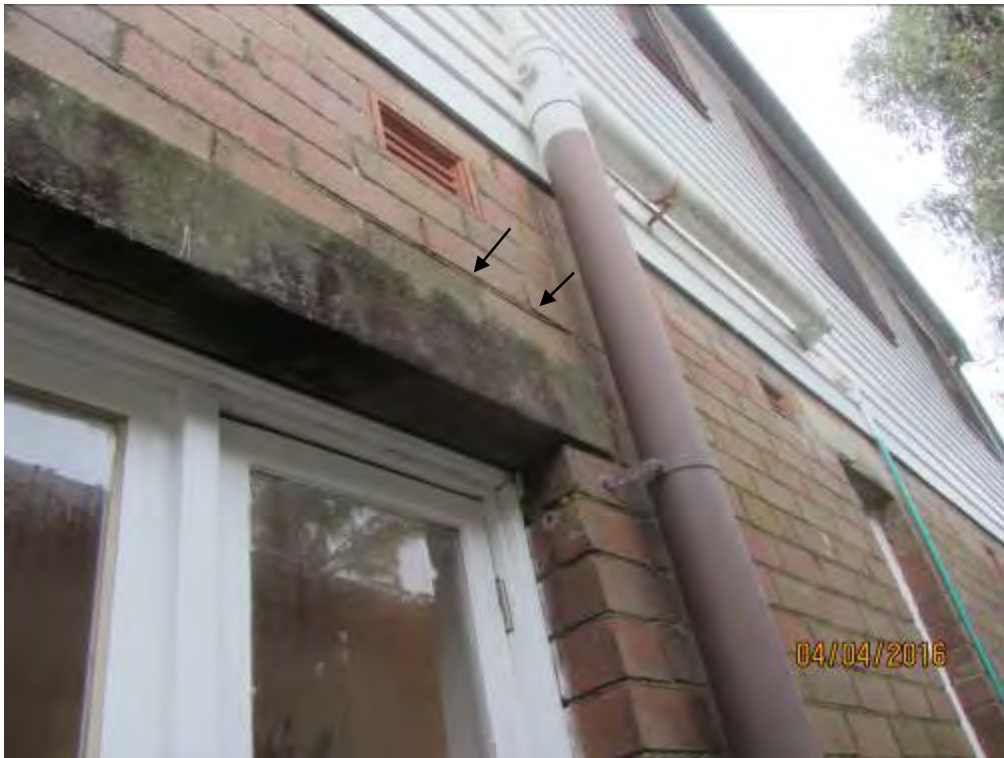
**Photograph 13** shows lateral movement to the brickwork over the eastern end of the Living room window

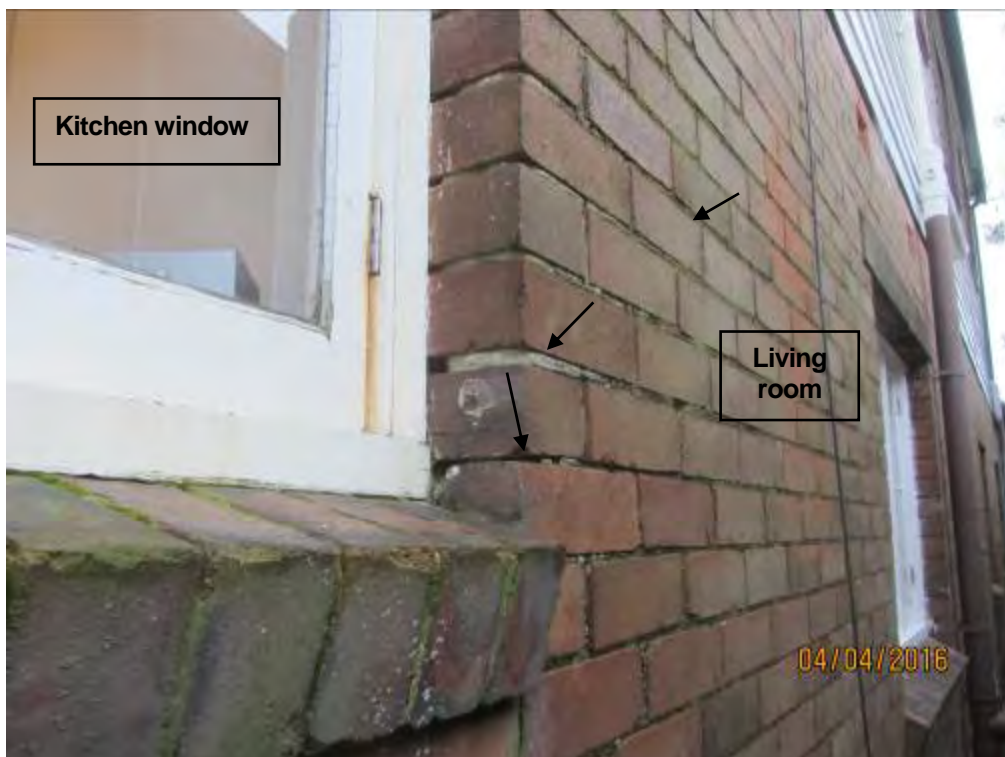
We noted fretting and displaced mortar around the Kitchen window openings and green staining and moss growth to the brickwork. **[Photographs 14, 15 and 16]**

**Photograph 14** shows fretting mortar staining and moss growth to the panel of brickwork between the Kitchen and the Living room window

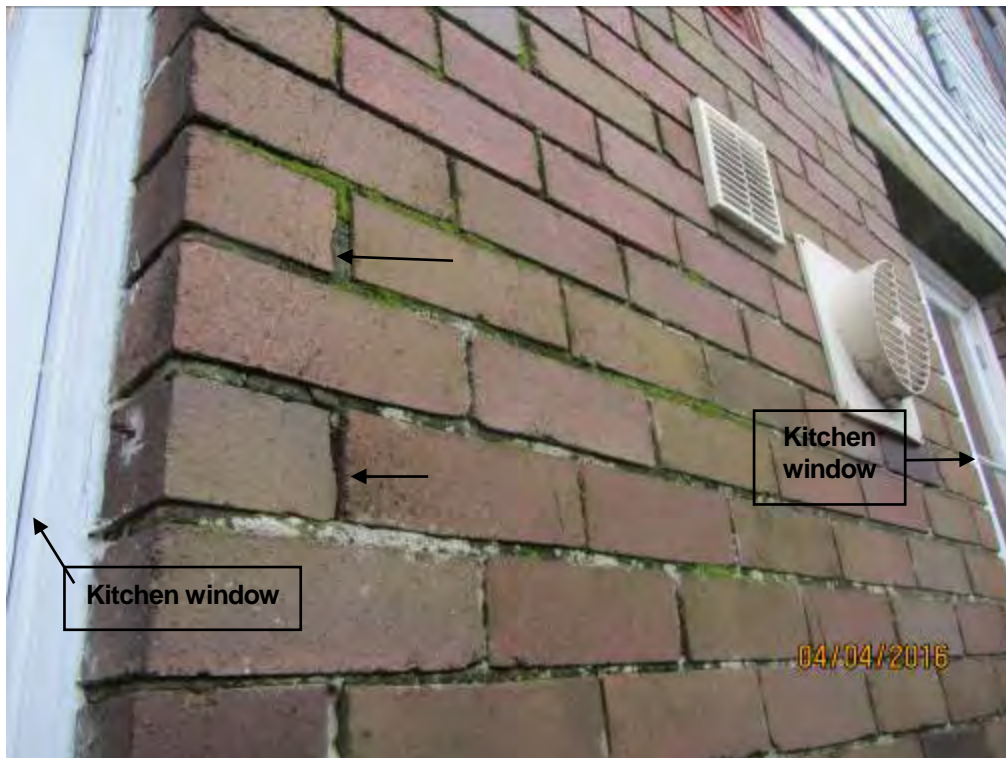
**Photograph 15** shows fretting mortar, staining and moss growth to the panel of brickwork between the Kitchen windows

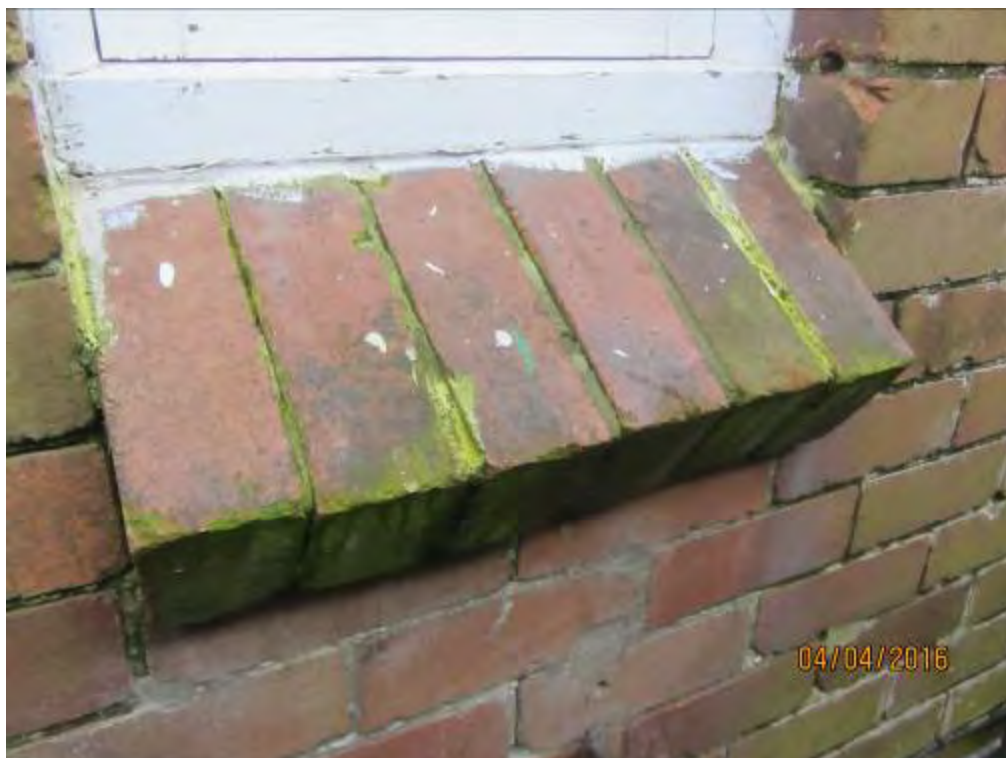
**Photograph 16** shows staining the moss growth around the Kitchen window

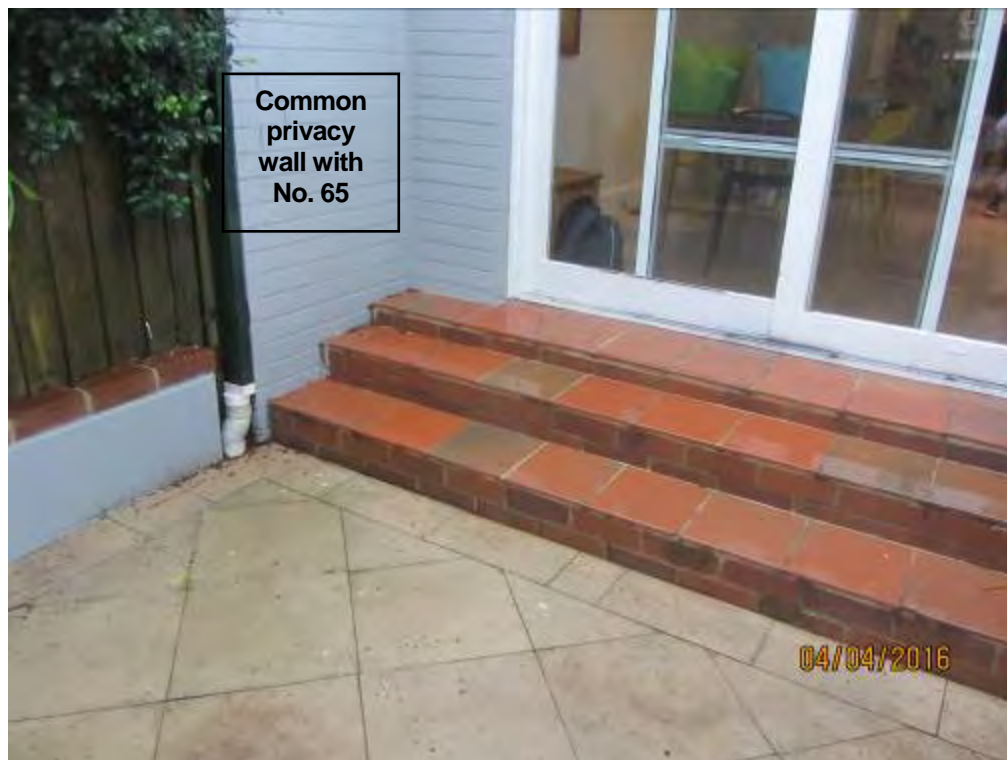
We noted that the rear entry steps have brick risers and clay tiles for treads. We noted that the grout to the tiles is complete and that the tiles when randomly "tap" tested appeared to be sound. **[Photograph 17]**

**Photograph 17** shows the condition of the rear entry steps

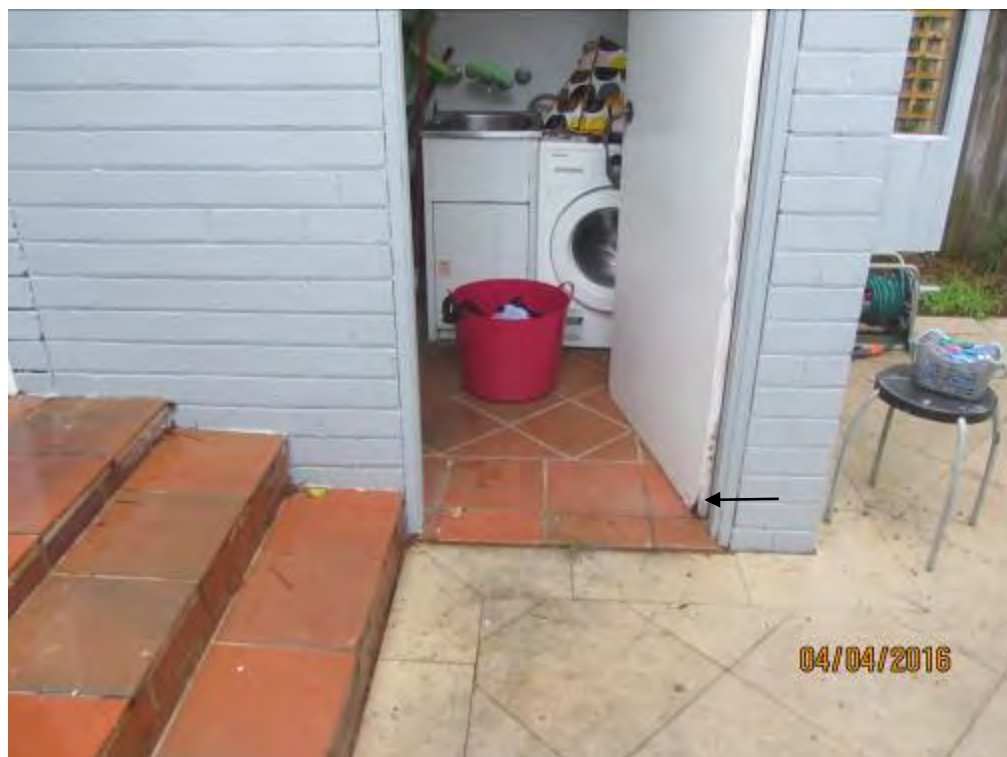
We noted that the floor is slab on ground finished with tiles. **[Photograph 18]**

We noted that the grout to the tiles is complete and that the tiles when randomly "tap" tested appeared to be sound.

**Photograph 18** shows the condition of the floor tiles to the Laundry – Note: the condition of the bottom of the door

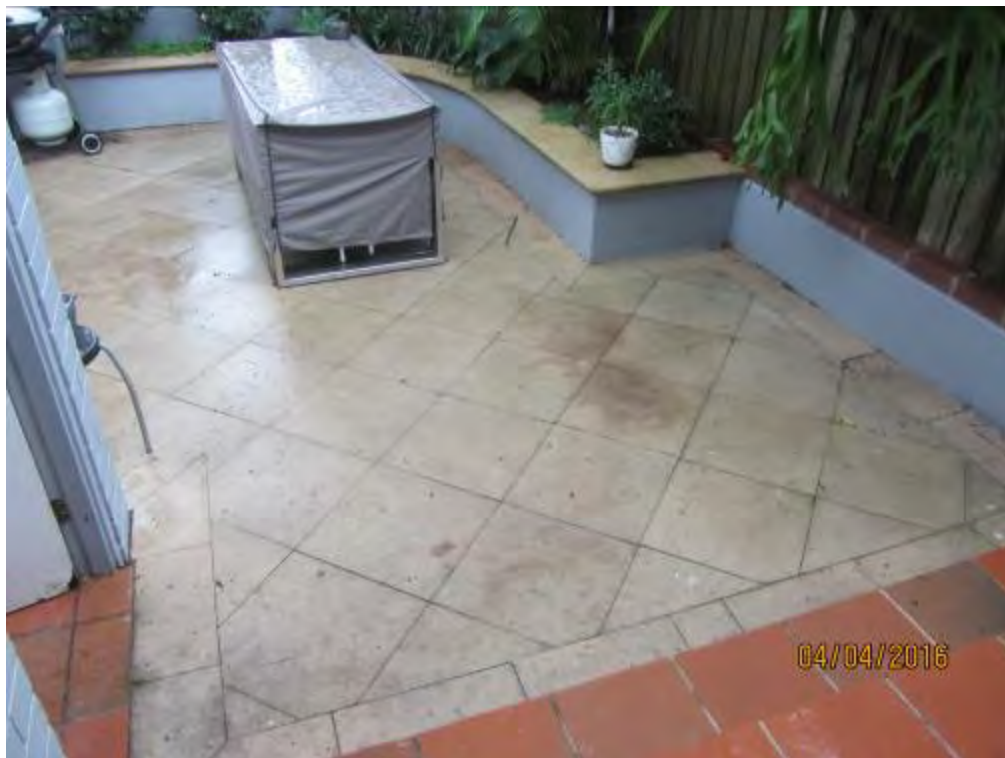
We noted that the courtyard area is finished with concrete pavers. We noted that the pavers are uniform in plane and that the pavers when randomly "tap" tested appeared to be sound. **[Photograph 19]**

**Photograph 19** shows the condition of the rear courtyard pavers

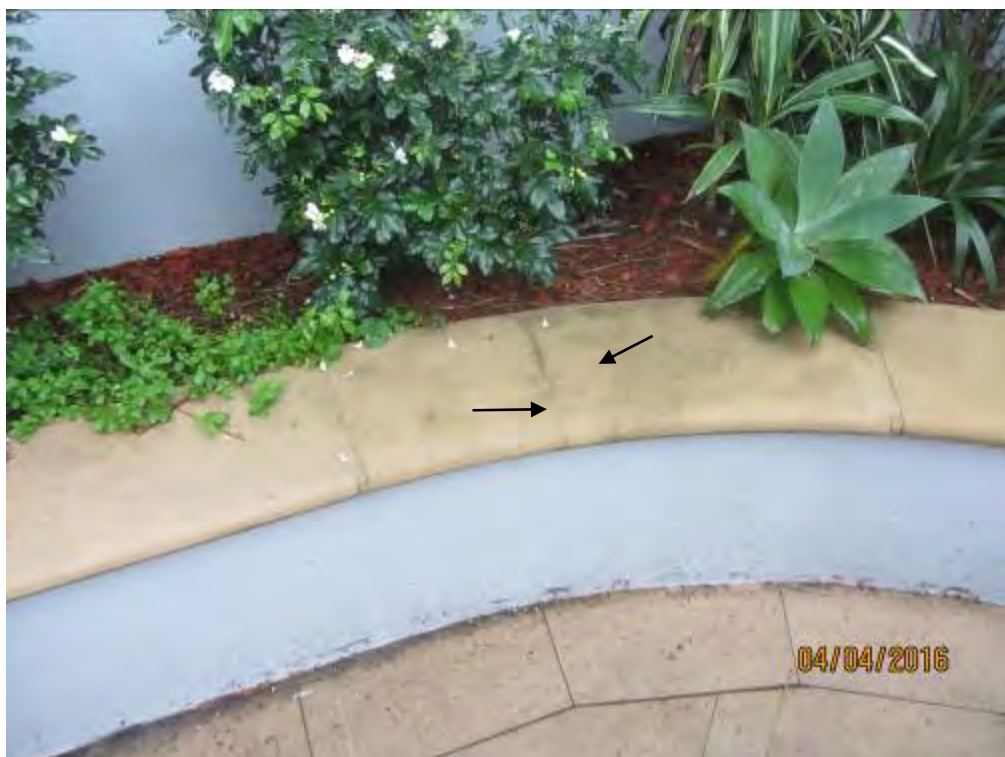
We noted that there is hairline cracking [1.0mm] to the sandstone capping to the garden bed retaining walls. **[Photographs 20, 21 and 22]**

**Photograph 20** shows typical hairline cracking to the garden bed retaining wall capping

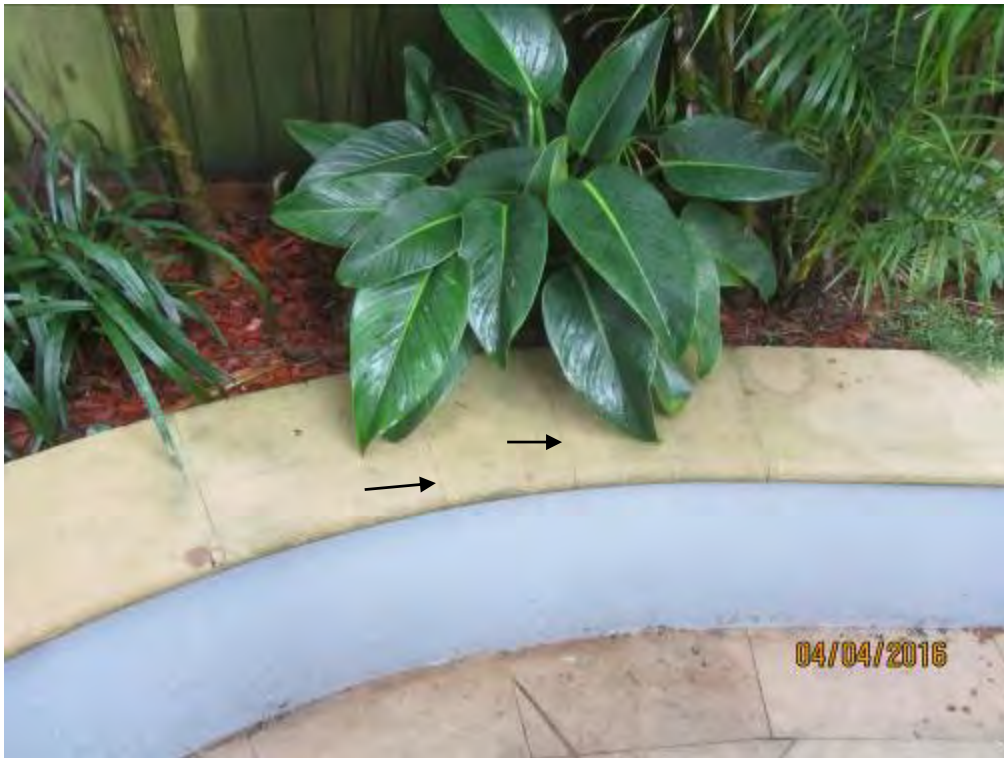
**Photograph 21** shows typical hairline cracking to the garden bed retaining wall capping

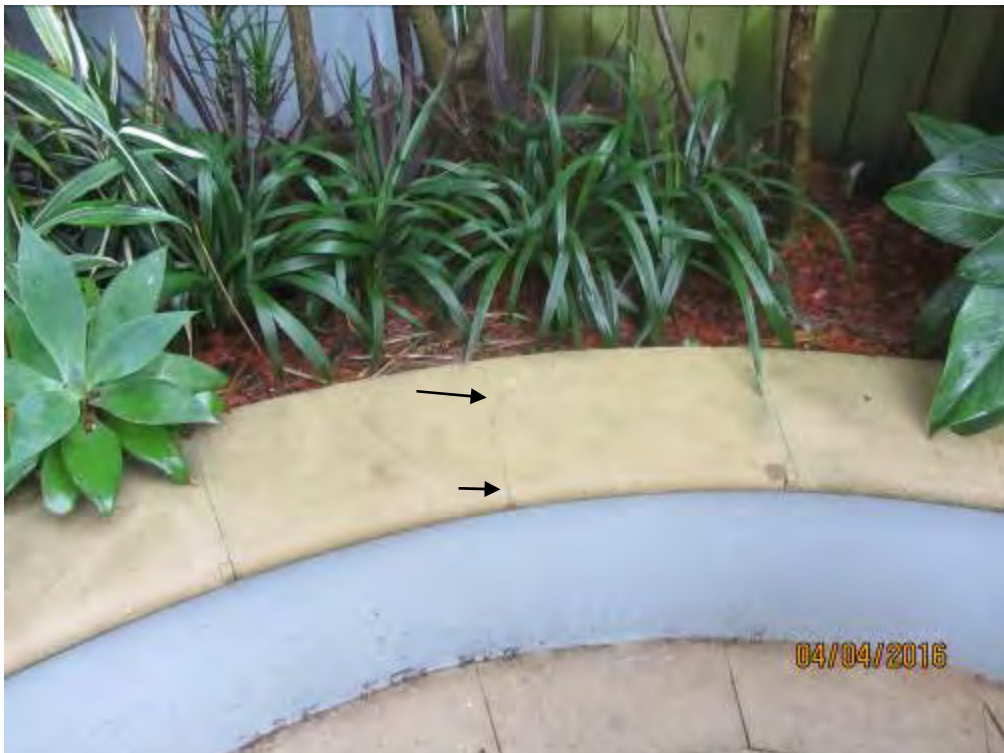
**Photograph 22** shows typical hairline cracking to the garden bed retaining wall capping

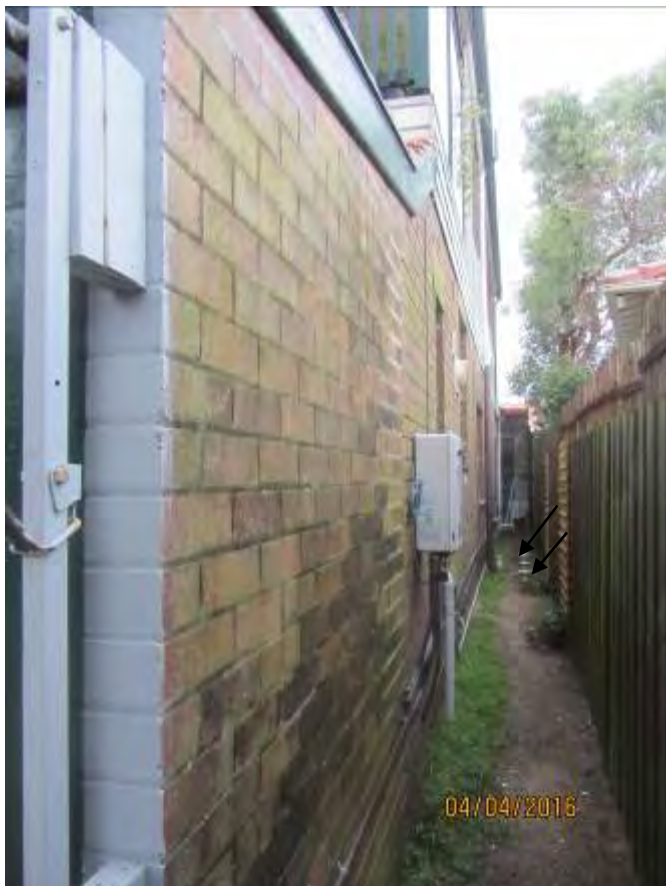
We noted that there is evidence of repairs / possible upgrading to the sewer drainage along the southern boundary. **[Photograph 23]**

**Photograph 23** shows the southern boundary – Note: there is evidence of previous repairs to the drainage system

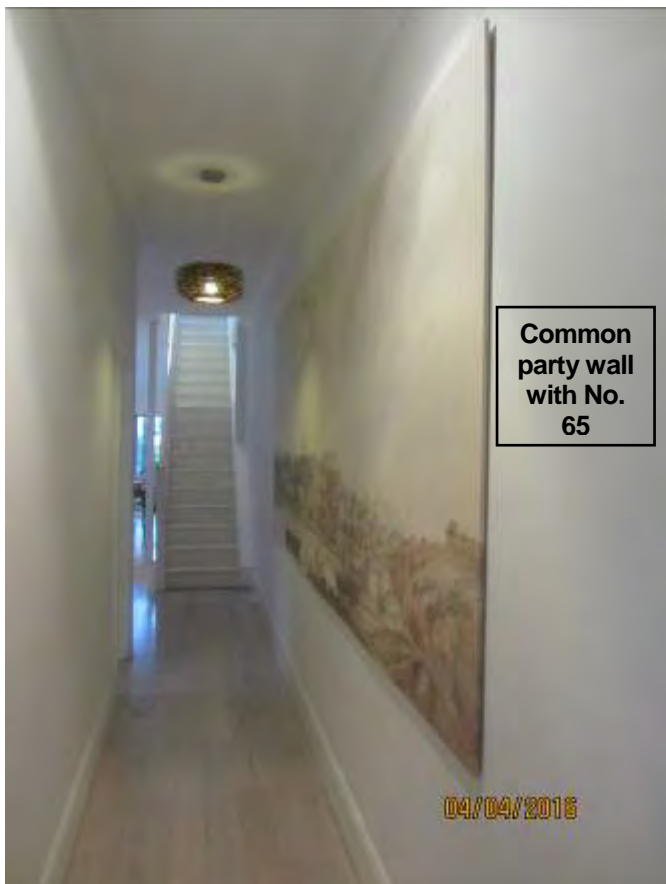
We noted that the northern wall of the Hallway is the *common party / separation* wall with the adjoining property, No. 65 Glenayr Avenue. We noted that the wall is partially concealed with large picture. **[Photograph 24]**

**Photograph 24** shows the Hallway viewed towards the Living room – Note: the extent of the painting attached to the common party wall

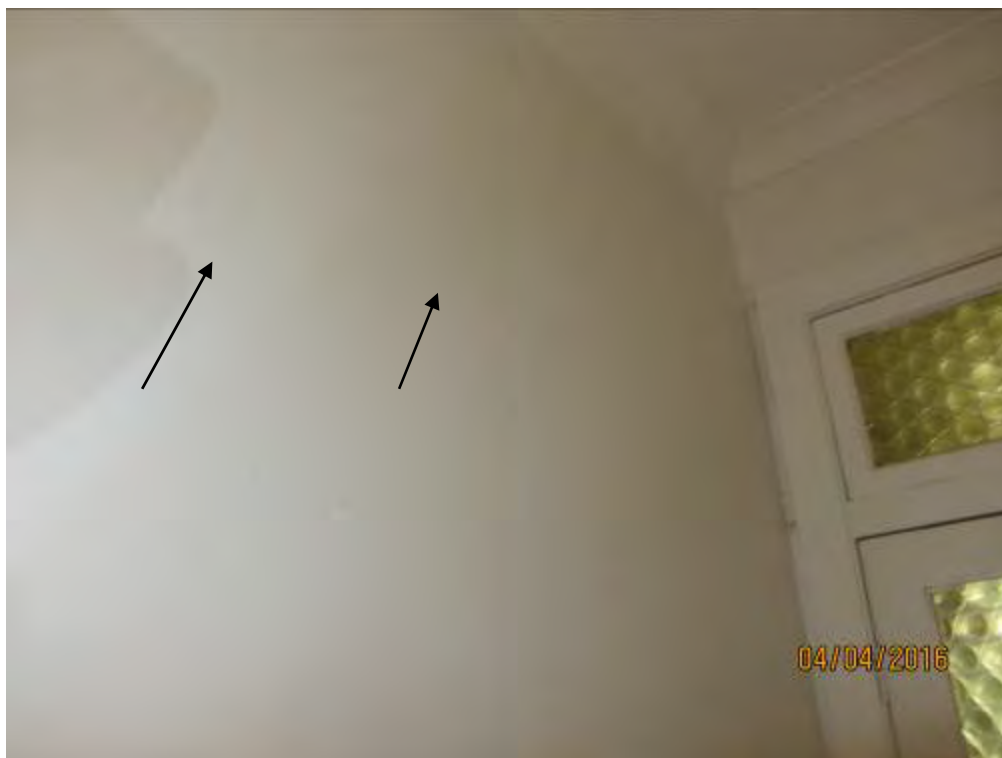
We did not observe any recent noticeable cracking to the surface coated cement rendered wall surfaces. We noted that there is a different surface texture to the top of the wall, from our experience indicative of the original picture rail being removed. **[Photograph 25]**

**Photograph 25** shows different surface texture to the *common party* wall indicative of the removal of the picture rail

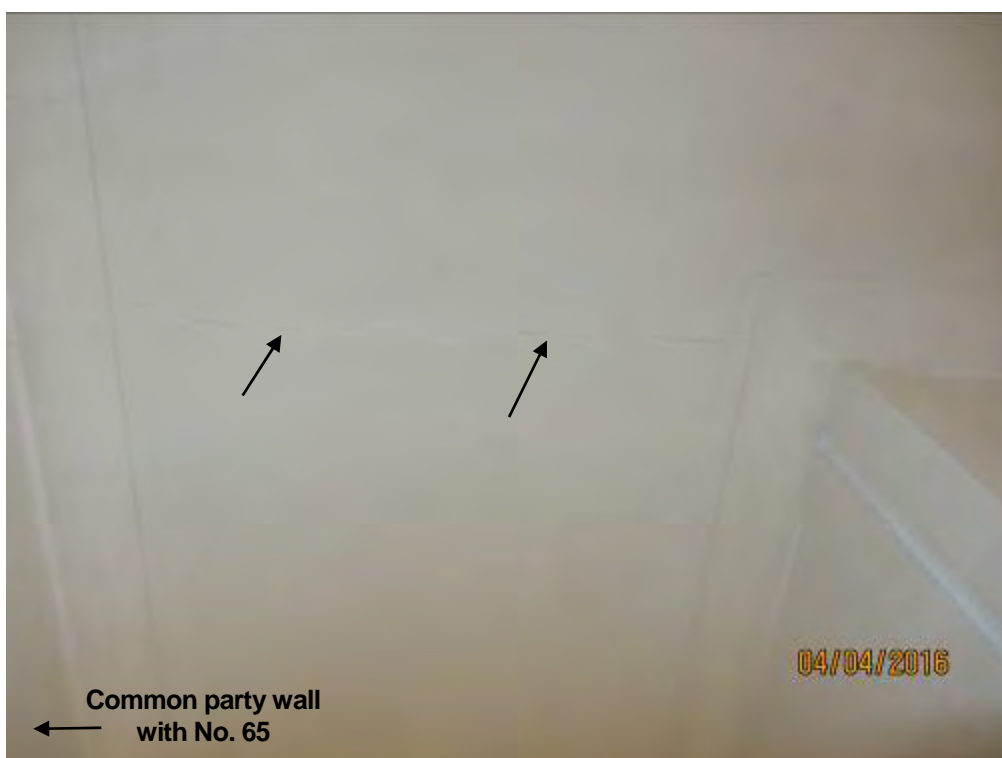
We did not observe any cracking to the plasterboard ceiling lining or to the cove profile plaster cornices. Notwithstanding this we did not a hairline crack to the set joint between the Hallway ceiling and the Living room ceiling. **[Photograph 26]**

**Photograph 26** shows the hairline crack to the set joint to the plasterboard at the junction of the Hallway and Living room

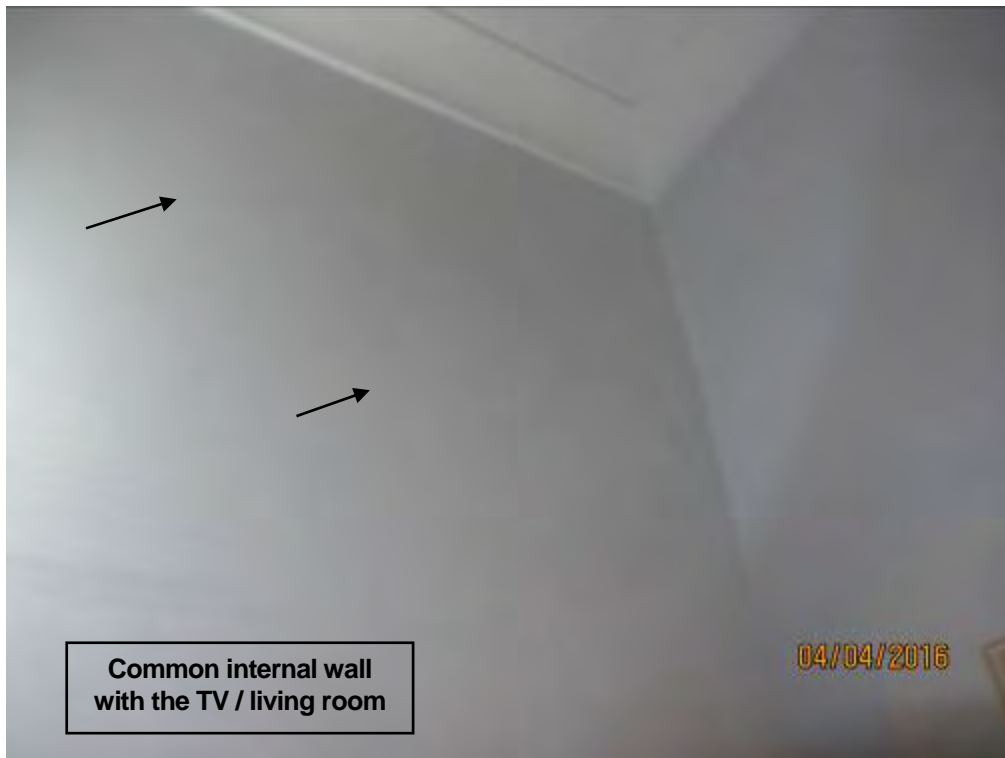
We did not observe any recent noticeable cracking to the surface coated cement rendered wall surfaces. Notwithstanding this, we did not a previously repaired radial crack extending from the northwest corner of the room towards the cornice. **[Photograph 27]**

**Photograph 27** shows previously repaired radial crack to the northwest corner of the front Bedroom

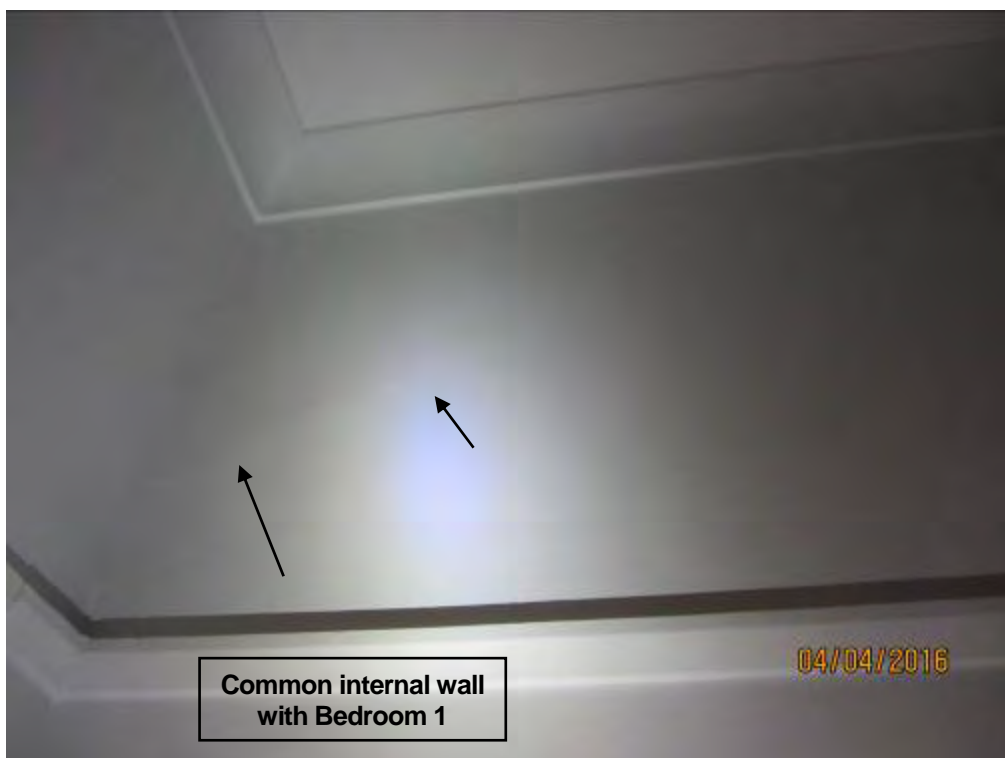
Notwithstanding this, we did not a previously repaired radial crack extending from the northeast corner of the room towards the cornice. **[Photograph 28]**

**Photograph 28** shows previously repaired radial crack to the northeast corner of the TV / Living room
