## Dilapidation Assessment Report

Prepared for: **Cape Cod Australia Pty. Limited**  
Job address: **67 Glenayr Avenue, North Bondi NSW**  
Property Owner/s: **Mr. P. Bize**  
Report reference: **WAVERLEY COUNCIL**  
Development Application No: not available  
Date of assessment: **4<sup>th</sup> April 2016**

**Re: Dilapidation Report: No. 67 Glenayr Avenue, North Bondi**

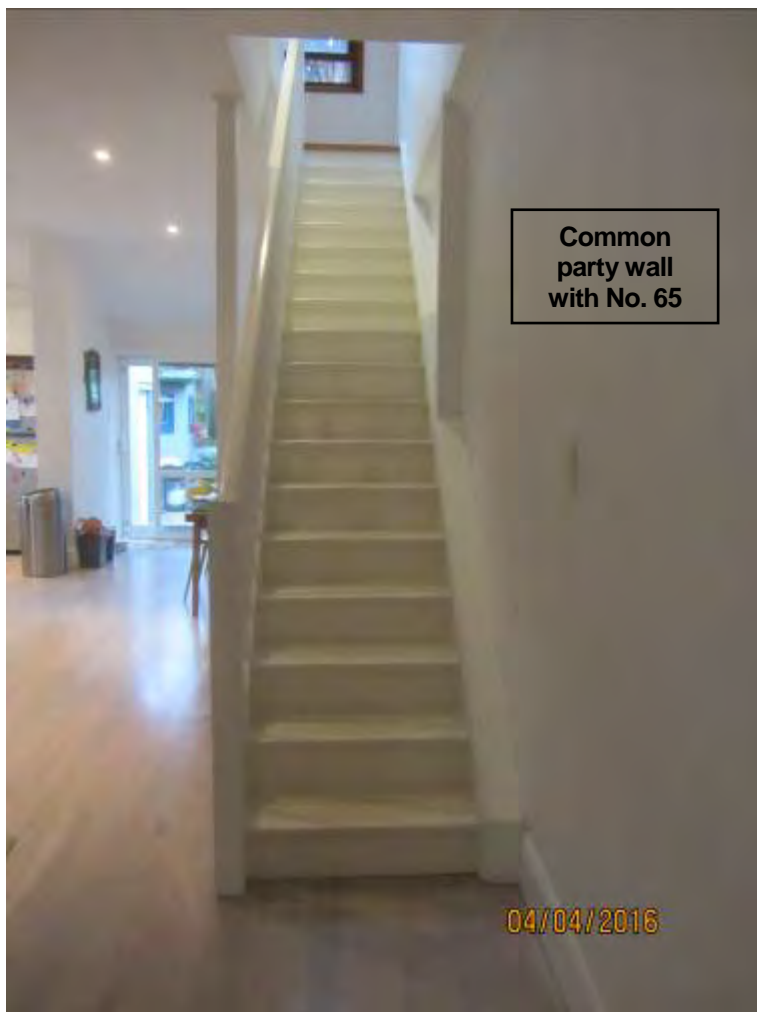
We noted that the closed tread timber staircase abuts / supported by the *common party / separation* wall with the adjoining property, No. 65 Glenayr Avenue. **[Photograph 29]**

**Photograph 29** shows the internal stairs supported by the *common party wall*

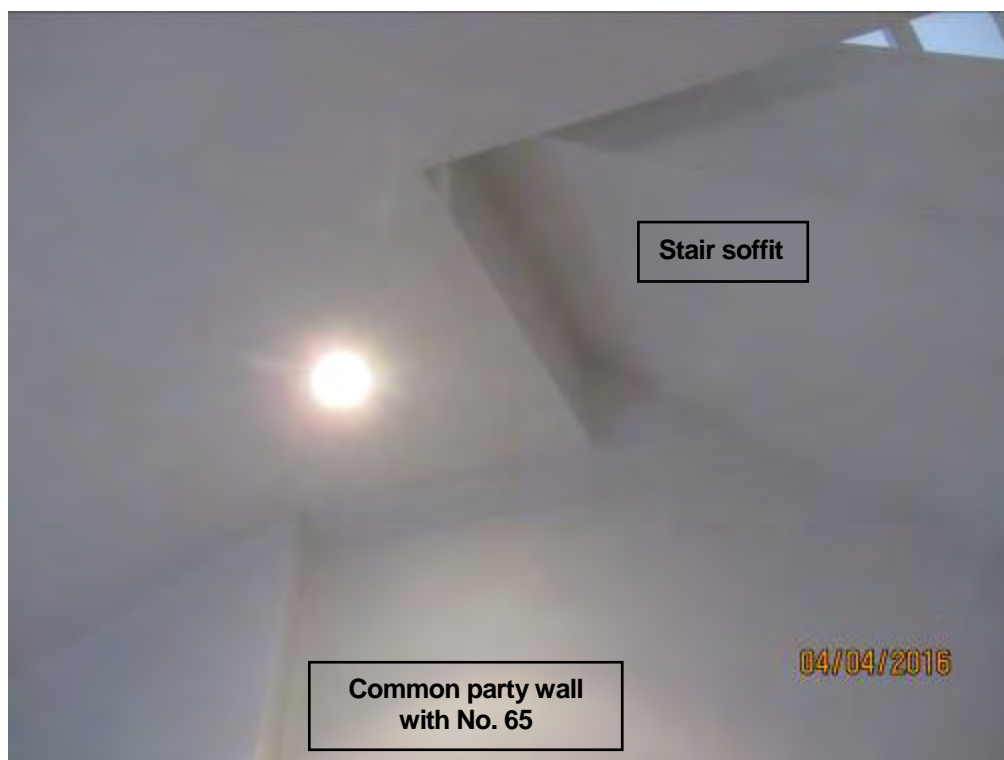
We did not observe any cracking to the to the plasterboard ceiling or to the cove profiled cornices or to the square set wall ceiling junctions particularly along the *common party / separation* wall. **[Photograph 30]**

**Photograph 30** shows the square set wall / ceiling junction under the staircase

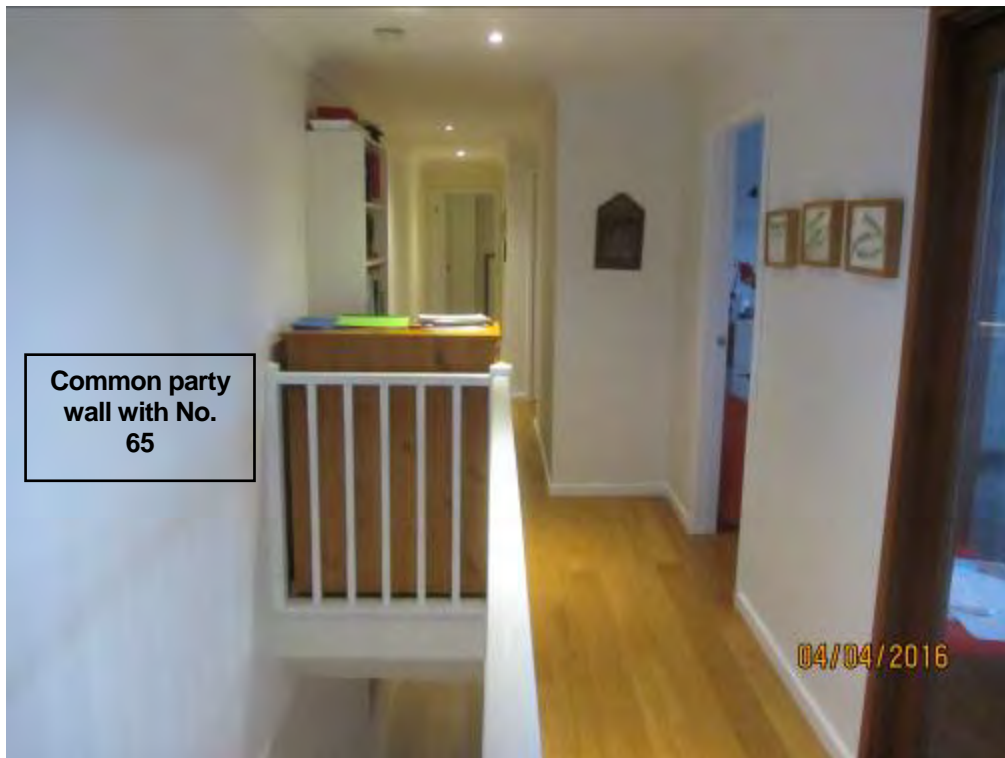
We noted that the northern wall of the area is the *common party / separation* wall with the adjoining property, No. 65 Glenayr Avenue. **[Photograph 31]**

**Photograph 31** shows the stairwell / foyer / Hallway of the upper floor level

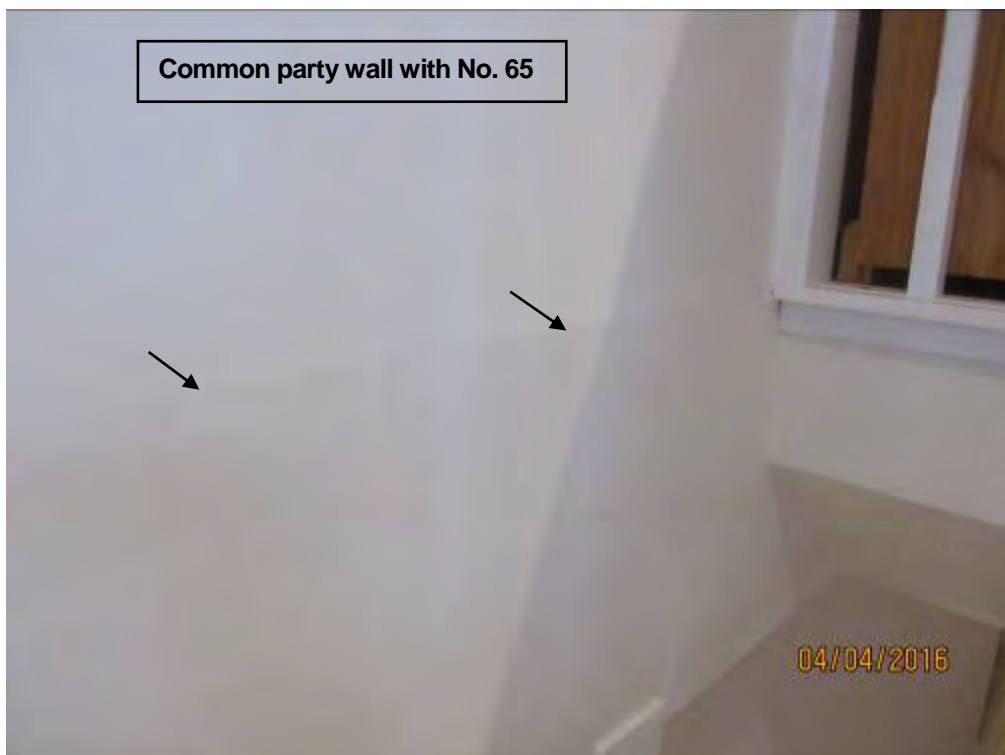
We did not observe any cracking to the plasterboard wall linings. Notwithstanding this we noted 'peaking' of the plasterboard at the junction between the ground floor level and the upper level framed wall. **[Photograph 32]**

**Photograph 32** shows 'peaking' to the joint between the ground floor level and upper floor frame

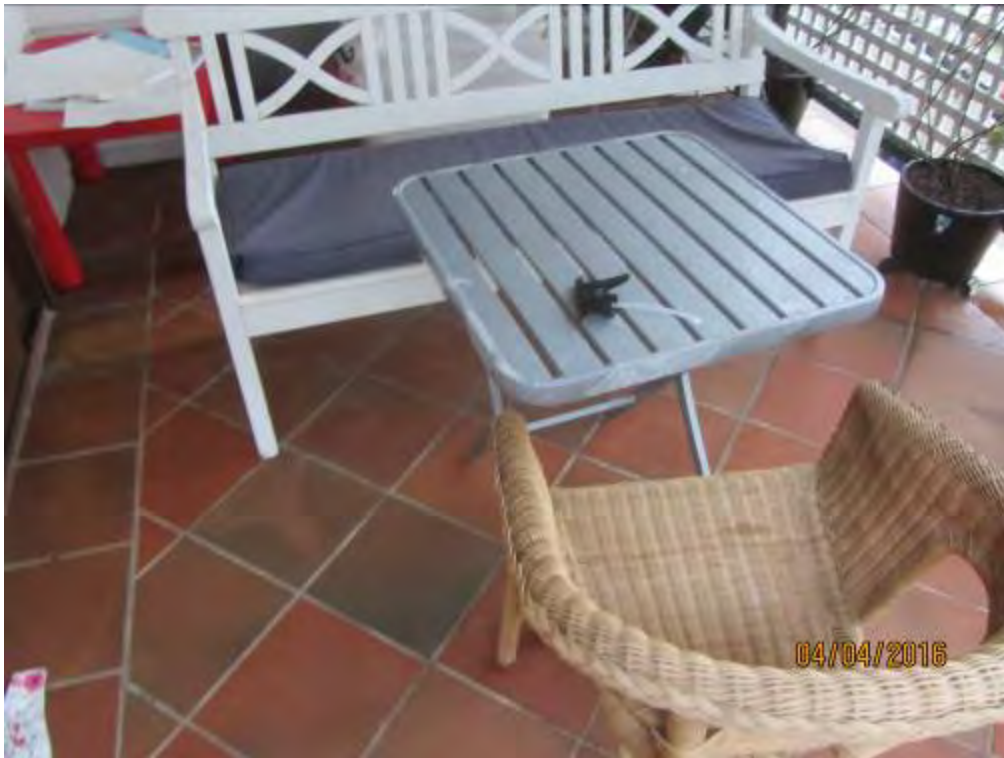
#### **[Photograph 33]**

We noted that the deck structure is probably compressed fibre-cement sheet with quarry tiles forming the deck surface. We noted that the deck is constructed over a habitable room [Kitchen]. Due to concealment by the deck tiles we are unable to comment on the method of waterproofing the deck or the condition of the waterproofing. We noted that the method of construction does not permit inspection of the under deck area.

We noted that the grout to the deck tiles is generally complete and that the tiles when randomly “tap” tested appeared to be sound.

We noted that the treated pine lattice and balustrade is generally in good condition.

**Photograph 33** shows the condition of the tiling to the rear upper level balcony
