HAZARDOUS MATERIALS ASSESSMENT REPORT

Job details: Owner/s: Mr. I. Maric & Ms. S. Malnar
Location: 12 Celebes Street, Kings Park NSW

Our reference: HM03800315

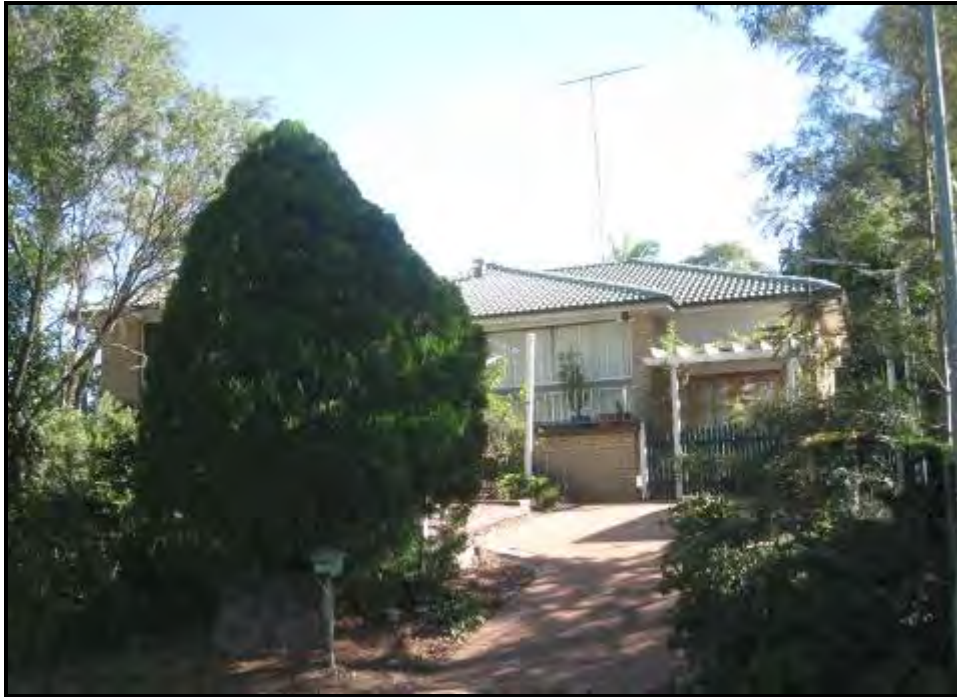
Front southern elevation of the residence
