## Dilapidation Assessment Report

Prepared for: **Cape Cod Australia Pty. Limited**  
Job address: **13 Towns Road, Vacluse**  
Property Owner/s: **Mr. & Mrs. Reid**  
Report reference: **WOOLLAHRA MUNICIPAL COUNCIL**  
Development Application No: not available  
Date of assessment: 4<sup>th</sup> February 2016

**Re: Dilapidation Report - No. 13 Towns Road, Vacluse**

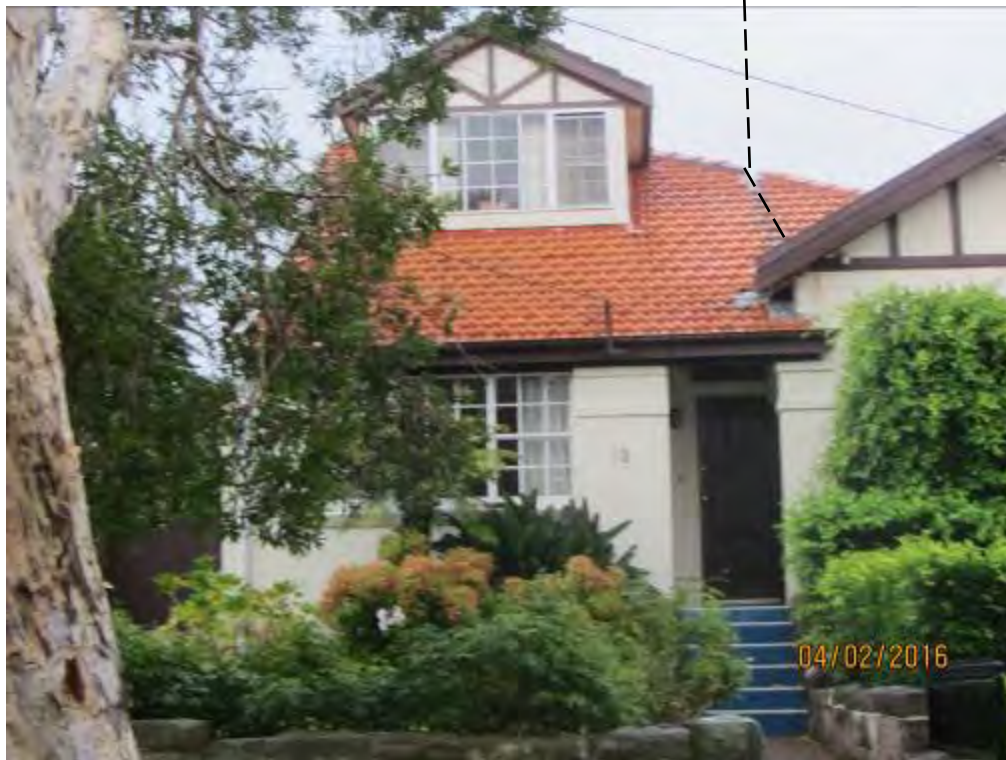
We observed that the terra cotta roof tiles to the original roof surface and to the first floor addition are generally interlinked and securely bedded. During our internal inspection of the first floor rooms we found no evidence to suggest that the roof was not weather tight. **[Photograph 1]**

**Photograph 1** shows the front southern elevation of this property; No. 13 Towns Road

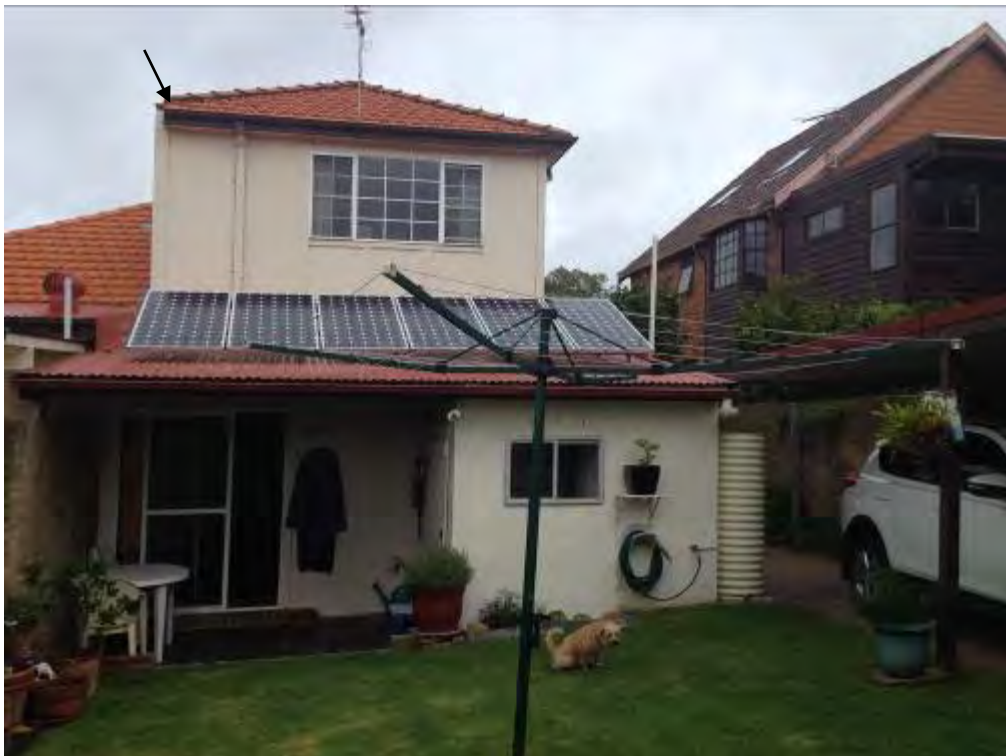
We noted that the eastern surface water from the first floor addition roof discharges into gutter located over the *common party / separation* wall with the adjoining property, No. 11 Towns Road. **[Photograph 2]**

We did not observe any recent cracking to the surface coated wall surfaces. **[Photograph 2]**

**Photograph 2** shows the rear northern elevation of the residence – Note: the gutter servicing the eastern first floor roof surface is located over the *common party / separation wall*

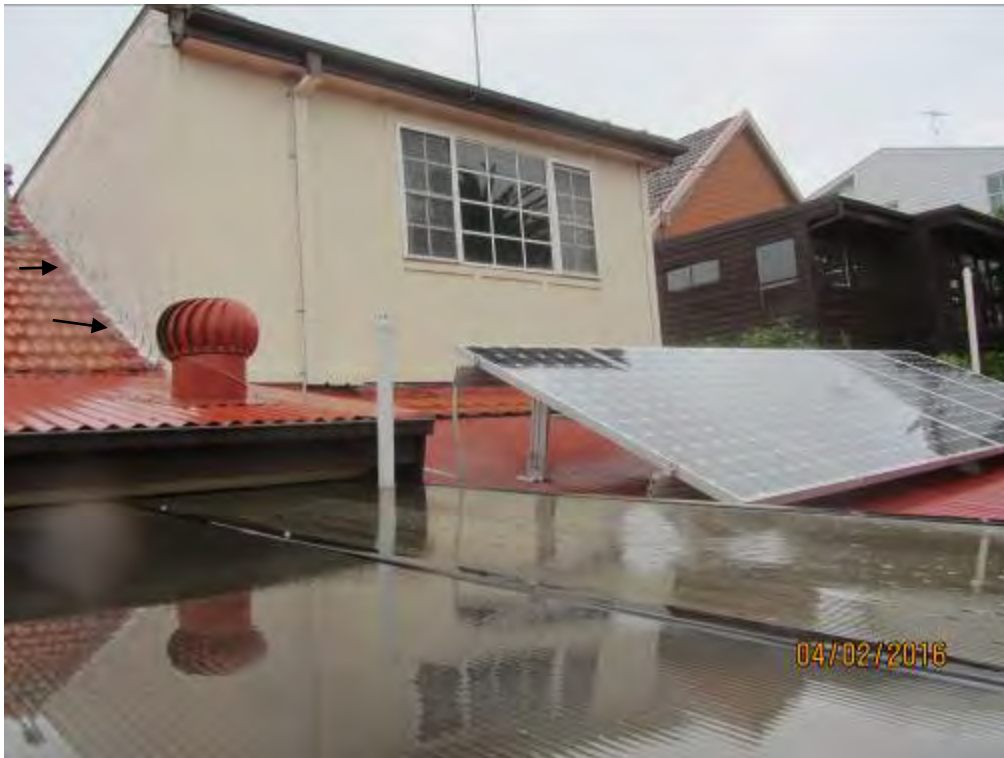
We also noted that the stepped flashing between the wall of the first floor addition and the terra cotta tiled roof of the adjoining property, No. 11 Towns Road is intact and forming a weather resistant seal between the wall and the roof surface. **[Photograph 3]**

**Photograph 3** shows the stepped flashing to the *common party / separation* wall [eastern elevation] and solar panels located over the rear skillion roof

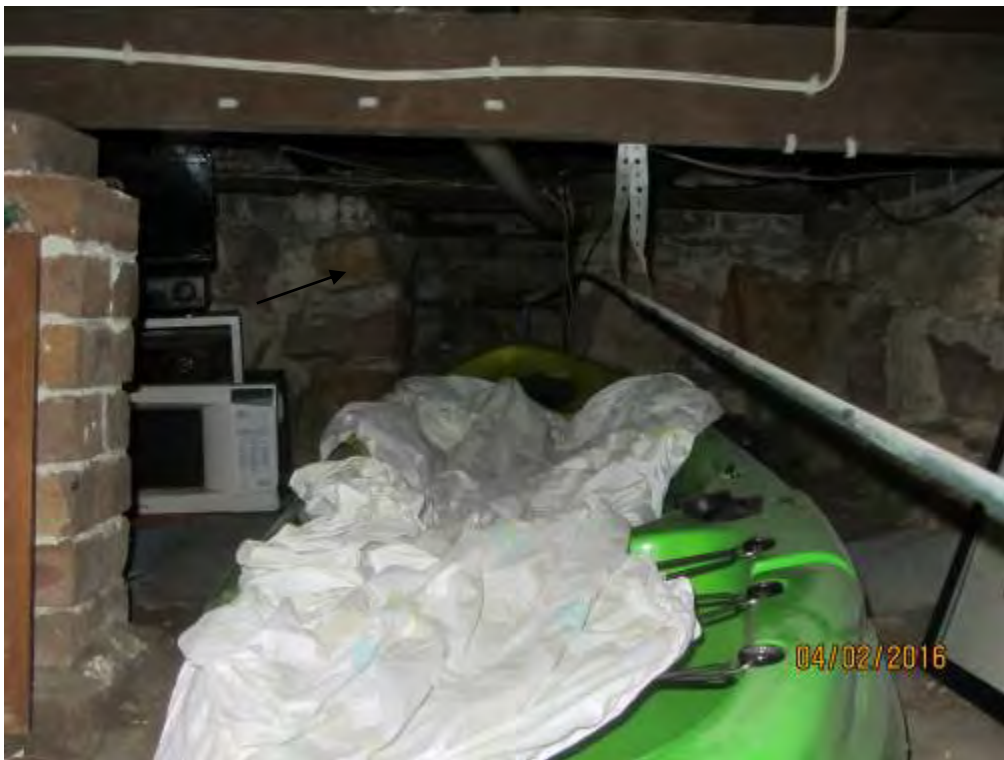
Based on our assessment of the under floor area to the adjoining property, “we noted that the *common party / separation* wall is supported below floor level on random sandstone rock footings”. **[Photograph 4]**

We are unable to provide comment on the structural adequacy of the footings supporting the *common party / separation* wall.

**Photograph 4** shows the random sandstone rock *common party / separation* wall in the sub floor area – viewed from the adjoining property

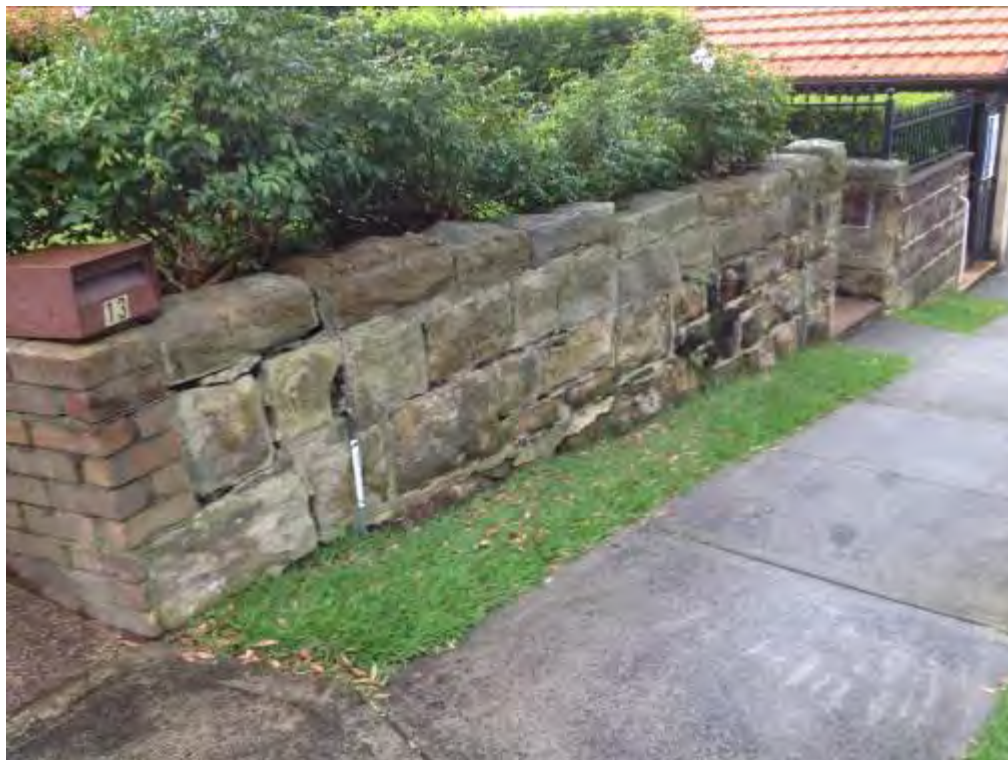
We noted that the front boundary is formed by a random sandstone block retaining wall. **[Photograph 5]**

We also noted areas of displaced mortar for the sandstone blockwork. **[Photograph 5]**

**Photograph 5** shows the condition of the random sandstone block front boundary wall – Note: missing / displaced mortar from between the blockwork

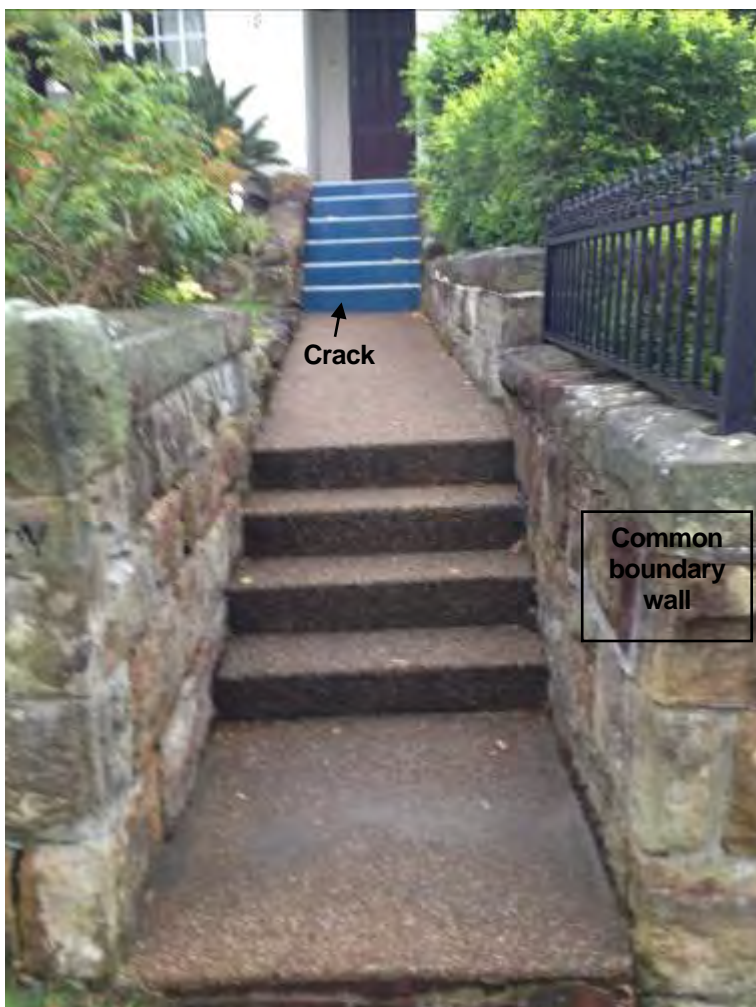
We notes that the front entry pathway and steps are finished with a proprietary ‘pebblecrete’ topping. We noted that the topping is generally sound. **[Photograph 6]**

We noted that the front entry steps leading from the entry path are finished with glazed tiles. We noted that there is a horizontal crack in the first riser tiles. **[Photographs 6 and 7]**

**Photograph 6** shows the front entry pathway and the entry steps and location of horizontal crack to the riser tiles to the first step

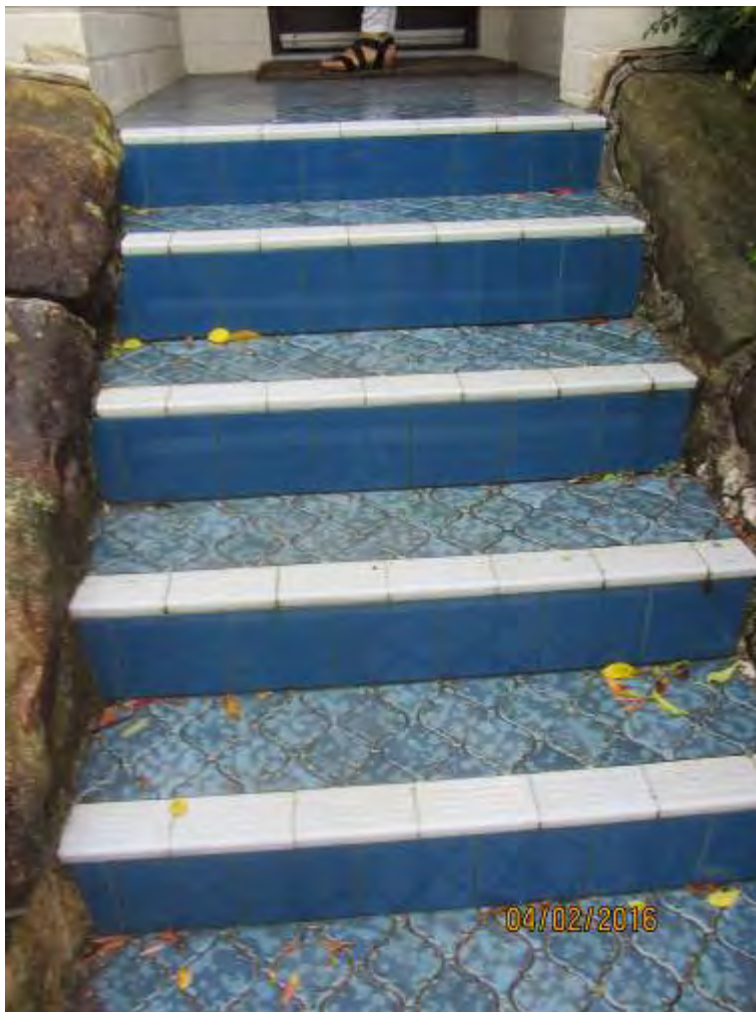
**Photograph 7** shows the condition of the front entry steps

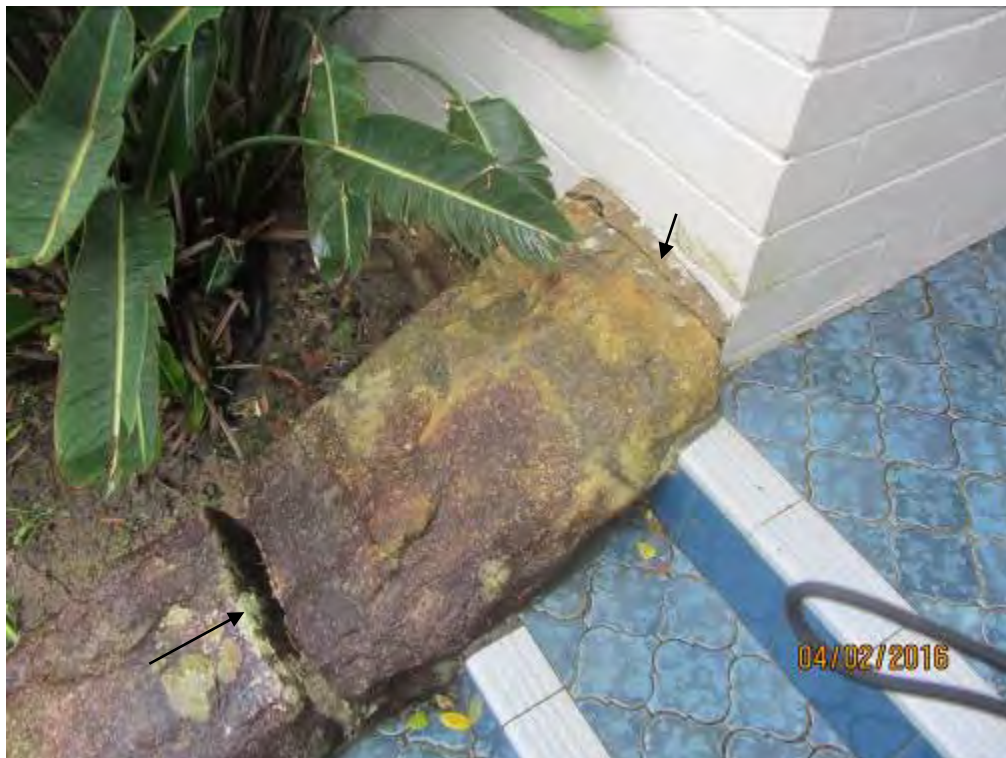
We noted that there is cracking between the sandstone blockwork abutting the steps and areas of displaced mortar for the sandstone blockwork. **[Photographs 8 and 9]**

**Photograph 8** shows cracking and displaced mortar to the sandstone blockwork to the entry steps

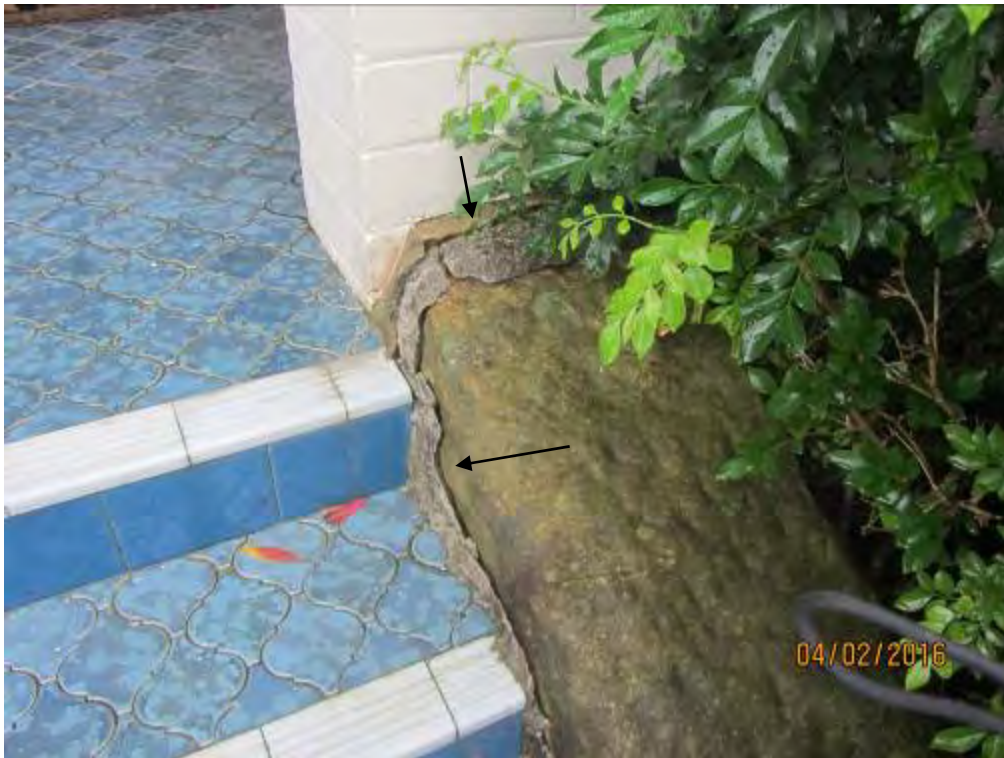
**Photograph 9** shows cracking between the front entry steps and the sandstone blockwork

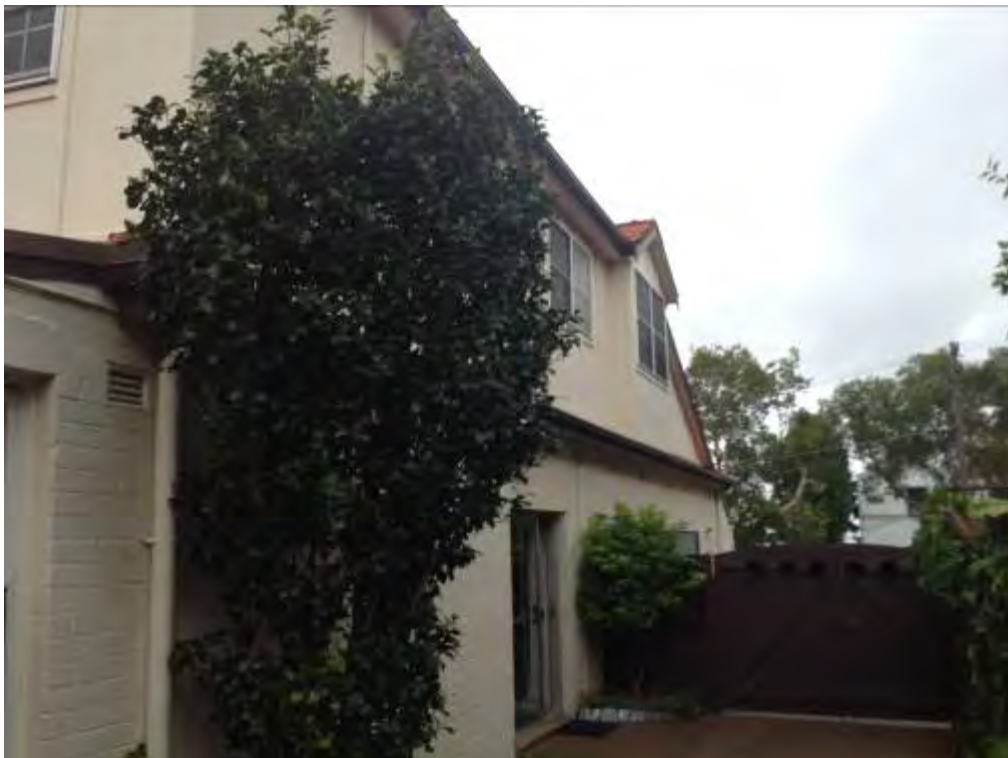
We noted that there is minor ageing and general deterioration of the surface coating to the cladding and timber trims. **[Photograph 10]**

**Photograph 10** shows the western elevation of the residence

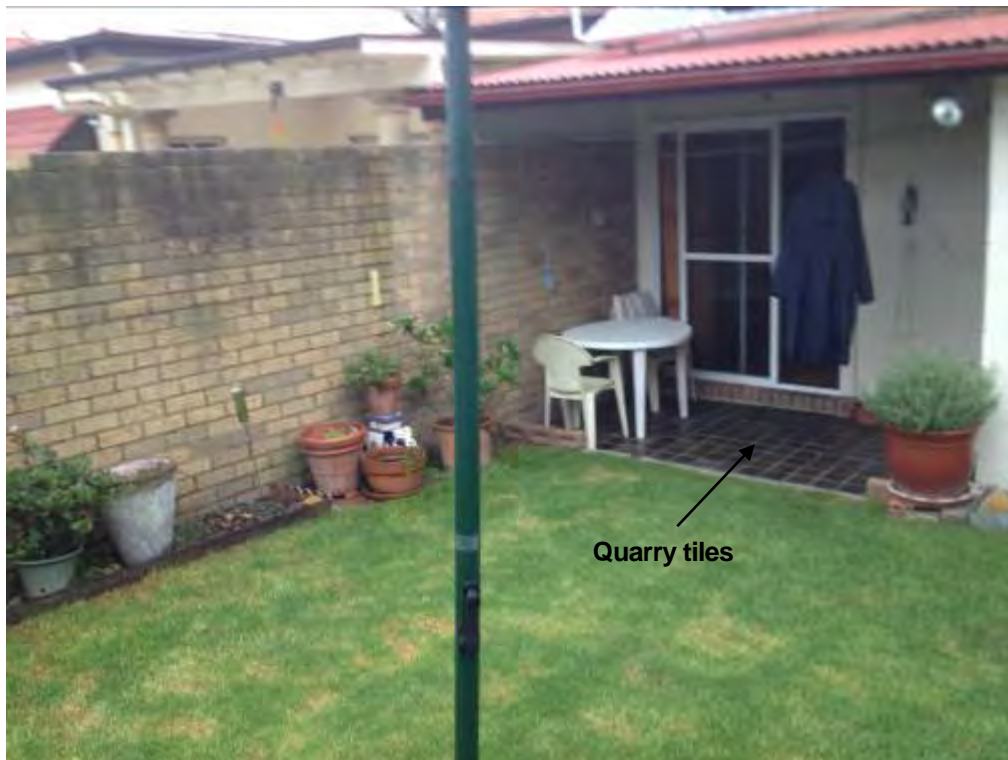
We noted that the grout to the quarry tiles to the rear patio is complete and that the tiles when randomly “tap” tested were sound. **[Photograph 11]**

We did not observe any recent cracking to the face brickwork. **[Photograph 11]**

**Photograph 11** shows the rear *common boundary* wall between the properties and quarry tiles to the rear patio

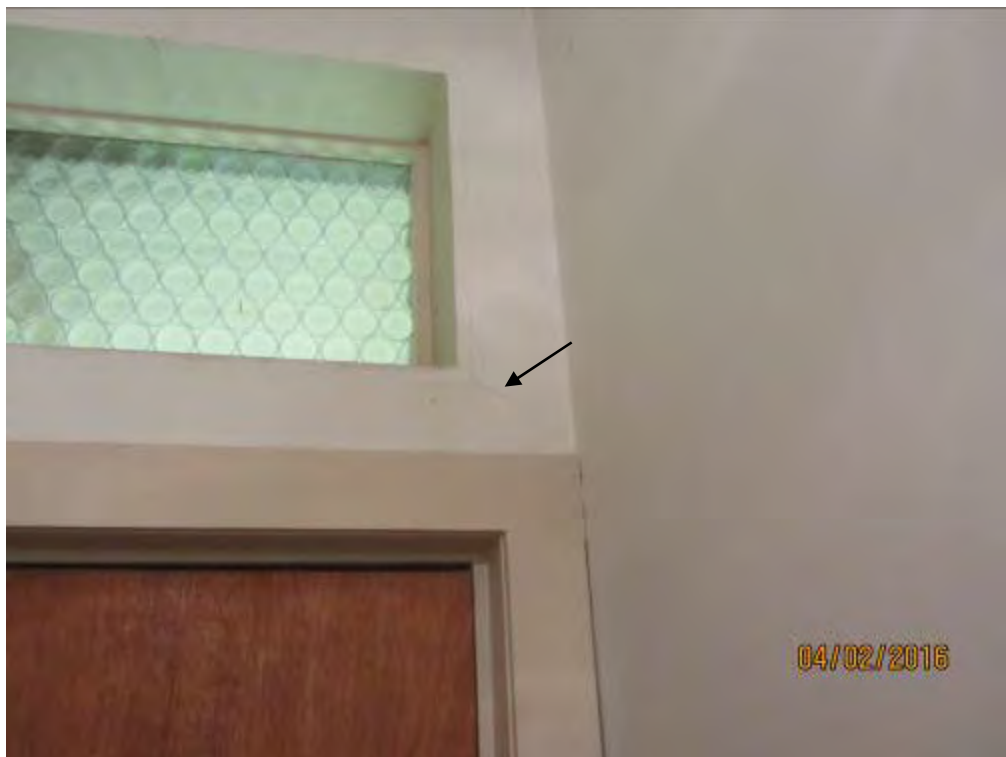
We noted a hairline radial crack [ $<1.0\text{mm}$ ] extending from the right hand side of the front entry door towards the highlight window. [**Photograph 12**]

**Photograph 12** shows the radial crack extending from the front entry door head towards the highlight

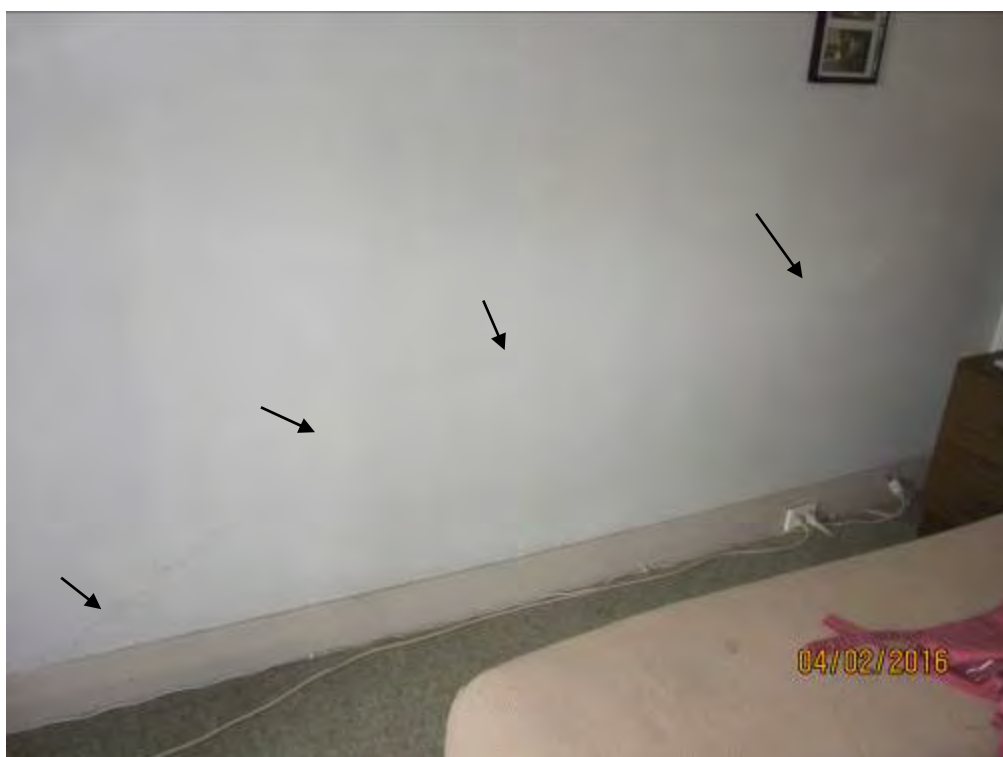
We noted hairline radial cracks [ $<1.0\text{mm}$ ] to the western external wall extending from floor level towards the northwest corner of the room. [**Photographs 14 and 15**]

**Photograph 14** shows a radial crack to the western wall of Bedroom 1 extending floor level towards the northwest corner of the room

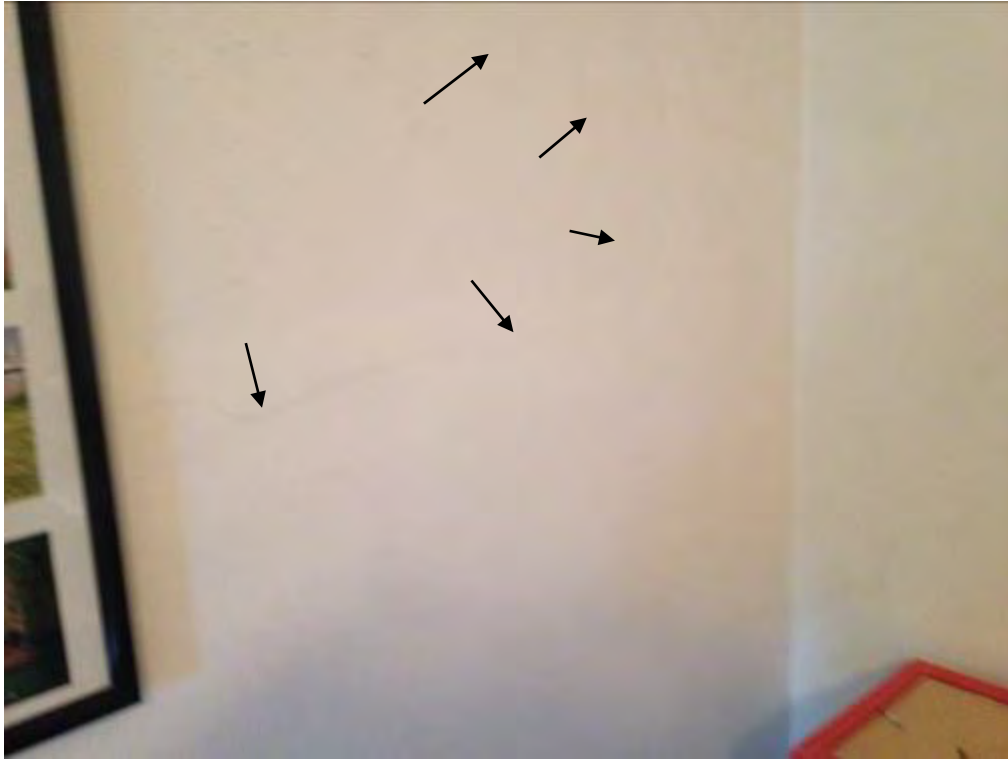
**Photograph 15** shows hairline cracks to the western wall of Bedroom 1 extending towards the northwest corner

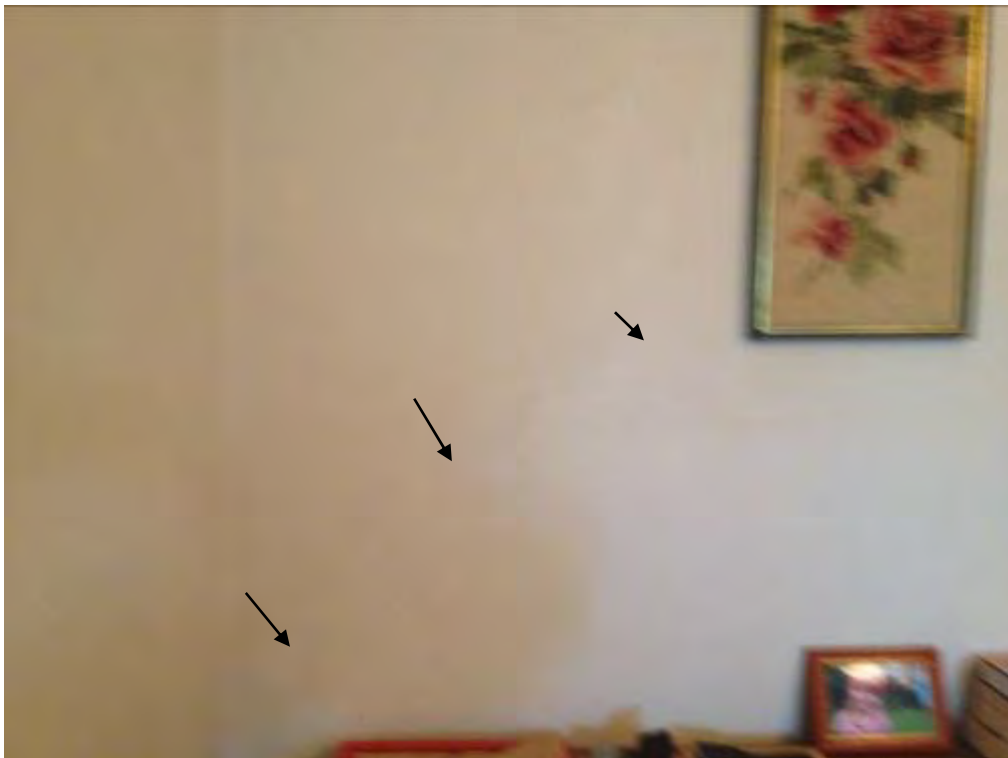
We noted that the crack further extends to the northern wall towards the cornice line. [**Photographs 16 and 17**]

**Photograph 16** shows a hairline crack to the north western corner of Bedroom 1

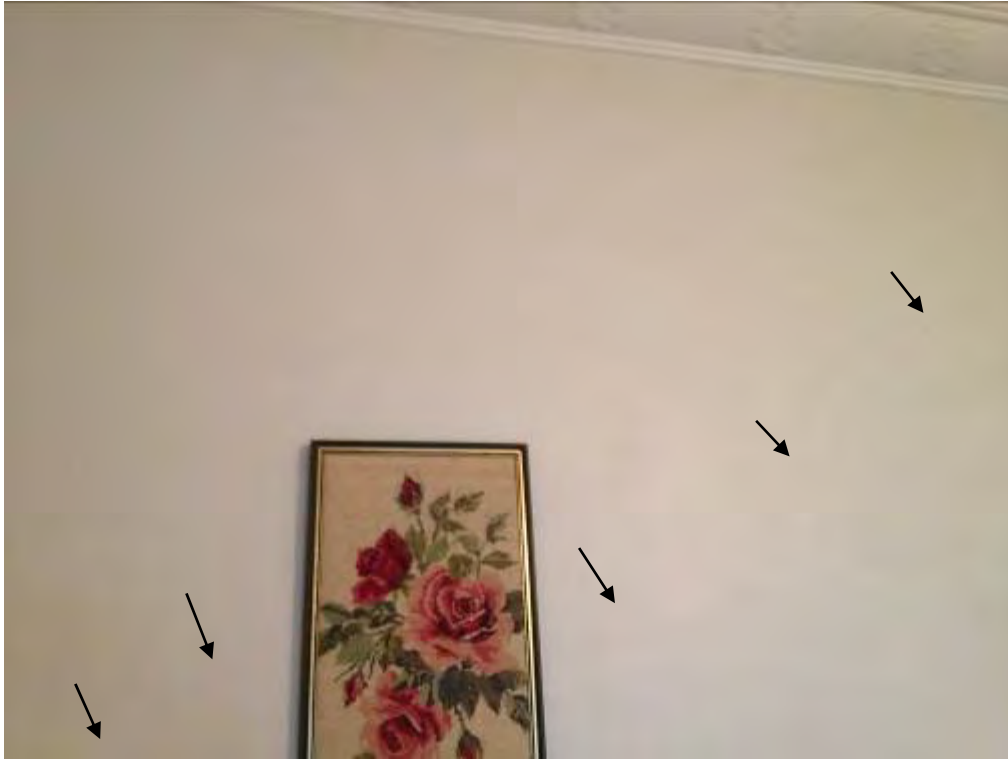
**Photograph 17** shows a hairline crack to the north wall of Bedroom 1

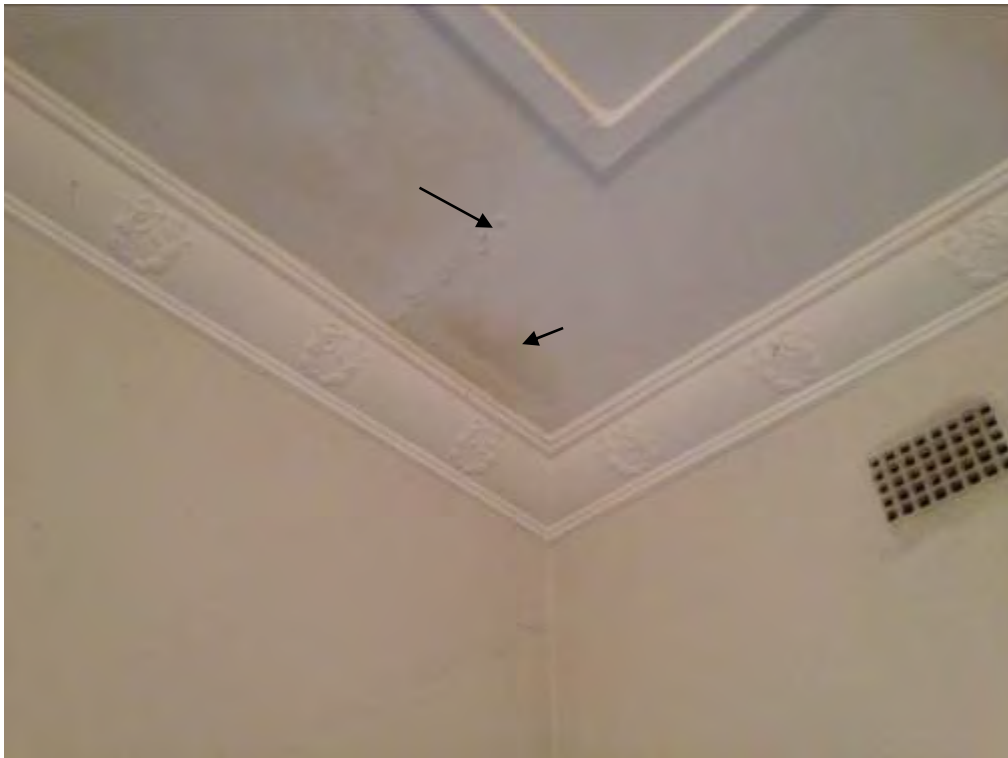
Notwithstanding this, we noted brown staining to the ceiling and a hairline crack to the set joint in the ceiling at the front southwest corner of the room. [**Photograph 18**]

**Photograph 18** shows staining to the ceiling and a crack to the ceiling to the southwest corner of Bedroom 1

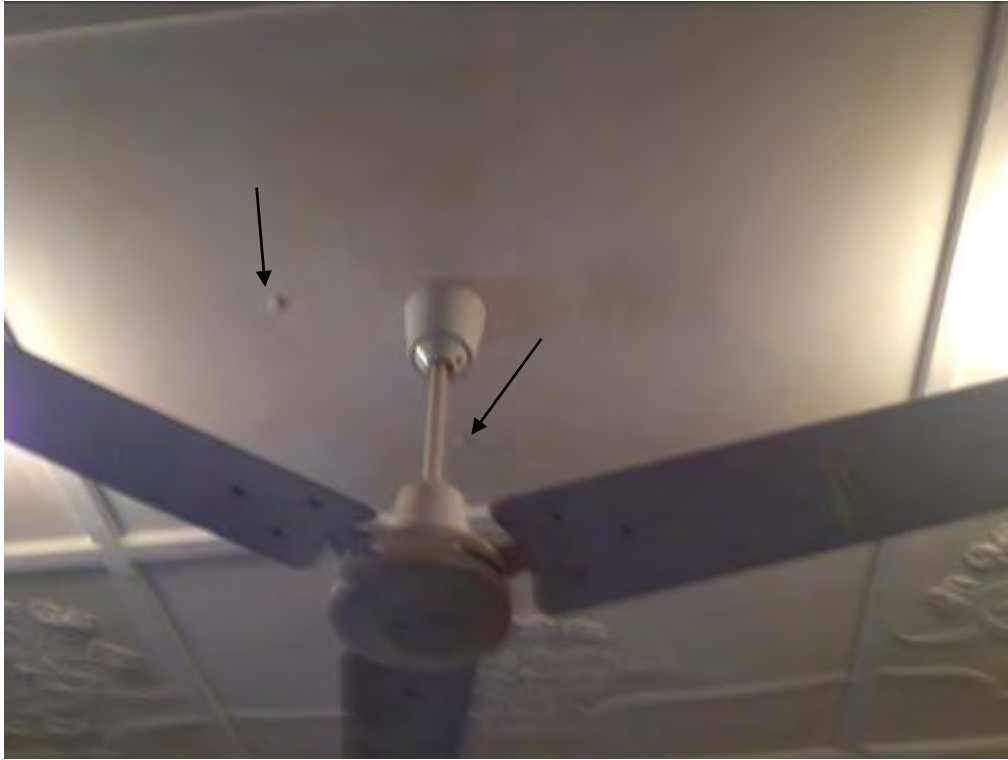
We noted flaking [lifting] paint from the ceiling in the immediate vicinity of the ceiling fan. [**Photograph 19**]

**Photograph 19** shows lifting paint from the ceiling of Bedroom 2

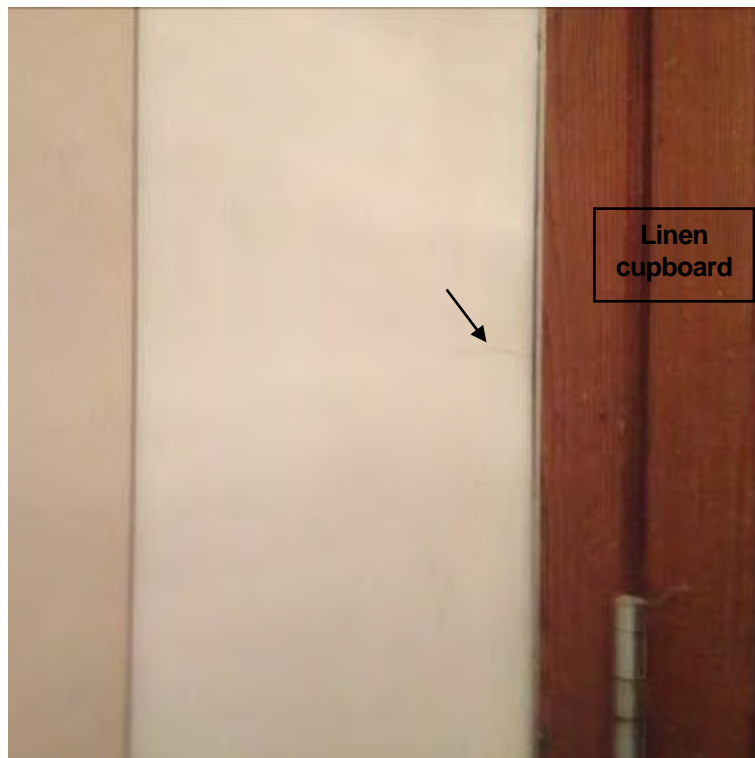
We noted a horizontal hairline crack adjacent to the left hand side of the linen cupboard door. [**Photograph 20**]

**Photograph 20** shows a hairline crack adjacent to the left hand side of the linen cupboard

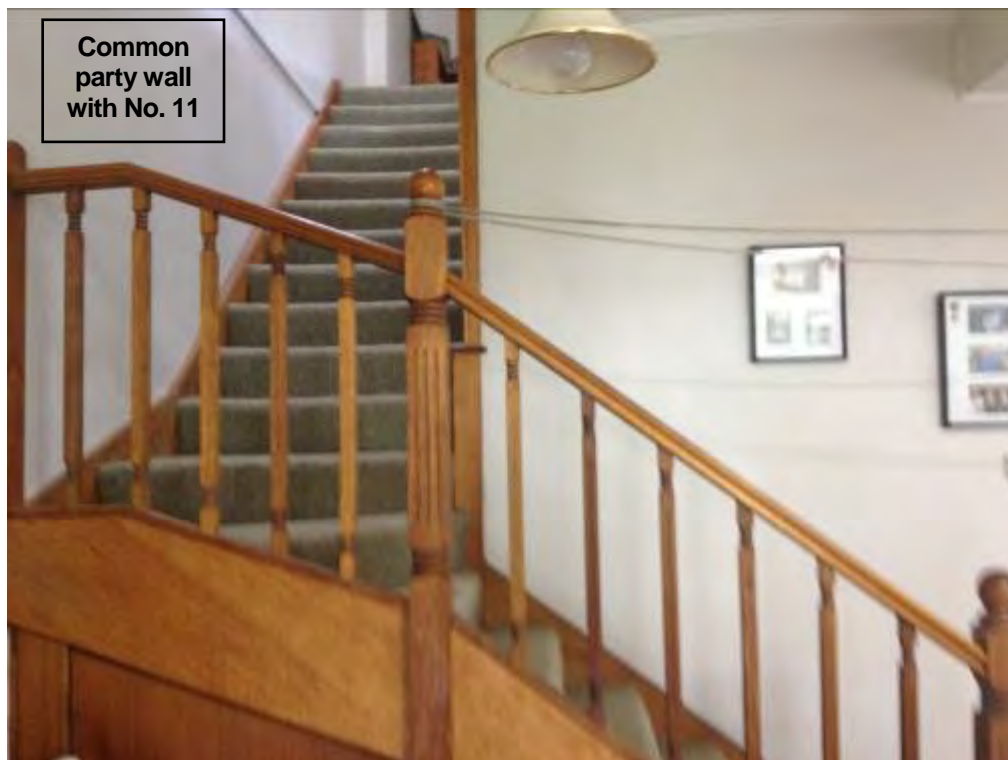
We did not observe any recent noticeable cracking to the surface coated cement rendered wall surfaces. We noted that the closed timber tread stairs are supported on the *common party / separation* wall. **[Photograph 21]**

**Photograph 21** shows the stair layout and the stairs being supported on the *common party/ separation* wall

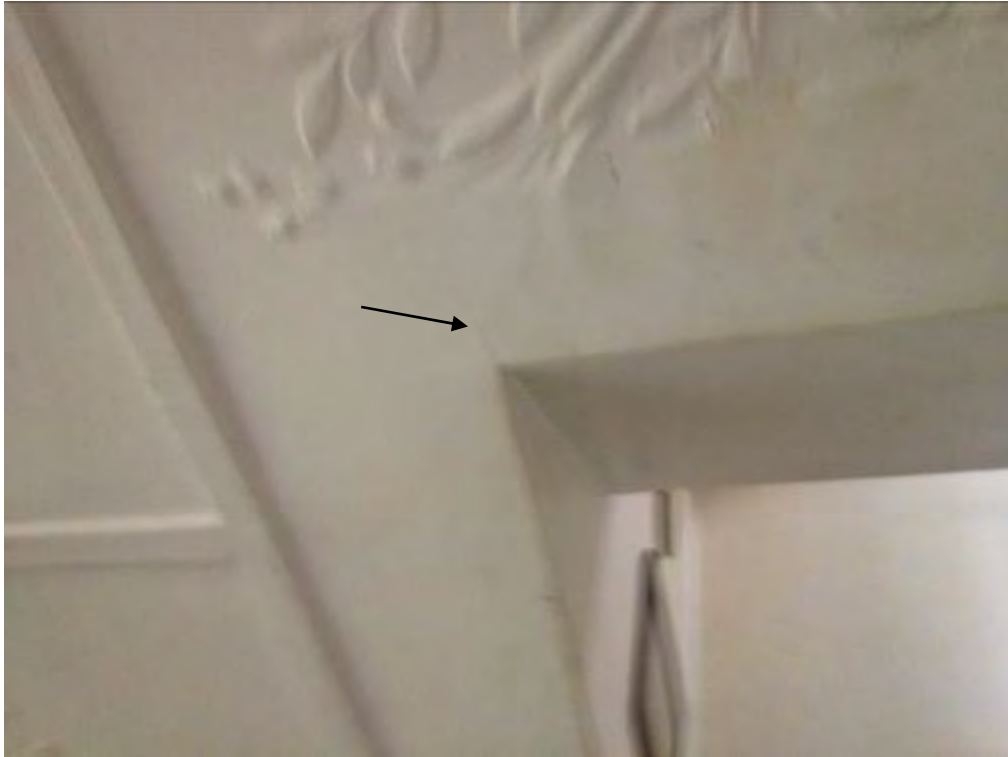
We also noted a hairline crack to the external corner of the bulkhead at the first landing to the stairs. **[Photograph 23]**

**Photograph 23** shows a hairline crack to the bulkhead at the first landing of the stair

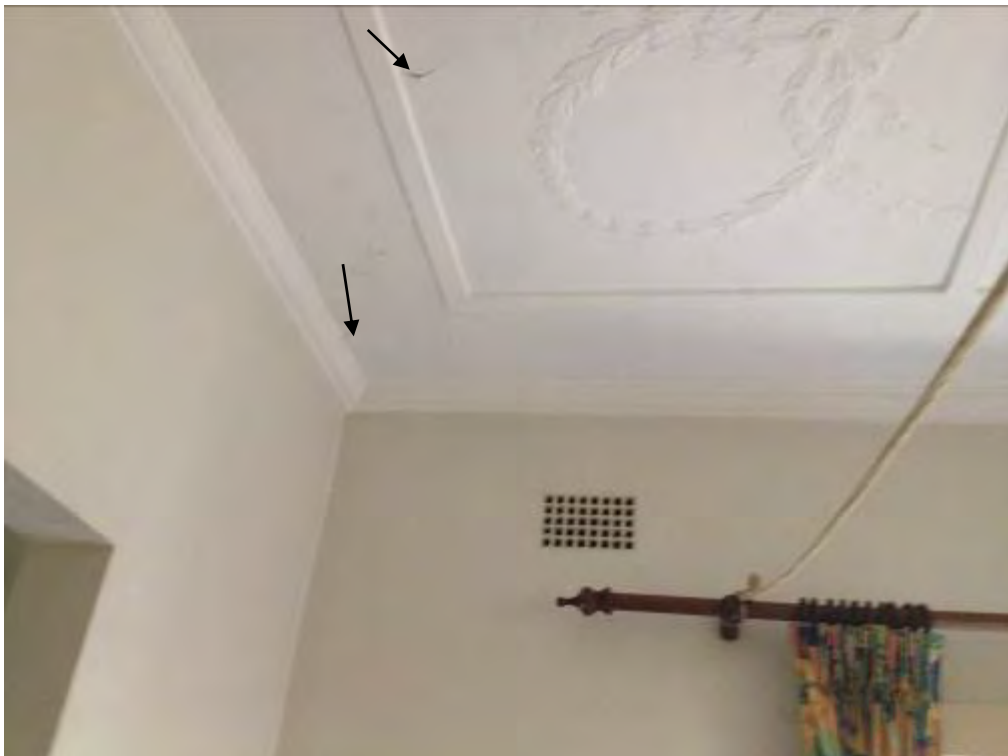
We noted flaking [lifting] paint from the ceiling at the southwestern corner of the room. **[Photograph 24]**

**Photograph 24** shows lifting paint from the ceiling at the southwest corner of the Dining room

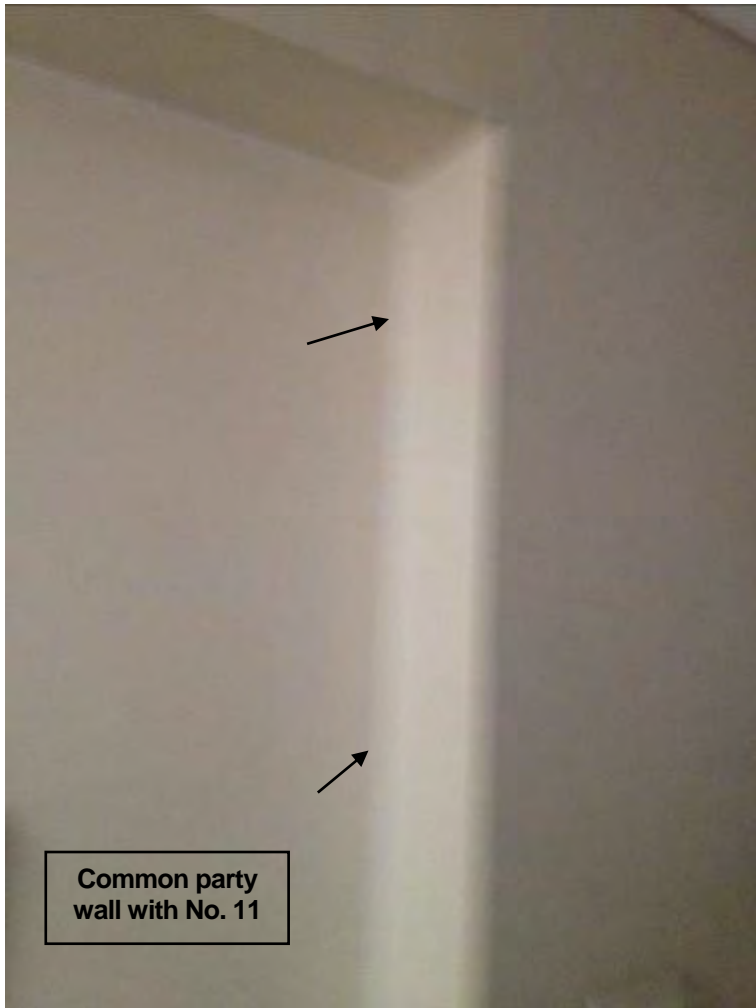
We noted a vertical hairline crack [ $<1.0\text{mm}$ ] to the recess in the eastern *common party / separation* wall at the top of the stairs. [**Photograph 25**]

**Photograph 25** shows a vertical hairline crack to the recess in the *common party / separation* wall at the top of the stairs

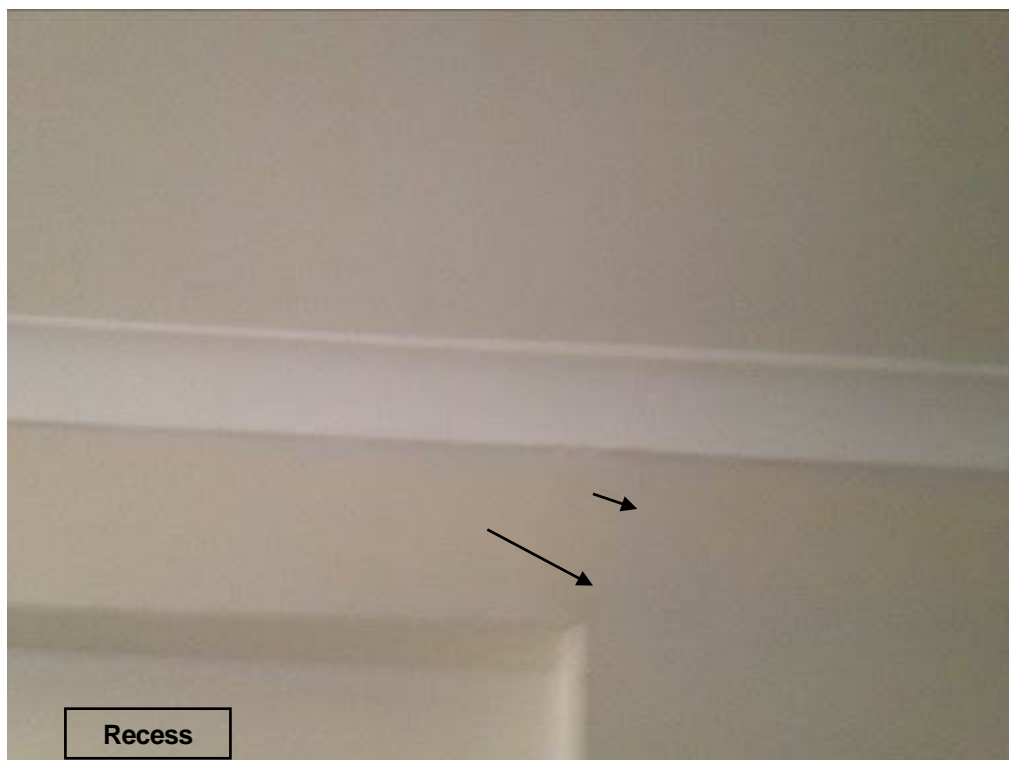
We also noted a vertical hairline crack [ $<1.0\text{mm}$ ] extending from the top of recess towards the cornice. [**Photograph 26**]

**Photograph 26** shows a hairline crack extending from the recess towards the cornice at the top of the stairs

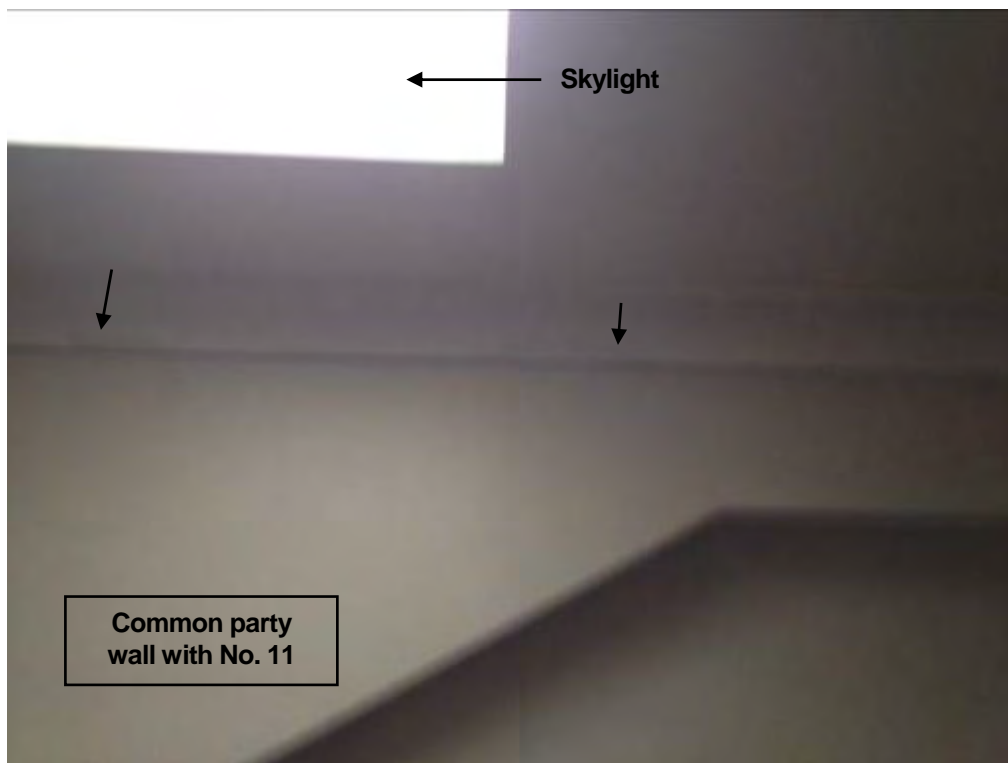
We noted patches of brown staining below the cornice over the stairs and abutting the *common party / separation* wall with the adjoining property, No. 11 Towns Road. [**Photograph 27**]

**Photograph 27** shows staining to the cornice abutting the *common party / separation* wall and above the stairs

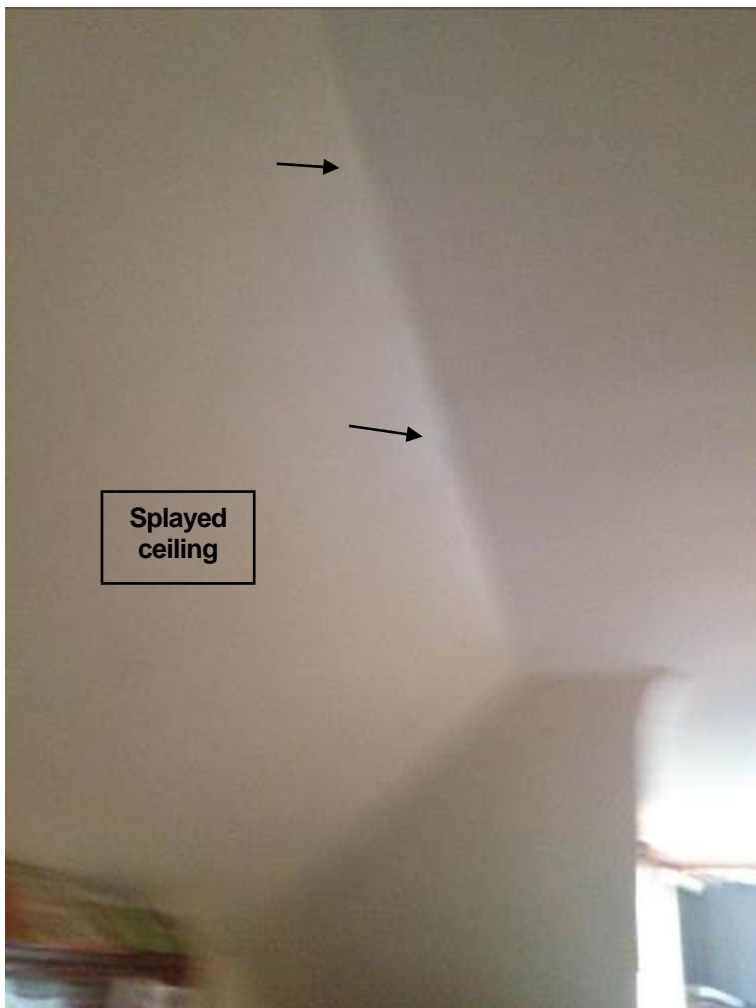
We noted that the ceiling is splayed at the *common party / separation* wall. We noted that there is a hairline crack [ $<1.0\text{mm}$ ] to the set joint between the splayed and level ceiling line. [**Photograph 28**]

**Photograph 28** shows a hairline crack to the set joint between the splay level ceiling of the front first floor Sitting / TV room

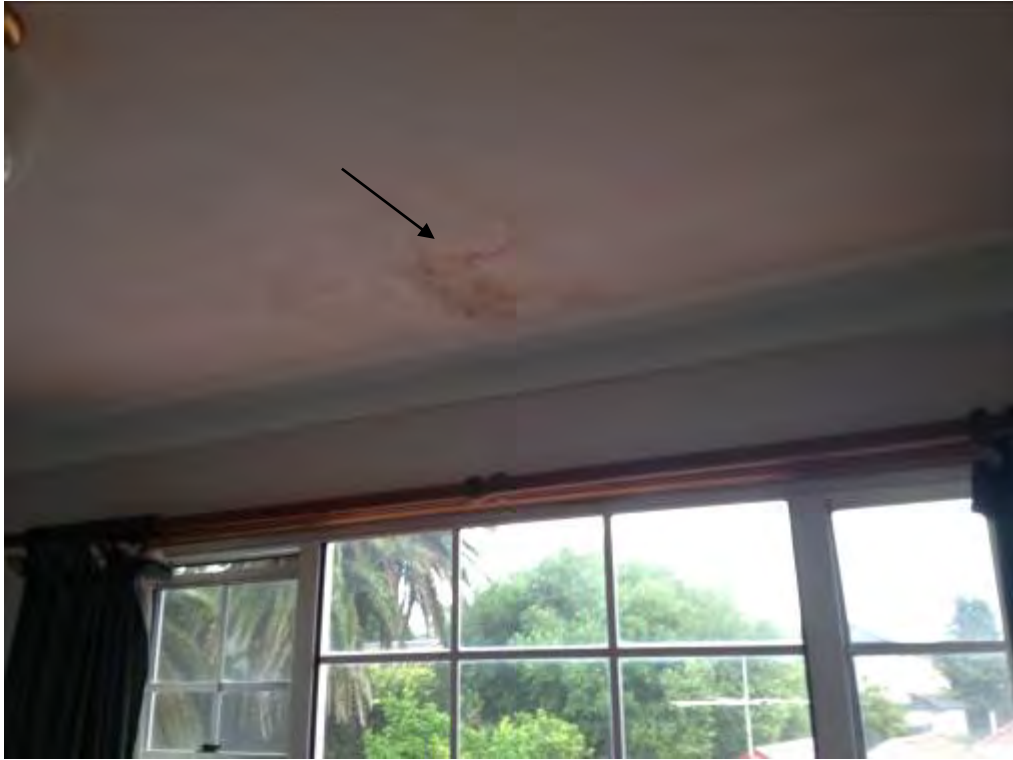
We noted brown staining to the ceiling abutting the rear northern wall. [**Photograph 29**]

**Photograph 29** shows staining to the ceiling to the first floor Bedroom 2
