HAZARDOUS MATERIALS ASSESSMENT REPORT

Job details: Owner: Mr. Cameron and Mrs. Nicole Quince.
Location: 3 Shepherd Street, MAROUBRA.

Plans for Job No: 7755/16

Our reference: HM05030716

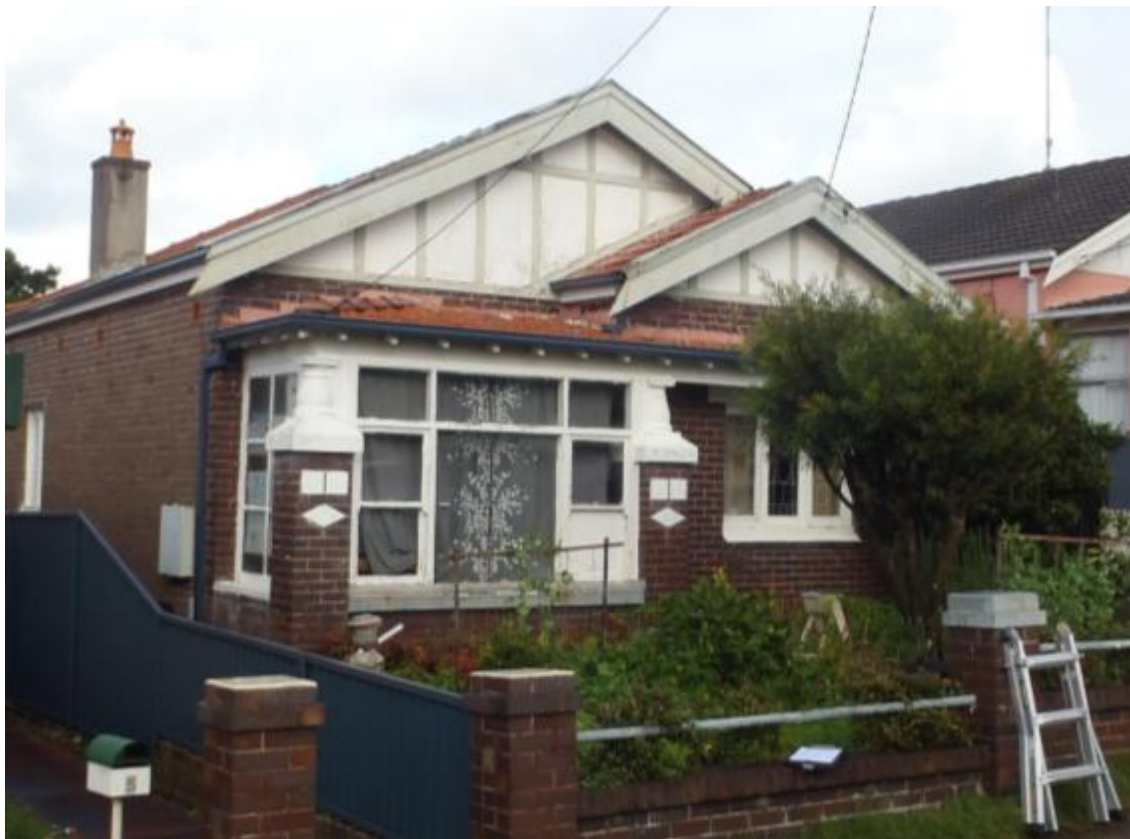
Front northern elevation of the residence
