HAZARDOUS MATERIALS ASSESSMENT REPORT

Job details: Owner/s: Mr. B. & Mrs. C. Loneragan
Location: 29 Glover Street, North Willoughby

Plans for Job No: 7629/14

Our reference: HM03830315

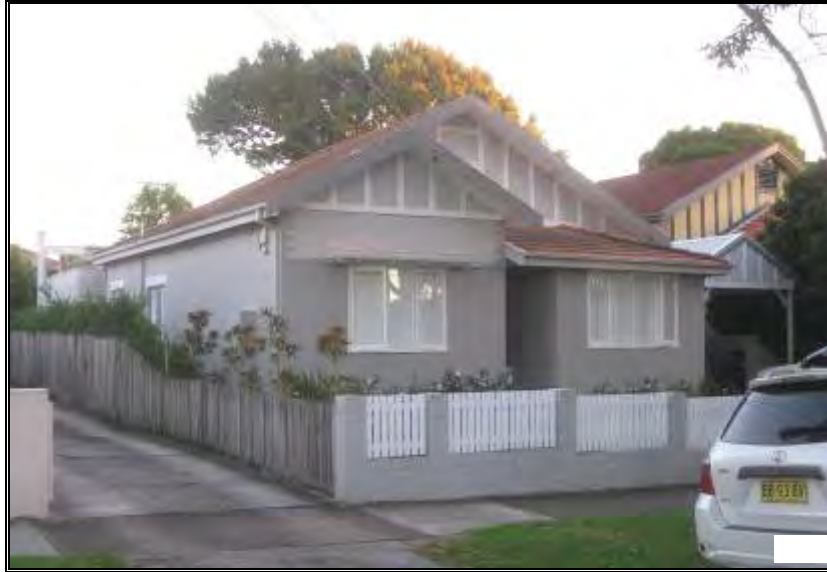
Front southern elevation of the residence
