HAZARDOUS MATERIALS ASSESSMENT REPORT

Job details: Owner/s: Mr. M. & Mrs. K. Hunter
Location: 23 Countess Street, Mosman NSW

Date of assessment: 24th June 2014

Our reference: HM03100514

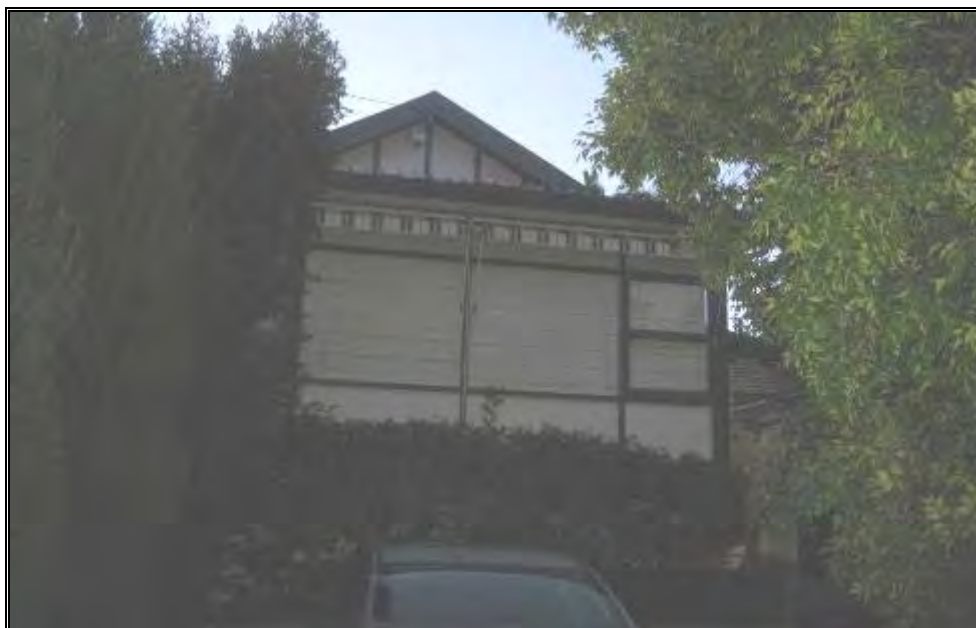
Front western elevation of the residence
