## **HAZARDOUS MATERIALS ASSESSMENT REPORT**

**Job details:** Owner/s: Mr. A. & Mrs. D. Blissett  
Location: 1 Leslie Street, Blacktown NSW

**Date of assessment:** 19<sup>th</sup> May 2015

**Our reference:** HM03960515

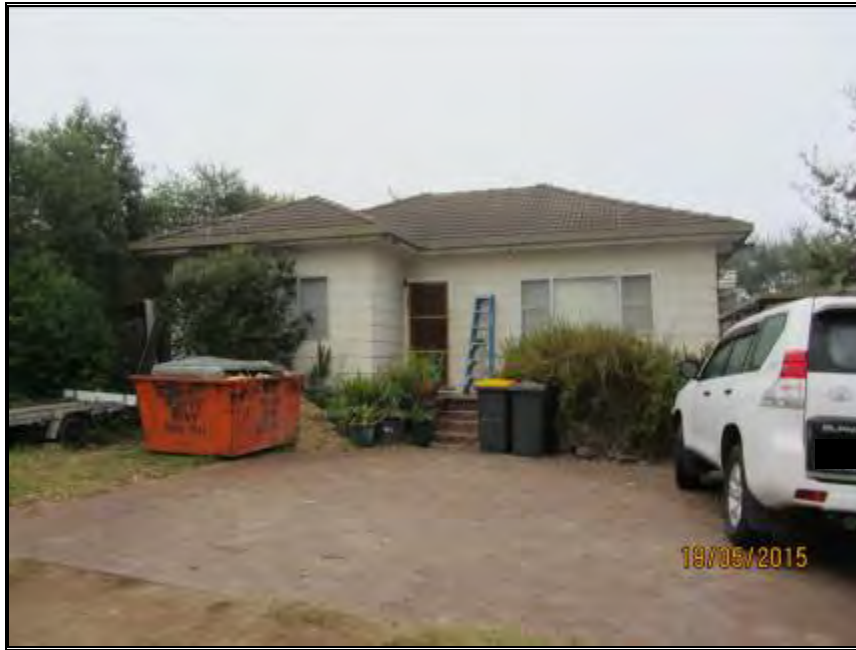
Front west elevation of the residence
