## **HAZARDOUS MATERIALS ASSESSMENT REPORT**

**Job details:** Owner: Mr. D. & Mrs. K. Biro.  
Location: 3 Nabiac Place, Westleigh.

**Plans for Job No:** 7840/17

**Our reference:** HM06161017

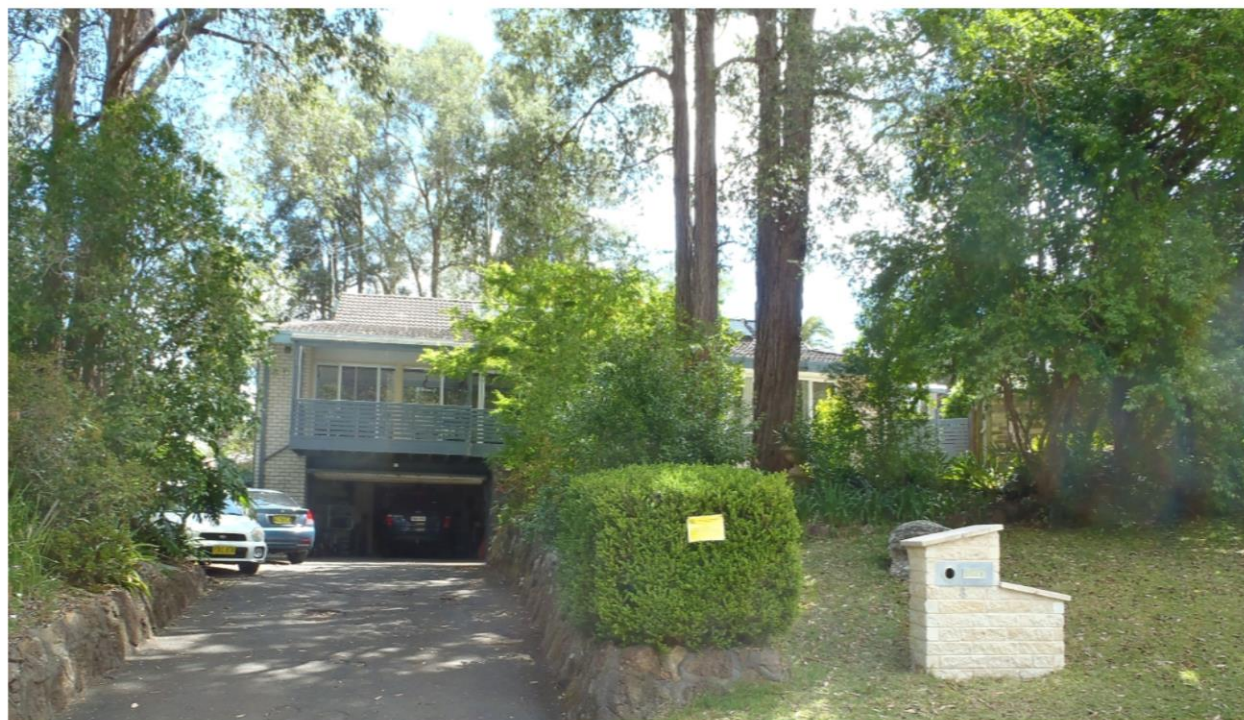
**Front eastern elevation of the residence**
