HAZARDOUS MATERIALS ASSESSMENT REPORT

Job details: Owner/s: Mr. M. & Mrs. E. Feldman
Location: 255 Military Road, Dover Heights

Our reference: HM03401014

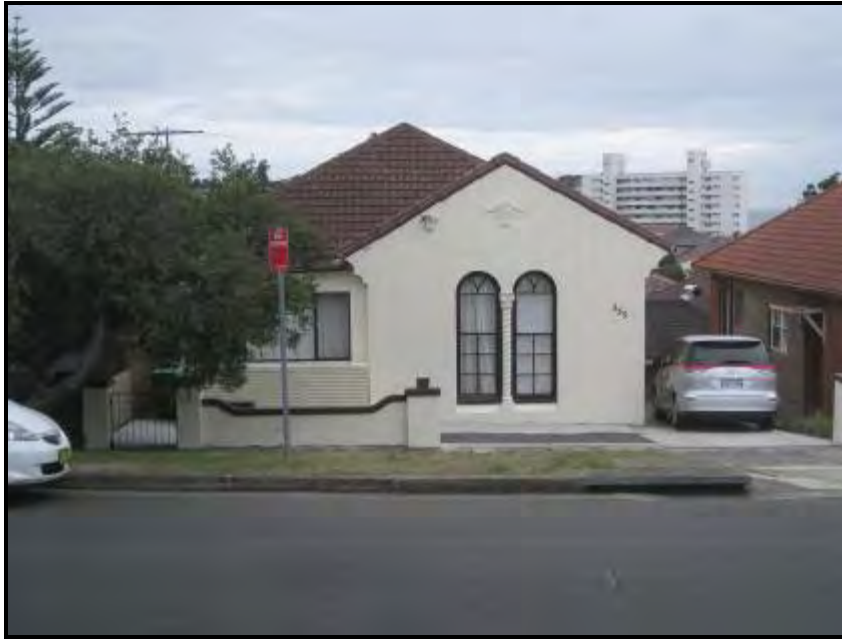
Front southern elevation of the residence
