Site Assessment Report

Prepared for: Cape Cod Australia Pty. Limited
Job address: 107 Haig Street, Maroubra NSW 2035
Property Owner: Ms. G. Renshaw
Report reference: Photographic report on the condition of the terra cotta roofing tiles to the above property prior to the construction of a first floor addition to the adjoining attached property: No. 109 Haig Street
Date of assessment: 22nd March 2016

Re: Tiled Roof Assessment – No. 107 Haig Street, Maroubra

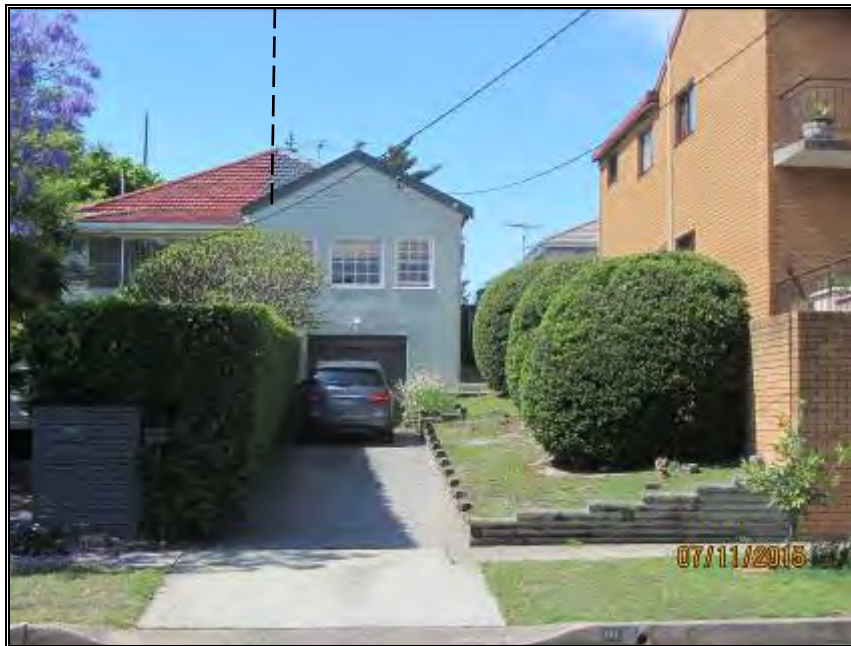
Shows the front northern elevation of this property: No.107 Haig Street, Maroubra

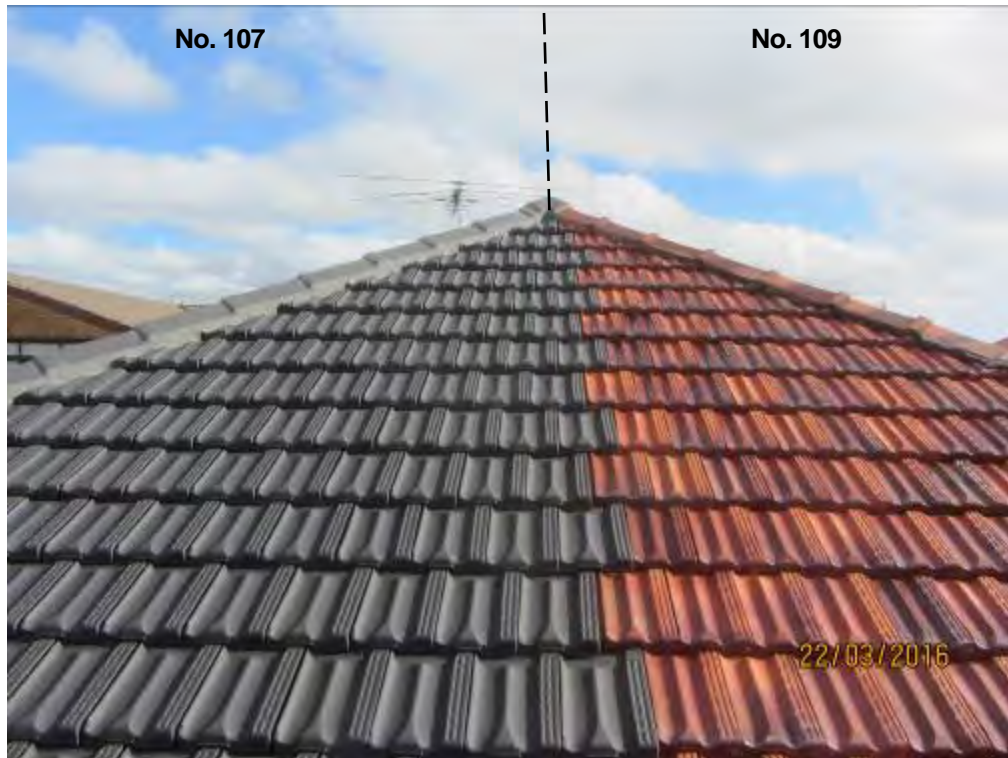
We observed that there is a difference in colour to the terra cotta roof tiles between this property and the adjoining property; No. 109 Haig Street. We noted that the tiles are of the same “marseille” profile. **[Photograph 1]**

We noted that the tiles at the junction between this property and the adjoining property No. 109 Haig Street are interlinked and securely bedded, in our opinion forming a weather resistant cover to the property. **[Photographs 1 and 2]**

We did not note any cracked or chipped tiles over all the roof surfaces. We noted that the surface of the tiles is clean and free of loose particles of mortar [pointing]. **[Photographs 1, 2, 3 and 4 - typical]**

Photograph 1 shows the tiles are interlinked and securely bedded to the rear southern roof surface

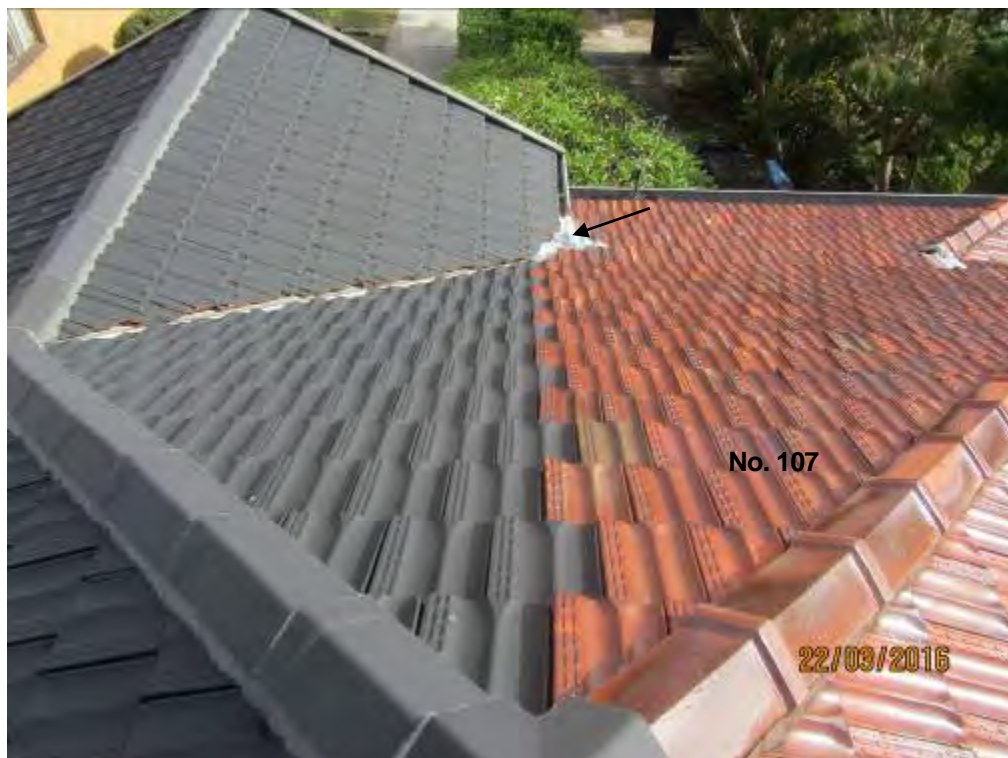
We noted that the cutting of tiles at the hips and front valley is neat and in a regular straight line. **[Photograph 2 and 9]**

We noted that the base of the front valley over Bedroom 1 discharges directly onto the roof tiles of the adjoining property; No. 109 Haig Avenue. **[Photograph 2]**

Photograph 2 shows the junction of the northern elevation roof surfaces – Note: the valley gutter flashing discharging onto the roof surface of the adjoining property

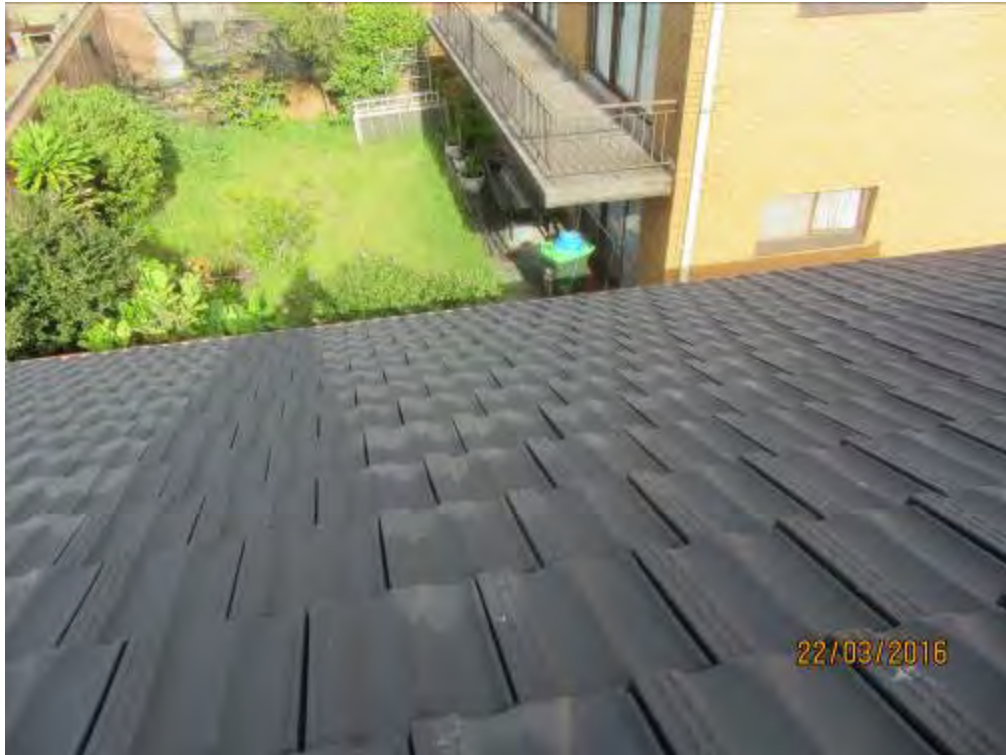
Photograph 3 shows the western roof surface – Note: tiles are interlinked and securely bedded

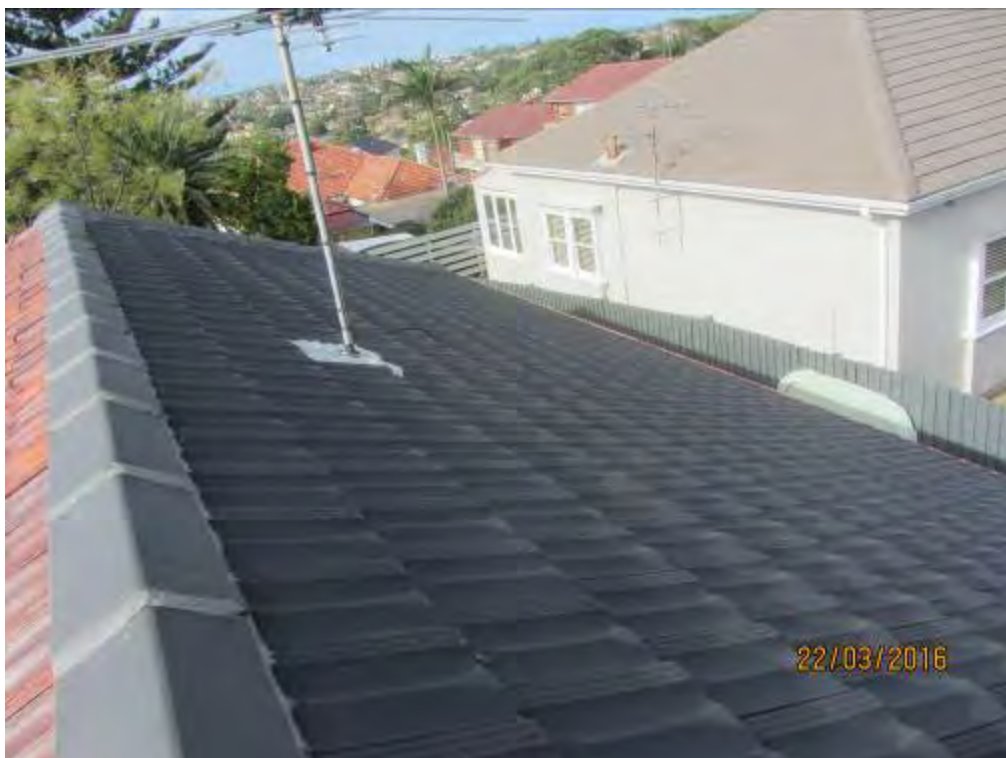
Photograph 4 shows the western elevation of the roof surface viewed from the north to the south [rear]

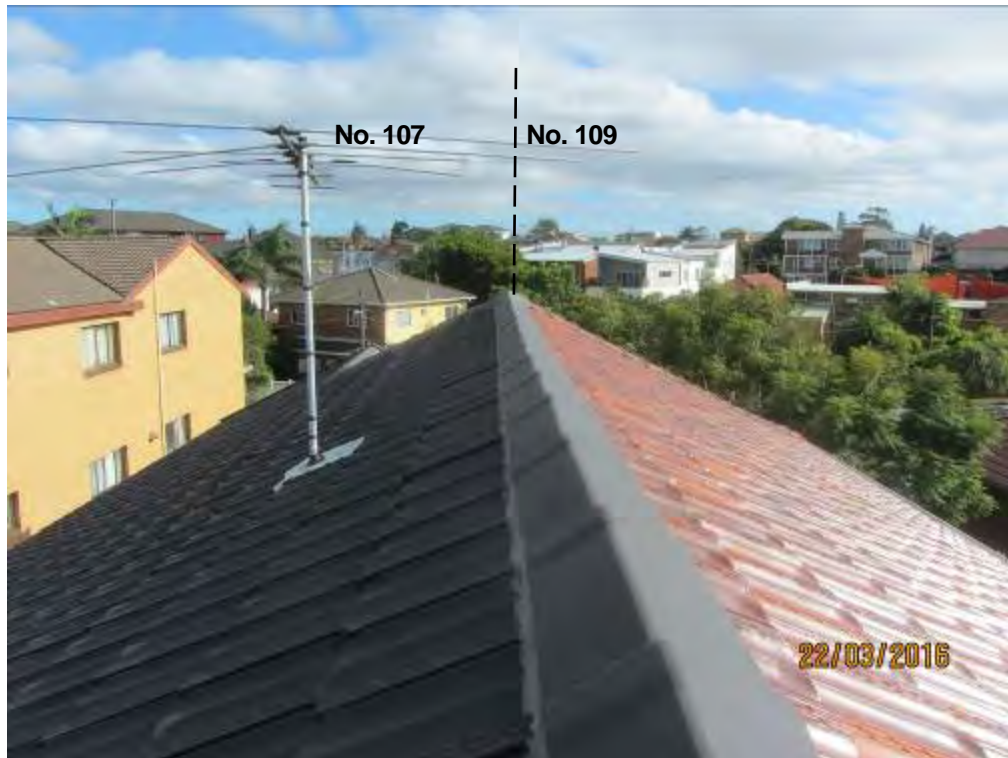
We noted that there is a straight regular line to the ridge and hip tiles. **[Photographs 5, 6 and 7]**

Photograph 5 shows the line of the ridge over the *common party / separation wall* – Note: the tiles are interlinked and securely bedded to the western roof surface

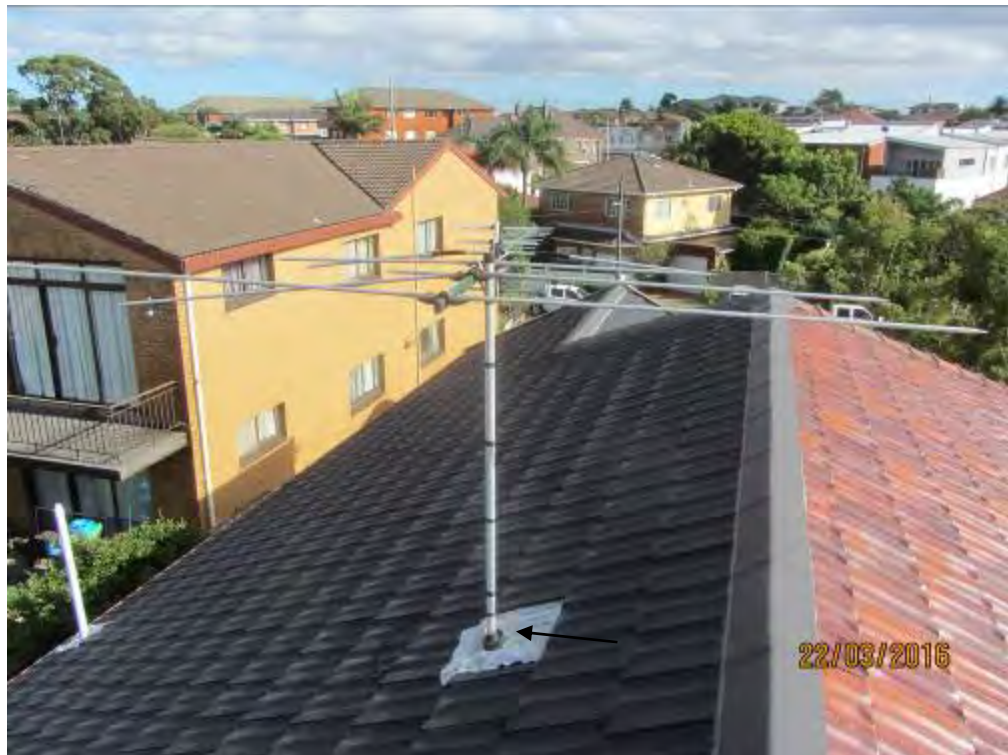
We observed that a television antennae is located on the western elevation roof surface. We noted that the post supporting the antennae is sealed to the roof surface with a nominal 300mm x 300mm lead flashing and a proprietary synthetic rubber collar flashing. We also noted that the lead flashing is not fully moulded to the tile profile. We noted that the arms of the antennae overhang the ridge over the *common party / separation* wall between the adjoining properties. **[Photograph 6]**

Photograph 6 shows the line of the ridge tiles over the *common party / separation wall*

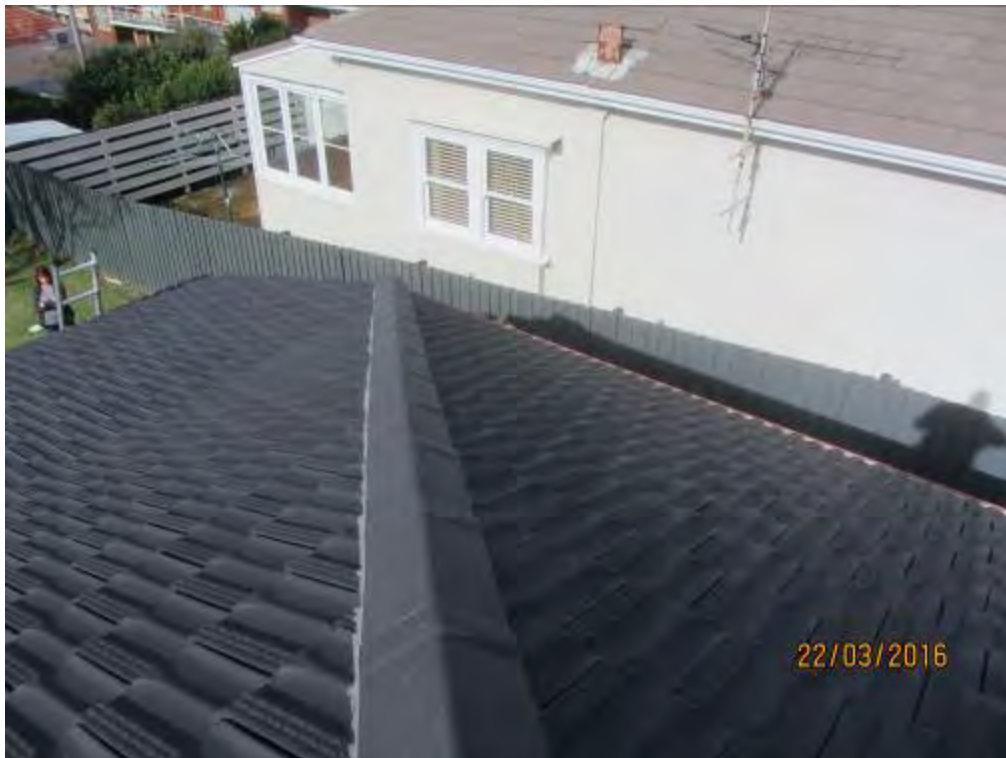
Photograph 7 shows the line of the southwest hip

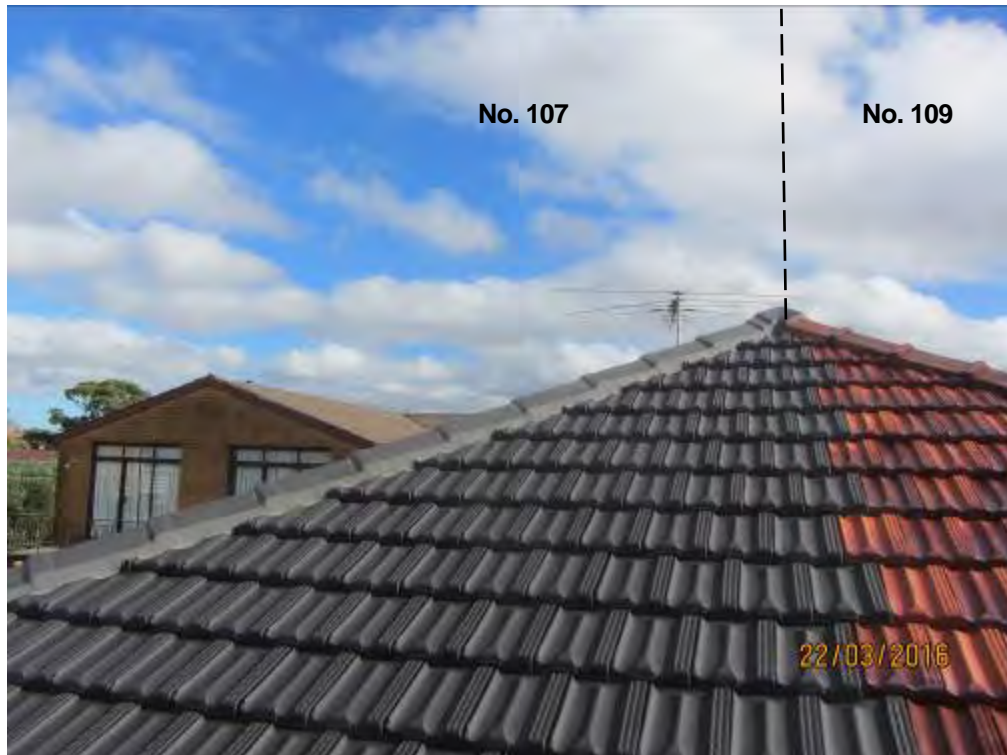
We noted that the pointing to the ridge and hip tiles is full, regular in appearance, uniform in colour and texture and neat in appearance. **[Photograph 8 - typical]**

Photograph 8 shows the pointing is complete to the southwest hip

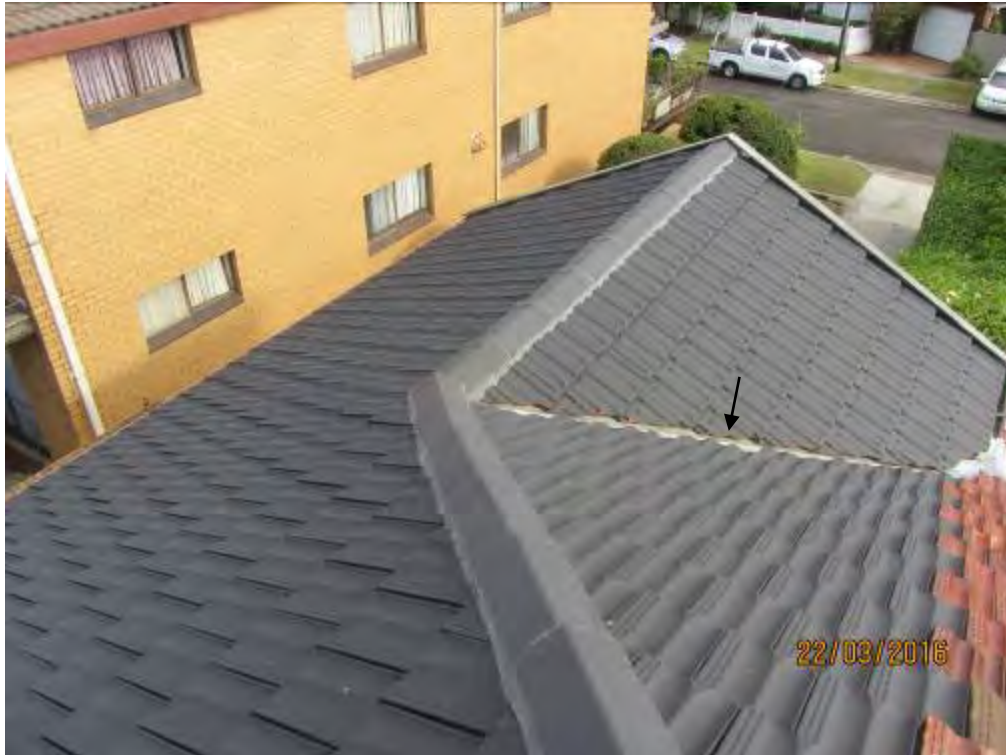
Photograph 9 shows the broken hip and ridge over Bedroom 1 and the Sunroom – Note: straight line of the valley tiles

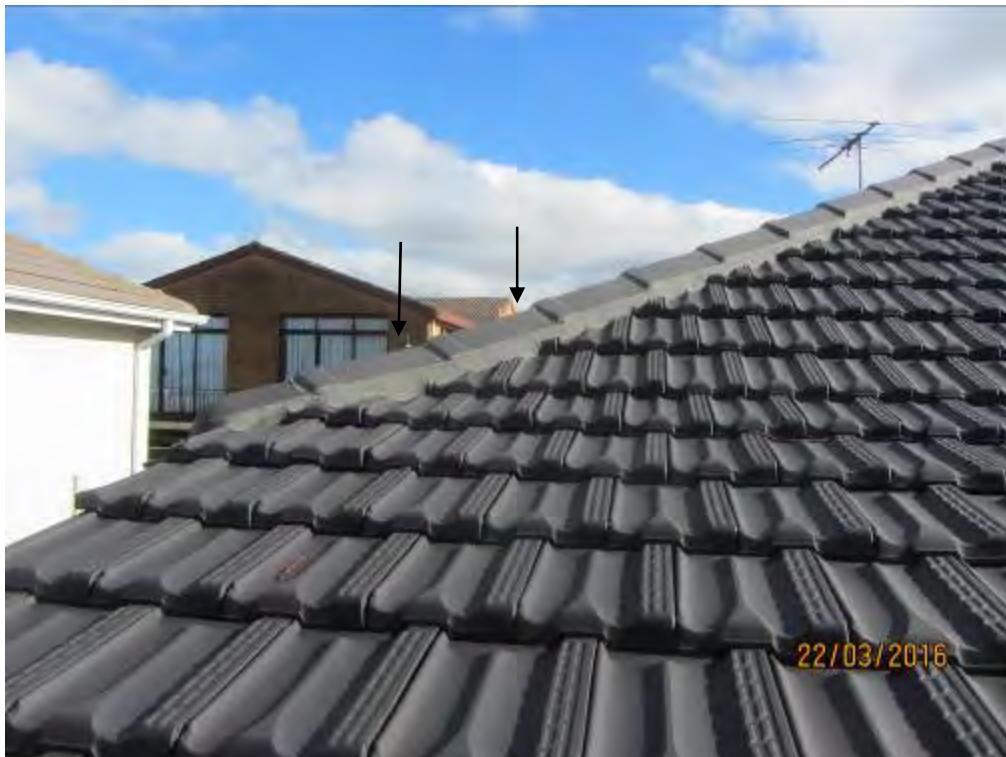
We noted that there is hairline shrinkage cracking to the pointing at the southwestern hip. **[Photograph 10]**

Photograph 10 shows hairline shrinking cracking to the hip pointing to the southwestern hip over the Laundry

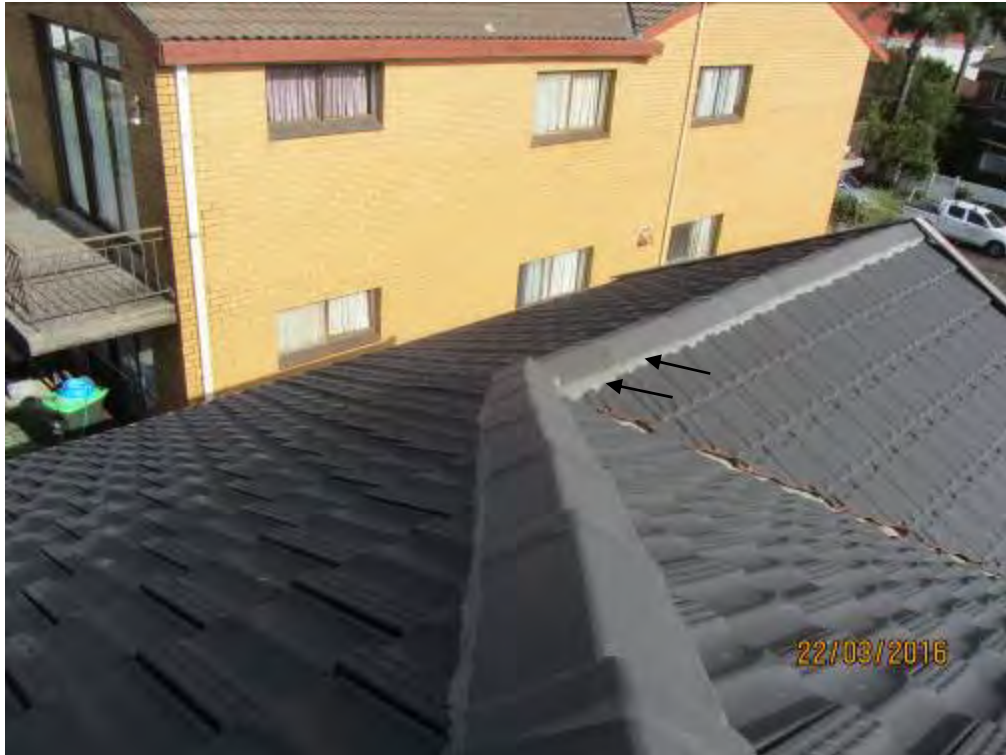
We also noted that there is hairline shrinkage cracking at the junction between the broken hip and ridge over front Bedroom 1 and Sunroom. **[Photograph 11]**

Photograph 11 shows the broken hip and ridge over Bedroom 1 and the Sunroom – Note: hairline shrinkage crack to the junction between the broken hip / ridge and the valley
