Dilapidation Assessment Report

Prepared for: Cape Cod Australia Pty. Limited
Job address: 131 Blair Street, NORTH BONDI.
Property Owner/s: Mr. Andrew & Mrs. Kristane Foxton.
Report reference: **WAVERLEY COUNCIL**
Development Application No: not available
Date of assessment: 13th July 2016

Re: Dilapidation Report

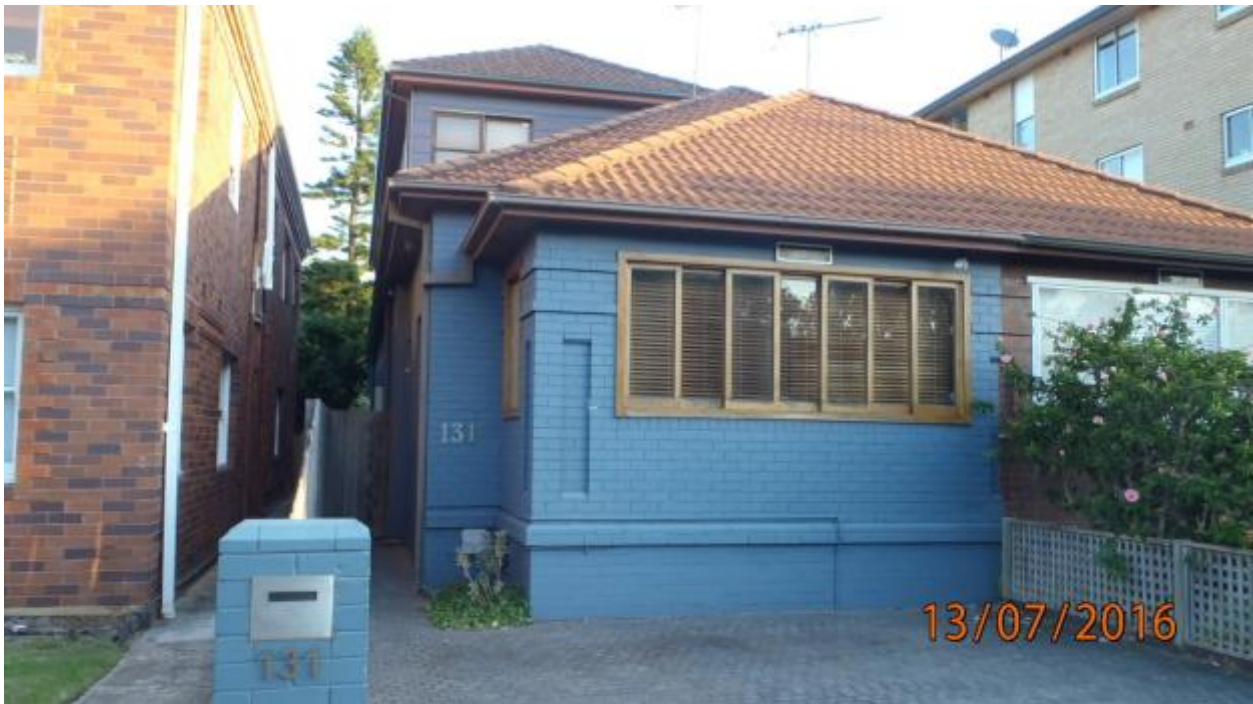
Shows the front northern elevation of the adjoining properties:
No.131 and No.129 Blair Street, NORTH BONDI.

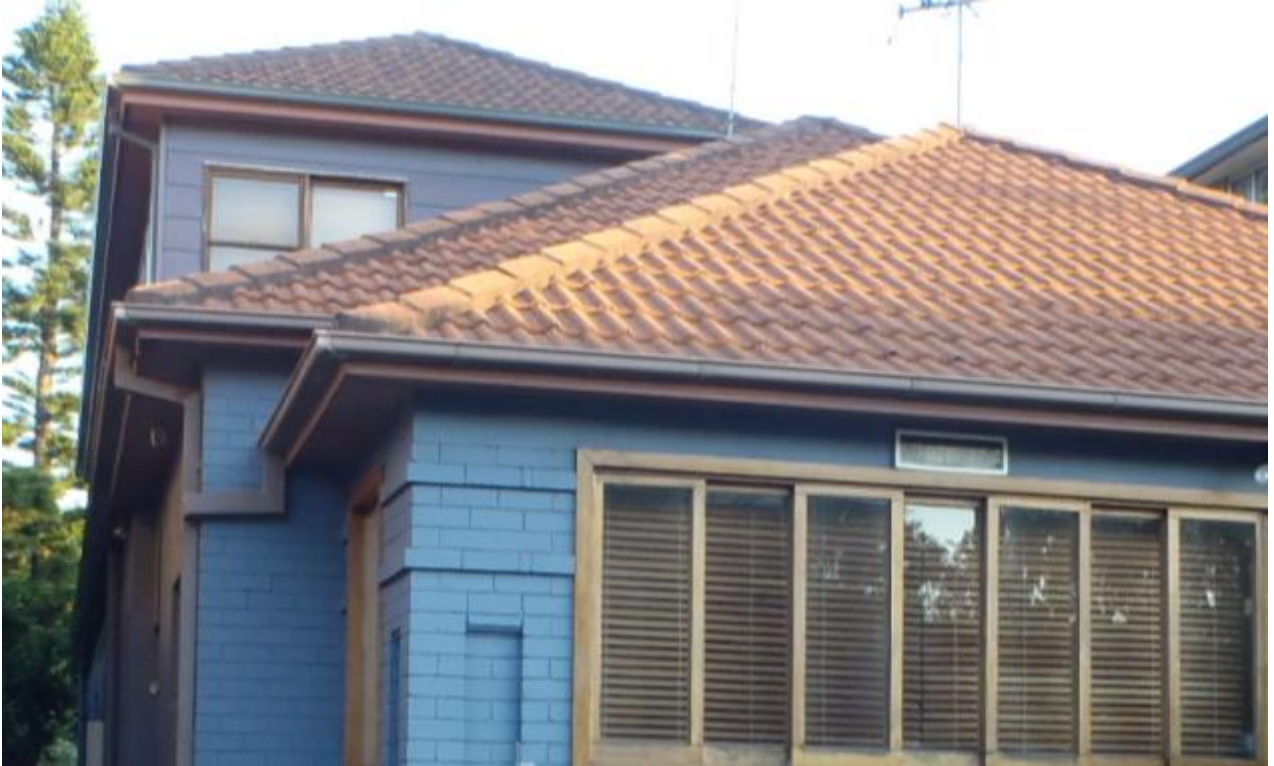
We observed that the terra cotta roof tiles to the original roof surfaces are generally interlinked and securely bedded, in our opinion forming a weather resistant cover to the residence. **[Photograph 1]**

Photograph 1 shows terra cotta roof tiles to the original and first floor extension roof surfaces.

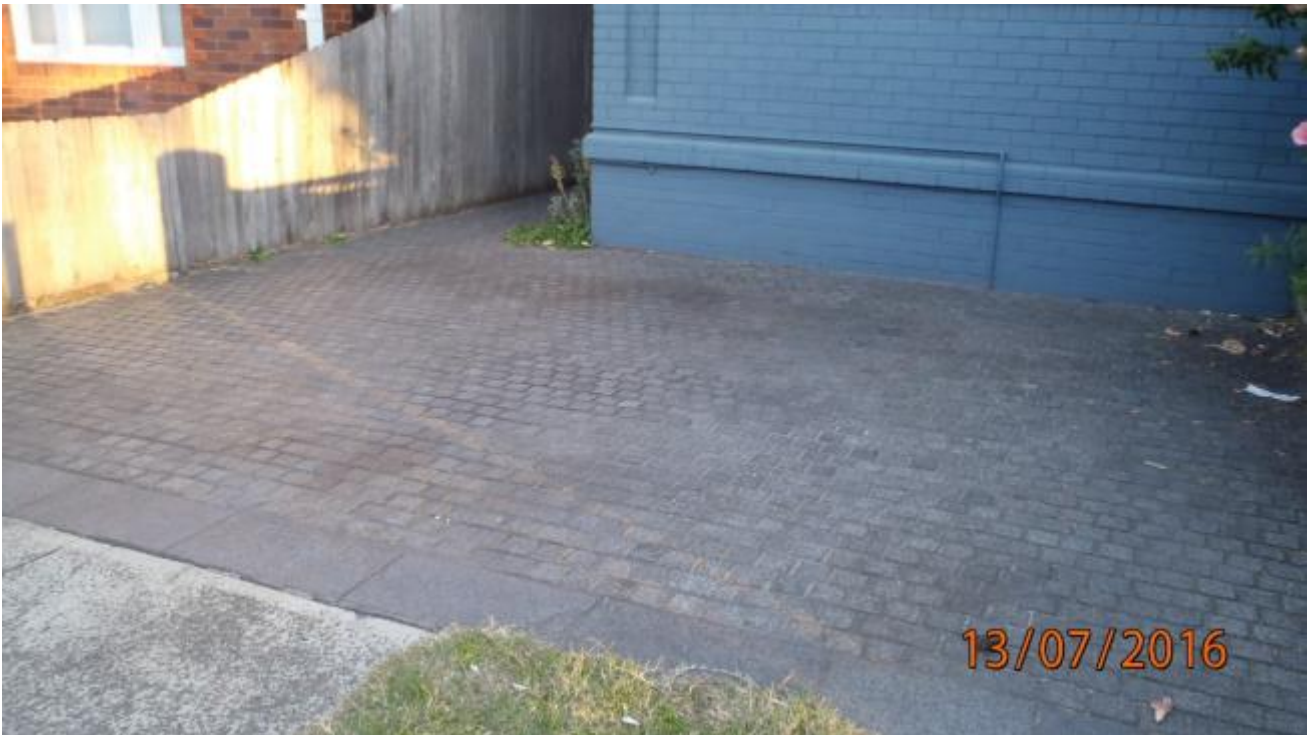
We noted that the front northern aspect has a paved driveway/car space. **[Photograph 2]** and also noted cracking to the front pathway **[Photograph 3]**

Photograph 2 shows the general condition of the front paved driveway/car space.

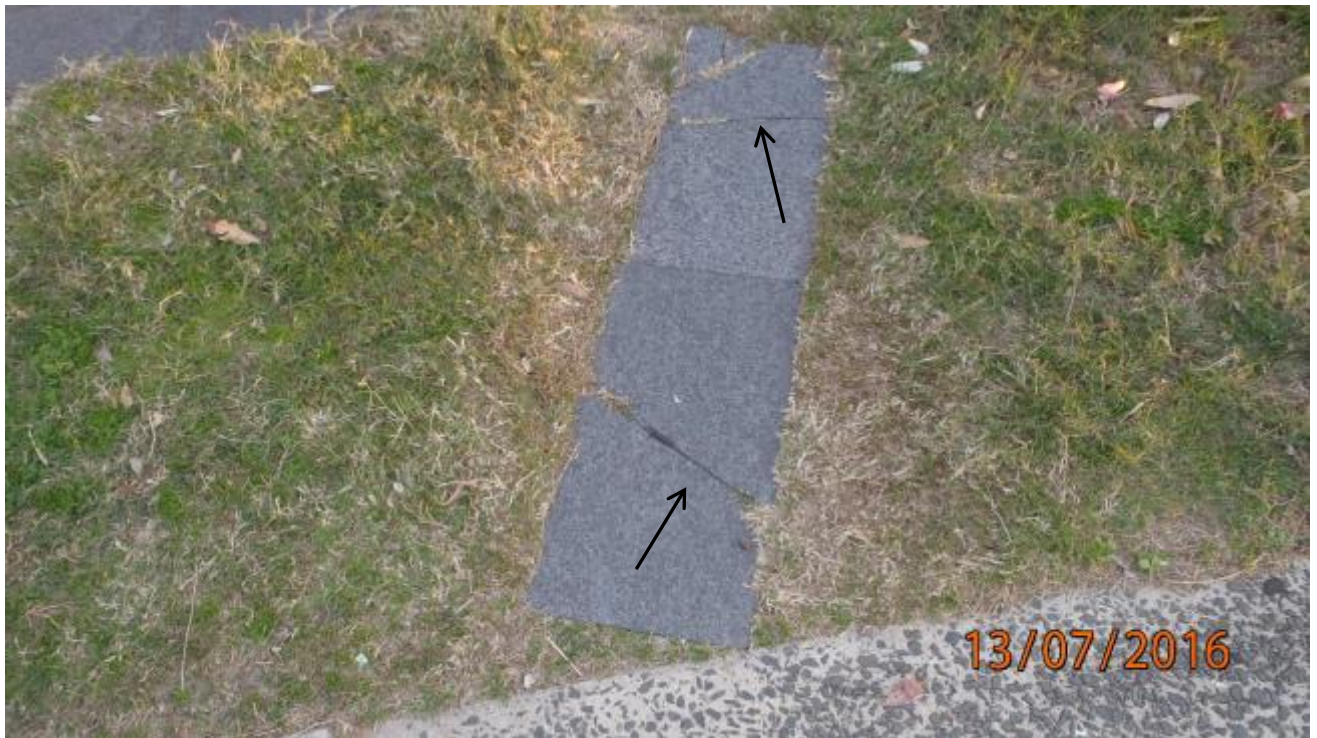
Photograph 3 shows cracking to the front pathway.

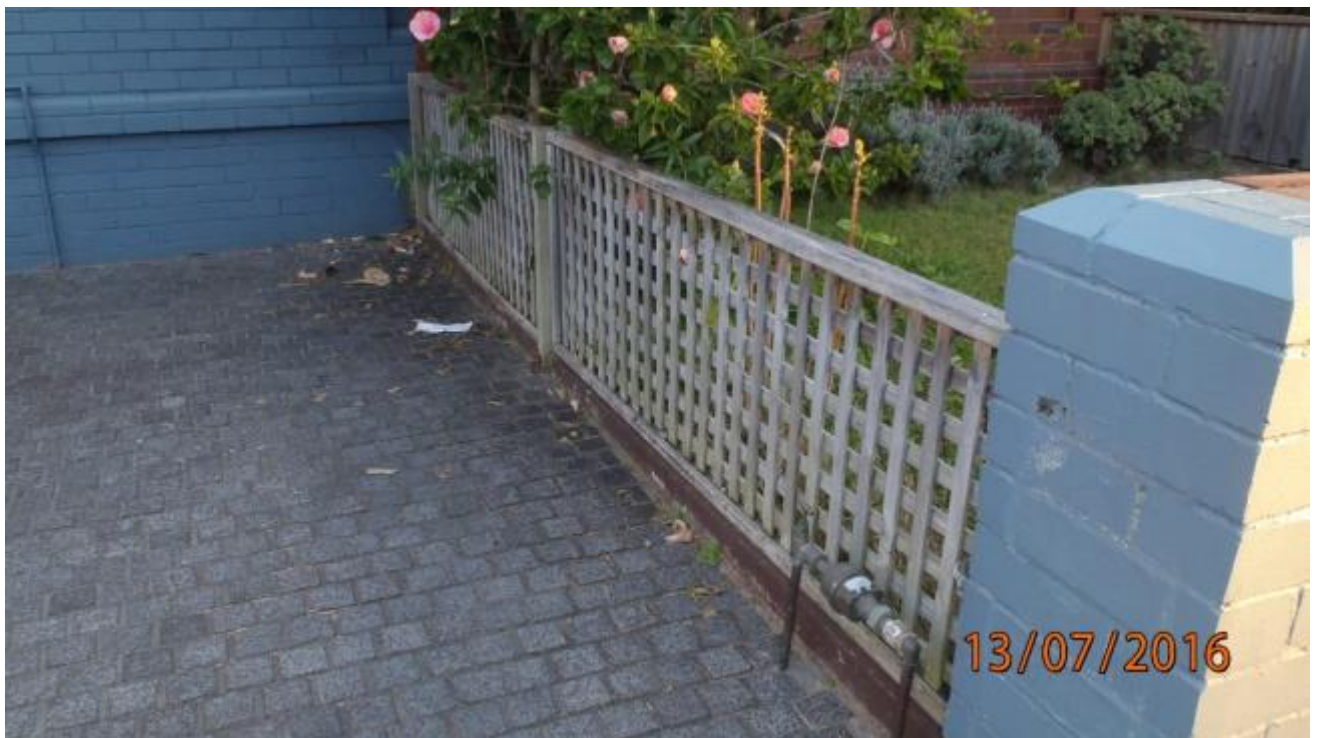
We noted that the common boundary fence is of treated timber construction with lattice inserts **[Photograph 4]**

Photograph 4 shows the general condition of the front common boundary fence.

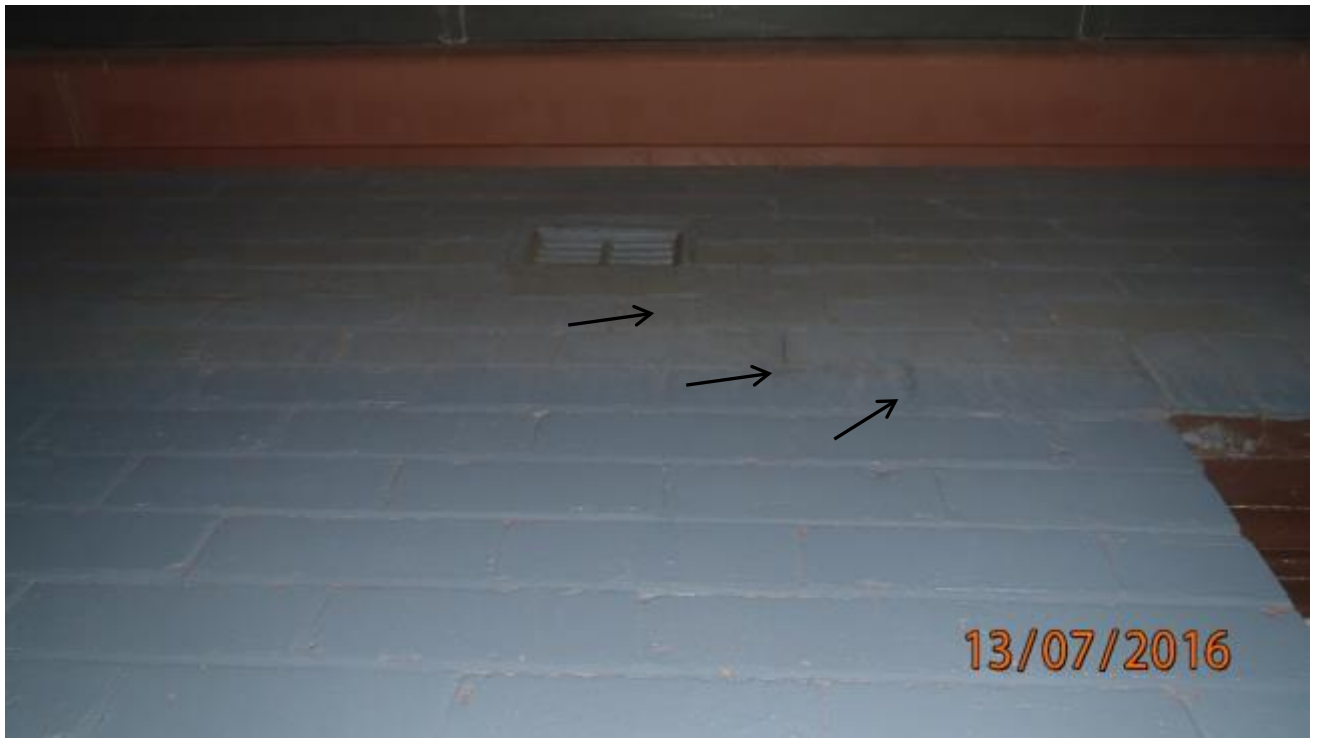
We noted evidence of a step crack repair extending from the wall vent outside Bedroom 2 to the top left corner of the Bedroom 2 window. **[Photograph 5]**

Photograph 5 shows a previously repaired step crack between the wall vent and the window head outside the Bedroom 2 window.

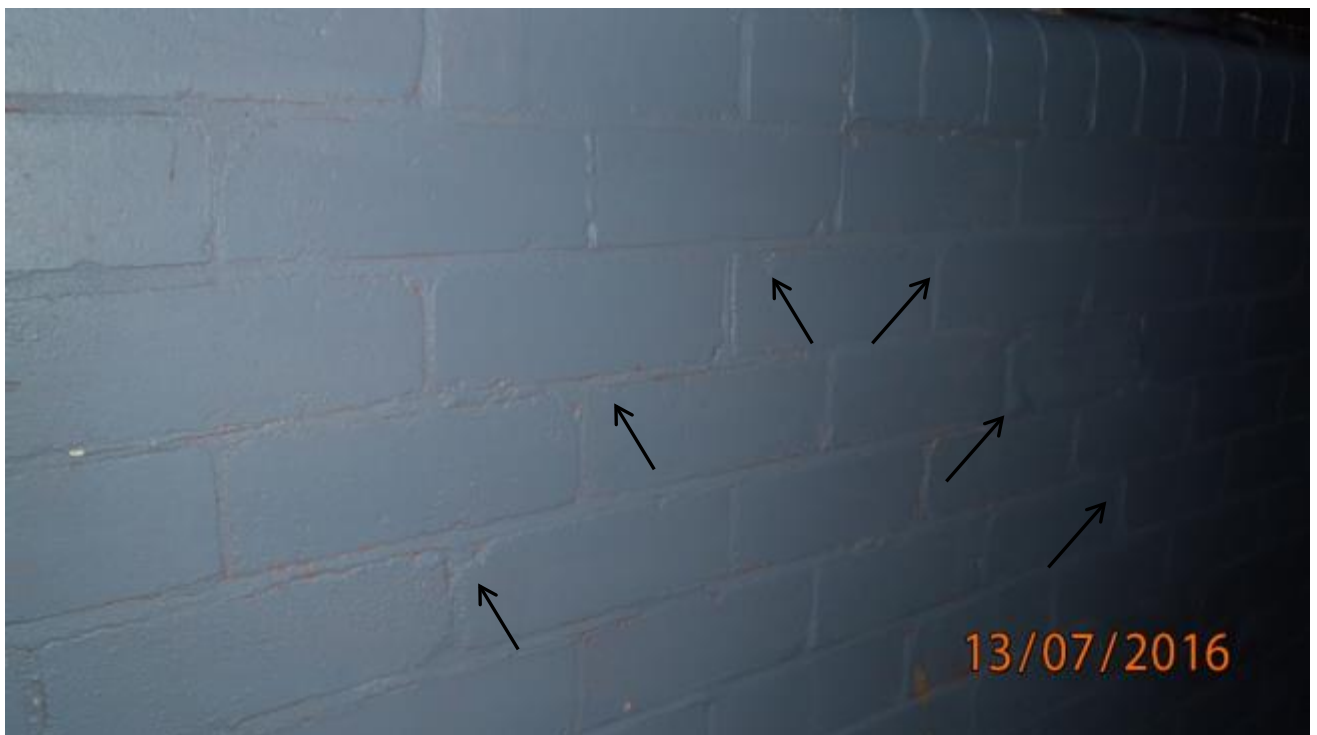
We noted evidence of a step crack repair extending from the left side of the Lounge Room window sill. **[Photograph 6]**

Photograph 6 shows previously repaired step cracking outside the Bedroom Lounge Room window.

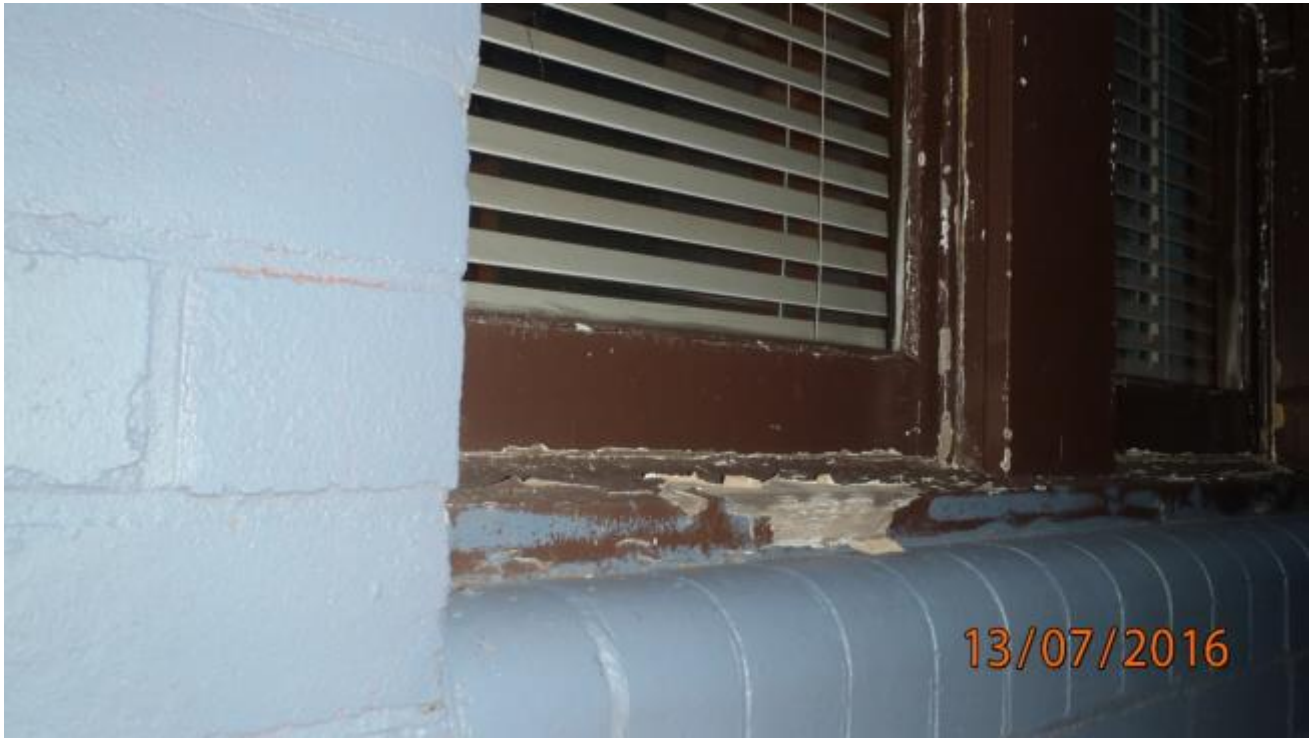
We noted general deterioration and flaking of the surface coating to the Lounge room window **[Photograph 7]**

Photograph 7 shows general deterioration and flaking of the surface coating to the Lounge room window.

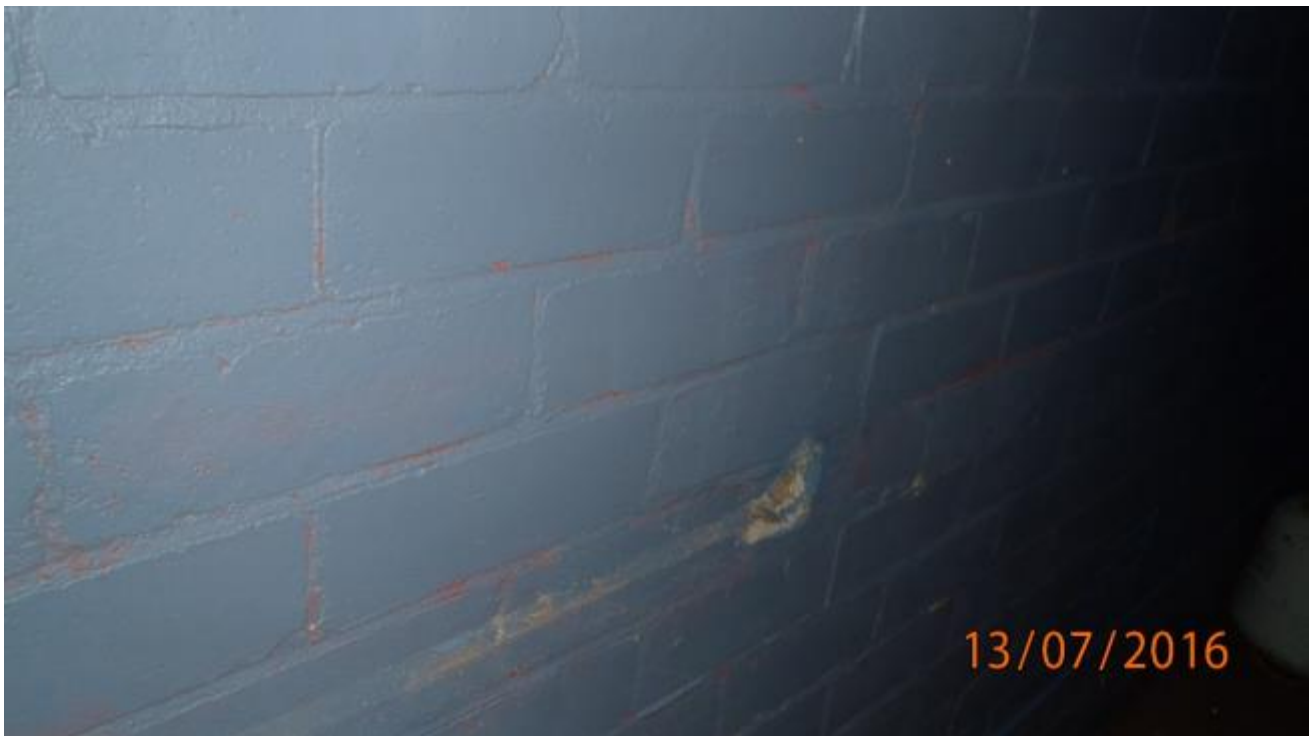
We noted damage to the surface coating and brickwork between the Kitchen and Lounge windows **[Photograph 8]**

Photograph 8 shows damage to the brickwork between the Kitchen and Lounge Room windows.

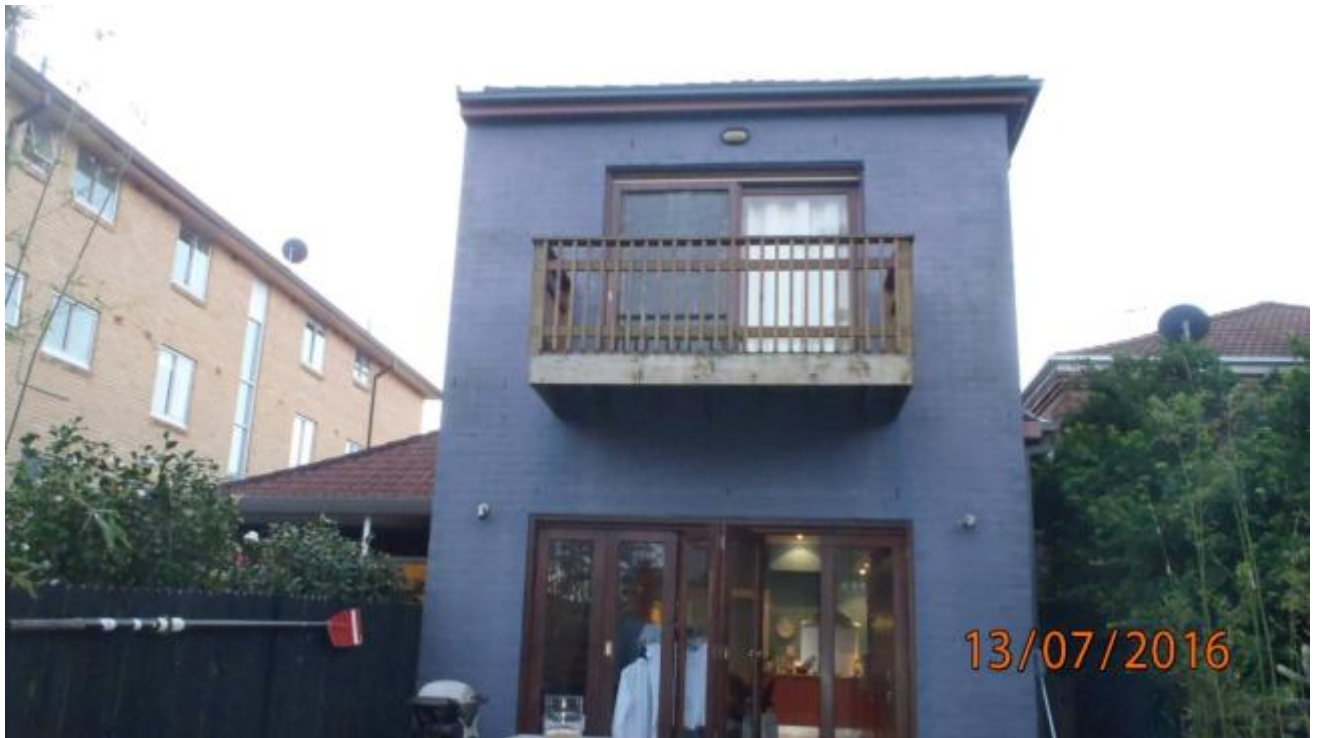
We did not observe any recent cracking to the surface coated clay masonry brickwork. **[Photograph 9]**

Photograph 9 shows the general condition of the rear southern elevation.

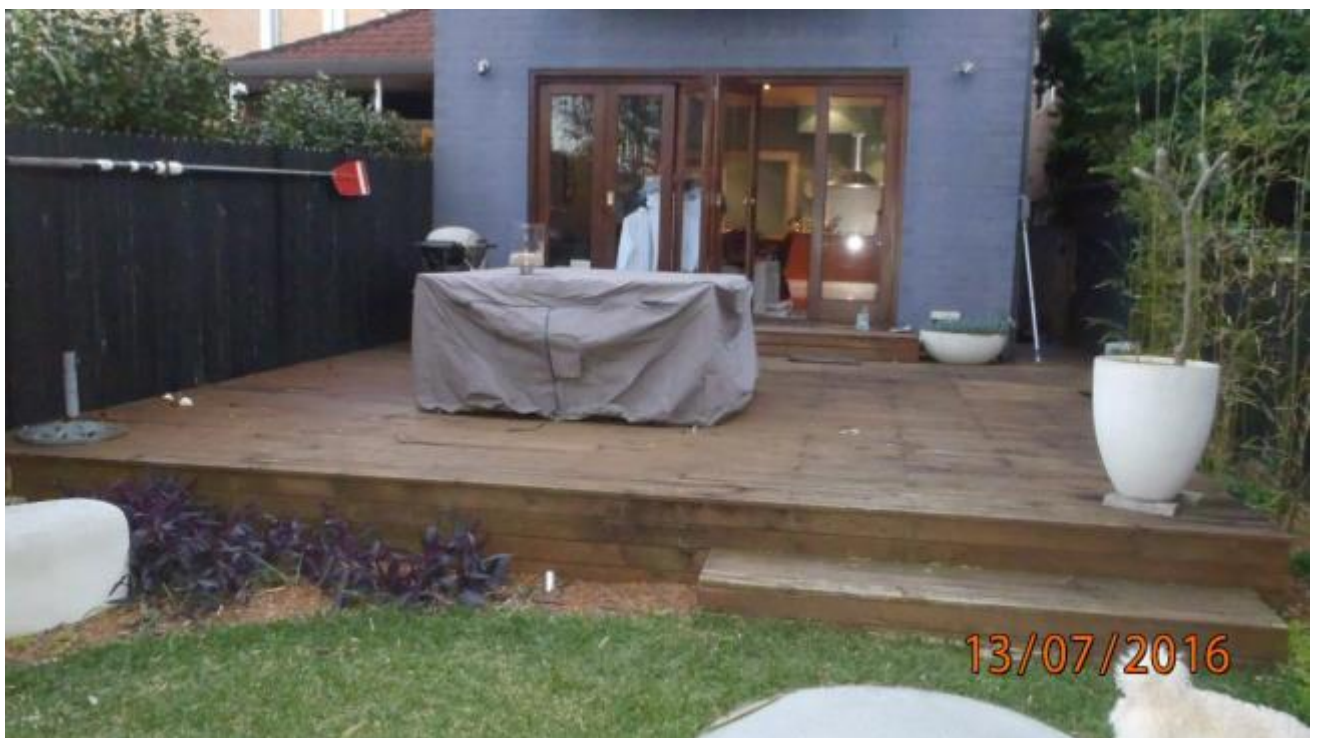
We noted that there is a timber deck structure extending from the rear doors of the residence **[Photograph 10]**

Photograph 10 shows the general condition of the rear deck structure.

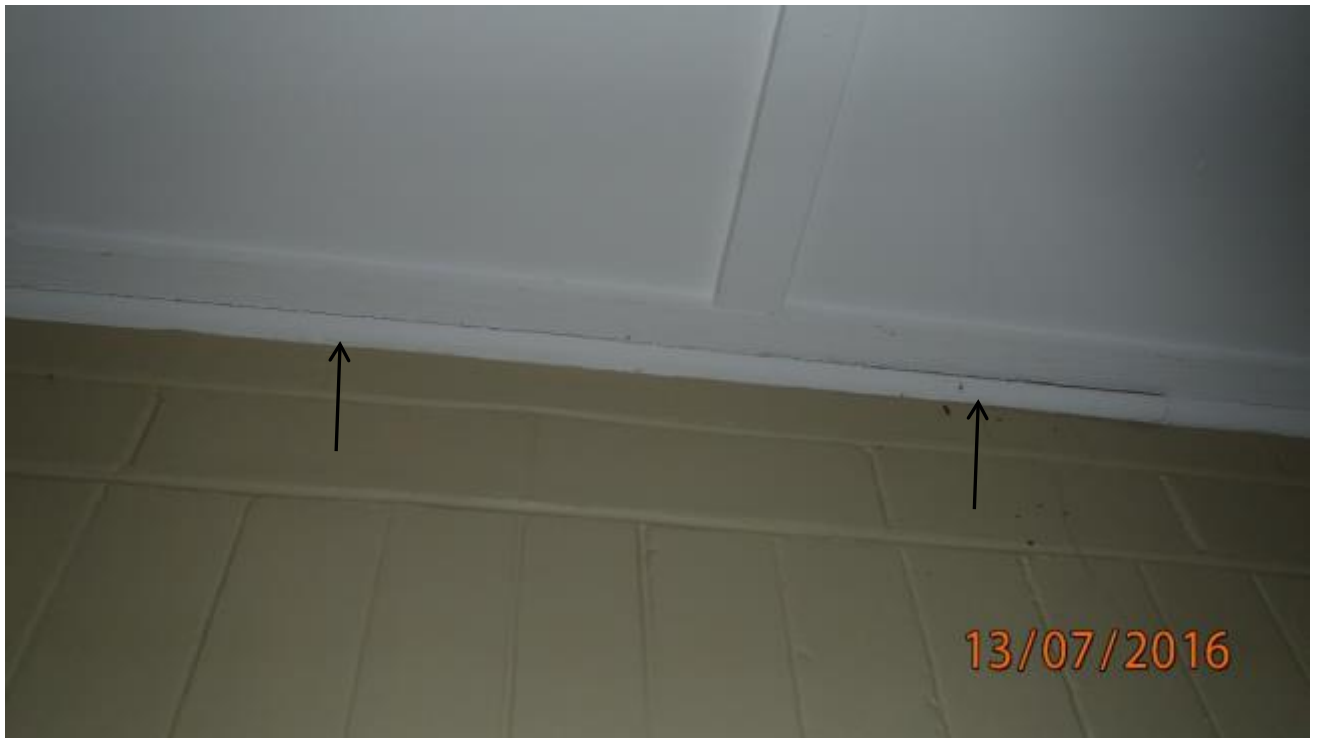
We noted a separation crack to the quad moulding / ceiling junction **[Photograph 11]**

Photograph 11 shows separation cracking between the moulding and ceiling

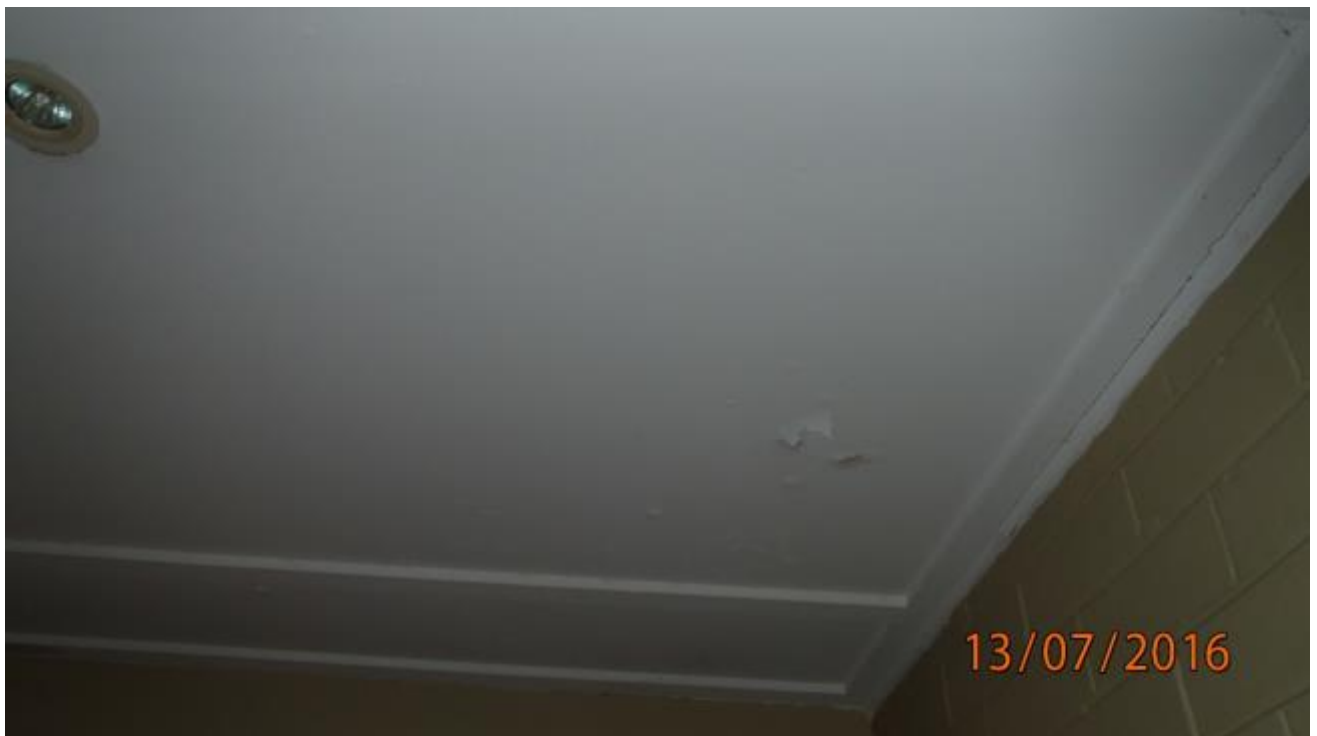
We noted flaking paint to the ceiling lining in the south eastern corner **[Photograph 12]**

Photograph 12 shows flaking paint to the ceiling lining in the Sunroom.

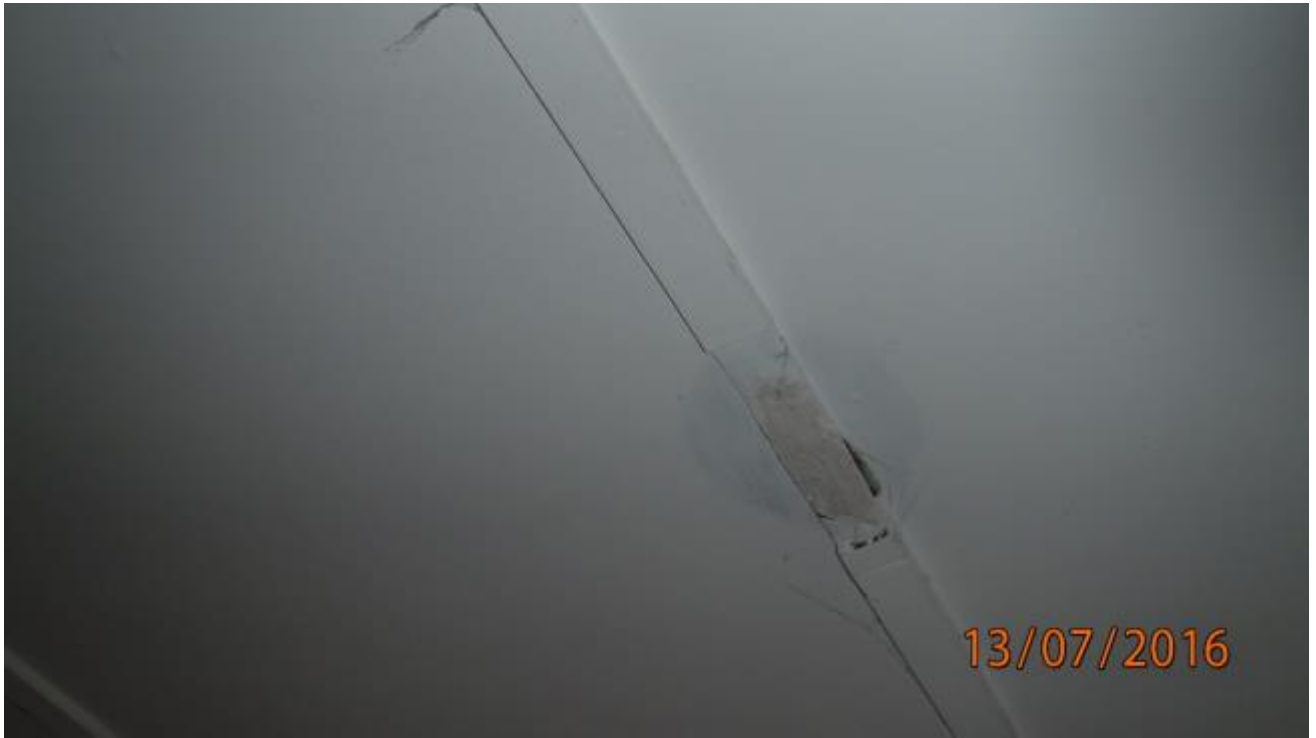
We noted a previous repair / light fitting removal from the centre of the ceiling lining **[Photograph 13]**

Photograph 13 shows a previous repair / light fitting removal in the Sunroom.

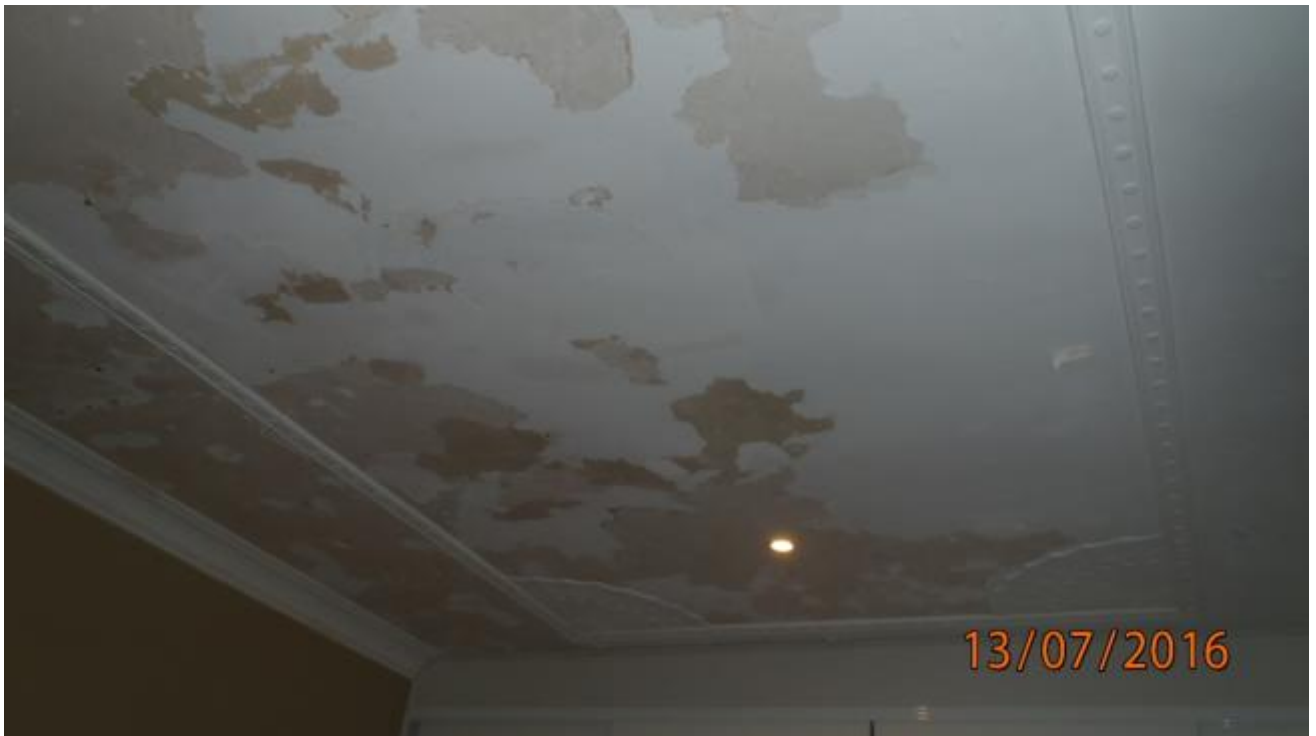
We noted general deterioration and flaking of the surface coating to the Bedroom 1 ceiling lining **[Photograph 14]**

Photograph 14 shows general deterioration of the surface coating to the ceiling of Bedroom 1.

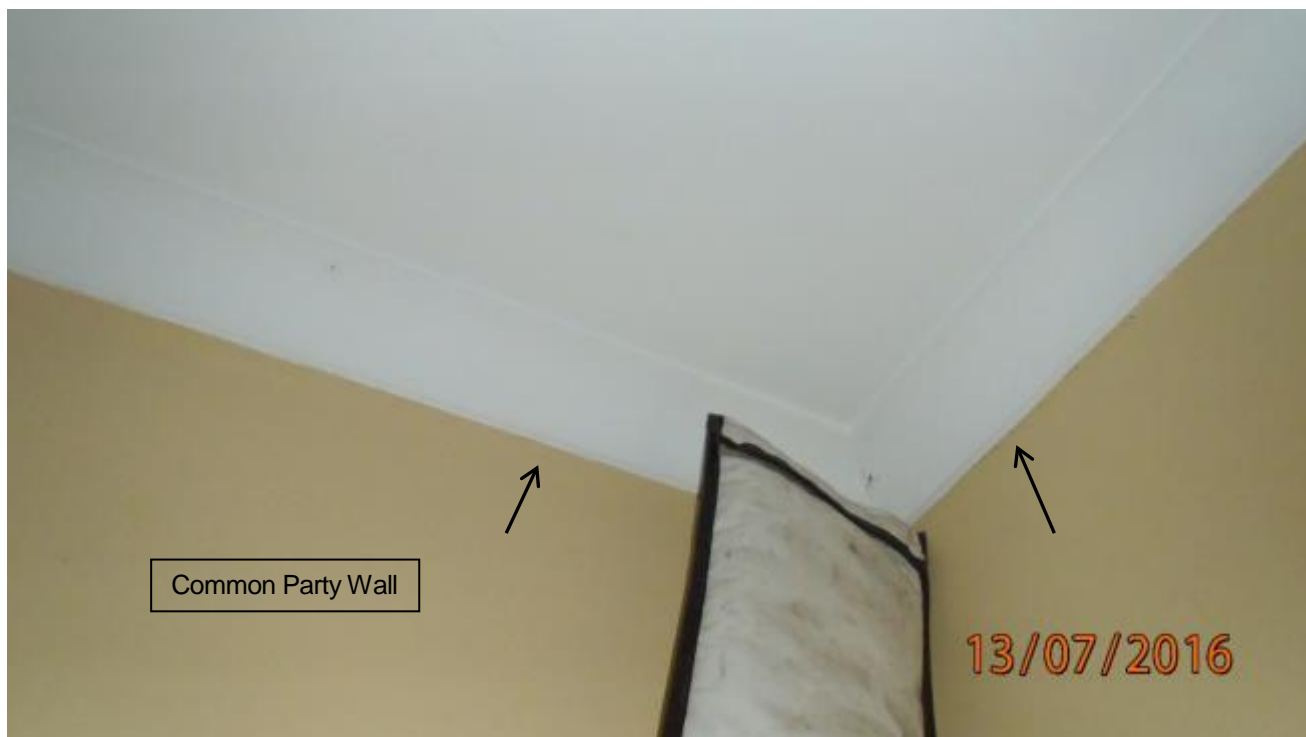
We observed a separation crack to the wall / cornice junction in the north western corner adjoining the common party wall with No. 129 Blair Street. **[Photograph 15]**

Photograph 15 shows separation cracking to the wall cornice junction in the Hallway.

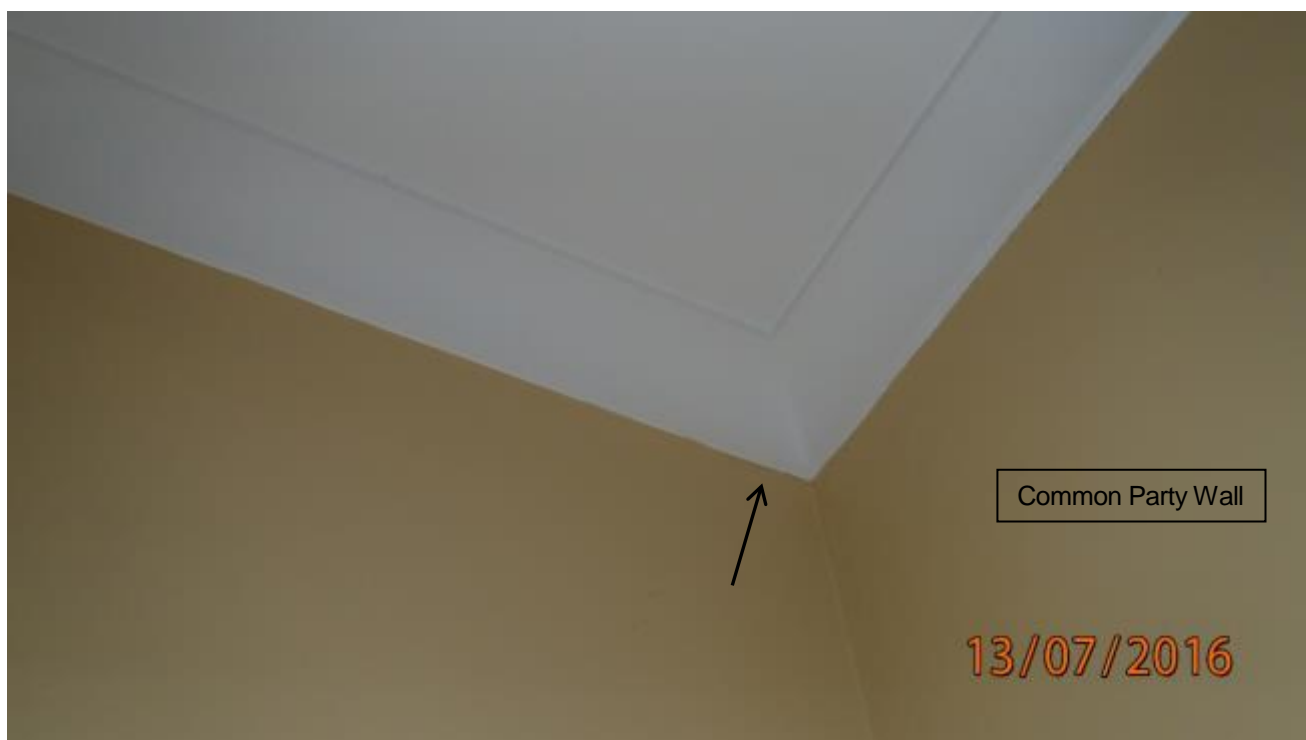
We observed separation cracking to the wall / cornice junction in the north western corner outside Bedroom 2 adjoining the common party wall with No. 129 Blair Street. **[Photograph 16]**

Photograph 16 shows separation cracking to the wall cornice junction in the Hallway

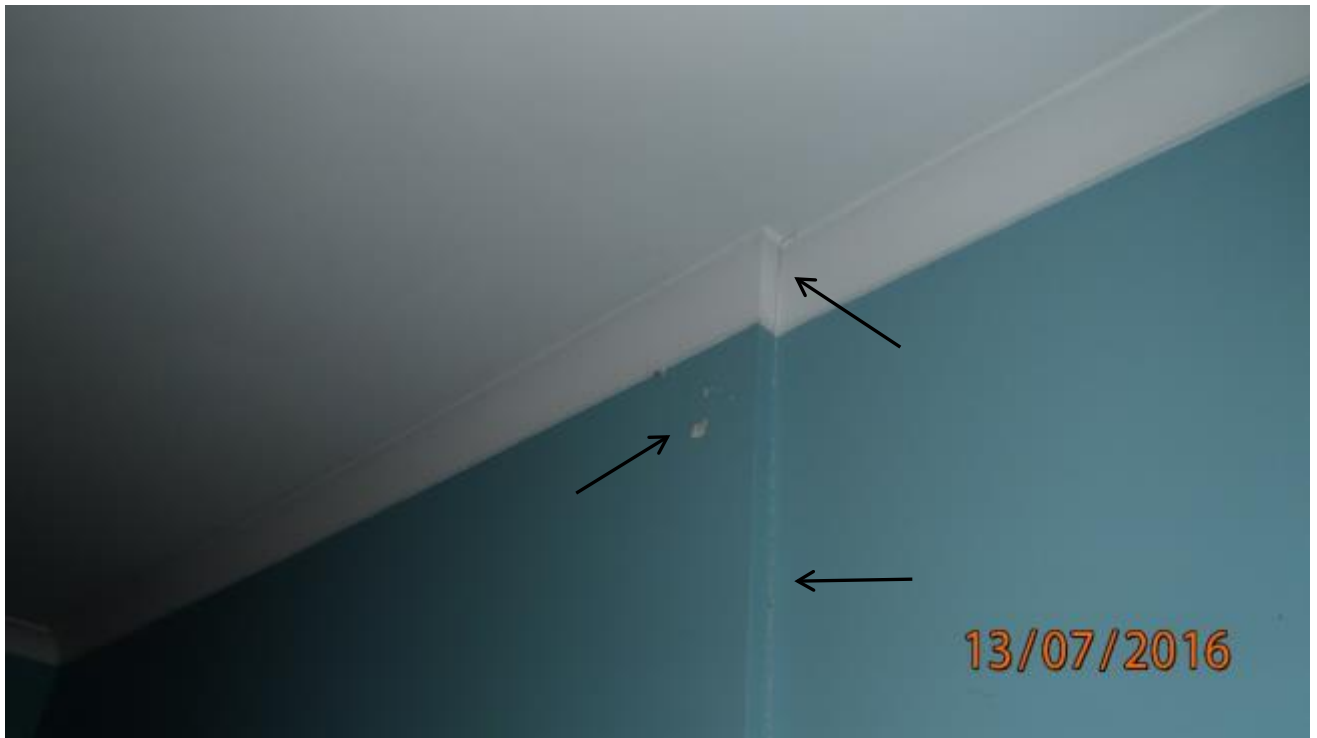
We observed a vertical crack to the wall / wall junction that extends through the cove profiled cornice on the plasterboard lined common party wall with No. 129 Blair Street, at the base of the stairs to the first floor addition. **[Photographs 17 and 18]**

Photograph 17 shows a vertical crack at the wall to wall junction and damage to the surface coating in the Hallway.

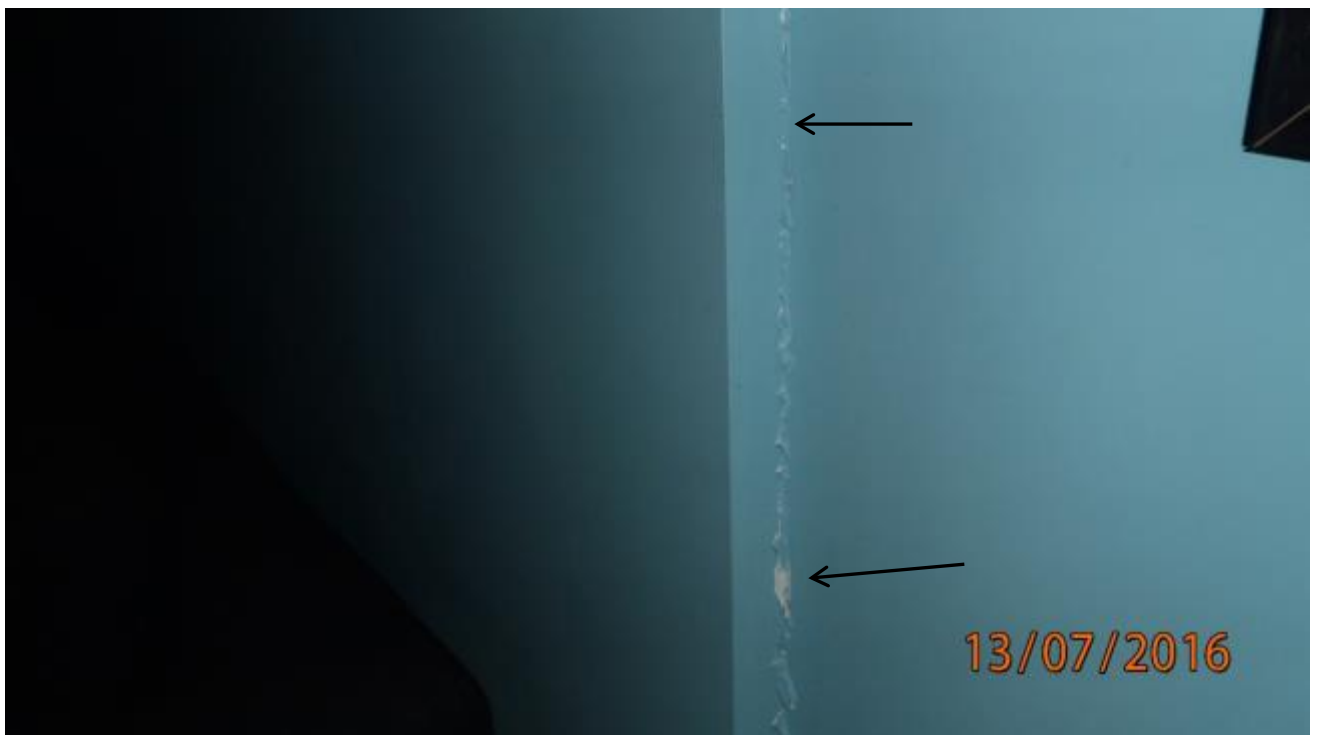
Photograph 18 shows a vertical crack at the wall to wall junction in the Hallway.

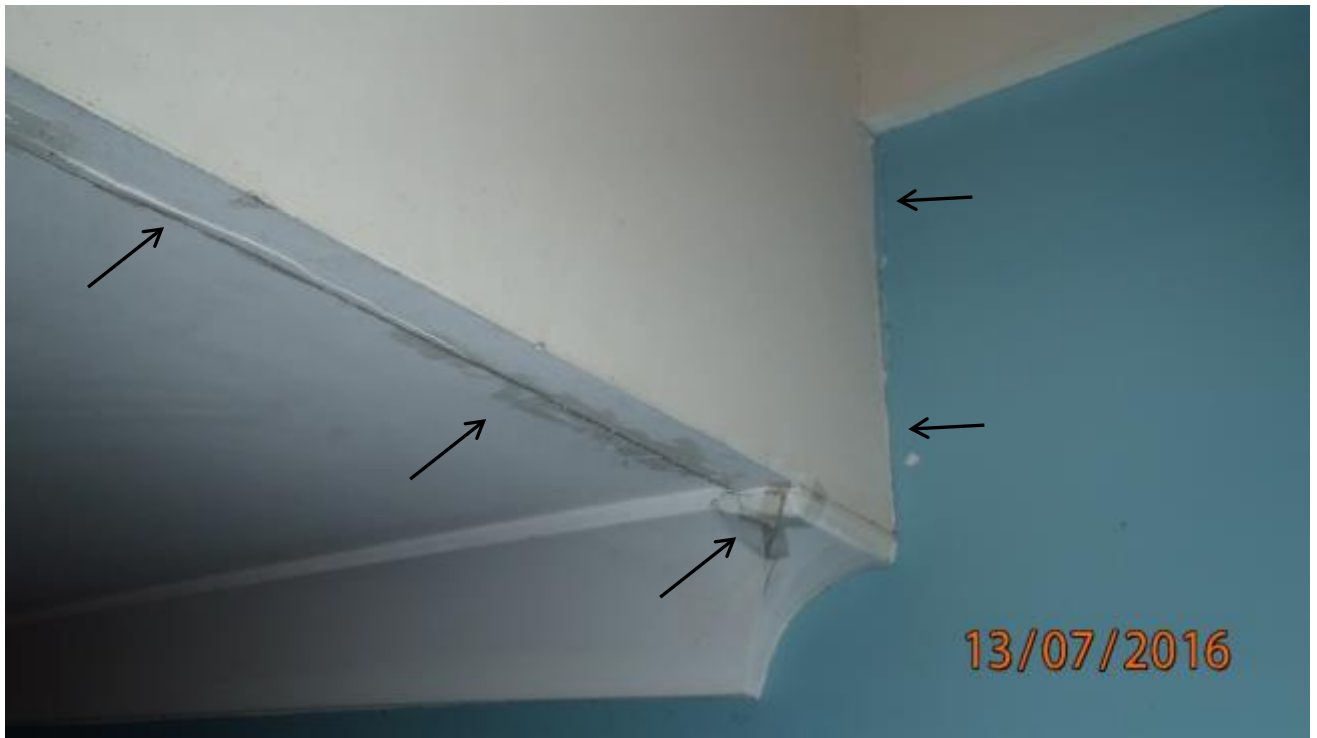
We observed general cracking and previous repairs to the plaster wall / ceiling junction, wall / wall junction and the plaster cornice above the first floor staircase **[Photograph 19]**

Photograph 19 shows previous repairs and cracking to the wall / wall junction and cornice under the staircase.

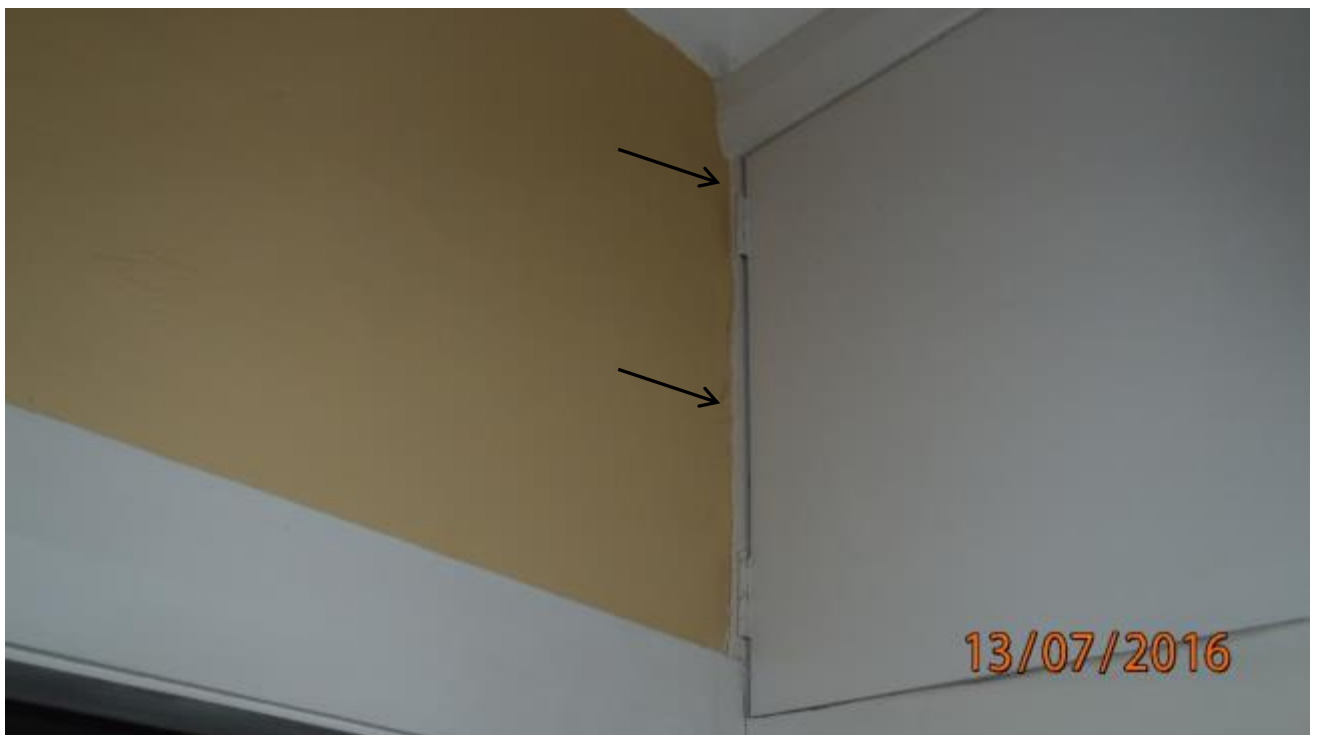
We noted vertical cracking to the wall door junction on the hinge side of the cupboard door **[Photograph 20]**

Photograph 20 shows a vertical crack adjacent to the cupboard in the Hallway.

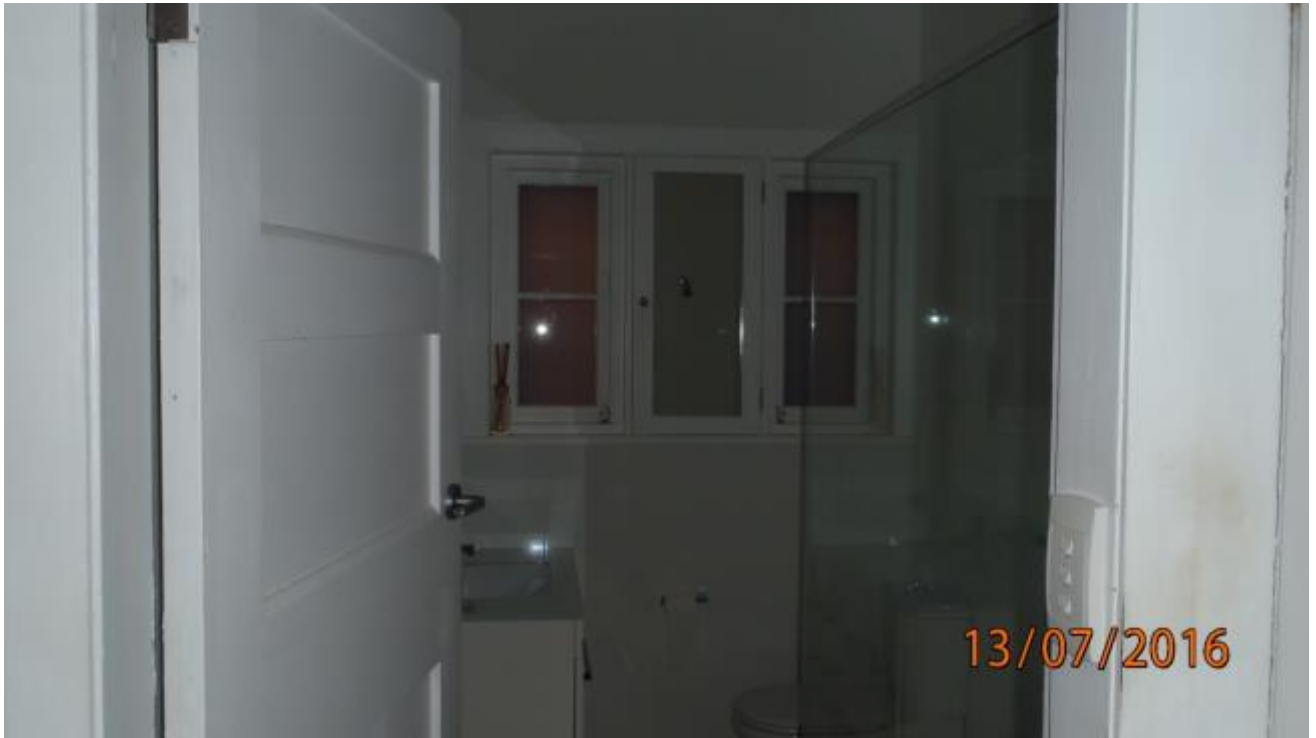
We noted that the grout to the wall and floor tiles is complete and that the wall and floor tiles when randomly “tap” tested appeared to be sound. We did not observe any recent cracking to the tile grout at the wall / wall, wall / floor junctions. **[Photograph 21]**

Photograph 21 shows the general condition of the Bathroom.
