Dilapidation Assessment Report

Prepared for: Cape Cod Australia Pty. Limited
Job address: 131 Blair Street, NORTH BONDI.
Property Owner/s: Mr. Andrew & Mrs. Kristane Foxton.
Report reference: **WAVERLEY COUNCIL**
Development Application No: not available
Date of assessment: 13th July 2016

Re: Dilapidation Report

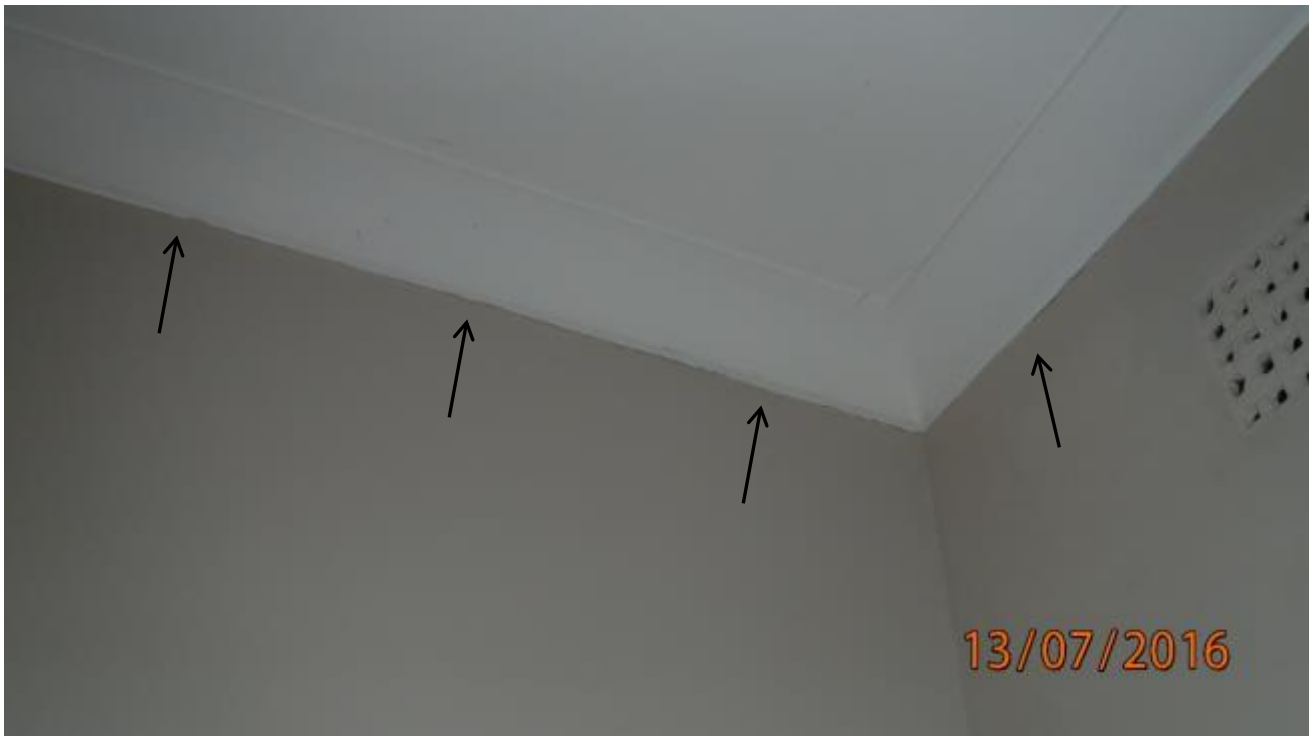
We observed a separation crack to the wall / cornice junction in the north eastern corner **[Photograph 22]**

Photograph 22 shows separation cracking to the wall cornice junction in Bedroom 2.

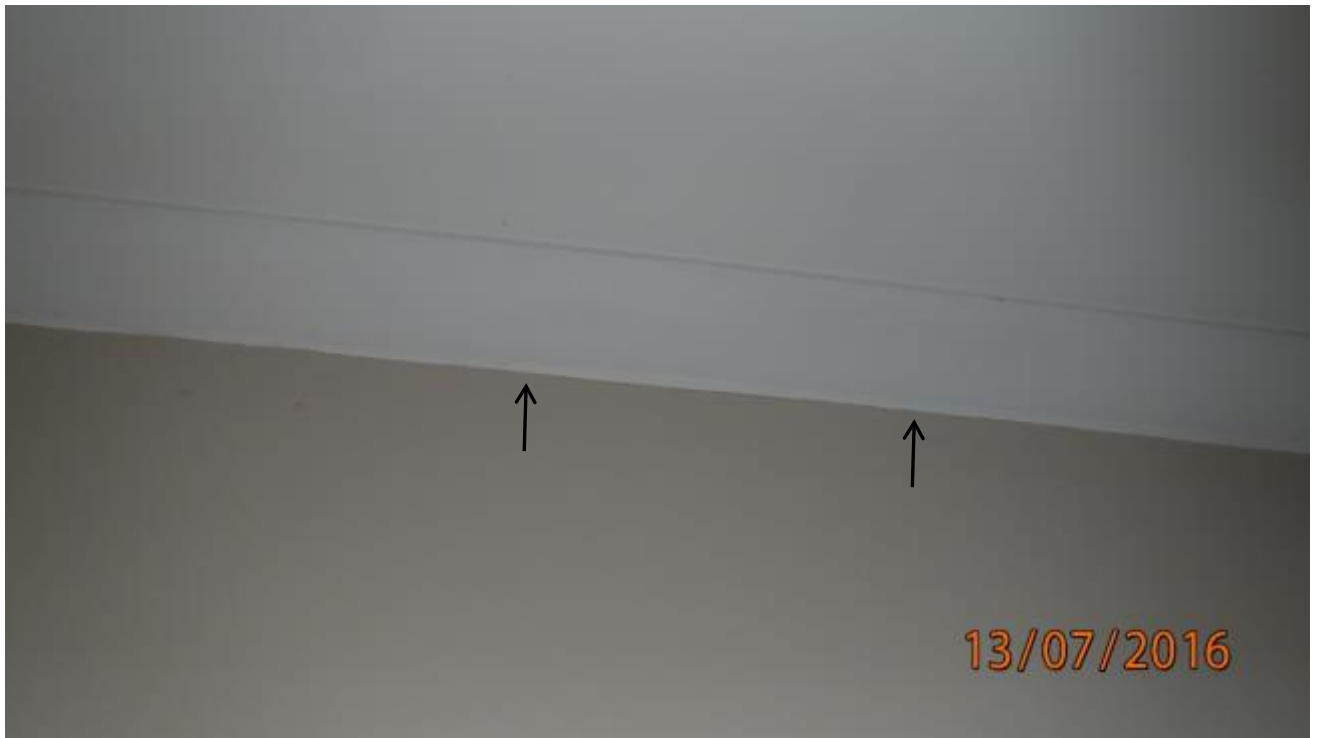
We observed a separation crack to the wall / cornice junction above the western wall **[Photograph 23]**

Photograph 23 shows separation cracking to the wall cornice junction in Bedroom 2.

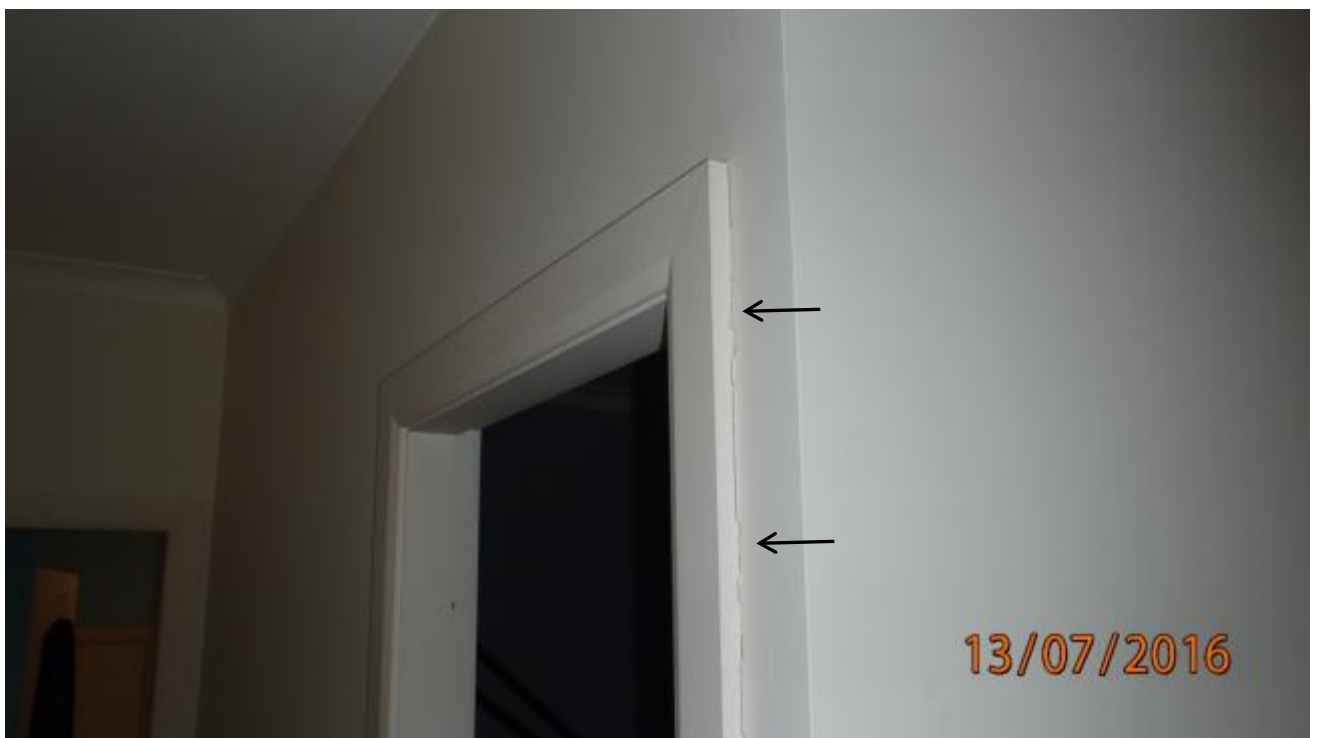
We observed a separation to the Bedroom 4 door architrave / wall junction **[Photograph 24]**

Photograph 24 shows separation cracking adjacent to the architrave outside Bedroom 4.

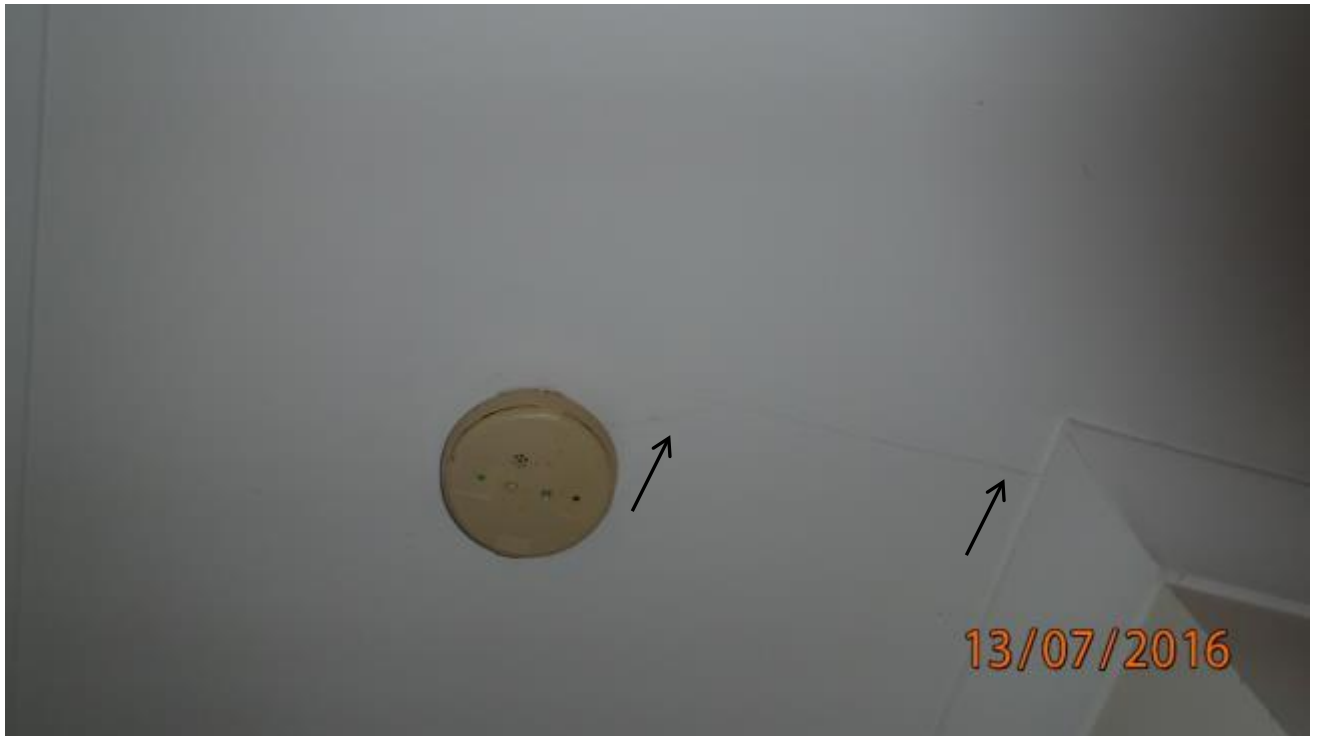
We noted cracking to the plasterboard ceiling lining extending from the cove profiled plaster cornice to the smoke alarm fixture. **[Photograph 25]**

Photograph 25 shows a crack to the ceiling lining adjacent to the smoke alarm fitting in the upstairs Hallway.

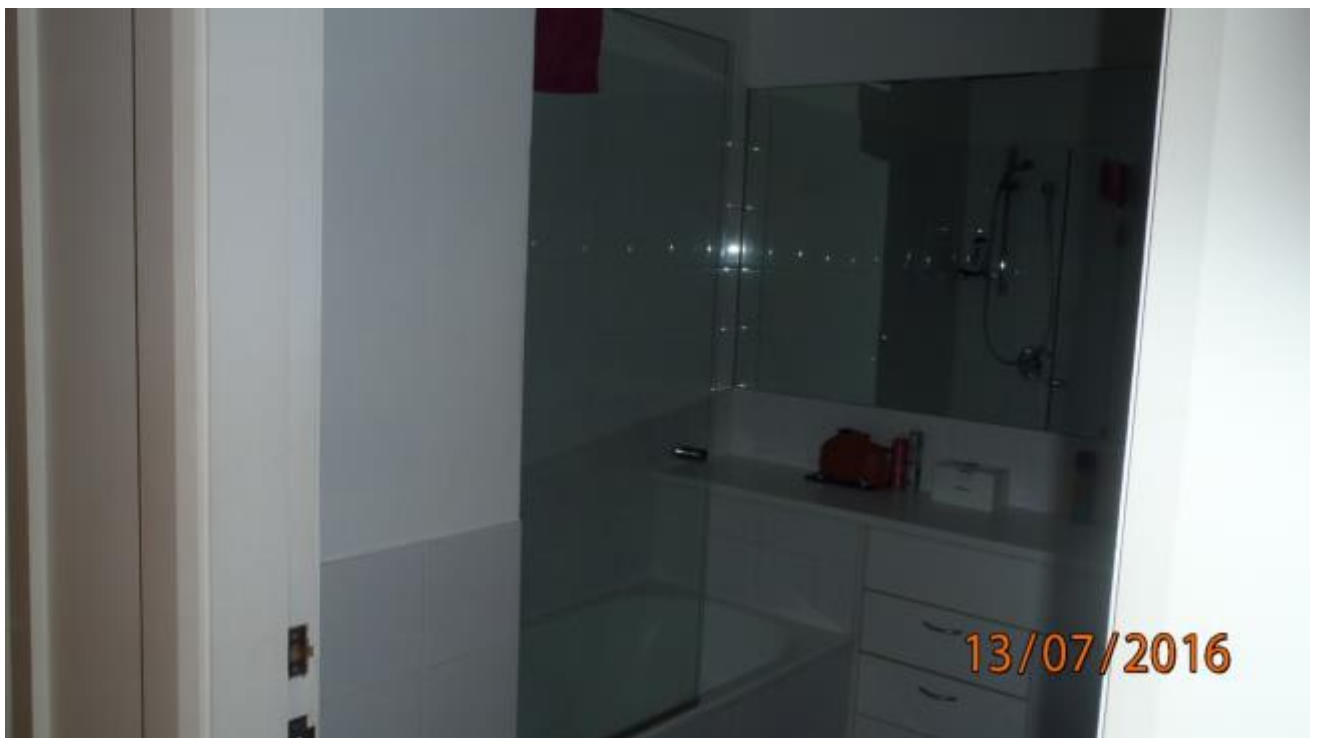
We noted that the grout to the wall and floor tiles is complete and that the wall and floor tiles when randomly "tap" tested appeared to be sound. We did not observe any recent cracking to the tile grout at the wall / wall, wall / floor junctions. [**Photograph 26**]

Photograph 26 shows the general condition of the upstairs Bathroom.

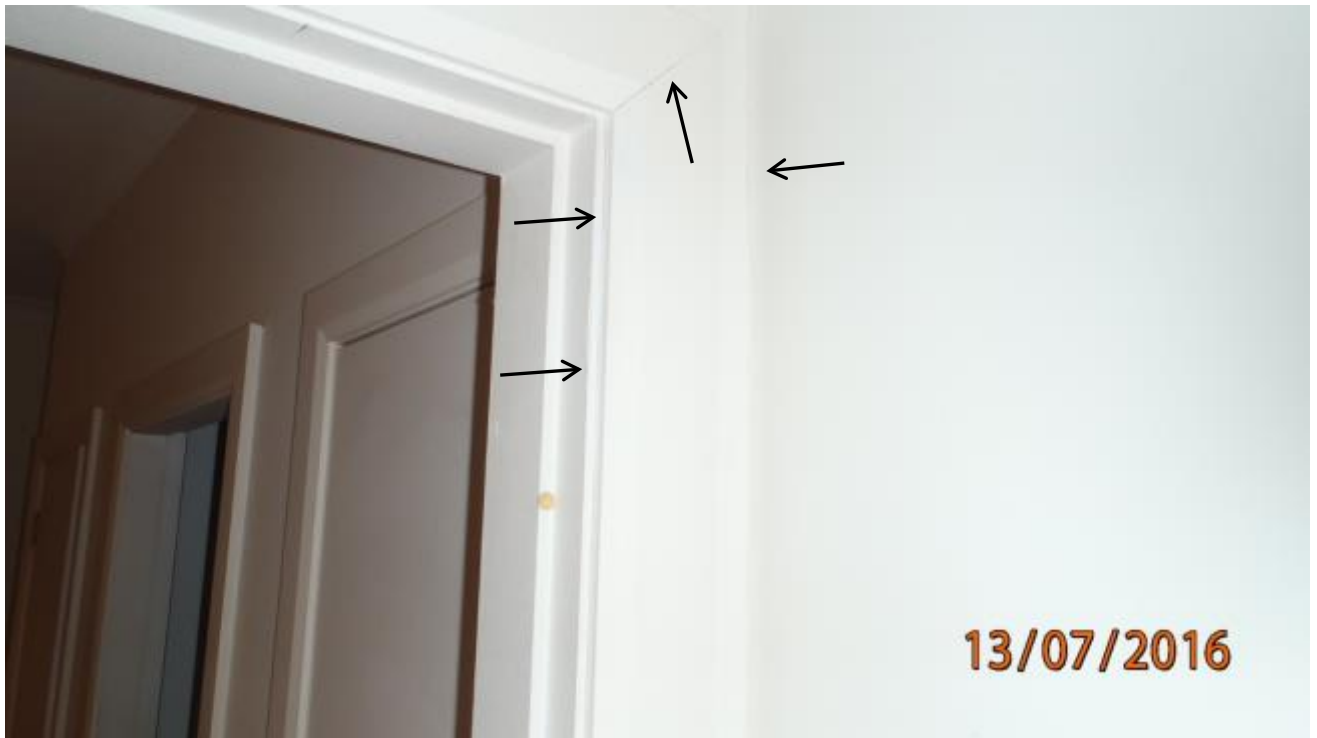
We noted vertical cracking to the architrave / door jamb junction and a radial crack extending from the architrave mitre joint towards the ceiling. [**Photograph 27**]

We noted vertical cracking to the wall to wall junction adjacent to the door [**Photograph 27**]

Photograph 27 shows vertical cracking to the architrave / door jamb junction and a radial crack extending from the architrave mitre joint towards the ceiling and vertical cracking to the wall to wall junction adjacent to the door.
