## Dilapidation Assessment Report

Prepared for: Cape Cod Australia Pty. Limited  
Job address: 11 Morrice Street, Lane Cove.  
Property Owner/s: Mrs. Therese Sheridan.  
Report reference: **LANE COVE COUNCIL**  
Development Application No: not available  
Date of assessment: 8<sup>th</sup> November 2016

**Re: Dilapidation Report – 11 Morrice Street, Lane Cove.**

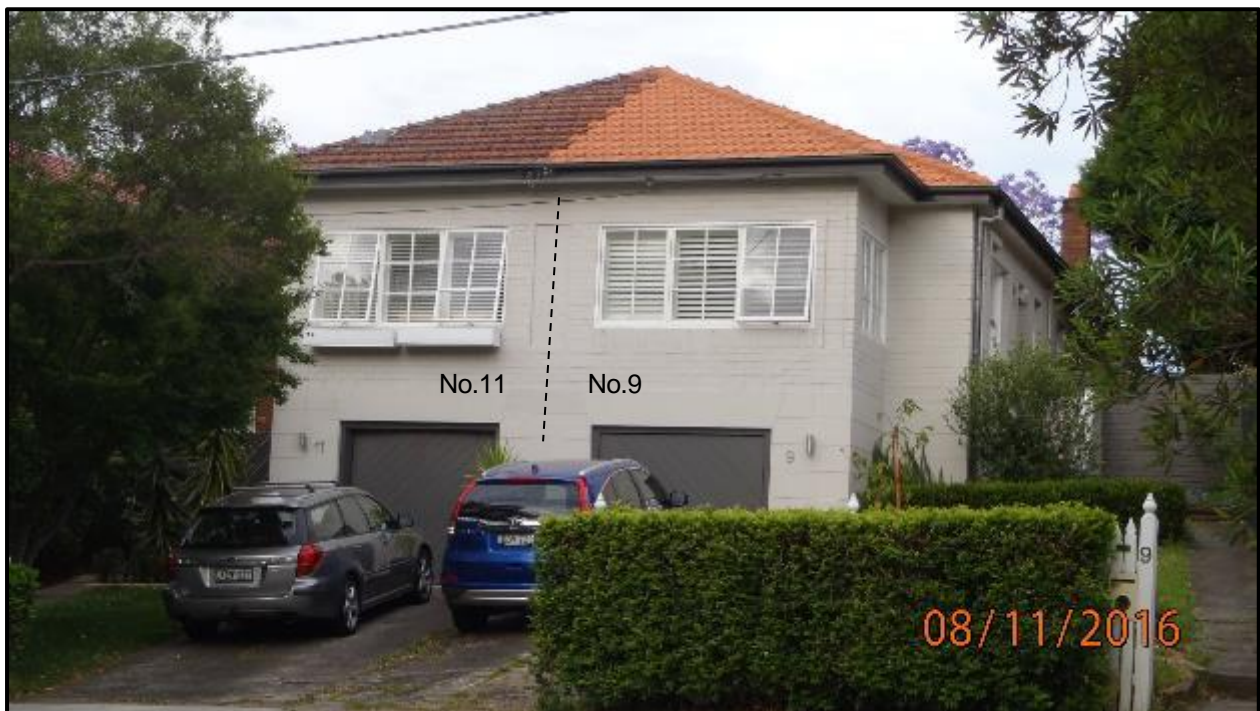
Shows the front eastern elevation of the adjoining properties:  
No.11 and No.9 Morrice Street, Lane Cove

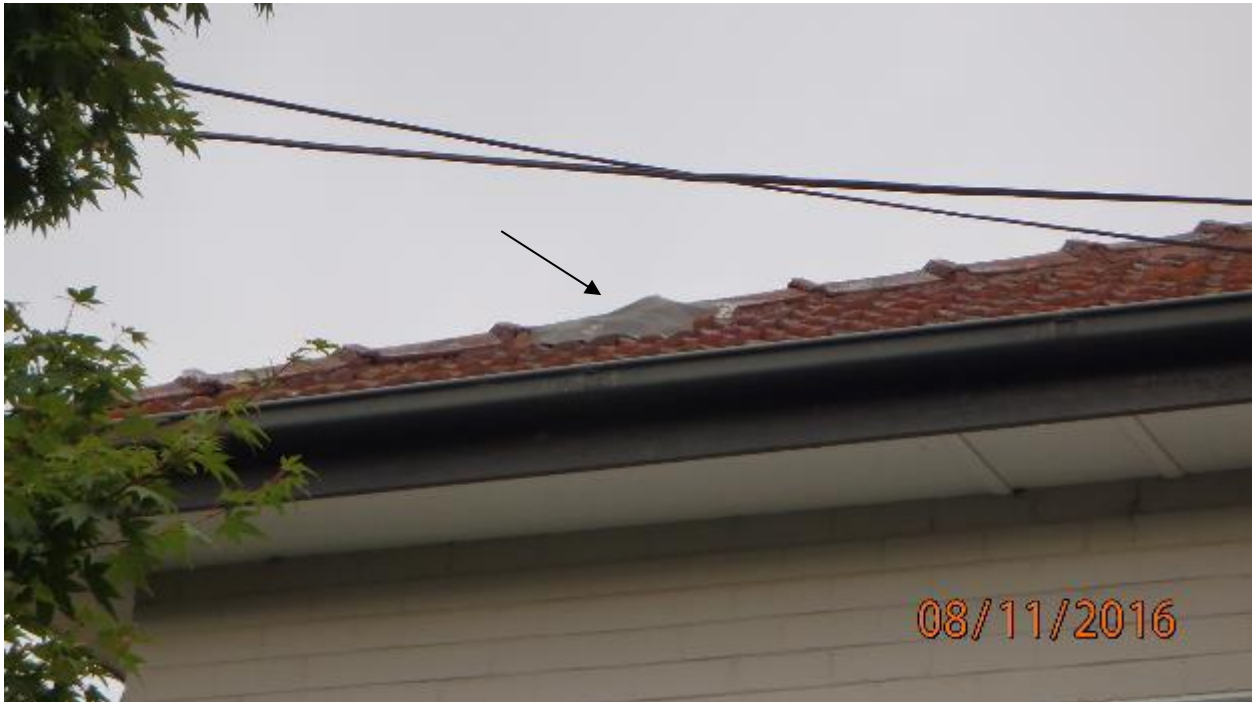
We noted extra flashing / weatherproofing provided to the hip tiles over the front southeast corner [Sunroom] of the residence. **[Photograph 1]**

**Photograph 1** shows extra flashing / weatherproofing provided to the hip tiles over the front southeast corner [Sunroom].

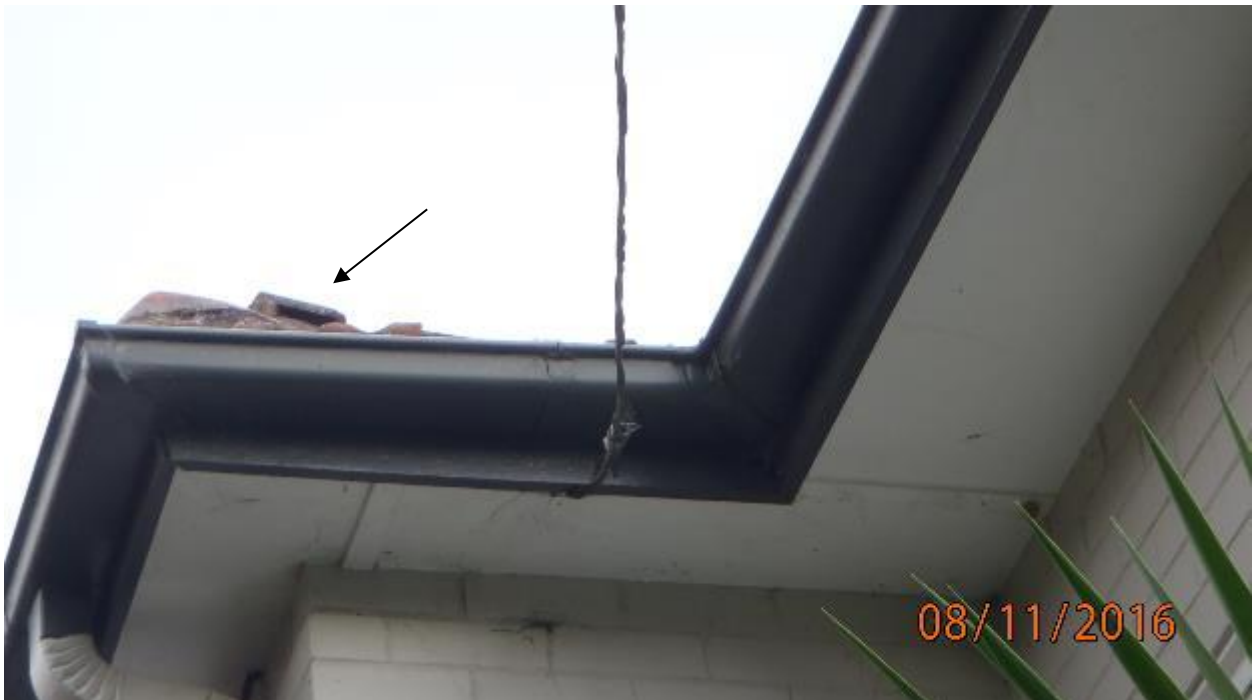
We noted lifting and some deterioration to the hip capping and pointing over the front southeast corner [Bedroom 1] of the residence. **[Photograph 2]**

**Photograph 2** shows lifting and some deterioration to the hip capping and pointing over the front southeast corner [Bedroom 1] of the residence.

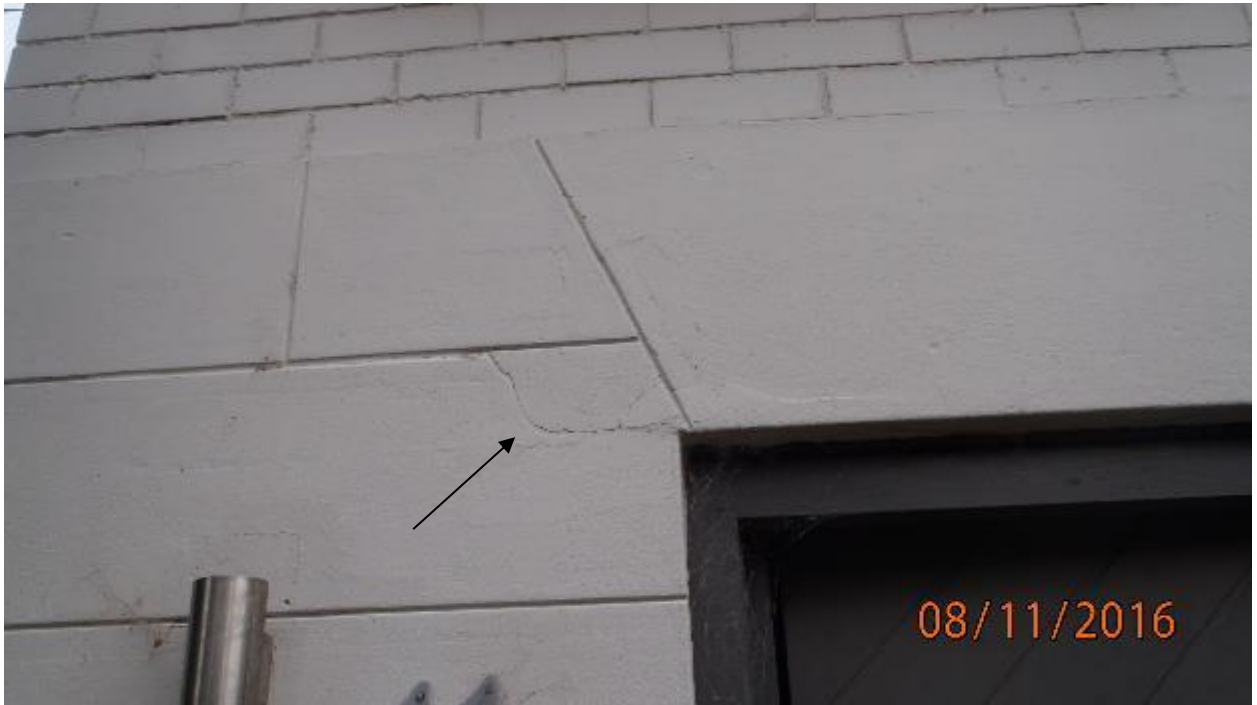
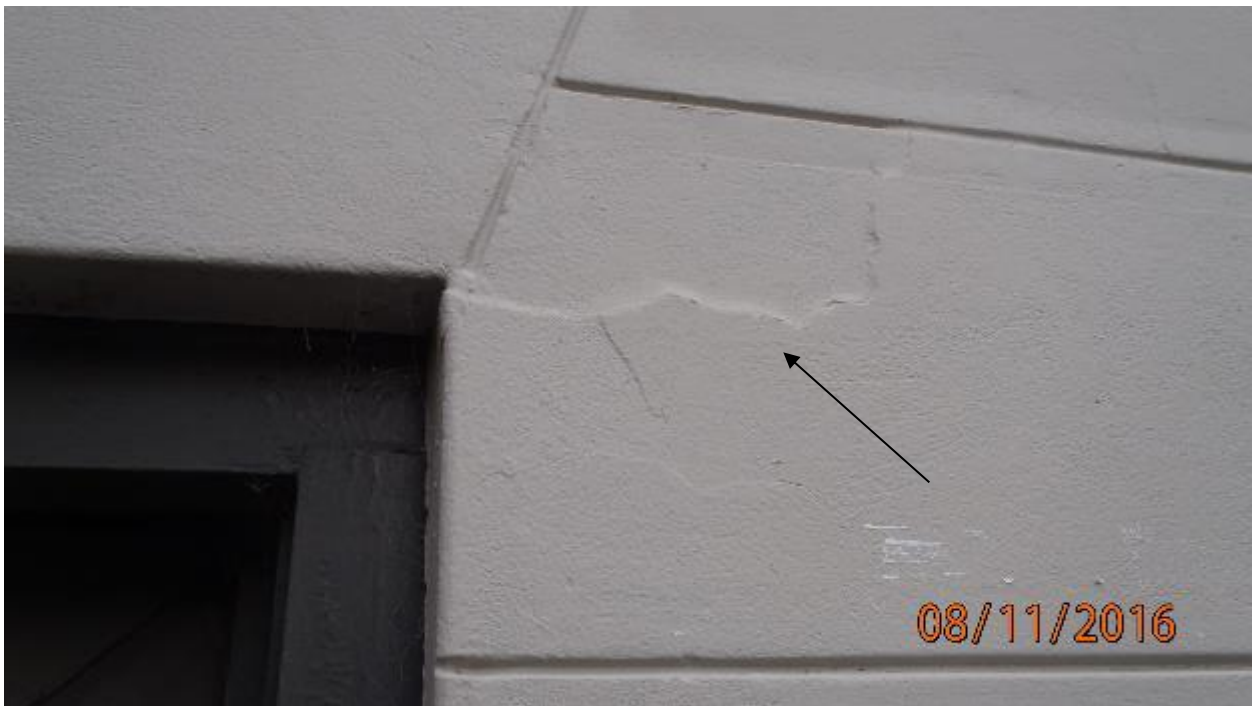
We noted hairline radial cracking above the garage door head. **[Photographs 3 & 4]**

**Photograph 3** shows radial cracking above the garage door head.

**Photograph 4** shows radial cracking above the garage door head.

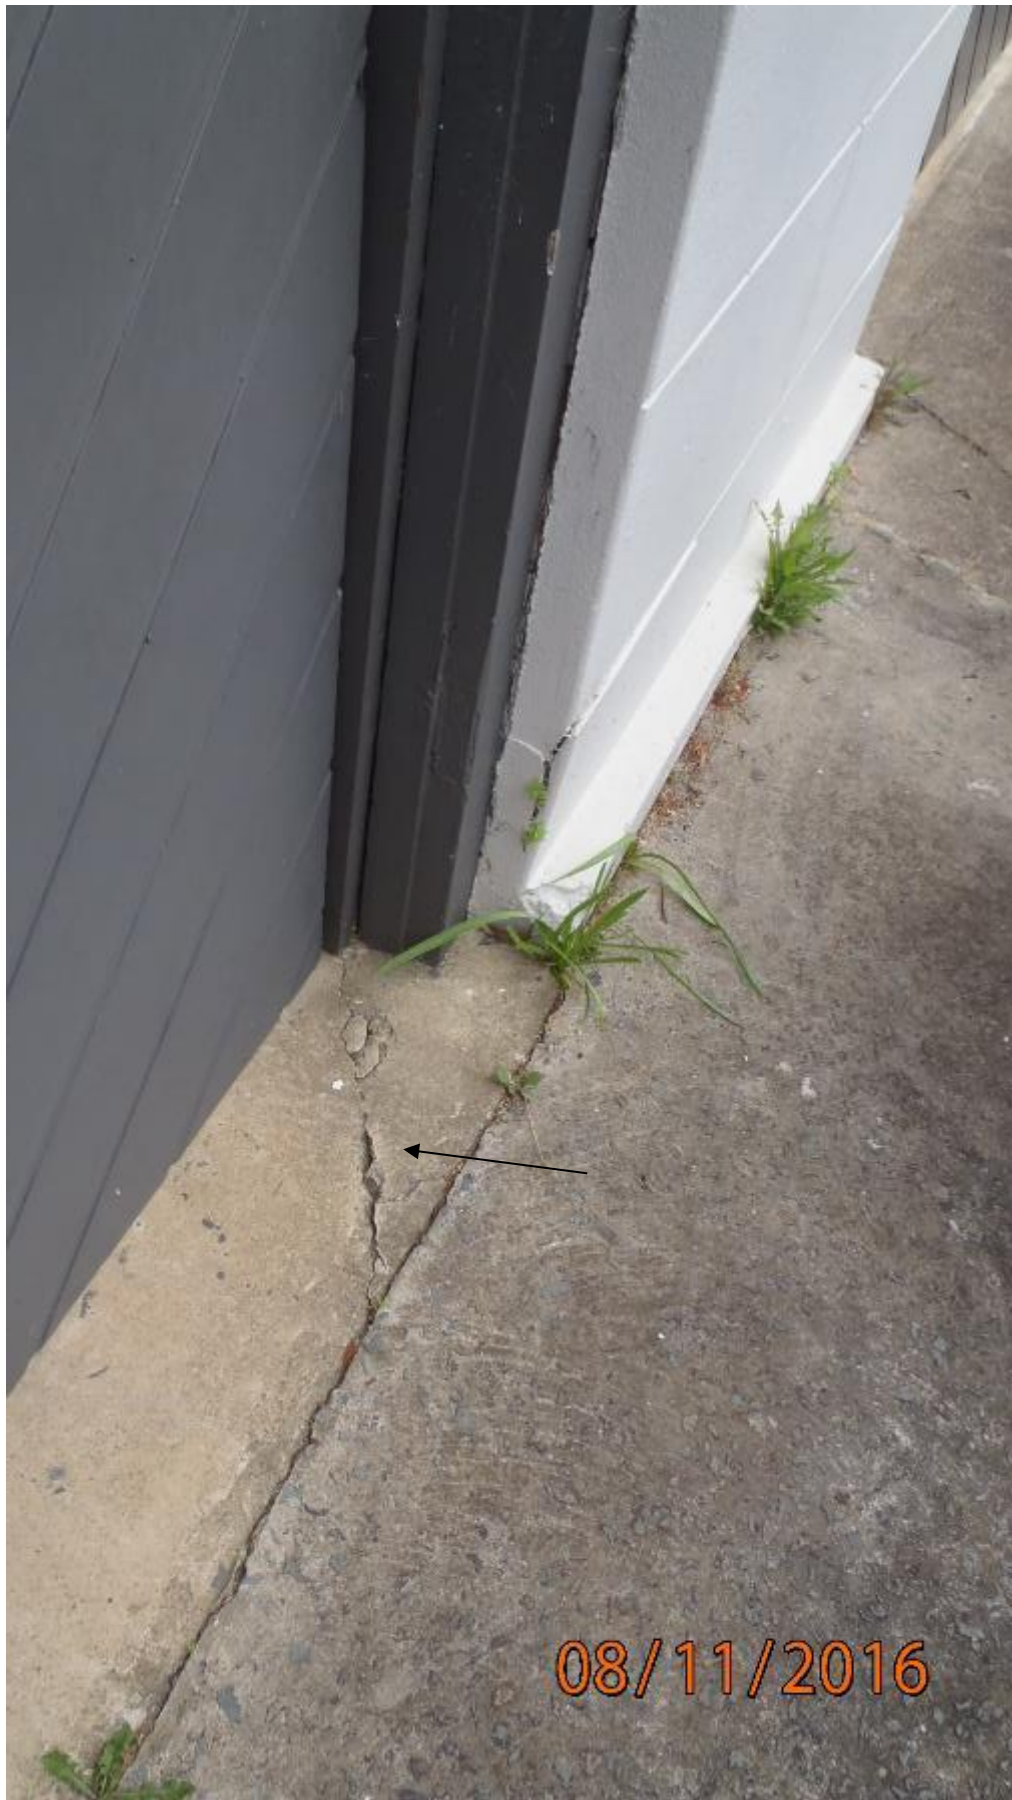
We noted shrinkage cracking to the concrete pavement outside the garage. **[Photograph 5]**

**Photograph 5** shows shrinkage cracking to the concrete pavement outside the garage.

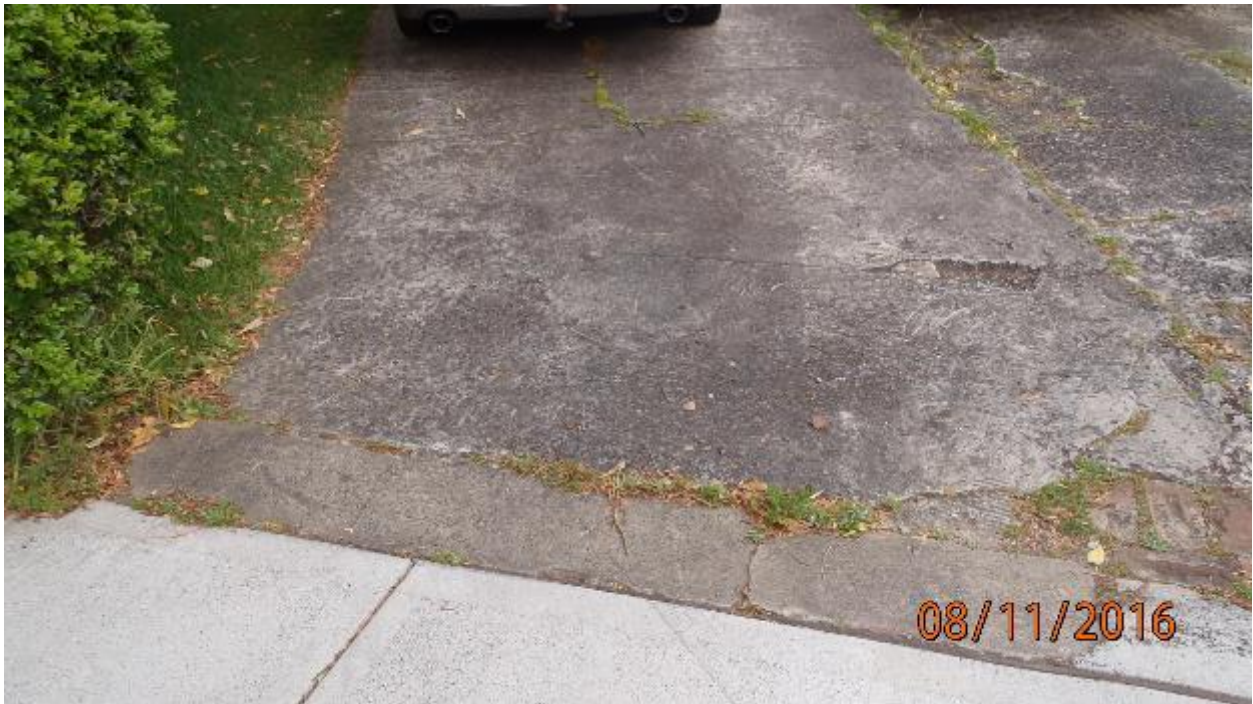
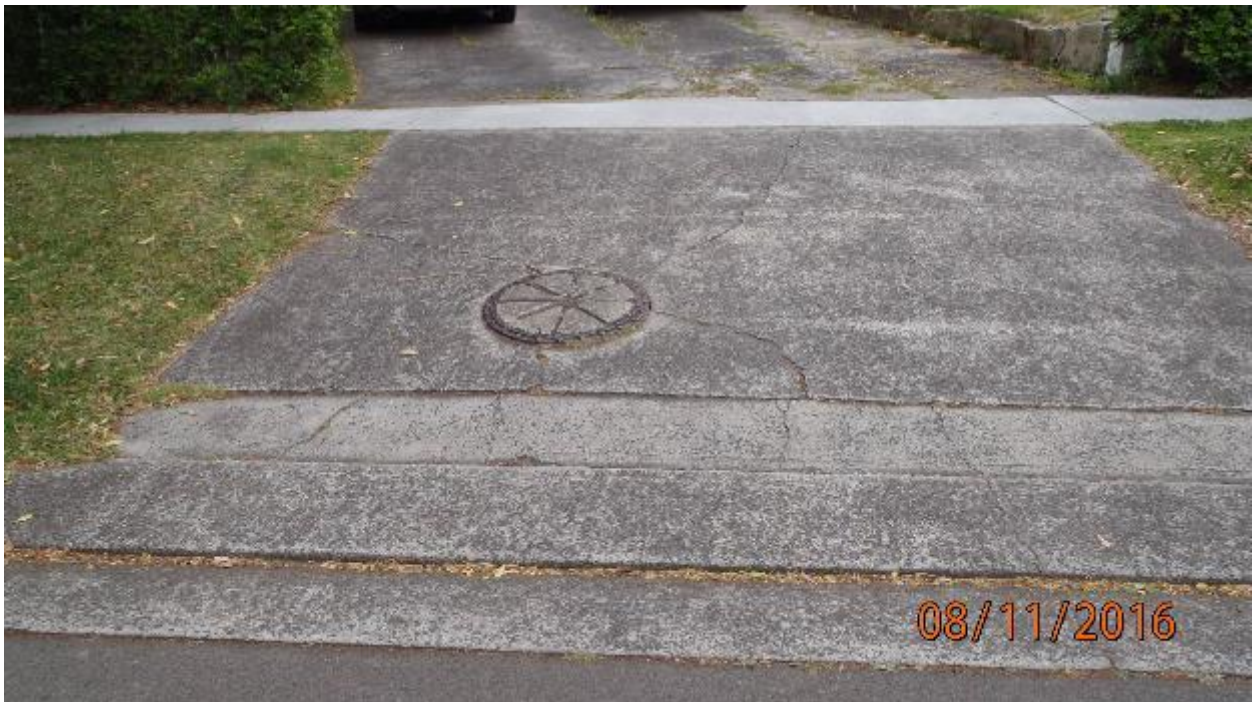
We noted cracking to the concrete driveway. **[Photographs 6 & 7]**

**Photograph 6** shows the general condition of the driveway pavement.

**Photograph 7** shows the general condition of the driveway pavement.

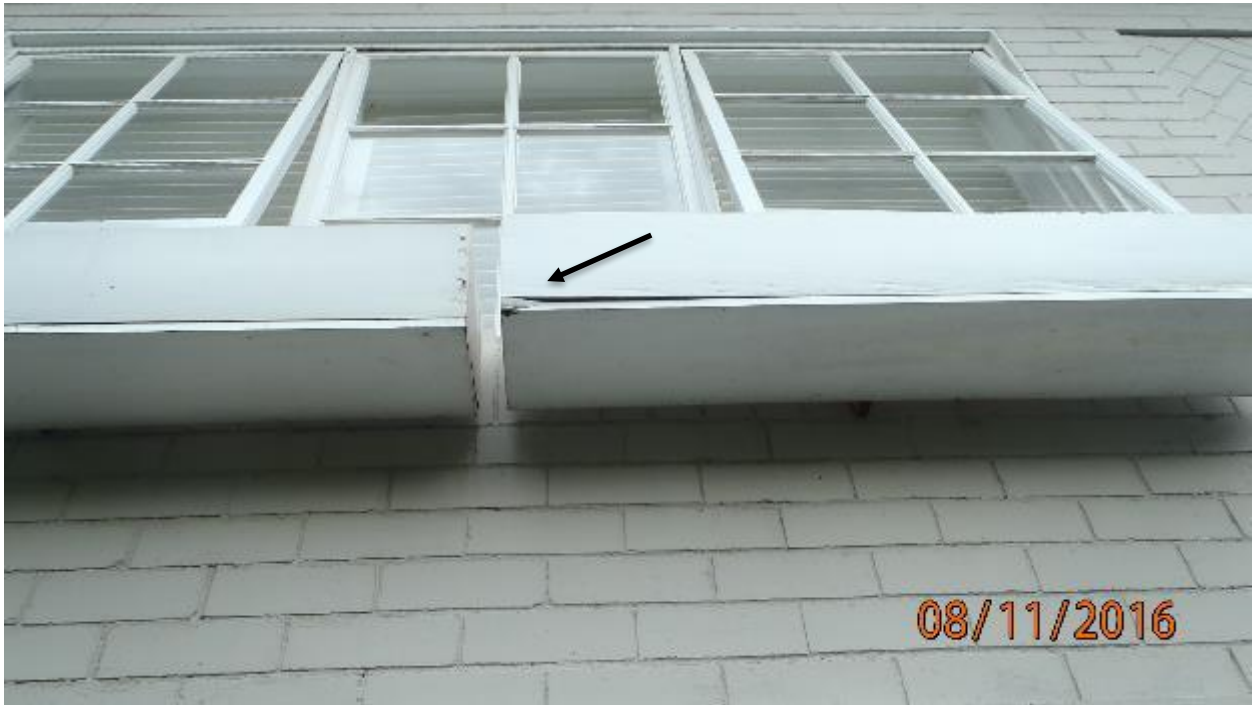
We noted damage to the planter boxes above the garage door. **[Photograph 8]**

**Photograph 8** shows damage to the planter boxes above the garage.

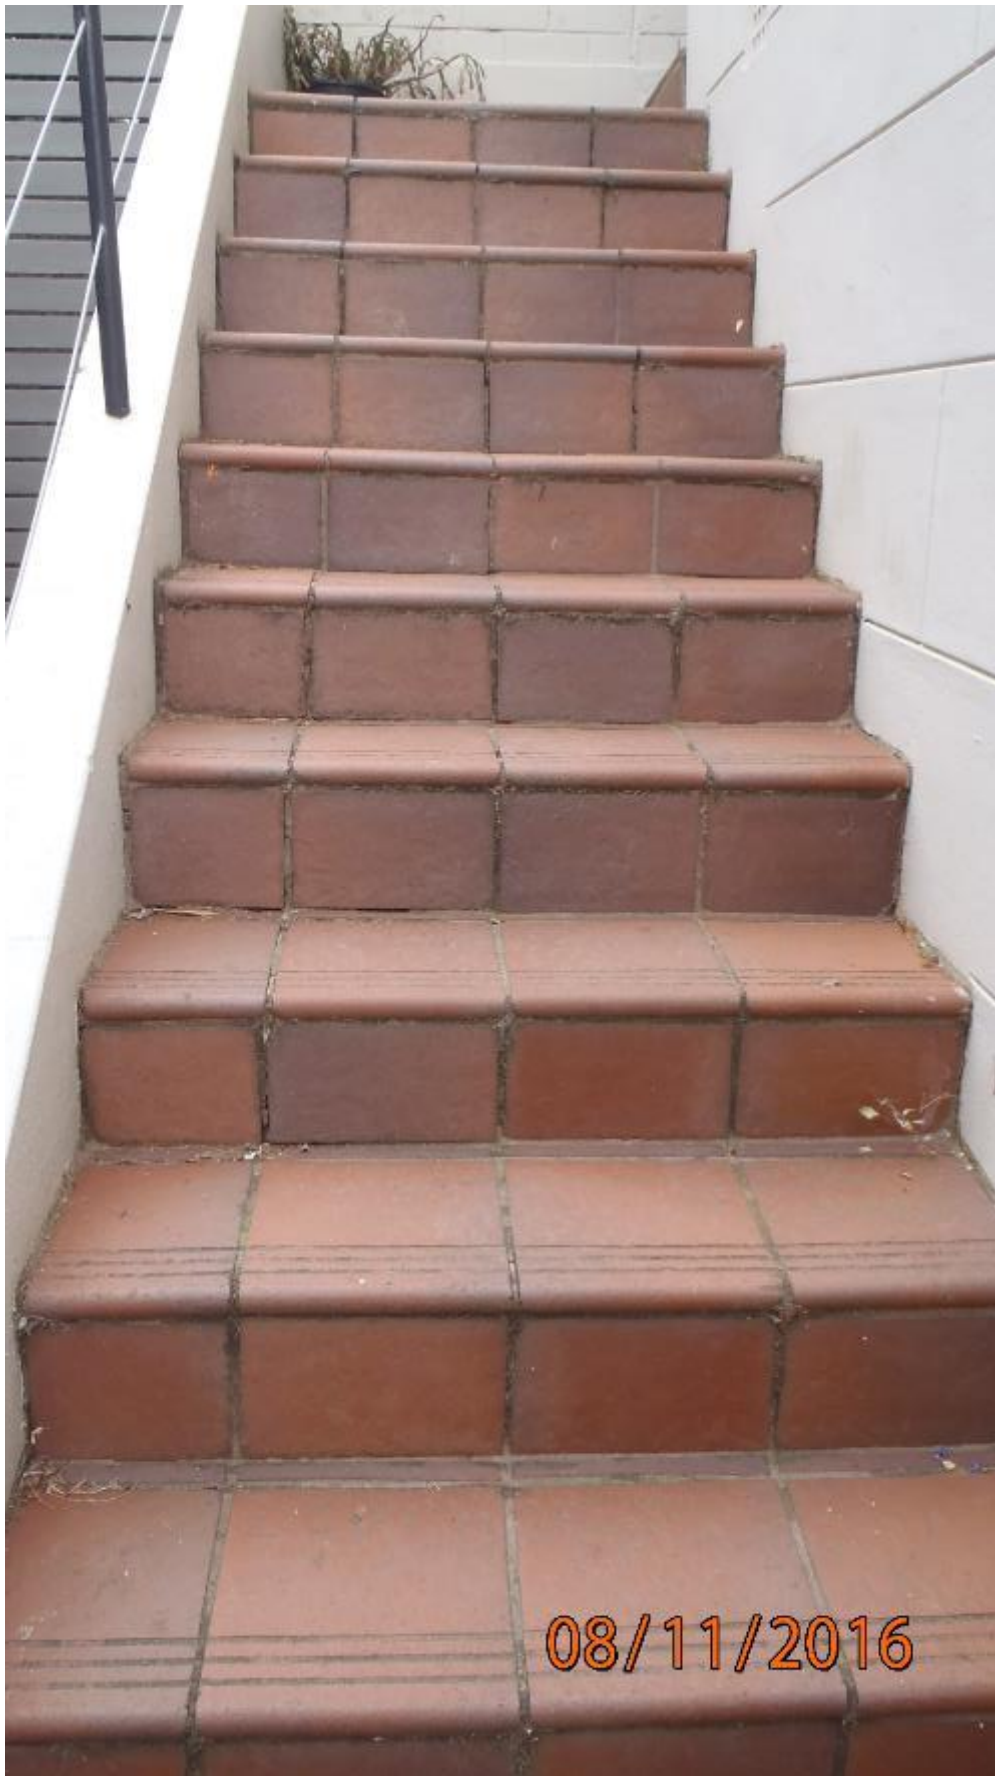
We noted displaced grout around the vitrified clay tiles to the front steps and landing. **[Photograph 9]**

**Photograph 9** shows displacement to the grout on the front steps.

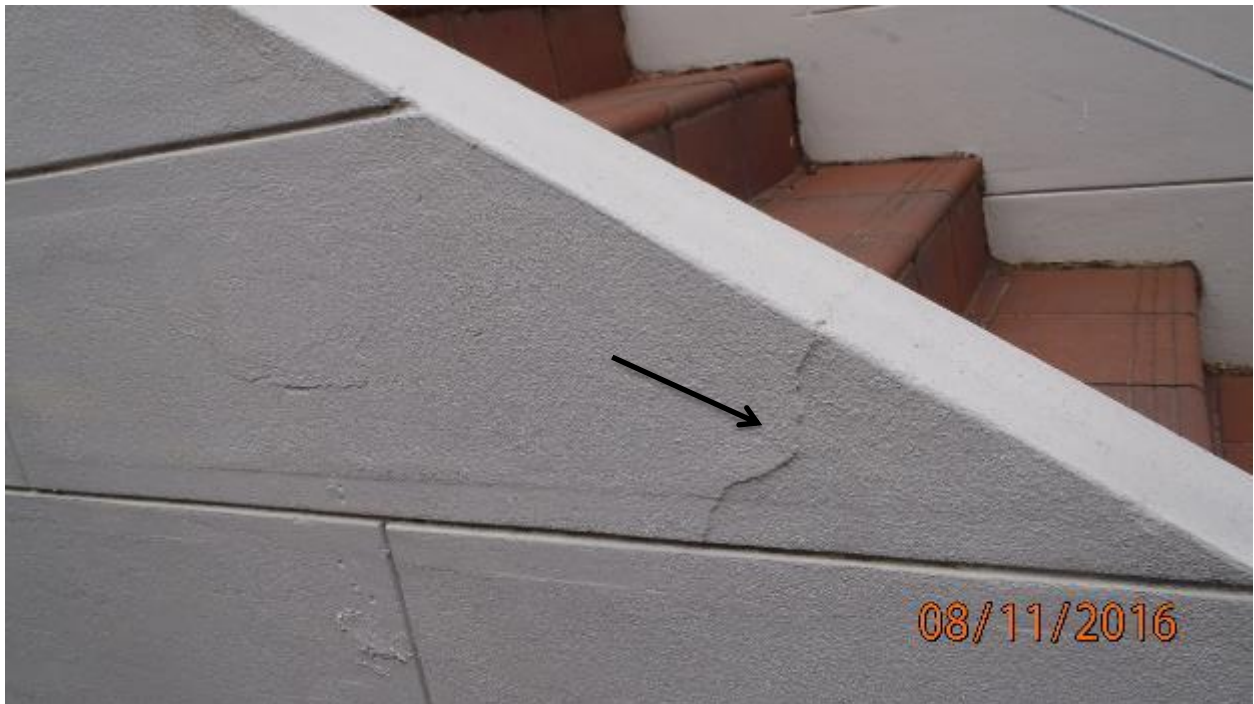
We noted cracking through the concrete block stringer on the front steps. **[Photograph 10]**

**Photograph 10** shows cracking to the front steps stringer wall.

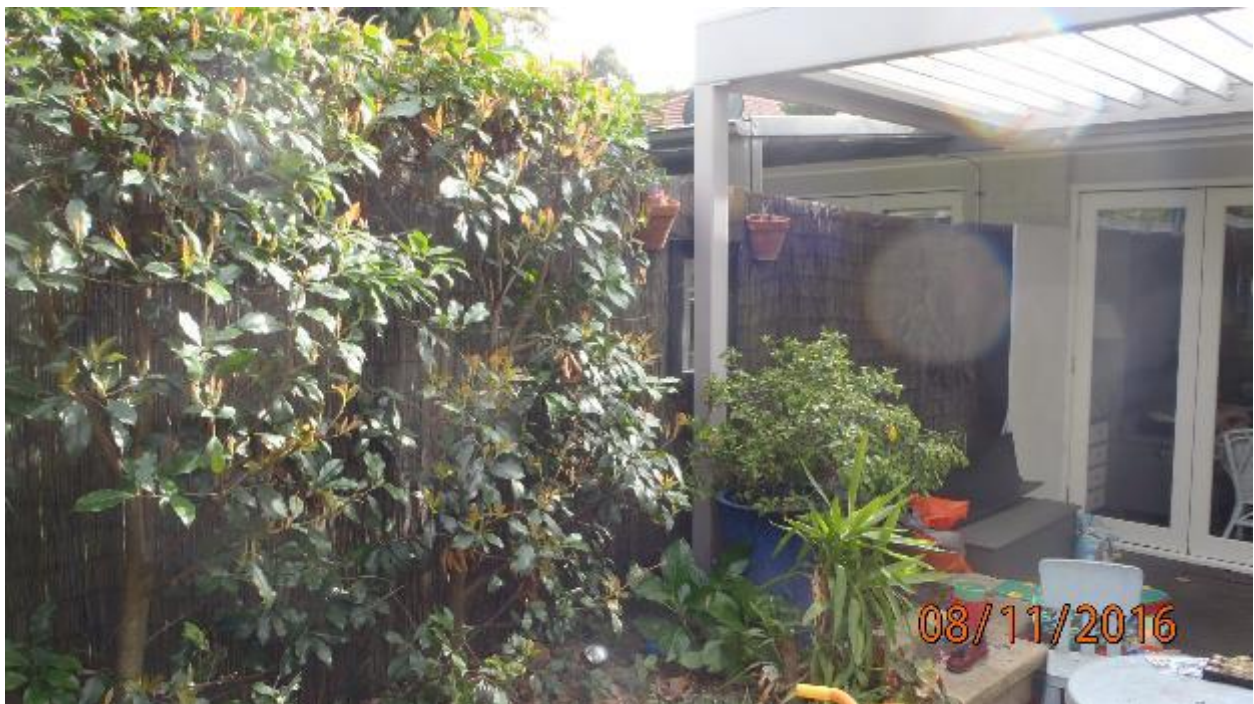
We noted that the rear *common* boundary fence with the adjoining property, No. 9 Morrice Street was of timber post and rail construction and was lined with brush covering **[Photograph 11]**

**Photograph 11** shows the general condition of the rear common boundary fence

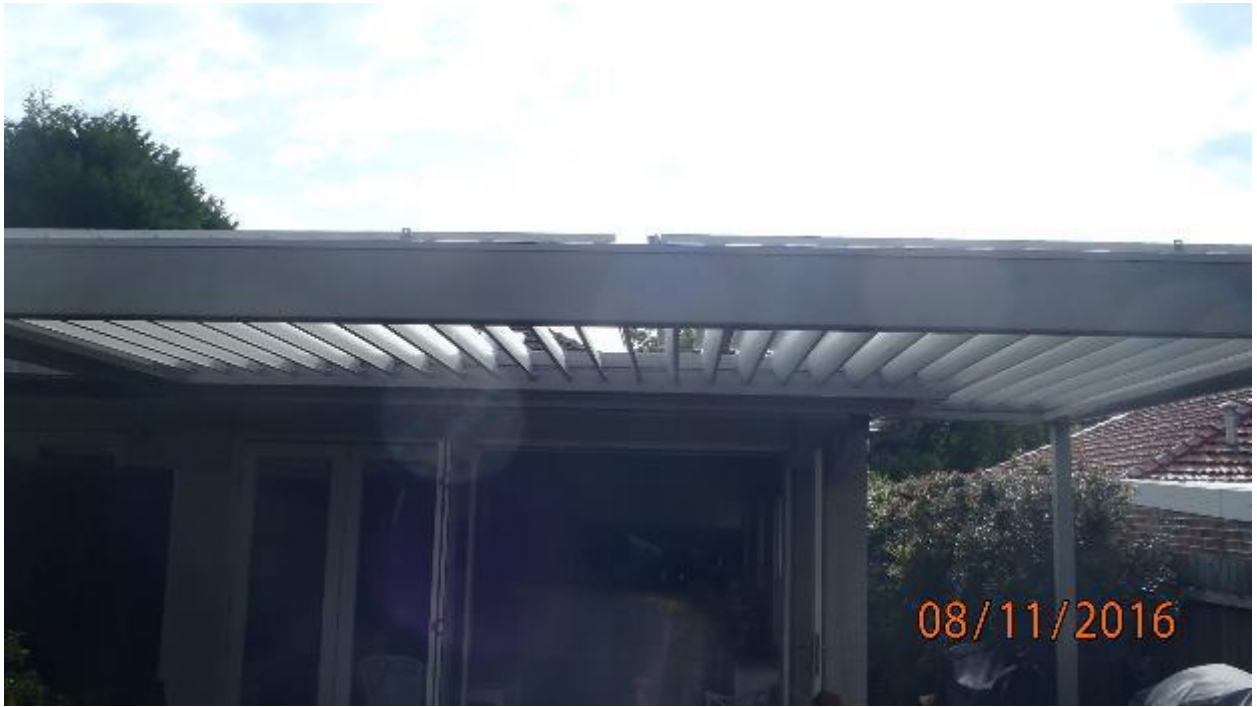
We noted a metal framed louvre awning at the rear over the timber deck. **[Photograph 12] 567**

**Photograph 12** shows the rear elevation of the residence.

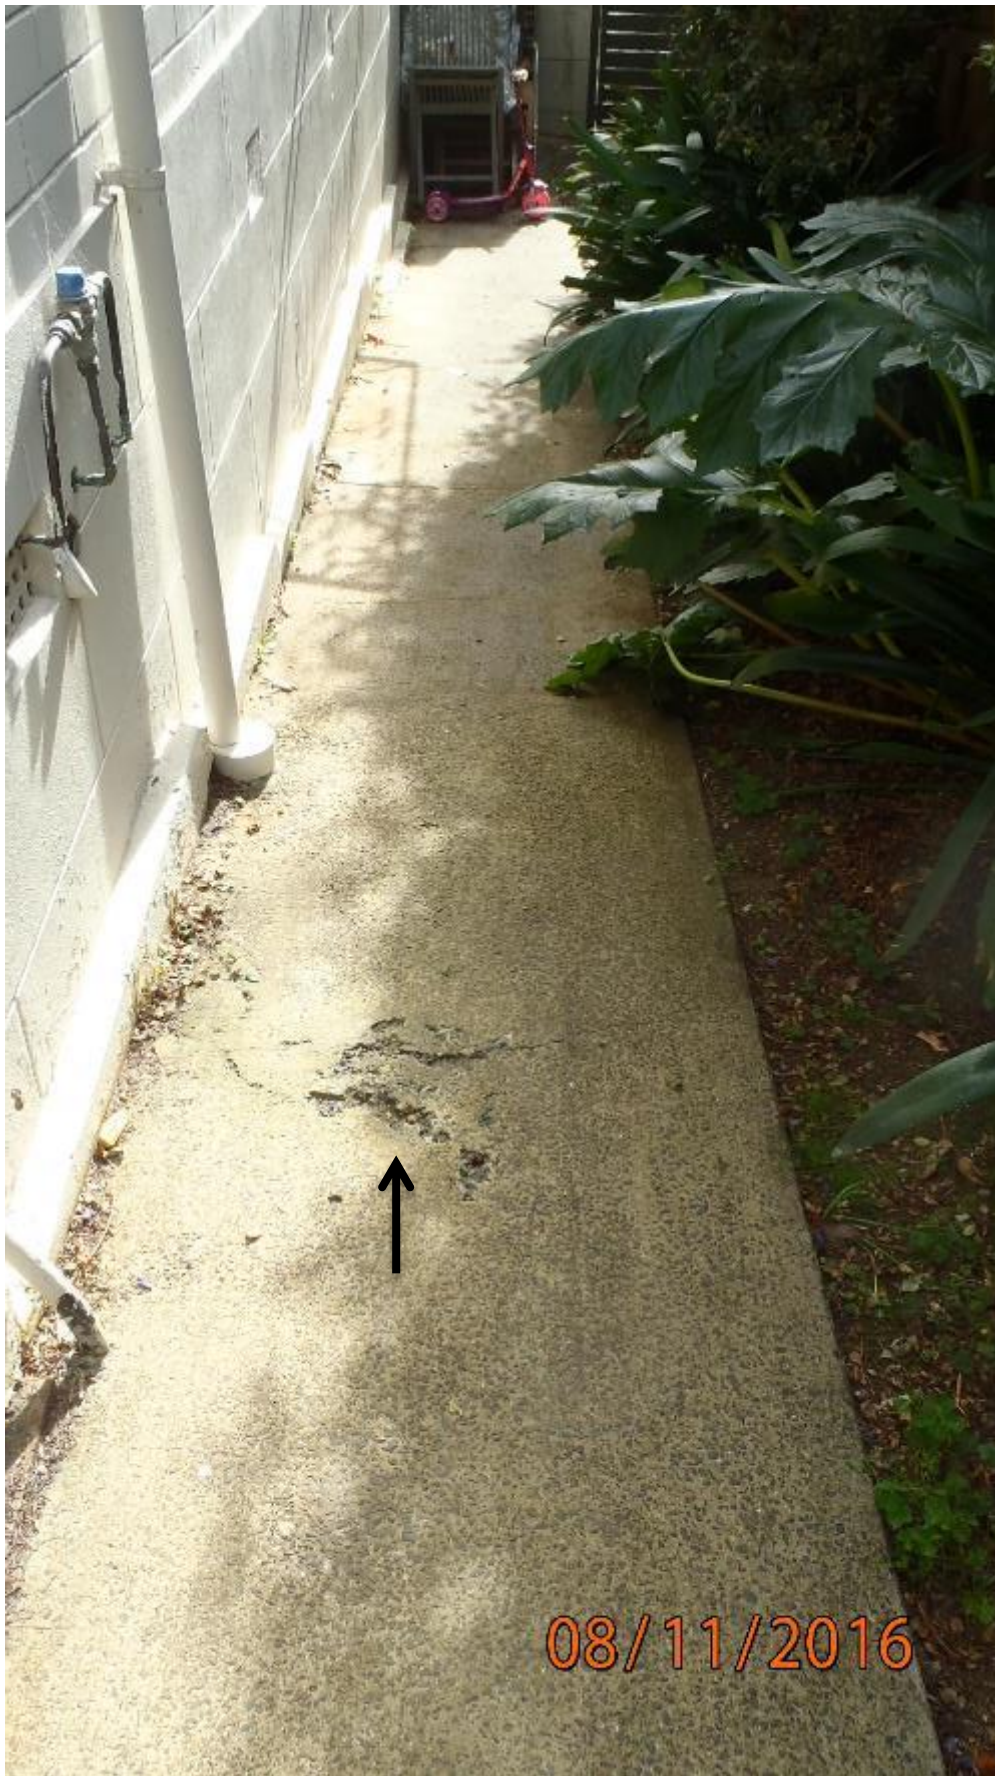
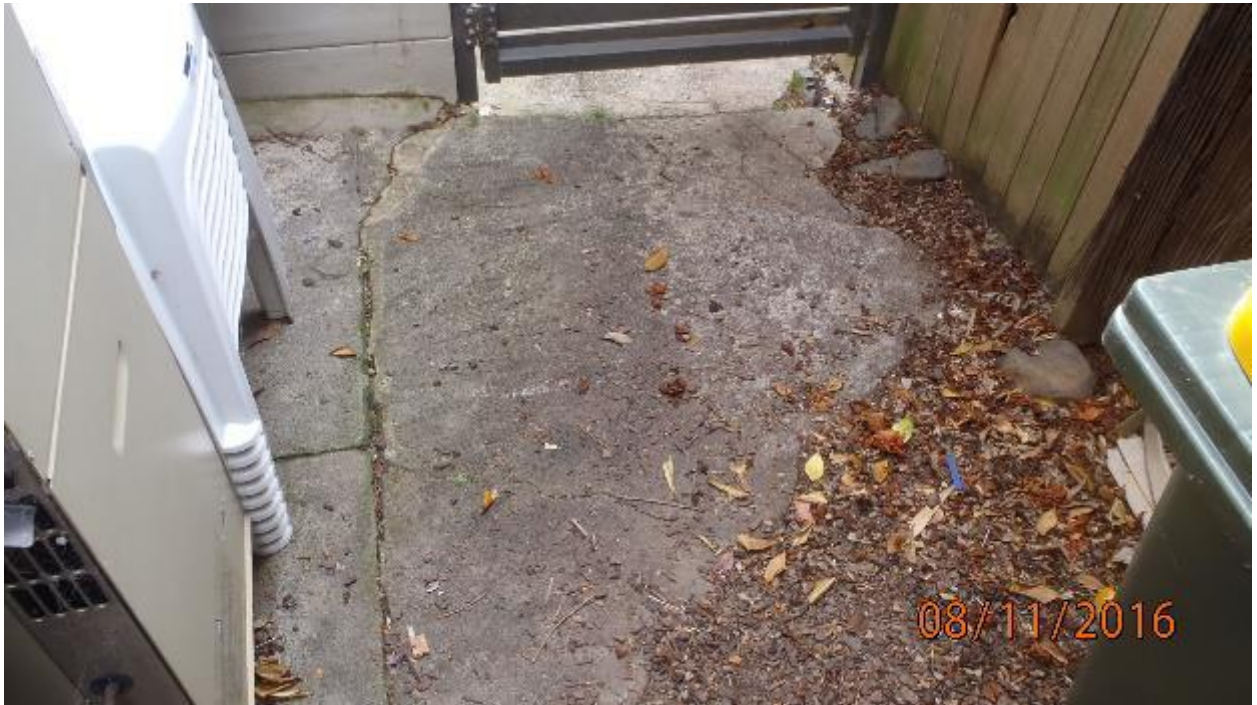
We noted shrinkage cracking and damage to the concrete pathway. [**Photographs 13 & 14**]

**Photograph 13** shows damage to the side concrete pathway

**Photograph 14** shows cracking and deterioration to the side concrete pathway adjacent to the side gate.

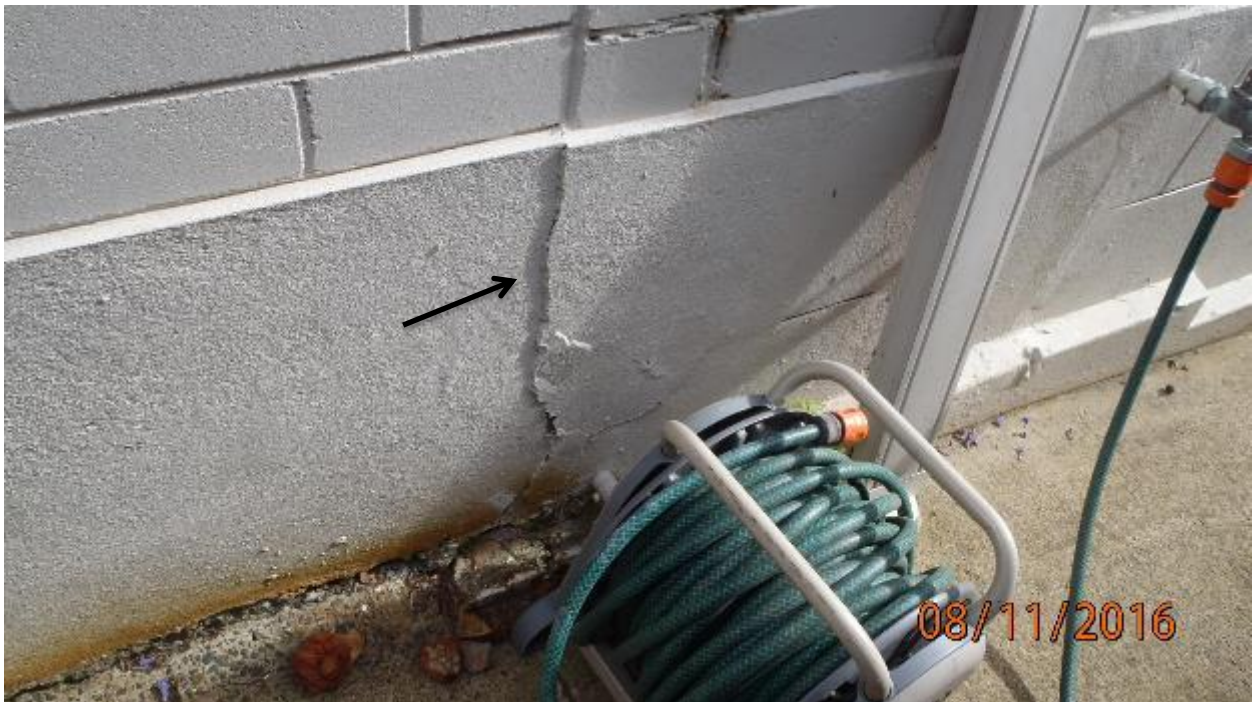
We noted cracking to the cement rendered foundations and staining to the base of the foundations outside the kitchen window. [**Photograph 15**]

**Photograph 15** shows cracking to the cement rendered foundations and staining to the base of the foundations outside the kitchen window.

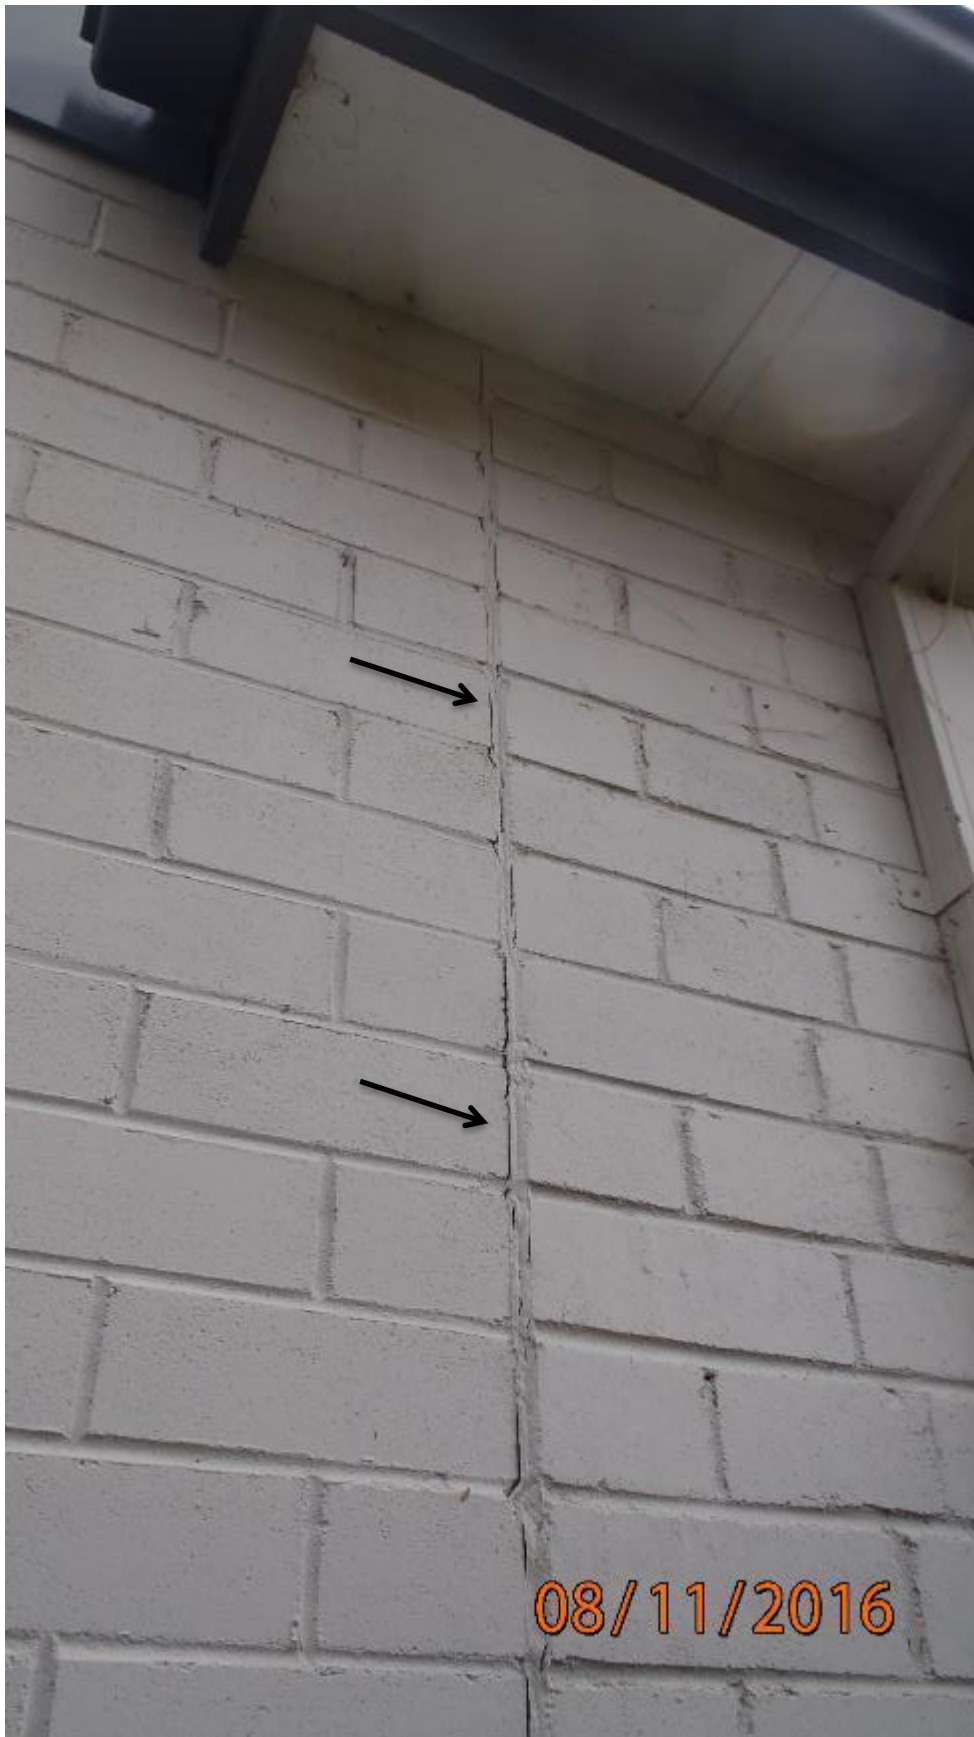
We noted cracking around the expansion joint in the brickwork outside the kitchen. [**Photograph 16**]

**Photograph 16** shows cracking around the expansion joint in the brickwork outside the kitchen.

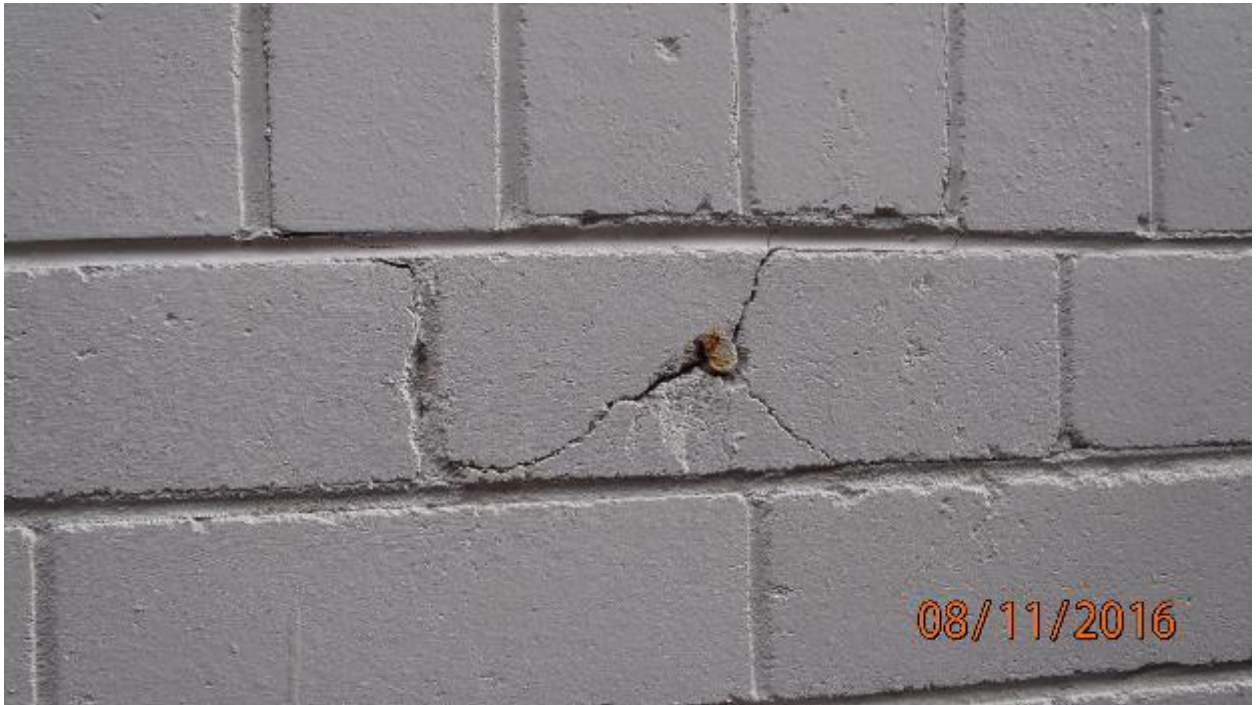
We noted radial cracking around a previous hole in the brickwork outside Bedroom 2.  
[**Photograph 17**]

**Photograph 17** shows radial cracking to the brickwork around a previous hole outside Bedroom 2.

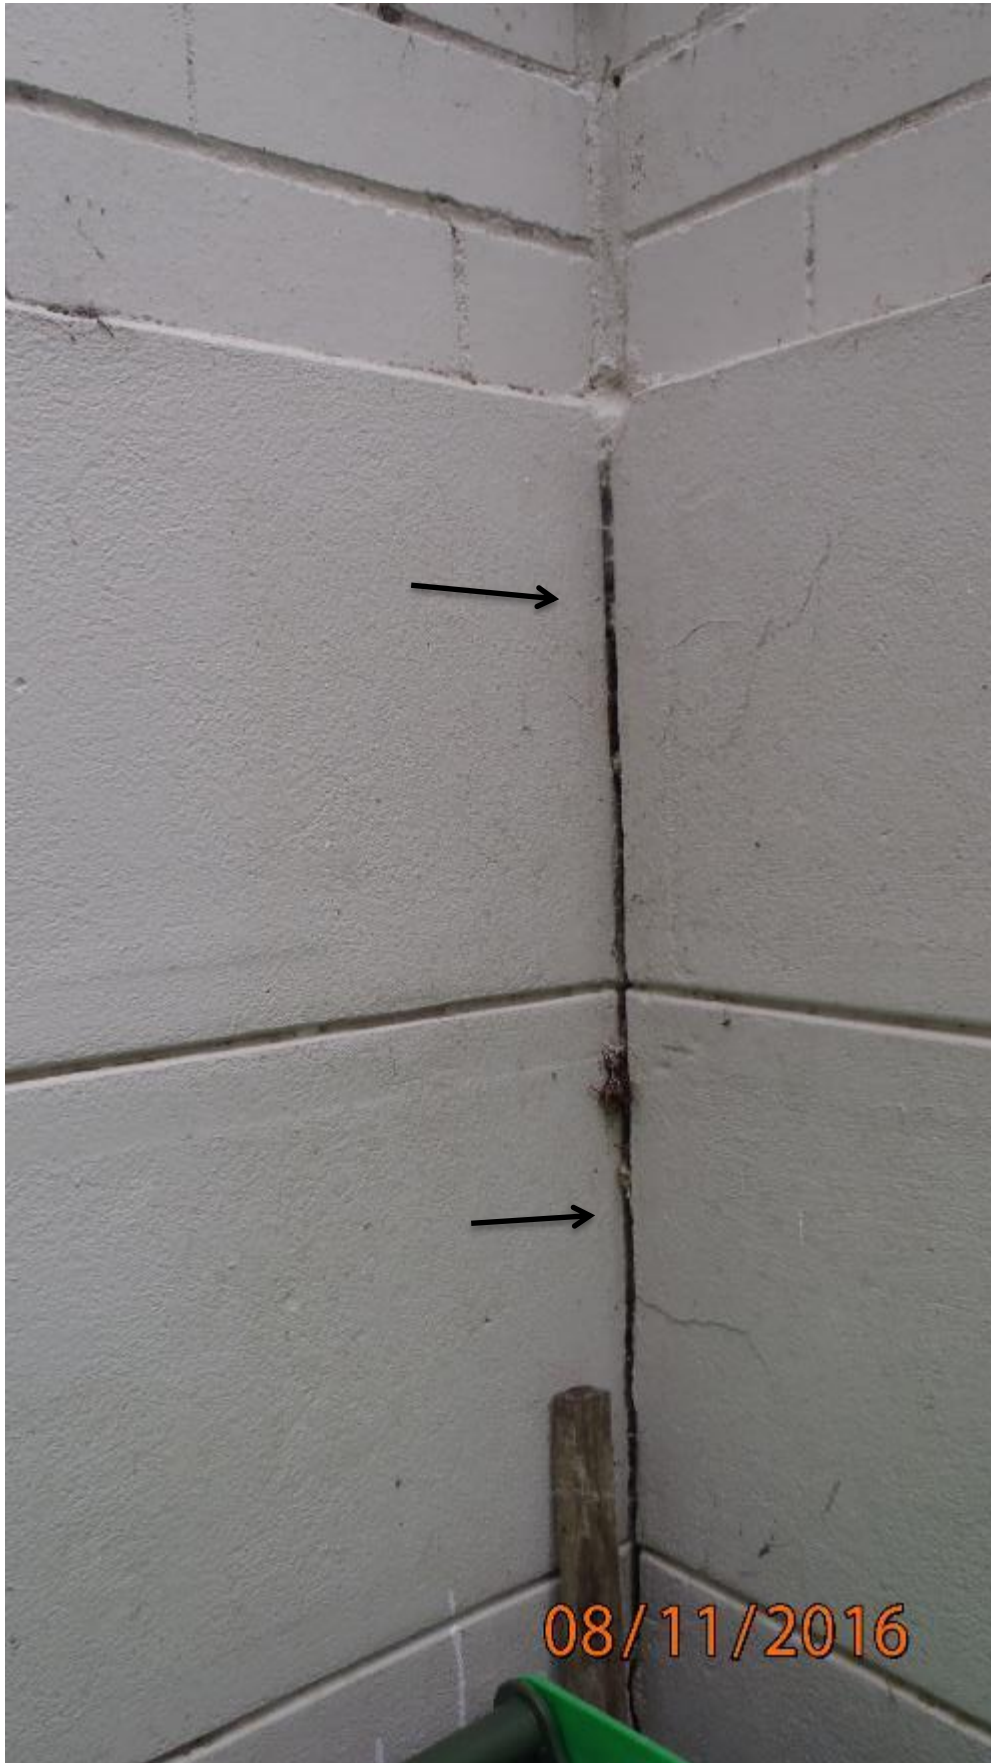
We noted separation cracking to the fence wall and the external residence wall. [**Photograph 18**]

**Photograph 18** shows separation and radial cracking to the fence wall and the external residence wall.

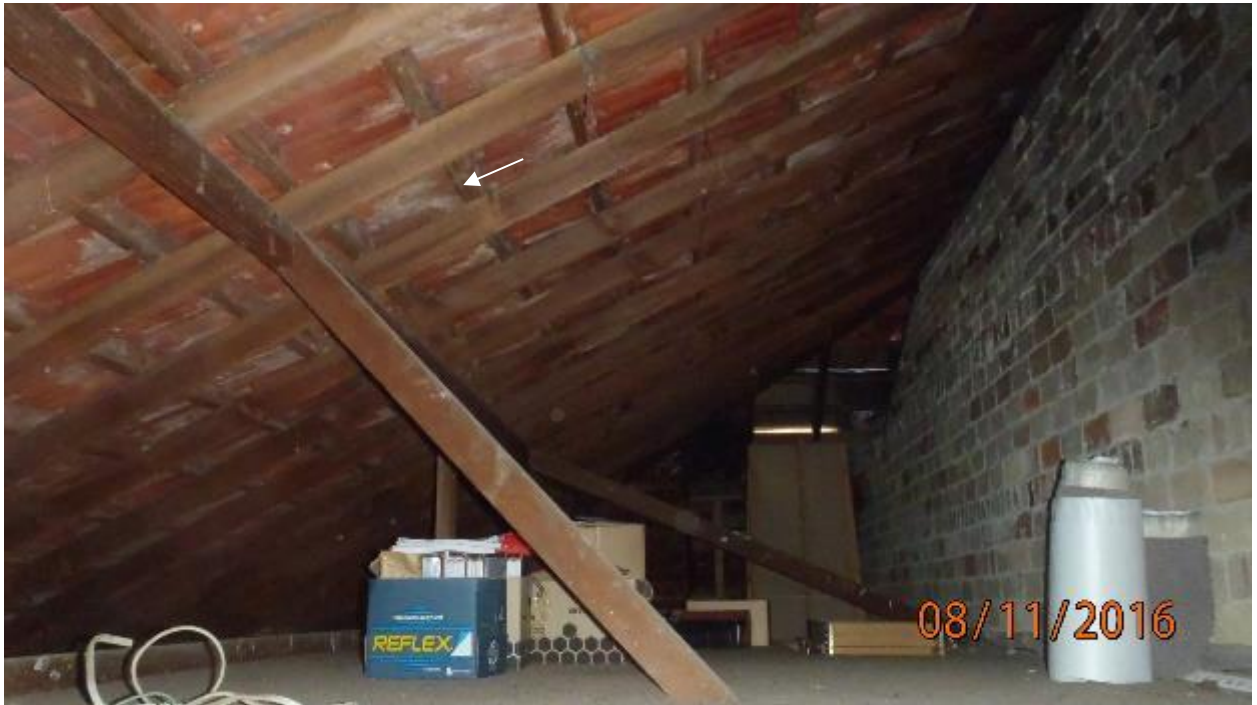
We noted that there is no sarking provided to the underside of the roofing tiles and further noted that the underside of the roof tiles showed signs of efflorescence and fretting. [**Photograph 19**]

We observed that the roof and ceiling timbers that are accessible are generally in good condition.  
[**Photograph 19**]

We also noted that there was an attic access ladder installed allowing access to the roof space and some goods were stored in the roof space. [**Photograph 19**]

We noted that the timber ceiling joists are built into the *common party* wall. We further noted that the common ridge to the roof is located over the *common party* wall. [**Photograph 19**]

**Photograph 19** shows signs of efflorescence and fretting to the terracotta tiles, and goods stored in the roof space.
