## Dilapidation Assessment Report

Prepared for: Cape Cod Australia Pty. Limited  
Job address: 11 Morrice Street, Lane Cove.  
Property Owner/s: Mrs. Therese Sheridan.  
Report reference: **LANE COVE COUNCIL**  
Development Application No: not available  
Date of assessment: 8<sup>th</sup> November 2016

**Re: Dilapidation Report – 11 Morrice Street, Lane Cove.**

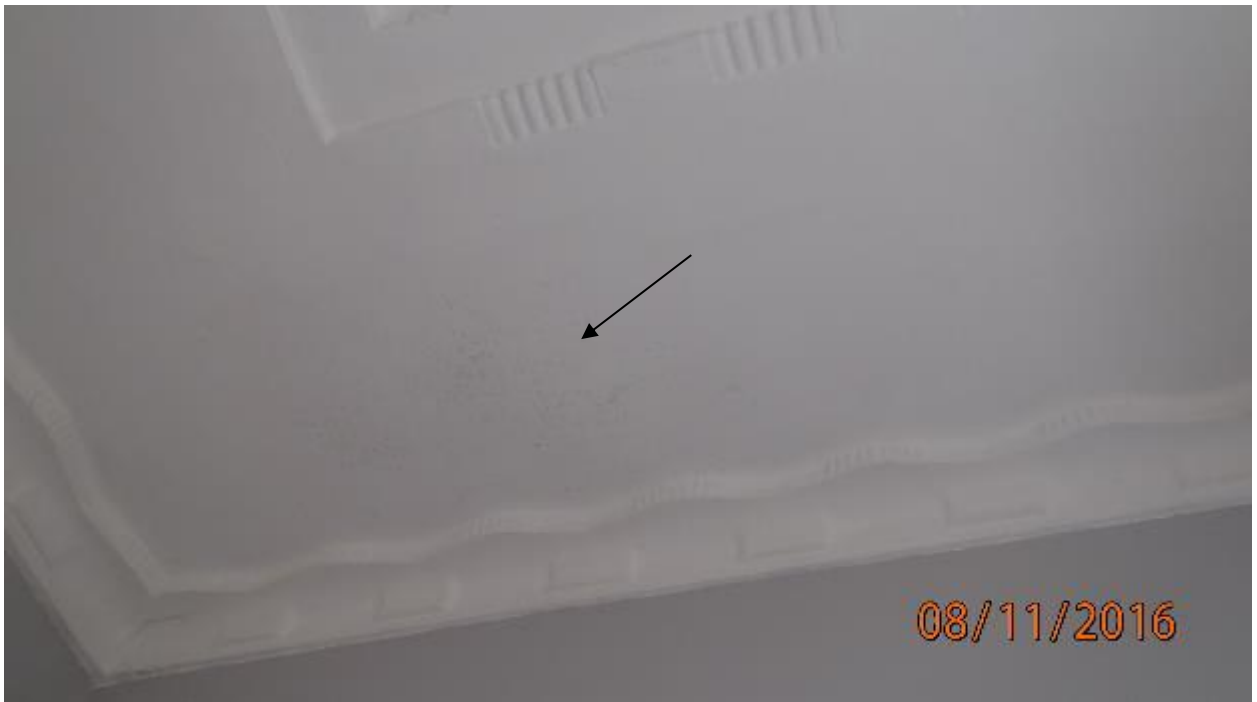
We noted staining to the ceiling and decorative plaster cornice in the south-eastern corner. **[Photograph 20]**

**Photograph 20** shows staining to the ceiling and decorative plaster cornice in the south-eastern corner of Bedroom 1.

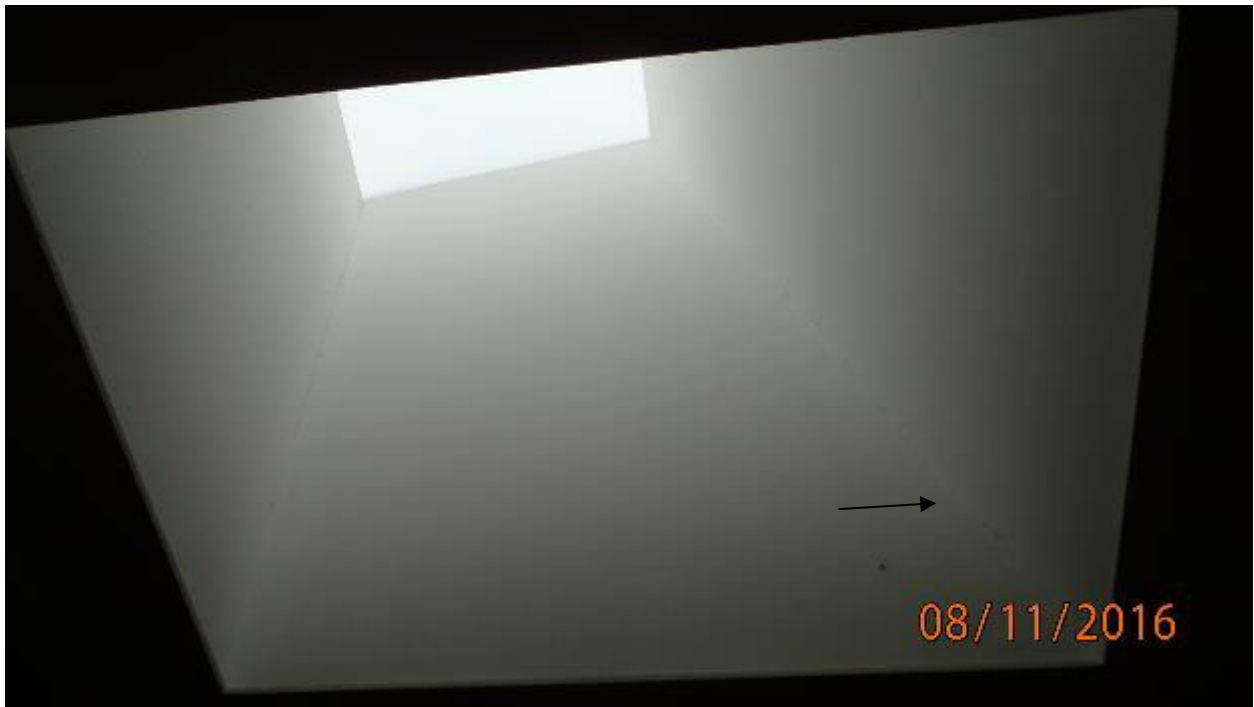
We noted that there is a skylight installed in the ceiling. We further noted vertical hairline cracking to the square set joints of the skylight. **[Photograph 21]**

**Photograph 21** shows vertical hairline cracking to the square set joints of the skylight.

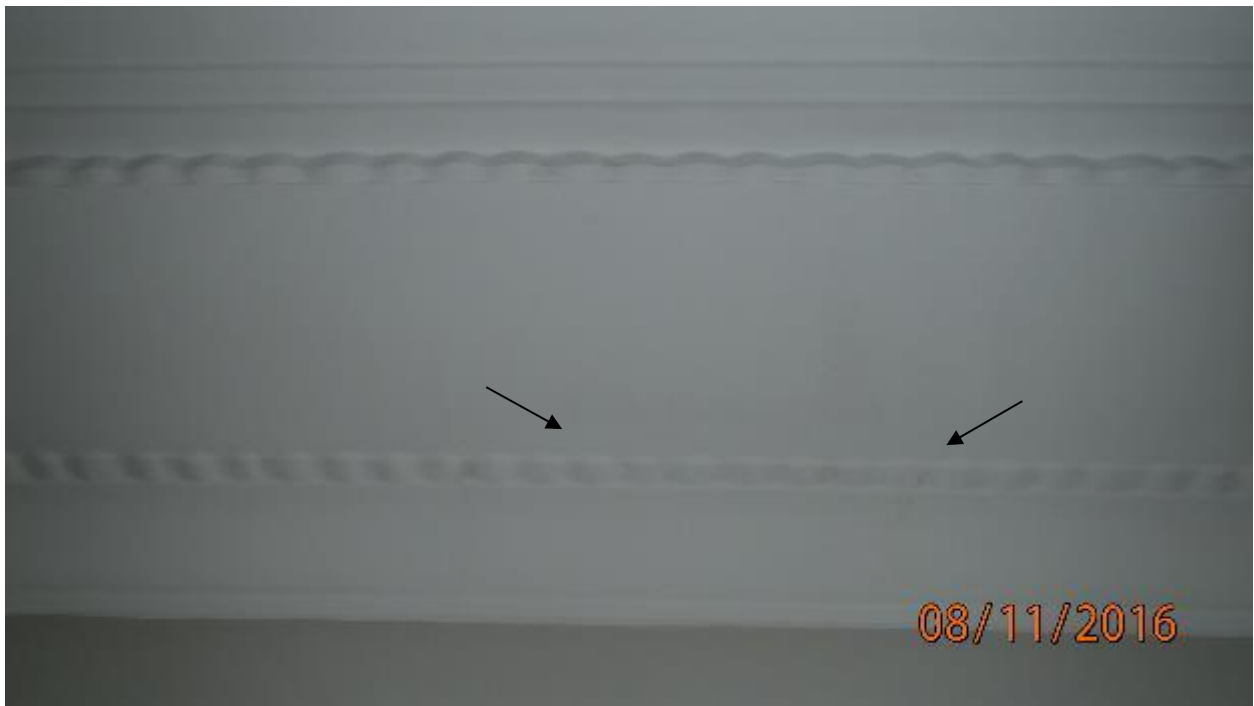
We noted evidence of a previous repair to the decorative plaster cornice along the *common party* wall with the adjoining property, No. 11 Morrice Street. **[Photograph 22]**

**Photograph 22** shows evidence of a previous repair to the decorative plaster cornice along the *common party* wall with the adjoining property, No. 11 Morrice Street.

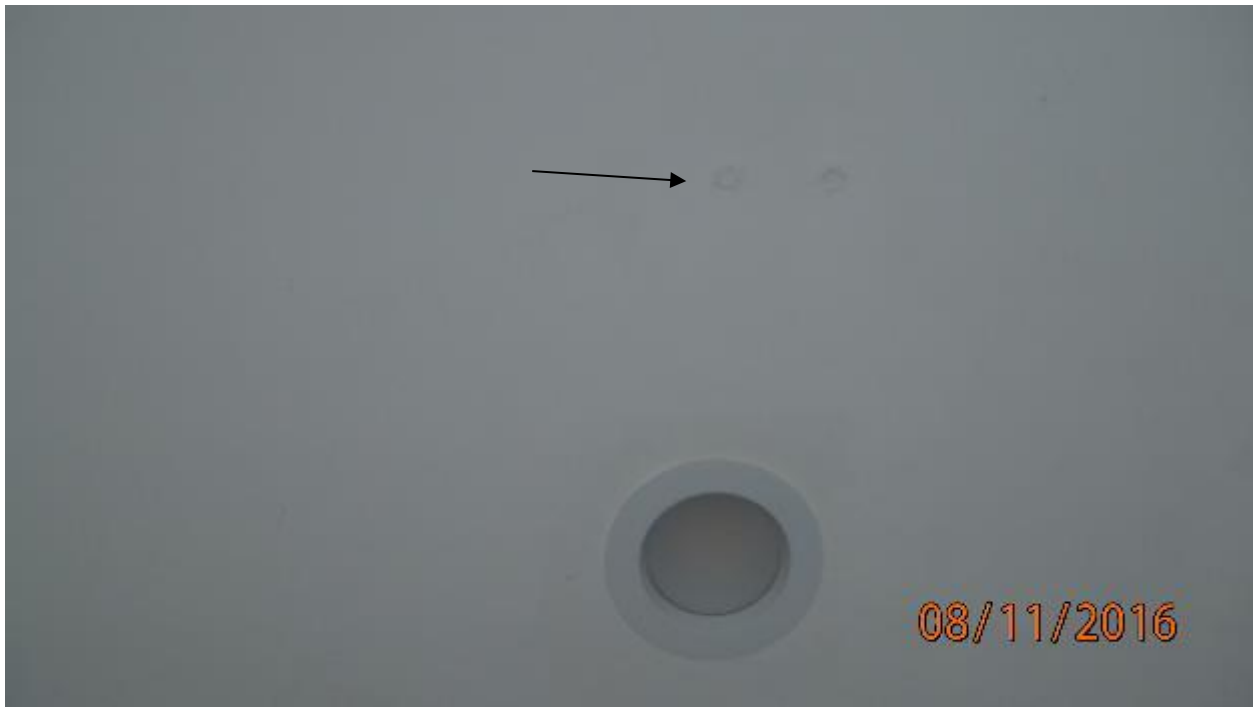
We noted displacement of the securers to the plaster ceiling adjacent to the downlight fitting **[Photograph 23]**

**Photograph 23** shows displacement of the securers to the plaster ceiling in the Hallway.

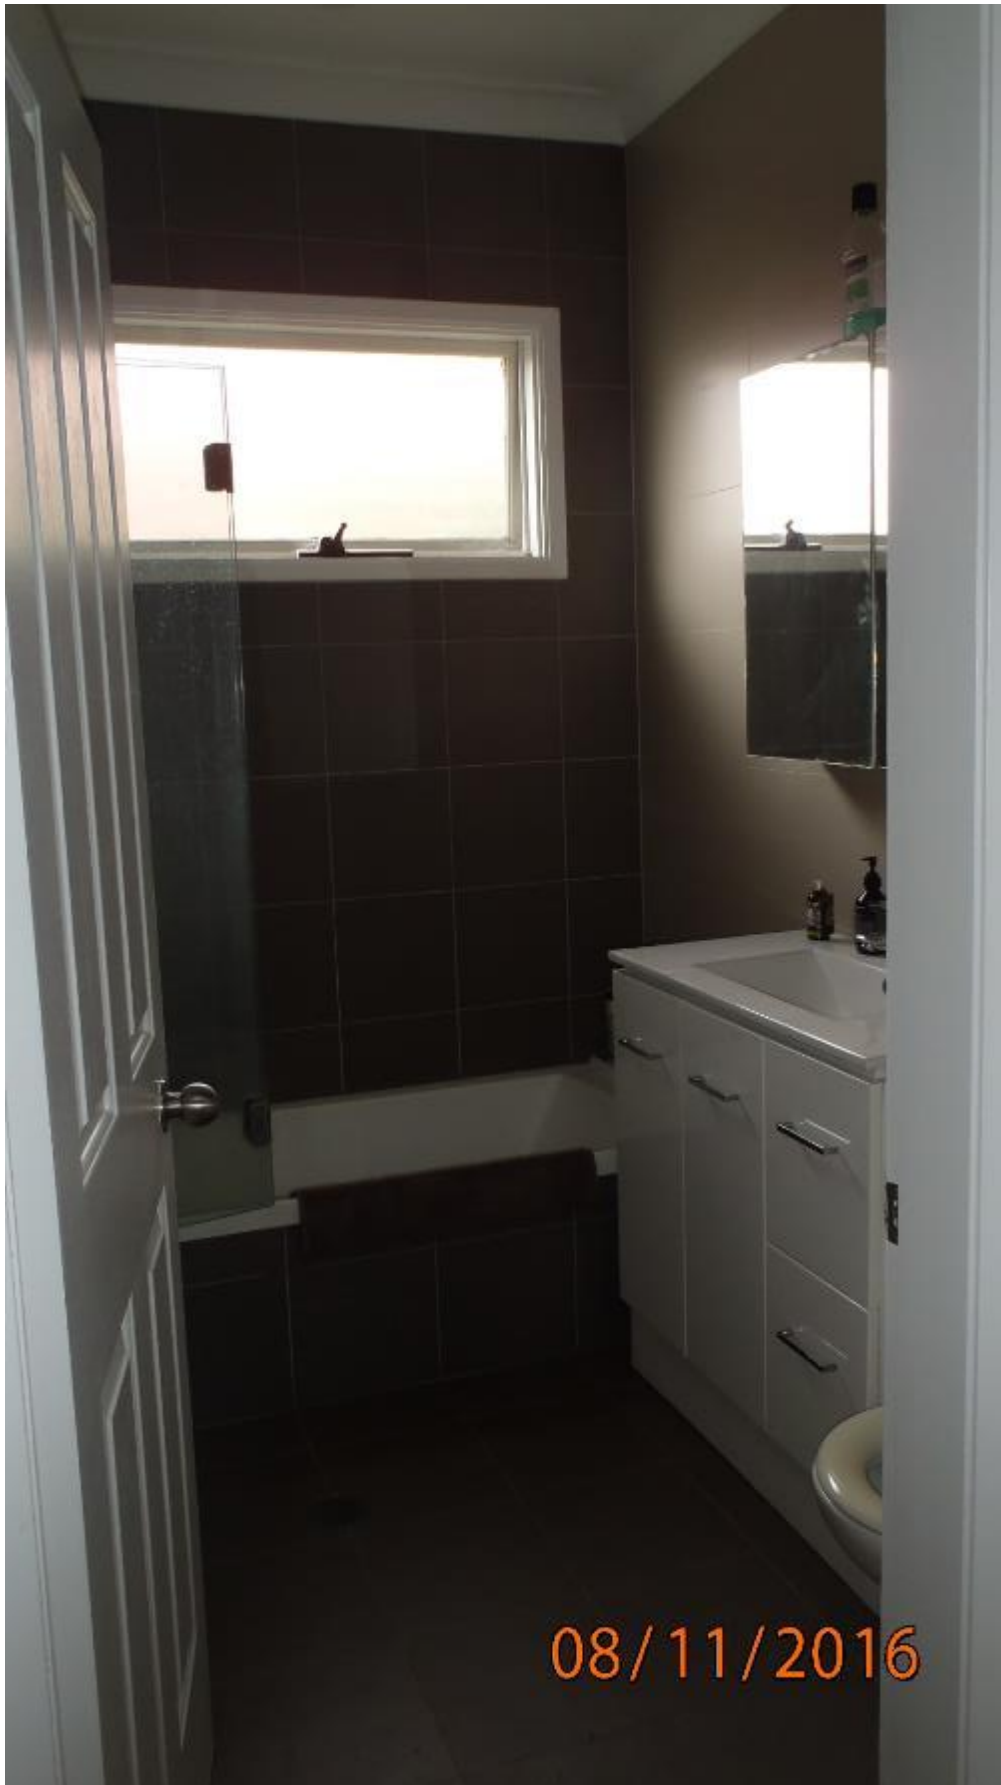
We noted that the grout to the wall and floor tiles is complete and that the wall and floor tiles when randomly “tap” tested appeared to be sound. We did not observe any recent cracking to the tile grout at the wall / wall, wall / floor junctions. **[Photograph 24]**

**Photograph 24** shows the general layout of the Bathroom.

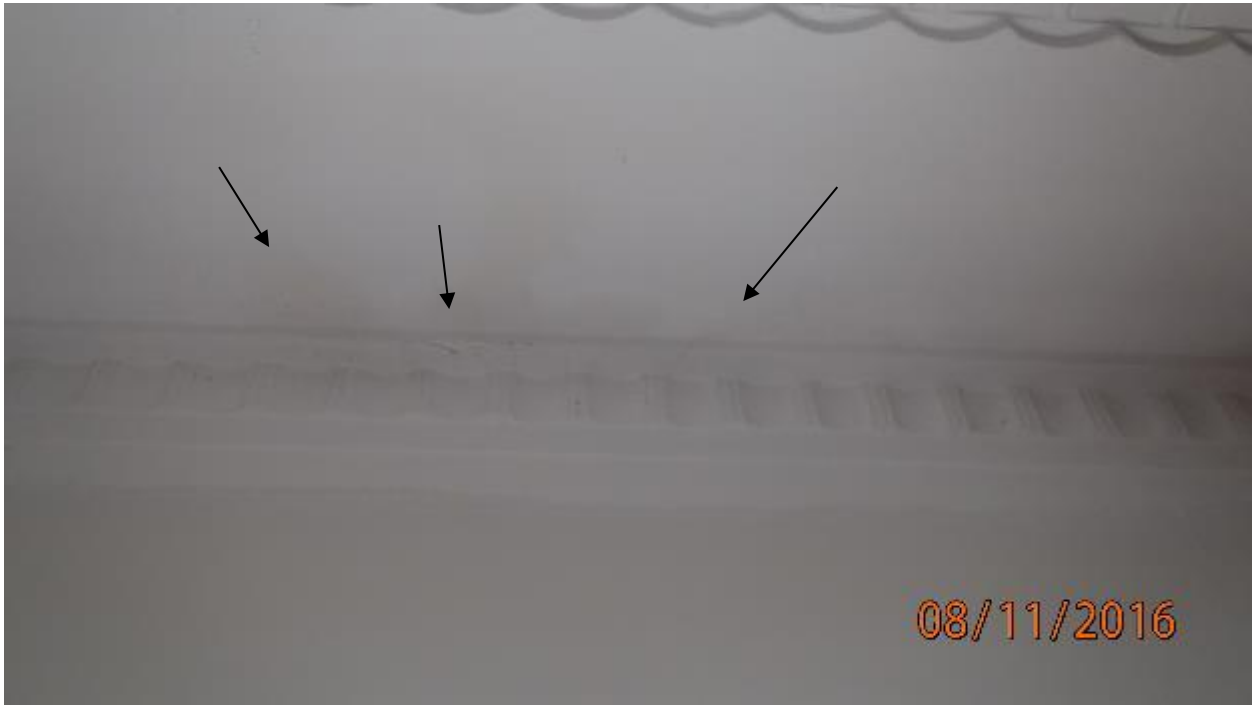
We noted flaking paint and staining to the decorative plaster ceiling and plaster cornice. **[Photograph 25]**

**Photograph 25** shows flaking paint and staining to the decorative plaster ceiling and plaster cornice in Bedroom 2.

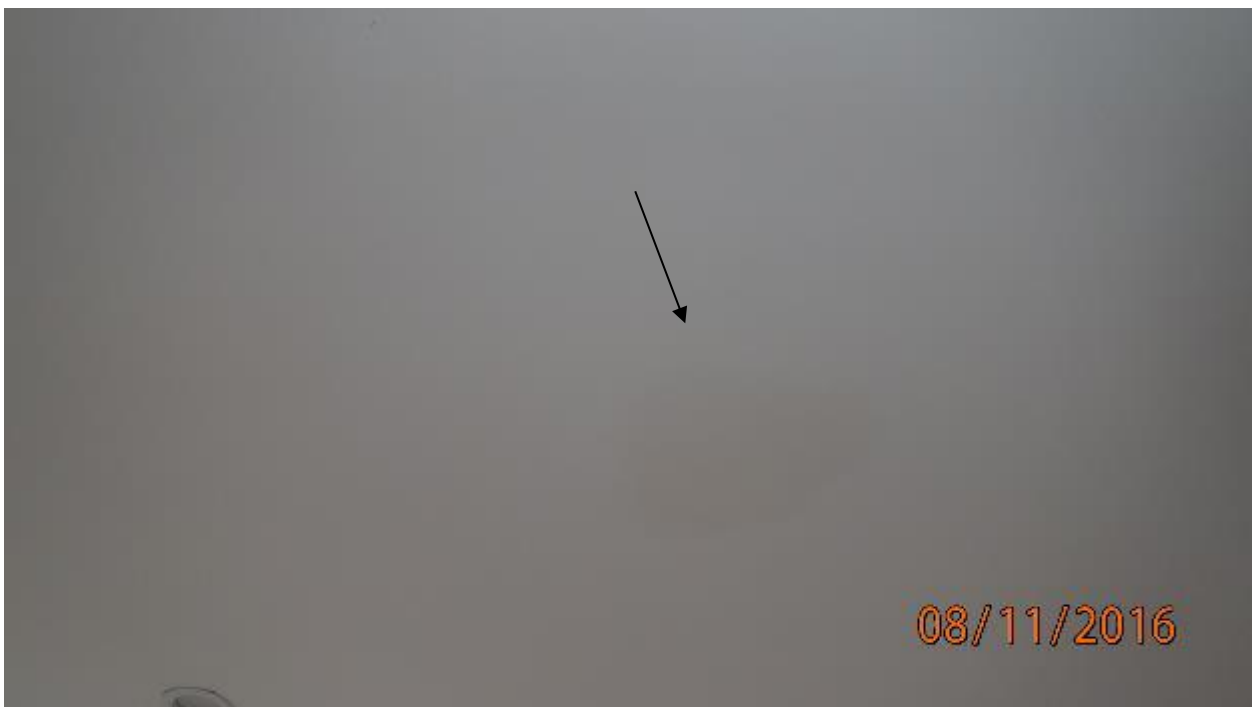
We noted evidence of a previous patch repair to the plaster ceiling. **[Photograph 26]**

**Photograph 26** shows evidence of a previous patch repair to the plaster ceiling in Bedroom 2.

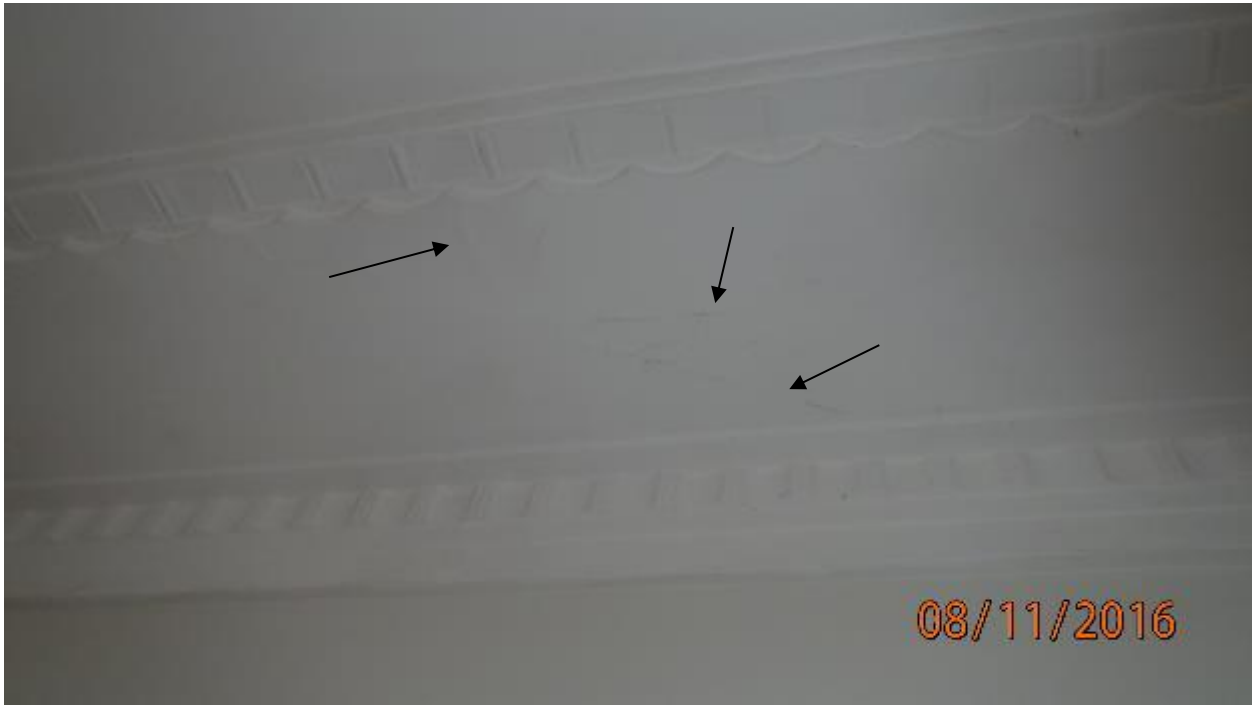
We noted flaking paint to the decorative plaster ceiling and plaster cornice. **[Photograph 27]**

**Photograph 27** shows flaking paint to the decorative plaster ceiling and plaster cornice.

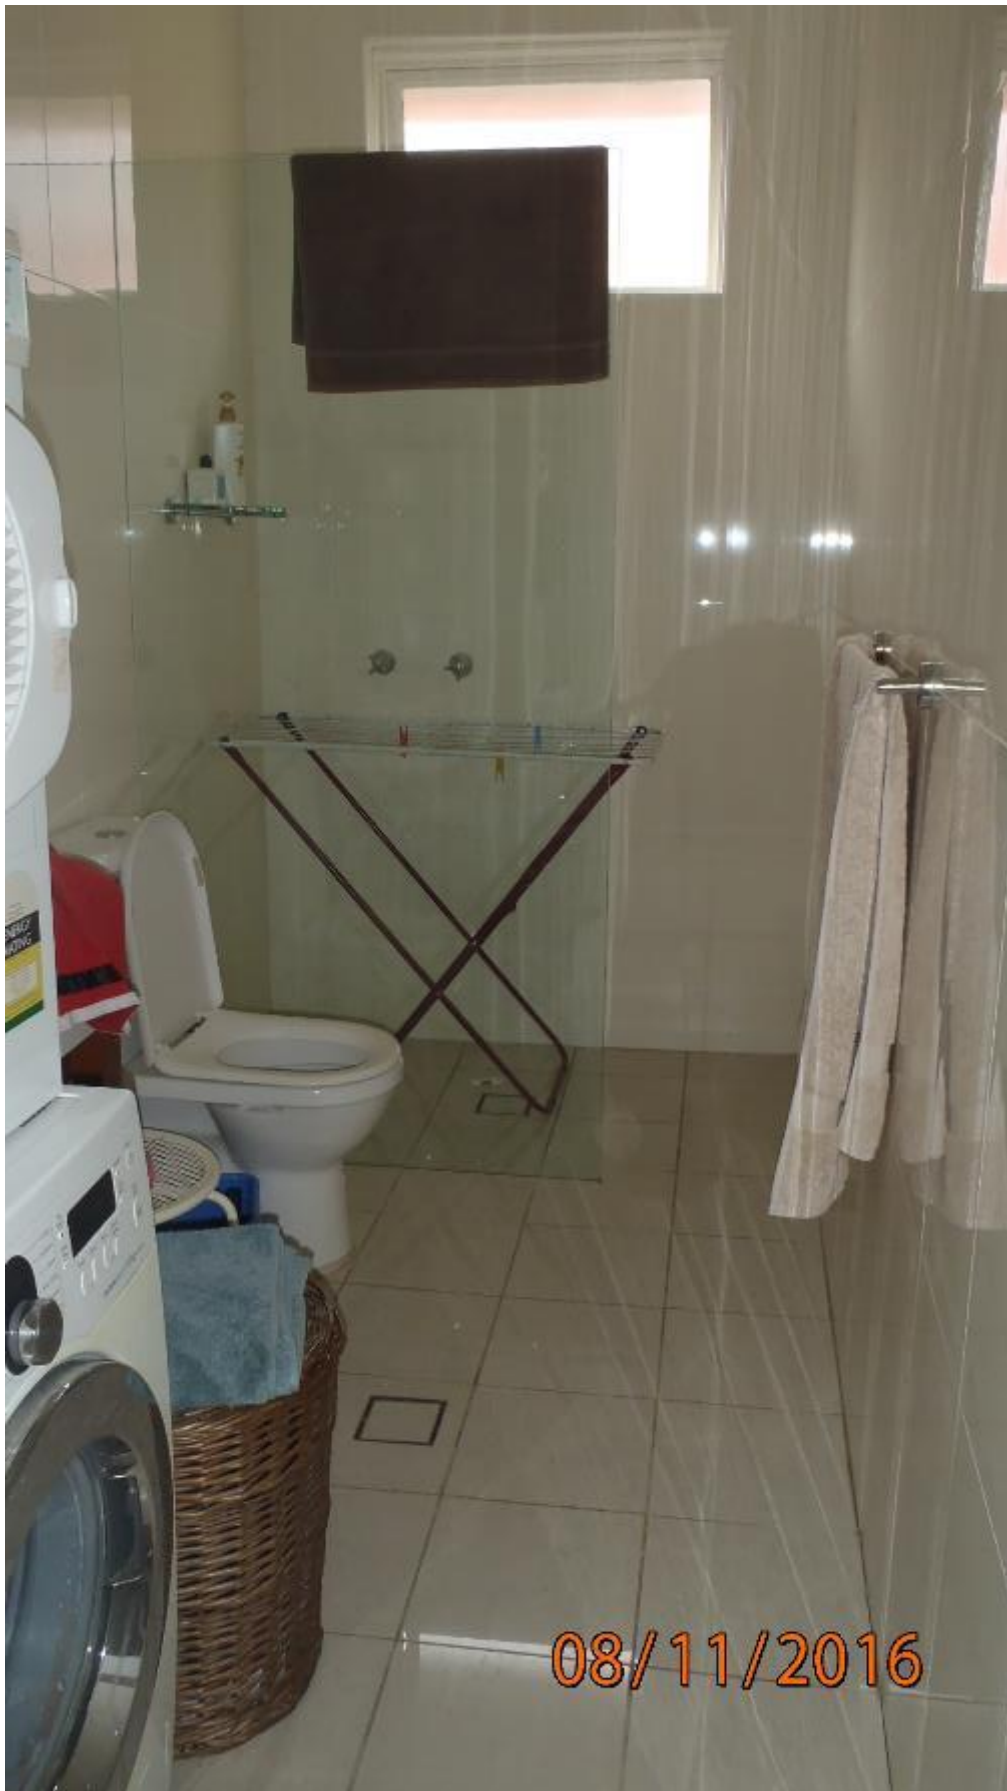
We noted that the grout to the wall and floor tiles is generally complete and that the wall and floor tiles when randomly “tap” tested appeared to be sound. **[Photograph 28]**

**Photograph 28** shows the general condition of the Laundry.

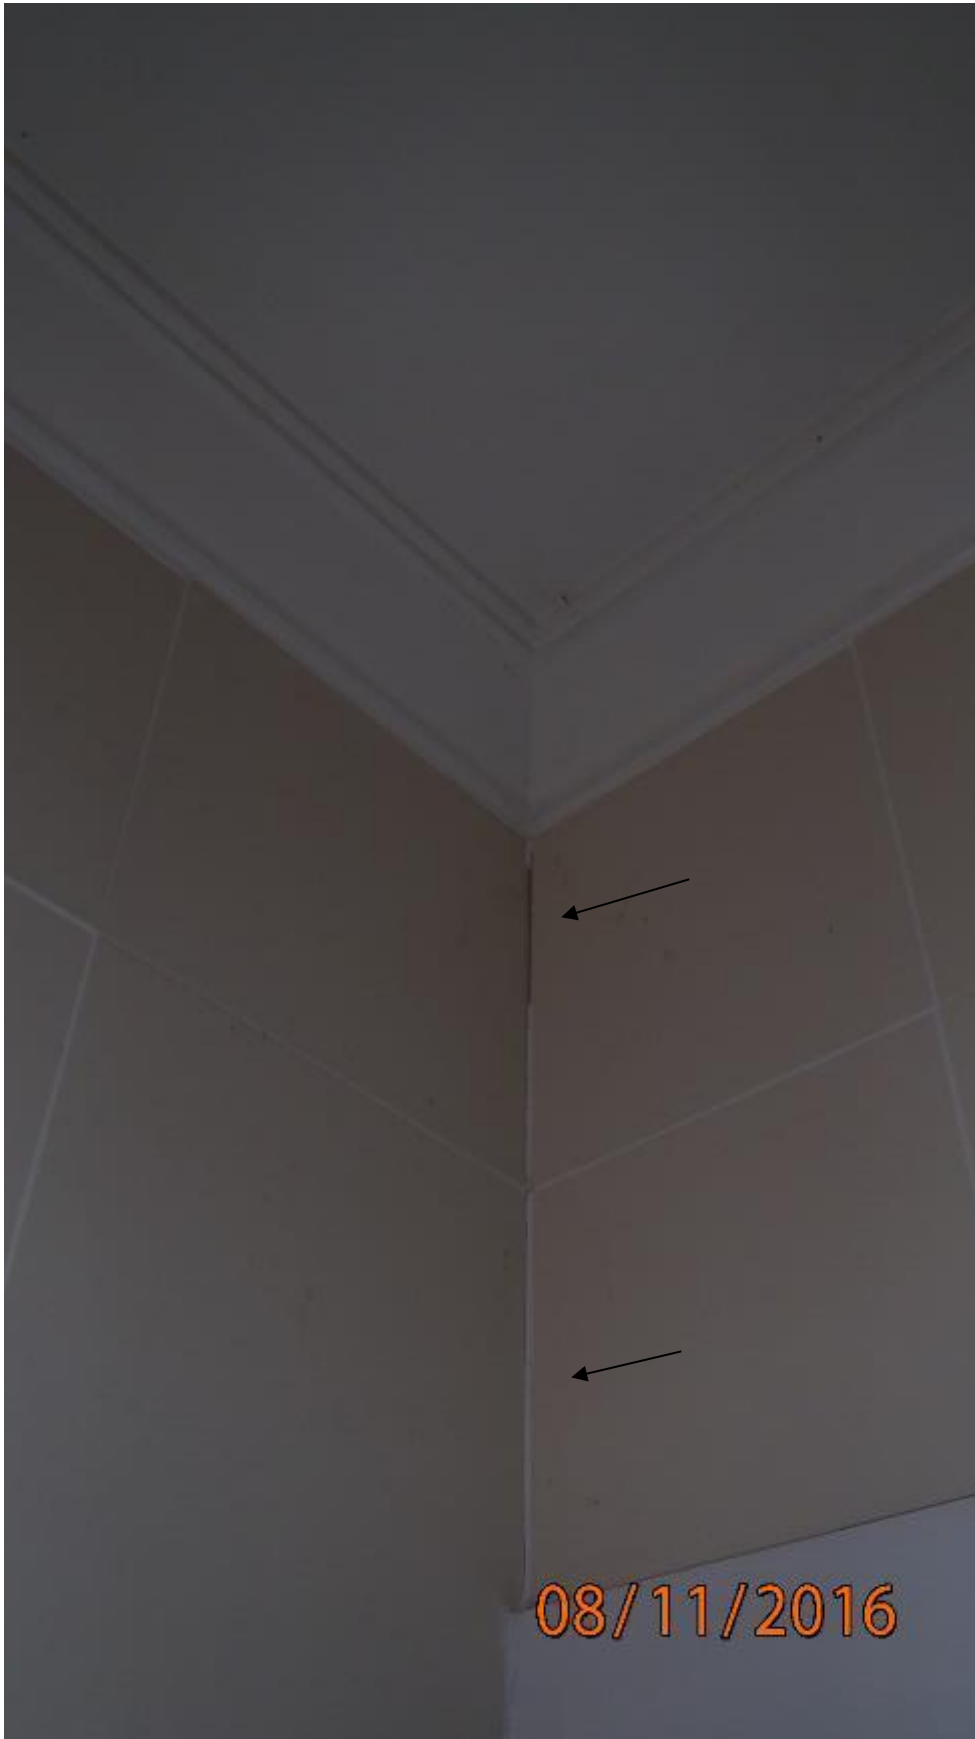
We noted displaced grout to the wall / wall joint in the north-western corner above the door. **[Photograph 29]**

**Photograph 29** shows displaced grout to the wall / wall joint in the north-western corner above the door in the Laundry.

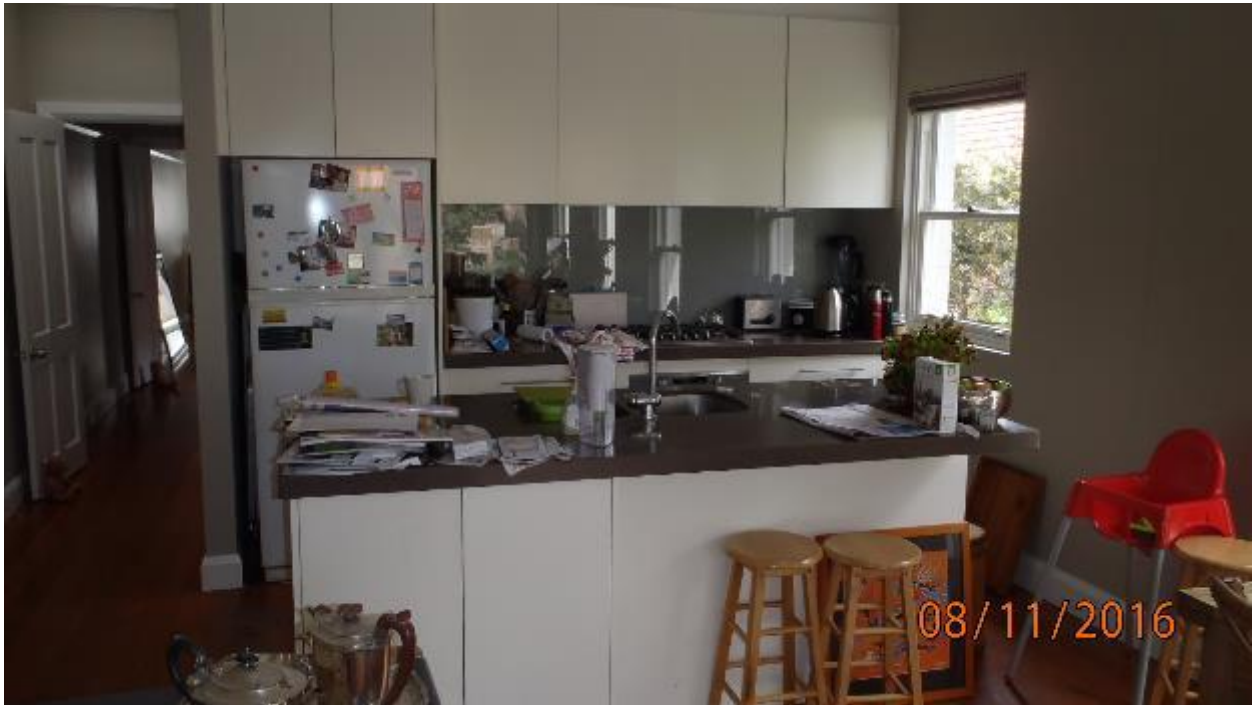
We noted that the room is open plan design with an island bench. [**Photograph 30**]

**Photograph 30** shows the general layout of the Kitchen.

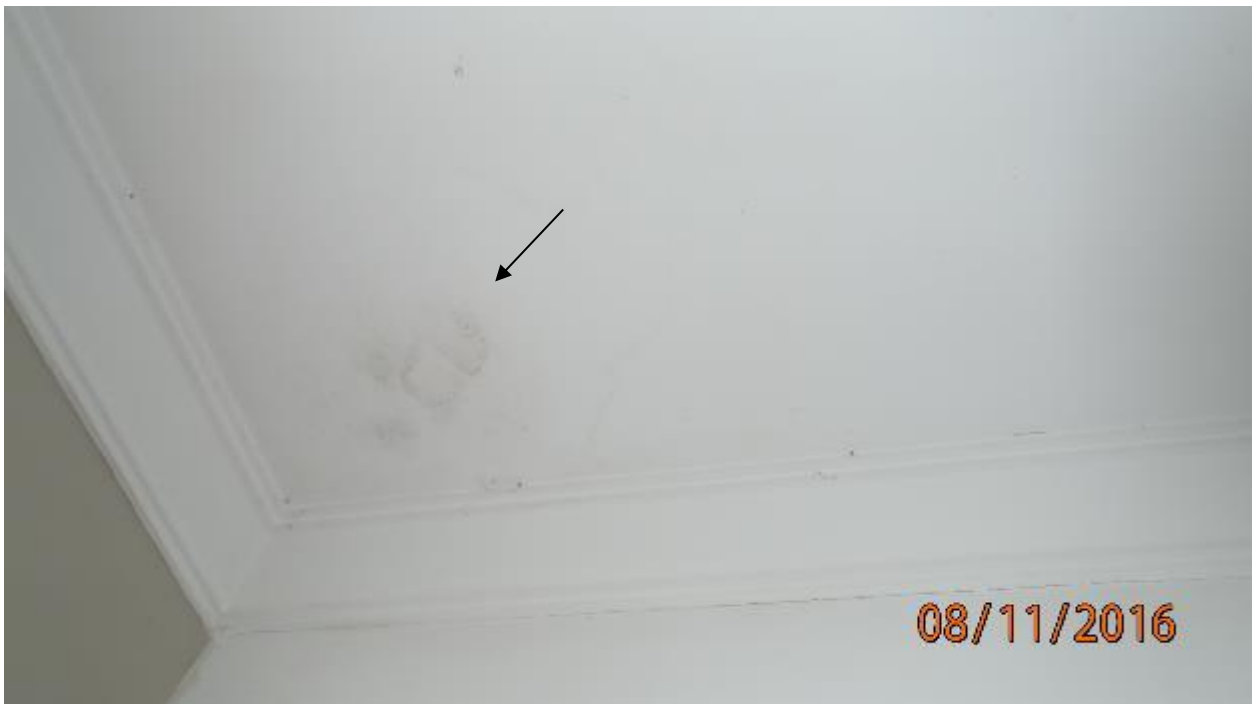
We noted staining to the plaster ceiling lining in the south-western corner. [**Photograph 31**]

**Photograph 31** shows staining to the plaster ceiling lining in the south-western corner in the Kitchen.

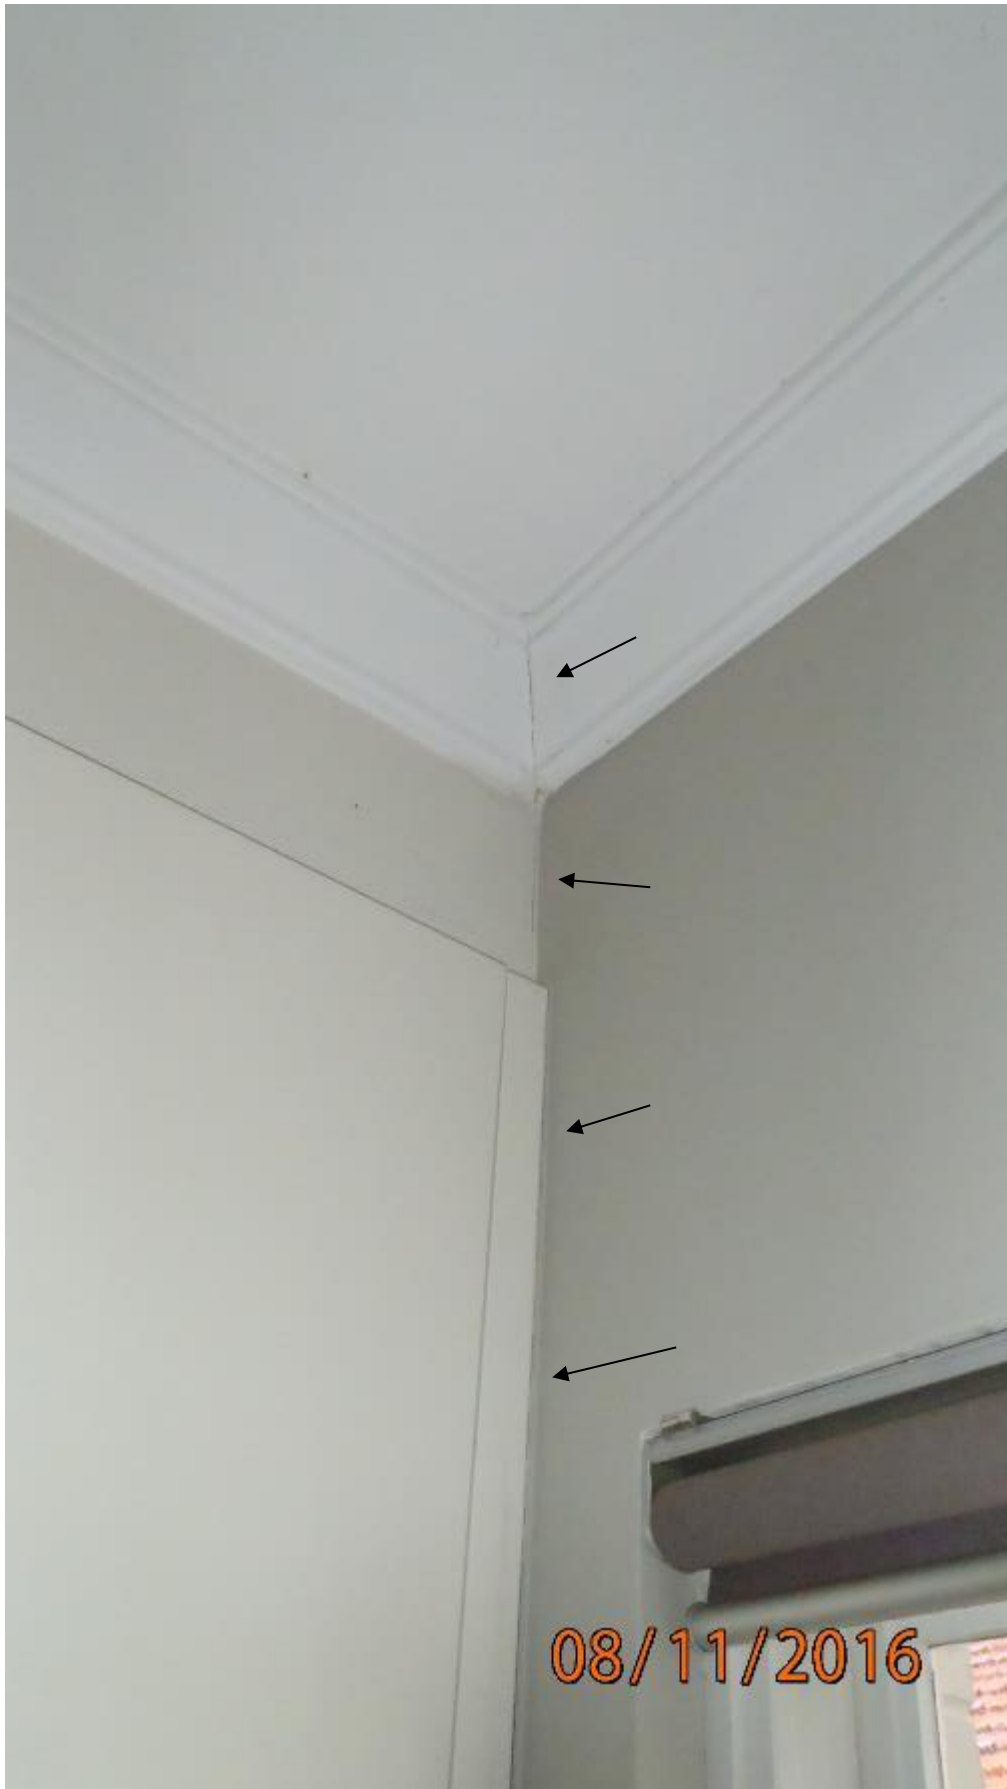
We noted hairline cracking [ $<1.0\text{mm}$ ] to the mitre joint in the plaster cornice in the south-eastern corner. [**Photograph 32**]

We noted vertical hairline cracking [ $<1.0\text{mm}$ ] to the wall / wall junction and the cupboard / wall junction in the south-eastern corner. [**Photograph 32**]

**Photograph 32** shows cracking to the mitre joint in the plaster cornice, the wall / wall junction and the cupboard / wall junction in the south-eastern corner in the Kitchen.

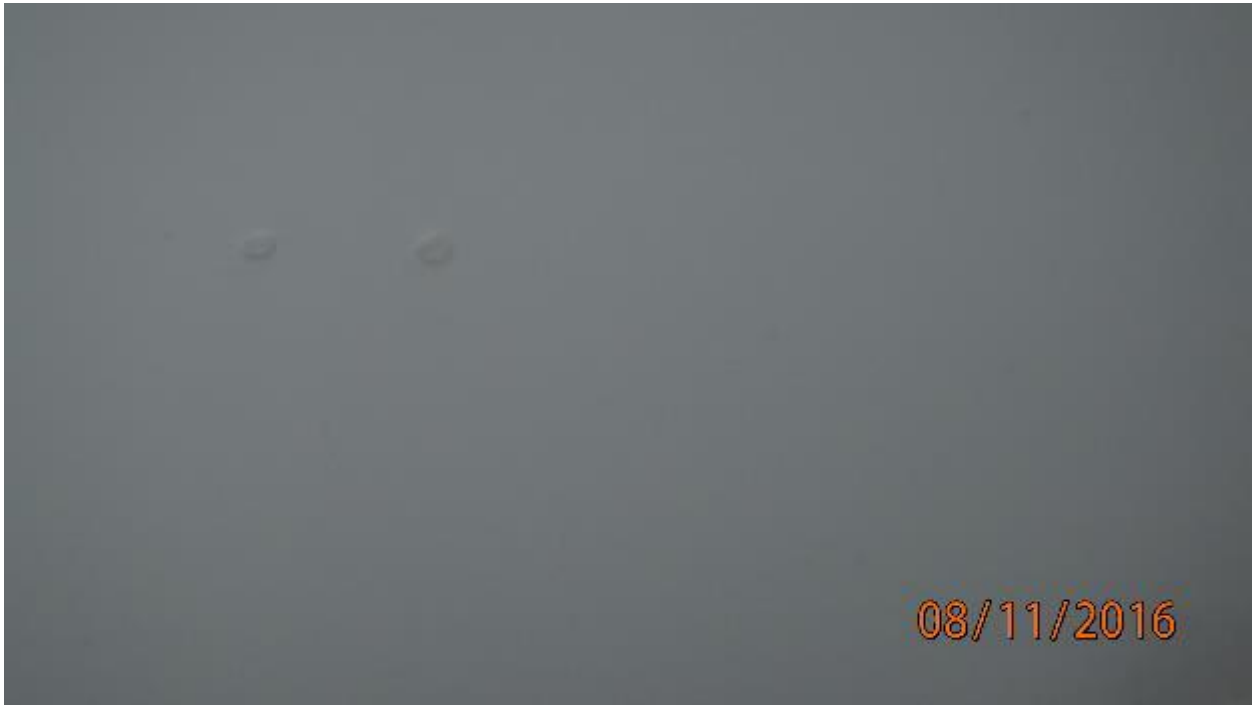
We noted displacement of the securers to the plaster ceiling. [**Photograph 33**]

**Photograph 33** shows displacement of the securers to the plaster ceiling in the Kitchen.

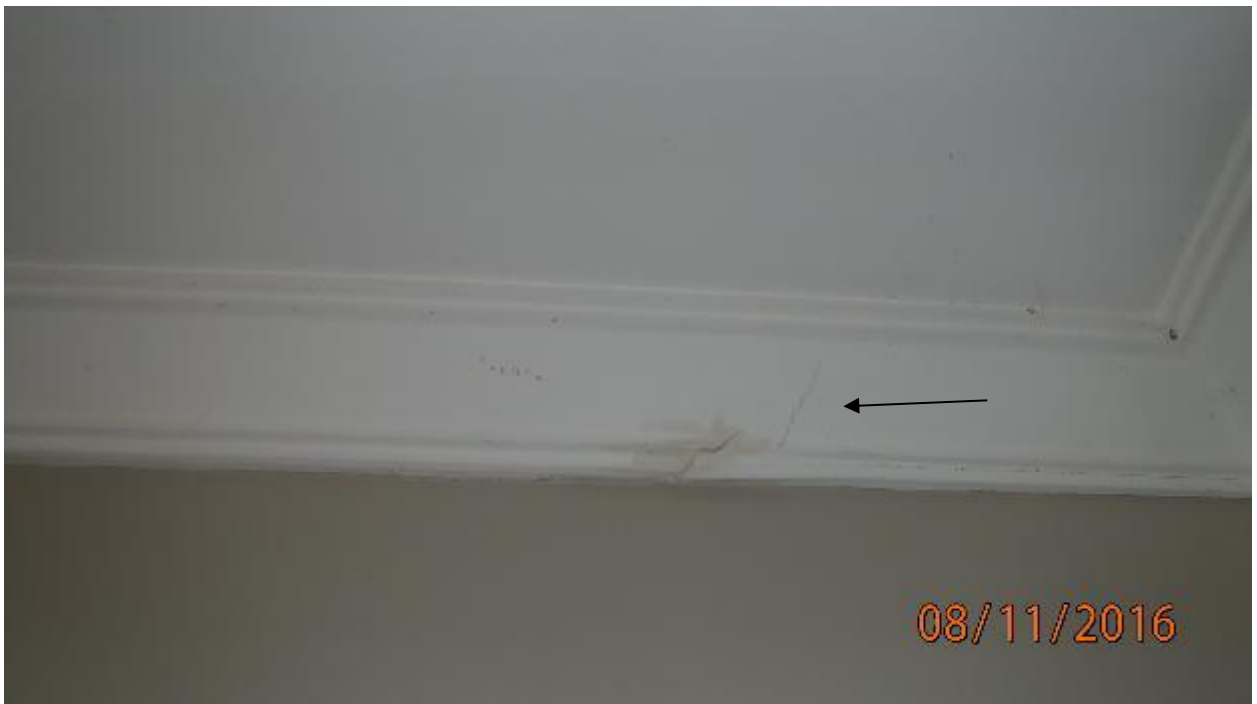
We observed cracking [ $1.0\text{mm} - 3.0\text{mm}$ ] of the plaster cornice and evidence of a previous repair above the *common party* wall with the adjoining property, No. 11 Morrice Street. [**Photograph 34**]

**Photograph 34** shows cracking of the plaster cornice and evidence of a previous repair above the common party wall with the adjoining property, No. 11 Morrice Street.

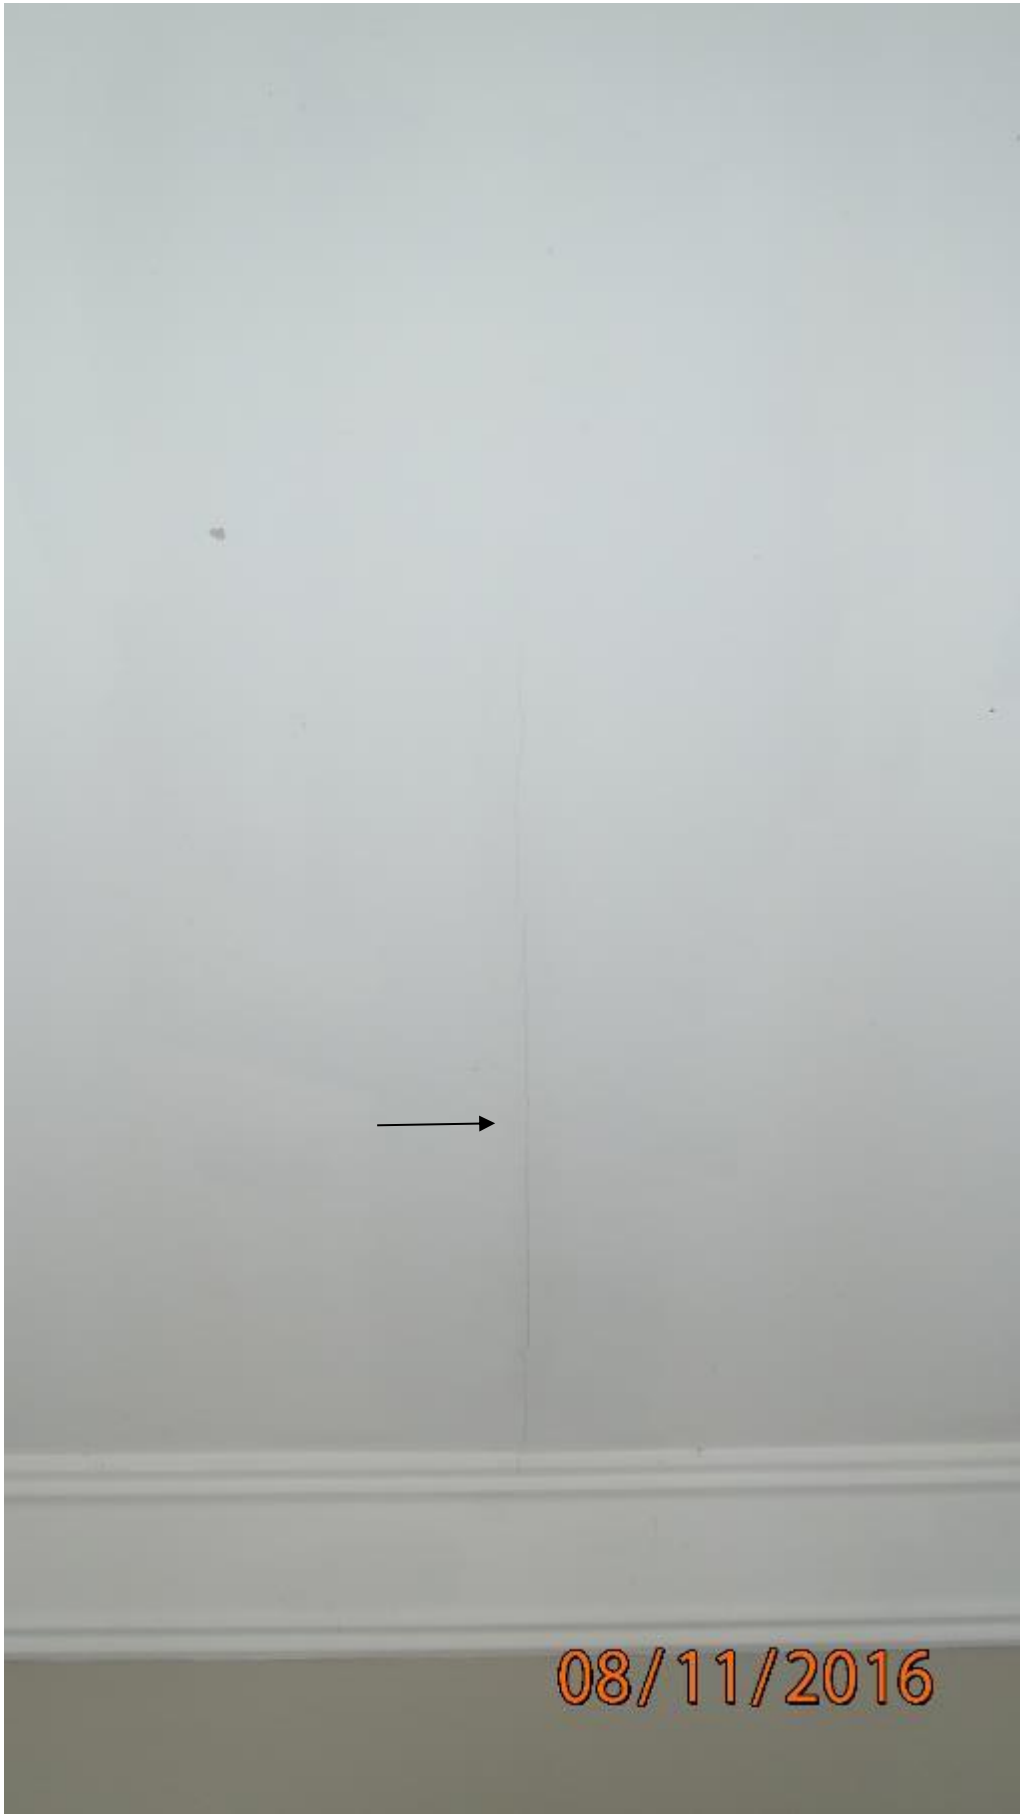
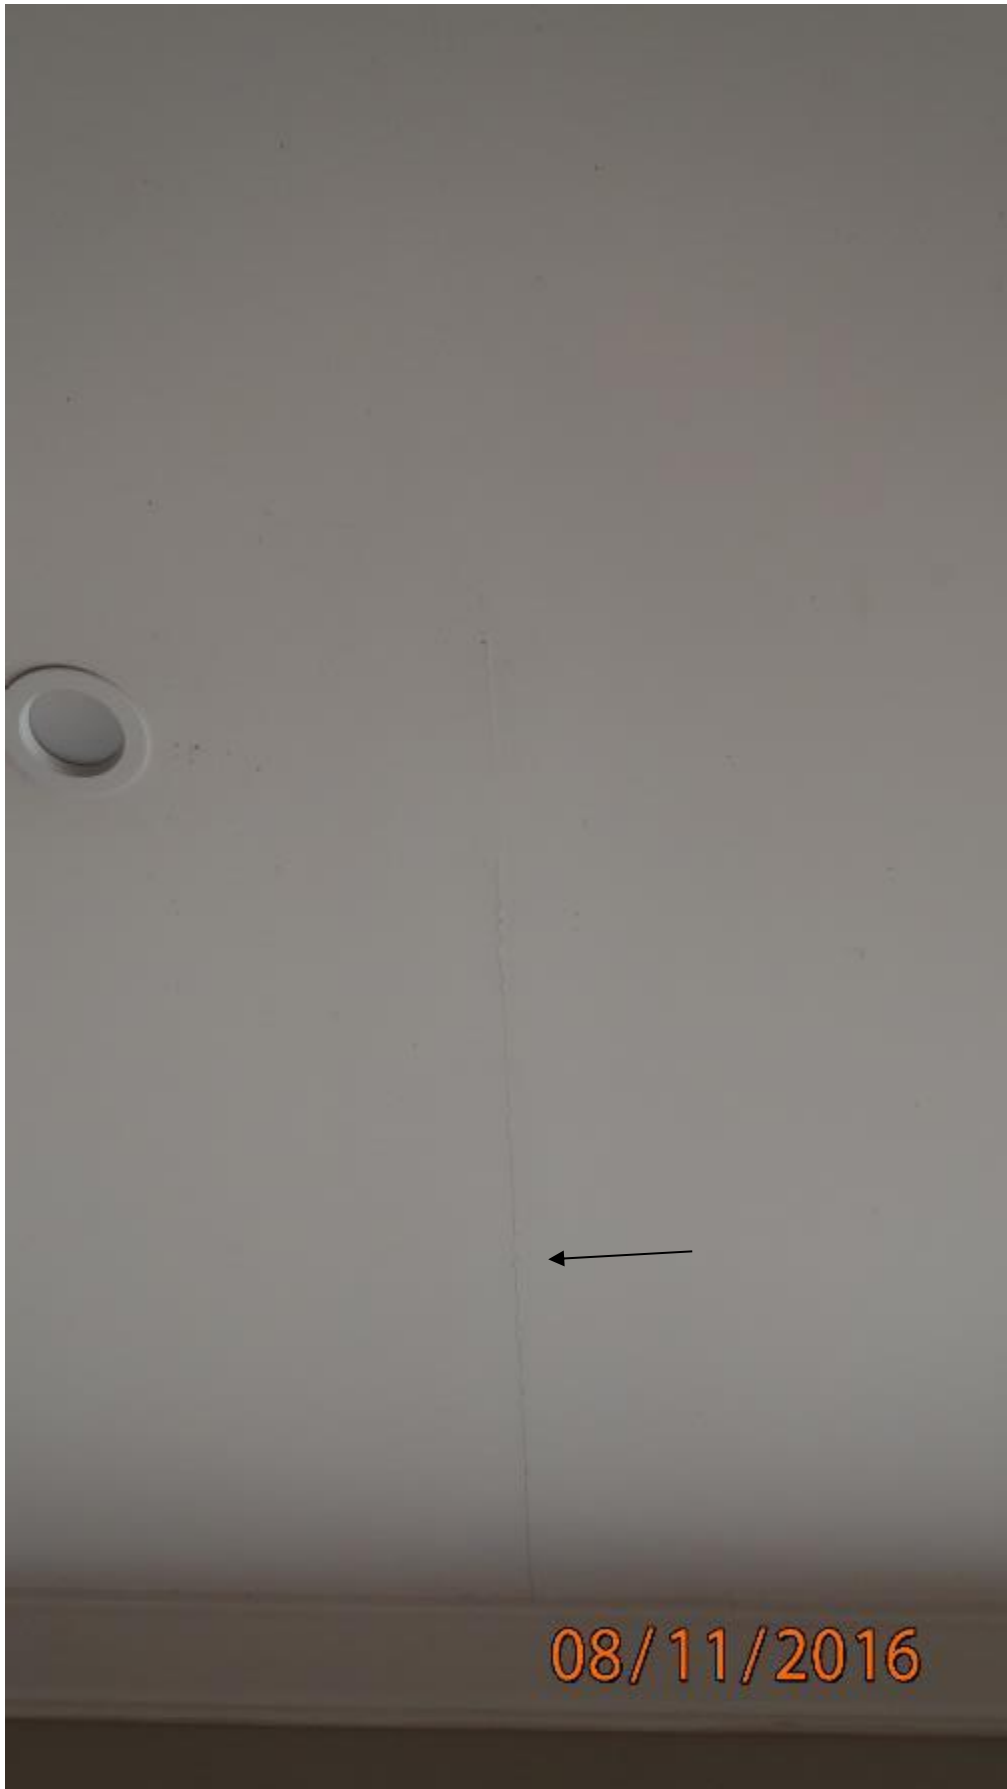
We noted hairline separation cracking [ $<1.0\text{mm}$ ] to the plaster ceiling lining extending across the Lounge room [**Photographs 35 & 36**]

**Photograph 35** shows cracking to the plaster ceiling lining extending across the Lounge room.

**Photograph 36** shows cracking to the plaster ceiling lining extending across the Lounge room.

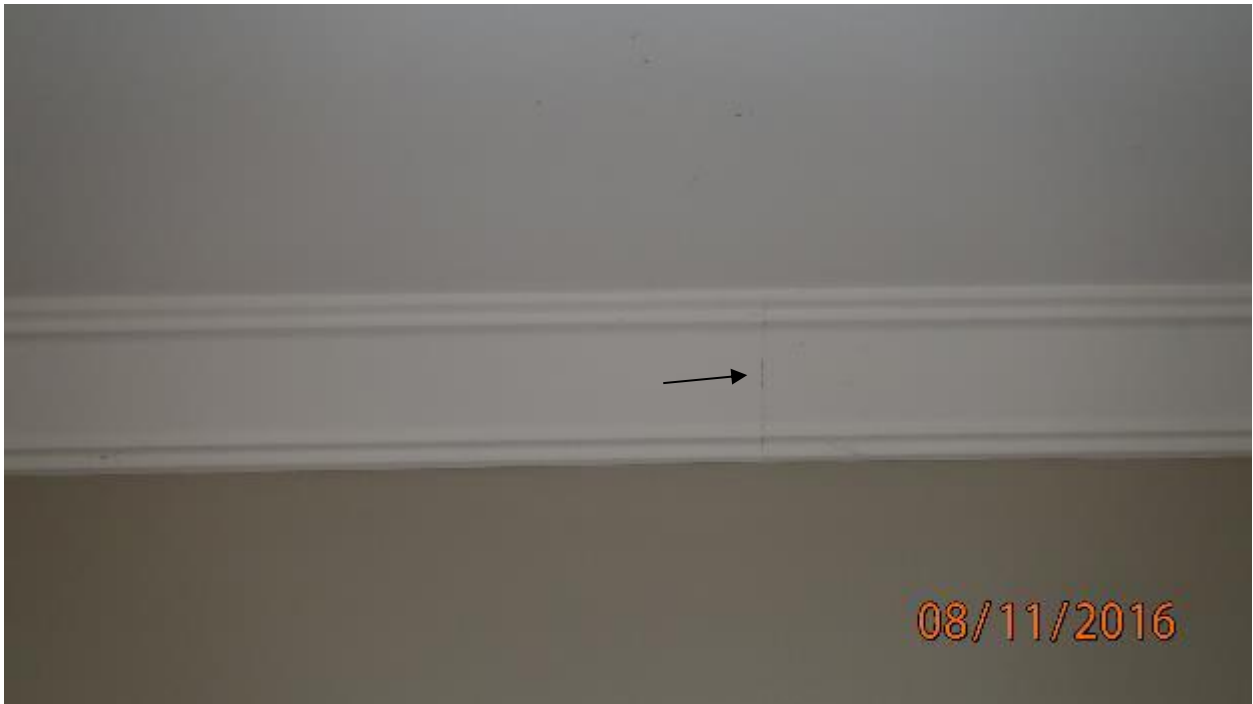
We noted cracking [ $<1.0\text{mm}$ ] to the cornice joint above the *common party wall* with the adjoining property, No. 11 Morrice Street. [**Photograph 37**]

**Photograph 37** shows cracking to the cornice joint above the common party wall with the adjoining property, No. 11 Morrice Street in the Lounge Room.
