## Dilapidation Assessment Report

Prepared for: Cape Cod Australia Pty. Limited  
Job address: 11 Morrice Street, Lane Cove.  
Property Owner/s: Mrs. Therese Sheridan.  
Report reference: **LANE COVE COUNCIL**  
Development Application No: not available  
Date of assessment: 8<sup>th</sup> November 2016

**Re: Dilapidation Report – 11 Morrice Street, Lane Cove.**

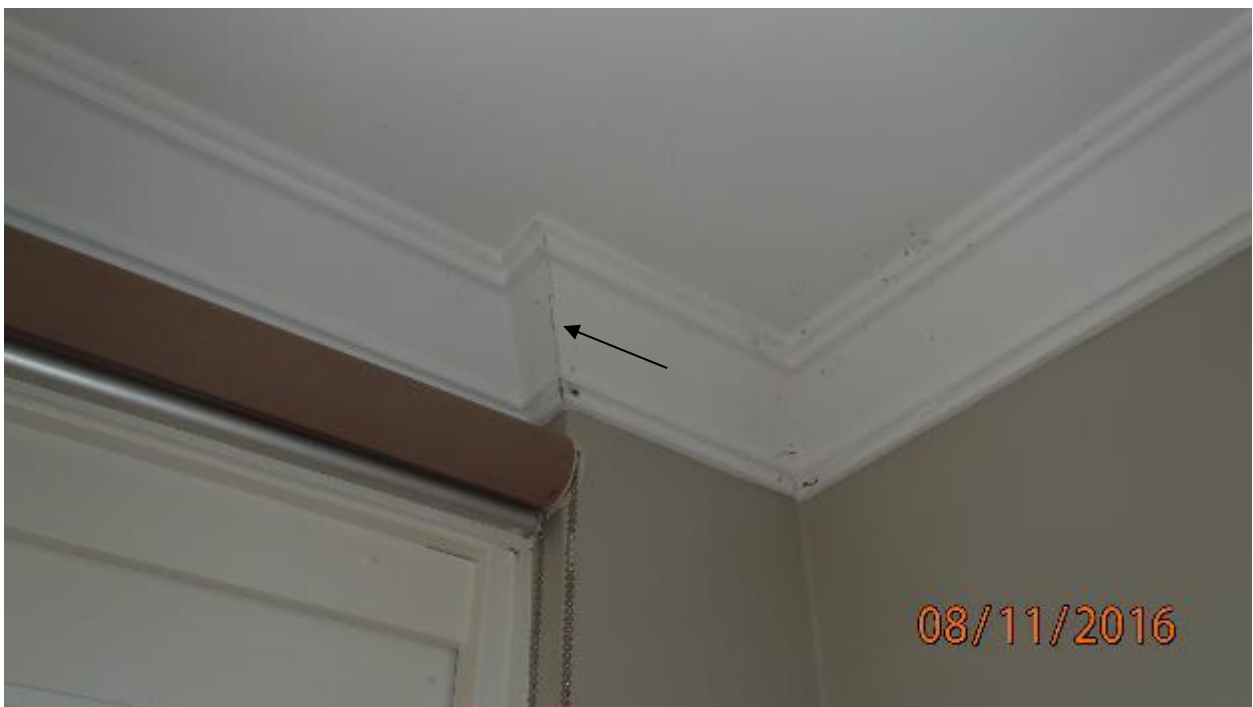
We noted cracking [ $<1.0\text{mm}$ ] to the mitre joint in the plaster cornice in the north-western corner. [**Photograph 38**]

**Photograph 38** shows cracking to the mitre joint in the plaster cornice in the north-western corner of the Lounge Room.
