HAZARDOUS MATERIALS ASSESSMENT REPORT

Job details: Owner: Mr. M. & Mrs. L. McAlister.
Location: 36 Henrietta Street, Waverley.

Our reference: HM05620517

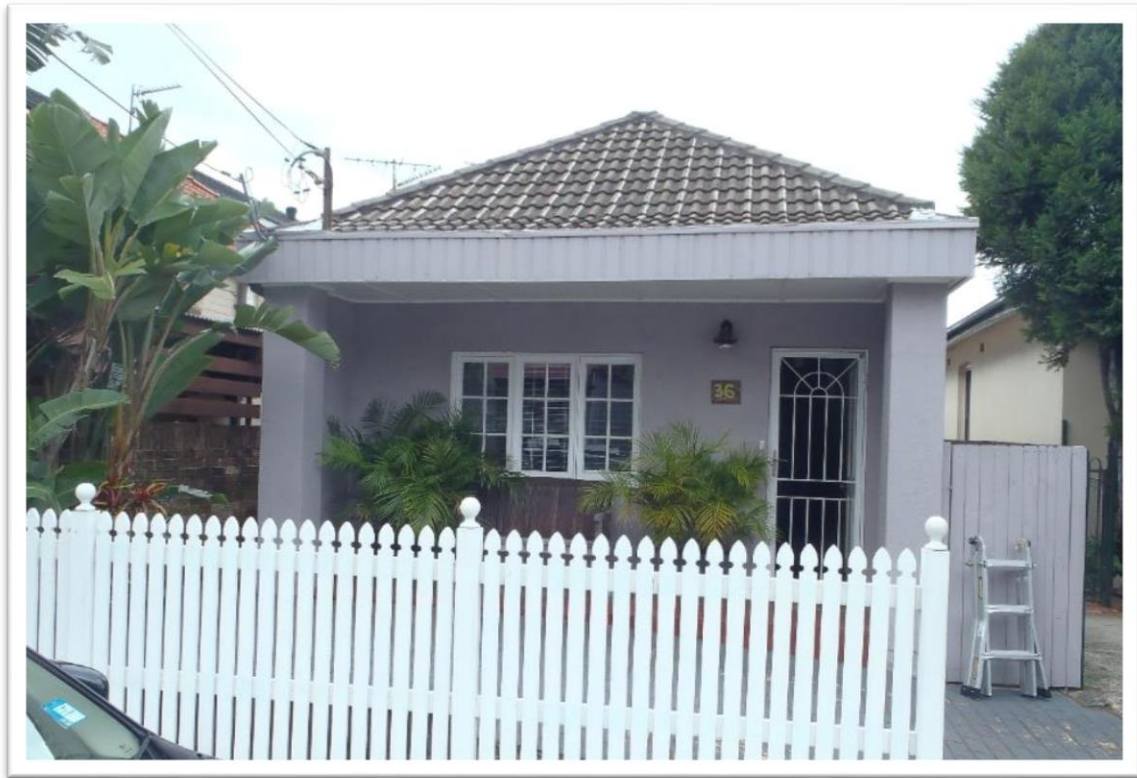
Front western elevation of the residence
