HAZARDOUS MATERIALS ASSESSMENT REPORT

Job details: Owner/s: Mr. R. & Mrs. M. Jenkins
Location: 27 Irvine Street, Kingsford NSW

Date of assessment: 27th January 2015

Our reference: HM03630115

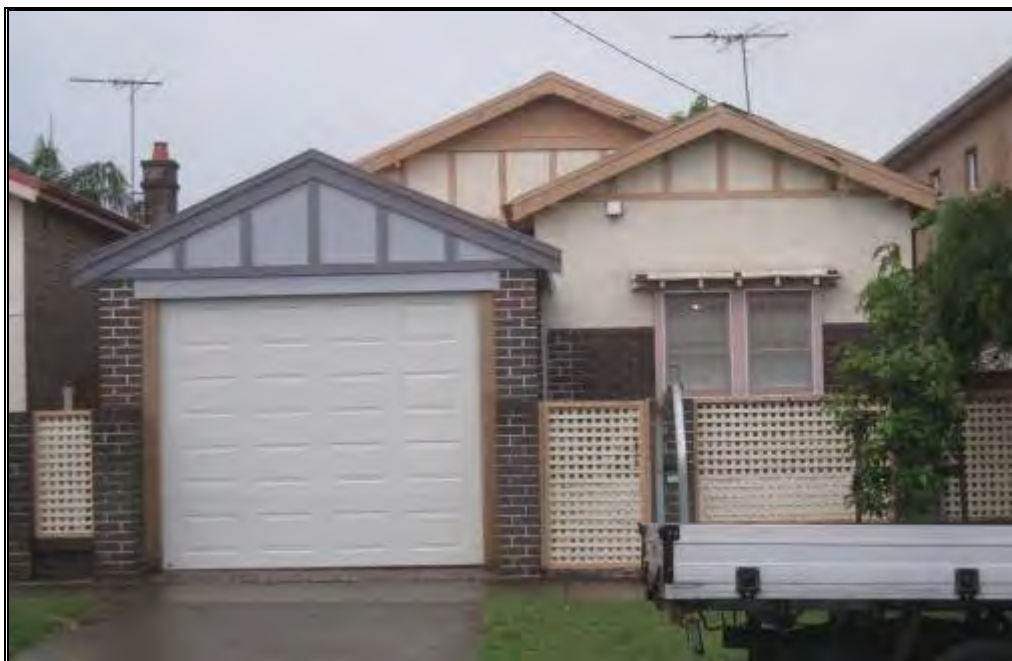
Front western elevation of the residence
