## Dilapidation Assessment Report

Prepared for: Cape Cod Australia Pty. Limited  
Job address: 46 Alfred Street, BRONTE.  
Property Owner/s: Bryan and Annie Downes  
Report reference: **WAVERLEY COUNCIL**  
Development Application No: not available  
Date of assessment: 13<sup>th</sup> July 2016

**Re: Dilapidation Report**

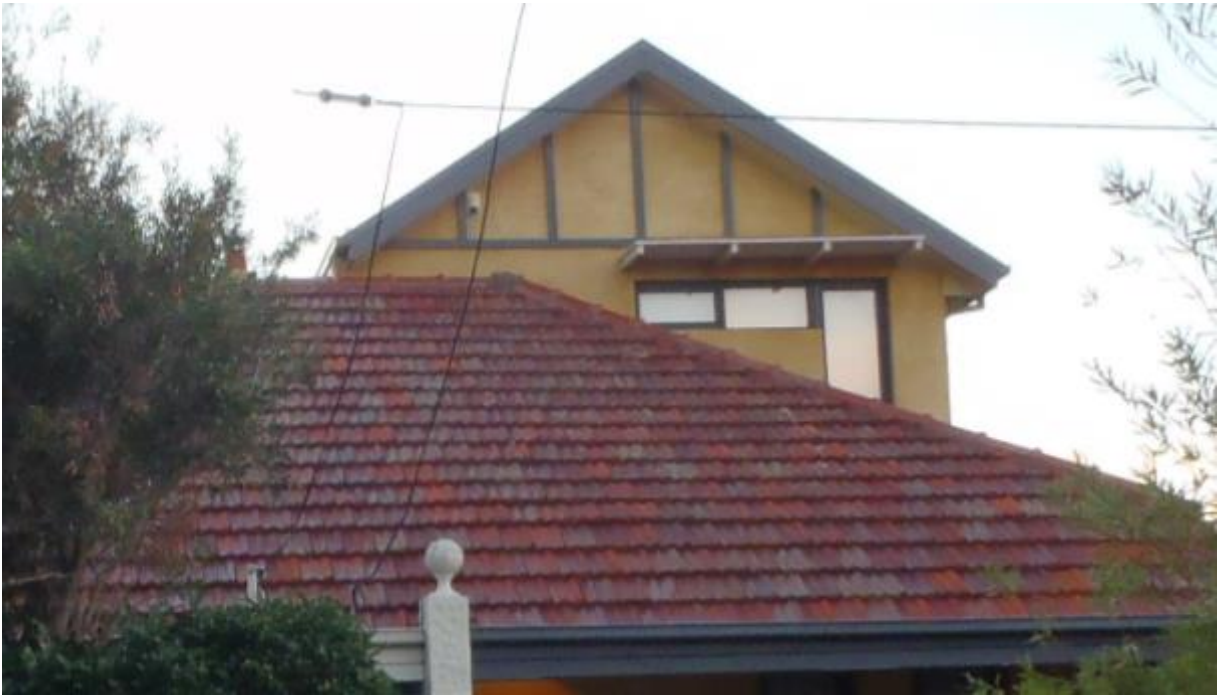
We observed that the terra cotta roof tiles to the original roof surfaces are generally interlinked and securely bedded, in our opinion forming a weather resistant cover to the residence. **[Photograph 1]**

**Photograph 1** shows terra cotta roof tiles to the original roof surfaces.

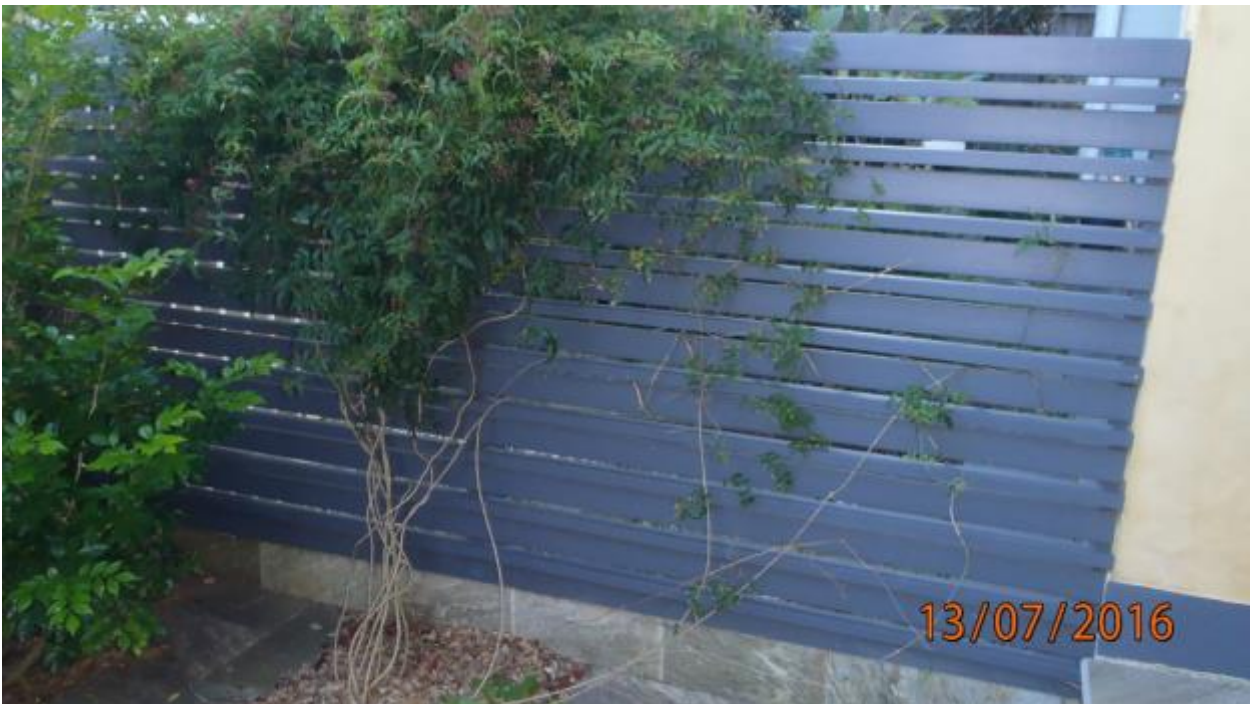
We noted that the *common* front boundary fence with adjoining property No.44 Alfred Street is of timber slat construction **[Photograph 2]**, the front boundary fence is a combination render brickwork and timber slat **[Photograph 3]**, and the rear *common* boundary fence with adjoining property No.44 Alfred Street is of post and rail timber fence with timber lattice extension. **[Photograph 4]**

**Photograph 2** shows the general condition of the *common* front boundary fence.

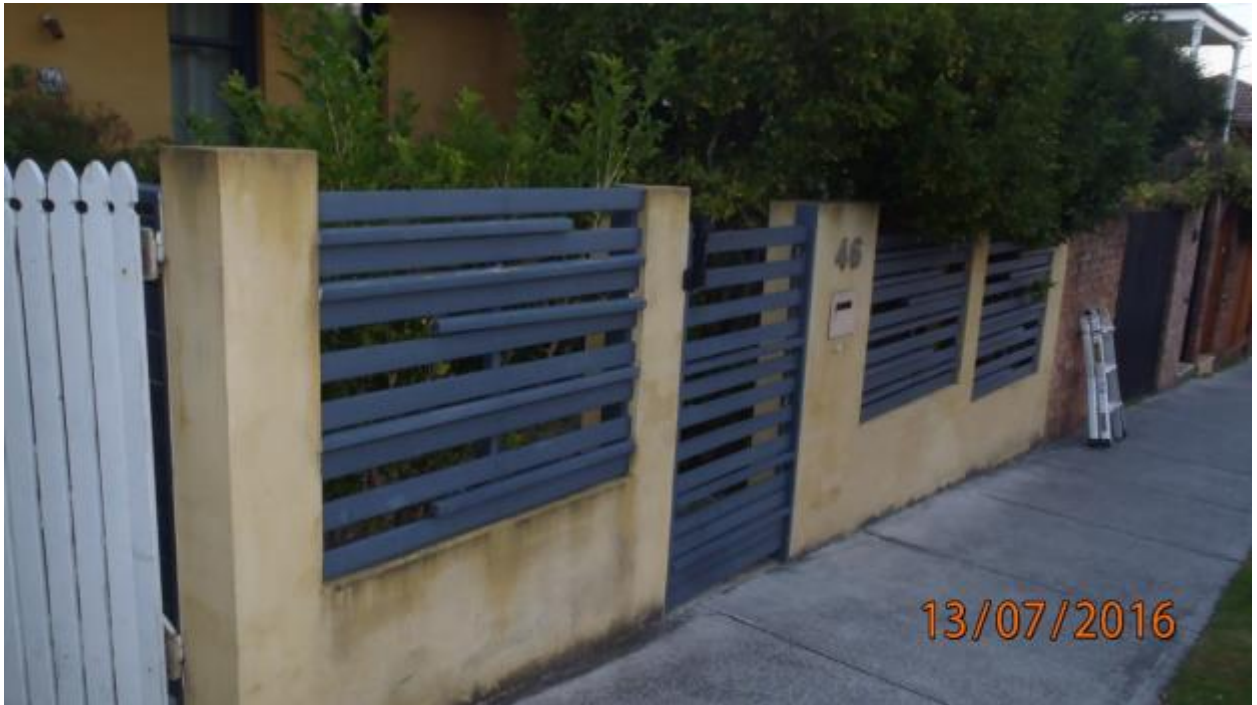
**Photograph 3** shows the general condition of the front boundary fence.

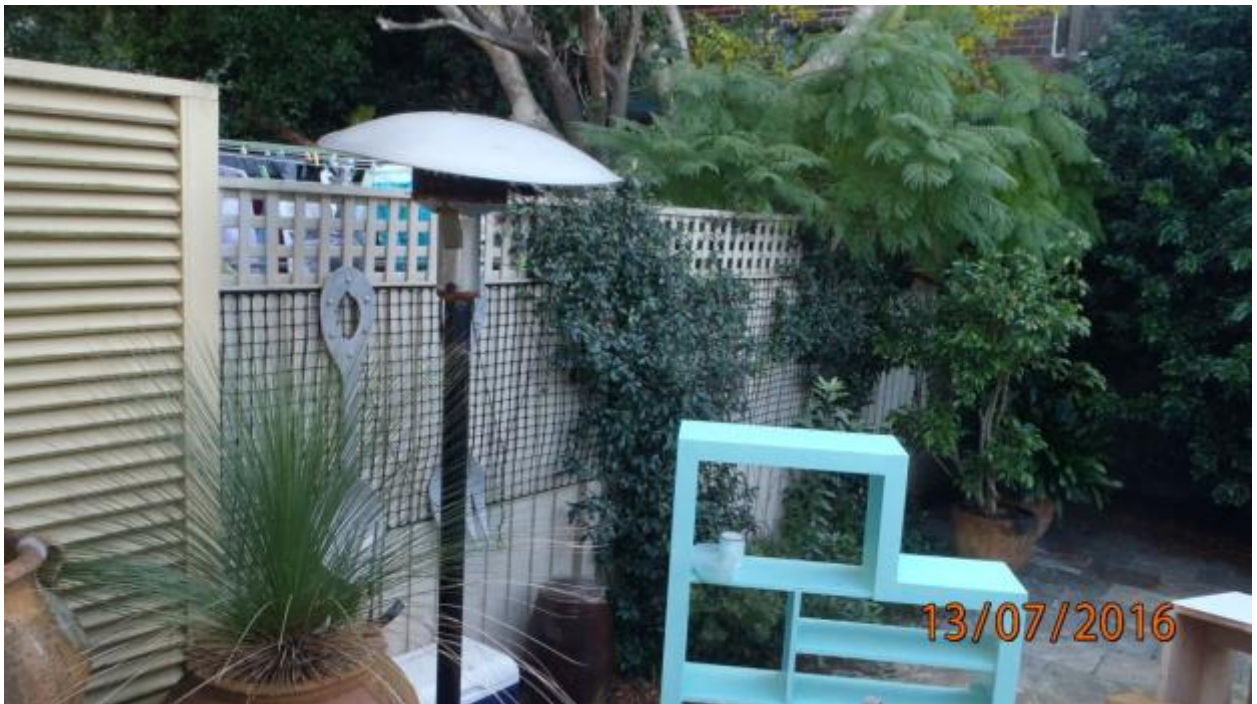
**Photograph 4** shows the general condition of the *common* front boundary fence.

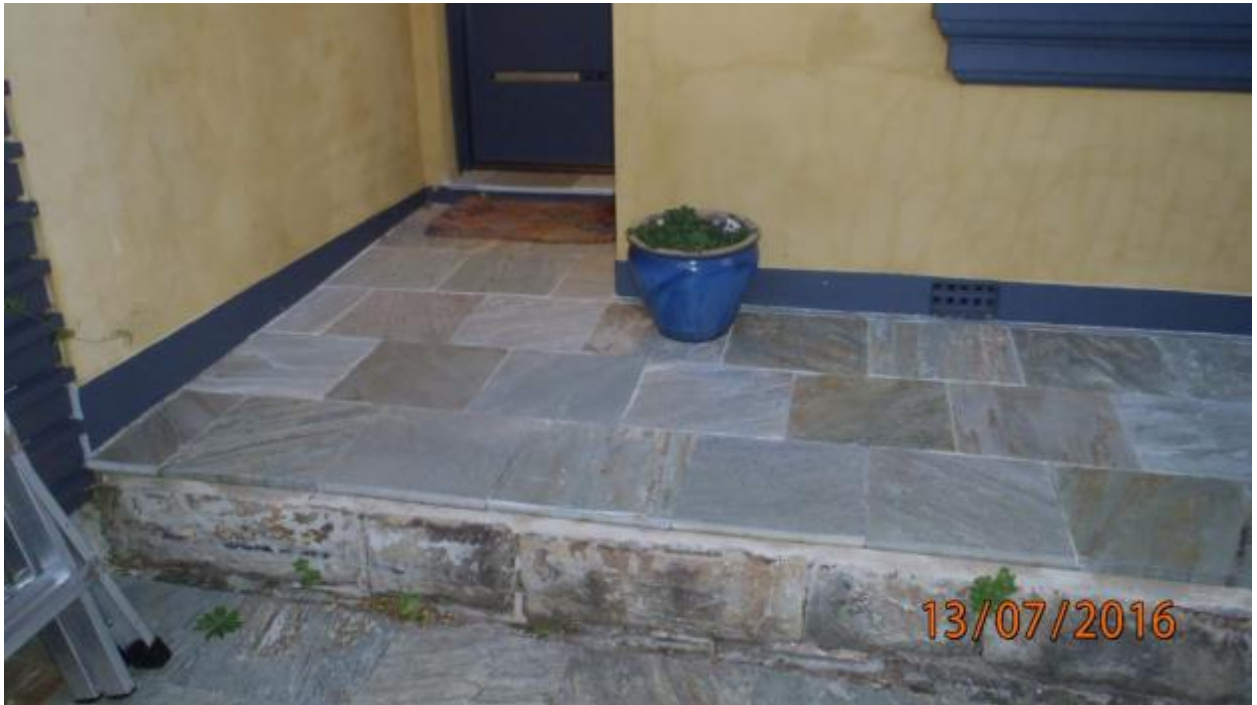
We noted that the front porch is a tiled suspended concrete slab construction supported by sandstone blocks and that the front pathway and side path are tiled. **[Photographs 5 and 6]**

**Photograph 5** shows the general condition of the Front porch.

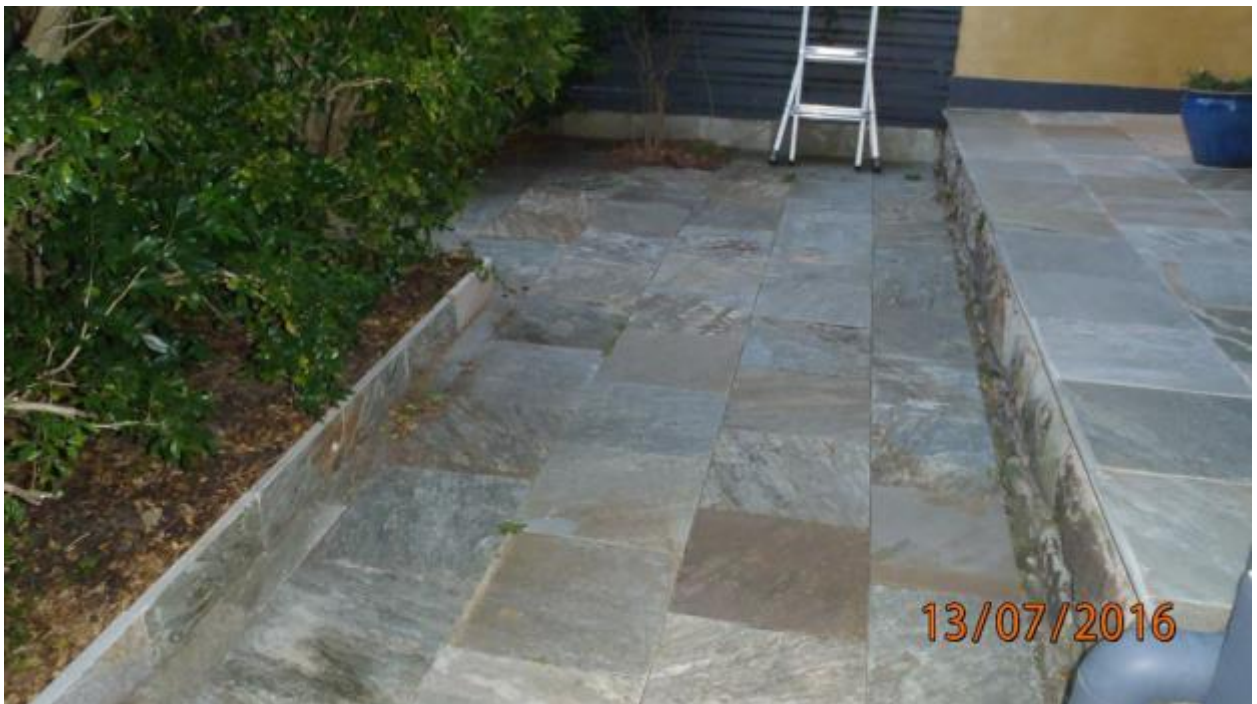
**Photograph 6** shows the general condition of the paved front pathway.

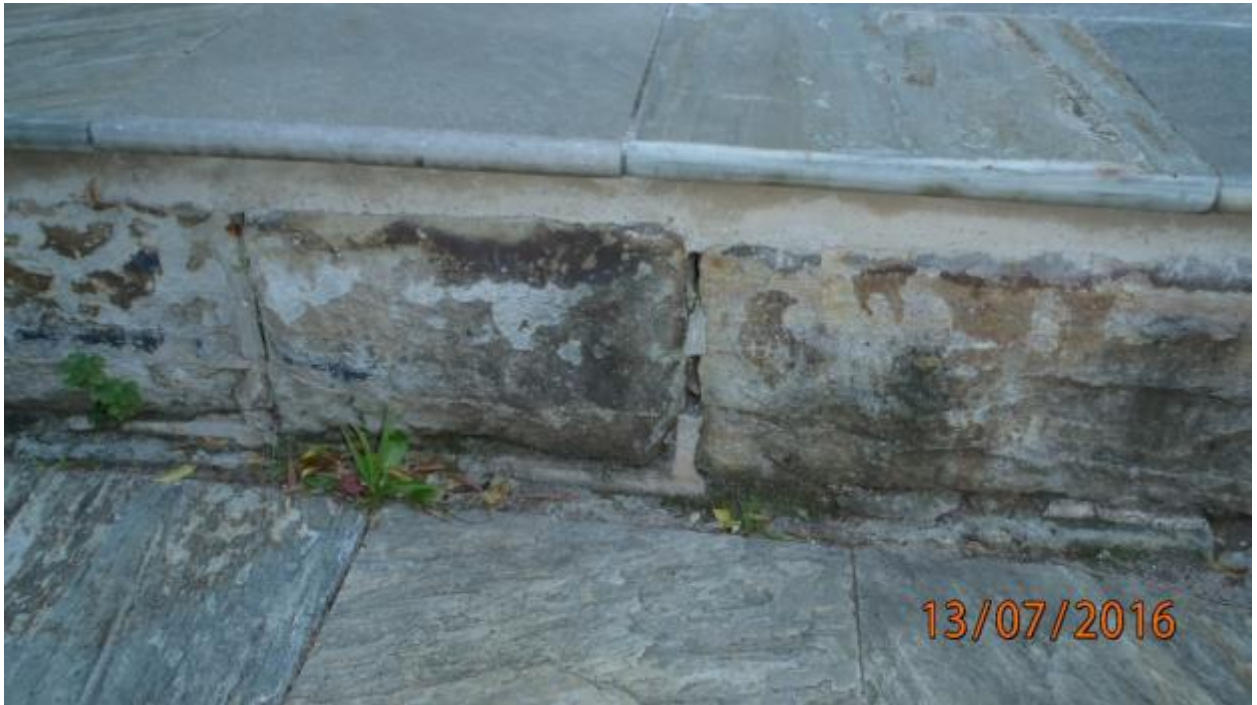
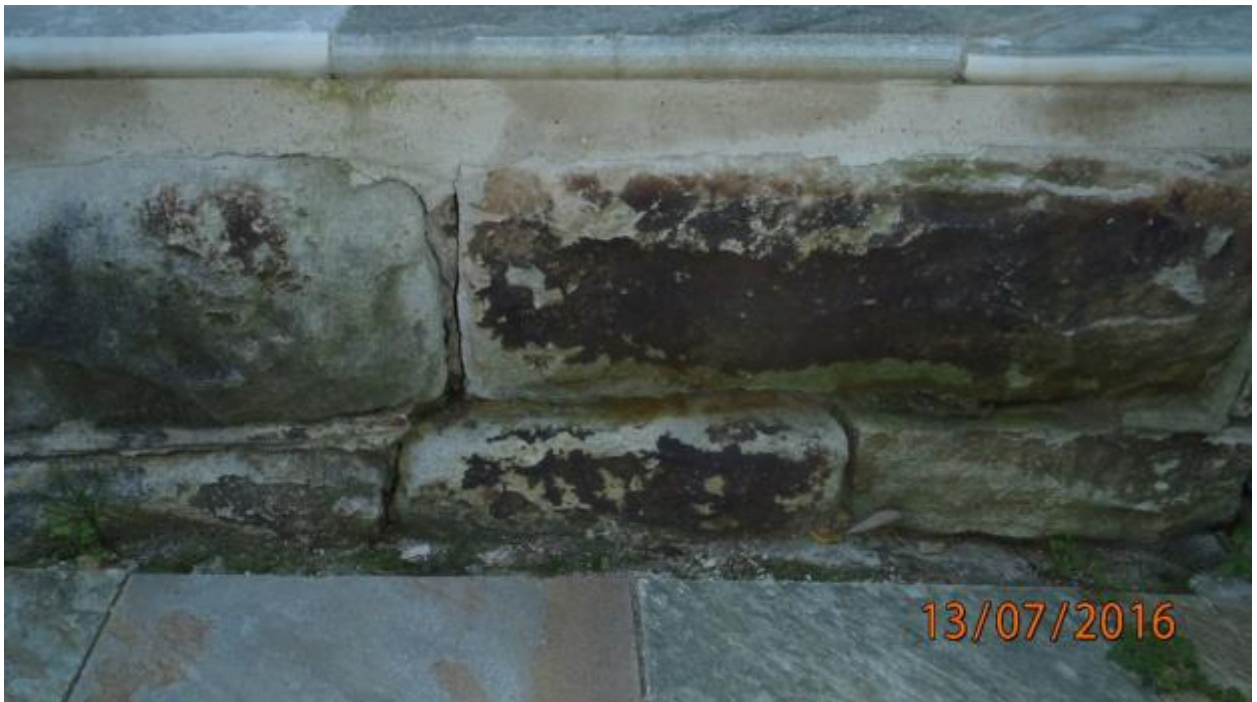
We noted displaced mortar to the sandstone blockwork supporting the front porch. **[Photographs 7 & 8]**

**Photograph 7** shows displaced mortar to the front porch.

**Photograph 8** shows displaced mortar to the front porch.

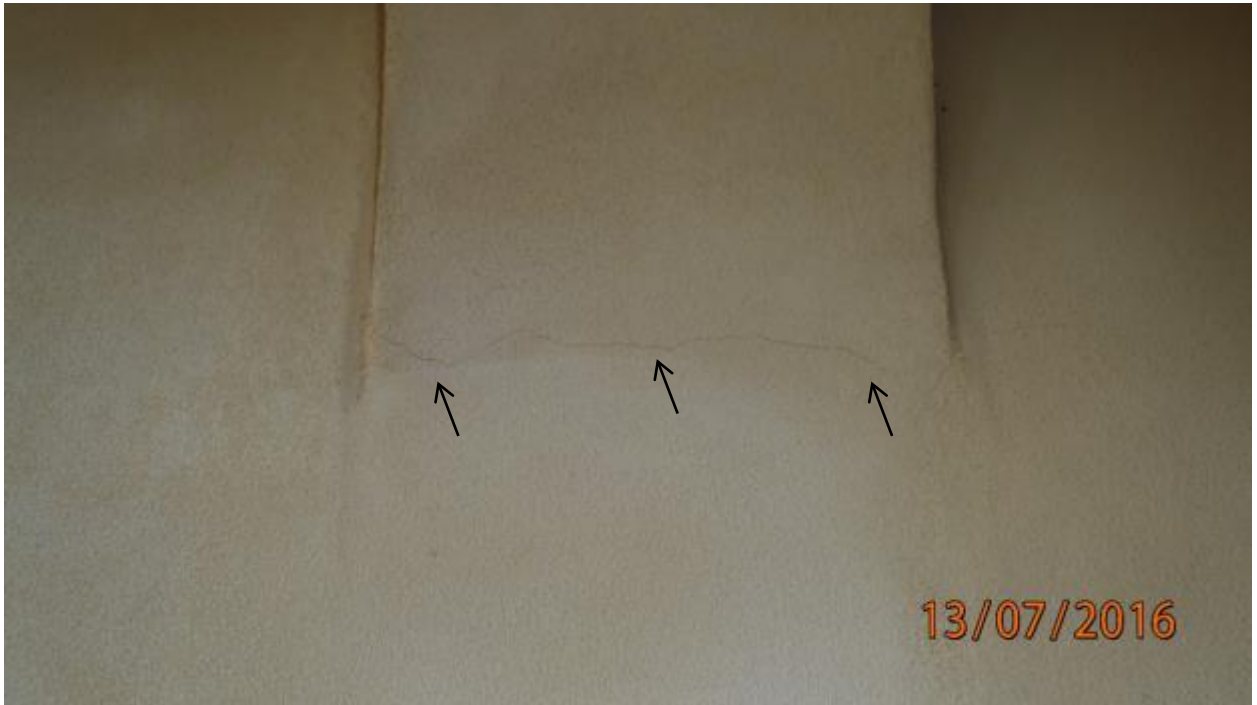
We noted a horizontal crack to the base of the front archway adjoining the *common privacy* wall to the front entry **[Photograph 9]**

**Photograph 9** shows a horizontal crack to the front porch archway.

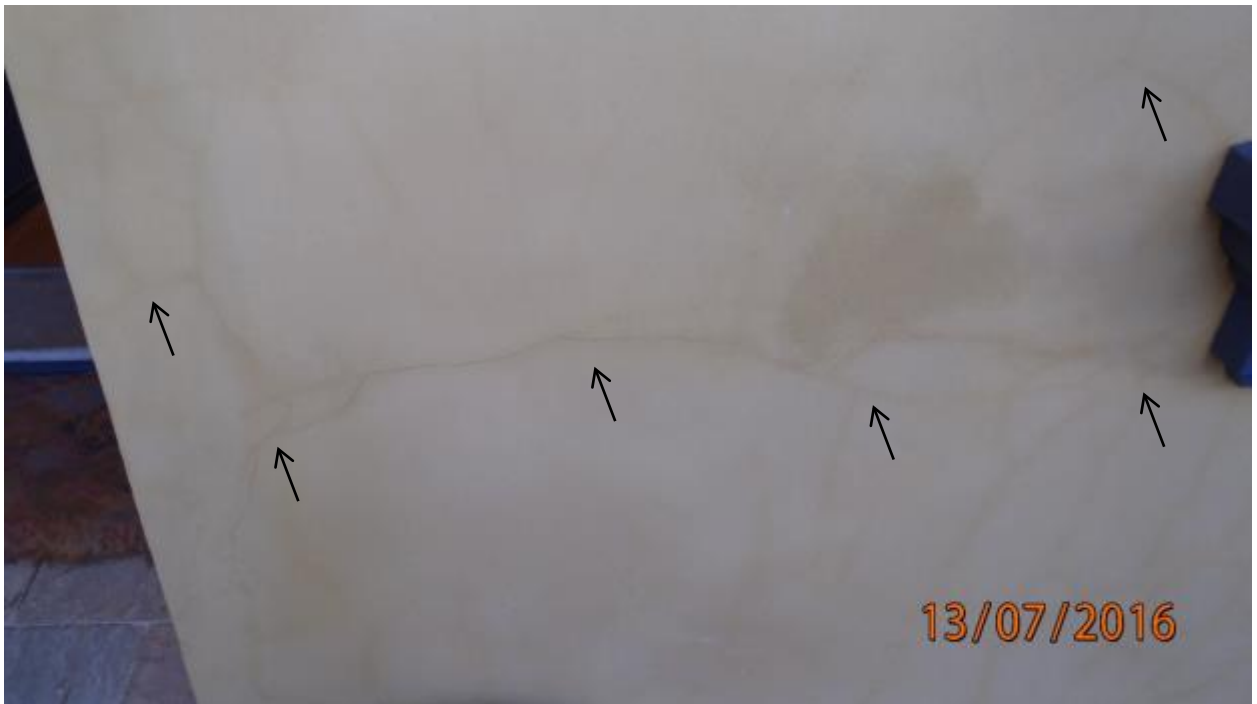
We noted horizontal and radial cracking extending from window sill of Bedroom 1 toward the front entry **[Photograph 10]**

**Photograph 10** shows horizontal and radial cracking to the left outside Bedroom 1 window.

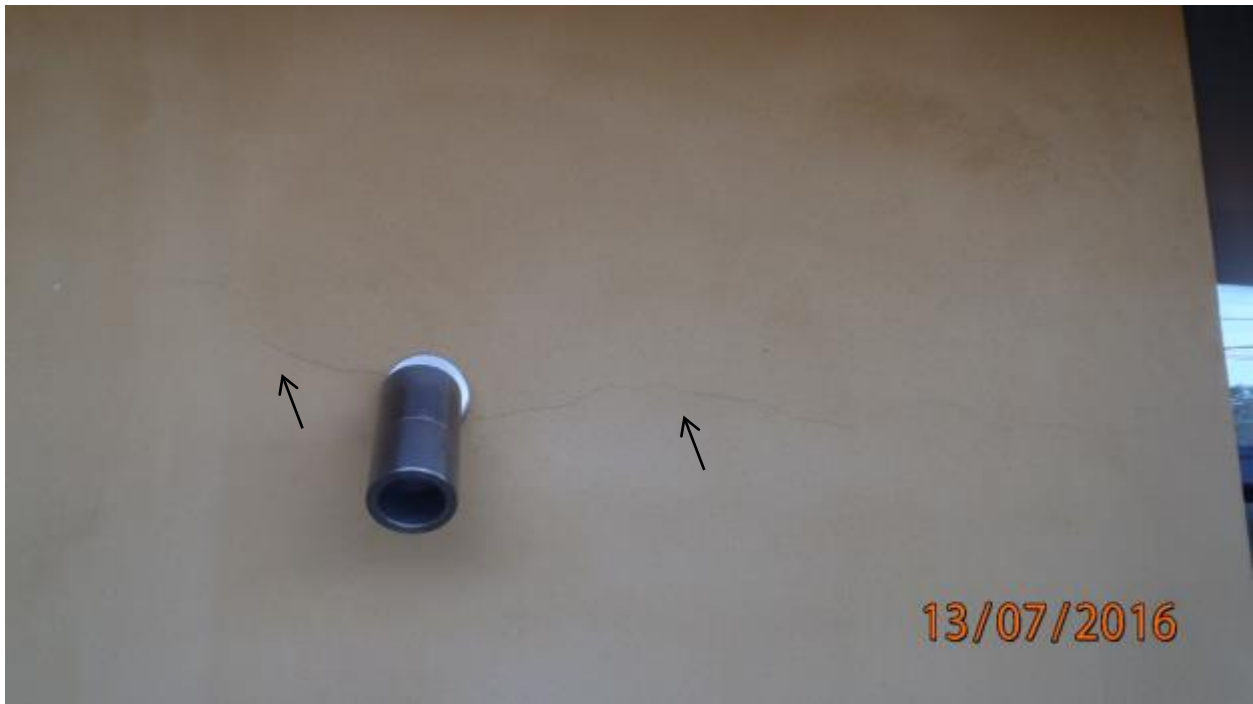
We noted horizontal cracking extending from the light fitting outside the front entry. **[Photograph 11]**

**Photograph 11** shows horizontal cracking around the front light fitting.

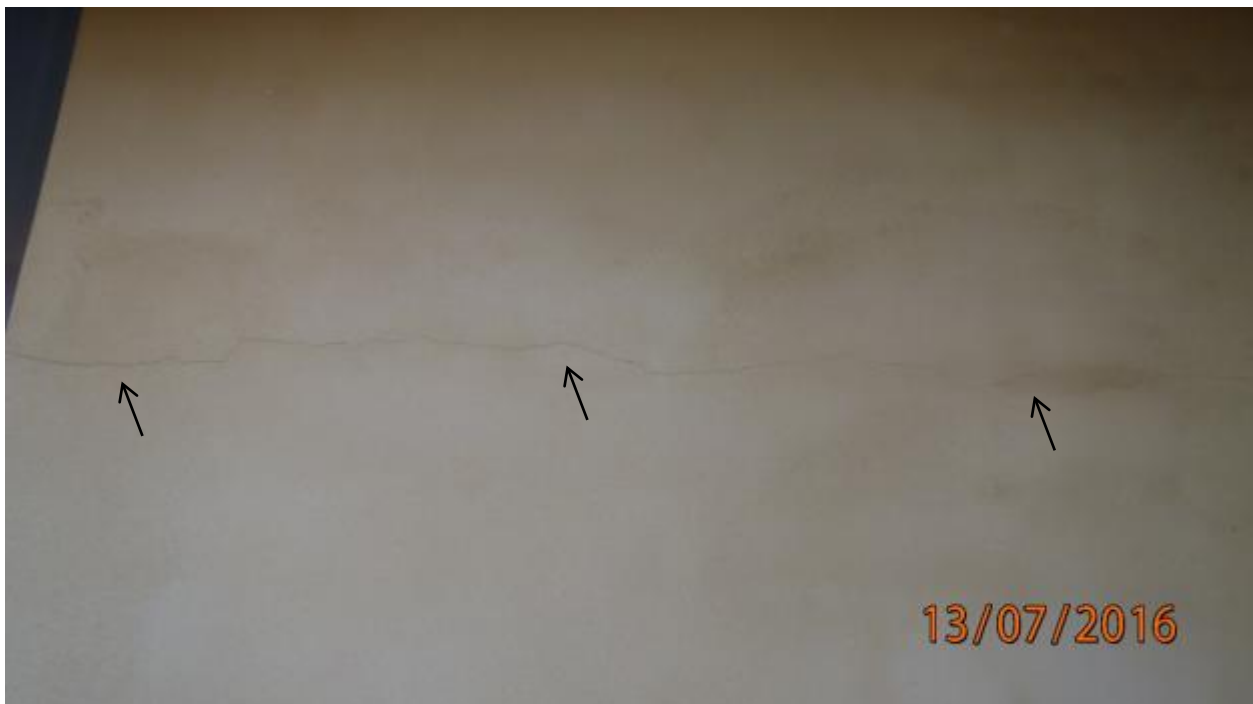
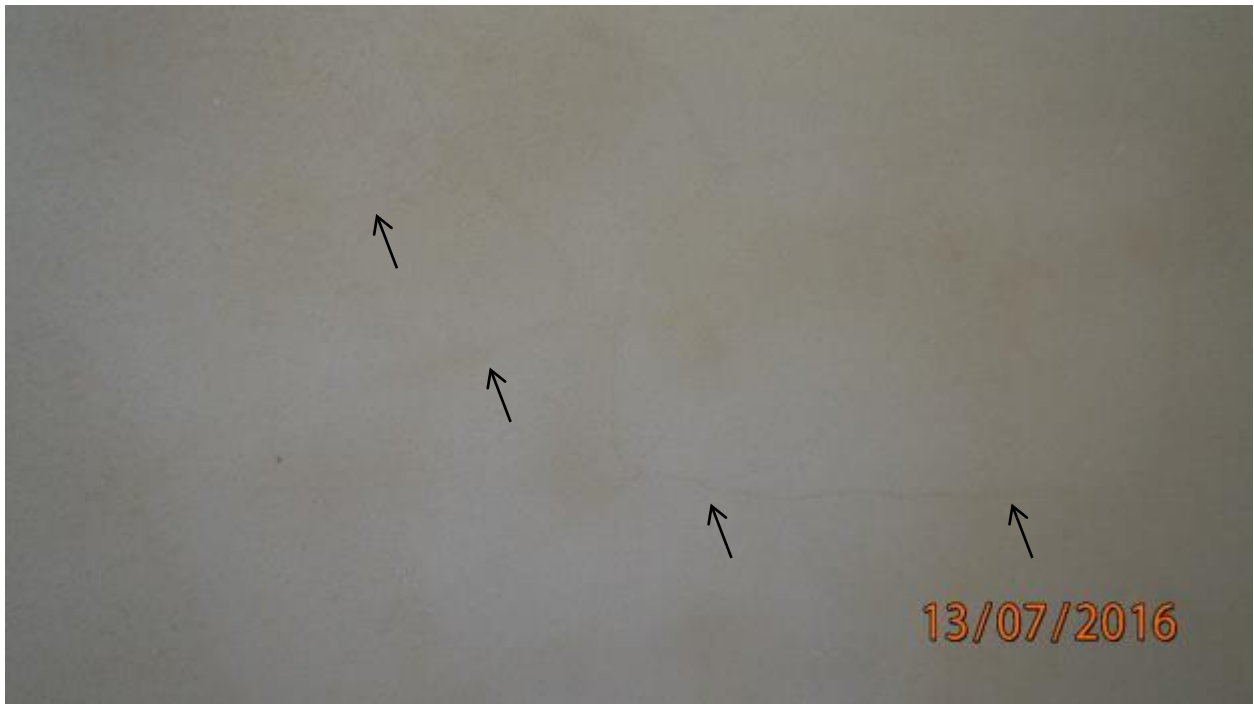
We noted horizontal and step cracking extending from the right of Bedroom 1 window. **[Photographs 12 & 13]**

**Photograph 12** shows horizontal and radial cracking to the right of Bedroom 1 window.

**Photograph 13** shows step cracking to the right of Bedroom 1 window.

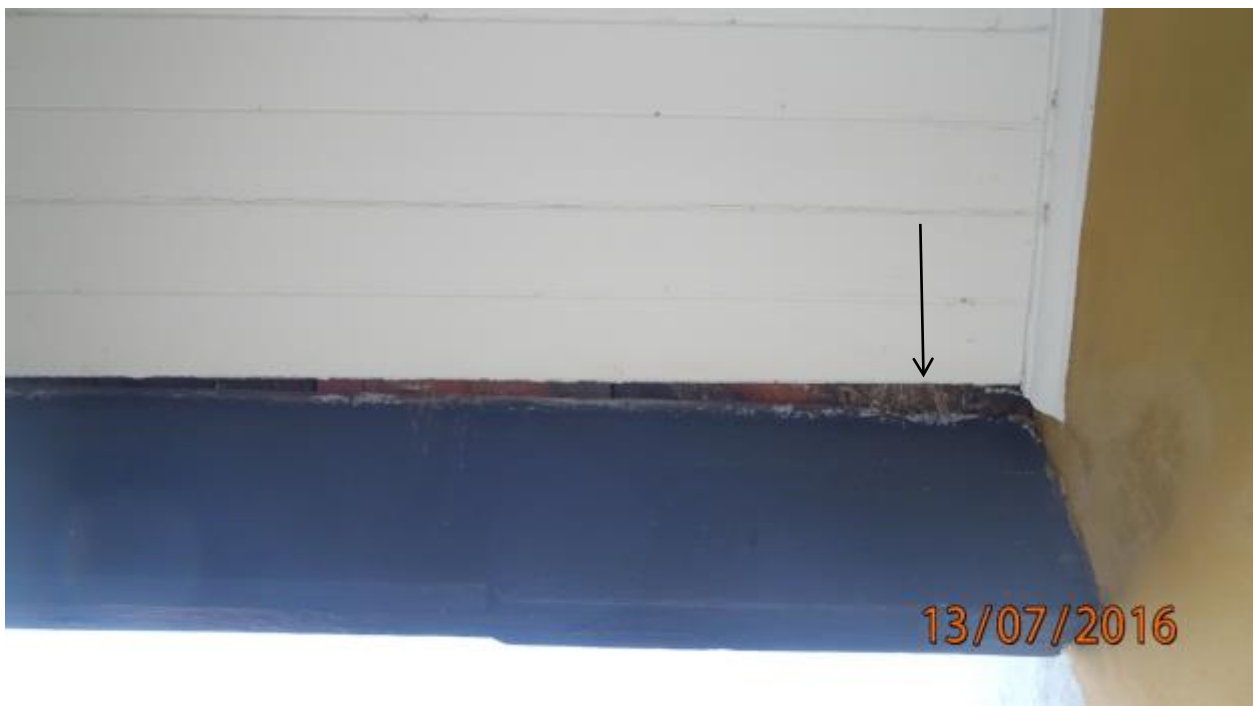
We noted a gap between the front porch eave soffit and the timber barge board. **[Photograph 14]**

**Photograph 14** shows a gap between soffit lining and barge board.

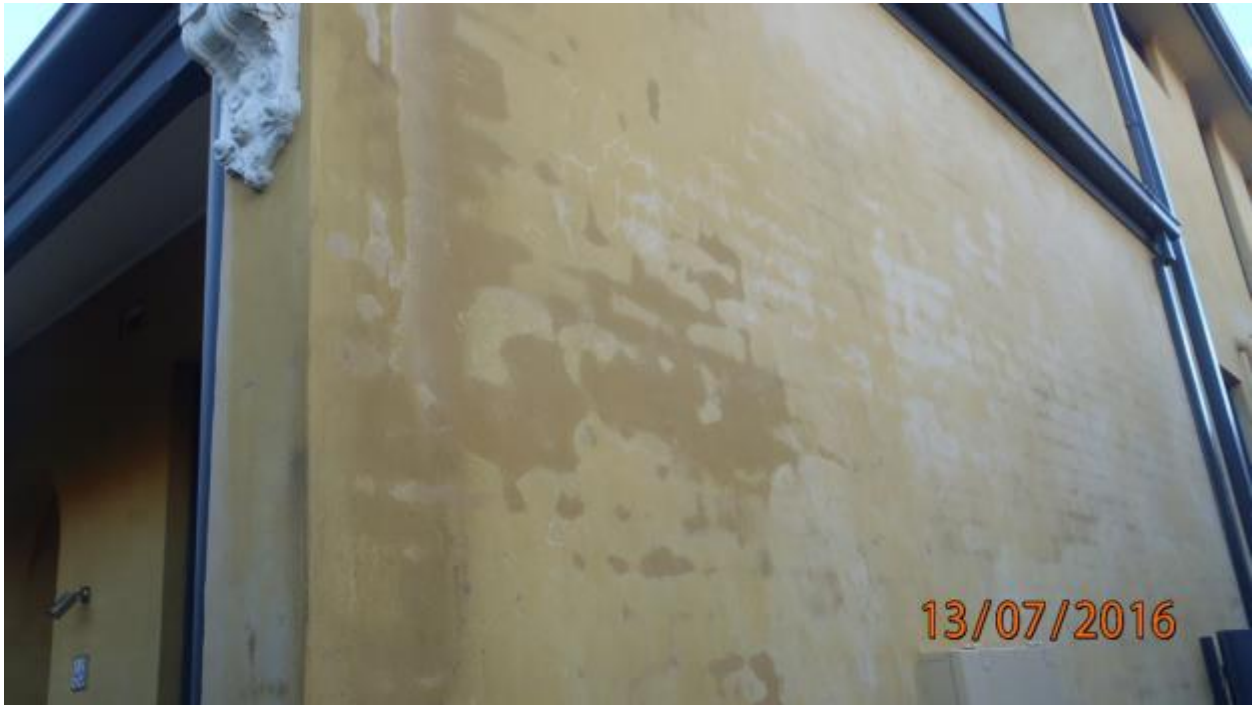
We noted general deterioration to the surface coating on the front south western corner of the residence **[Photograph 15]**

**Photograph 15** shows deterioration to the surface coating on the south west corner.

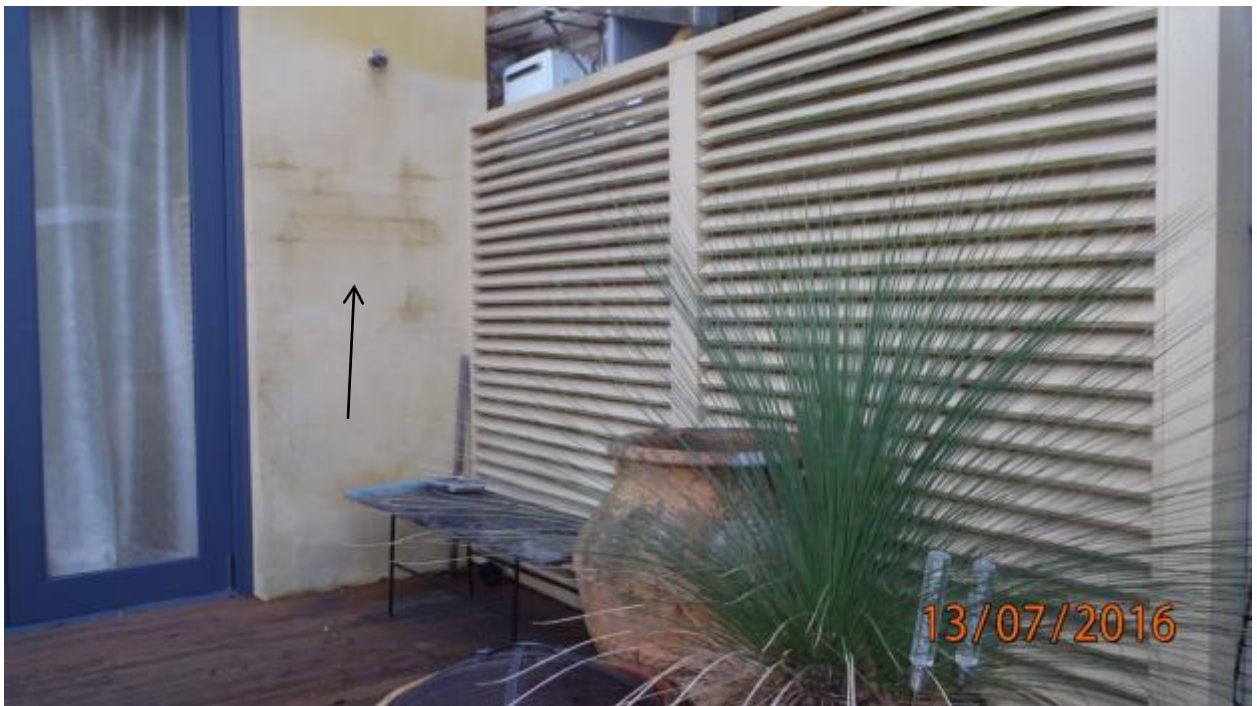
We noted general deterioration to the surface coating on the right of the rear doors under the light fitting **[Photograph 16]**

**Photograph 16** shows deterioration to the surface coating to the rear of the residence.

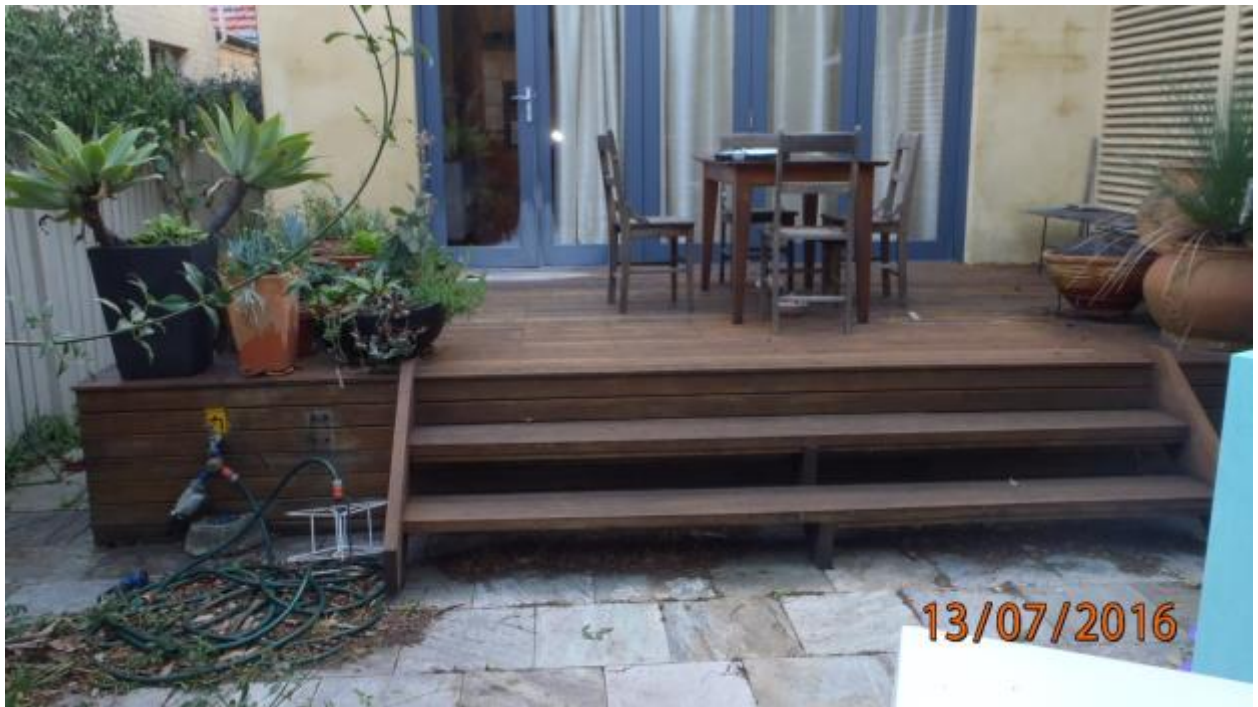
We noted that the timber deck structure is generally in good condition **[Photograph 17]**

**Photograph 17** shows the general condition of the rear deck.

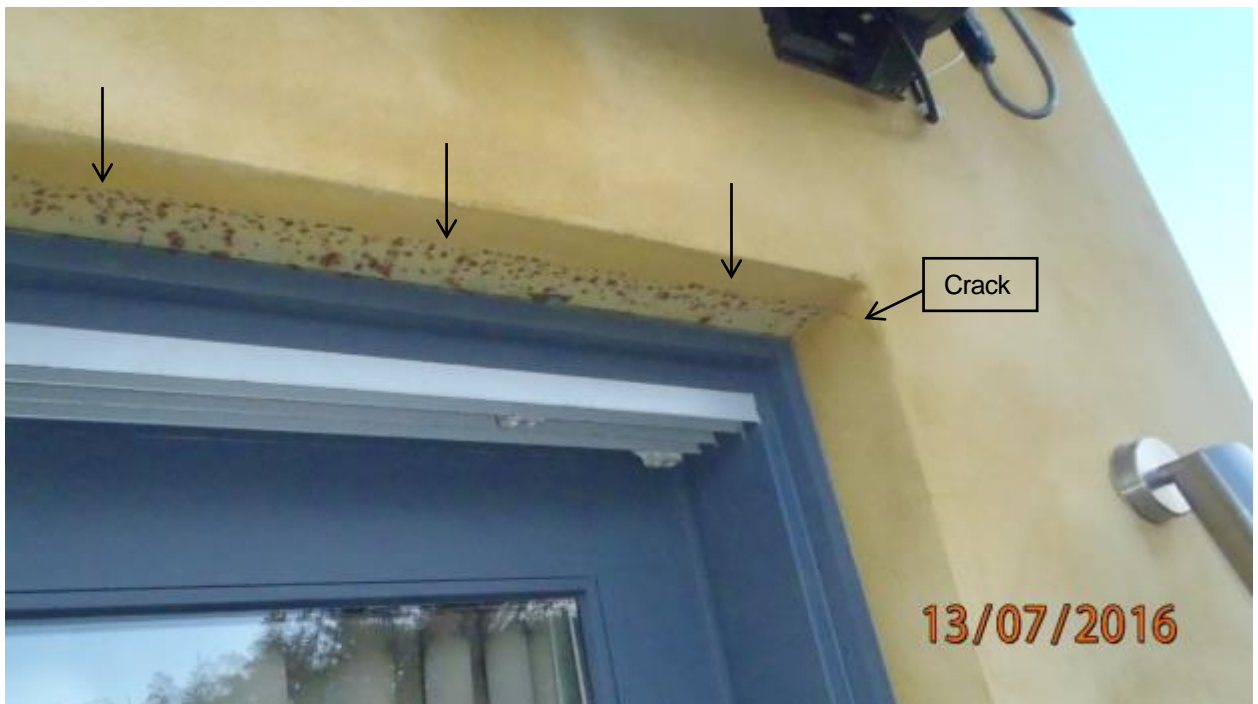
We noted that there is rusting to the lintel above the first floor balcony door. **[Photograph 18]**

We noted a settlement crack to the top right of the first floor balcony door. [**Photograph 18**]

**Photograph 18** shows the rusting above the balcony door and a settlement crack.

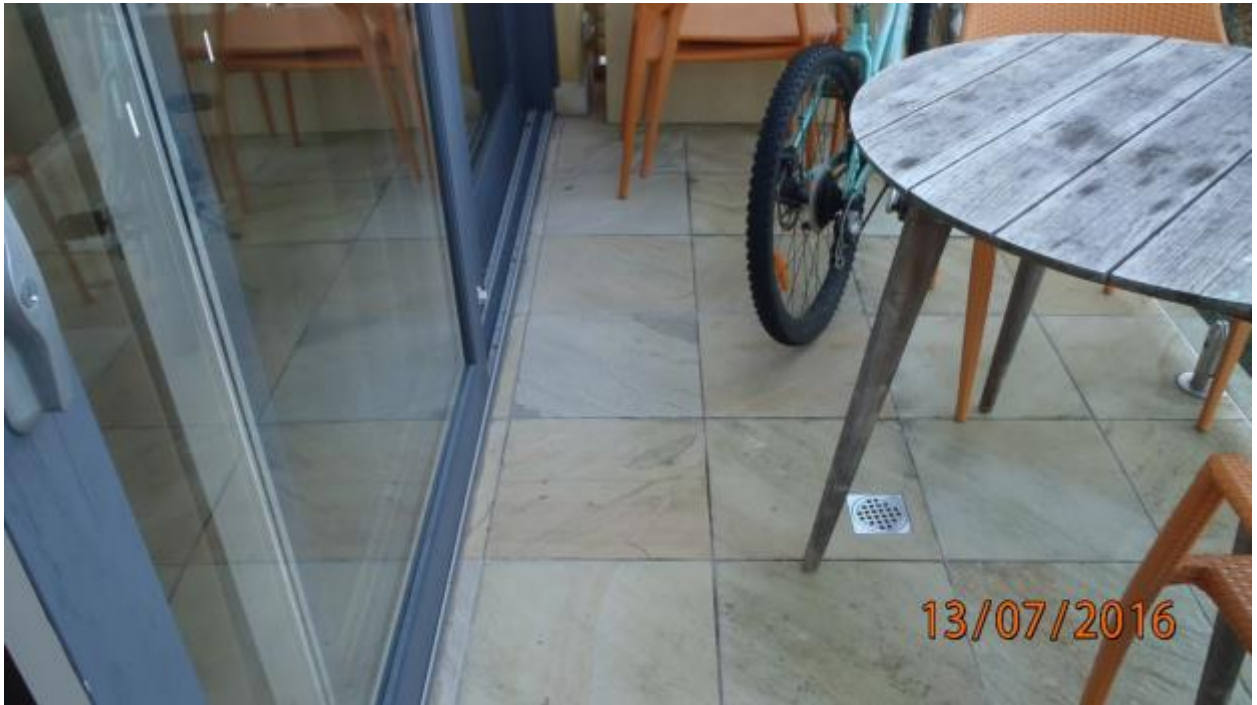
We noted that the tiles to the first floor balcony are generally in good condition. [**Photograph 19**]

**Photograph 19** shows the general condition of the rear balcony.

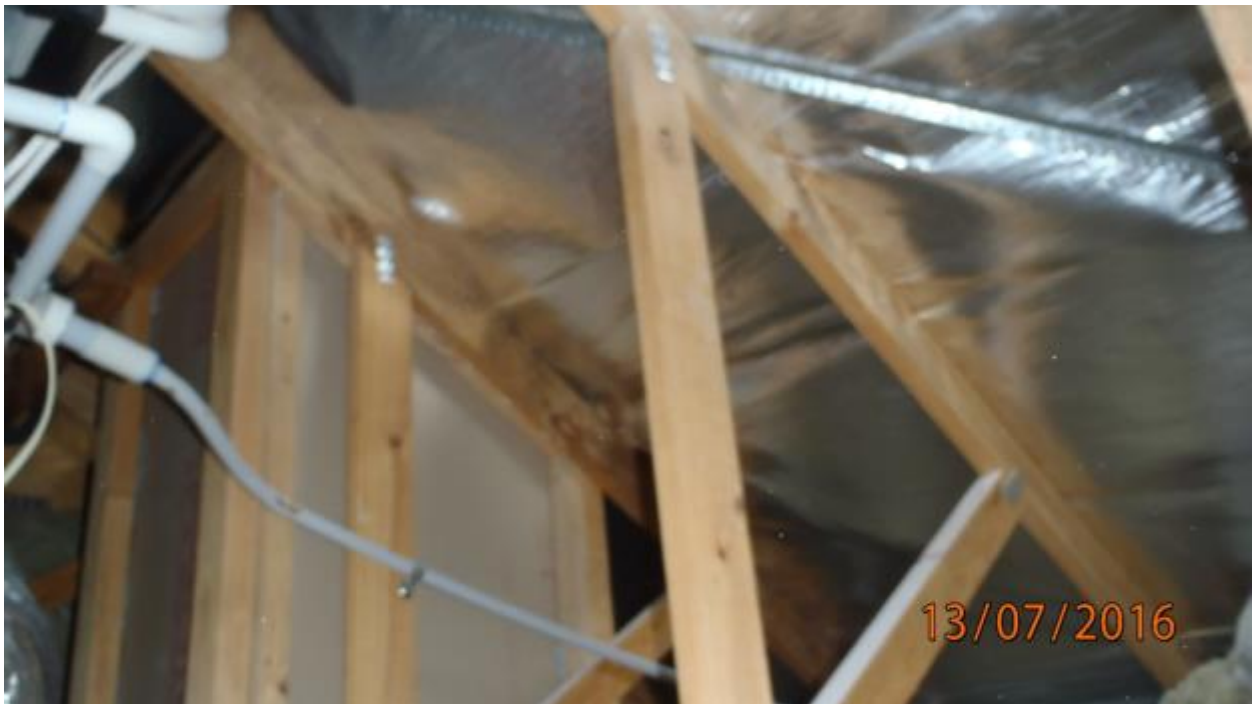
We noted that the first floor addition is of engineered timber truss design with sarking restricting access to the underside of the roof tiles. [**Photograph 20**]

**Photograph 20** shows the roof space to the first floor addition.

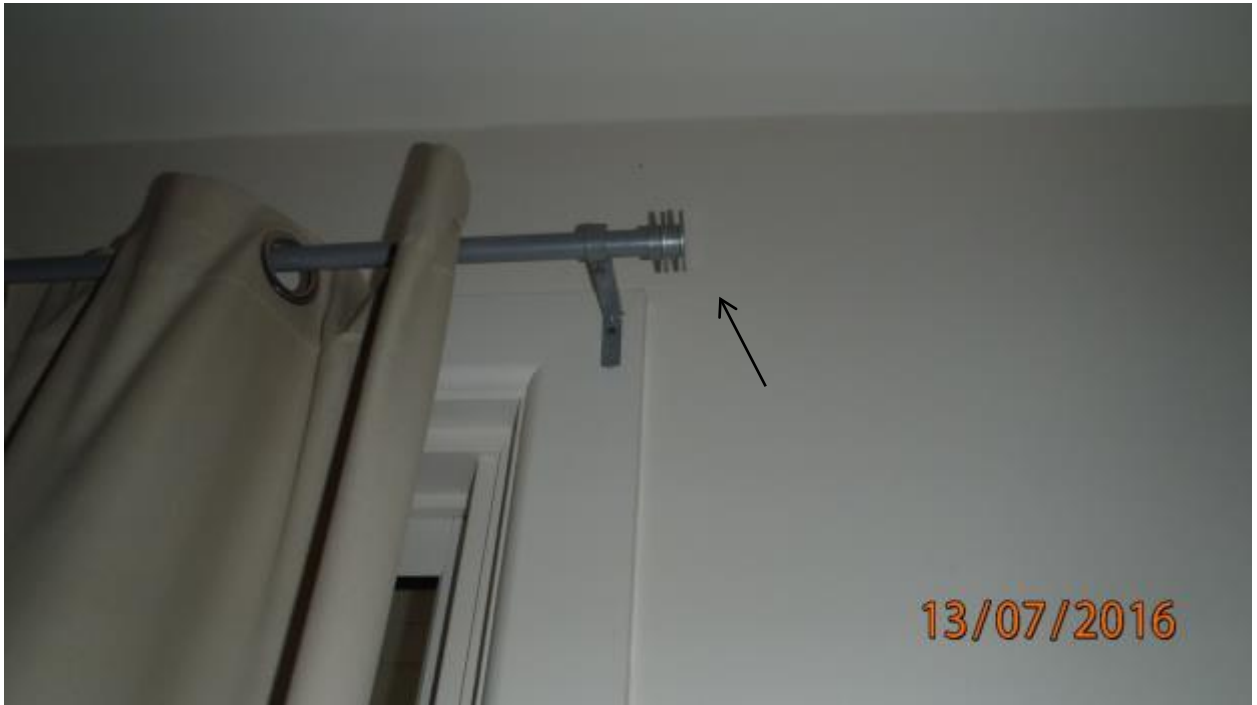
We noted a previous repair to the top right hand side of the window [**Photograph 21**]

**Photograph 21** shows a previous repair beside the Bedroom 1 window.

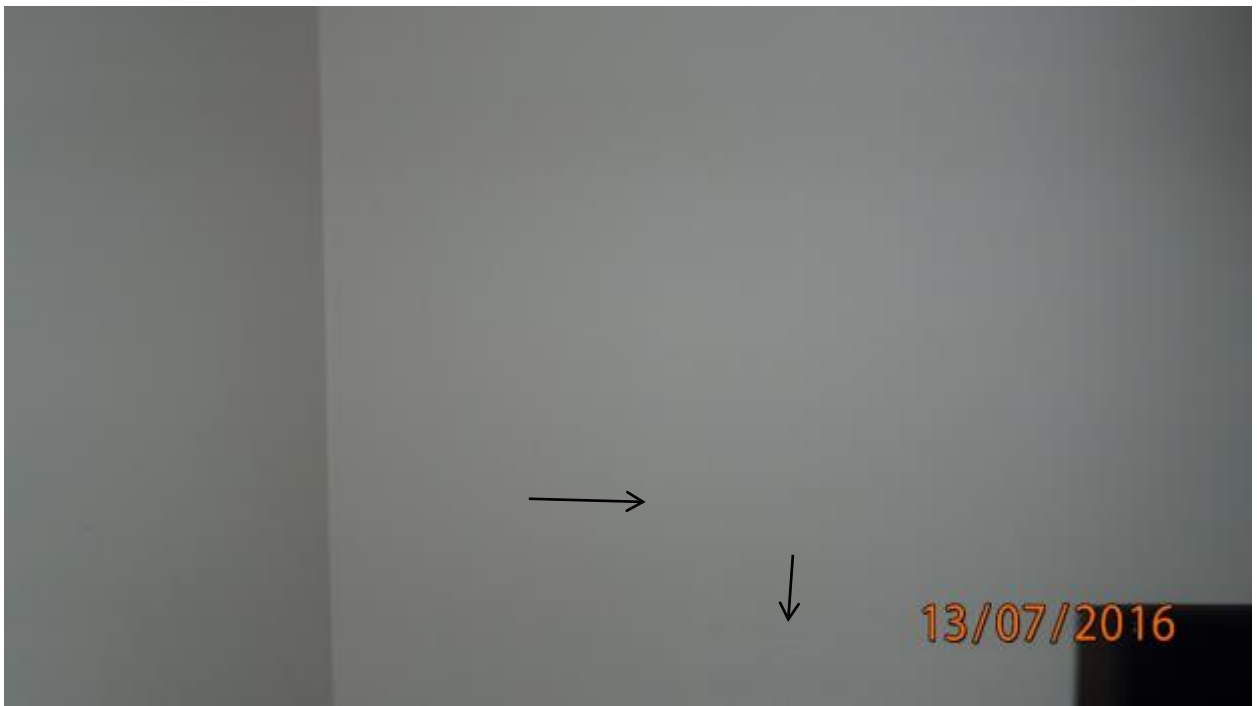
We noted a previous vertical and horizontal repair to the left hand side of the door opening [**Photograph 22**]

**Photograph 22** shows a previous horizontal and vertical repair adjacent to the door opening in Bedroom 1.

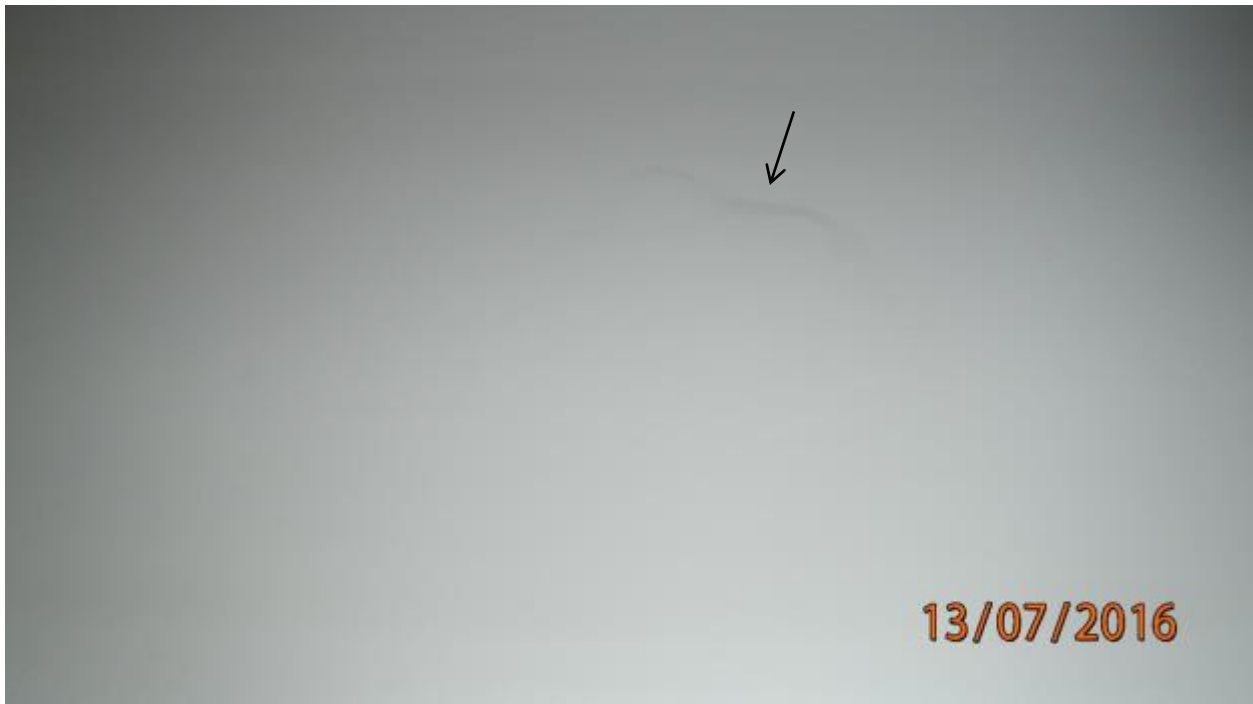
We noted a previous patch repair to the left hand side of the door opening [**Photograph 23**]

**Photograph 23** shows a previous patch repair adjacent to the door opening in Bedroom 1.

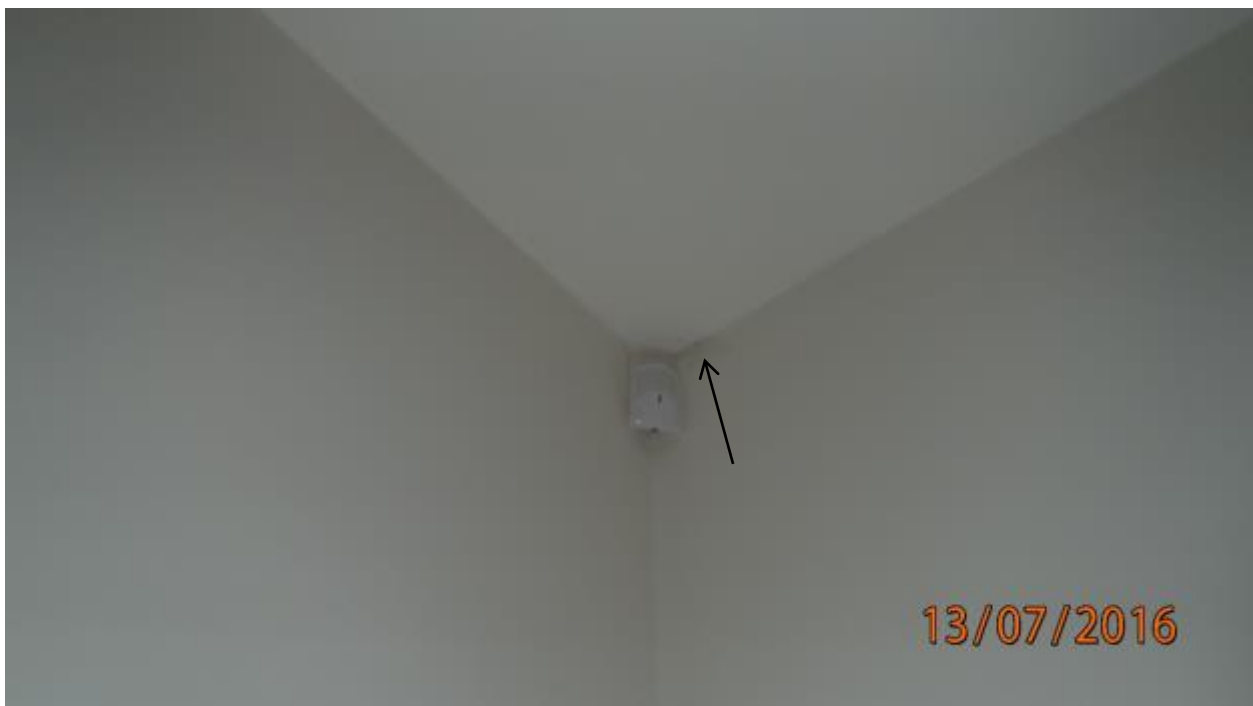
We noted a previous repair to the square set wall / ceiling junction in the northwest corner adjacent to the alarm sensor [**Photograph 24**]

**Photograph 24** shows a previous repair adjacent to the alarm sensor in Bedroom 1.
